# Northminster Multi-Storey Car Park

## Structural Review Report

## Structural Review Peterborough City Council

August 2019

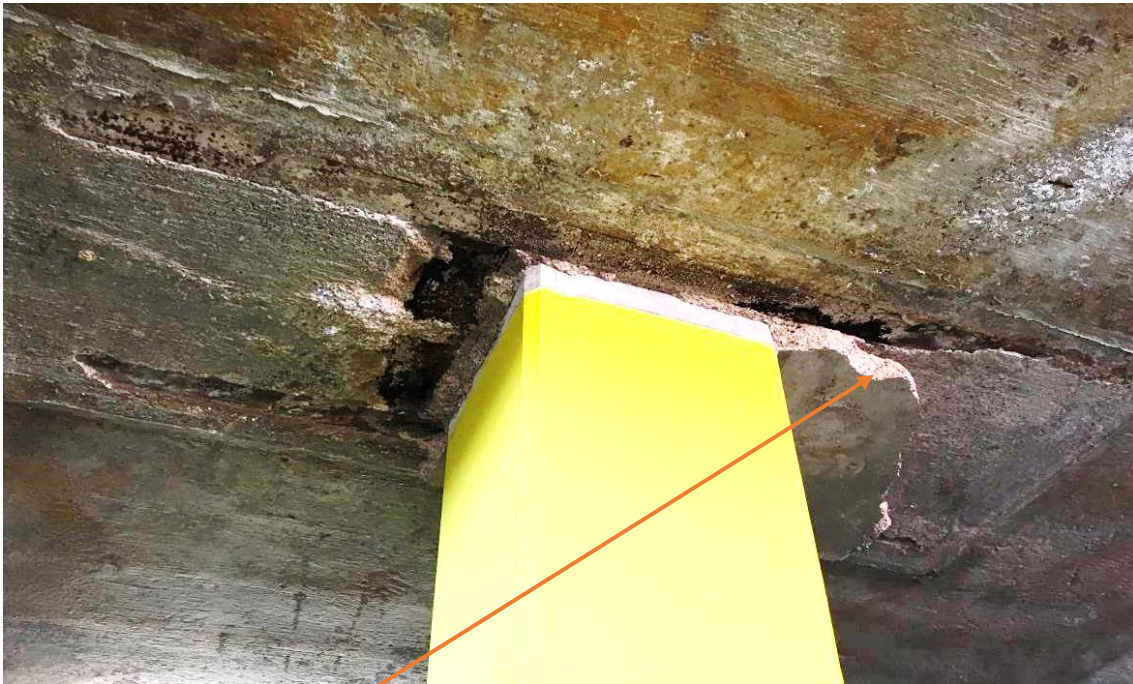
This corrosion is clearly affecting safety critical steel elements including the shear blocks and the highly stressed steel reinforcement adjacent to the connection between the slabs and columns. This corrosion has also led to the delamination of concrete directly beneath. See **figure 1**. It is worth noting that these areas are not easily inspected without carrying out localised concrete breakouts or using specialist surveying equipment. Therefore, the current condition, and potential deterioration to all the columns is currently unquantified.

*Figure 1: Spalled concrete protection around column exposing corroded steel collar.*

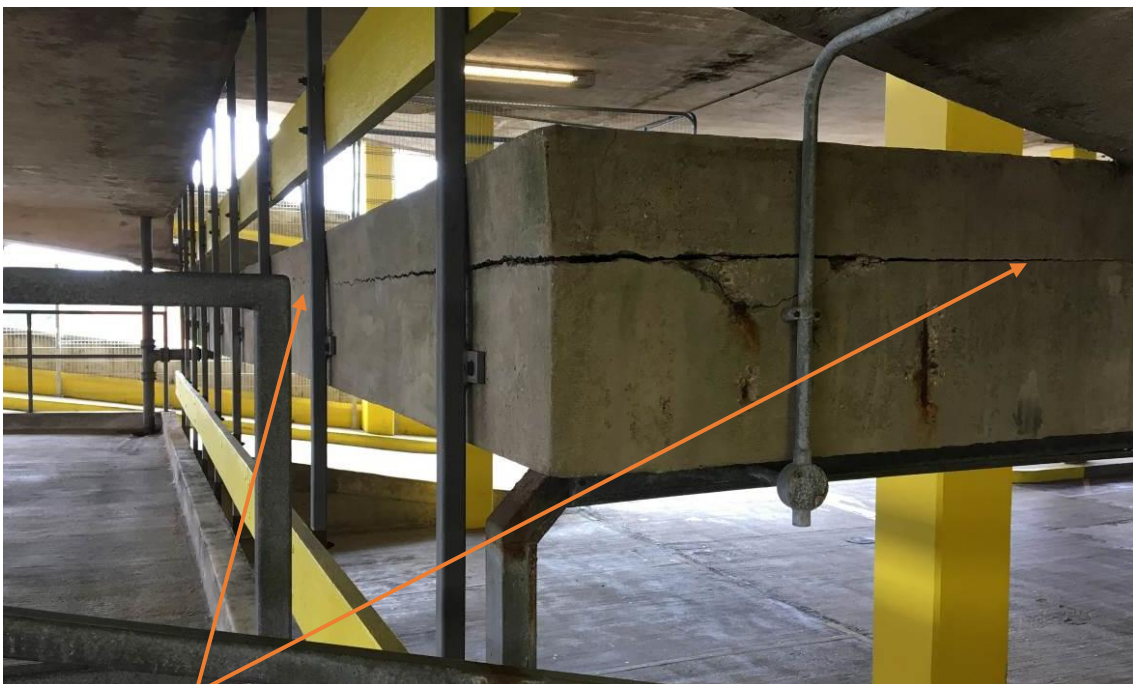
*Figure 2: Horizontal cracking (<12mm wide) along the edge of the deck between deck and upstand. Deck has noticeable deflected at the corner.*

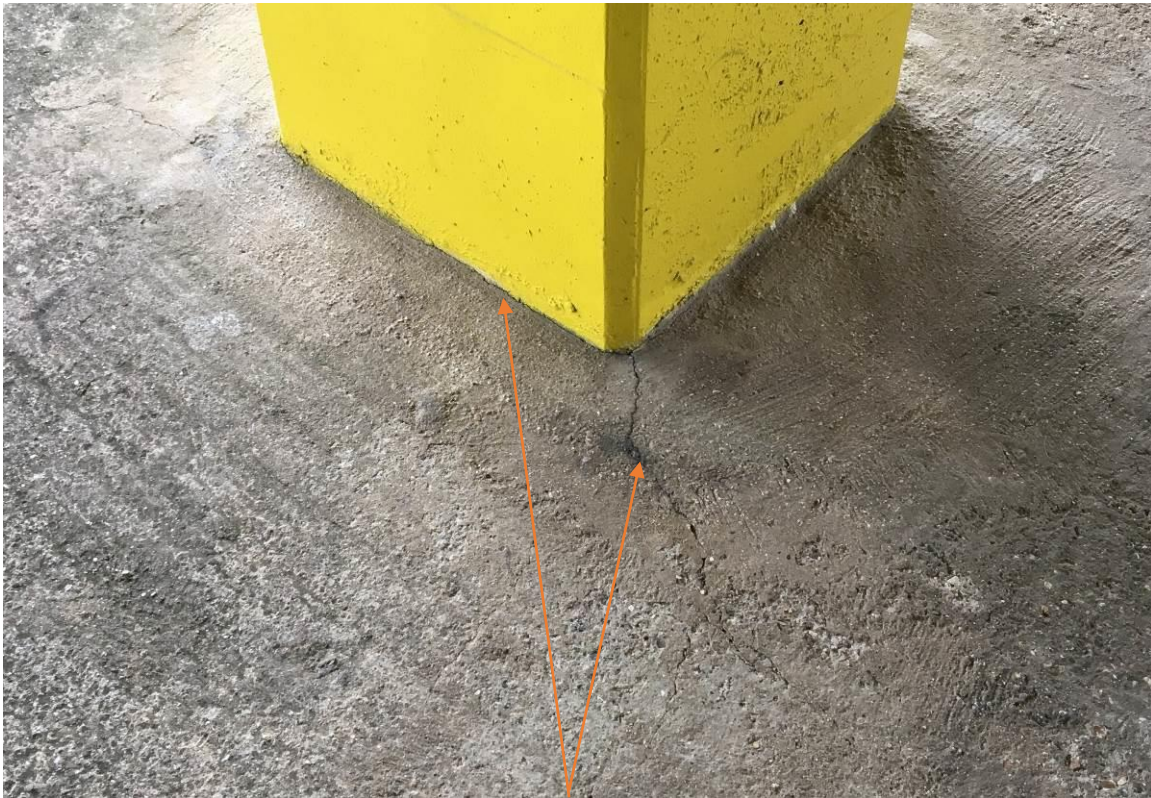
- There is radial cracking emanating from all columns and circumference cracking around some columns which appears to reflect patterns similar to that of a punching shear failure. These cracks appears to be a longstanding defects, however there is evidence of more recent deterioration with the appearance of fresh cracking through recent concrete repairs. See **figure 3**.

Figure 3: Fresh cracking through repair material around base of column, crack <2mm wide.

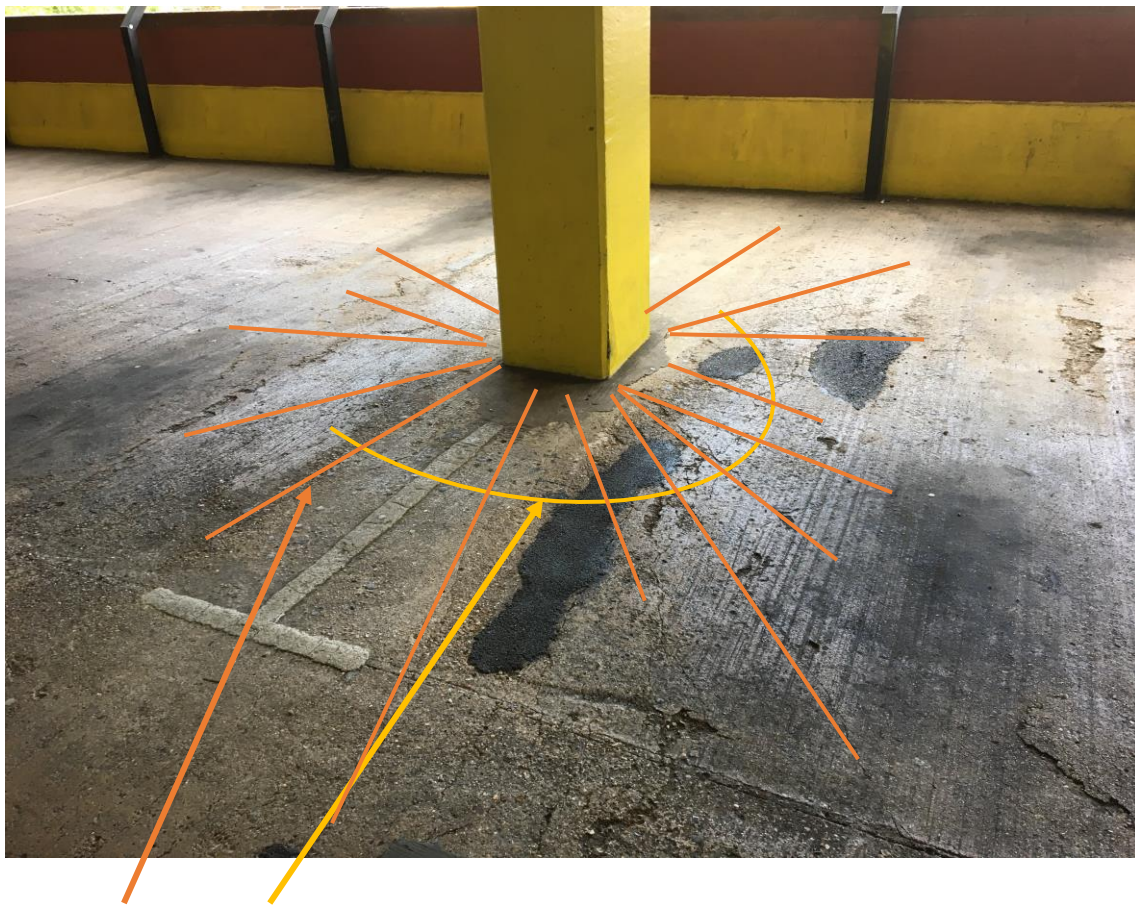
Figure 4: Radial and Circumference cracking around the base of a column on lower level.

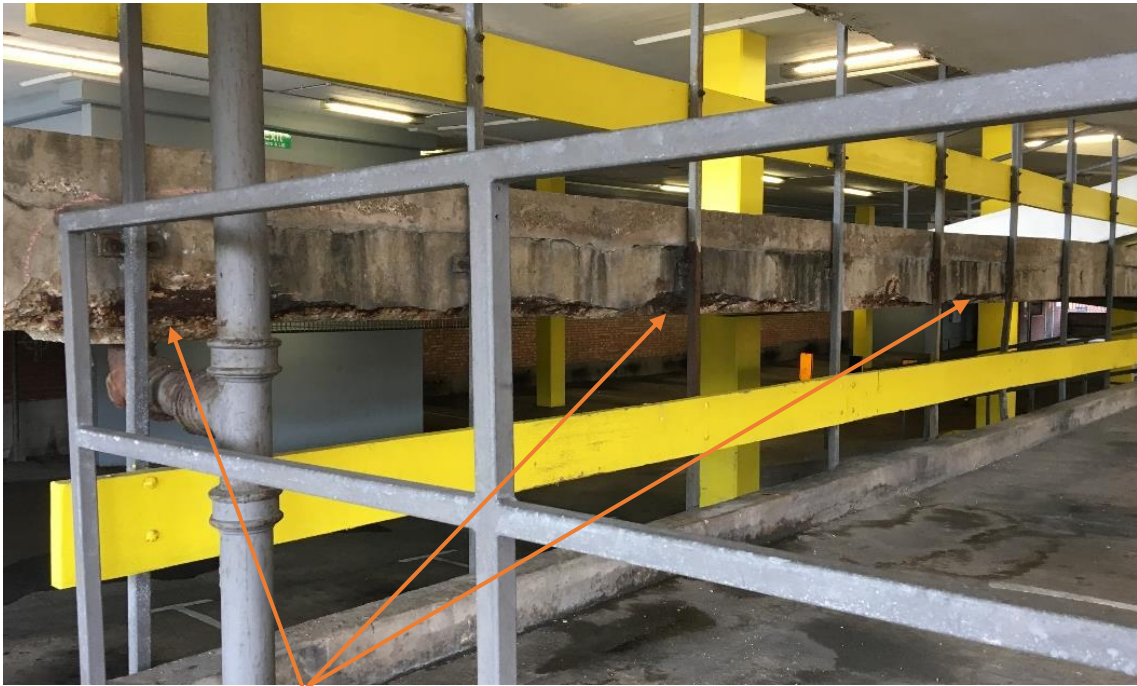
*Figure 5: Spalling to concrete exposing corroded reinforcement bars at edge of deck.*

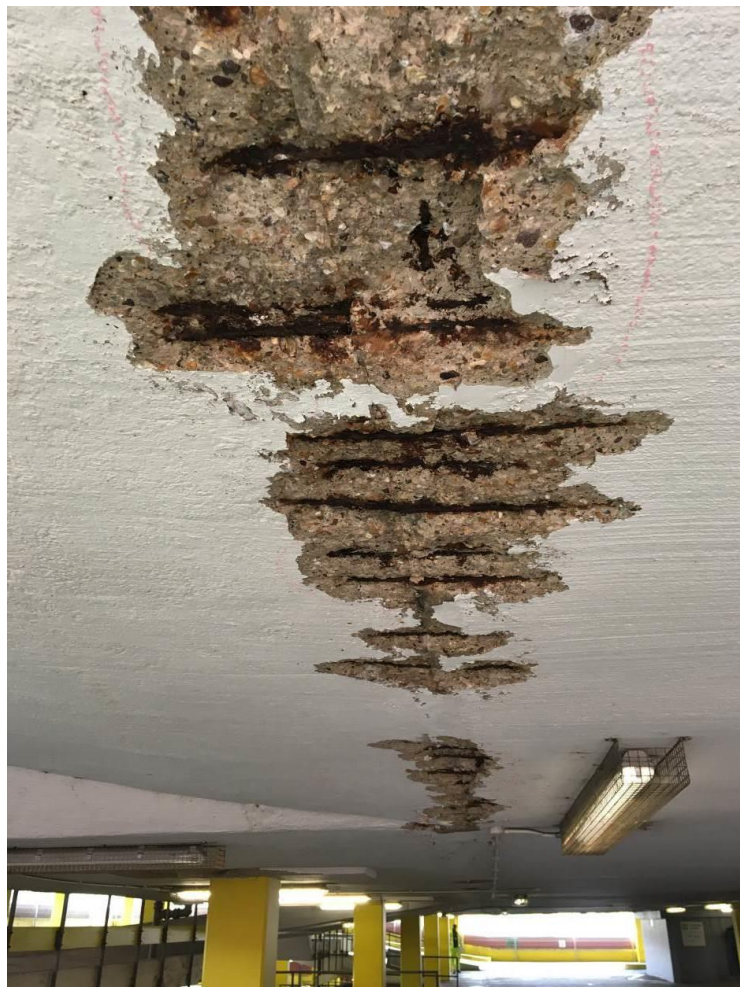
*Figure 6: Multiple areas of spalling to soffit throughout car park, exposing corroded reinforcement bars.*
