A	Amendments for tender		
Rev	Description	Drawn By	Date
Client:	Shaftesbury Town Hall	Drawn By:	SF
Dwg Title:	North & West Elevations	Checked By:	BW
Project:	Shaftesbury Town Hall, High Street, Shaftesbury, Dorset.	Scale	1:50
		Date:	27/3/23
Job No.:	5131	Dwg No.:	W05
		Revision:	A

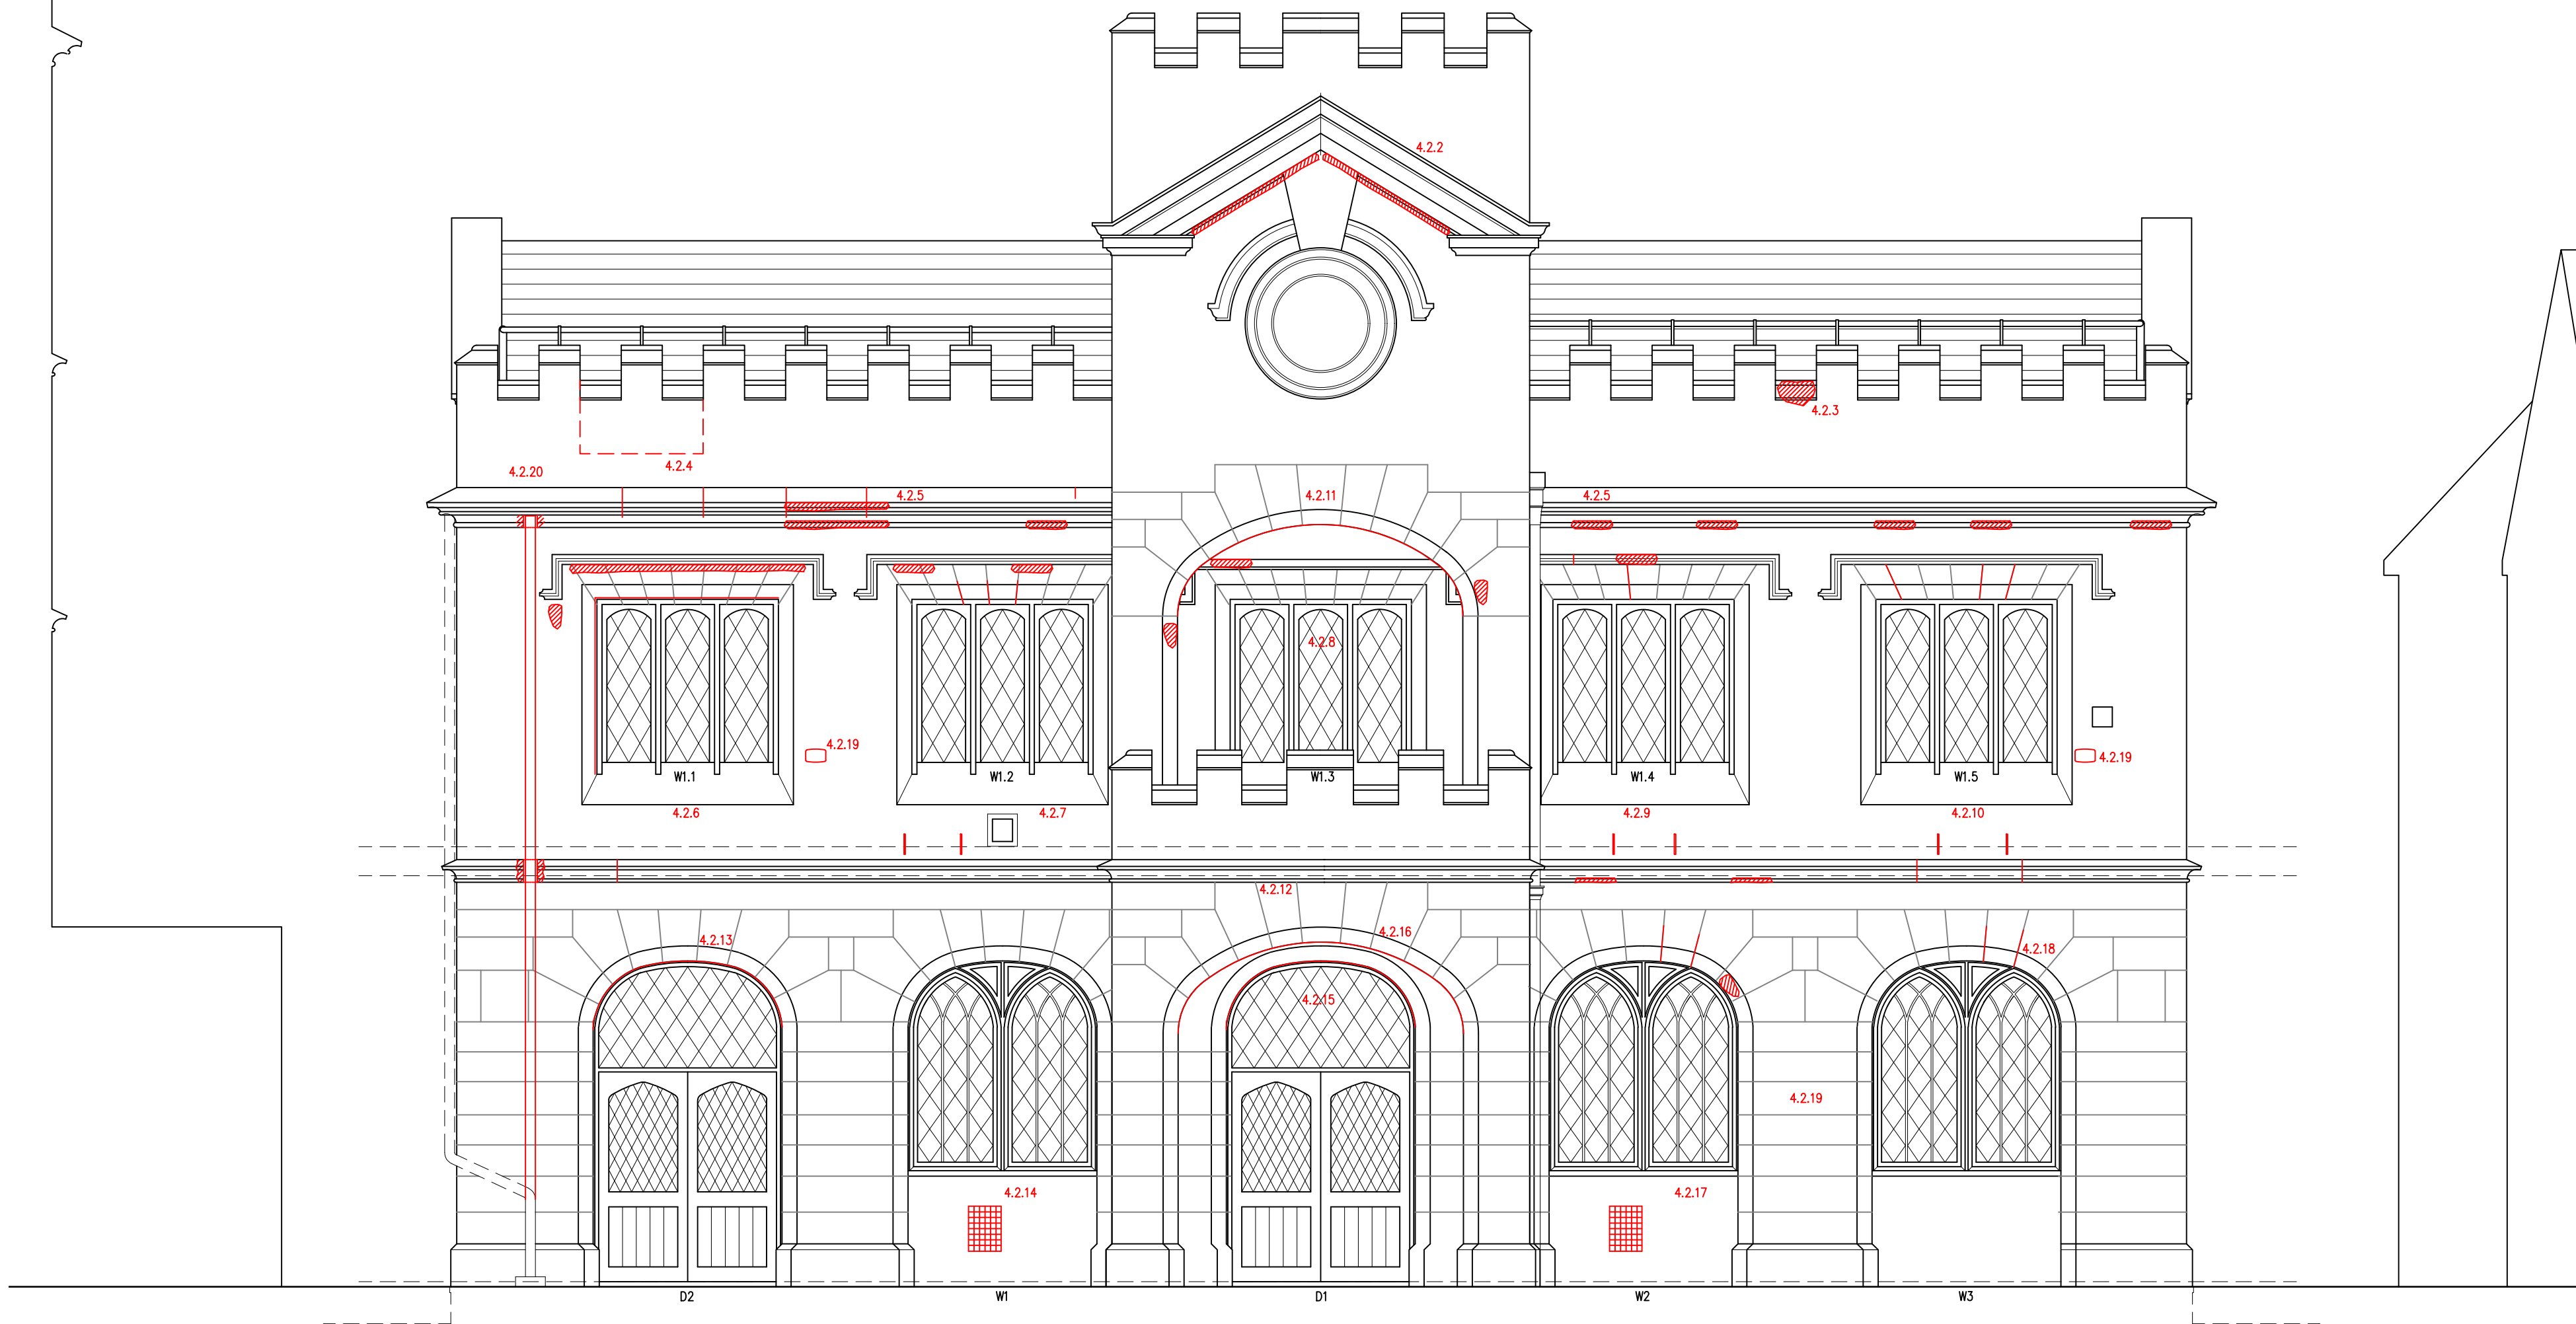
North Elevation

Walls are constructed of Shaftesbury greensand and Chilmark Ashlar stone. There is a large profile string mould at first floor level and projecting cornice at eaves with deep weathered top surface. Stonework to lower ground level has a chamfered offset which forms a plinth to the front (North).

- 3.1 Remove existing plastic wrap and fittings from the NE corner of the building. Re-configure the chute through the North parapet and line with lead, including overflow detail to match those of the south elevation. Fit new hopper and round cast iron downpipe to match existing passing through the cornice and string courses as described below, and attach to the existing section of cast iron pipe below (ie straight drop mounted on the North elevation). See specification section R10.

- 4.2.1 Re-point open joints to the west side of the clock tower as marked on PWCR stone repair drawings and detailed in section C41 of this specification, and replace the missing slate louvre from the vent.

- 4.2.2 Allow to gently brush off minor scaling to the pediment of the clock tower to remove loose material.

- 4.2.3 Pin and epoxy fix sheered section of stone to (inside face) of merlon and mortar repair as section C41.

- 4.2.4 Carefully re-align the parapet stone to the East of the clock tower (where the flagpole was previously fitted) and re-pointed in its new position.

- 4.2.5 Remove moss and vegetation as described in 4.1 above, and gently brush off exfoliation and scaling to the underside moulding of the cornice. Point open joints to the cornice, (allow to fully re-point 10 no joints to this elevation).

- 4.2.6 Remove moss to the hood mould over W1.1 and gently brush off exfoliation and scaling to the underside of the moulding. Using hand tools, rake out defective mortar from the East jamb of the window and over the window head. Repair the lost face of stone using mortar repairs (Chilmark stone colour match to be agreed). Repair the stone moulding beneath the hood and two number damaged voussiors at the RH end of the window using mortar repair as C41. Re-align where possible, pin and point open joints to the flat arched head. Note blistering beneath the hood moulding on the LHS of the window is to be carefully removed, and revealed stone re-faced.

- 4.2.7 Remove moss to the hood mould over W1.2 and gently brush off exfoliation and scaling to the underside of the moulding. Repair the fine stone moulding beneath the hood and one number damaged voussior using mortar repair as C41. Re-align where possible, pin and point open joints to the flat arched head. Make good damage to weathered window sill. Remove the redundant heater flue beneath the window, and block the opening using Chilmark stone facing to match existing.

- 4.2.8 Gently brush off window surround and hood mould to remove exfoliation. Using hand tools remove defective mortar repairs from arched head. Piece in missing detail from hood mould and repair two damaged voussiors using mortar repair as C41.

- 4.2.9 Remove moss to the hood mould over W1.4 and gently brush off exfoliation and scaling to the underside of the moulding. Re-point 2 open joints. Cut out failed section of hood mould and replace with new piece of Chilmark stone as C41. Pin the small fractured section of voussior and re-point. Re-align where possible, pin and point open joints to the flat arched head.

- 4.2.10 Remove moss to the hood mould over W1.5 and gently brush off exfoliation and scaling to the underside of the moulding. Re-point 4 open joints, and repair the hood mould section lost to erosion using mortar repairs as C41. Pin the fractured section of voussior and re-point. Re-align where possible, pin and point open joints to the flat arched head.

- 4.2.11 Carefully remove the ferrous metal strap beneath the clock tower arch, and fit a new stainless steel strap to match the existing profile. Bed and fix back into the arch to replicate the existing fixings but using stainless steel. Pin the fractured stone to the RH (west) end of the arch blown by the existing resting fixings, and make good with mortar repairs to match the (greensand) stone surrounding.

- 4.2.12 Gently brush off string course to remove exfoliation. Infill missing detail from mould as shown on drawing and using mortar repair, and re-point (6) open joints, all as C41.

- 4.2.13 Point open joints and redundant fixing holes to the head/sill of door D2. Note that the timber beam ends are to remain.

- 4.2.14 Remove the redundant heater flue from the panel beneath W1 block the opening with cavity construction and render externally to match existing

- 4.2.15 Point open joints and redundant fixing holes to the head/sill of door D1. Note that the timber beam ends are to remain.

- 4.2.16 Clean visible sections of ferrous straps to the underside of the three arched openings to the porch. Treat metal with jonite rust converter in accordance with manufacturer's instructions and decorate to match adjacent material (colour TBA).

- 4.2.17 Remove the redundant heater flue from the panel beneath W2 block the opening with cavity construction and render externally to match existing. Point 3 open joints to voussiors and repair one ornate to arched head using (greensand) mortar repair as C41.

- 4.2.18 Point 2 open joints to voussiors to W3 as C41.

- 4.2.19 Across the North elevation allow to remove 2 no partnership security boxes, redundant metal angles (for window boxes) and fixings, 5 no redundant ironwork fittings, town council notice boards and make good fixings. Also allow to remove redundant plug holes in stone facing and repair with mortar (20 total)

- 4.2.20 Form a chute through the parapet, and holes through string course and cornice to accommodate the re-positioned downpipe to the East end of the north elevation as shown on drawings and to match the downpipe to the west of the porch.

- 4.2.21 Redecorate boxings to clock weights are located in the internal corners of the porch and balcony as M60.

- 4.2.22 Metal casement leaded lights to first floor to be repaired by Salisbury Cathedral works department as provisional sum in A54. Redecorate timber windows as M60, colour to be agreed.

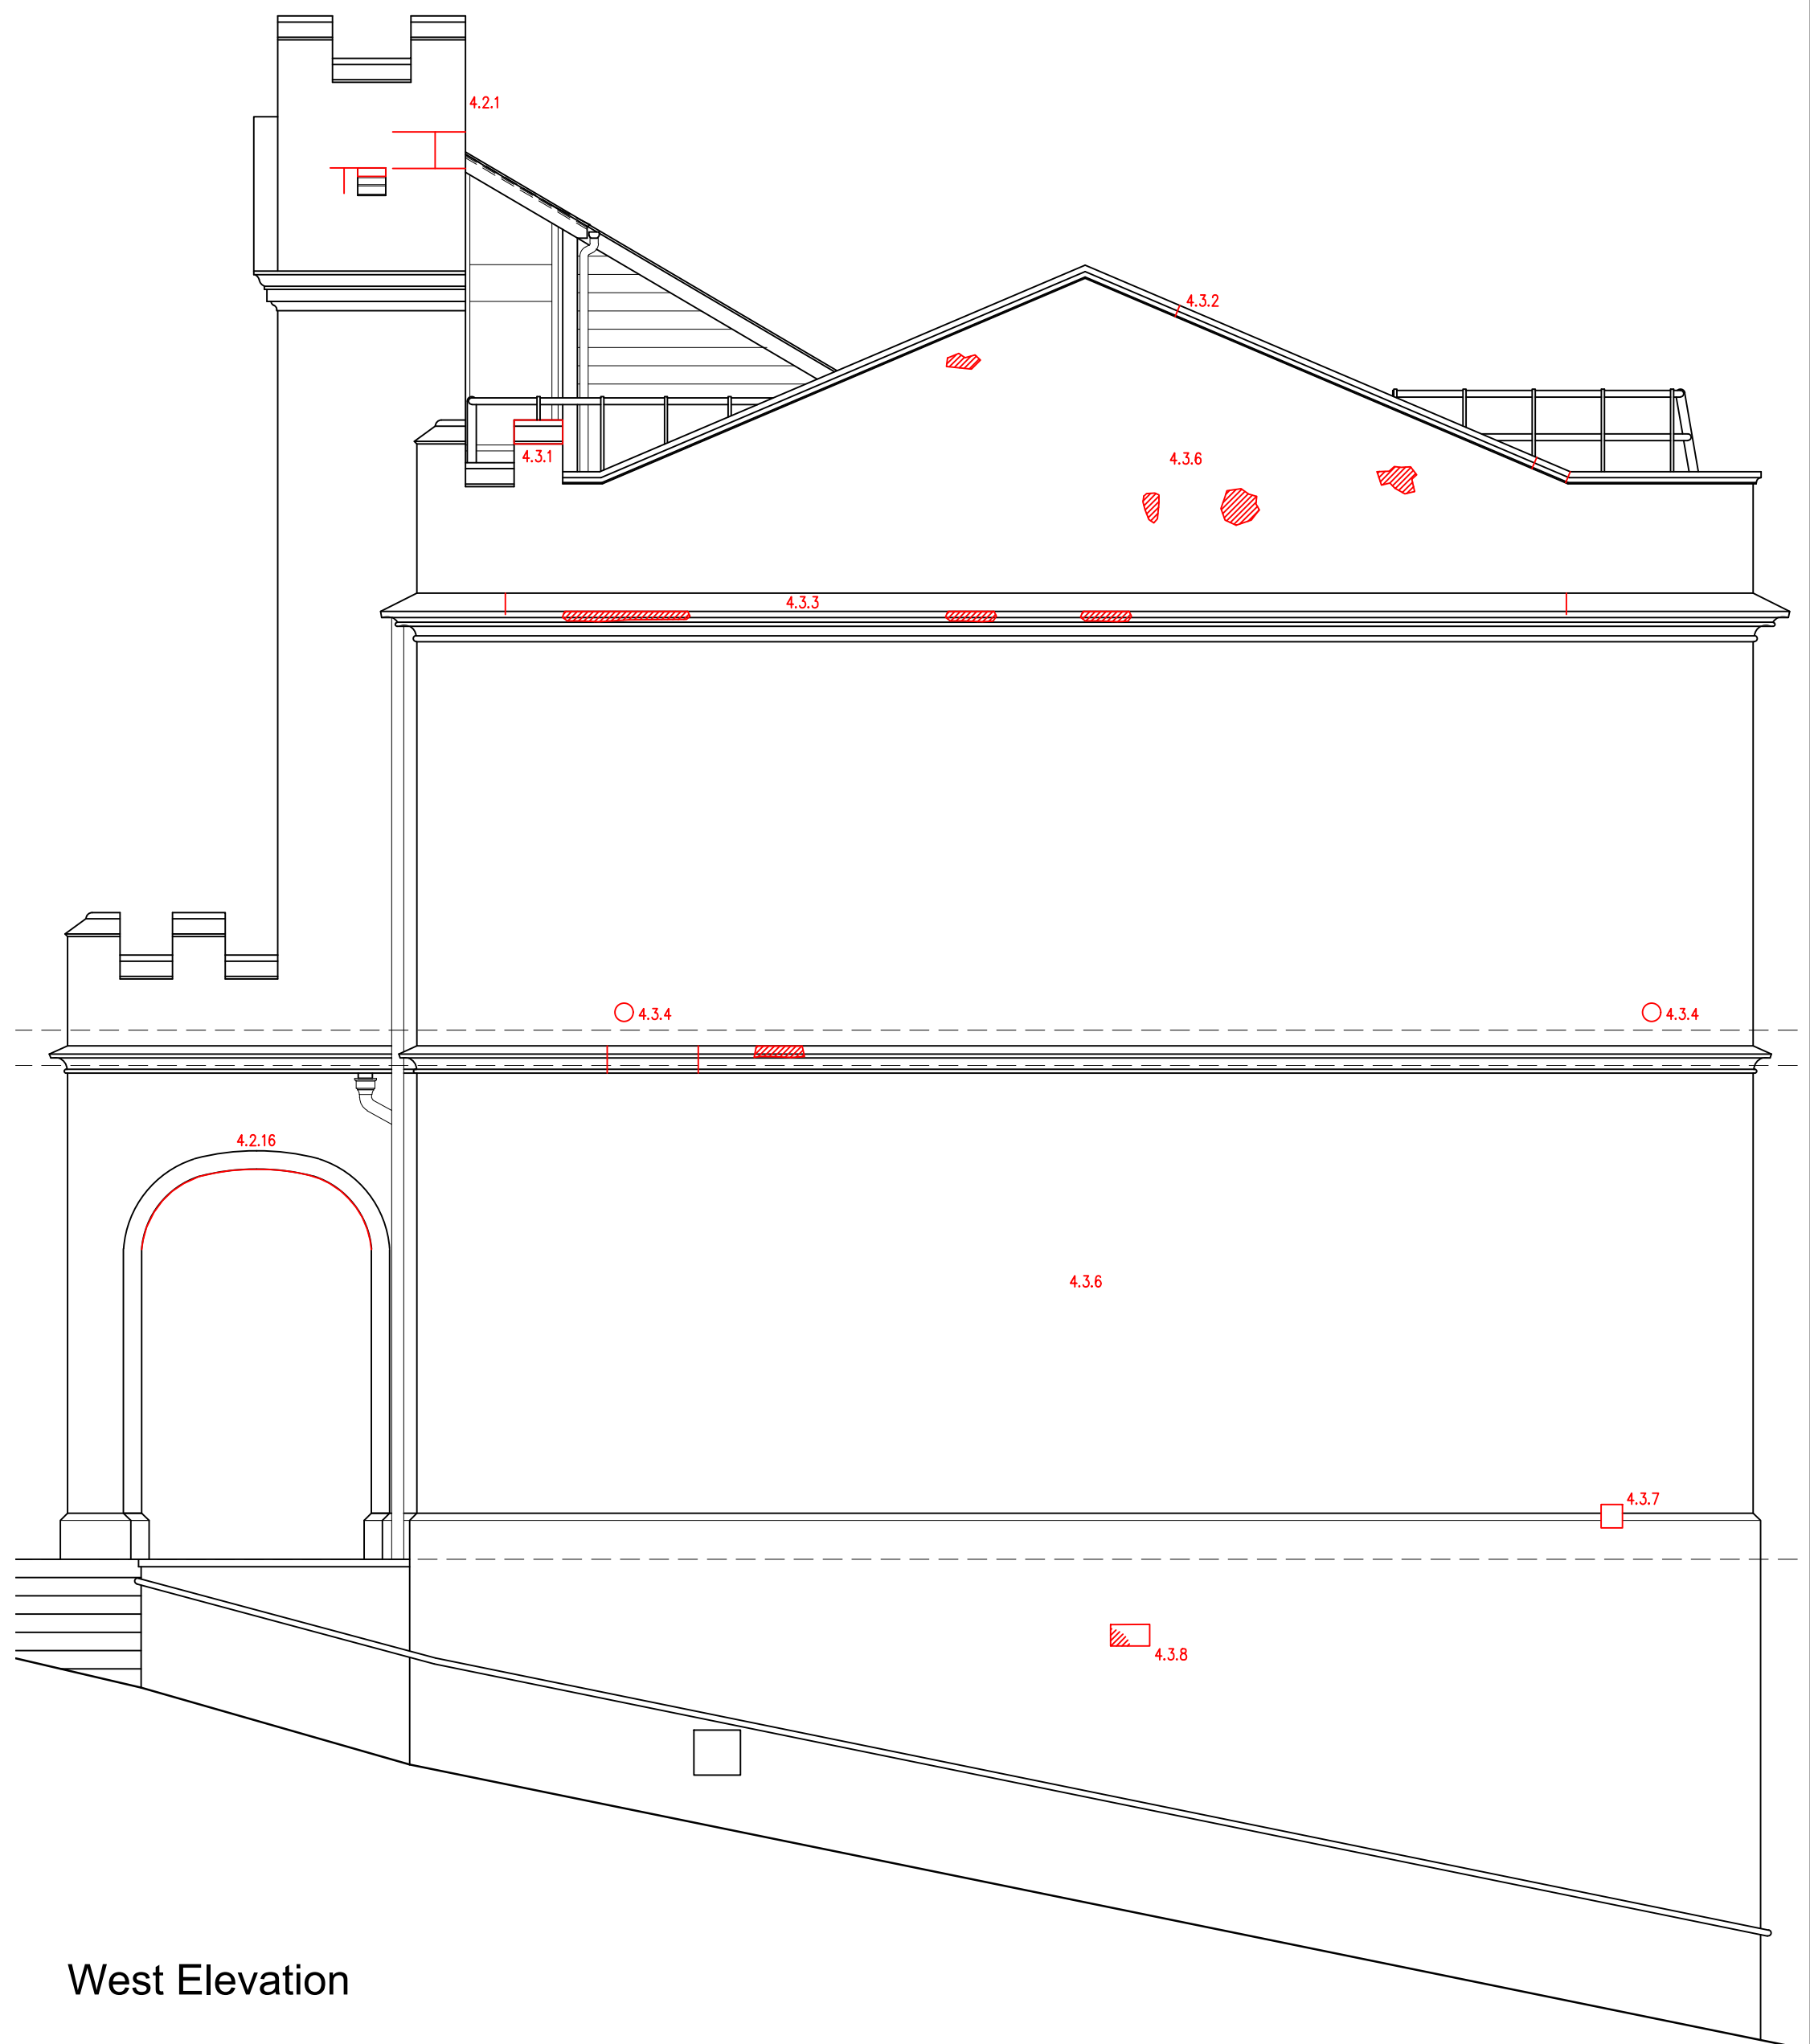
West Elevation

- 4.3.6 The whole gable elevation has a number of open joints, pitting and cavities where stone has failed in the past. Review with the architect prior to commencement, and carry out mortar repairs to prevent water ingress to these. Allow to carry out 20 such repairs to 100 x 100 x 12mm cavities within the tender price.

- 4.3.1 Allow to dowl and re-bed the missing merlon capping to the N corner (currently stored in the clock chamber).

- 4.3.2 Re-point 3 open joints to the gable parapet coping.

- 4.3.3 Remove moss and vegetation as described in 4.1 above, and gently brush off exfoliation and scaling to the underside moulding of the cornice. Point open joints to the cornice, (allow to fully re-point 4 no joints to this elevation), and repair damaged or missing moulding to sections indicated on drawings with mortar repair as described in C41.

- 4.3.4 Remove 2 redundant circular flues through the wall above string course. Cut the facing stone to accept rectangular stone infill pieces of full course depth (greensand) and patch repair, maintaining the ashlar course line through the centre of the repair. Where the repair is less than 150mm from an existing perp, allow cutting out and replacing the stone up to the perp joint. Tool face of new stones to match existing. All as C41.

- 4.3.5 Gently brush off string course to remove exfoliation. Infill missing detail from mould as shown on drawing and using mortar repair, and re-point (4) open joints, all as C41.

- 4.3.7 Remove 1 no redundant rectangular flue crossing the plinth line close to the south corner. Cut the facing stone down to the course line below, and piece in a new stone of full course depth (greensand) with top edge weathered to match the existing plinth including the plinth. Tool face to match existing. All as C41.

- 4.3.8 Allow to cut out 1 badly spalled stone below the plinth line and repair with stone replacement as C41. Tool face of stone to match existing

- 4.3.9 Decorate metal grille and handrail as specified in M60.
