16-0159 M&E

**A SUMMARY REPORT OF THE EXISTING MECHANICAL
AND ELECTRICAL BUILDING SERVICES**

NEVILLE HOUSE

CORBY

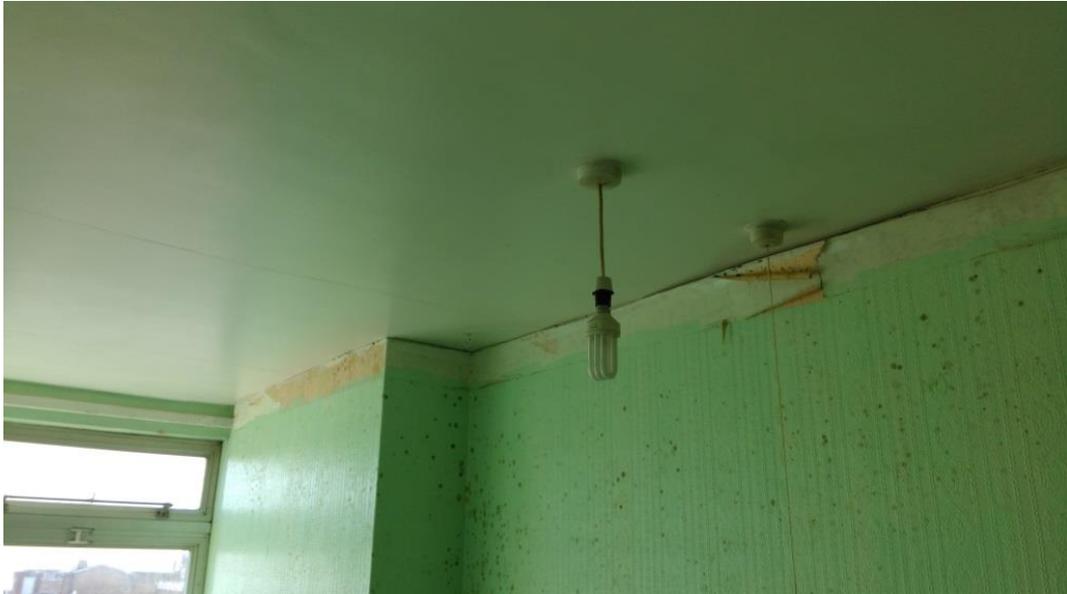
Figure 1. Flat 12 – Lighting and local pull cord.

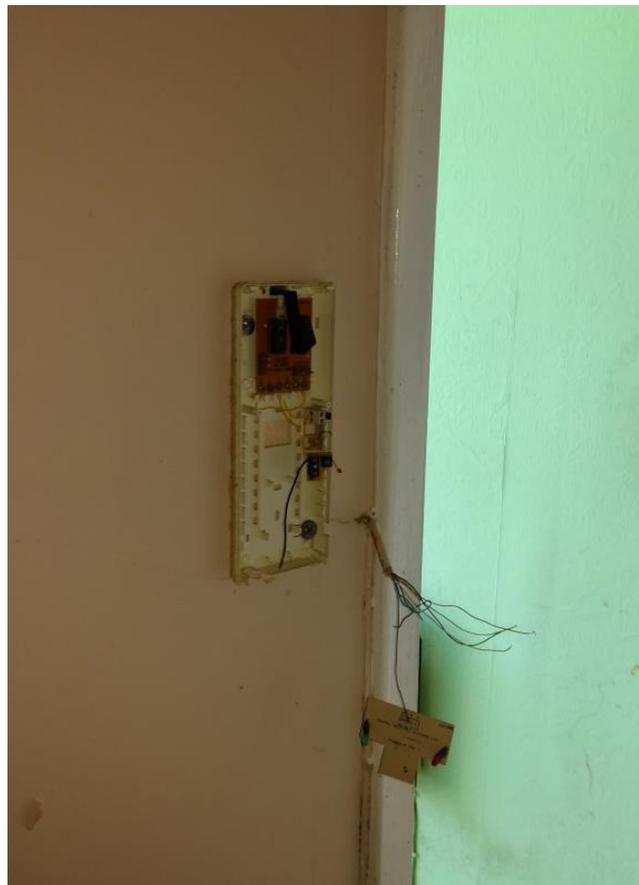
Figure 2. Flat 12 - Access control.

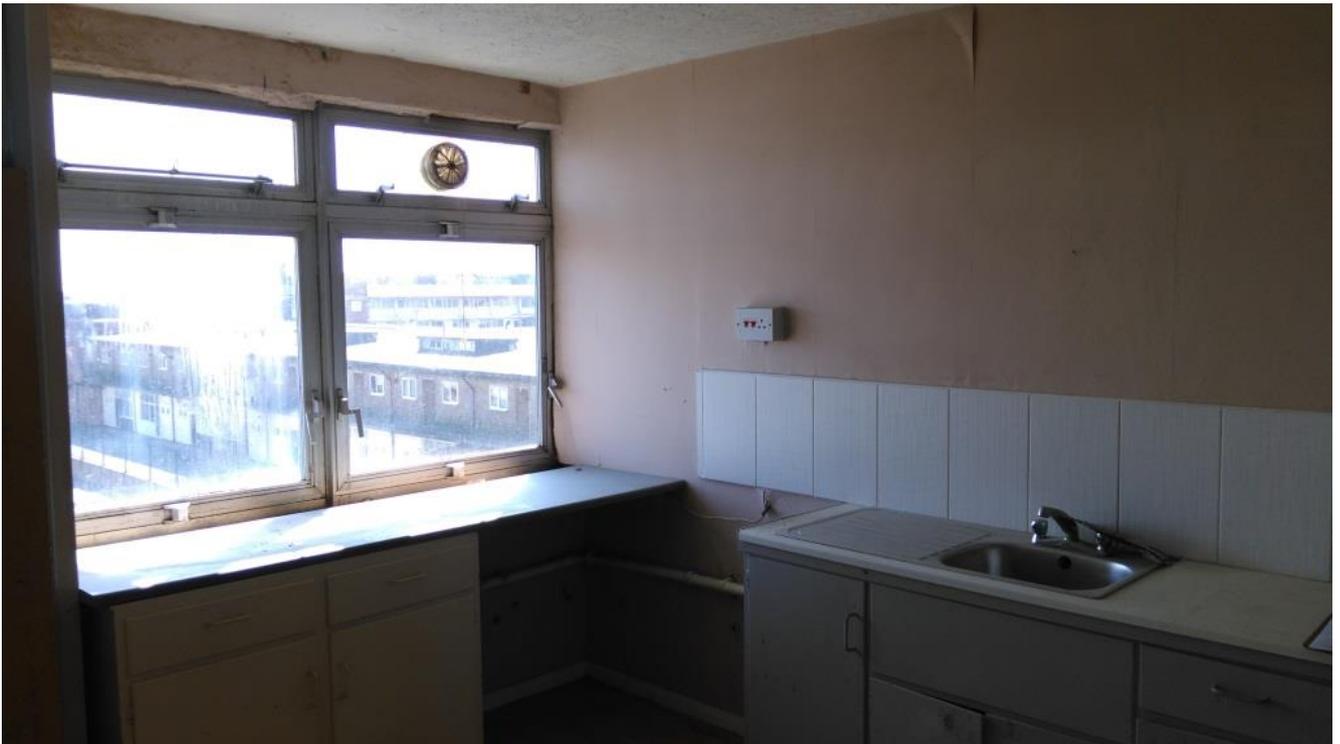
Figure 3. Flat 12 - Kitchen area with local in glass ventilator.

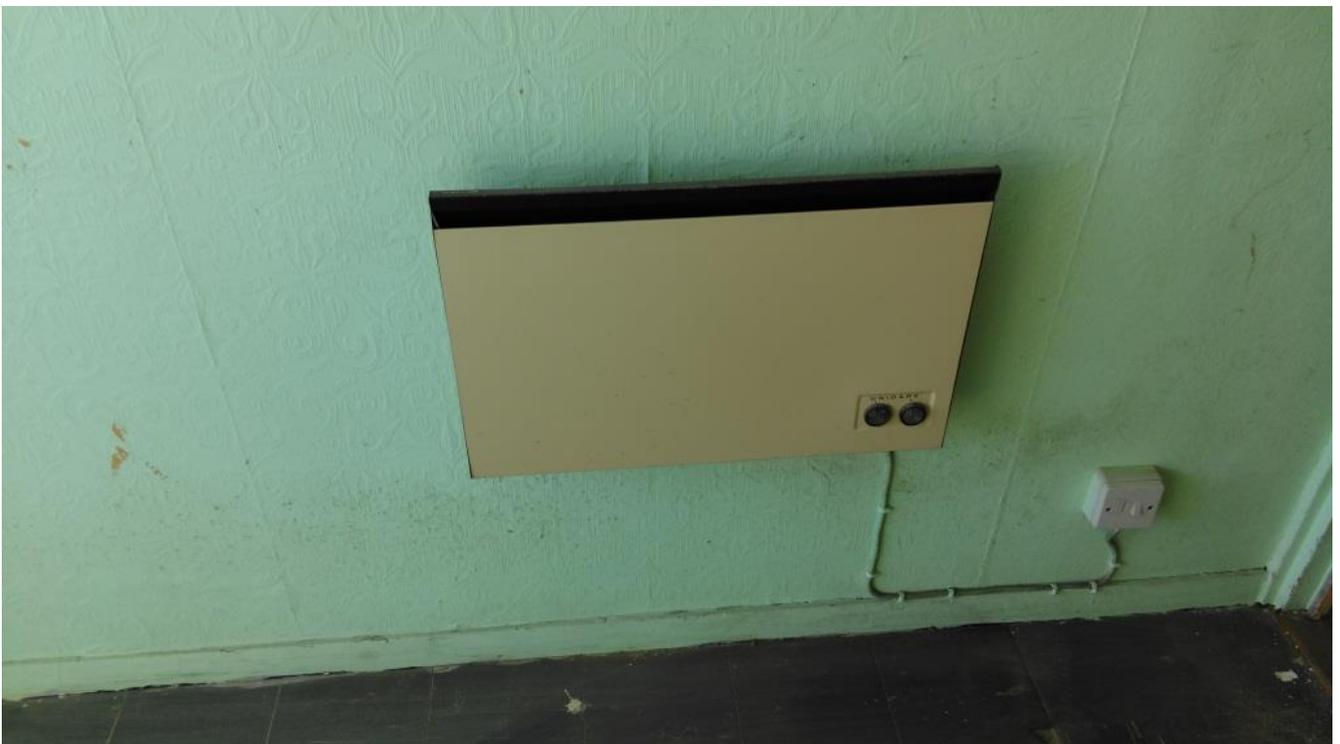
Figure 4. Flat 12 - Existing electric panel heater.

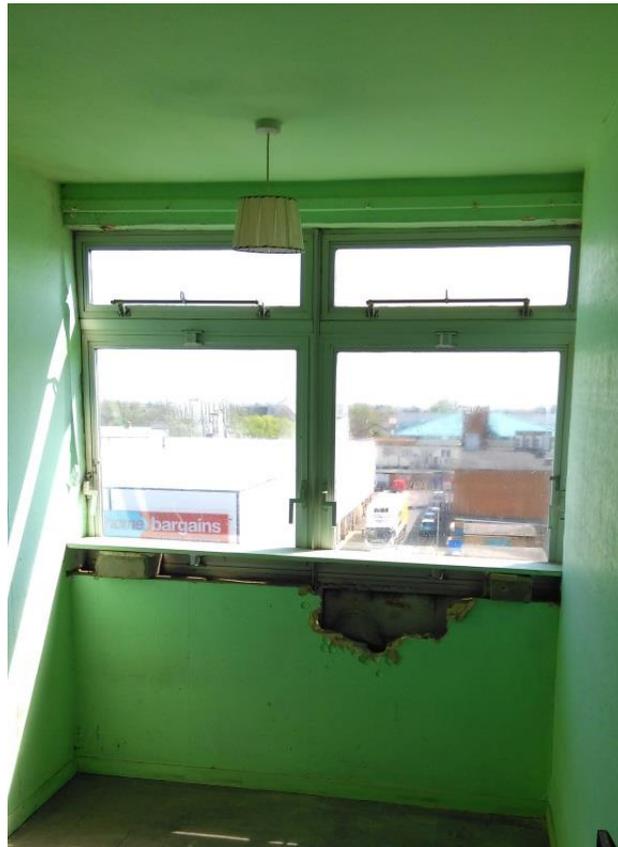
Figure 5. Flat 12 – Lighting & condition of building fabric.

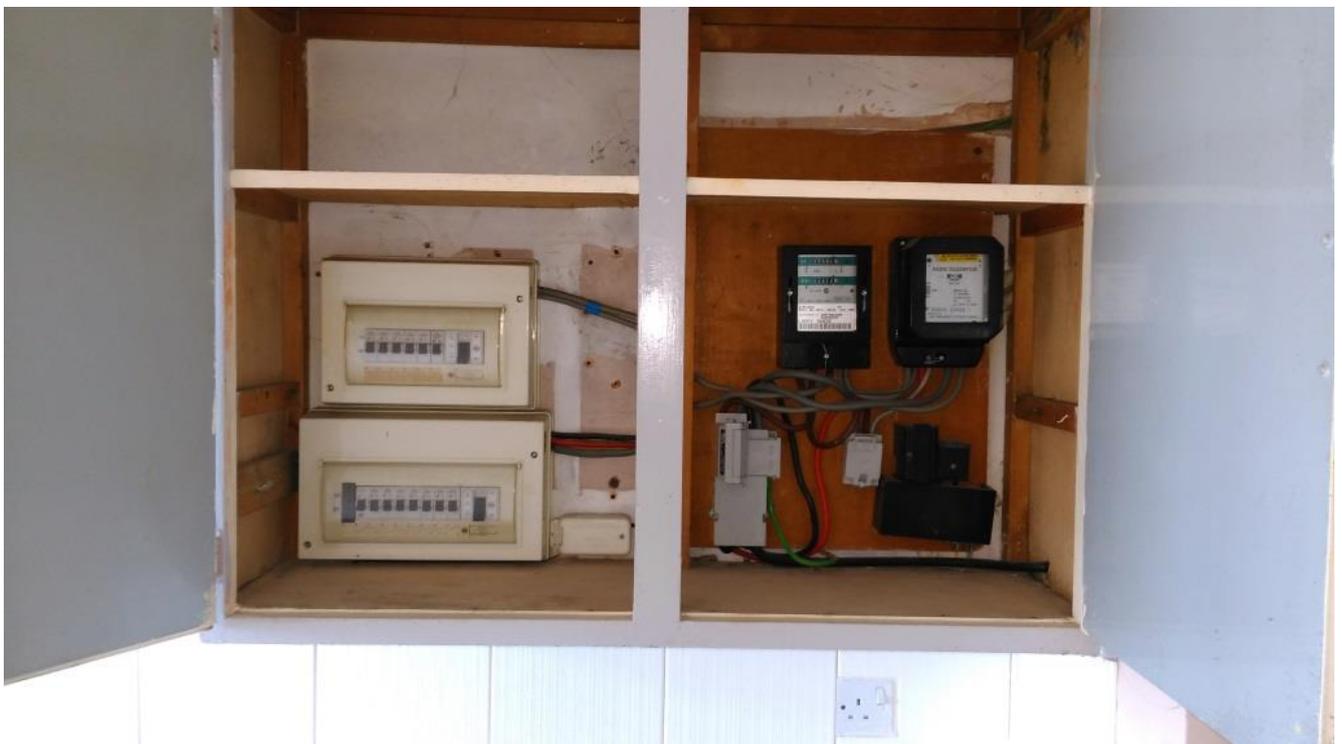
Figure 6. Flat 12 – Incoming electrical supply & local metering.

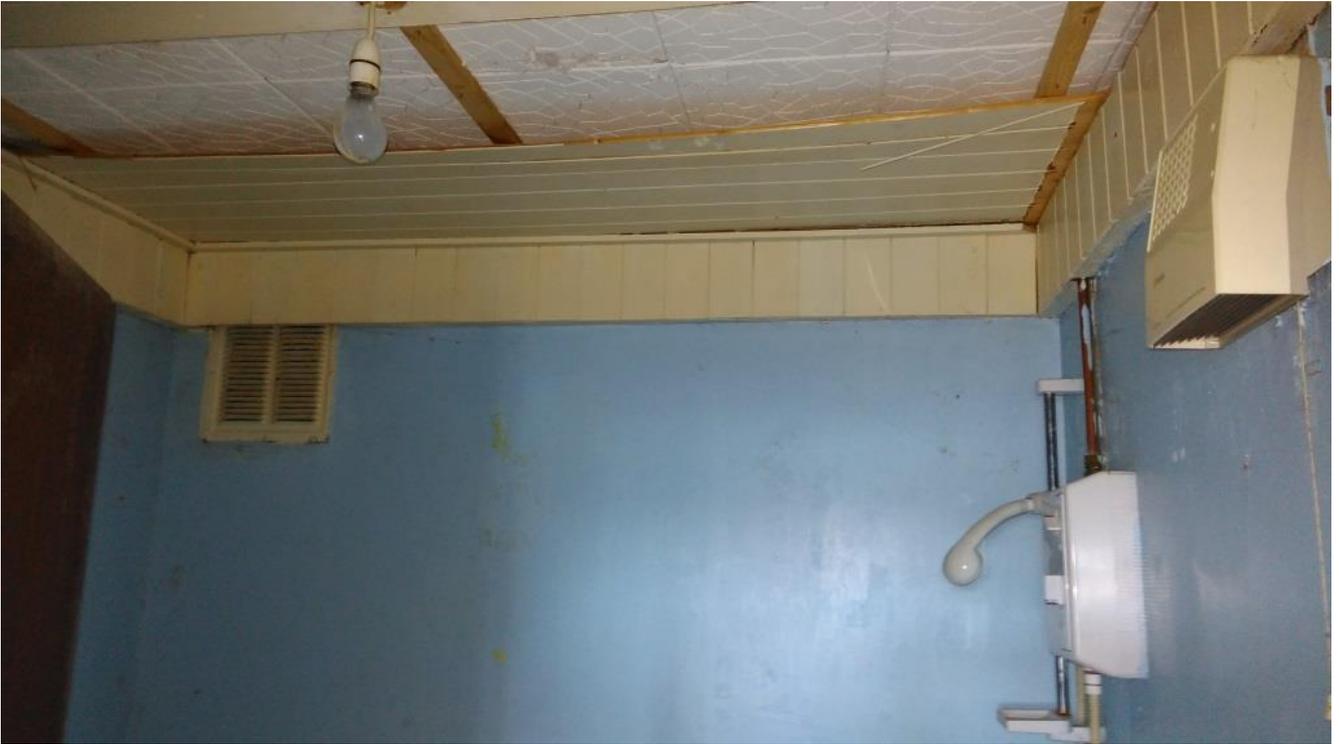
Figure 7. Flat 12 – Bathroom area lighting, ventilation and high level heater.

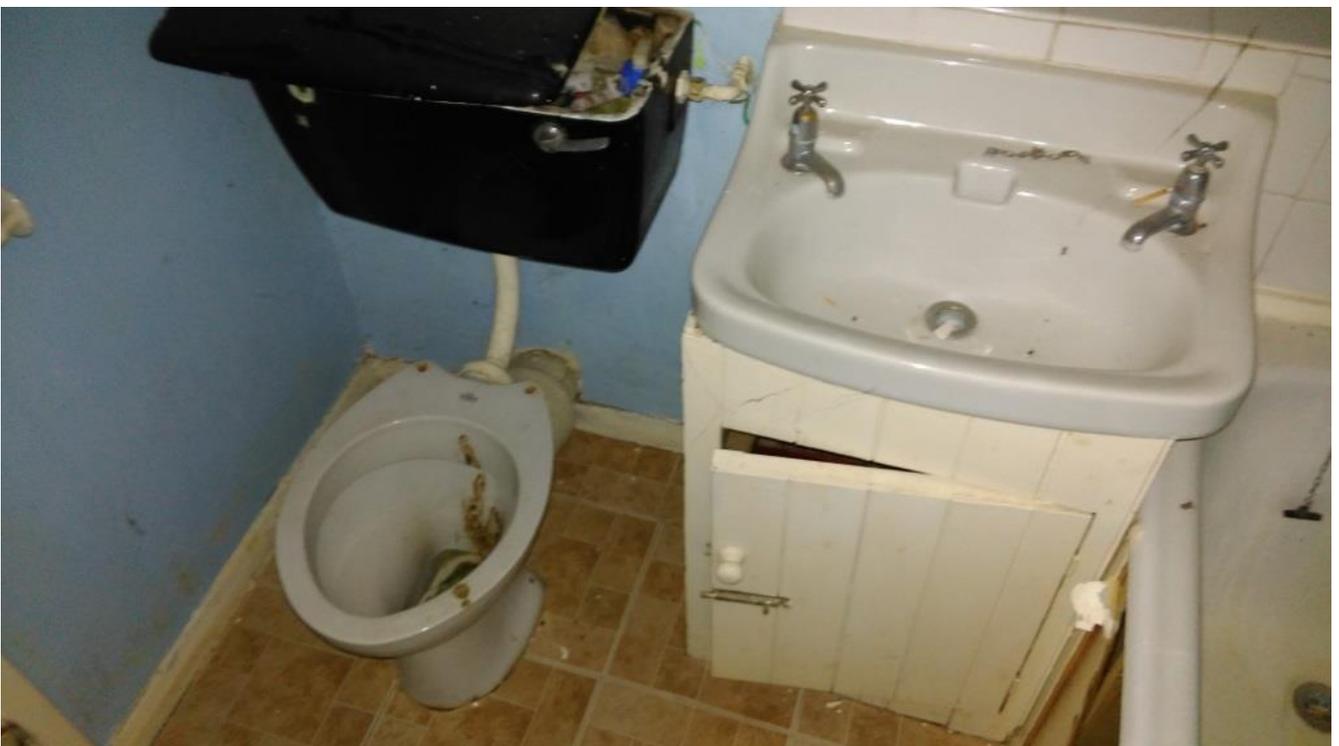
Very little of the above ground drainage system is visible, however those areas that are visible appear generally in a poor condition along with the sanitary fittings which are also in a poor condition. We recommend a complete fit out of these areas due to the age and condition they are currently in.

Figure 8. Flat 12 – Bathroom sanitary ware condition.

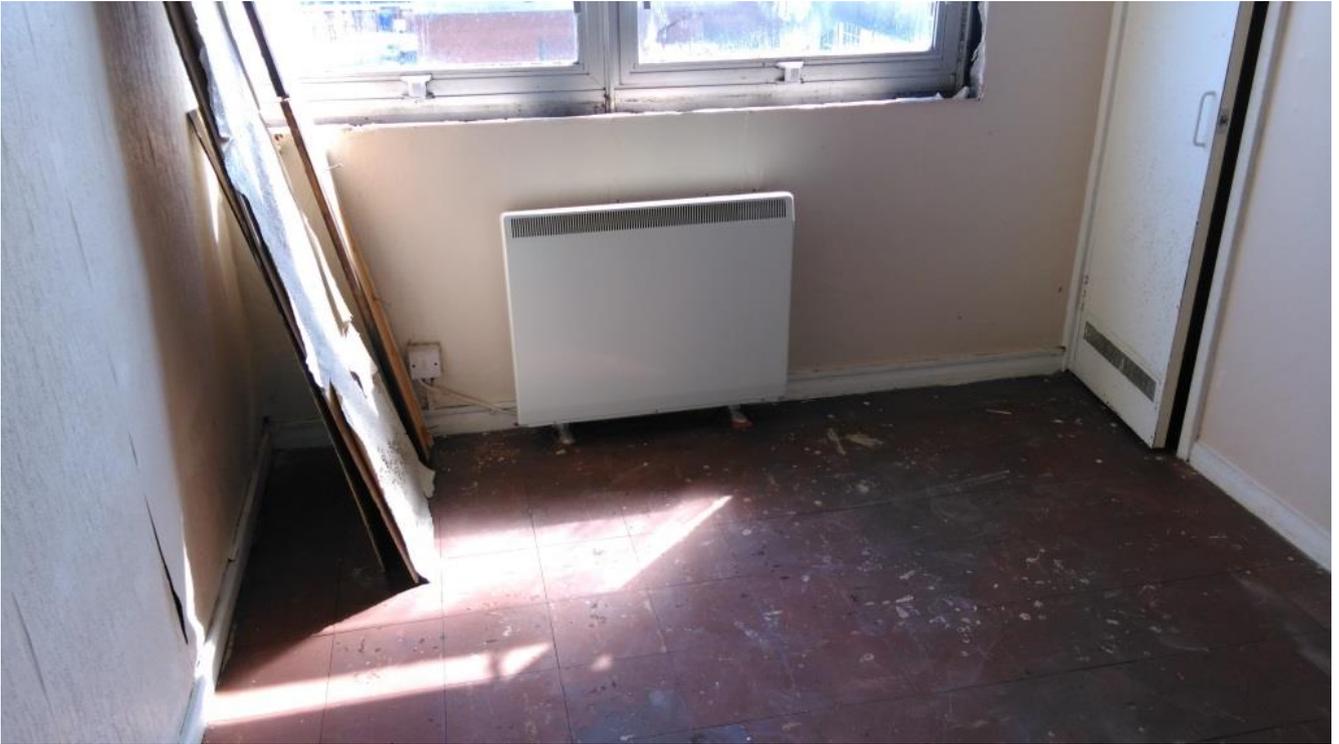
Figure 9. Flat 12 – Electric storage heater

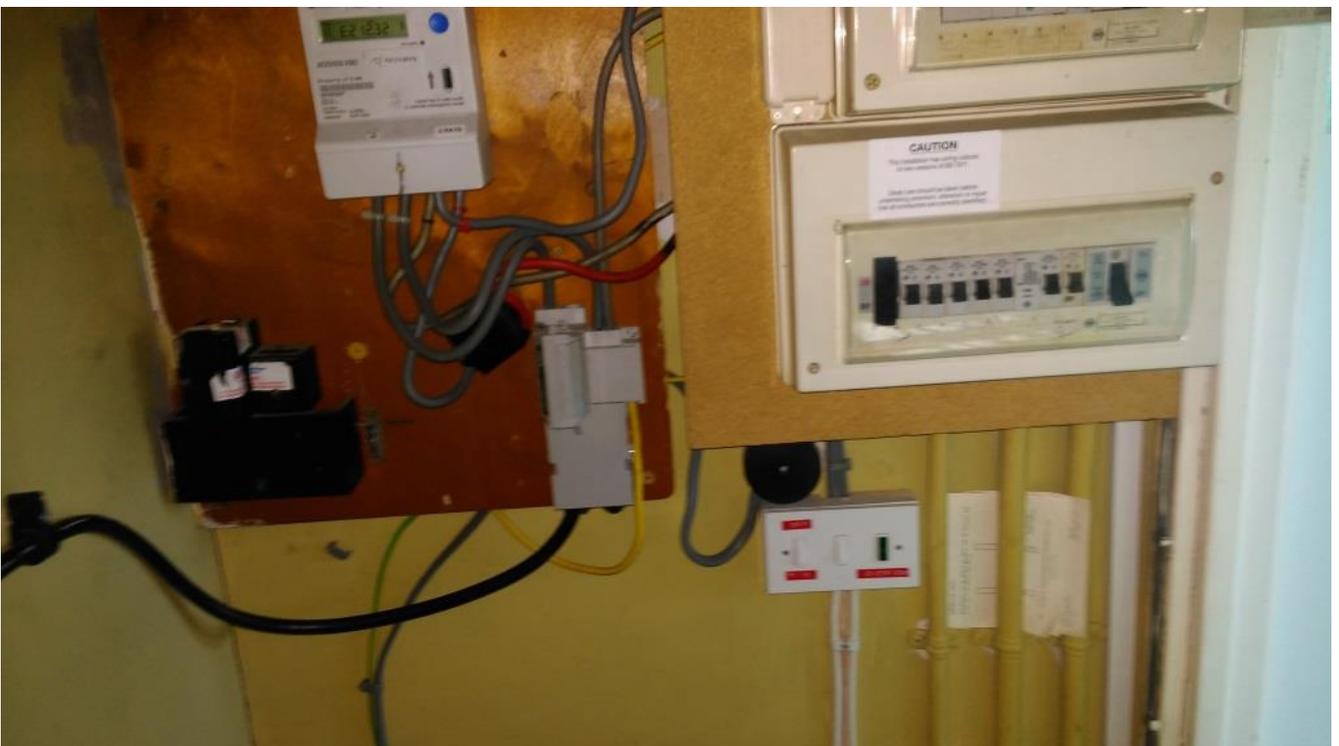
Figure 10. Flat 10 – Incoming electrical supply & local metering.

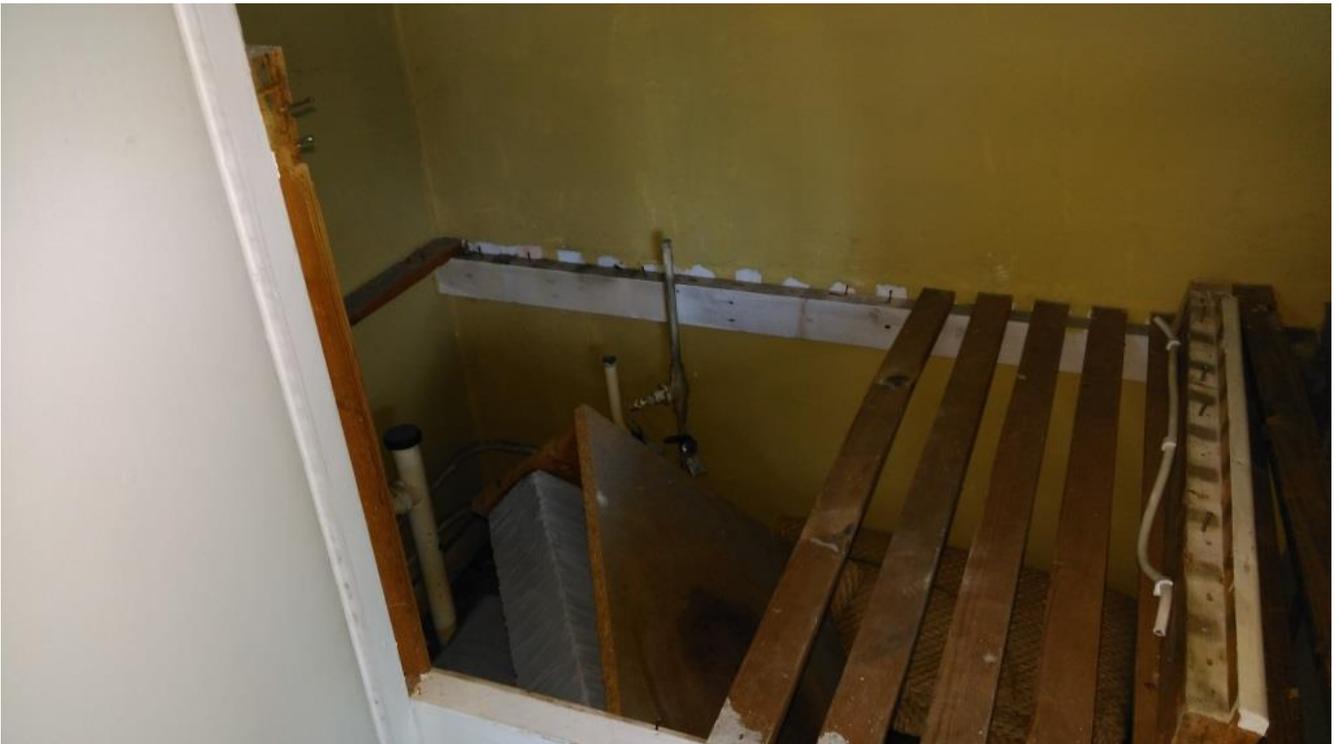
Hot water was originally generated by the use of an electric emersion cylinder which was located in purpose built cupboard in each of the flats. This has since been removed with local pipework services isolated. Hot water services pipework appears to be installed to serve each flat via just a flow system with no form of trace heating installed.

Figure 11. Flat 10 – Domestic hot water cylinder removed.

We recommend a new hot water system to serve the kitchen and bathroom areas to be installed to each of the flats, as currently hot water cannot be generated for an occupant due the existing system has been removed.

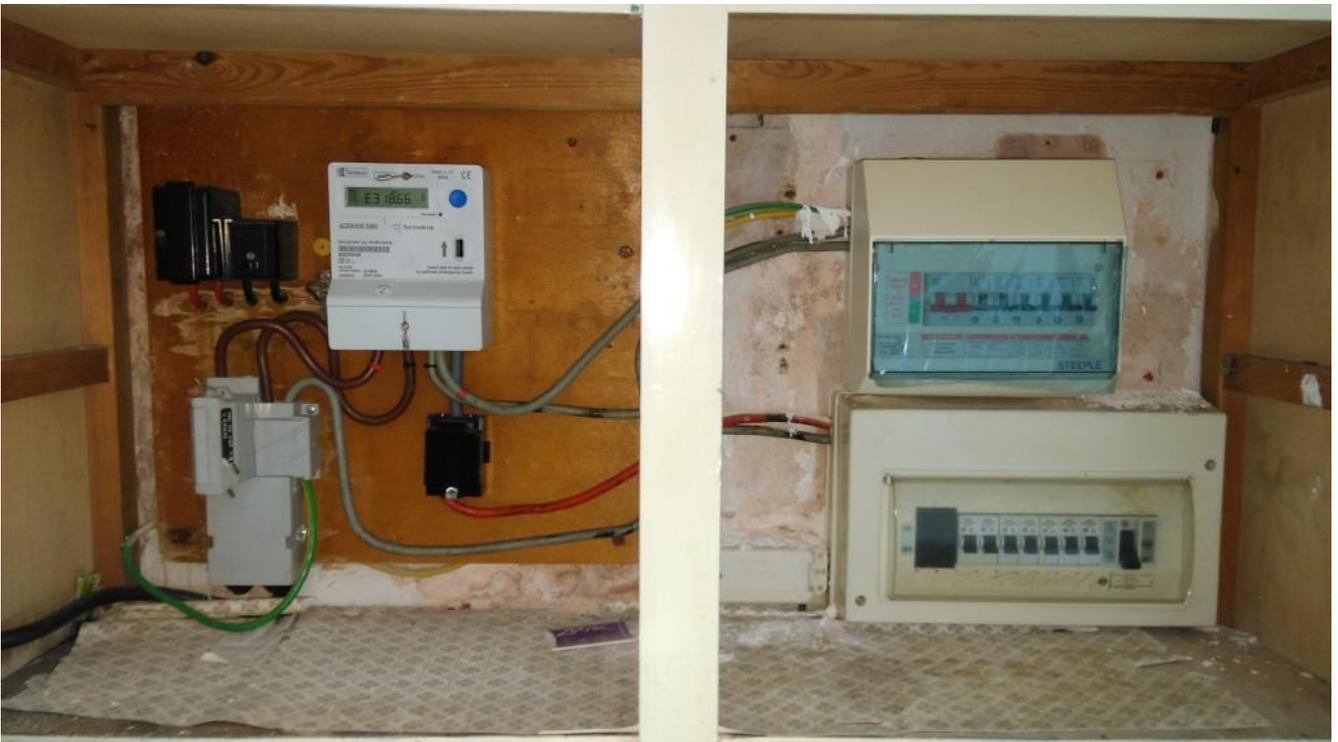
Figure 12. Flat 1 – Incoming electrical supply & local metering.

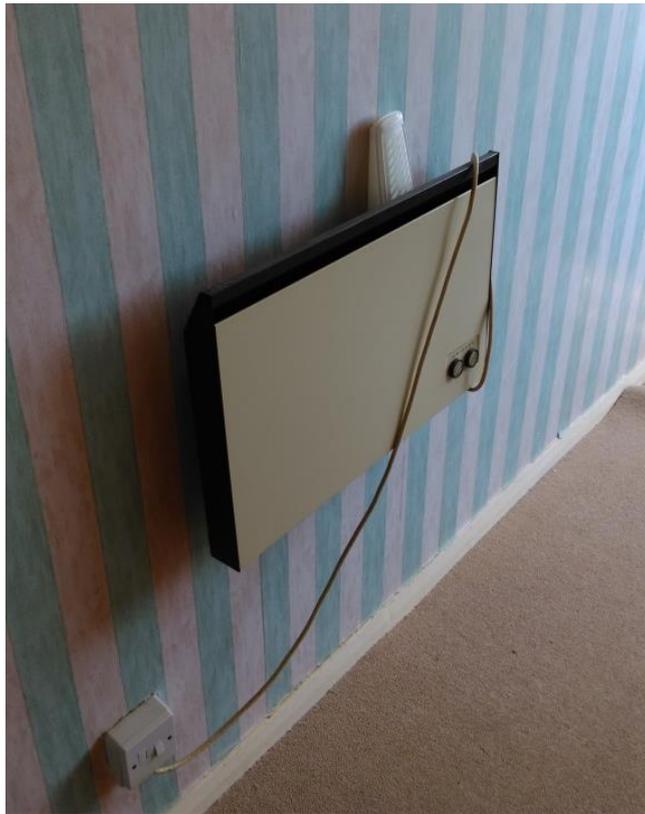
Figure 13. Flat 1 – Electric panel heater.

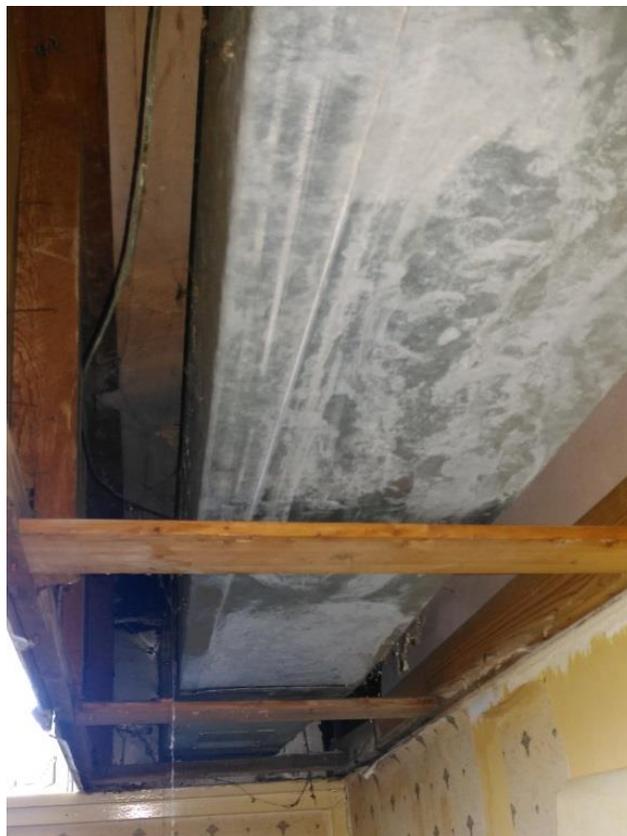
Figure 14. Flat 1 – Ventilation system to bathroom area.

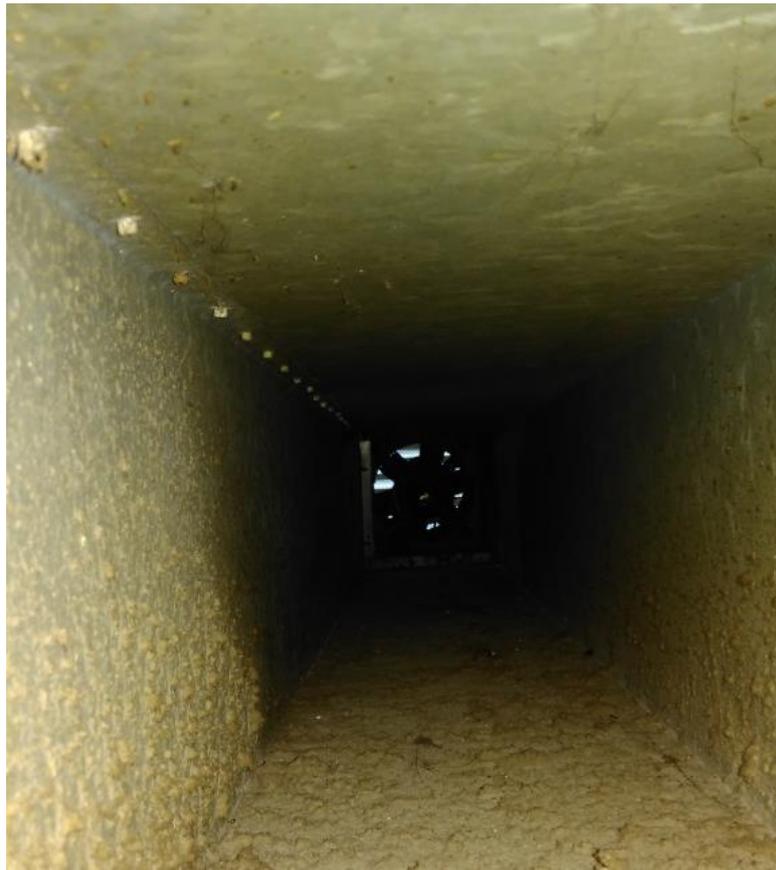
Figure 15. Flat 1 – Inside condition of Ventilation ductwork and highlighting the extract fan.

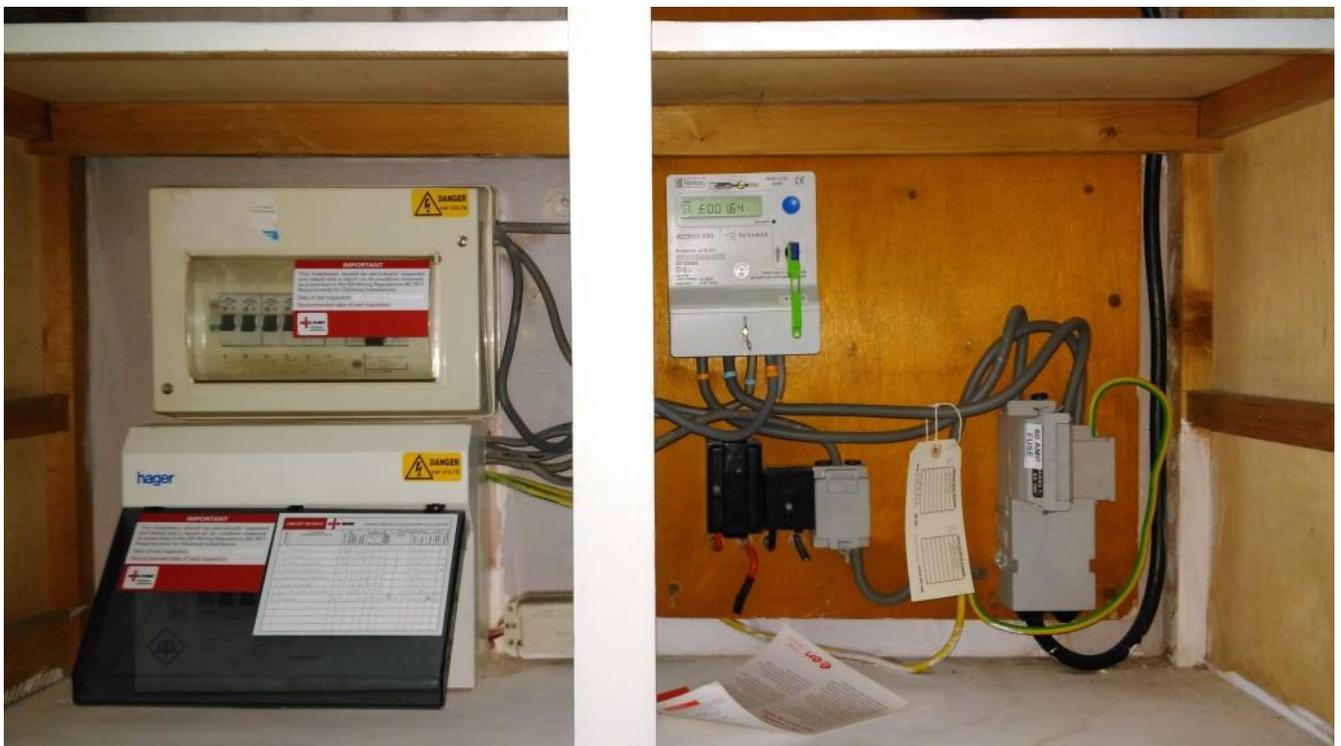
Figure 16. Flat 2 – Incoming electrical supply & local metering.

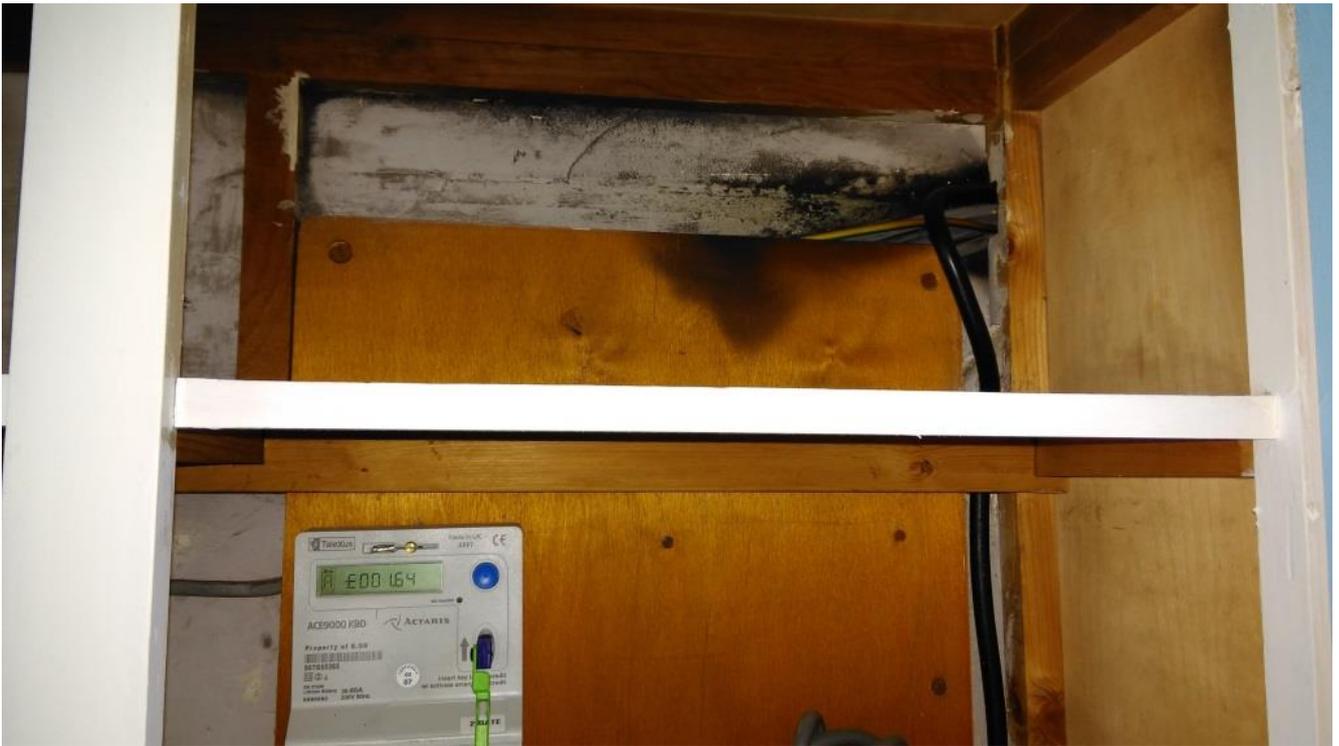
Figure 17. Flat 2 – Incoming electrical supply.

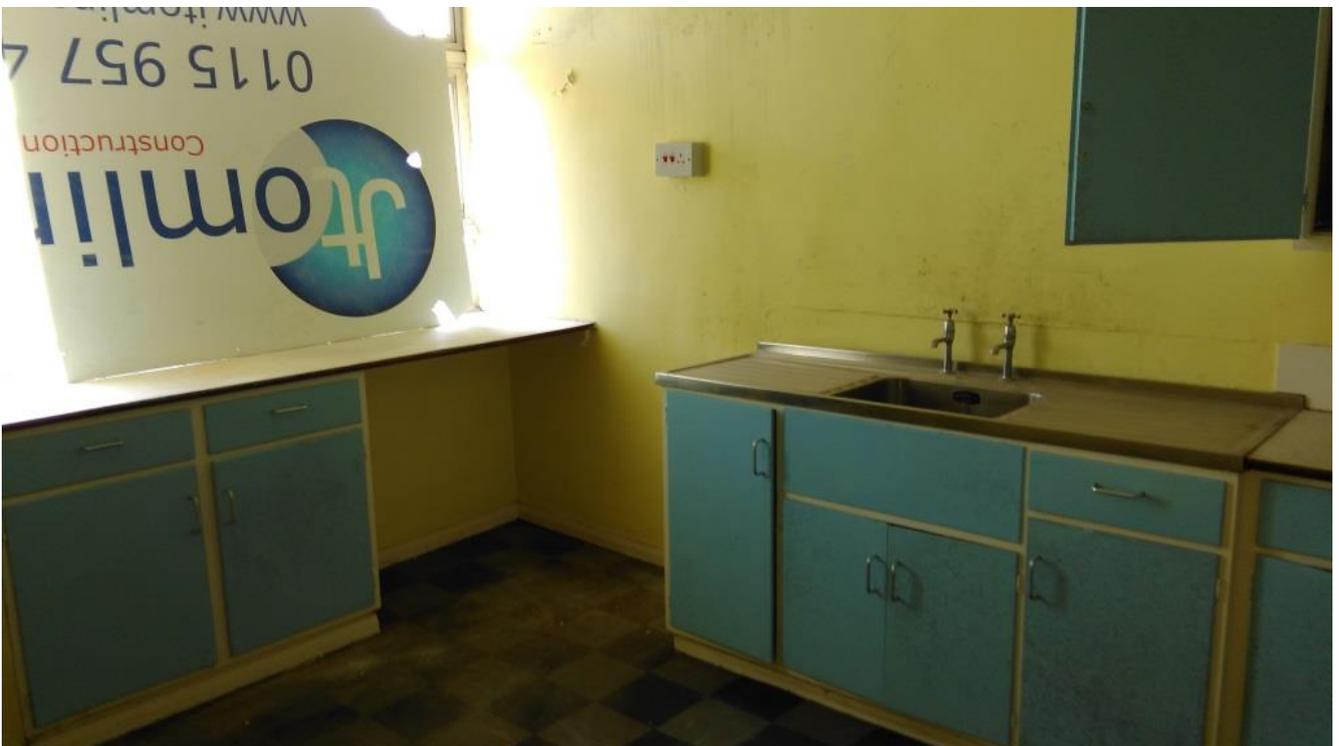
Figure 18. Flat 2 – Kitchen Area

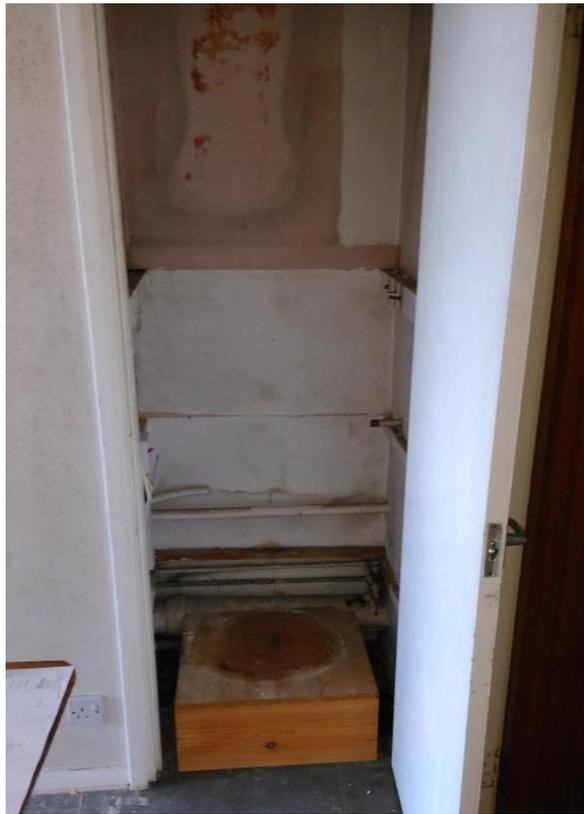
Figure 19. Flat 2 - Domestic hot water cylinder removed.

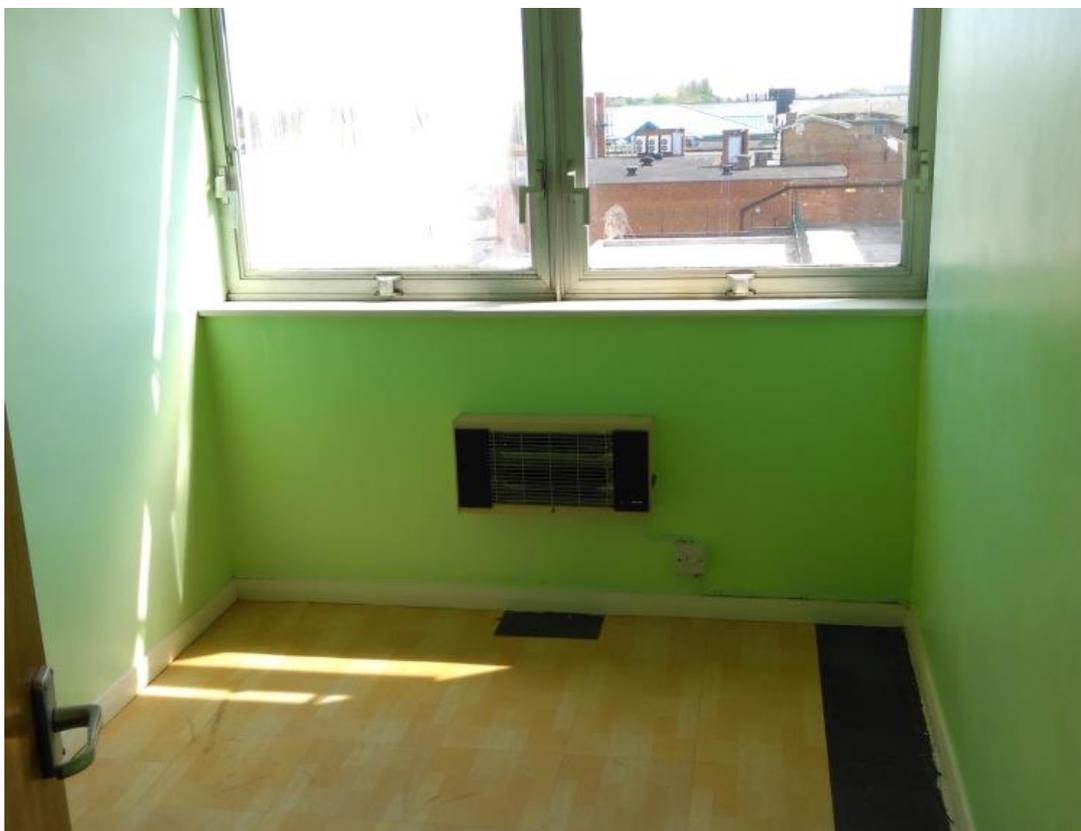
Figure 20. Flat 2 – Electric panel heater.

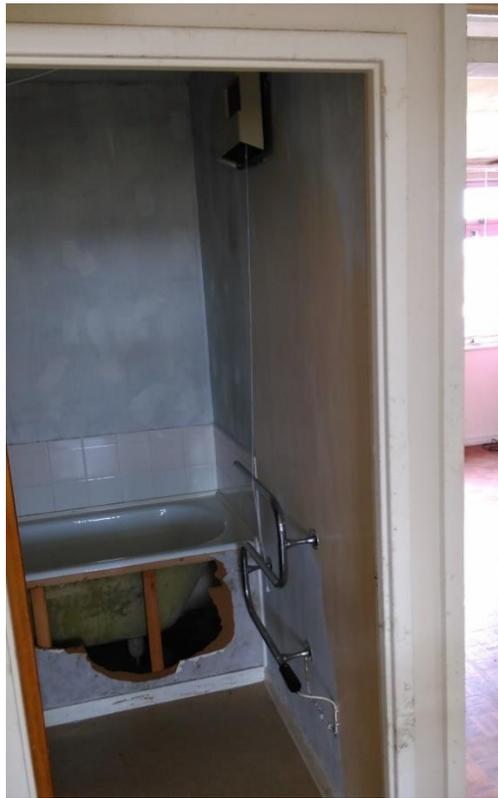
Figure 21. Flat 2 – Bathroom area.

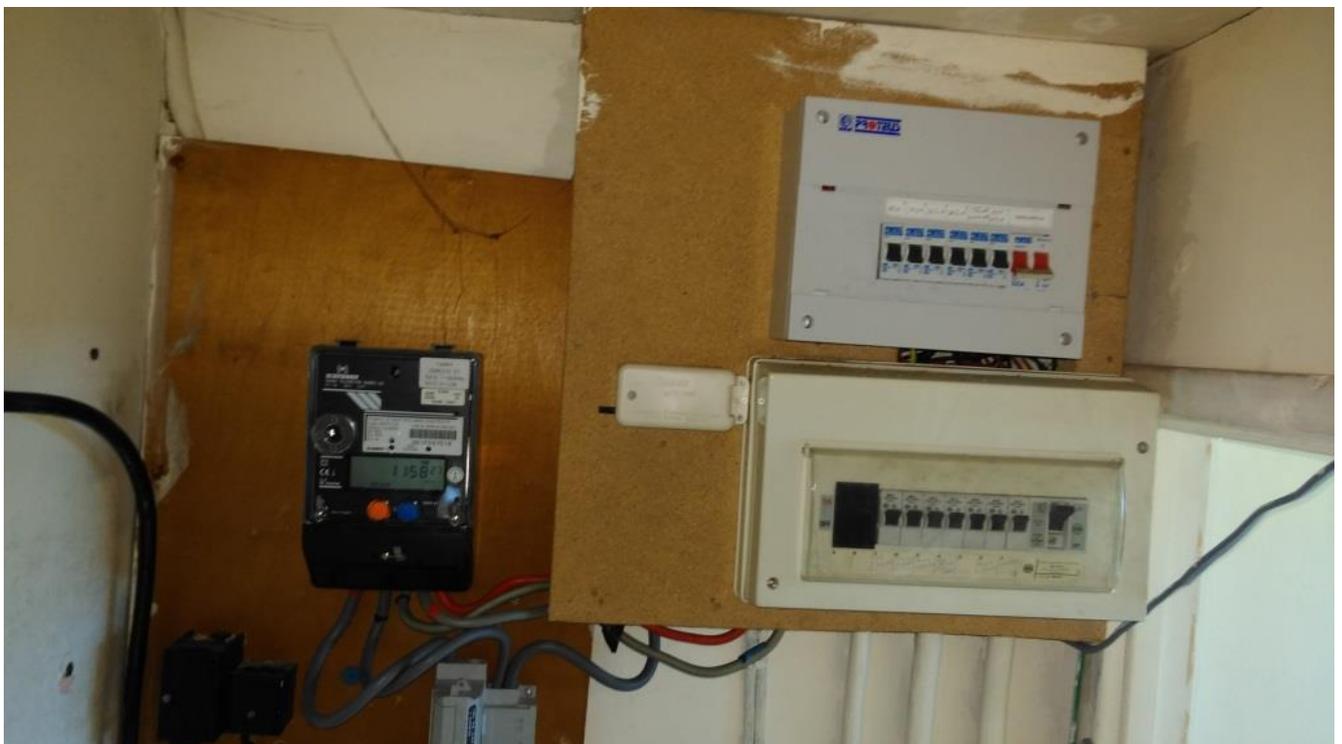
Figure 22. Flat 8 – Incoming electrical supply & local metering.

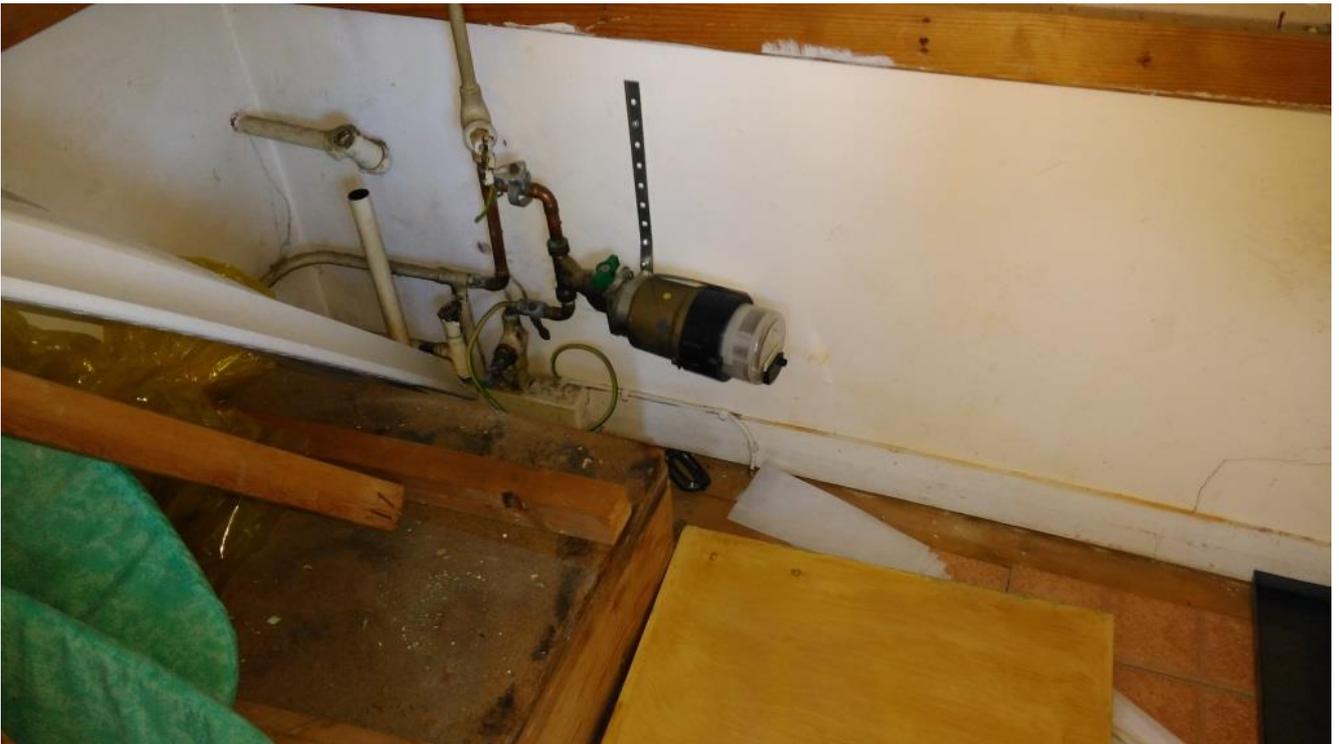
Figure 23. Flat 8 – Incoming water supply & local metering.

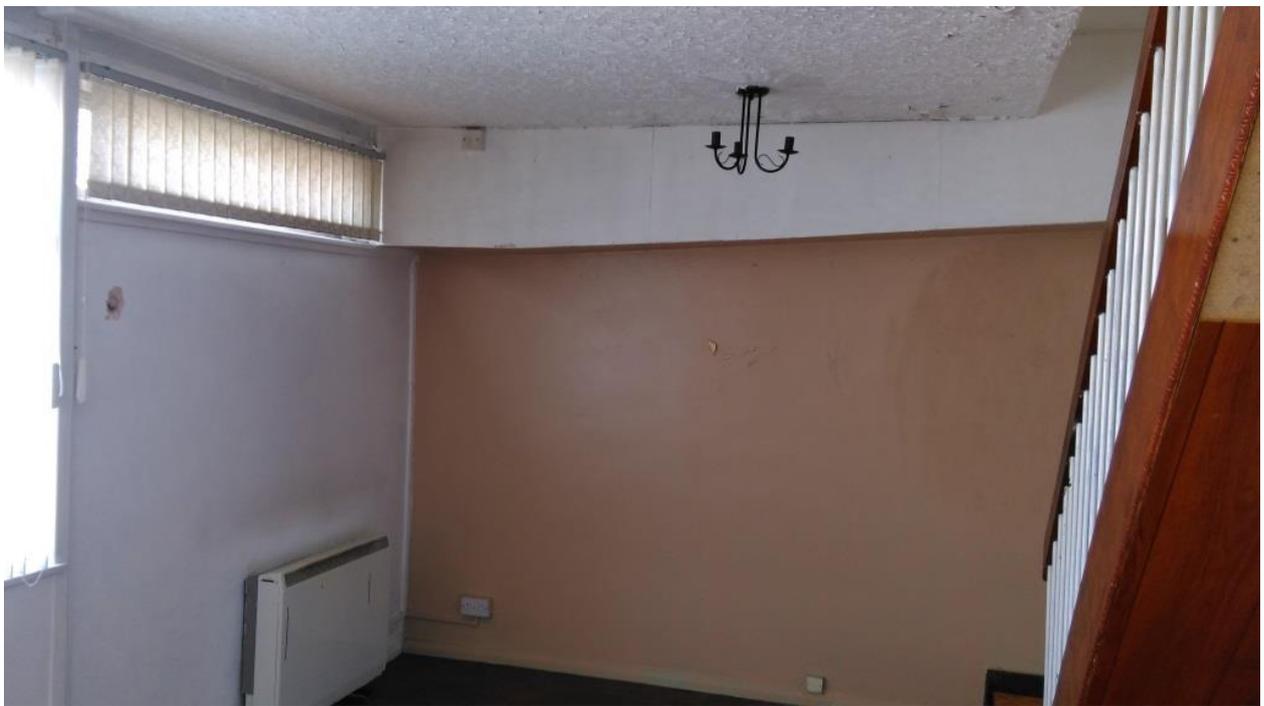
Figure 24. Flat 8 – Electric storage heater and local lighting.

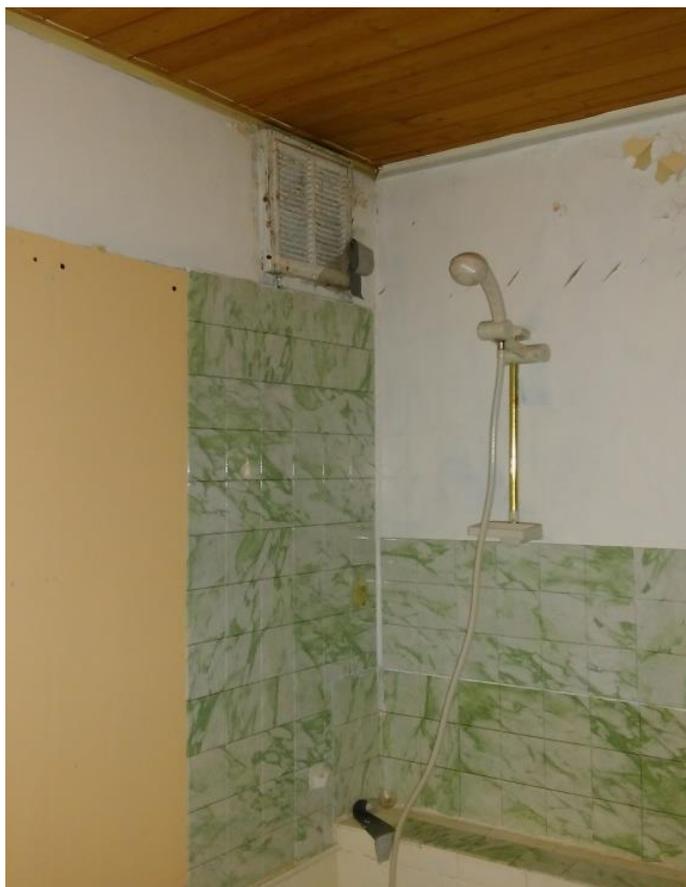
Figure 25. Flat 8 – Bathroom area ventilation system.

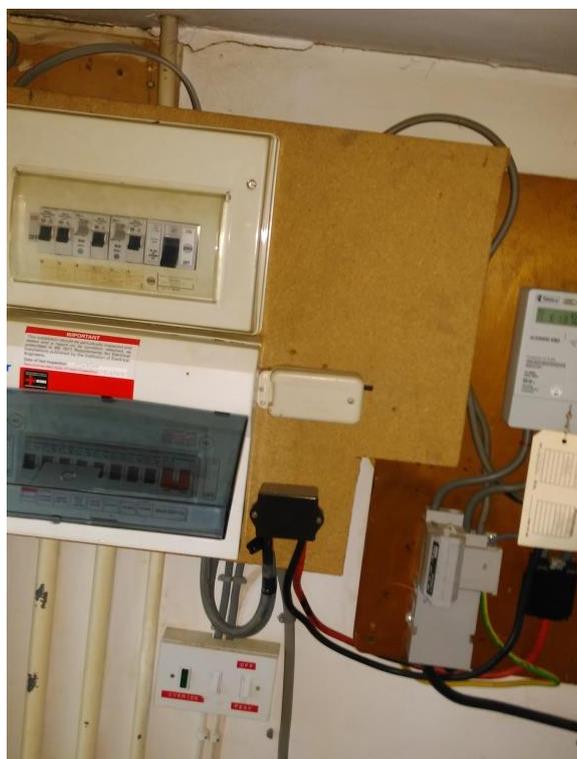
Figure 26. Flat 7 – Incoming electrical supply & local metering.

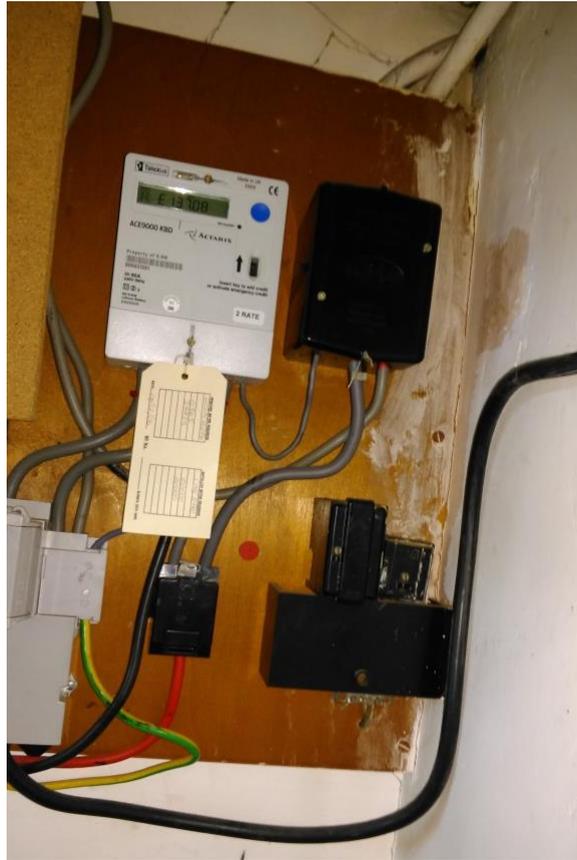
Figure 27. Flat 7 – Incoming electrical supply & local metering.

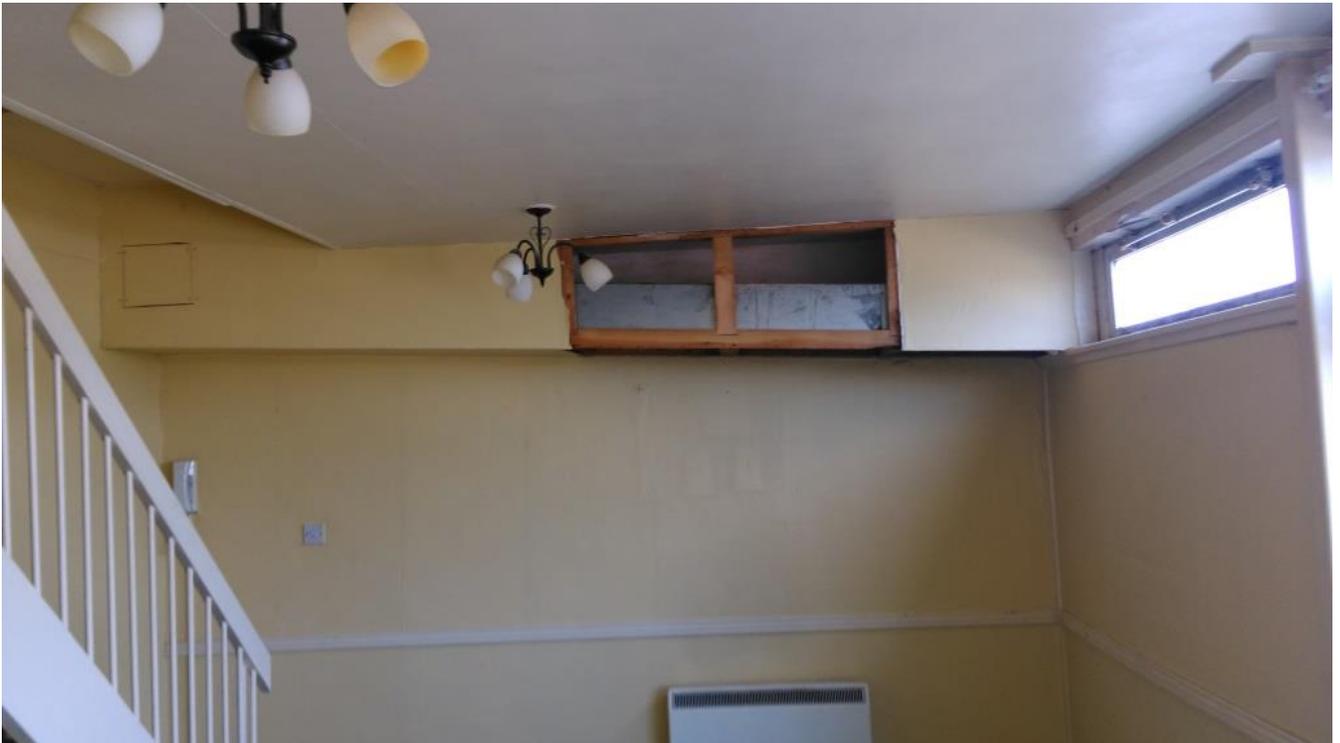
Figure 28. Flat 7 – Ventilation system serving bathroom area and electric storage heater.
