16-0159 M&E

**A SUMMARY REPORT OF THE EXISTING MECHANICAL
AND ELECTRICAL BUILDING SERVICES**

NEVILLE HOUSE

CORBY

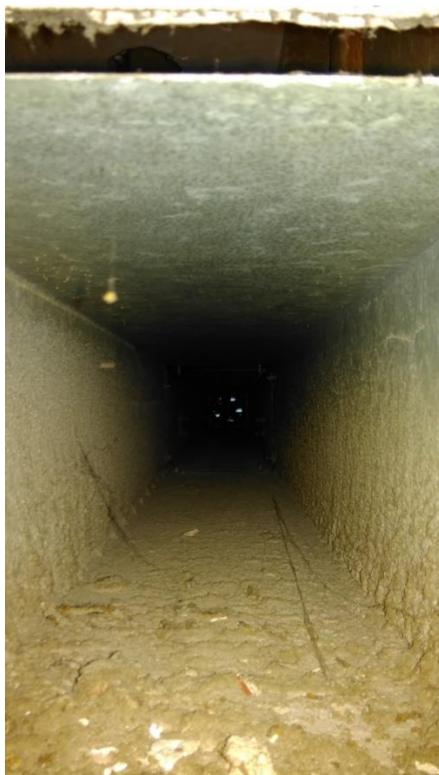
Figure 29. Flat 7 – Inside condition of Ventilation ductwork and highlighting the extract fan.

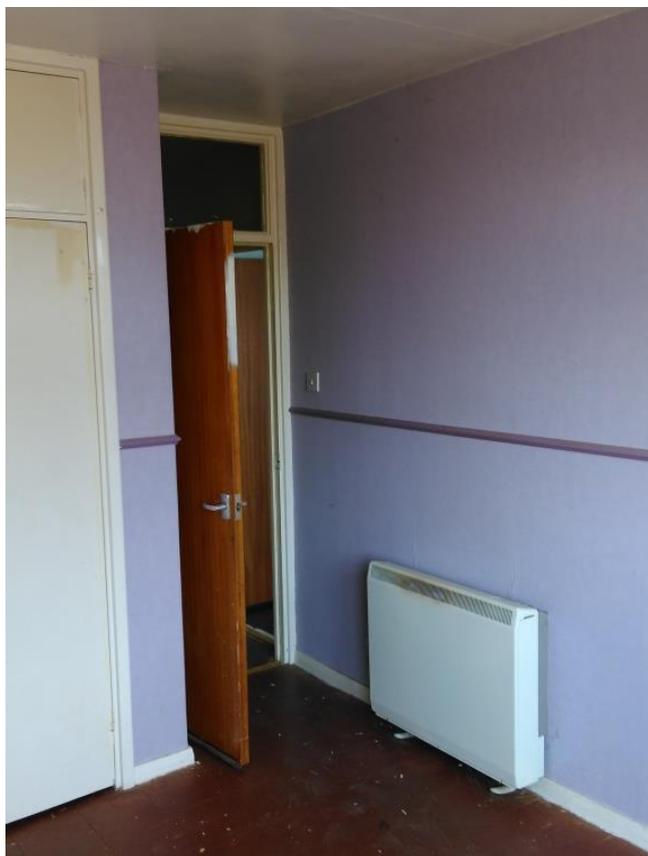
Figure 30. Flat 7 – Electric storage heater.

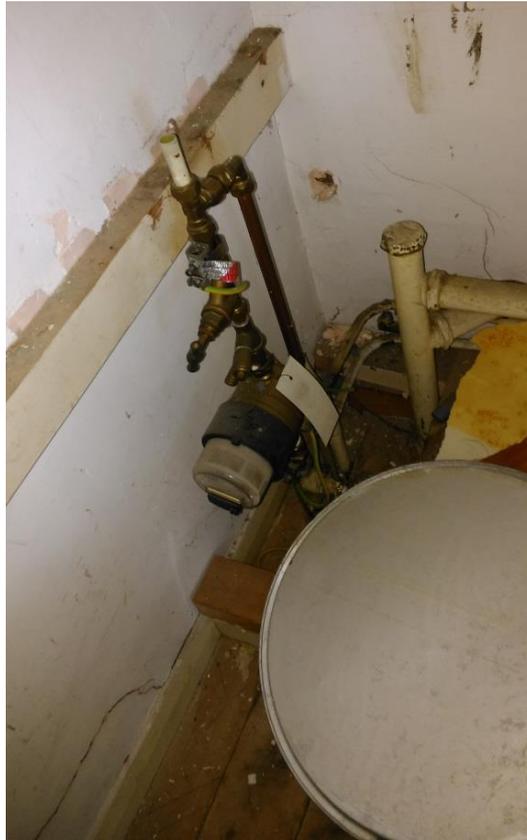
Figure 31. Flat 9 – Incoming water supply & local meter.

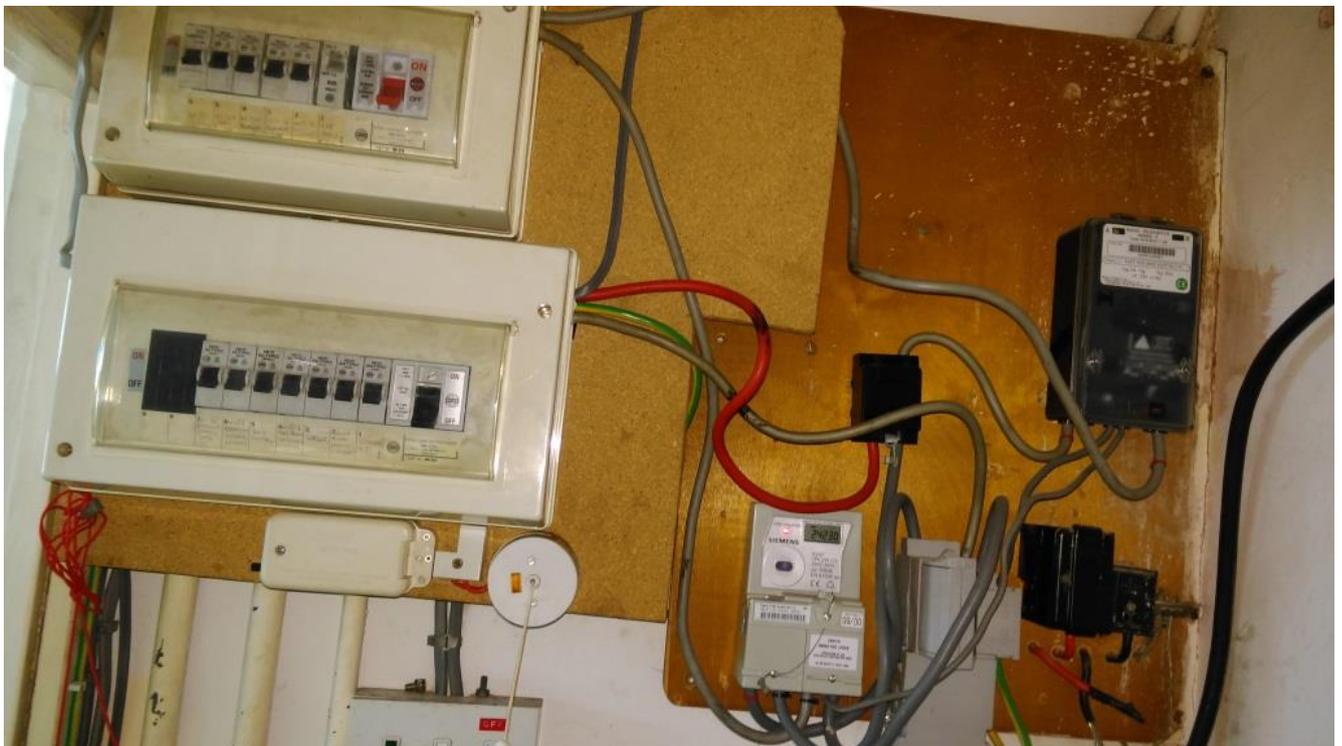
Figure 32. Flat 9 – Incoming electrical supply & local metering.

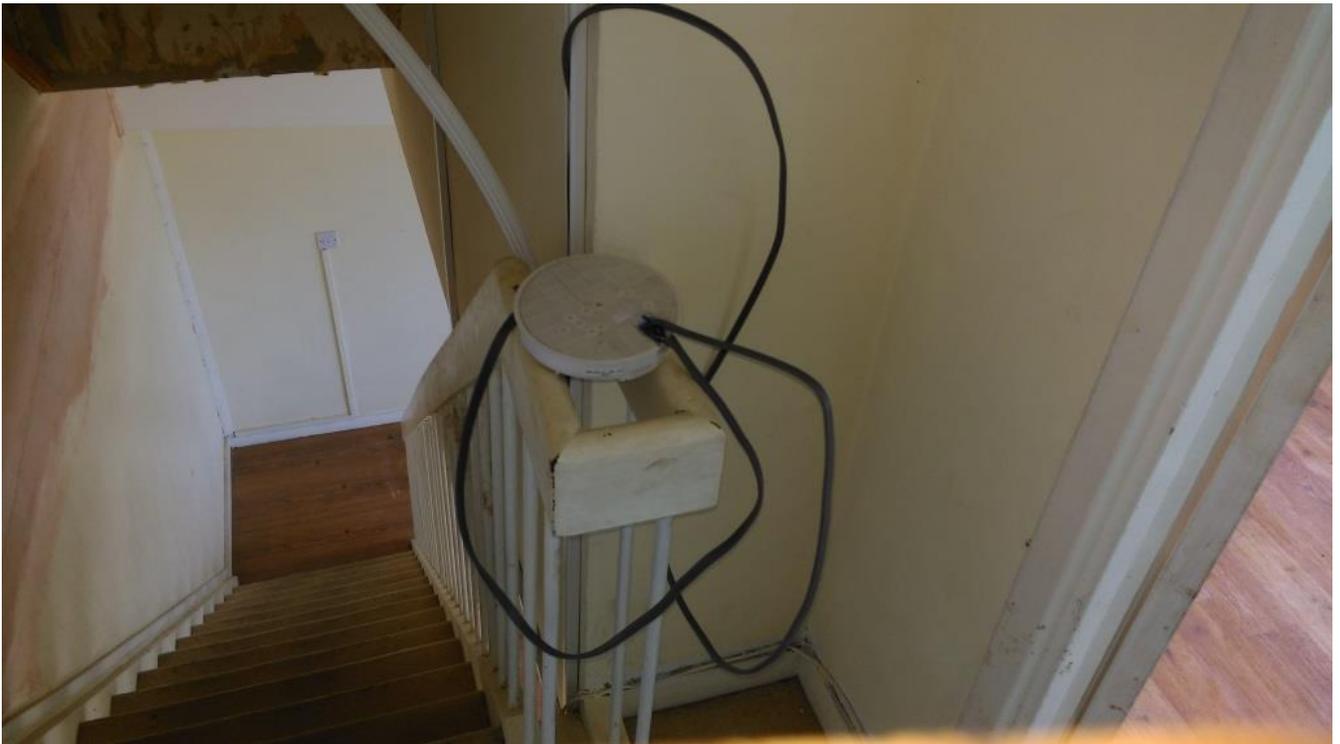
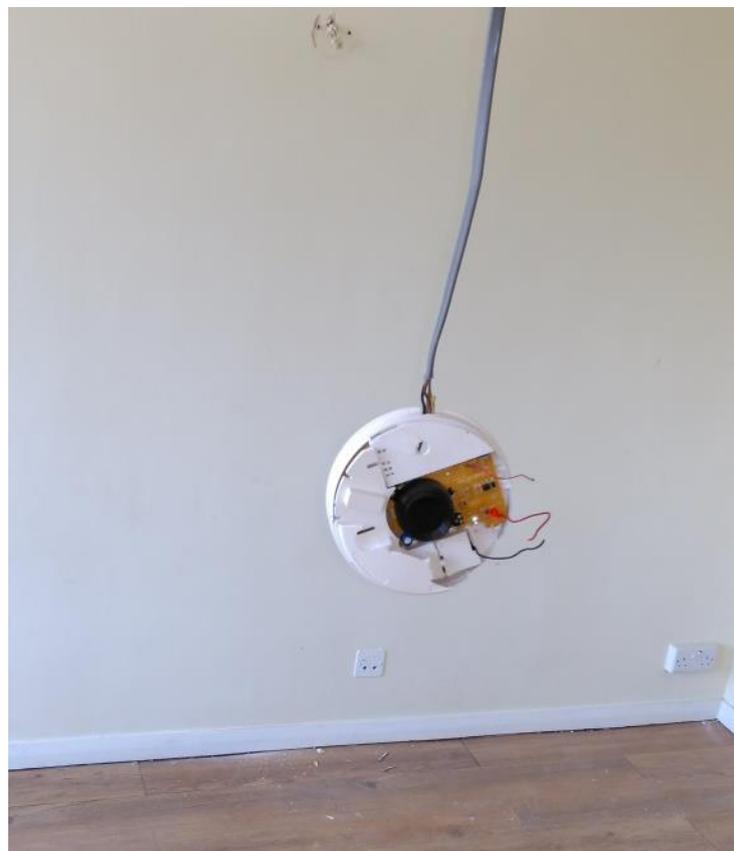
Smoke detectors located within the fifth floor had dust caps mounted on smoke heads. Flat 9 is installed with a complaint smoke detection system but has been pulled out from its fixings and wiring is loose.

Figure 33. Flat 9 – Faulty smoke detection system

Figure 34. Flat 9 – Faulty smoke detection system

A complete overhaul of the fire alarm system is required due to the age and condition of the existing system.

Fire alarm equipment shall be inspected for compliance with BS 5839-1 and BS 5839-6.

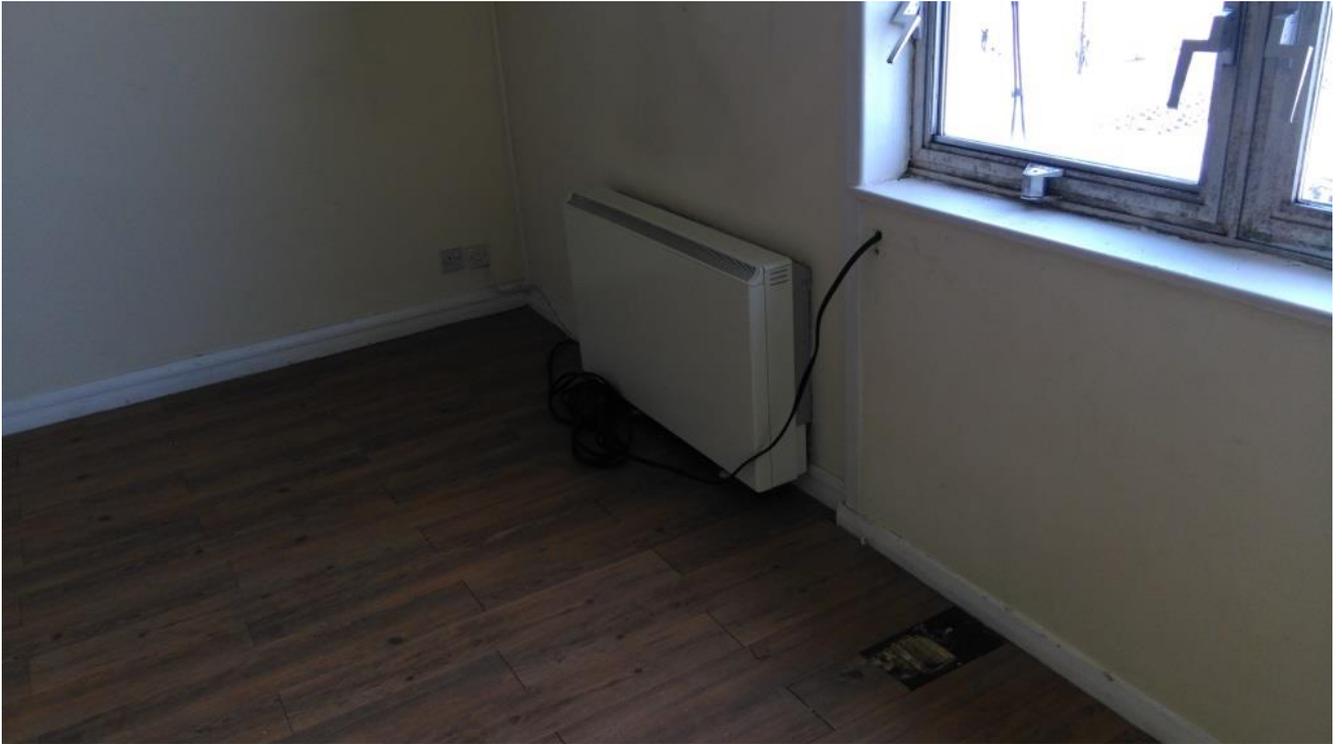
Figure 35. Flat 9 – Electric storage heater.

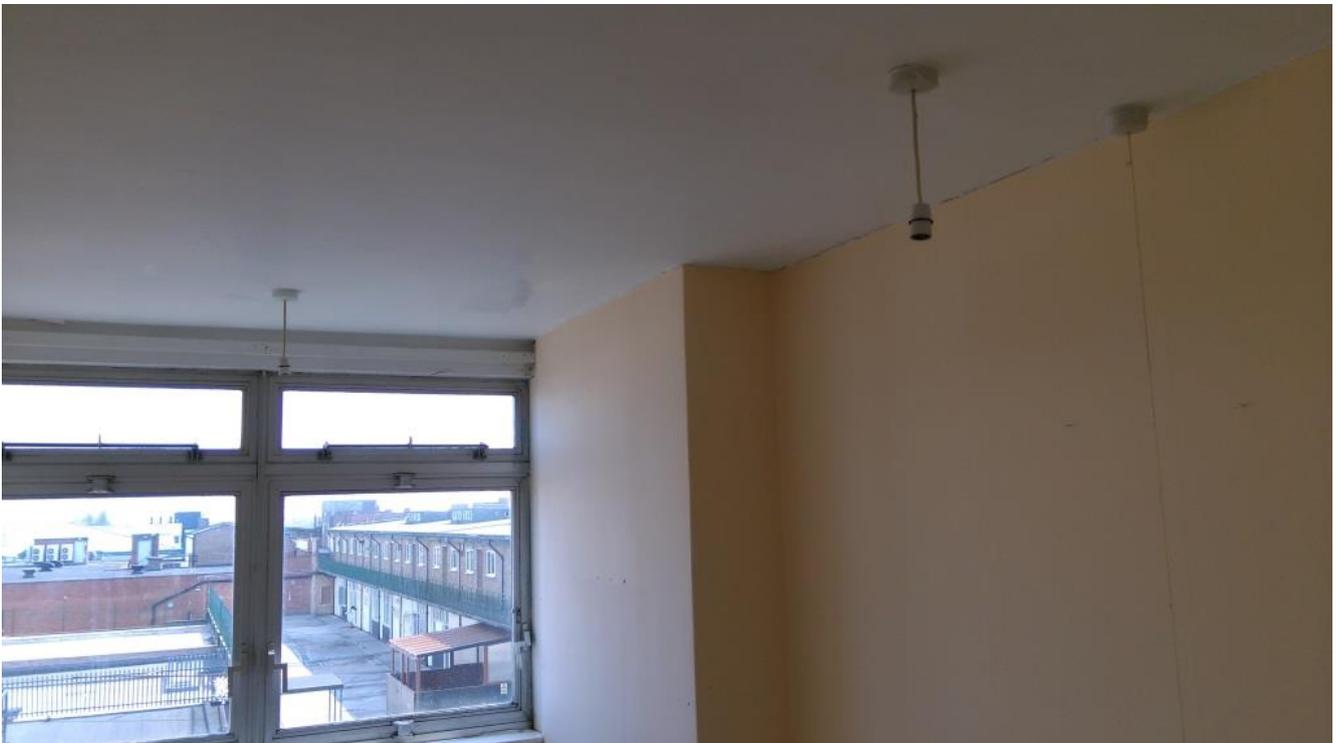
Figure 36. Flat 9 – Lighting and local pull cord.

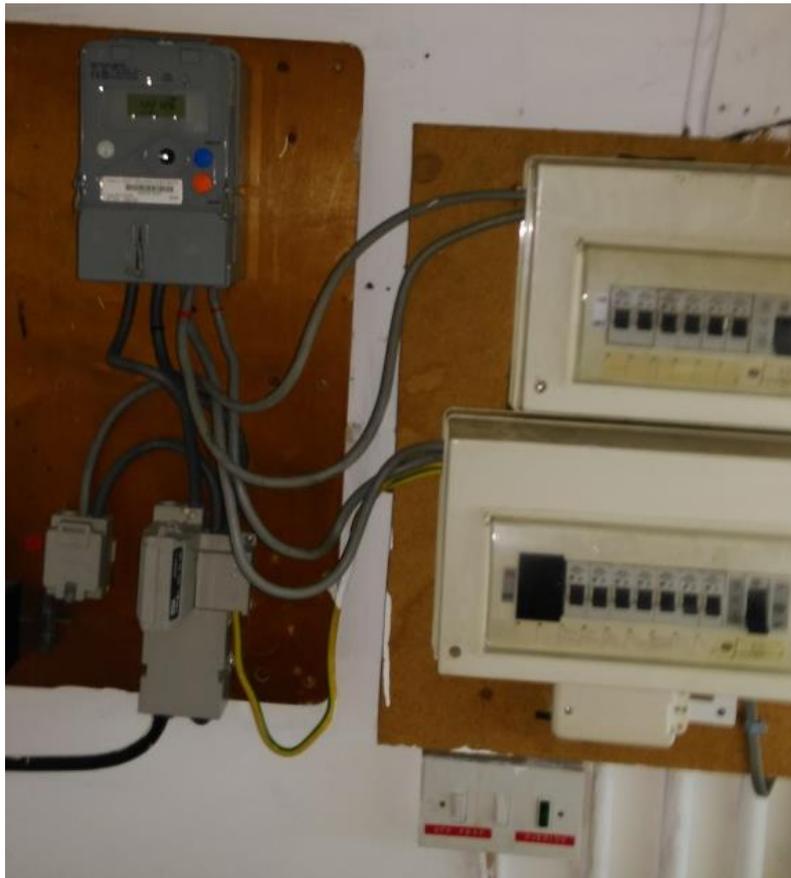
Figure 37. Flat 6 – Incoming electrical supply & local metering.

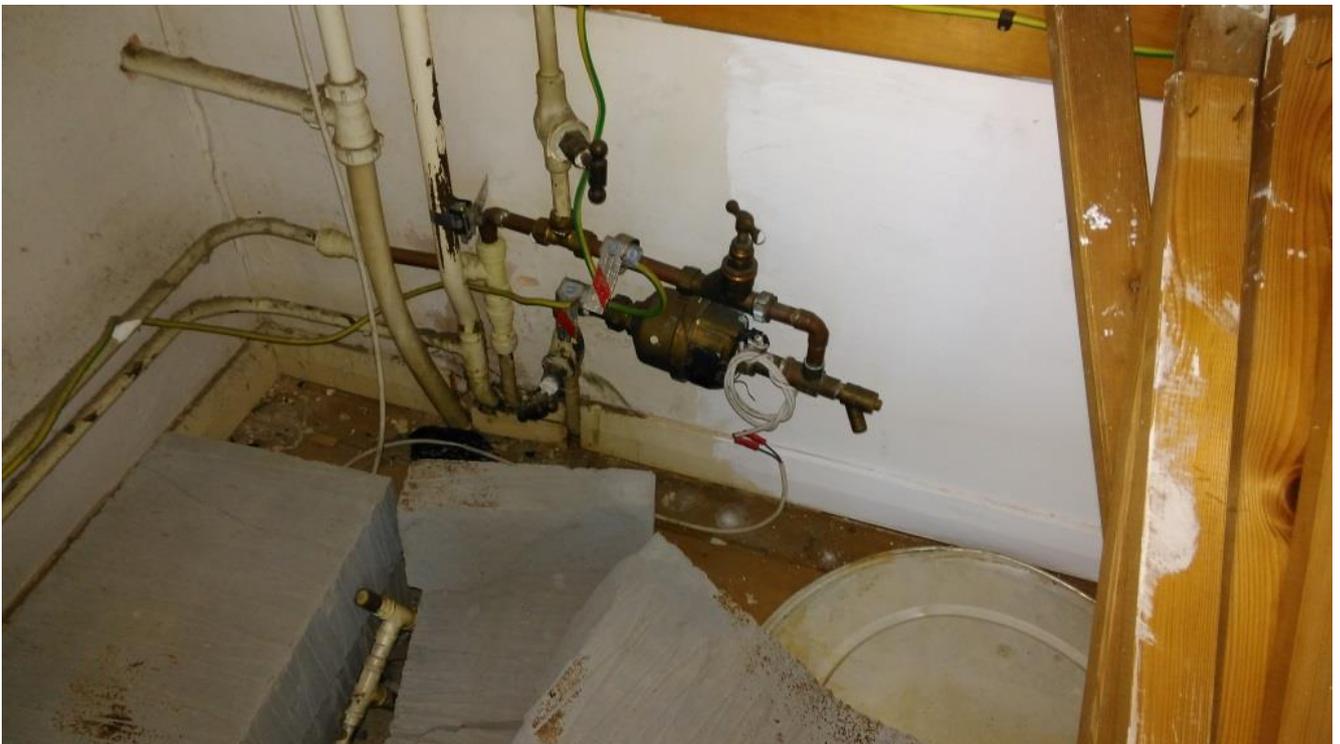
Figure 38. Flat 6 - Incoming water supply & local meter.

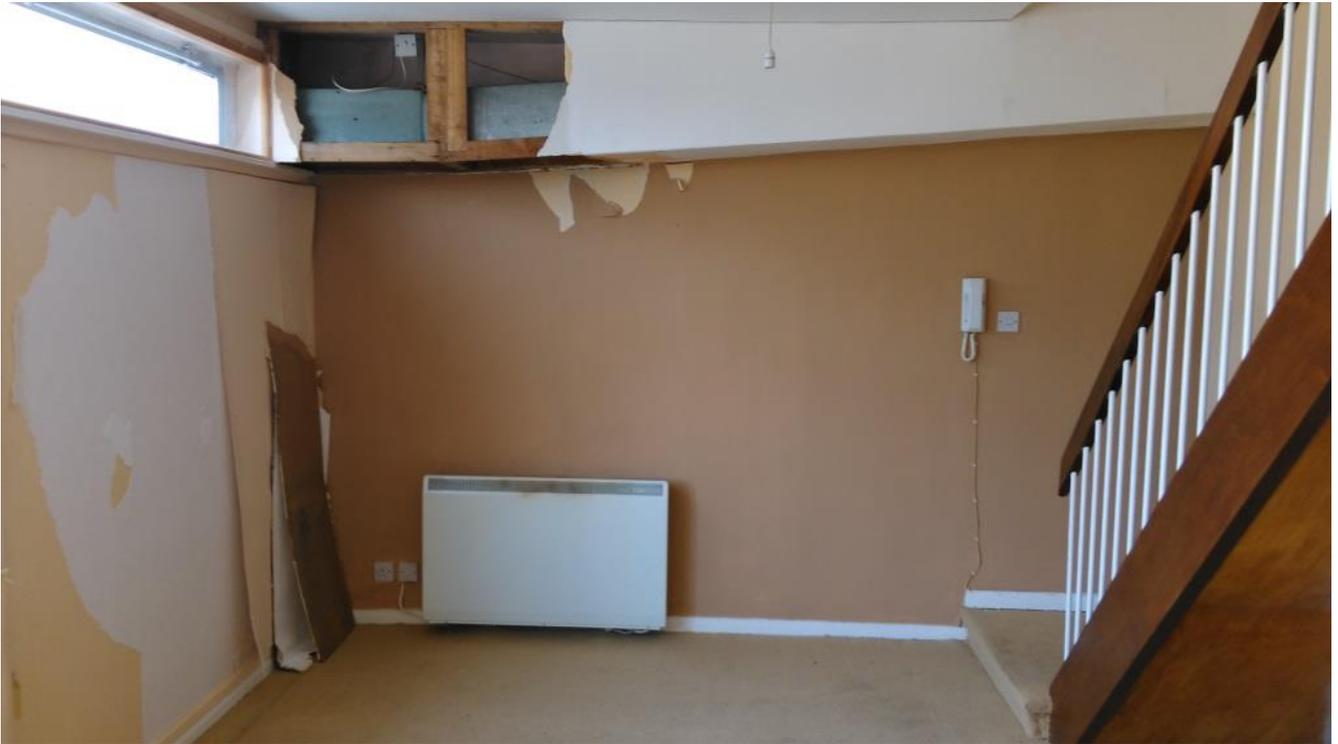
Figure 39. Flat 6 – Electric storage heater, Access control and Ventilation system serving Bathroom area with power supply serving local extract fan.

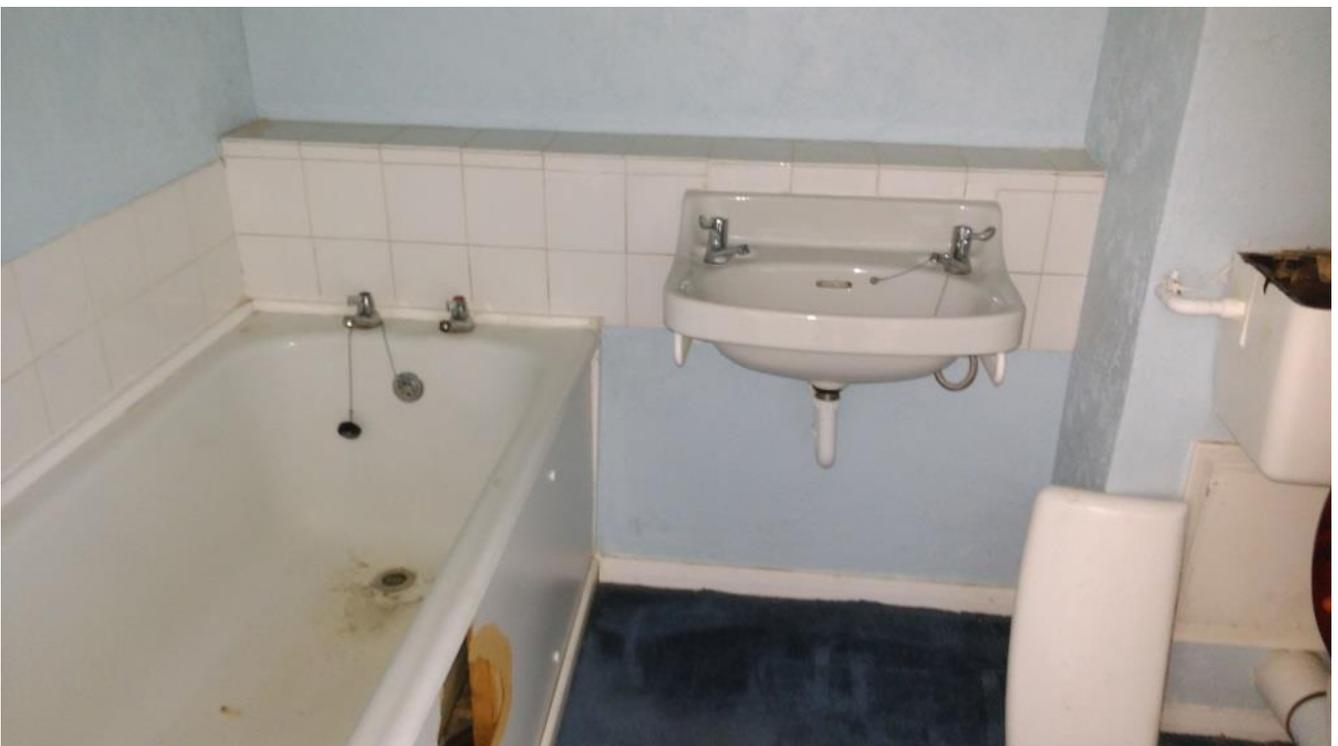
Figure 40. Flat 6 – bathroom area.

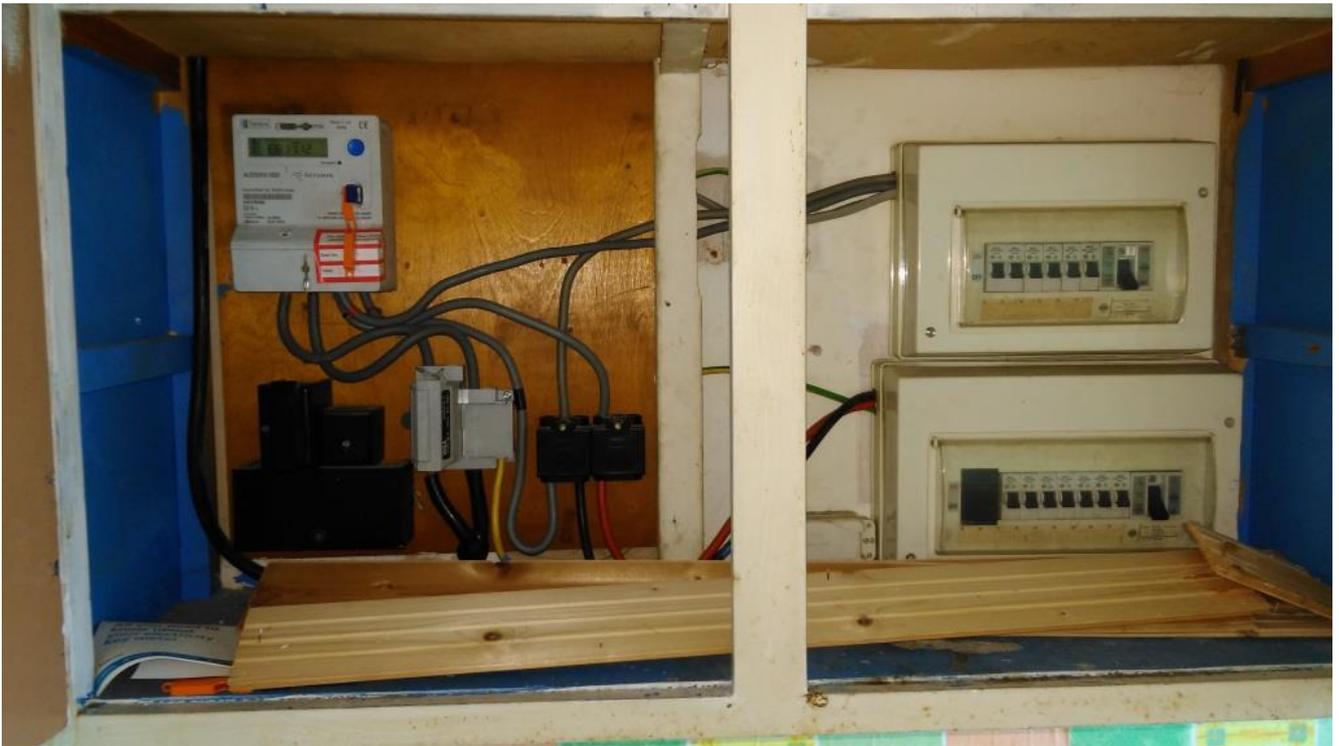
Figure 41. Flat 5 – Incoming electrical supply & local metering.

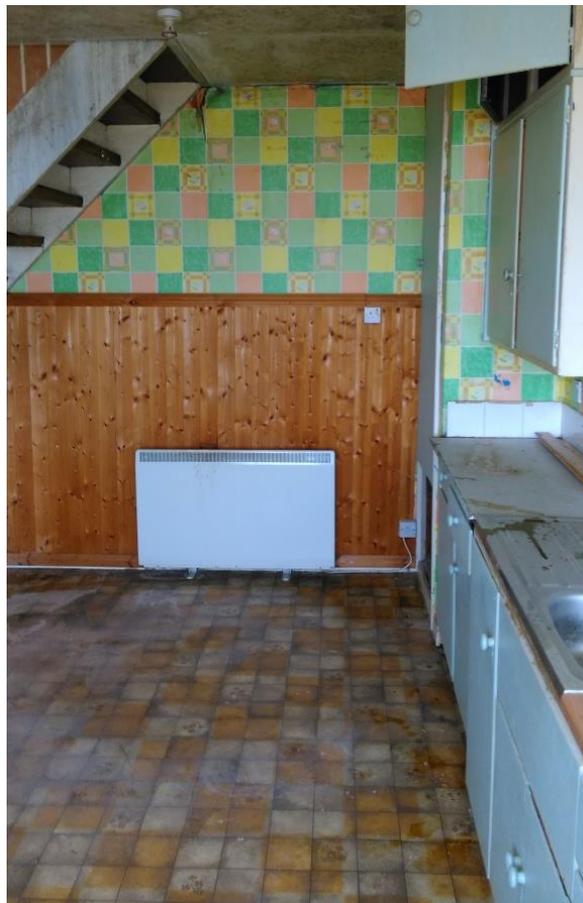
Figure 42. Flat 5 – Kitchen area Lighting and Electric storage heater.

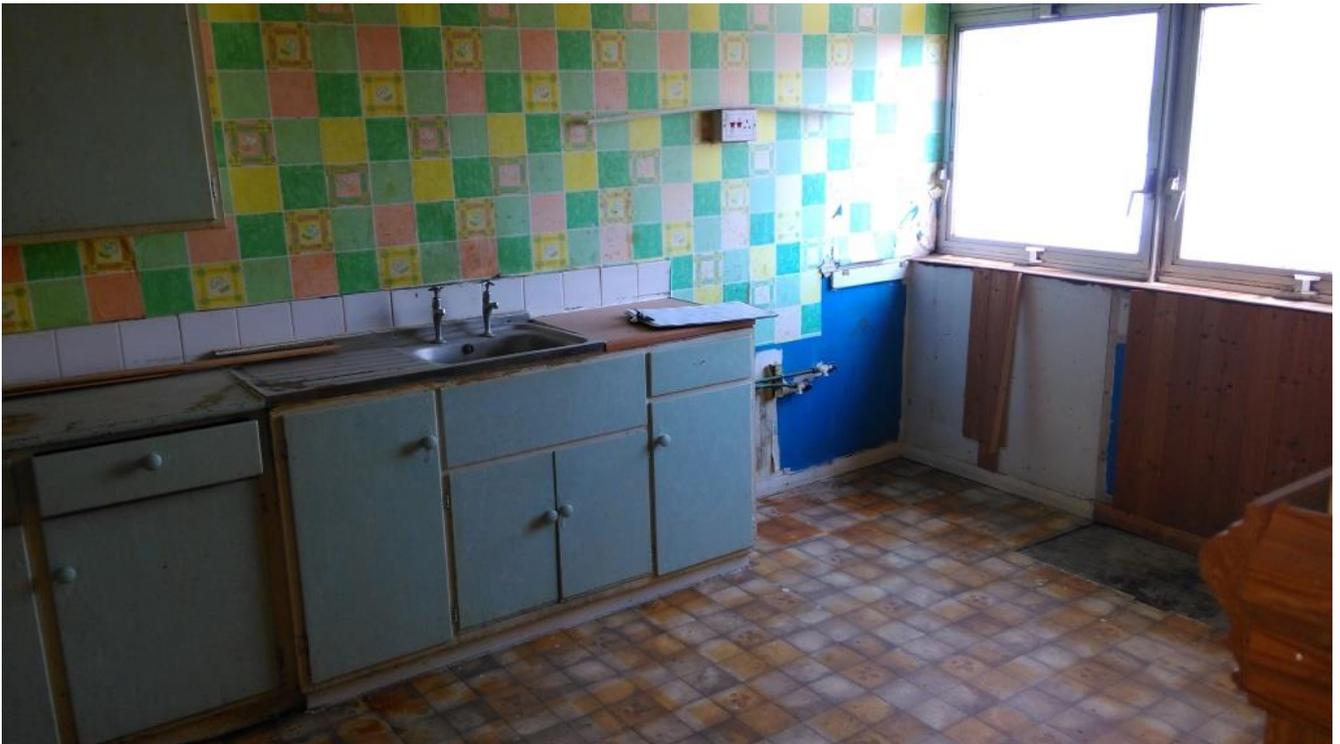
Figure 43. Flat 5 – Kitchen area.

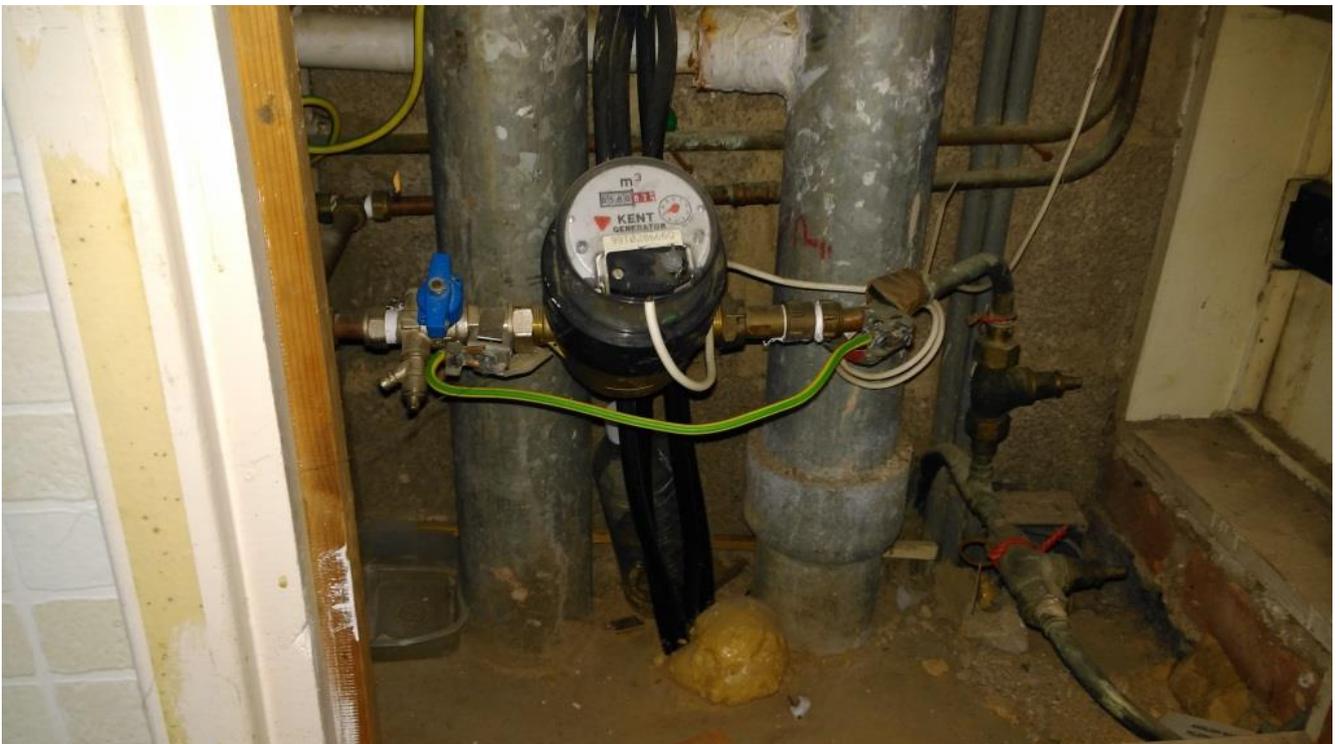
Figure 44. Flat 5 - Incoming water supply & local meter.

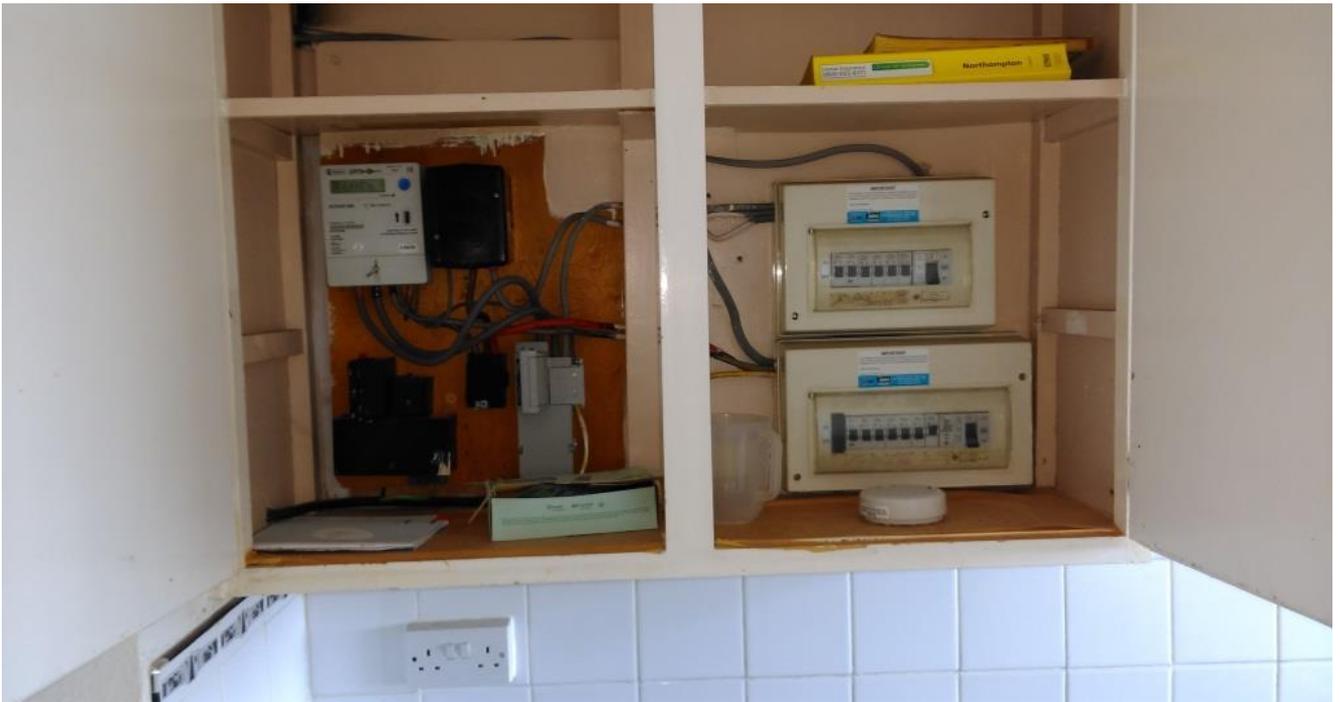
Figure 45. Flat 5 – Incoming electrical supply & local metering.

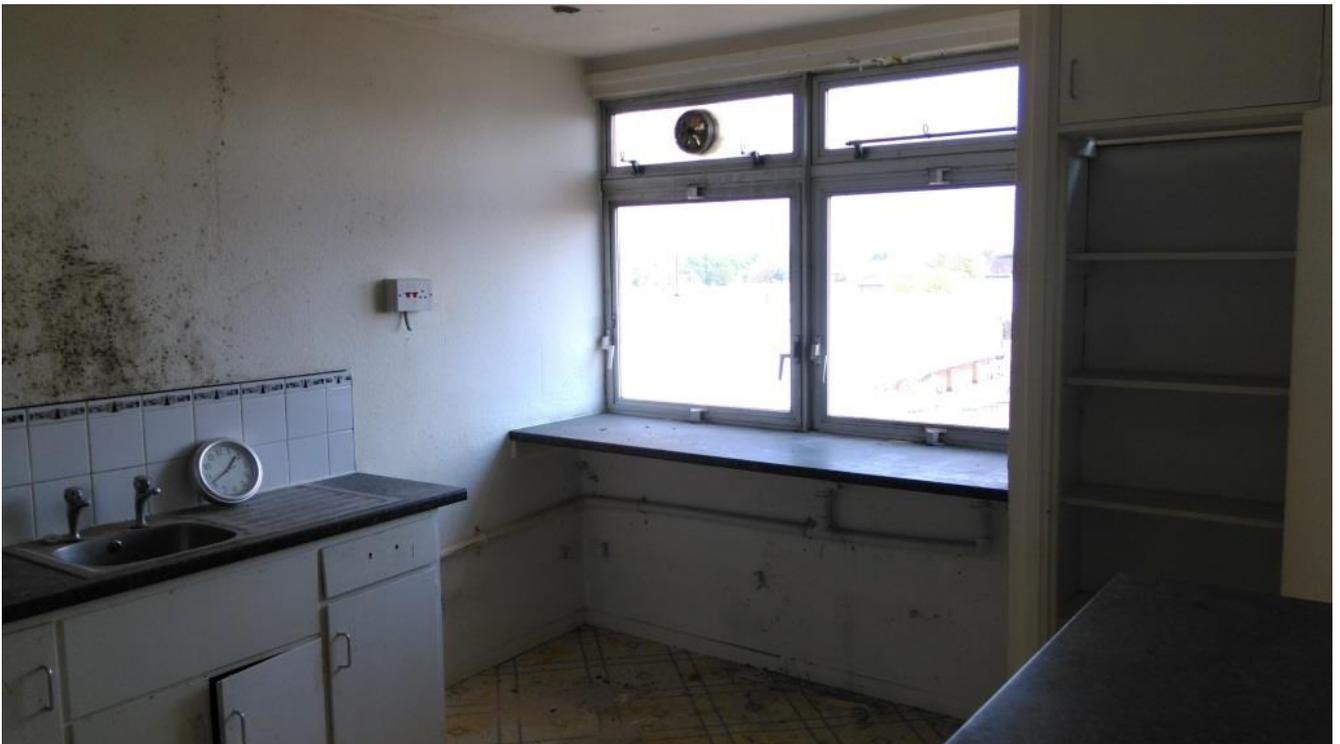
Figure 46. Flat 3 – Kitchen area with local in glass ventilator.

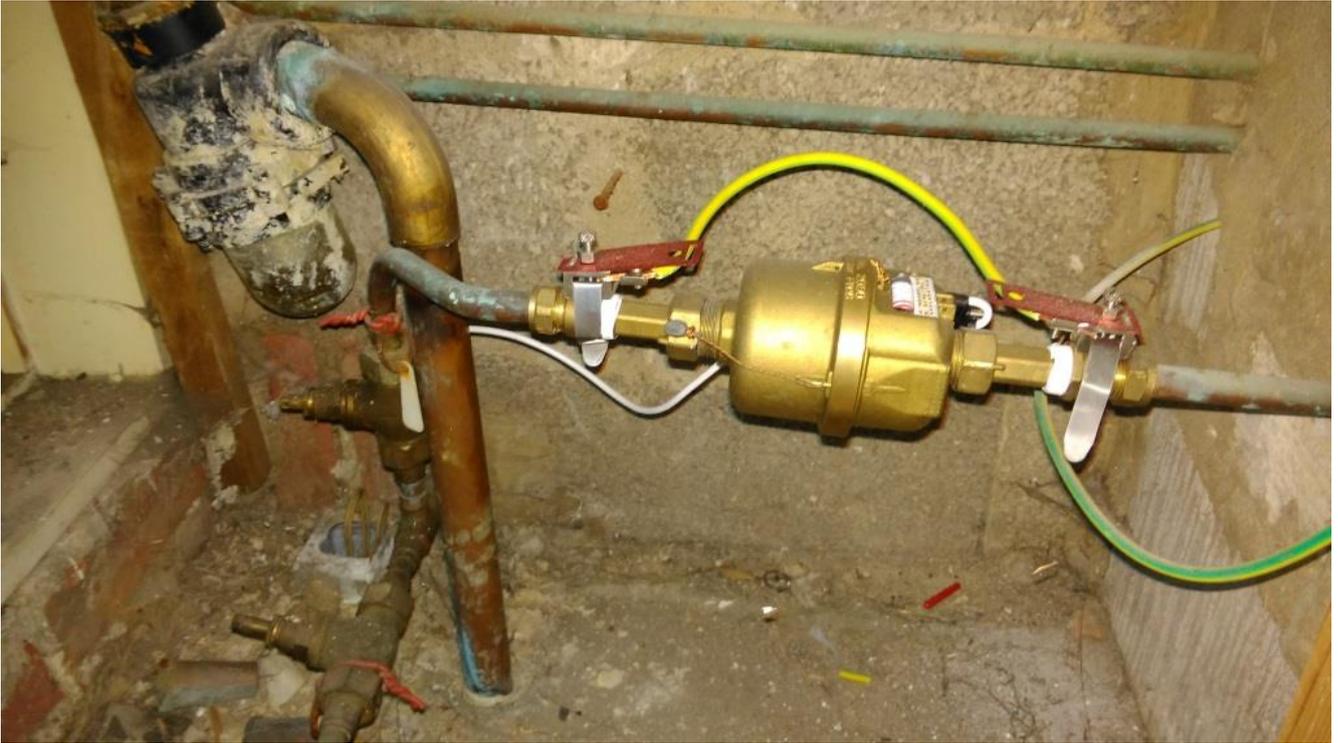
Figure 47. Flat 3 - Incoming water supply & local meter.

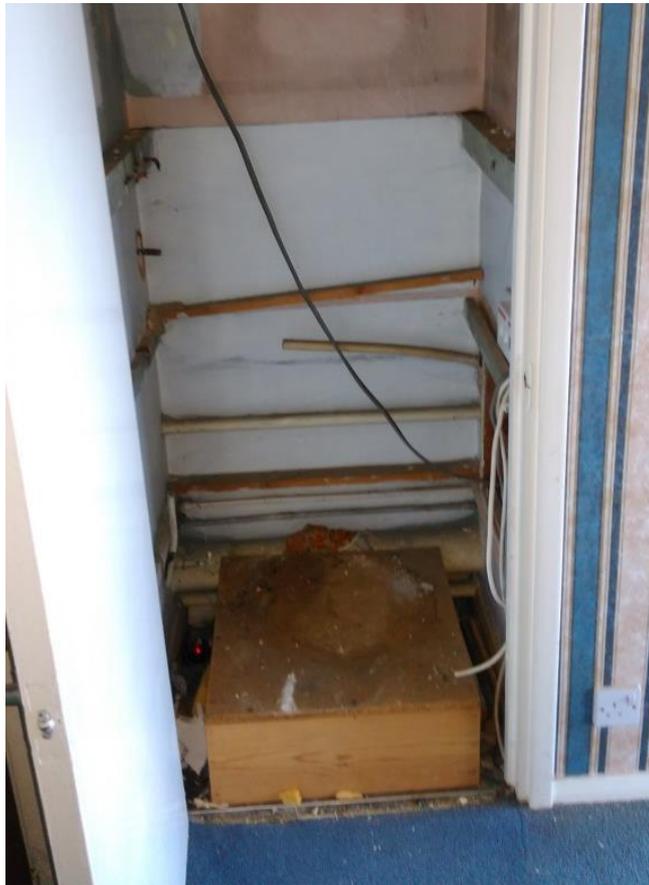
Figure 48. Flat 3 - Domestic hot water cylinder removed.

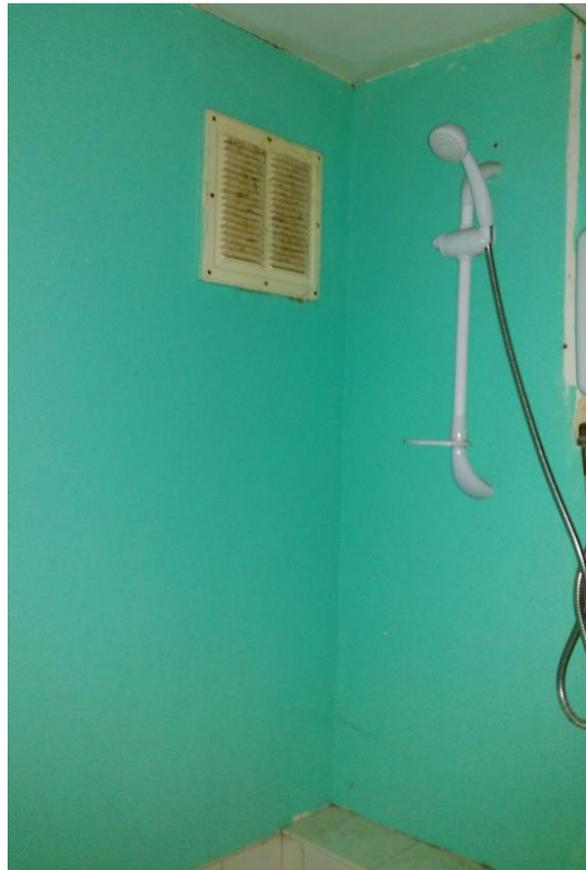
Figure 49. Flat 3 – Bathroom area ventilations system.

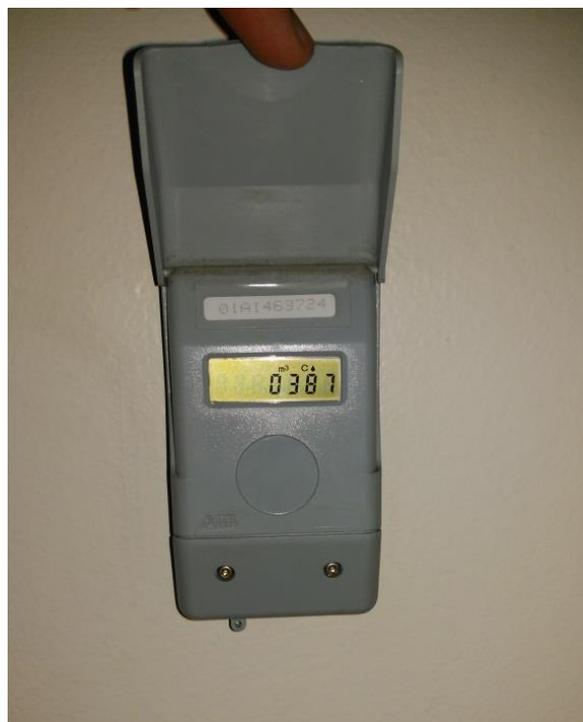
Figure 50. Flat 3 – Water meter display located in corridor.

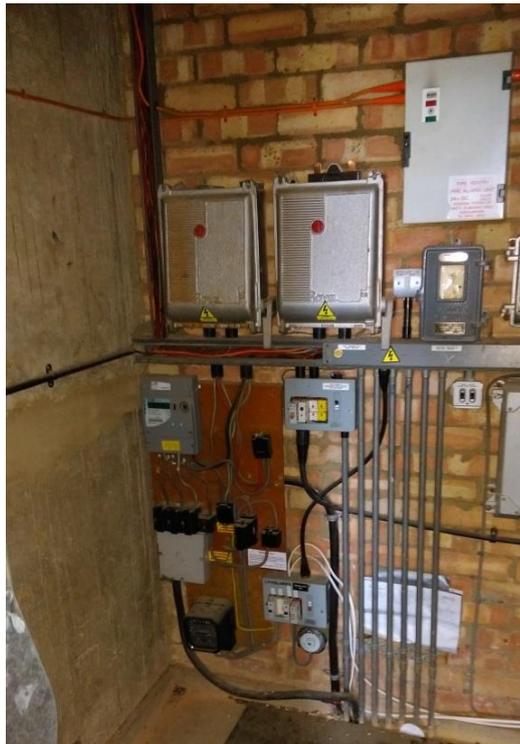
Figure 51. Main incoming electrical serving the building.

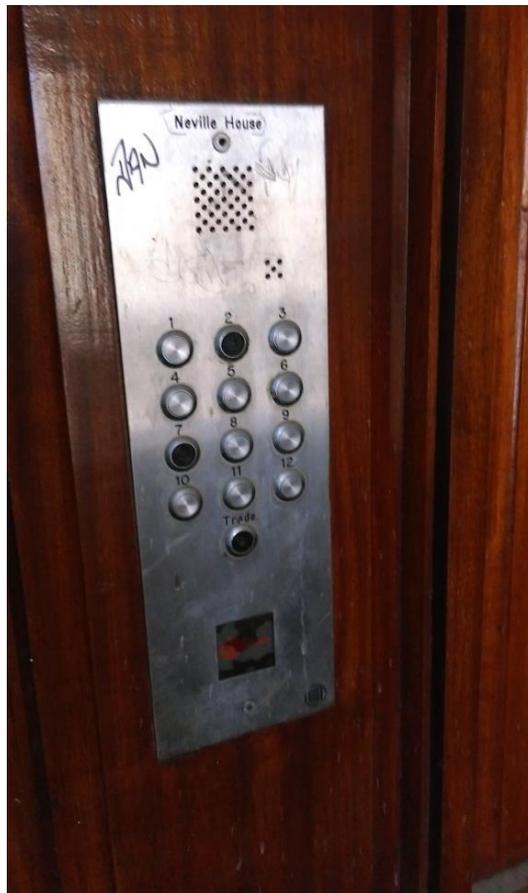
Figure 52. Access control keypad located in the first floor lobby.

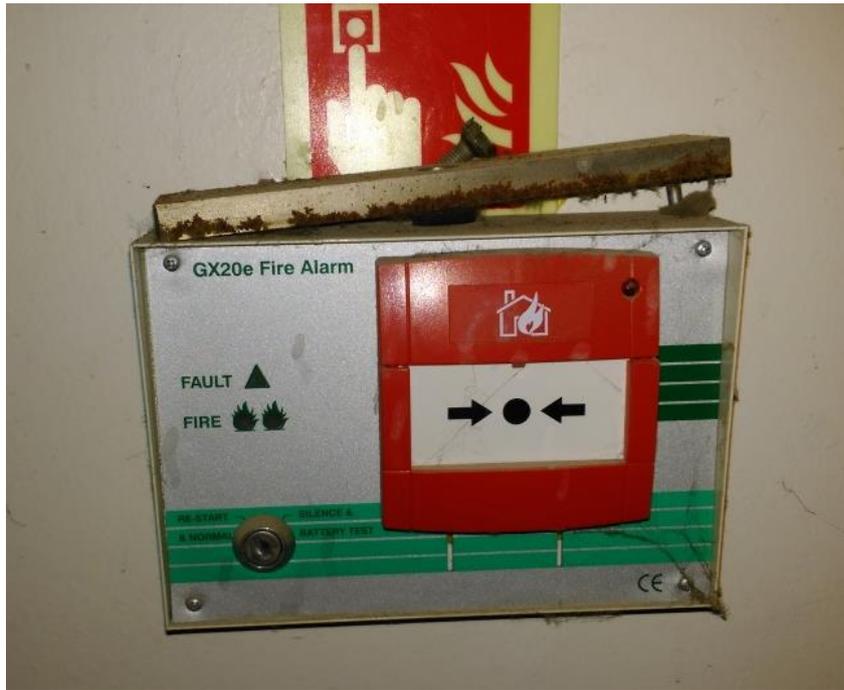
Figure 53. Fire alarm panel located on the third floor landing area.

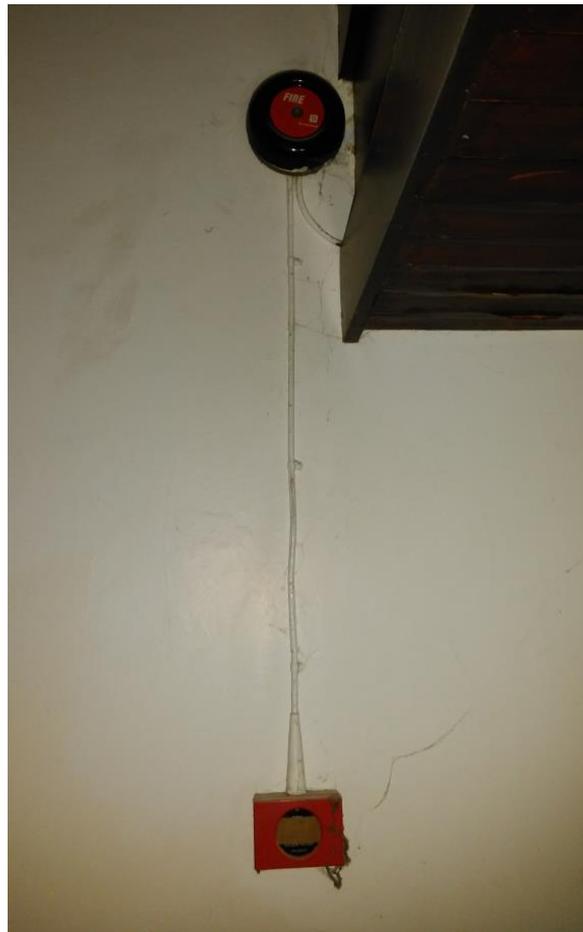
Figure 54. Fire call point and alarm bell located on third floor landing.

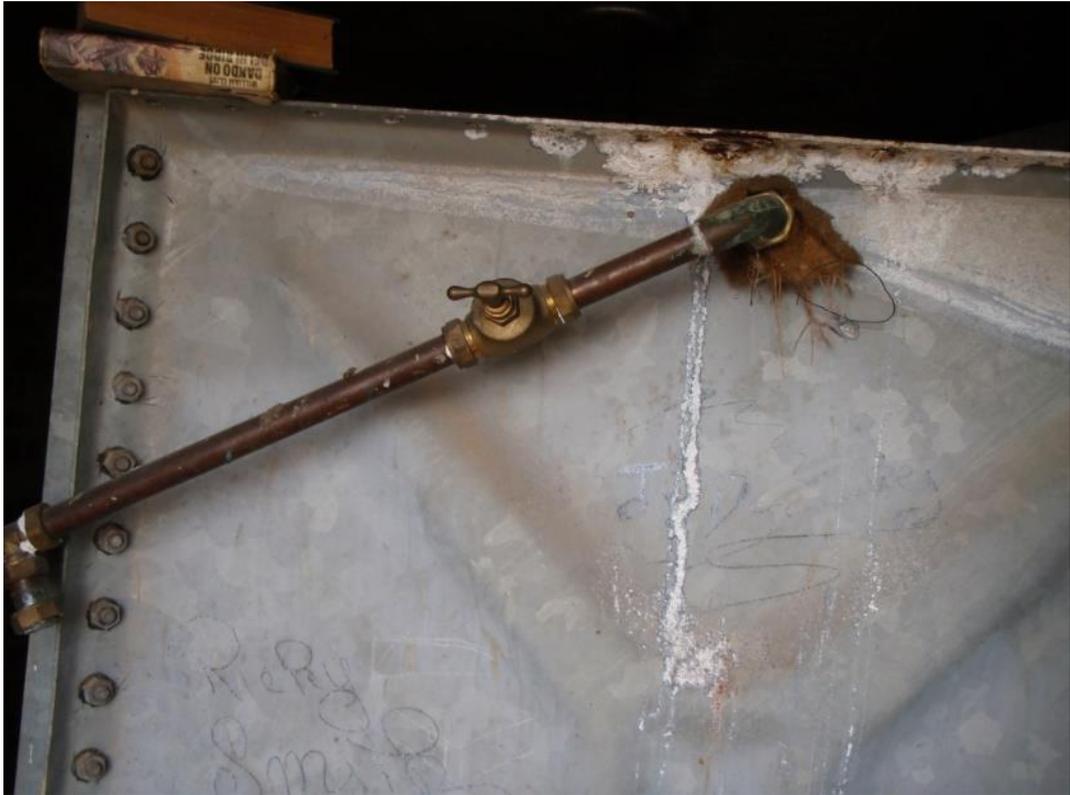
The mains incoming water to each of the flats is supplied via water storage tanks located on the fourth floor plant room. The current condition and age of the storage tanks are non-compliant to current water legislations and will require replacing. We understand at some point the water storage tank was decommissioned and flats 3, 8, 9 and 12 were modified to be fed direct from the mains cold services with local metering installed.

Figure 55. Cold water storage tank located on fourth floor.

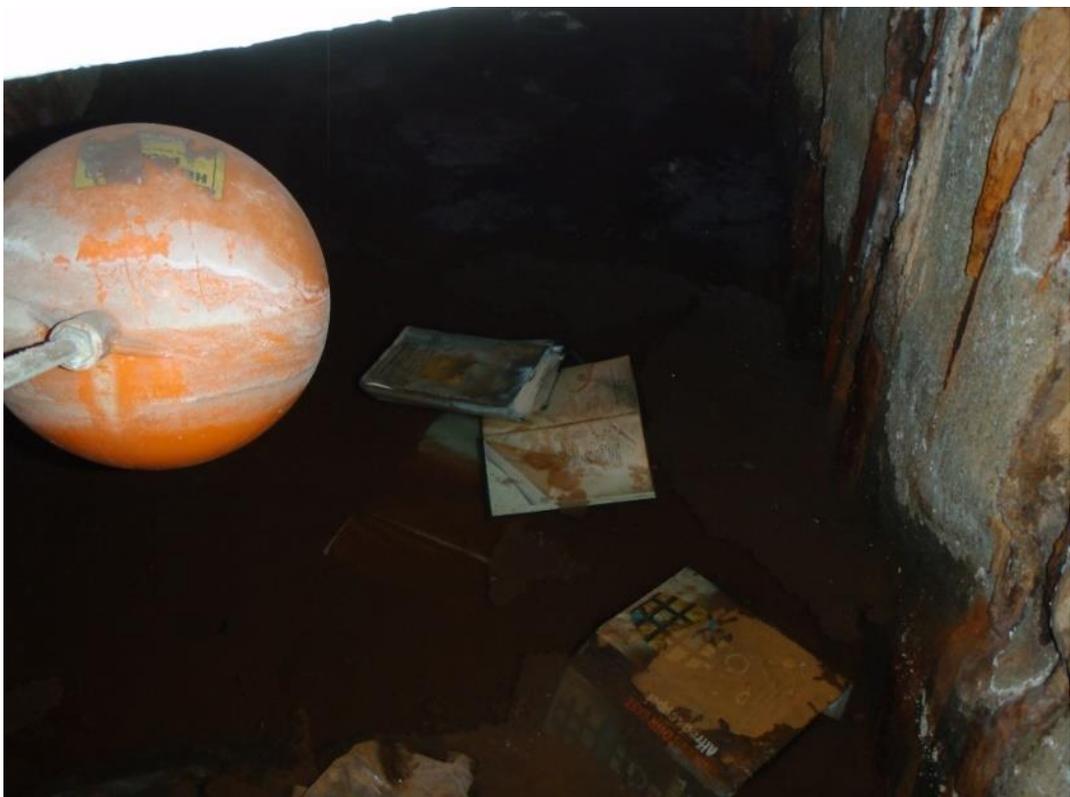
Figure 56. Internal condition of cold water storage tank located on fourth floor.

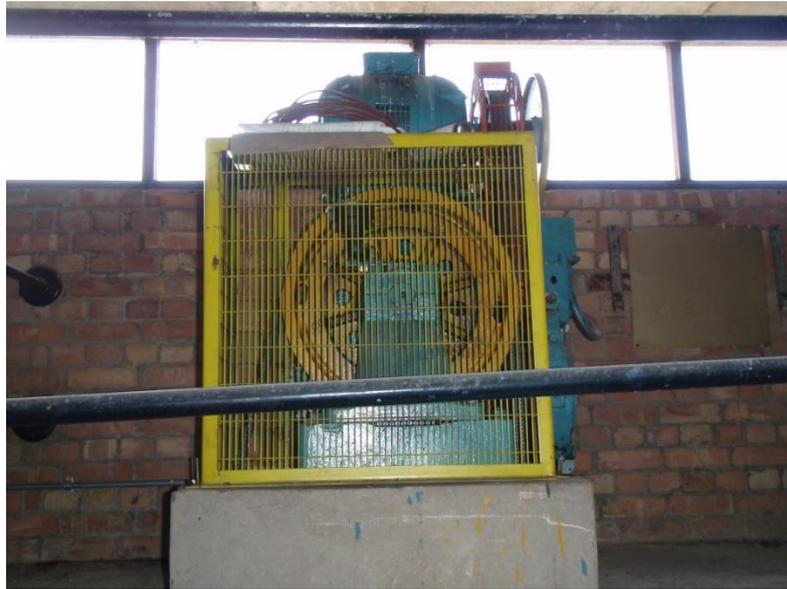
Figure 57. Lift motor room.

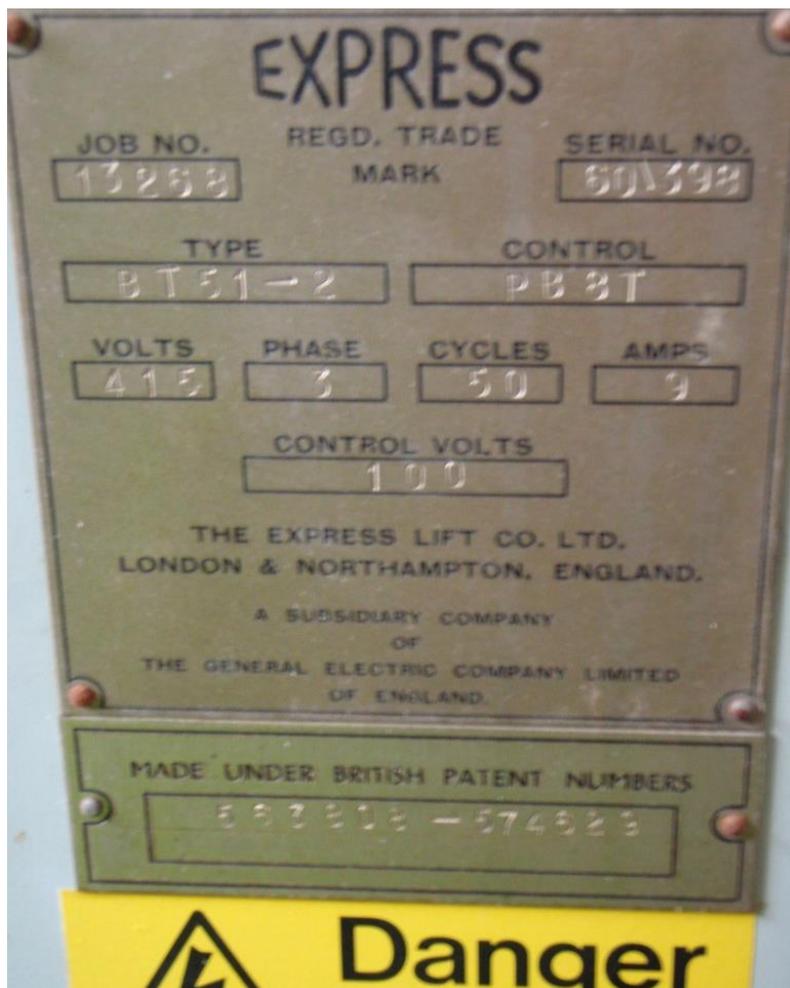
Figure 58. Details of the existing lift.
