16-0159 M&E

**A SUMMARY REPORT OF THE EXISTING MECHANICAL
AND ELECTRICAL BUILDING SERVICES**

NEVILLE HOUSE

CORBY

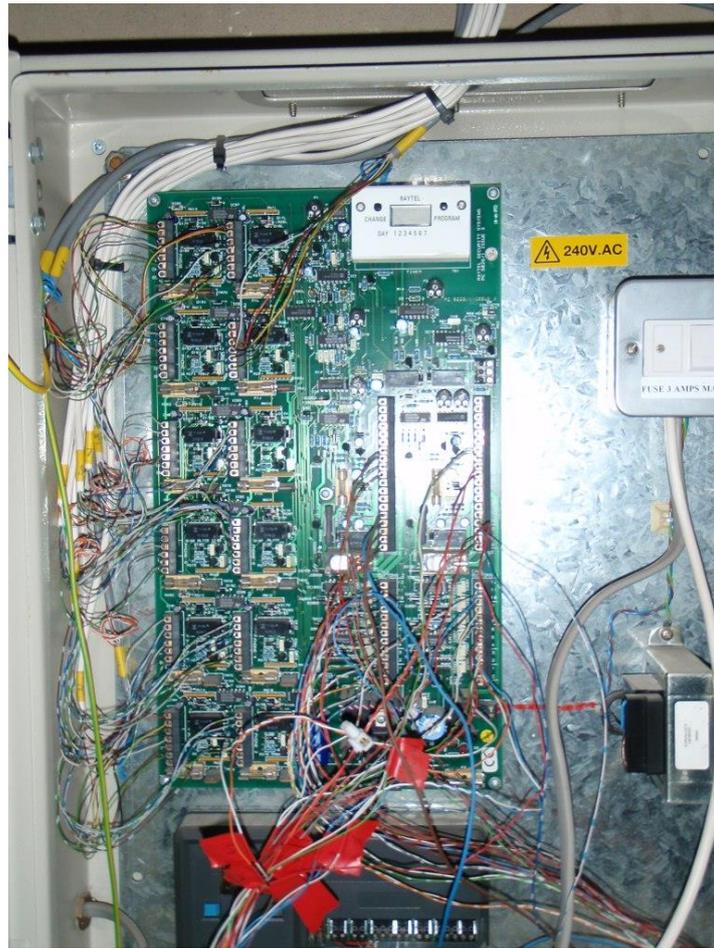
Figure 59. Inside main BT Patch panel.

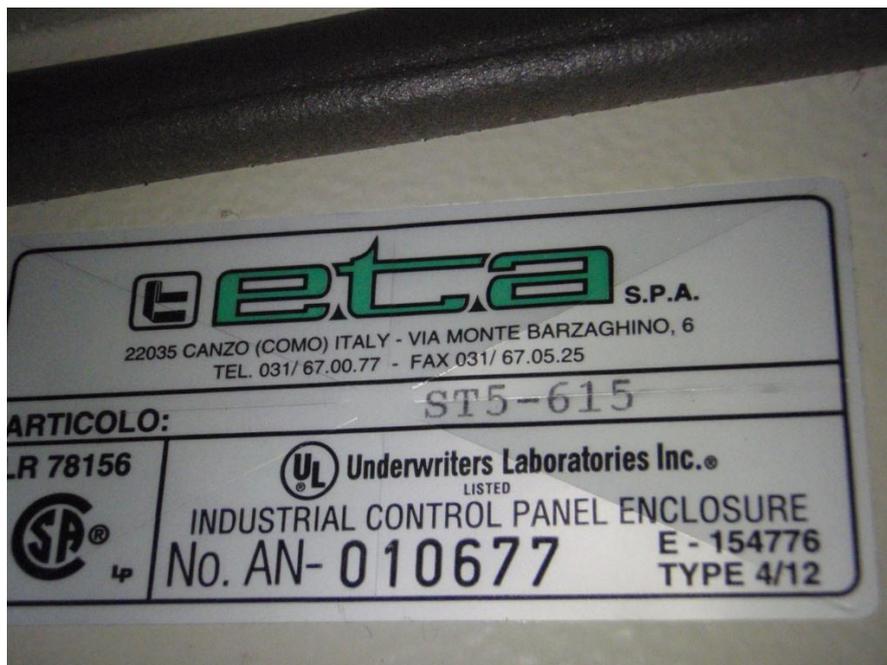
Figure 60. Details Main BT Patch panel.
