# ROOF CONDITION REPORT

**NORTH NORTHANTS COUNCIL**

**BRIGSTOCK LATHAM PRIMARY SCHOOL, LATHAM STREET,  
KETTERING, NORTHAMPTONSHIRE NN14 3HD**

**Prepared by:** George Husson (CS2) & Andrew Fox (Garland UK)  
**Checked by:** Matthew Cochrane BA(Hons) MSc  
**Date:** 22 September 2023  
**Our reference:** -  
**Revision:** A

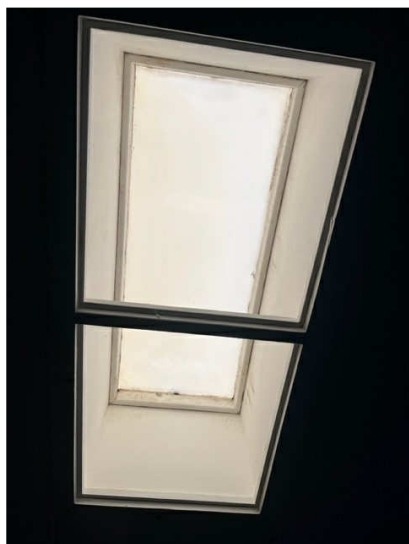
Photo 1

A look from inside at the fragile rooflights. They have degraded over the years and are now letting in reduced amount of natural light

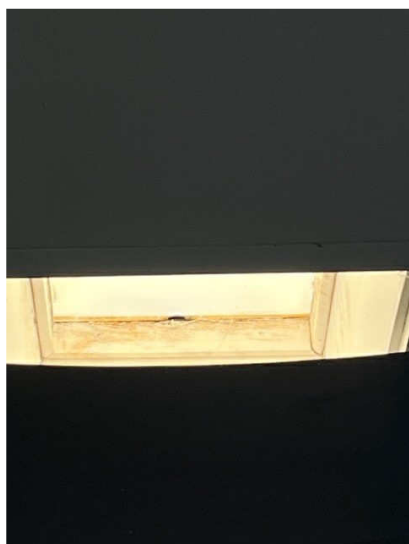
Photo 2

Evidence of water ingress at the rooflights

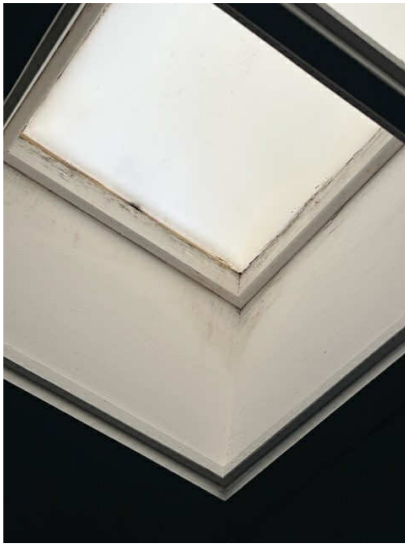
Photo 3

Evidence of water ingress around the rooflights

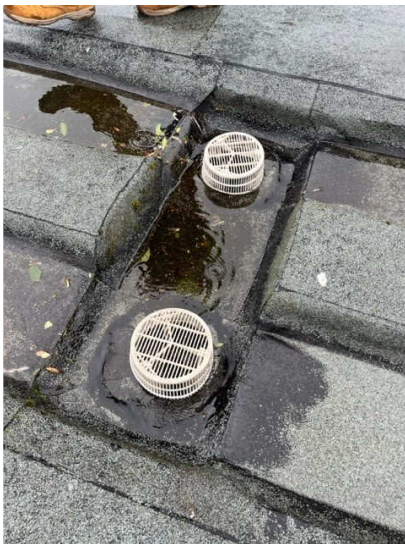
Photo 4

A look at the the two outlets at the central box gutters above the red kites classroom. Leaks are occurring around these failing outlets due to failing felts which are now nearing the end of their useful life

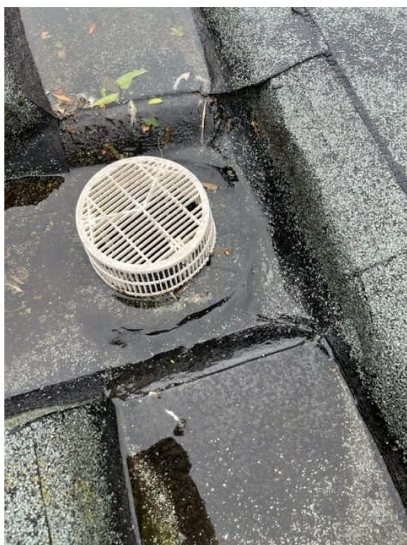
Photo 5

Outlets are well maintained but the felts are poorly bonded leading to water ingress. As part of major works it is recommended that the roofs drainage is changed to external

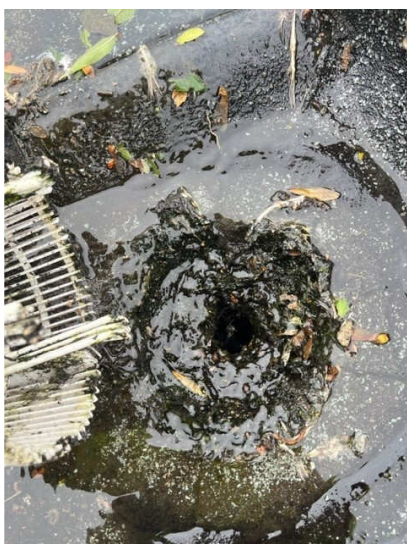
Photo 6

Felts poorly bonded into the outlets

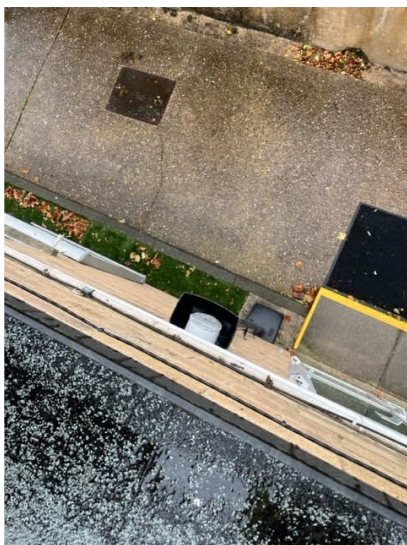
Photo 7

The outlets drain inside the roof space and exits externally via a chute and downpipe

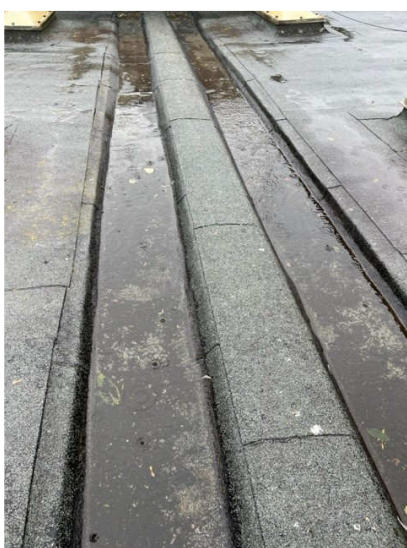
Photo 8

A look at the ponding water at the box gutters due to poor falls. The new roof system will be designed with cut to falls insulation which will drain water efficiently from the box gutters and externally via new chutes and downpipes

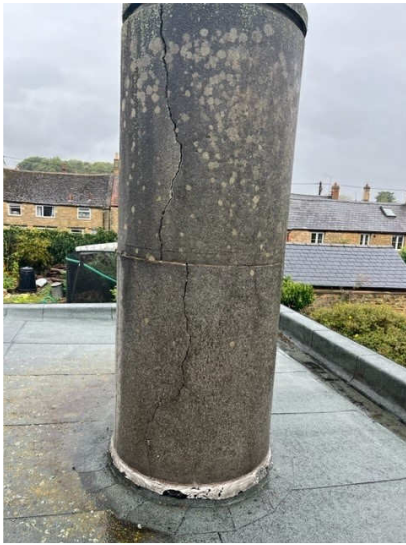
Photo 9

Chimney is in a poor condition with cracks evident, these should be repaired during major roofing works to prevent any water ingress into the new roof system

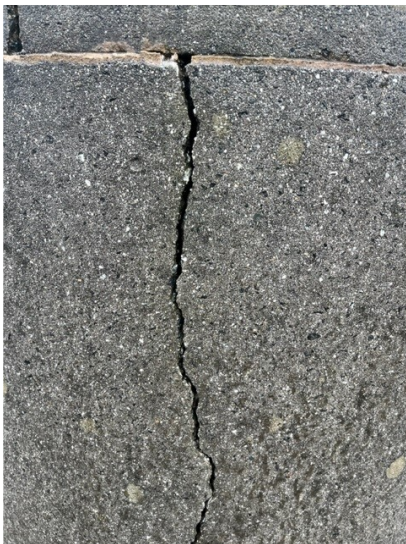
Photo 10

Cracks at the chimney

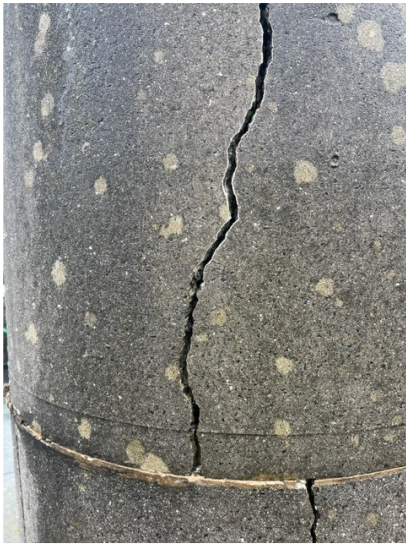
Photo 11

Cracks at the chimney to be repaired

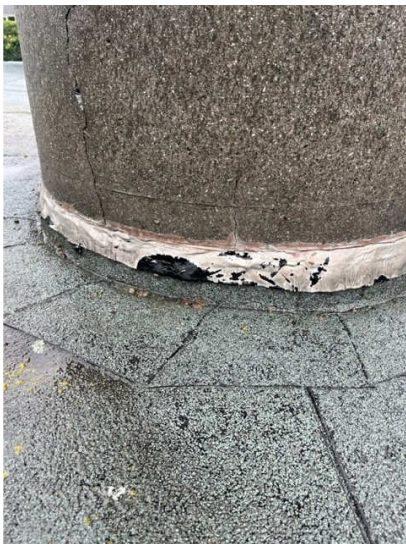
Photo 12

Lead flashing to the chimney upstands is in a poor condition

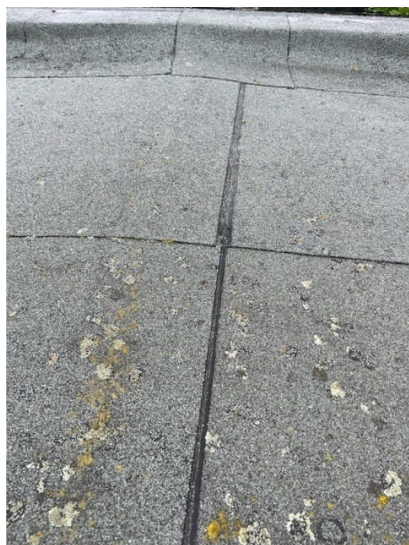
Photo 13

Some slippage at the cap sheets head laps

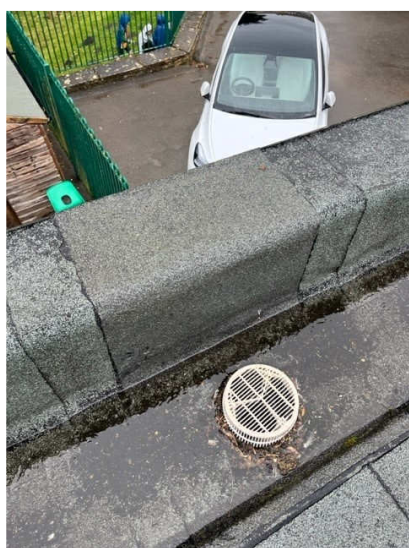
Photo 14

Repair to the roofs perimeter following water ingress

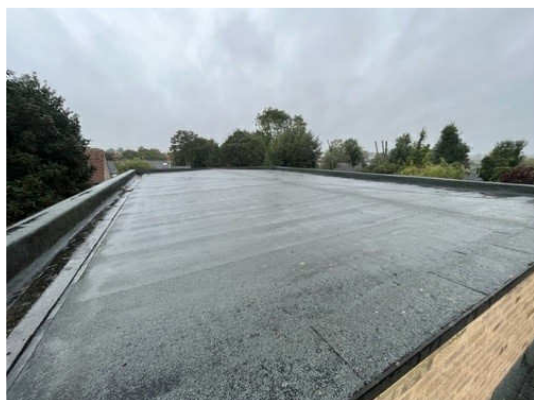
Photo 15

An overview of the hall roof which drains efficiently to the eaves where box gutters are situated. Leaks are being experienced at the failed waterproofing to the gutters and outlets

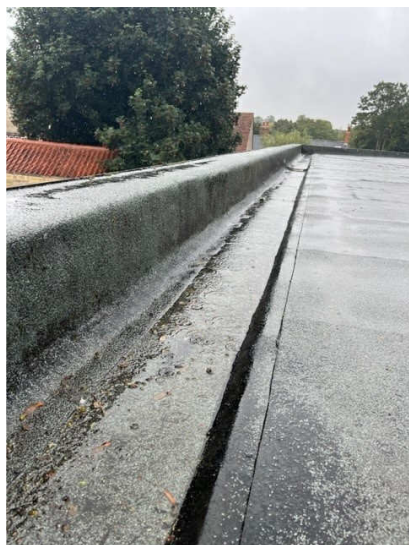
Photo 16

Box gutters at the roofs eaves, ponding water is evident leading to leaks at the failing laps

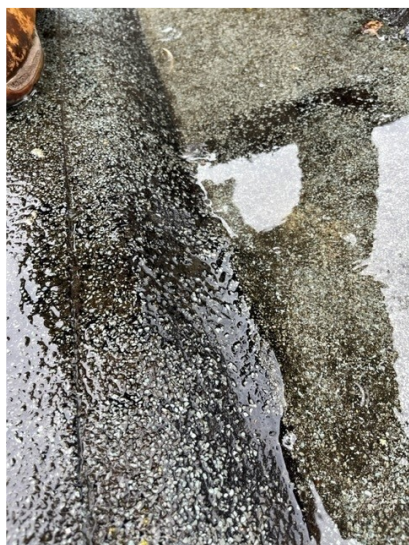
Photo 17

Evidence of water being squeezed from the gutters

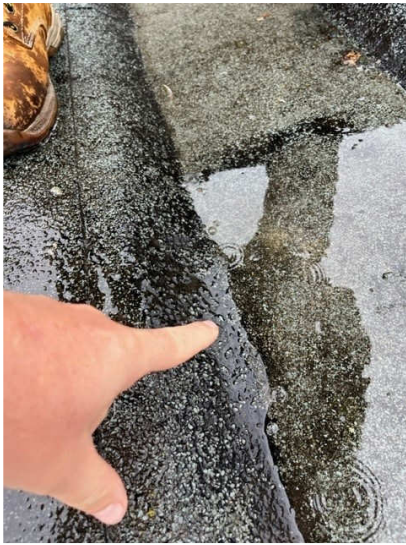
Photo 18

Water being squeezed out of the failing felts in the gutters

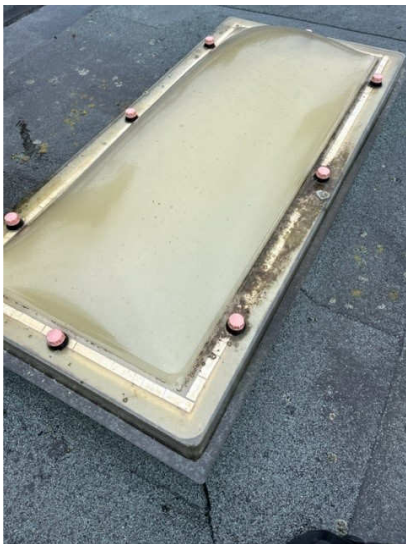
Photo 19

A look at the fragile degraded rooflights

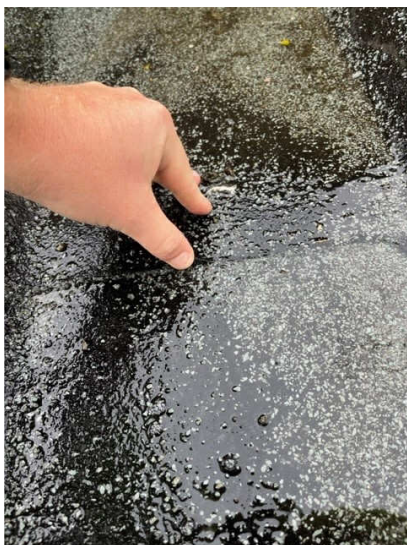
Photo 20

Failing laps at the felts leading to water ingress at gutters

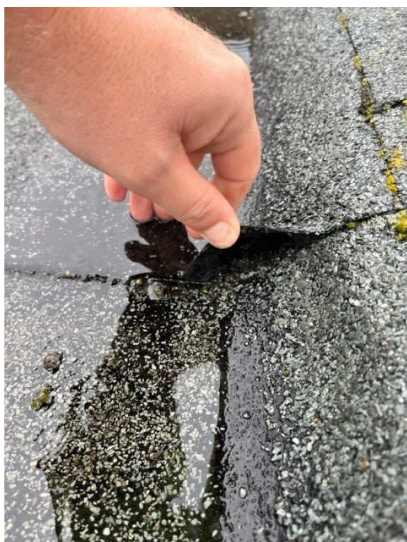
Photo 21

Failing laps at the felts leading to water ingress at gutters

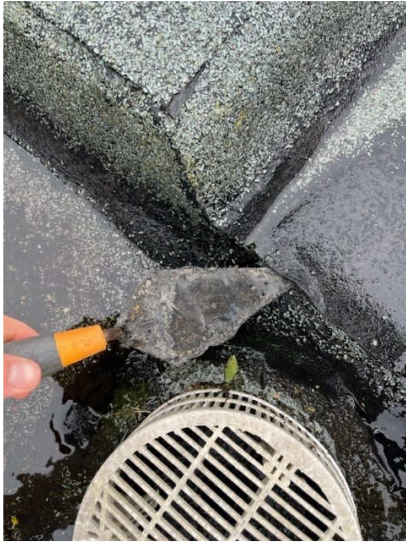
Photo 22

Failing laps at the felts leading to water ingress at gutters

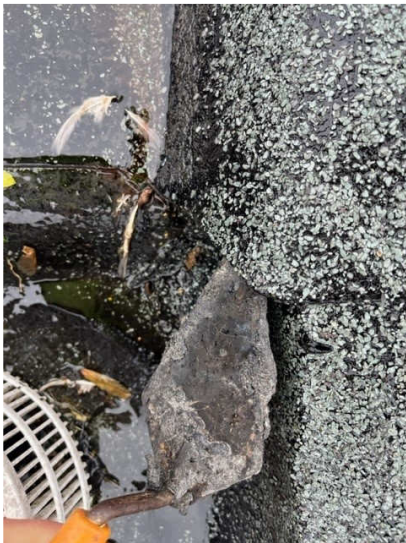
Photo 23

Failing laps at the felts leading to water ingress at gutters

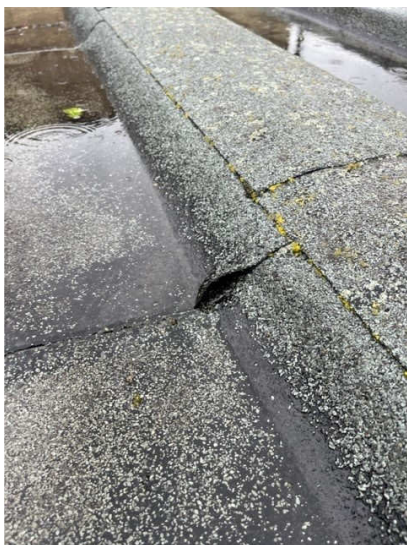
Photo 24

Failing laps at the felts leading to water ingress at gutters

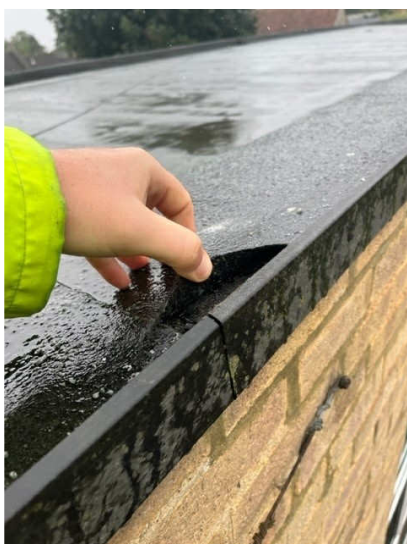
Photo 25

Lap failure is evident around the entire roofs perimeter where the aged felts have become deboned from the edge trim. Moss growth is evident which confirms water ingress under the trim and felt

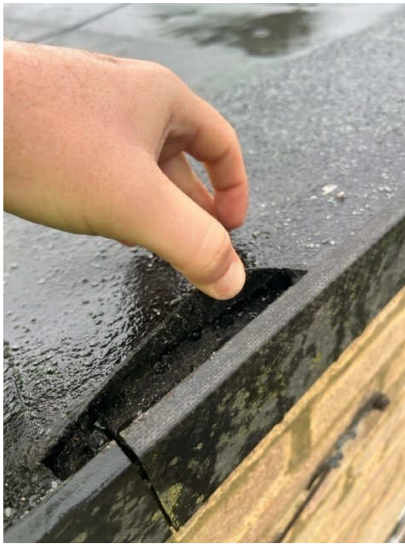
Photo 26

Lap failure is evident around the entire roofs perimeter where the aged felts have become deboned from the edge trim. Moss growth is evident which confirms water ingress under the trim and felt

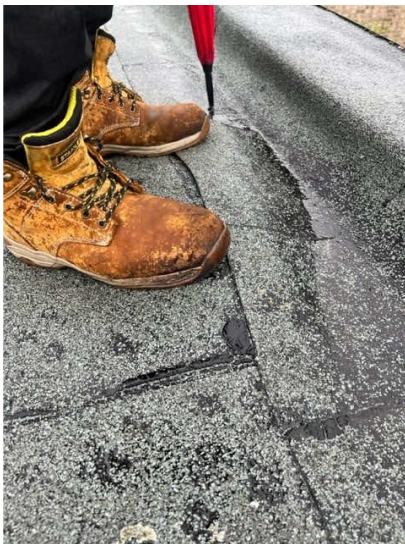
Photo 27

Blister at the roofs field

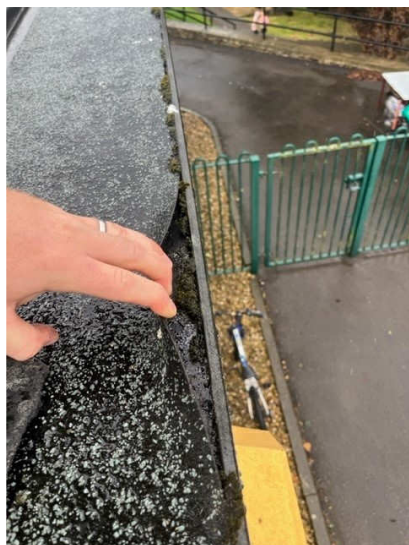
Photo 28

Lap failure is evident around the entire roofs perimeter where the aged felts have become deboned from the edge trim. Moss growth is evident which confirms water ingress under the trim and felt

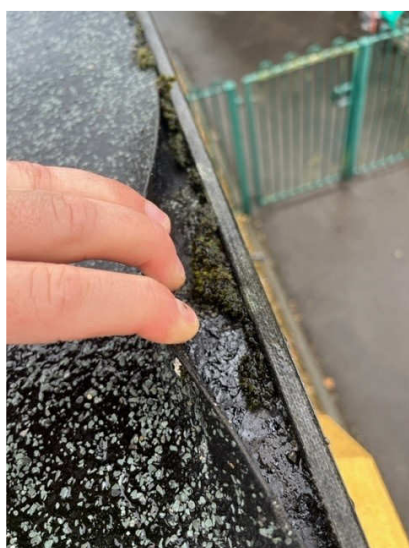
Photo 29

Lap failure is evident around the entire roofs perimeter where the aged felts have become deboned from the edge trim. Moss growth is evident which confirms water ingress under the trim and felt

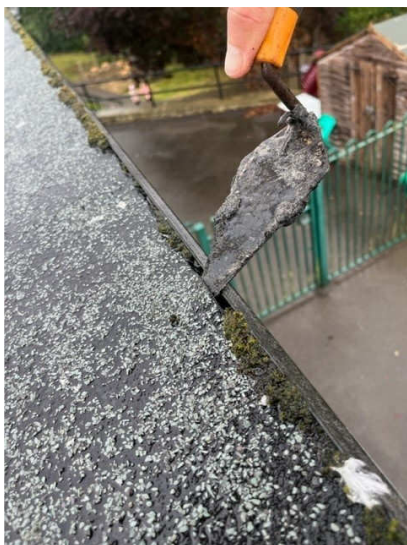
Photo 30

Lap failure is evident around the entire roofs perimeter where the aged felts have become deboned from the edge trim. Moss growth is evident which confirms water ingress under the trim and felt

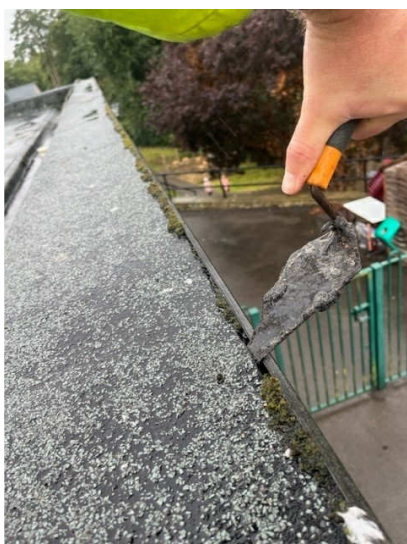
Photo 31

Lap failure is evident around the entire roofs perimeter where the aged felts have become deboned from the edge trim. Moss growth is evident which confirms water ingress under the trim and felt

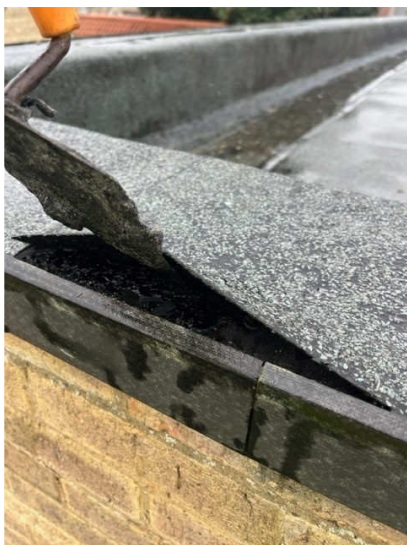
Photo 32

Lap failure is evident around the entire roofs perimeter where the aged felts have become deboned from the edge trim. Moss growth is evident which confirms water ingress under the trim and felt

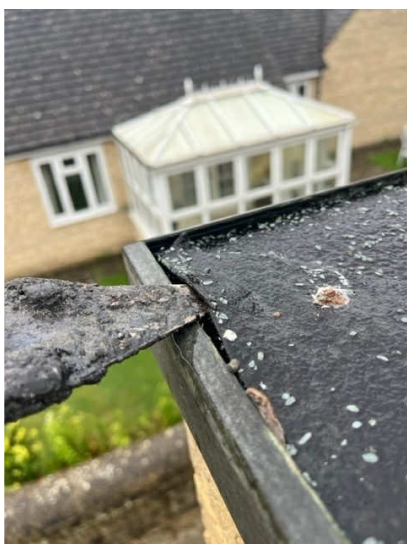
Photo 33

Lap failure is evident around the entire roofs perimeter where the aged felts have become deboned from the edge trim. Moss growth is evident which confirms water ingress under the trim and felt

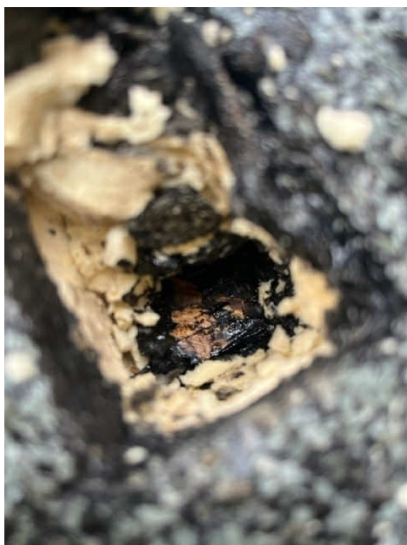
Photo 34

Core samples confirm the same build up with falls in the timber deck. The roofs have a poor thermal performance

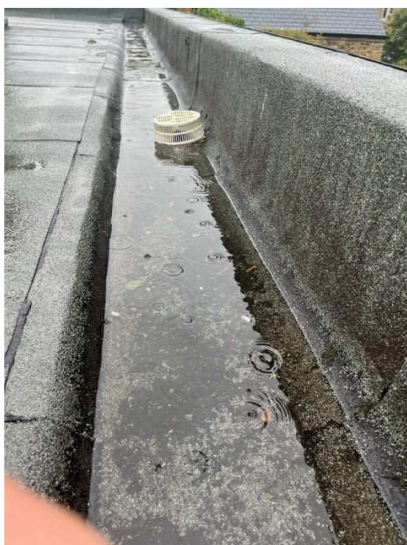
Photo 35

A look at the ponding water at the halls gutters, the gutters have a poor fall. Failing laps to the gutter and outlet leading to roofs leaks.

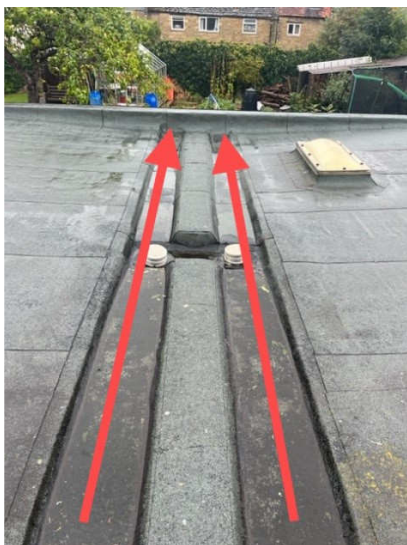
Photo 36

A look at the double box gutters to the lower roof which hold water and are leaking. Garland would design the gutters to drain externally, upgrading the existing hopper and downpipe to ensure it can cope with the amount of rainwater discharged

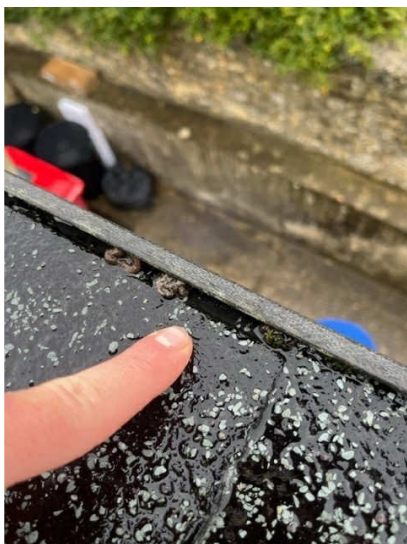
Photo 37

Felts poorly bonded into the edge trim, a source for water ingress

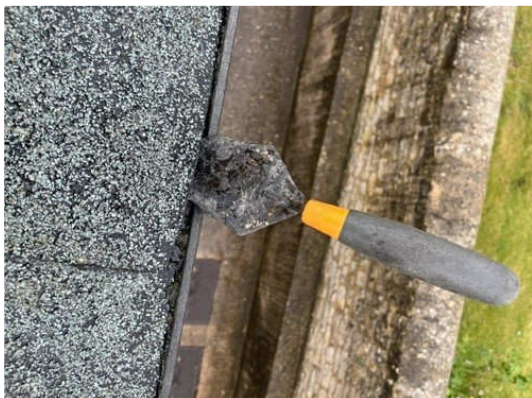
Photo 38

Failed felt to the edge trims

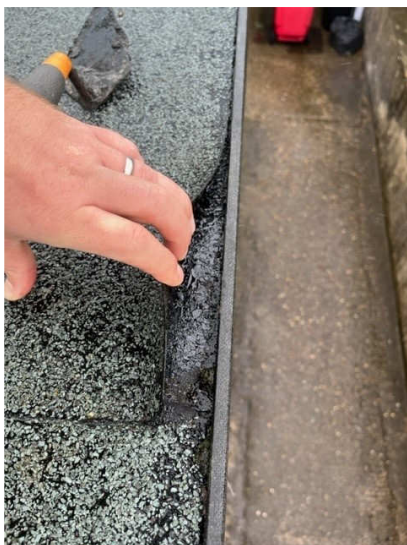
Photo 39

Failed felt to the edge trims

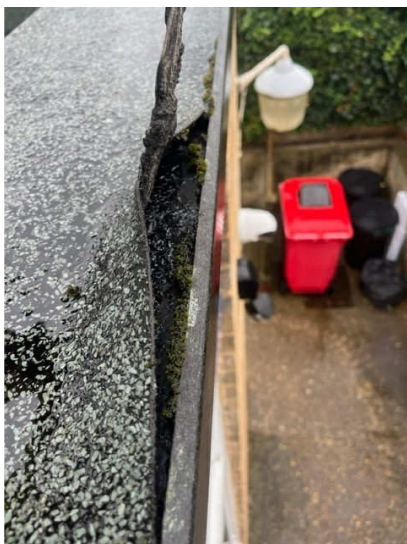
Photo 40

Failed felt to the edge trims

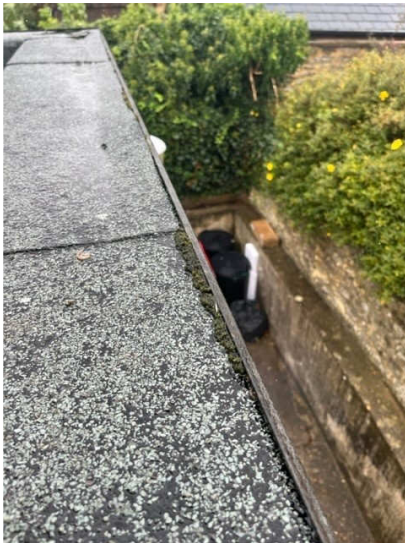
Photo 41

Moss growth at the edge trim suggesting water ingress under the felts

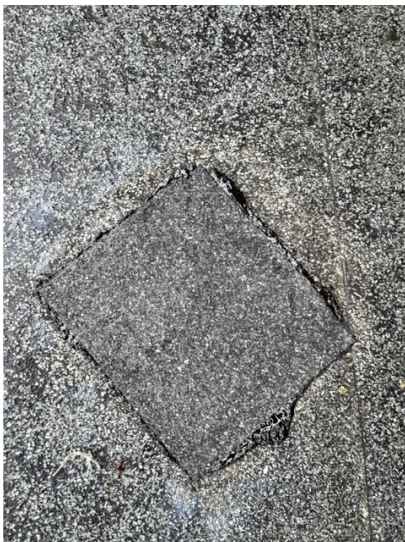
Photo 42

Fully bonded patch repair to the core sample

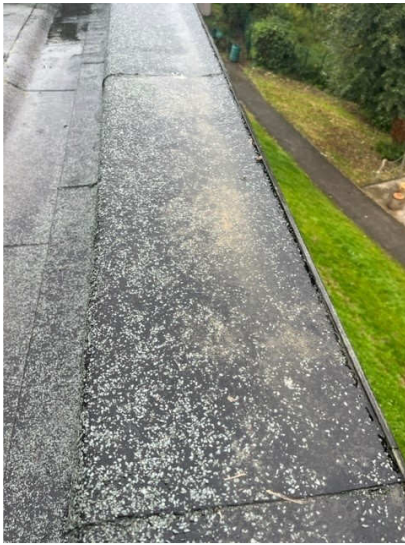
Photo 43

Water sitting on the top of the parapet wall leading to water ingress under the failing felts at the edge trim

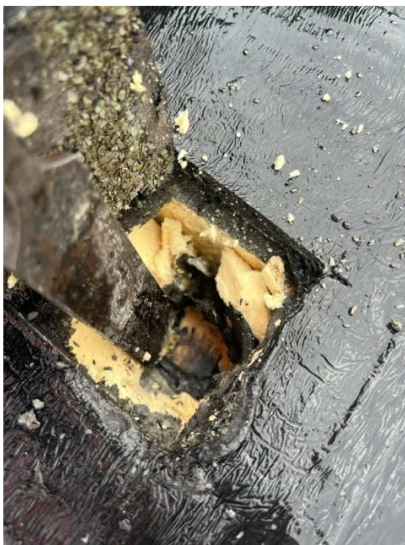
Photo 44

Core sample at the hall roof confirms the same build up throughout

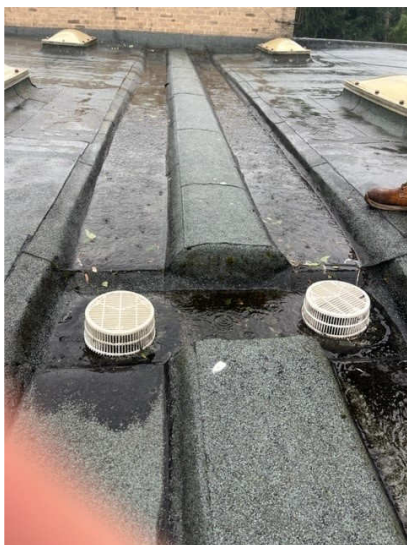
Photo 45

A look at the ponding water in the gutters, the gutters and outlets are failing resulting in water ingress into the classroom below which has taken the lights out

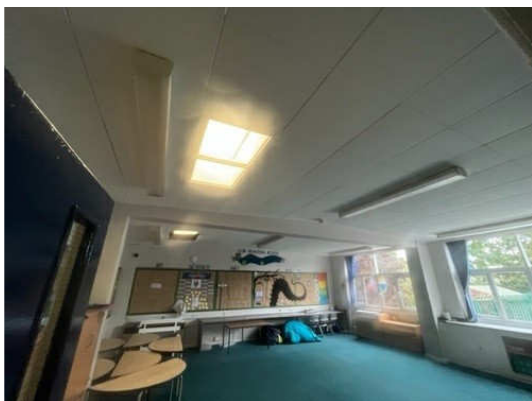
Photo 46

Lighting taken out following roof leaks

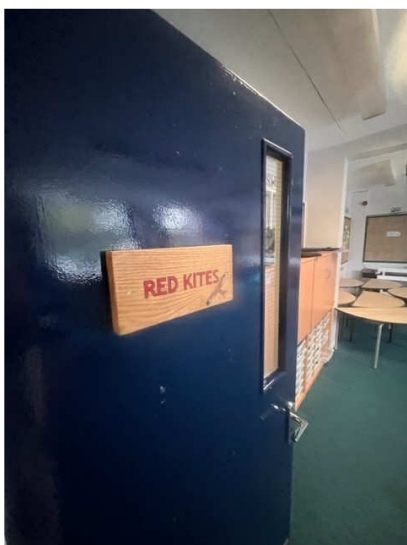
Photo 47

Red kite suffering roof leaks which has taken the lighting out

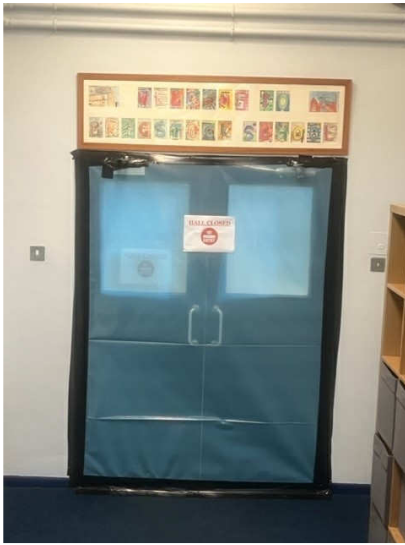
Photo 48

Hall sealed off following roof leaks at the asbestos ceilings
