**REPORT NUMBER 13198/146**

**ASBESTOS SURVEY AT**

**Risborough Community Centre,  
Wards Parks, Stratton Road, Princess  
Risborough, HP27 9AX**

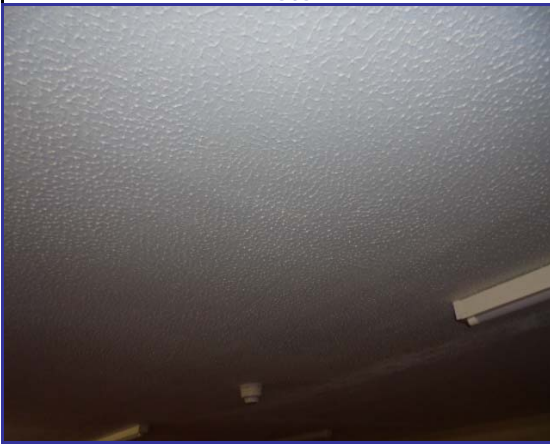
<b>Building</b> Community Centre	<b>Job no</b> 13198/146	<b>Sample No</b> SES 070220 03	<b>Photo</b>

General remarks: The Artex coating is applied to the ceiling area. The Artex coating should be monitored regularly for signs of damage and/or deterioration.

<b>Area</b> Cherry Baker Room	<b>Condition</b> Good		
<b>Location</b> Ceiling	<b>Type of material</b> Artex		
<b>Installation</b> Artex	<b>Content</b> CHRYSTILE  Trace		
<b>Material Assessment Score</b> <b>2</b>			<b>RISK CATEGORY</b> <b>D</b>
<b>General remarks</b> The Artex coating is applied to the ceiling area. The Artex coating should be monitored regularly for signs of damage and/or deterioration.

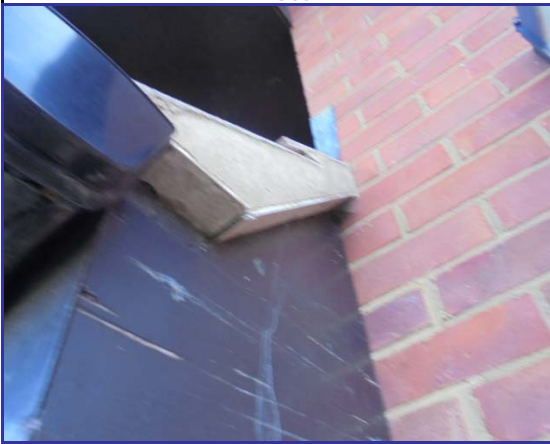
<b>Building</b> Community Centre	<b>Job no</b> 13198/146	<b>Sample No</b> SES 070220 06	<b>Photo</b>

General remarks: The insulation boards form the undercloak panels beneath the roof edge tiles throughout the exterior. The insulation board under cloak should be monitored regularly for signs of damage and/or deterioration.

<b>Area</b> Exterior	<b>Condition</b> Good		
<b>Location</b> Roof Edges	<b>Type of material</b> Insulation Board		
<b>Installation</b> Insulation Board Under cloak	<b>Content</b> CHRYSTILE  Significant		
<b>Material Assessment Score</b> <b>4</b>			<b>RISK CATEGORY</b> <b>C</b>
<b>General remarks</b> The insulation boards form the undercloak panels beneath the roof edge tiles throughout the exterior. The insulation board under cloak should be monitored regularly for signs of damage and/or deterioration.

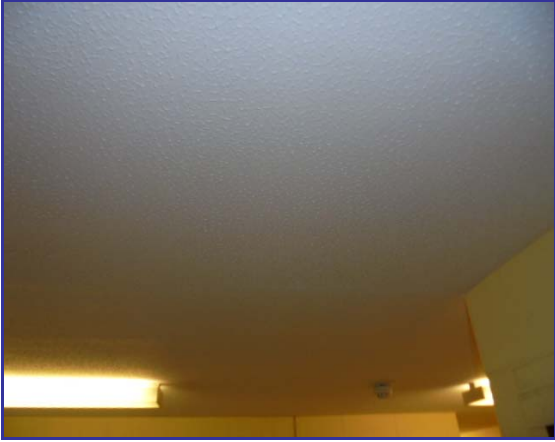
<b>Building</b> Community Centre	<b>Job no</b> 13198/146	<b>Sample No</b> SES 070220 X03a	<b>Photo</b>

General remarks: The Artex coating is applied to the ceiling area. The Artex coating should be monitored regularly for signs of damage and/or deterioration.

<b>Area</b> Main Corridor		<b>Condition</b> Good					
<b>Location</b> Ceiling		<b>Type of material</b> Artex					
<b>Installation</b> Artex		<b>Content</b> CHRYSTILE					
		Trace					
<table border="1"> <tr> <td><b>Material Assessment Score</b></td> <td><b>2</b></td> <td><b>RISK CATEGORY</b></td> <td><b>D</b></td> </tr> </table>			<b>Material Assessment Score</b>	<b>2</b>	<b>RISK CATEGORY</b>	<b>D</b>	<b>General remarks</b> <p>The Artex coating is applied to the ceiling area. The Artex coating should be monitored regularly for signs of damage and/or deterioration.</p>
<b>Material Assessment Score</b>	<b>2</b>	<b>RISK CATEGORY</b>	<b>D</b>

**Remedial measures:** **Extent:** **Material Assessment score**  
**Monitor** 22 M2 **2**
