Refurbishment / Demolition Asbestos Survey

The Stephen Longfellow Academy
Temporary accomodation
Block 4
Bruntcliffe Academy
Bruntcliffe Lane
Morley LS27 0LZ

Issue number:	1
Survey number:	10937
Survey date:	24/05/2017
Client:	The Stephen Longfellow Academy
Survey carried out by:	Andrew Stather
Survey compiled by:	Jane Brown
Survey checked by:	<i>A.M. Brown.</i>

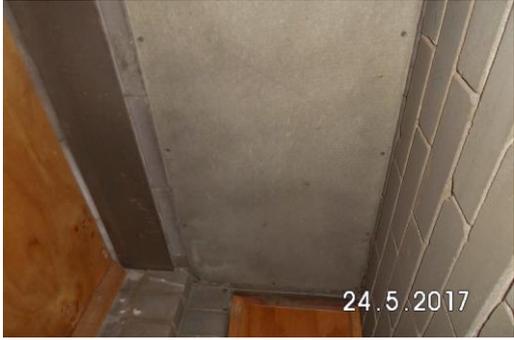
Level of ID:	Previously sampled	Ref:	PS
	Building / Floor: Main / Ground Area: 032 Store Location: Cupboard Description: Cement panel to inside of cupboard Asbestos Type: Chrysotile Amount: 1m2			
Recommendations:				
Remove in accordance with the Control of Asbestos Regulations 2012 and dispose of as hazardous waste

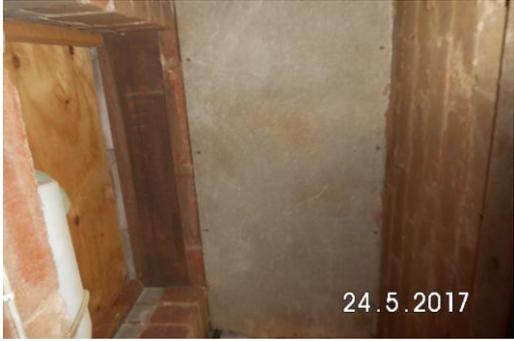
Level of ID:	Previously sampled	Ref:	PS
	Building / Floor: Main / Ground Area: 033 Store Location: Cupboard Description: Cement panel to inside of cupboard Asbestos Type: Chrysotile Amount: 1m2			
Recommendations:				
Remove in accordance with the Control of Asbestos Regulations 2012 and dispose of as hazardous waste

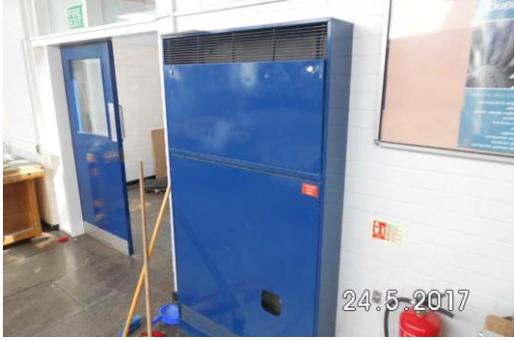
Level of ID:	Visually inspected	Ref:	-
	Building / Floor: Main / Ground Area: 034 Circulation Location: Heater Description: No suspect materials to heating unit Asbestos Type: No suspect materials Amount: Typical			
Recommendations:				
No action required

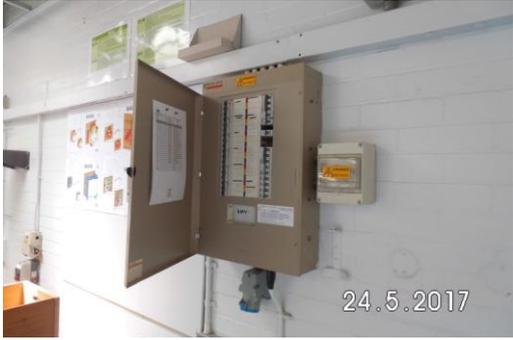
Level of ID:	Visually inspected	Ref:	-
	<p>Building / Floor: Main / Ground</p> <p>Area: 035 Resistant Materials</p> <p>Location: Electrics</p> <p>Description: Modern distribution box</p> <p>Asbestos Type: No suspect materials</p> <p>Amount: Typical</p>

No action required

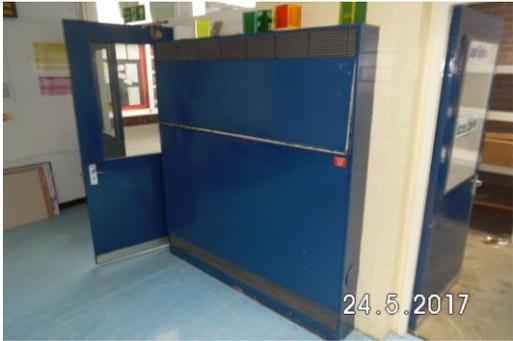
Level of ID:	Visually inspected	Ref:	-
	<p>Building / Floor: Main / Ground</p> <p>Area: 035 Resistant Materials</p> <p>Location: Heater</p> <p>Description: No suspect materials to heating unit</p> <p>Asbestos Type: No suspect materials</p> <p>Amount: Typical</p>

No action required

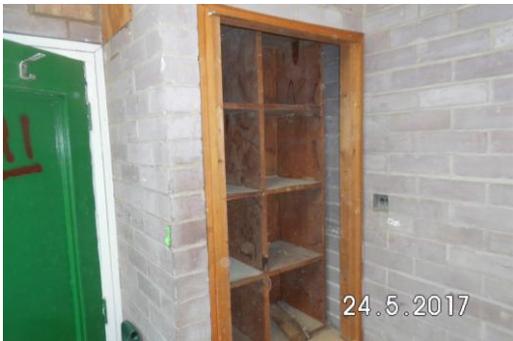
Level of ID:	Previously sampled	Ref:	PS
	<p>Building / Floor: Main / Ground</p> <p>Area: 036 Store</p> <p>Location: Cupboard</p> <p>Description: Cement panel to inside of cupboard</p> <p>Asbestos Type: Chrysotile</p> <p>Amount: 1m2</p>

Remove in accordance with the Control of Asbestos Regulations 2012 and dispose of as hazardous waste

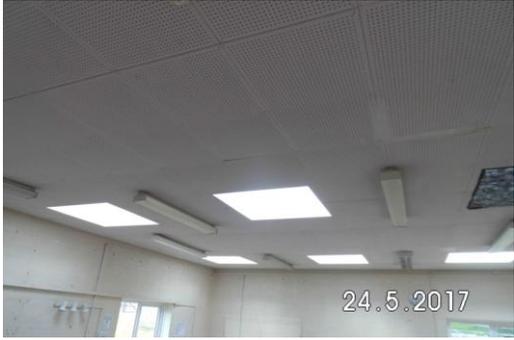
Level of ID:	Previously sampled	Ref:	PS
	Building / Floor: Main / Ground Area: 037 Textiles Location: Ceiling Description: Insulation board panels to ceiling Asbestos Type: Amosite Amount: 76m2

Remove in accordance with the Control of Asbestos Regulations 2012 and dispose of as hazardous waste

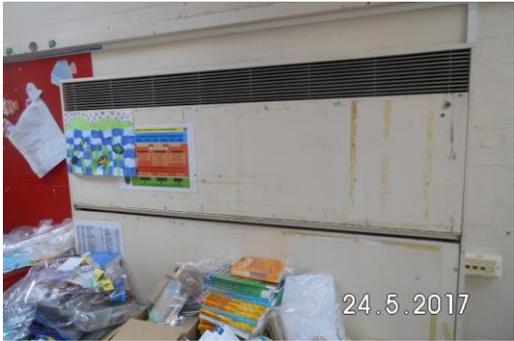
Level of ID:	Visually inspected	Ref:	-
	Building / Floor: Main / Ground Area: 037 Textiles Location: Heater Description: No suspect materials to heating unit Asbestos Type: No suspect materials Amount:

No action required

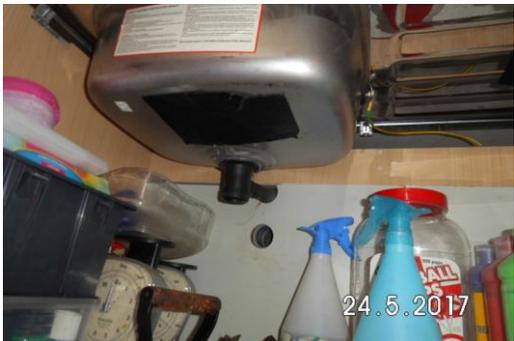
Level of ID:	Visually inspected	Ref:	-
	Building / Floor: Main / Ground Area: 037 Textiles Location: Sink Description: Modern acoustic pad to underside of basin Asbestos Type: No suspect material Amount: Item

No action required

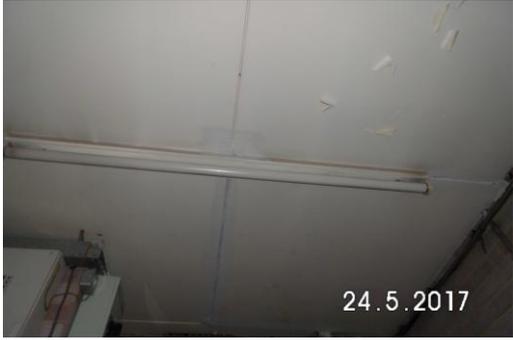
Level of ID:	Previously sampled	Ref:	PS
	Building / Floor: Main / Ground Area: 038 Store Location: Ceiling Description: Insulation board panels to ceiling Asbestos Type: Amosite Amount: 6m2

Remove in accordance with the Control of Asbestos Regulations 2012 and dispose of as hazardous waste

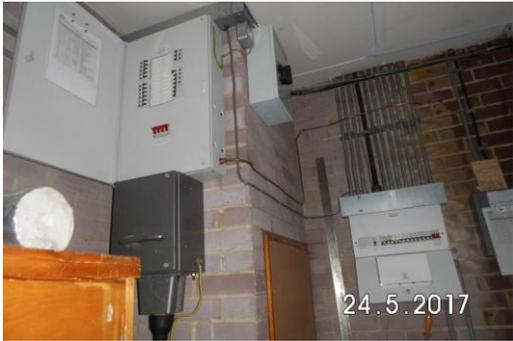
Level of ID:	Visually inspected	Ref:	-
	Building / Floor: Main / Ground Area: 038 Store Location: Electrics Description: Modern fuse box and distribution box Asbestos Type: No suspect materials Amount:

No action required

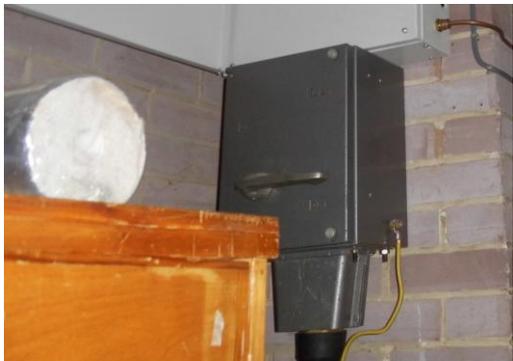
Level of ID:	Presumed	Ref:	P1
	Building / Floor: Main / Ground Area: 038 Store Location: Electrics Description: Textiles presumed within isolator box Asbestos Type: Chrysotile Amount: Items

Remove in accordance with the Control of Asbestos Regulations 2012 and dispose of as hazardous waste

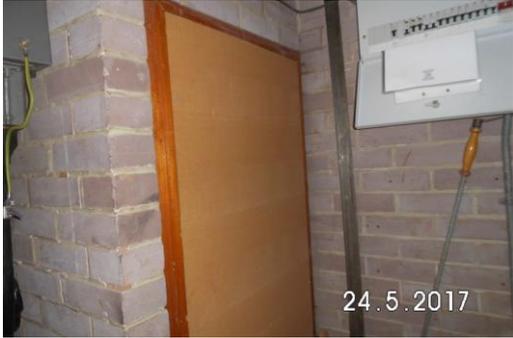
Level of ID:	Previously sampled	Ref:	PS
	Building / Floor: Main / Ground Area: 038 Store Location: Cupboard Description: Cement panel to inside of cupboard Asbestos Type: Chrysotile Amount: 1m2

Remove in accordance with the Control of Asbestos Regulations 2012 and dispose of as hazardous waste

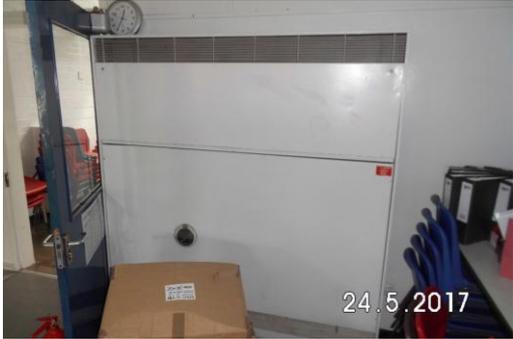
Level of ID:	Visually inspected	Ref:	-
	Building / Floor: Main / Ground Area: 039 Learning Zone Location: Heater Description: No suspect materials to heating unit Asbestos Type: No suspect materials Amount:

No action required

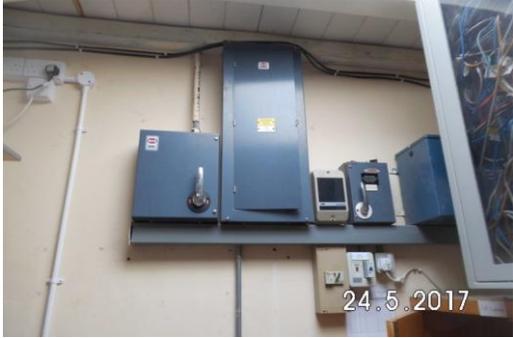
Level of ID:	Visually inspected	Ref:	-
	Building / Floor: Main / Ground Area: 040 Store Location: Electrics Description: Modern switchgear Asbestos Type: No suspect materials Amount:

No action required

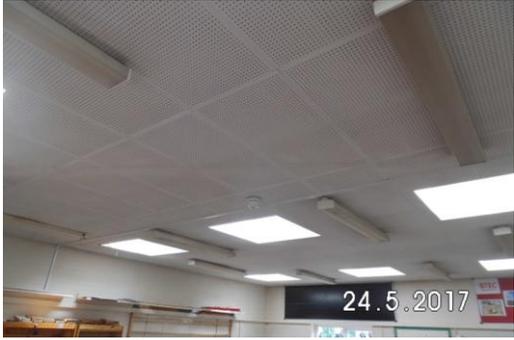
Level of ID:	Previously sampled	Ref:	PS
	<p>Building / Floor: Main / Ground</p> <p>Area: 043 Resistant Materials</p> <p>Location: Ceiling</p> <p>Description: Insulation board panels to ceiling</p> <p>Asbestos Type: Amosite</p> <p>Amount: 72m2</p>

Remove in accordance with the Control of Asbestos Regulations 2012 and dispose of as hazardous waste

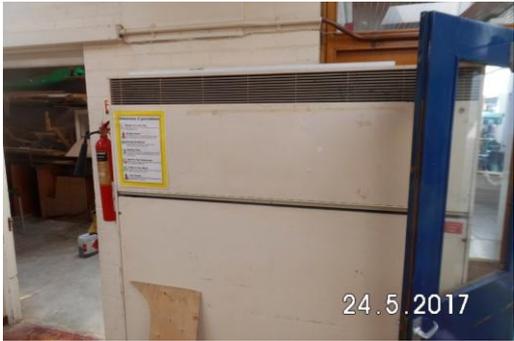
Level of ID:	Visually inspected	Ref:	-
	<p>Building / Floor: Main / Ground</p> <p>Area: 043 Resistant Materials</p> <p>Location: Heater</p> <p>Description: No suspect materials to heating unit</p> <p>Asbestos Type: No suspect materials</p> <p>Amount:</p>

No action required

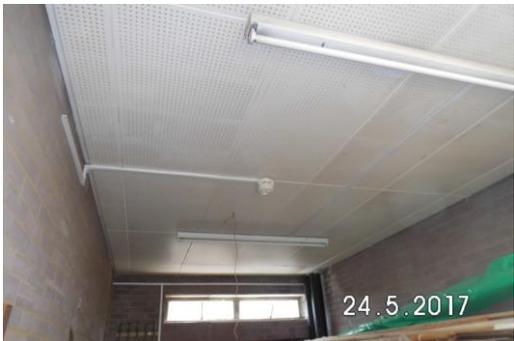
Level of ID:	Previously sampled	Ref:	PS
	<p>Building / Floor: Main / Ground</p> <p>Area: 044 Store</p> <p>Location: Ceiling</p> <p>Description: Insulation board panels to ceiling</p> <p>Asbestos Type: Amosite</p> <p>Amount: 18m2</p>

Remove in accordance with the Control of Asbestos Regulations 2012 and dispose of as hazardous waste

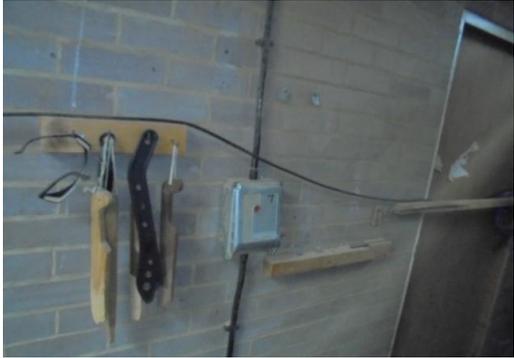
Level of ID:	Previously sampled	Ref:	PS
	Building / Floor: Main / Ground Area: 044 Store Location: Electrics Description: Textile fuse tapes within fuse box Asbestos Type: Chrysotile Amount: Items			
Recommendations:				
Remove in accordance with the Control of Asbestos Regulations 2012 and dispose of as hazardous waste

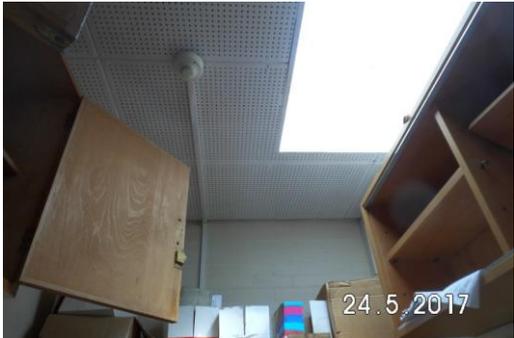
Level of ID:	Previously sampled	Ref:	PS
	Building / Floor: Main / Ground Area: 045 Circulation Location: Ceiling Description: Insulation board panels to ceiling Asbestos Type: Amosite Amount: 6m2			
Recommendations:				
Remove in accordance with the Control of Asbestos Regulations 2012 and dispose of as hazardous waste

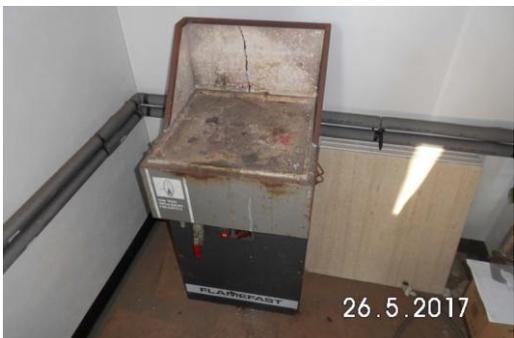
Level of ID:	Previously sampled	Ref:	PS
	Building / Floor: Main / Ground Area: 057 Boiler House Location: Walls Description: Insulation board lining to brazing bench Asbestos Type: Amosite Amount: Item			
Recommendations:				
Remove in accordance with the Control of Asbestos Regulations 2012 and dispose of as hazardous waste

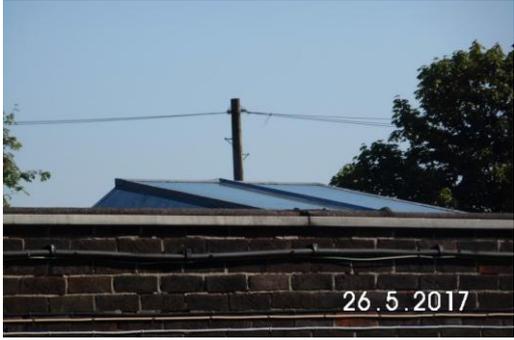
Level of ID:	Presumed	Ref:	P2
	Building / Floor: Main / External Area: Roof Location: Glazings Description: Asbestos rope gaskets presumed to glazings on roof Asbestos Type: Chrysotile Amount: All			
Recommendations:				
Remove in accordance with the Control of Asbestos Regulations 2012 and dispose of as hazardous waste
