Columba Cook

Burrard-Neale Monument Lymington

Condition Survey and Cleaning Trials

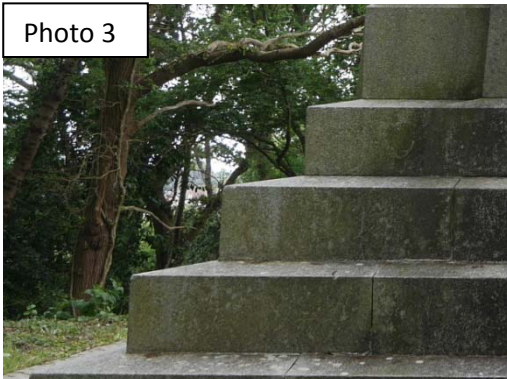
Photo 3

4. The following trials were carried out:
 - A. 0.3 x 1 m trial to step on east elevation of stone plinth using the ThermaTech at 100°C (photo 3 and 4).

Cleaning trial 'A' – before

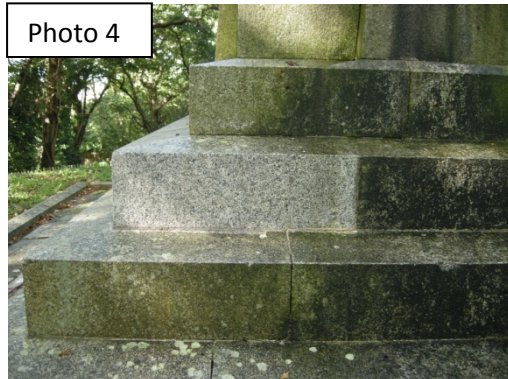
Photo 4

5. The ThermaTech system quickly removed the general soiling on the face of the granite in trials A, B, C, D, E, and F. A temperature of 120°C was recommended to prevent biological growths from re-establishing quickly. This system also removed the majority of the white precipitate in cleaning trial G.

Cleaning trial 'A' - after

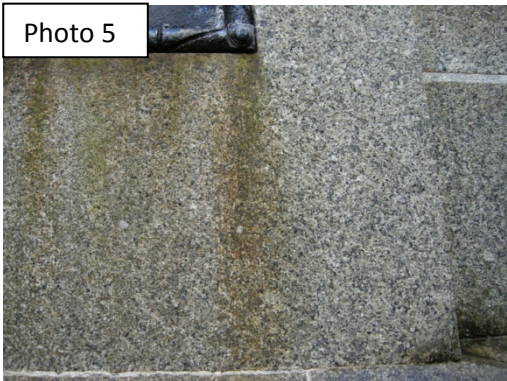
Photo 5

- B. 0.3 x 0.2 m trial below southern corner of cast iron plaque on west elevation using the ThermaTech at 120°C (photo 5 and 6).
 - C. 0.3 x 0.2 m trial to top step of west elevation of base using the ThermaTech at 120°C (photo 7 and 8).

Cleaning trial 'B' – before

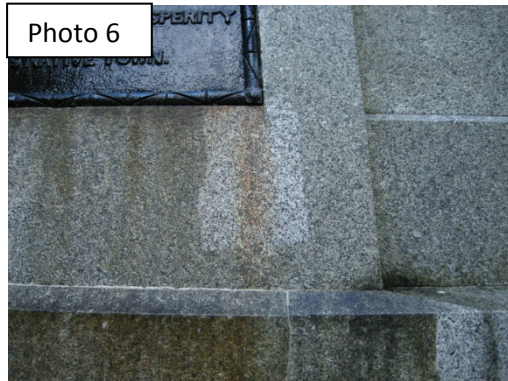
Photo 6

6. The ThermaTech system did not entirely remove the dark stains from sheltered areas or the rust staining at the base of the plaques (photos 6 and 8) in trial B and C. A further trial using the ThermaTech system followed by JOS was tried on similar staining in trial D and E.

Cleaning trial 'B' – after

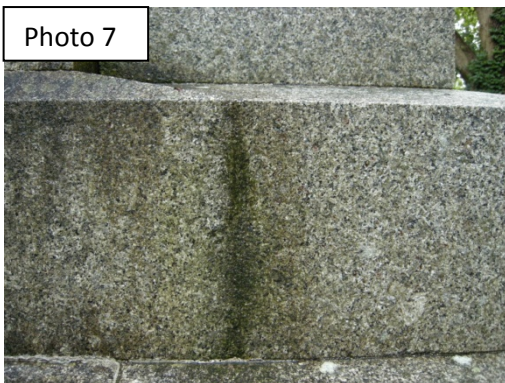
Cleaning trial 'C' – before

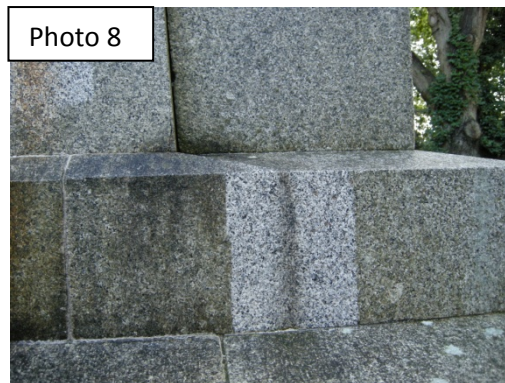
Cleaning trial 'C' – after

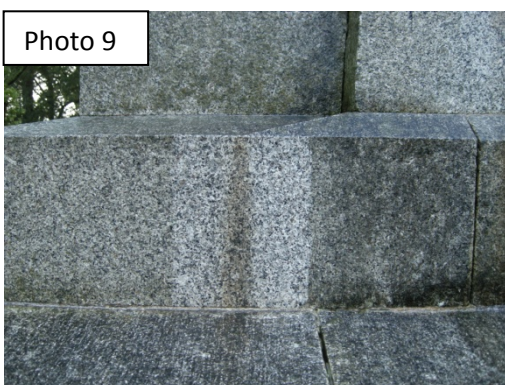
- D. 0.3 x 0.2 m trial below northern corner of cast iron plaque on west elevation using the ThermaTech at 120°C and JOS calcite abrasive at 4 bars.
 - E. 0.3 x 0.2 m trial to top step of west elevation of base using the ThermaTech at 120°C and JOS calcite abrasive at 4 bars (photo 9 and 10).

Cleaning trial 'E' – after Thermatech

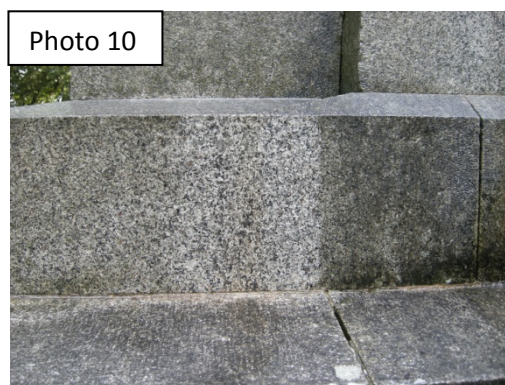
7. The JOS system was effective at removing surface staining like the remnants of the dark staining on the western elevation, trial D, and the eastern elevation, trial F (photos 10 and 12). This method of cleaning also removed the remaining white precipitate in trial G (photo 14). It was not effective at removing penetrating stains like the rust stains below the cast iron plaques.

Cleaning trial 'E' – after Thermatech and JOS

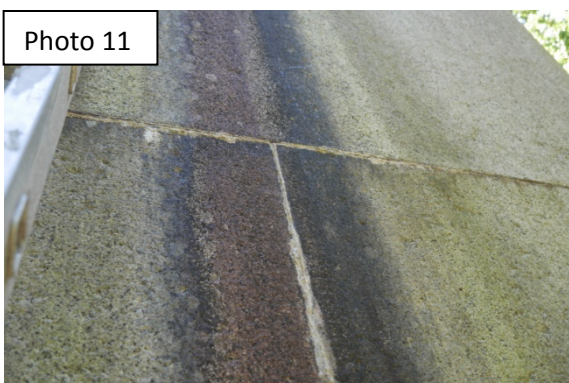
- F. 0.3 x 0.2 m trial to dark staining on lowest blocks of east elevation of obelisk using the ThermaTech at 120°C and JOS calcite abrasive at 4 bars (photo 11 and 12).

Cleaning trial 'F' – before

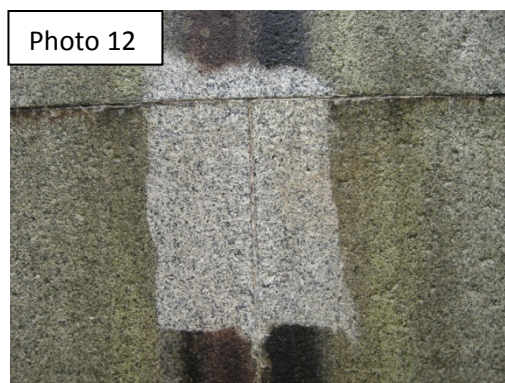
Cleaning trial 'F' – after

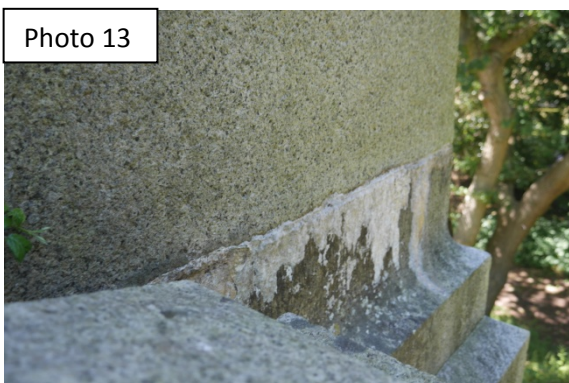
- G. 0.2 x 0.5 m trial to white precipitate on northeastern corner of the base of obelisk using the ThermaTech at 120°C and JOS calcite abrasive at 4 bars (photo 13 and 14).

Cleaning trial 'G' – before

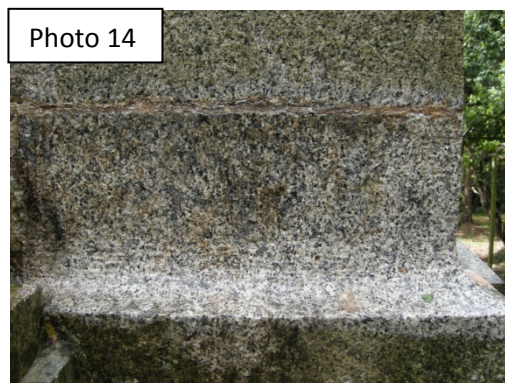
Cleaning trial 'G' – after

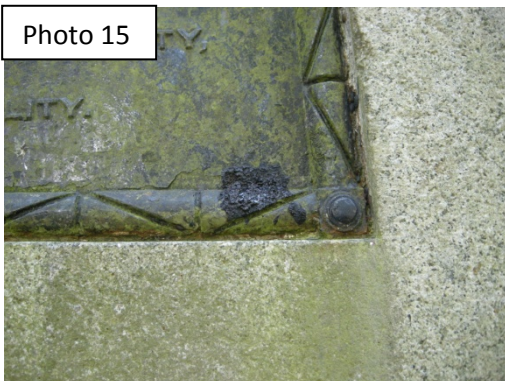
- H. Nitromors All Purpose paint stripper (formulation containing dichloromethane) to western corner of plaque on north elevation. Dwell time approximately 1 hour (photo 15 and 16).

Cleaning trial 'H' – Nitromors applied

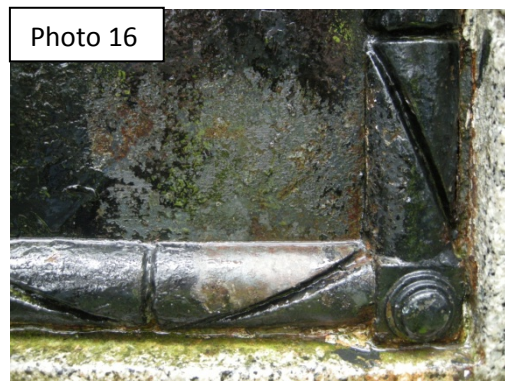
8. Nitromors, trial H, was applied with a brush and allowed to dwell on the metal for approximately one hour. At the end of the trial the residue was removed using a paint scraper and then washed with the ThermaTech to remove any residual paint stripper. The trial resulted in the removal of the paint to bare metal (photo 16).

10. An additional trial, J, was made using the ThermaTech system to soften the paint layers on the metal surface. Some of paint layers were removed using this system and it could be used effectively in conjunction with Nitromors.

Cleaning trials 'H' and 'J' – after

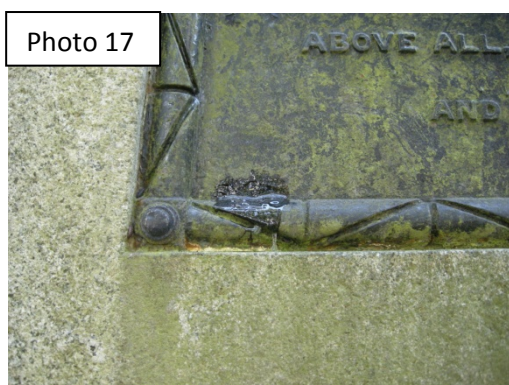
Cleaning trial 'I' – Langlow Safer Stripper applied

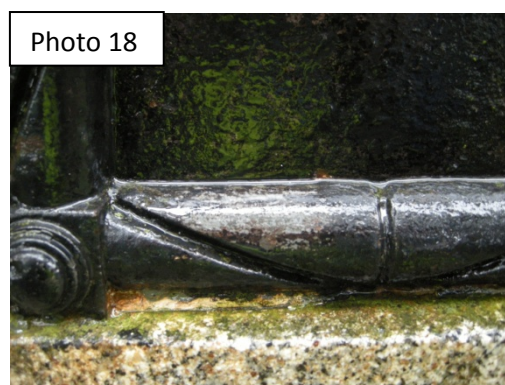
9. Langlow Safer Paint and Varnish stripper, trial I, was applied in the same manner as trial H. The stripper softened the paint layers but did not result in the removal of the paint back to the bare metal.

Cleaning trial 'I' – after

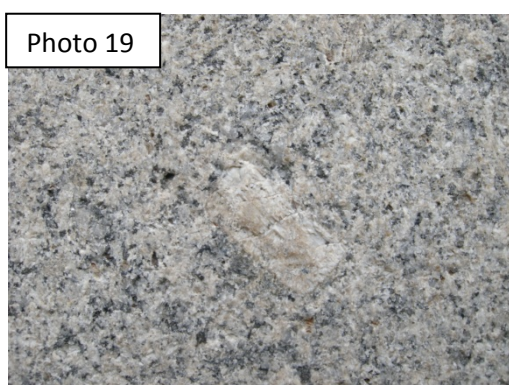
2. Dartmoor Blue Granite, also known as quarry granite, is a moderately coarse grained stone composed of quartz, white feldspar and white and black mica. There are isolated large crystals of perthitic orthoclase within the granite matrix (photo 19). As stated above, granite has a hardness of 6/7 out of 10 on the Mohs hardness scale. The minerals contained in granite are much more resistant to weathering than those in limestone which has a comparative hardness of 3 on the Mohs scale.

Granite matrix with orthoclase megacryst

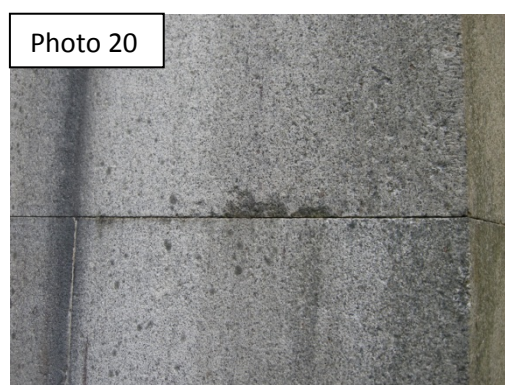
3. There are isolated, minor signs of erosion and mechanical damage to the granite such as chipped arrises probably occurred when the blocks were originally lifted into place. There are few pits in the surface of the stone where large feldspar crystals may have come away.

during the original shaping process or eroded preferentially at a later date (photo 20). This damage is superficial and does not require any action.

Superficial damage to stone arris

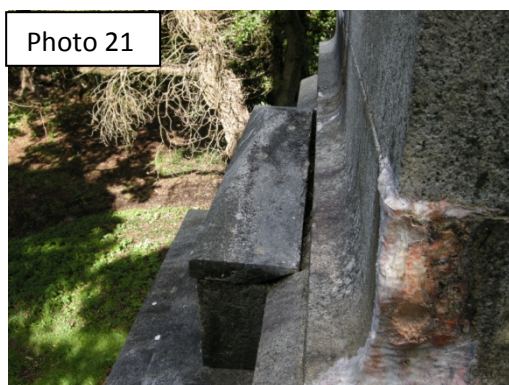
Displaced cap to pediment on west elevation

5. The missing stonework should be re-fixed in its original positions and the stone cap to the pediment of the west elevation should be lifted and rebidged.

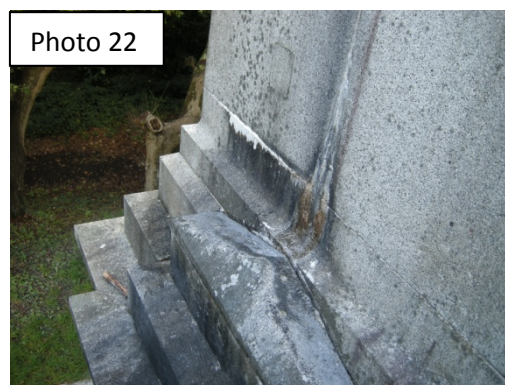
1. A close inspection of the west elevation of the monument was not possible with the powered access lift. Observations of the condition of the west elevation have been made from the ground and obliquely from the access lift.
2. The west elevation, along with the south, is affected most by the prevailing south-westerly winds. There is a large area of dark staining down the centre of the needle starting approximately half way up its height. This carried down over the centre of the stepped base of the needle. There is a minor accumulation of the white deposit at the base of the needle.
3. The cap to the central pediment has been pushed forward and should be lifted off and re-bedded (photo 21).
4. There is a rectangular piece repair in the centre of the lowest granite block of the needle which was probably carried out during the original construction (photo 22).

White precipitate and piece repair to west elevation

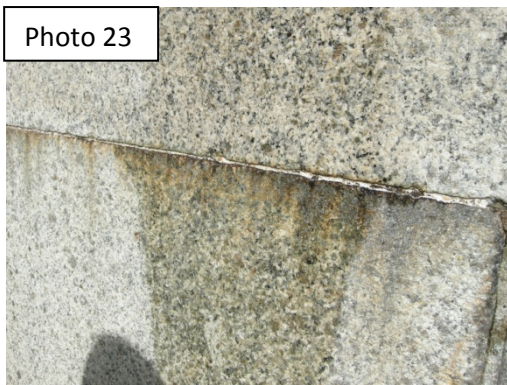
2. Many of the stone joints are either open or show signs of secondary deposition of lime from the bedding mortar (photo 24). There was evidence of water running out of the joints approximately half way up the face of the needle (photo 23). During the inspection, a strong gust of wind pushed water out of the joint of the base of the blocks at this level indicating that wind driven rain penetrates through the core of the monument.

Photo 23
Water running from the joints of the south elevation

4. It is recommended that all joints are raked out and assessed. Where there is evidence that the bedding mortar has failed the joints should be stopped with clay and grouted. The joints should be re-pointed using an appropriate NHL 5 hydraulic lime mortar.

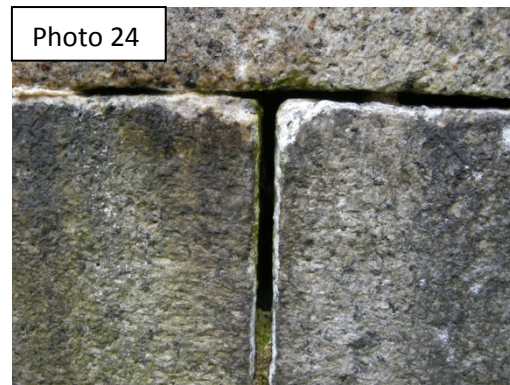
Photo 24
Open joints in south elevation

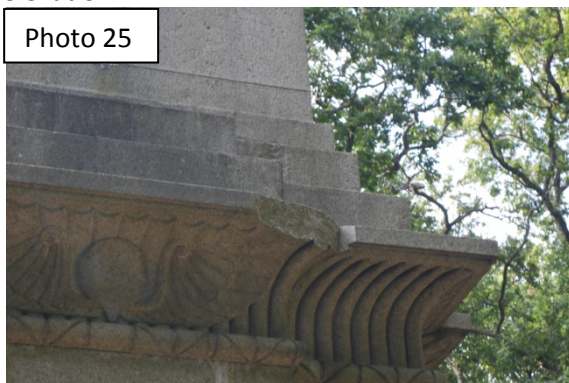
3. The stone cap to the pediment is missing and a corner of the cornice has been broken off (photo 25). These stone pieces are being stored safely in the council's yard and can be reinstated as part of the repairs.

Photo 25
Damaged cornice and missing cap to south elevation

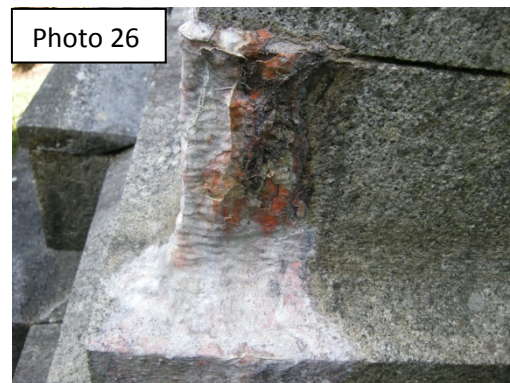
4. There is a thick white and orange deposit on the southwest corner at the base of the needle. This material is quite soft under a hard crust and is easily removed. The stone under the deposit may be damaged and an allowance should be made for a repair (photo 26).

Photo 26
Thick white and orange deposit on southwest corner of south elevation

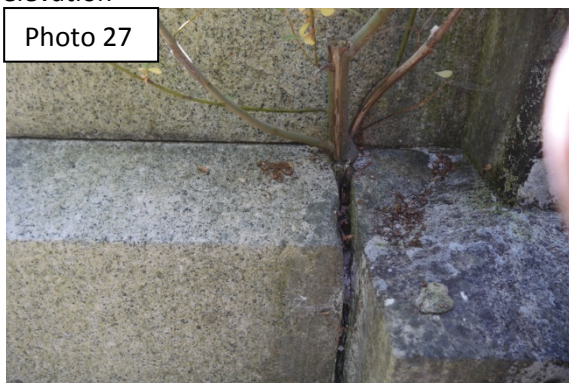
3. A buddleia growing out of a joint in the cornice on the southern side of the central stone tablet has opened up the joint and shifted the central section of the cornice forward (photos 27 and 28). The open joint allows water to run behind the stones which in turn can cause further damage. The buddleia should be treated with a systemic weed killer and, once the plant has died back, its roots removed and the joint made good.

Photo 27
Buddleia displacing stonework on east elevation

6. The buddleia should be treated with a systemic weed killer and, once the plant has died back, its roots removed and the joint deep packed and pointed.

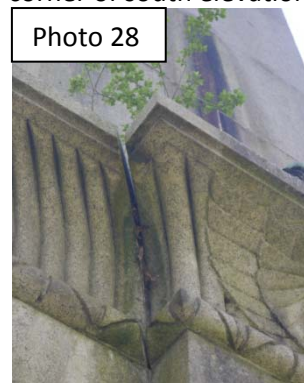
Photo 28
Movement of cornice below buddleia

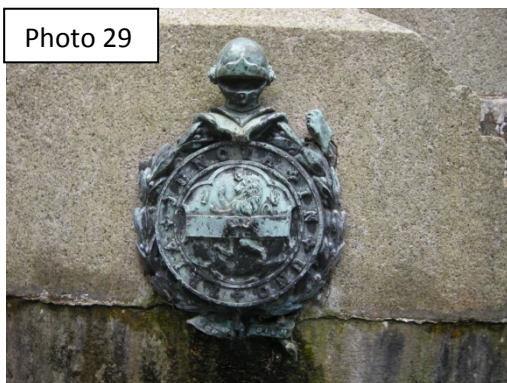
4. There is a bronze medallion fixed centrally above the cornice (photo 29). Sir Harry Burrard Neale was a Knight Grand Cross of the Order of the Bath. The medallion consists of the arms of the Burrard-Neale family encircled by the motto of the Order of the Bath, *Tria Juncta In Uno (Three Joined in One)*, held between two laurel branches. The branches emerge from scroll work at the base of the medallion bearing the motto *Ich Dien (I Serve)* for the Military Division.

Photo 29
Bronze medallion with Order of the Bath motto on east elevation – note missing detail to laurel wreath

8. The bronze medallion should be carefully removed, straightened and the missing sections replaced before re-fixing in its original position.
9. It is recommended that new drainage, in the form of a shallow crate style soakaway, should be installed to the east of the monument.

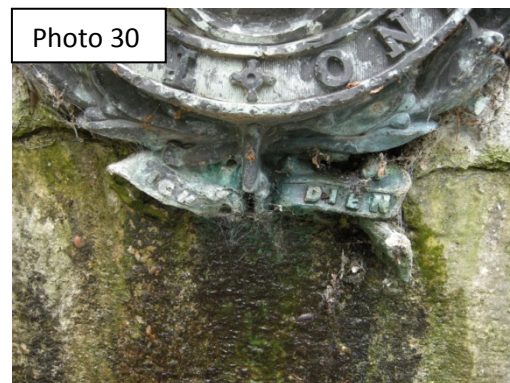
5. The medallion is fixed into stone with non-ferrous fixings caulked with lead. A section of laurel branch is missing and there is some damage to the left hand scroll (photo 30). The medallion may have originally been decorated with the colours of the Order.

Photo 30
Damage to base of medallion and moisture leaching out from stonework

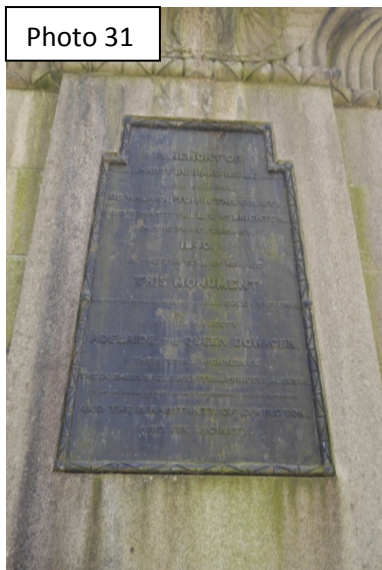
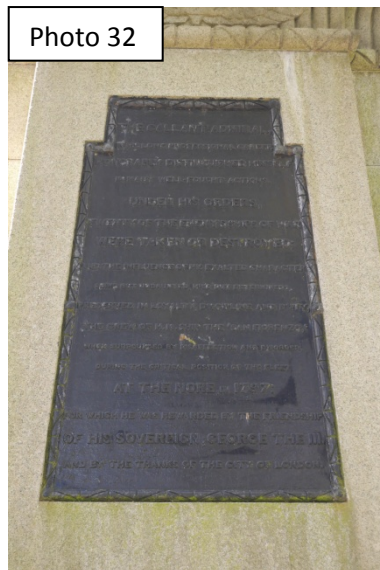
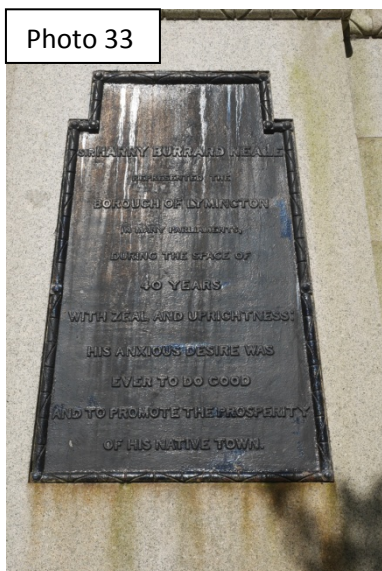
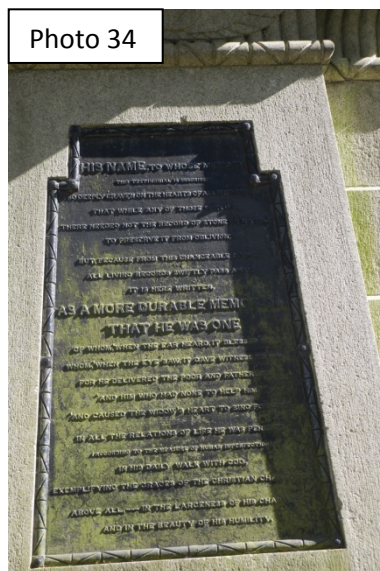
1. The plaques are not bronze, as stated in the RIBA paper, but cast iron. They are in good condition and do not show any signs deterioration from rust. The raised lettering has been obscured somewhat by the accumulation of successive paint layers (photos 31 – 34). It is

recommended that existing paint layers are removed before the plaques are redecorated. This work can be done in situ.

7. The cast iron plaques should be cleaned using the DOFF system to remove as much of the paint as possible. Any remaining paint layers should be removed using a proprietary paint stripper. The plaques should be decorated immediately, before rust can set in, using a three coat single pack alkyd system.

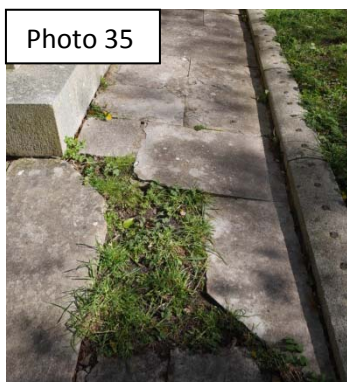
1. The Purbeck stone paving around the base of the monument is in poor condition (photo 35). The monument sits on a brick foundation in line with the stone faces of the plinth. The granite kerbs around the monument are laid on a shallow brick foundation with the Purbeck paving stones bedded on sand in between. Water collecting around the base of the monument has washed away the sand bedding material under the slabs causing them to sink and expose the brick foundation (photo 36).
2. The paving stones will need to be carefully lifted and good stones set aside for reuse. A new foundation incorporating new drainage should be laid prior to relaying the paving. The paving should be laid with a fall to the east to take runoff into new drainage on that side of the monument. An allowance should be made for replacing at least 50% of the Purbeck paving stones.

Broken and missing paving stones

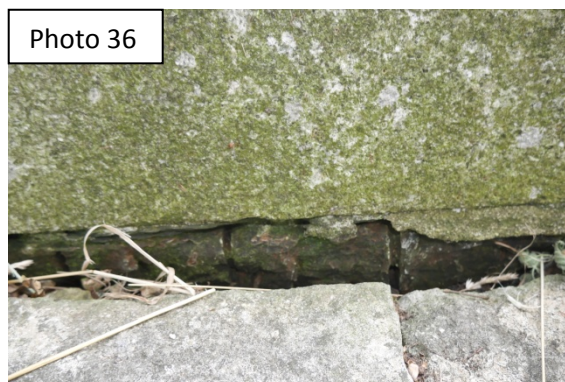
Brick foundation exposed by subsidence of limestone paving

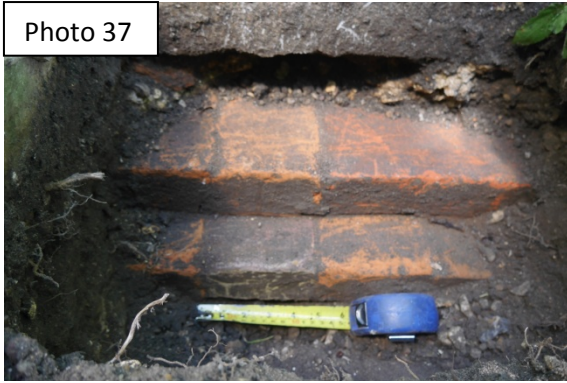
Photo 37

1. Drainage is effected through two holes through the brick foundation of the kerb on each side (photo 37 and 38). The drainage relies on water being taken away from the base of the monument and into the gravel fill which characterises the mound on which the monument sits. These drainage channels have silted up (drawing S1).
2. New drainage should run to a shallow crate style soakaway under the path from the car park. The soakaway will need to be positioned outside of the root protection areas of trees T1, T2 and T3.

Brick foundation to granite kerb and drainage chanel under paving stones

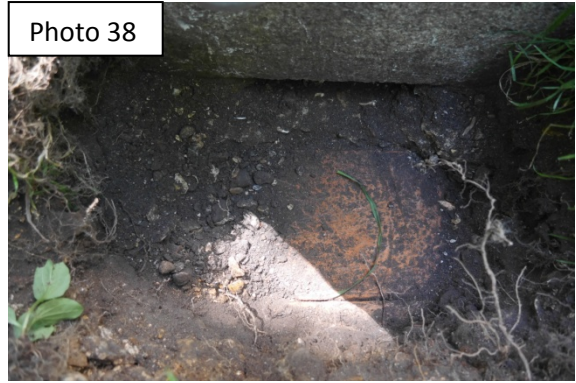
Photo 38

Drainage chanel exterior to monument

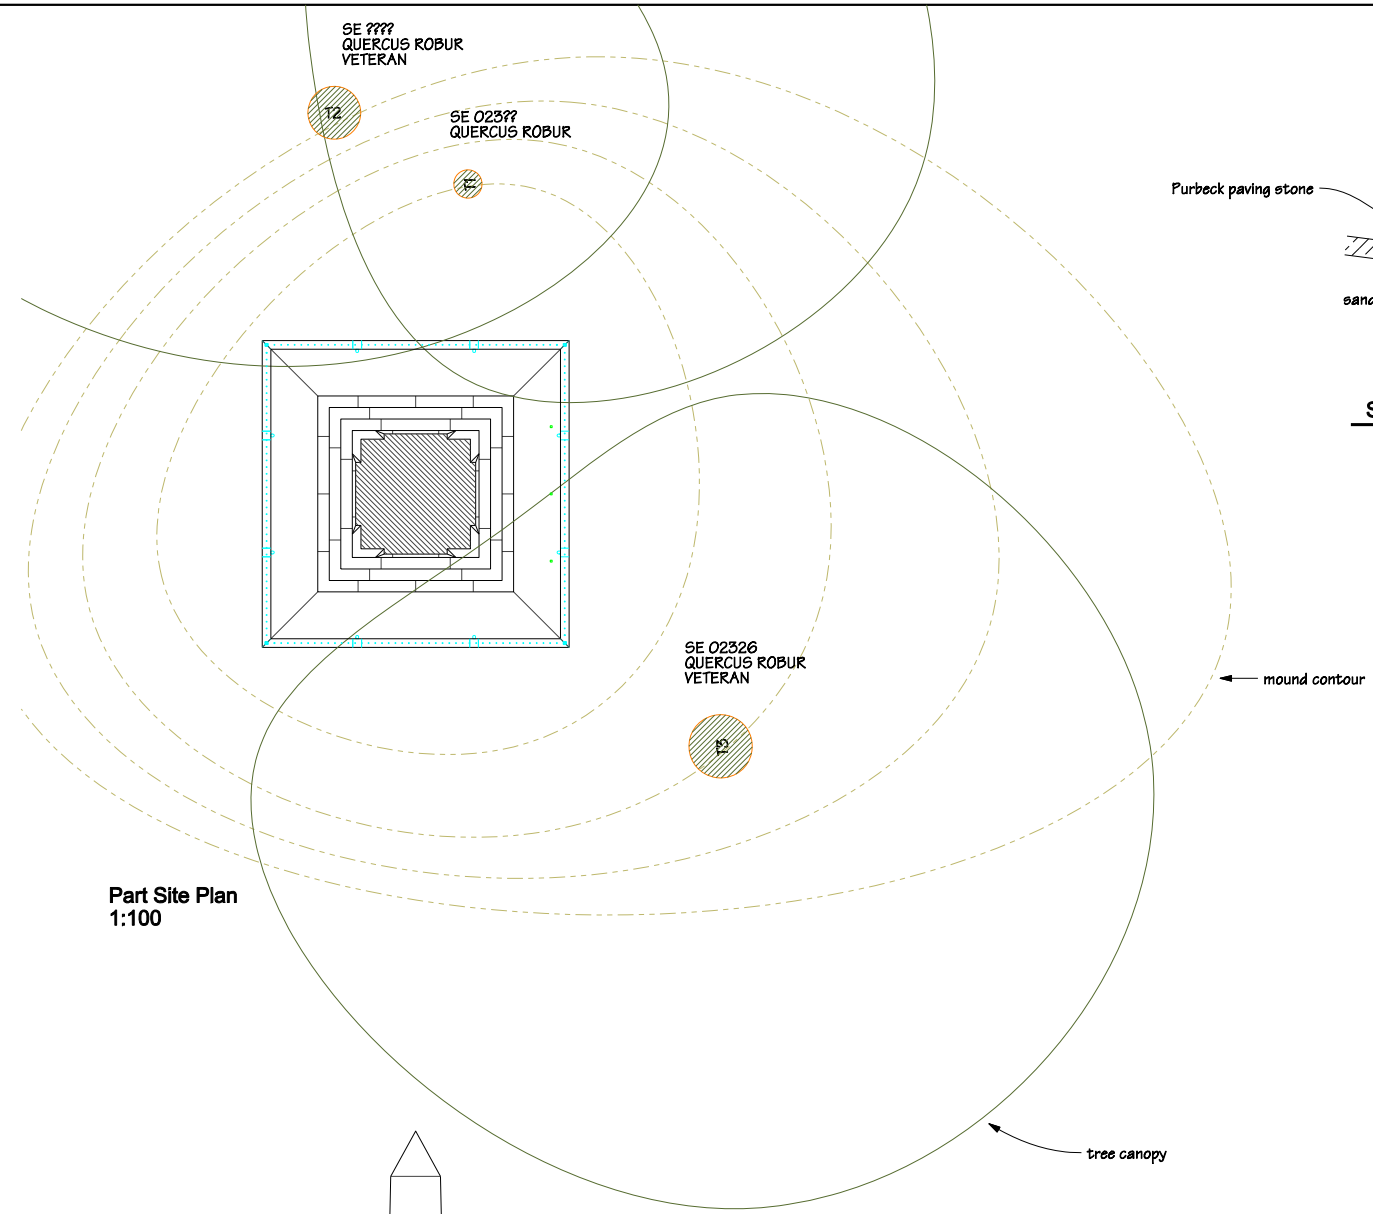
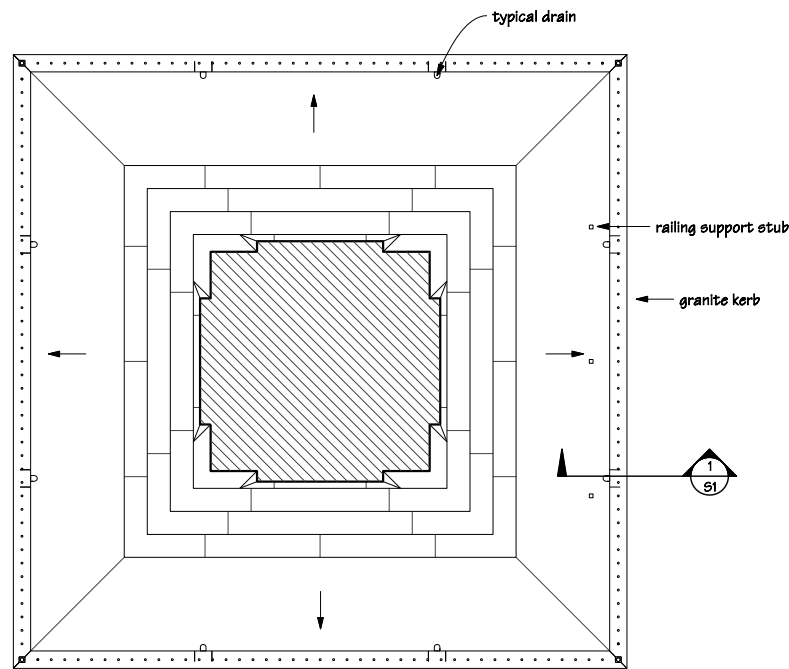
S1 A

8. When plotted accurately, drawing S1, it can be seen that it is likely that the roots of all three trees are impinging on the brick foundations. It is recommended that further investigations into the impact of the trees of the foundations are carried out.

1. Further investigations into the impact of trees T1, T2 and T3 on the brick foundations of the monument should be put in hand.
2. It is recommended that all elevations of the monument are cleaned with using DOFF/ThermaTech steam cleaning. This should be followed with JOS cleaning to areas of heavy soiling.
