National Asset Delivery Technical Surveys and Testing

569243 - A46 NB SB Sixhills Geotech – Water Erosion

Site Information

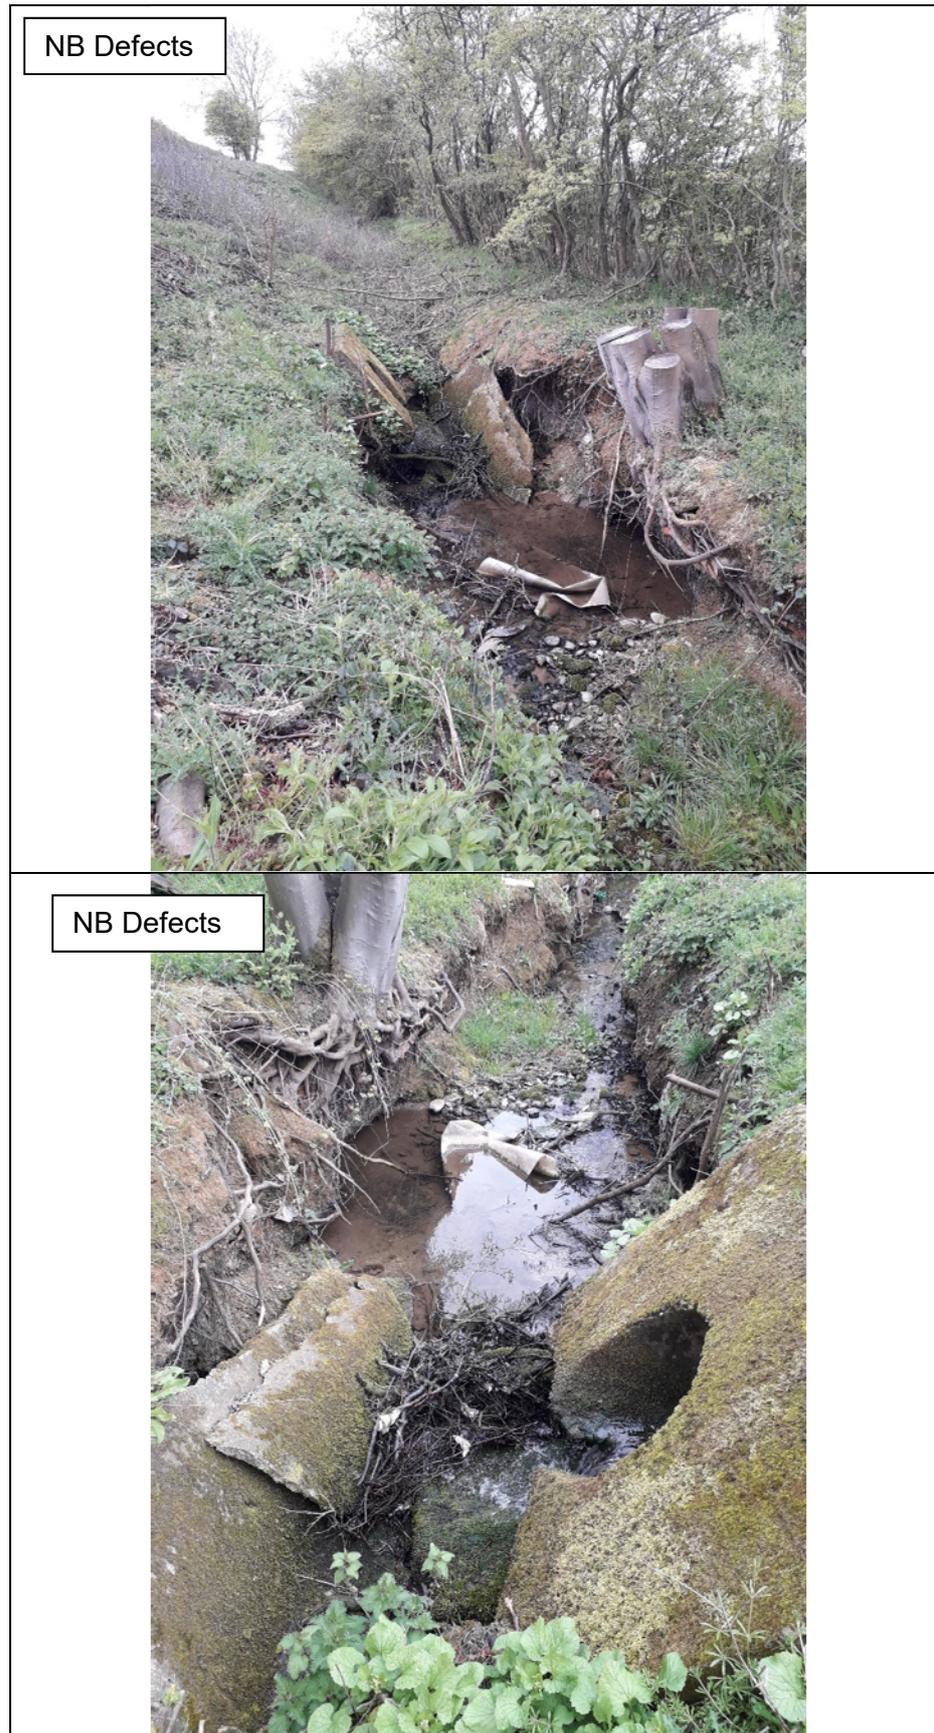
Figure 6-12: Photographs of major defects (Ratcliffe)

The northbound embankment hosts two significant earthwork defects. The first main defect relates to the defective drainage associated to the earthwork. A culvert outlet headwall has become undermined through water erosion due to the constant flow of a stream through the culvert that runs perpendicular to the earthwork, projecting the stream water directly onto the unlined ditch. Subsequently, the unlined ditch has become severely undermined on either side and resulted in the earthwork toe overhanging the ditch. The second main defect pertains to clay pipe drainage existing on the earthwork slope and has been subject to freeze-thaw over the years and shattered. The drainage water now flows out onto the earthwork toe and has resulted in a large gorge developing. The earthwork hosts geotechnical defects such as a soil bulge at the toe of the slope and substantial subsidence across the earthworks mid slope. It is not yet conclusive whether these defects have developed due to the defective drainage associated to the earthwork. Dense vegetation obscures the earthwork making the full extent of the defects uncertain.

The southbound embankment hosts two significant earthwork defects. Both defects consist of large 1m soil slips near the crest with the addition of tension cracks, animal burrows and soil bulging. The defects are located in close proximity to the culvert, which has caused issues on the northbound earthwork, and has therefore raised questions as to whether the southbound earthwork is in a similar condition which can only be investigated once vegetation is cleared. Historic observations of an “undermined pipe” have been recorded on the earthwork but could not be elaborated upon or confirmed whether it relates to the culvert inlet due to dense vegetation. There are also a number of observations relating to water erosion channels down the earthwork face.
