Structural Appraisal

Cotton Dell Bridge Culverts

Staffordshire Wildlife Trust

Ref: 8968

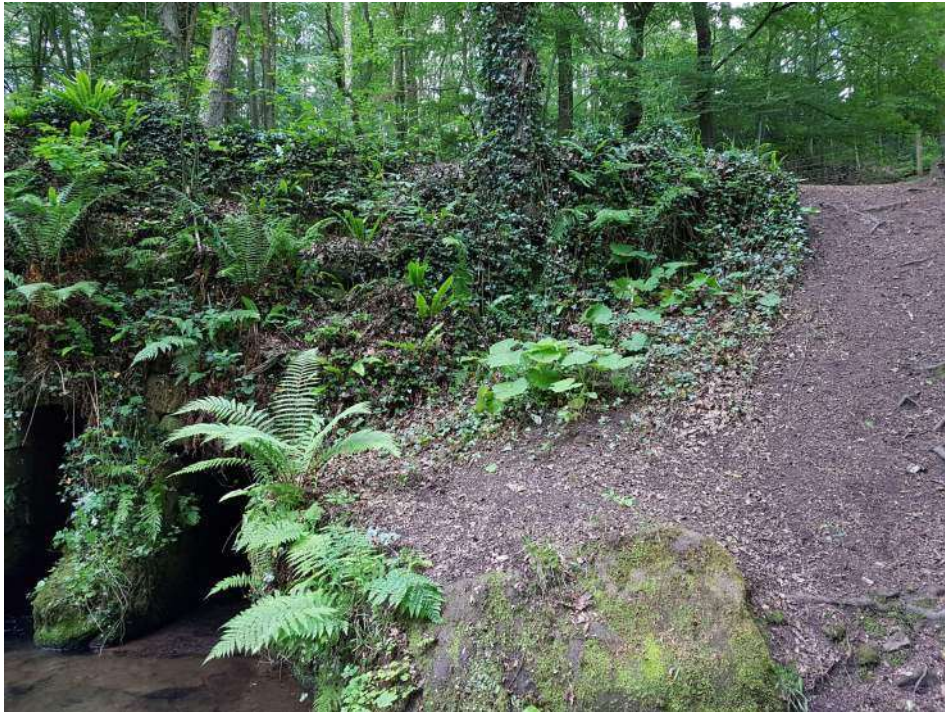
WWW1 – Wing Wall to culvert is significantly overgrown with vegetation. There also appears to be a tree growing out of the side/top of the wall. The tree appears to have been cut off approximately 2m above the bridge deck level.

- 401. Recommendations and repair proposed outline in appendix C remain applicable.
- 402. We advise that all vegetation and trees growing adjacent or within the culvert structure are removed to mitigate further risk of movement and to assist with further surveys/inspections.

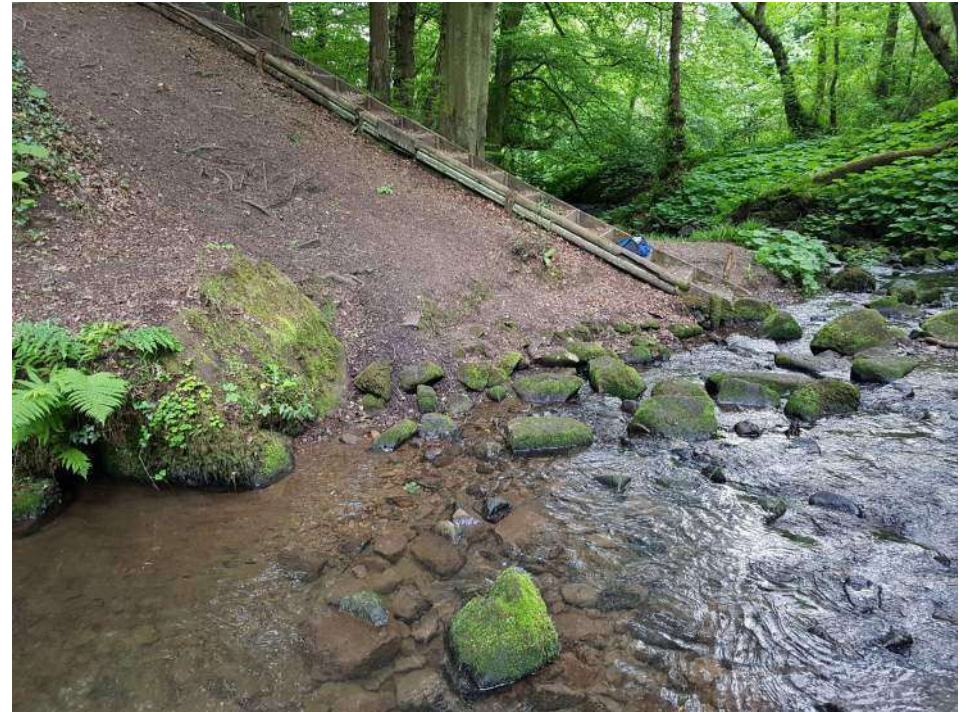
WWW2 – There is evidence to suggest that a low level retaining wall existed at the water's edge which at some point has failed and there is evidence of large pieces of stonework in this vicinity having fallen on to the bed of the stream.

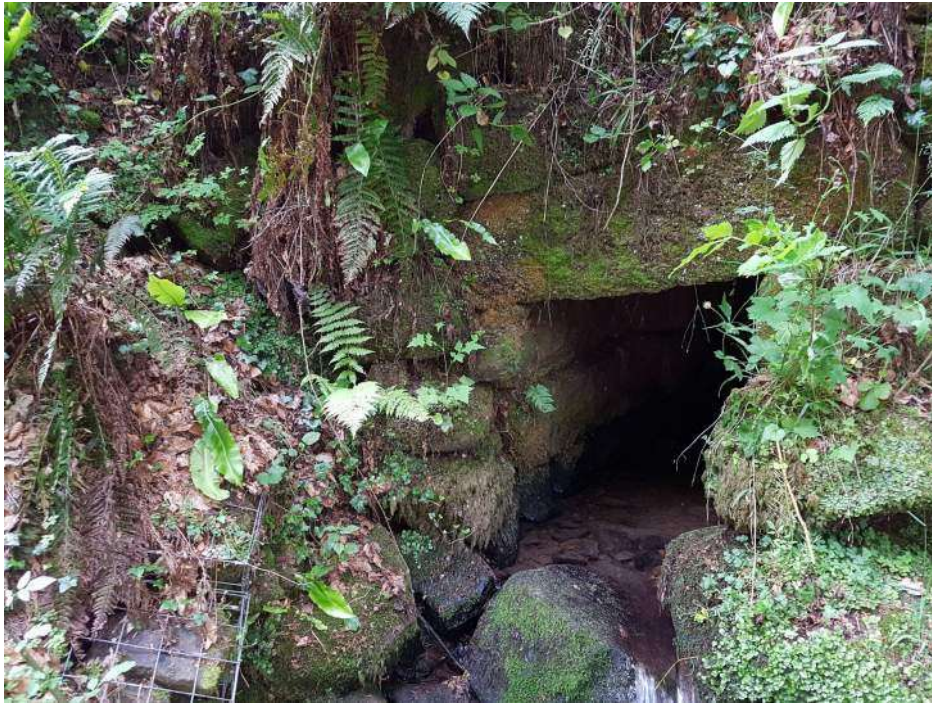
- 303. Regarding defect NW1 the abutment is considered to be in inadequate condition and offers insufficient support to the wall and deck over.
- 304. Regarding NWW1 there is evidence to suggest that the embankments and the gabion retaining wall structure is unstable.

NW1 – Partial support of the first soffit slab was noted. It appears that the wall above the soffit slab has become dislodged and is now partially supported on what could be considered loose stonework.

- 403. Regarding defect NW1 and NW2 we recommend local rebuilding of the abutment is undertaken.
- 404. NWW1 though it is thought that the embankments and gabion structures have undergone movement, we are not able to predict whether further movement of the gabion walls or the embankments is likely to occur. We therefore recommend that regular inspections of the structure are introduced on an annual basis to establish whether significant movement can be identified.

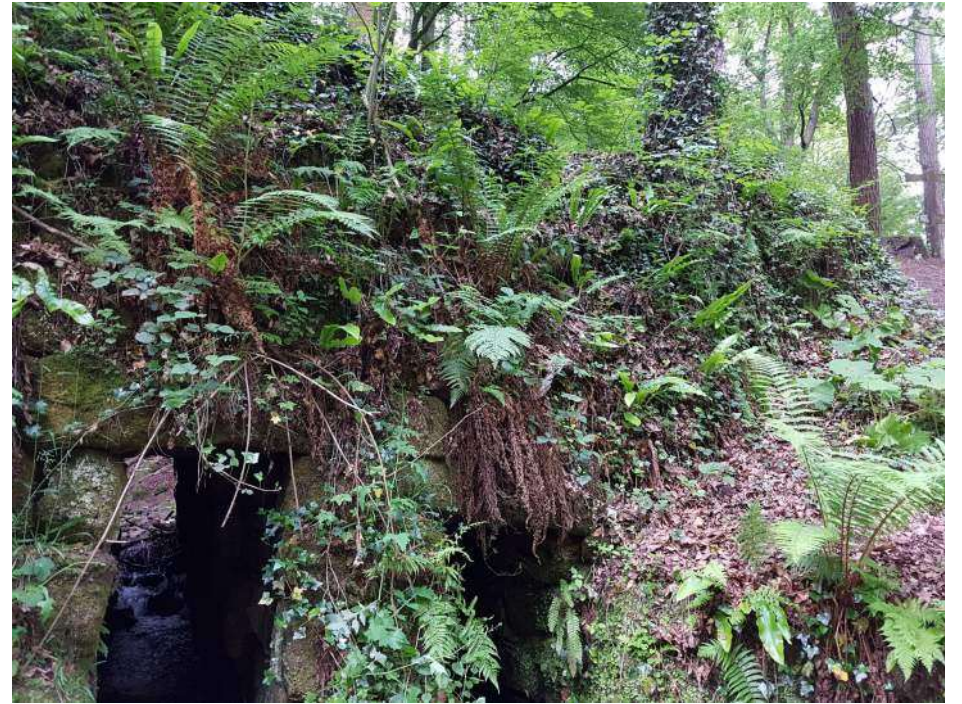
NW2 – The wall is heavily obscured by vegetation, therefore the survey of the face of the wall was limited. There was evidence of a number of saplings growing out of the wall.

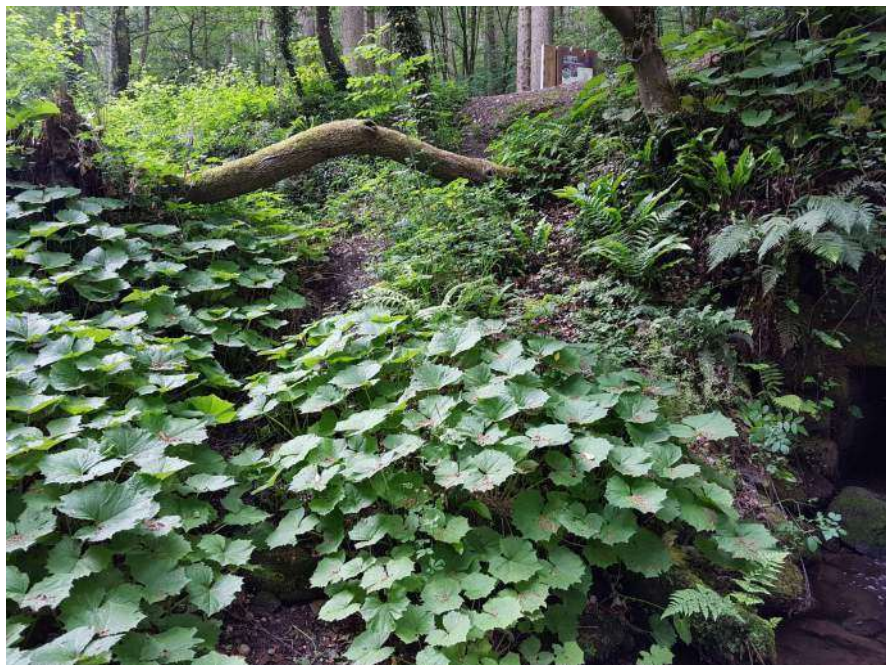
NWW1 – There is evidence to suggest that some form of landslide, or earthworks, may have been undertaken in this area.

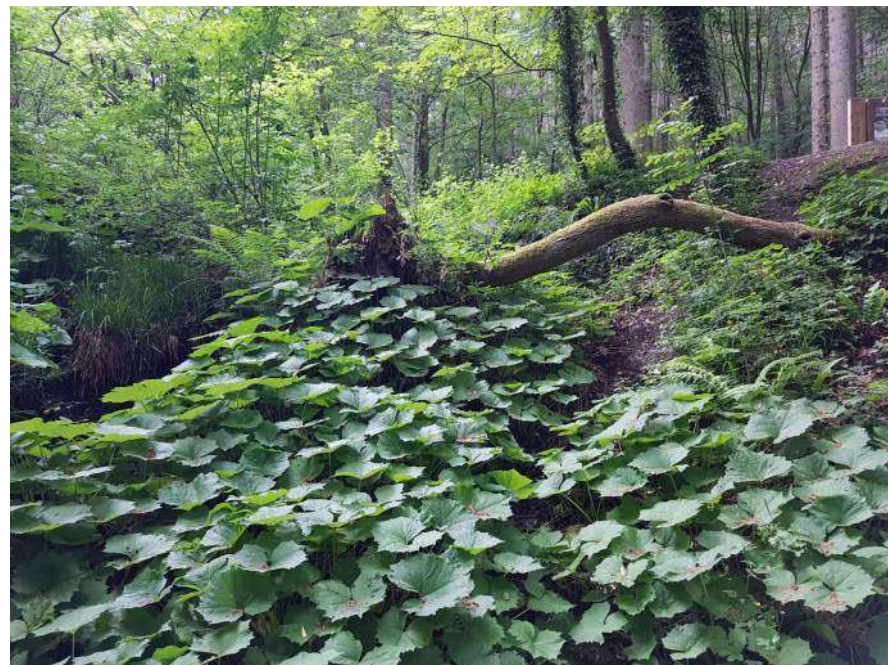
NWW2 – There was evidence of a fallen tree within the vicinity of the Wing Wall.

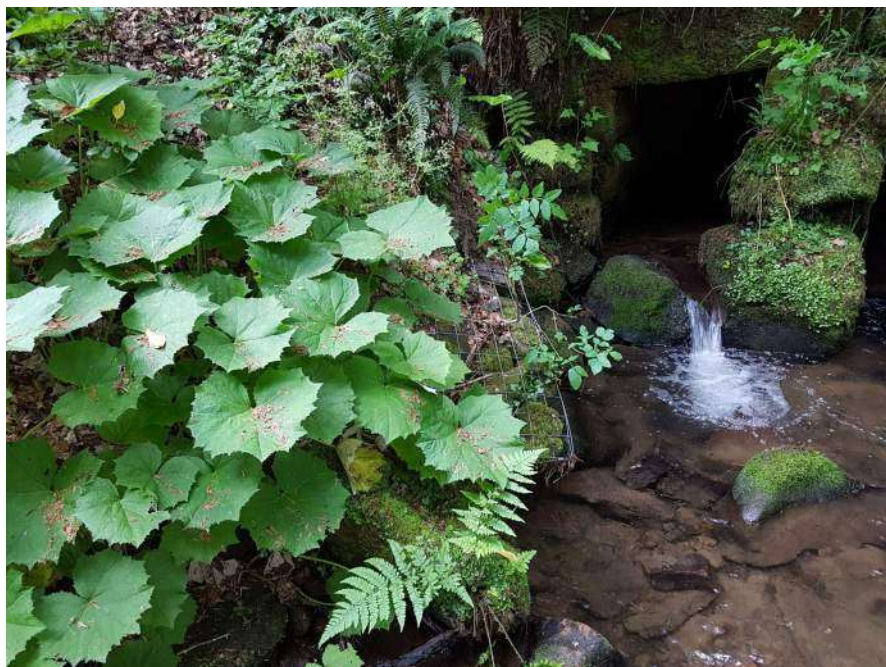
NWW3 – There is evidence of a more recent gabion wall construction in front forming part of the slope.

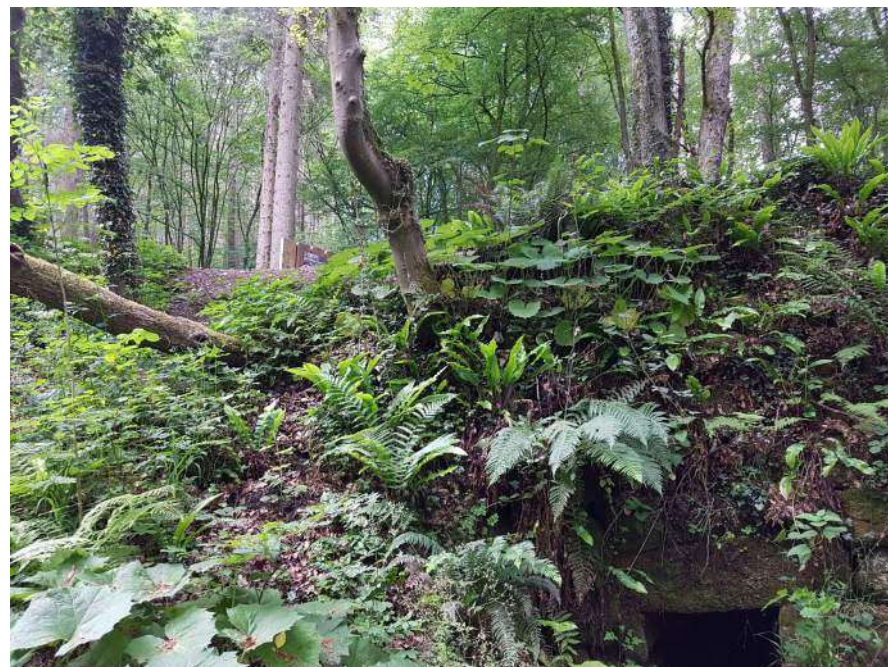
NWW4 – There is a healthy tree growing out the side of the Wing Wall approximately 200mm in diameter and circa 10m tall.

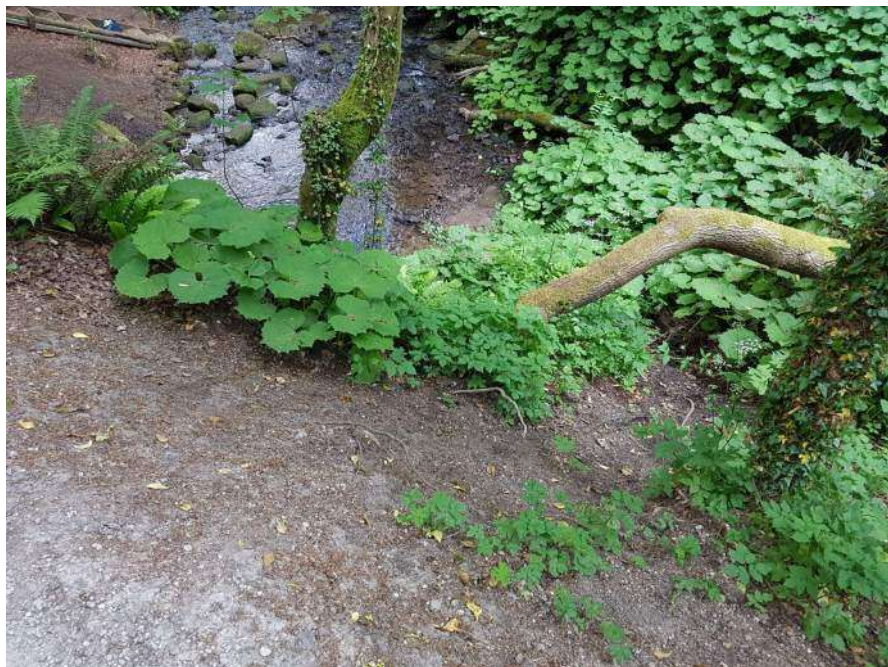
NWW5 – Further evidence of earthworks being undertaken were identified within this vicinity. The embankment, from the bridge deck level down to the bottom of the stream, appears to be approximately 1:1 gradient.

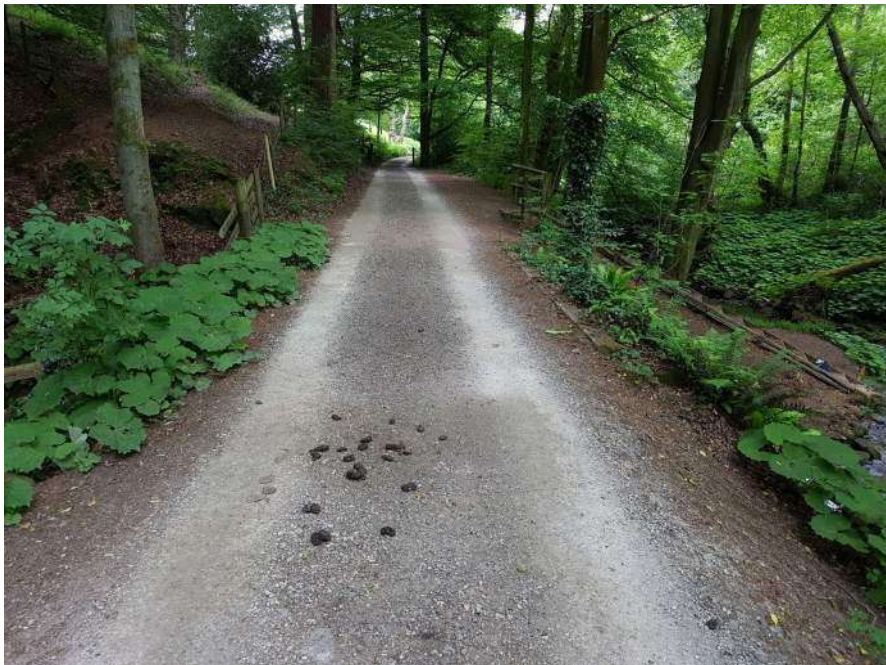
- 305. Regarding BD1 the tilting of the sleepers at ground level to the sides of the bridge deck suggest that there is slight instability of the roadway at the fringes.

BD1 – The bridge deck generally appears in line, and no obvious significant undulations to the surface were noted.

- 405. Regarding BD1 we recommend that the sleepers on the top of the bridge deck are reset so they are in line and level so any further movement of the edges of the deck can be observed and if required, addressed.

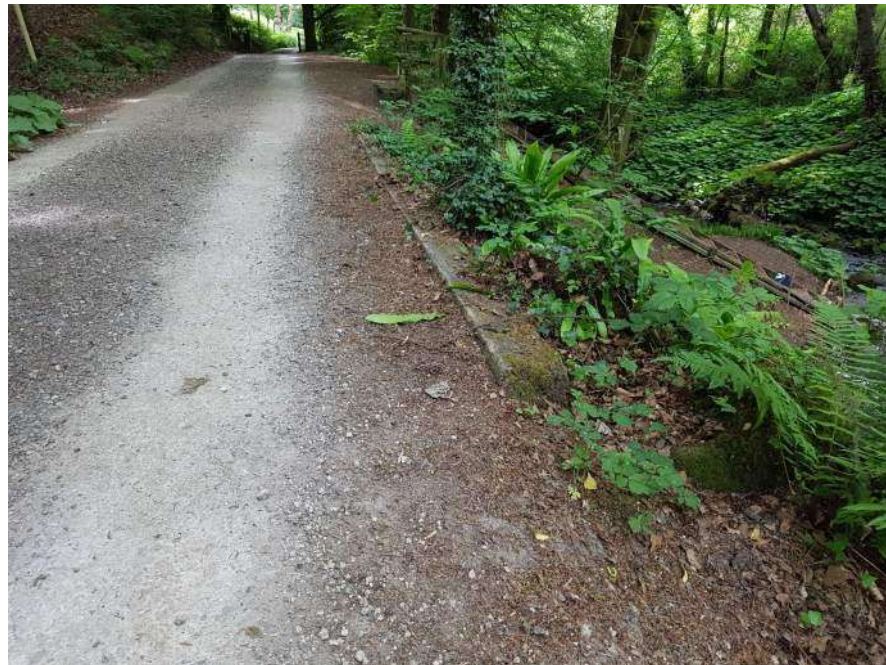
BD2 – There were two timber sleepers, one on each side located at the edge of the roadway. Both timbers appear to have rotated towards the Wing Wall.

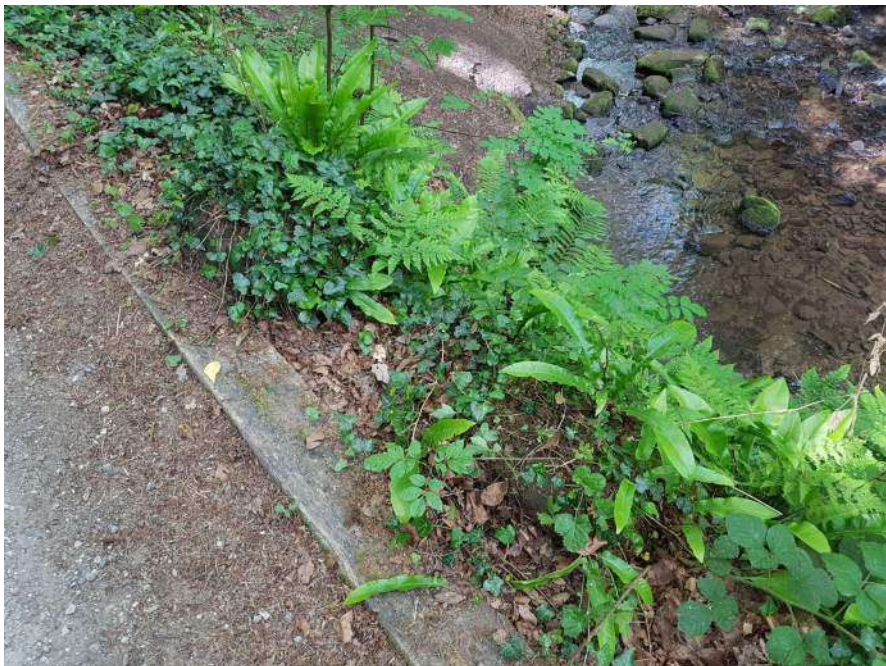
BD3 – 4No. stones sat proud above the level of the road surface to the corner of the bridge deck.

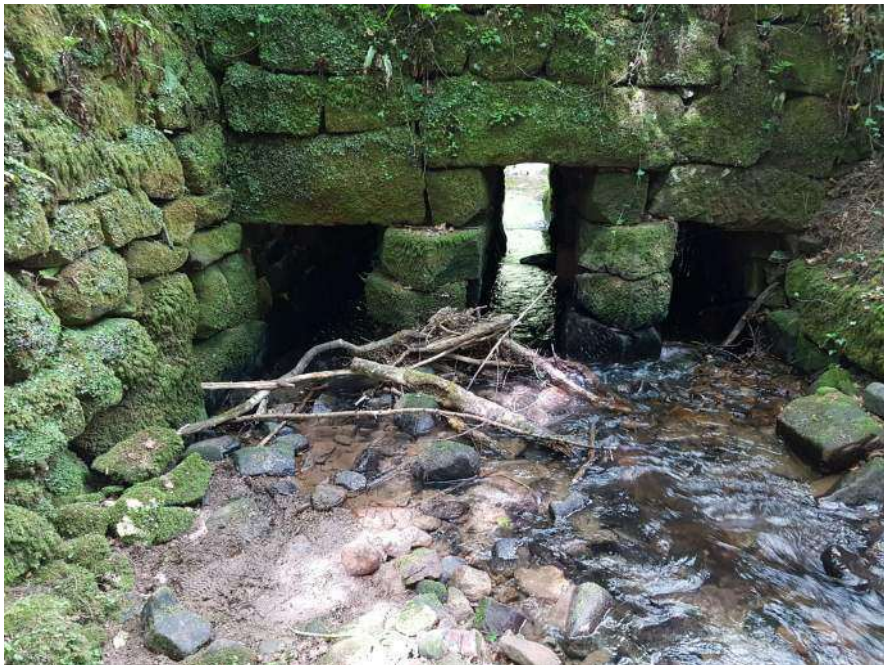
- 306. Regarding SE1 there was significant debris noted at the base of the southeast wall which left unaddressed could cause issues with potential blockages and restriction of flow.

SE1 – A significant amount of branches and debris was noted at the base of the wall.

- 406. Regarding SE1 we recommend that suitable measures are introduced to mitigate the risk of significant build of debris. We advise that at regular intervals, perhaps a 3-monthly basis, or after extraordinary weather events, the stream is inspected and cleared of any debris that may potentially block the flow of the stream.

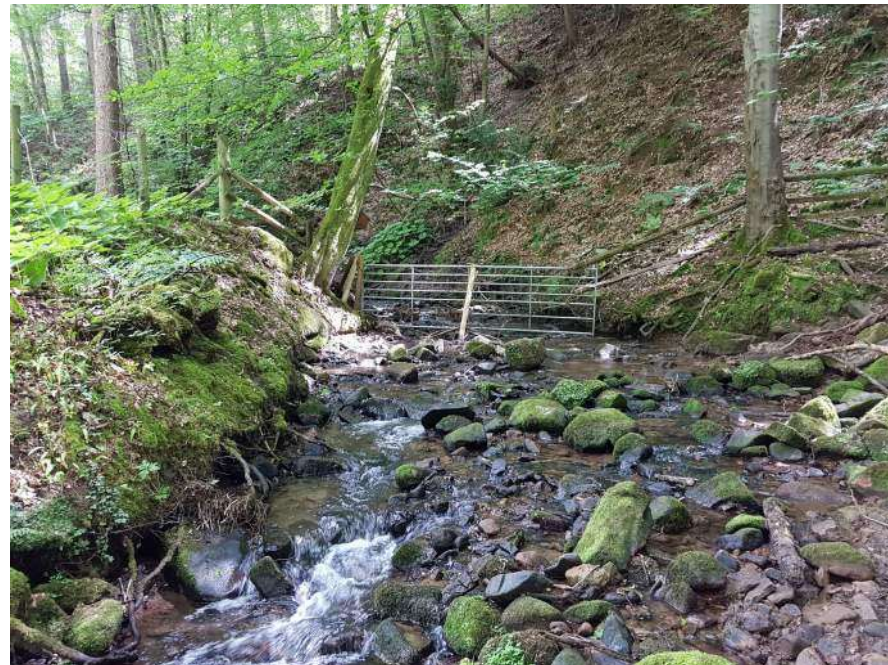
SE2 – It was noted that a makeshift fence/gate had been installed crossing the brook approximately 20m upstream from the structure.

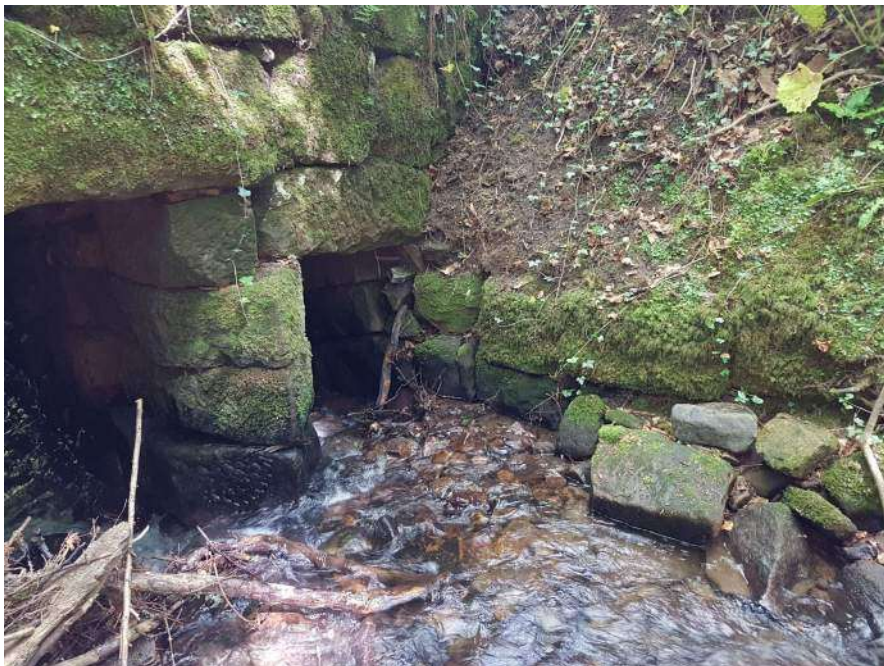
- 307. Regarding SE3 the stone soffit appears to be inadequately supported at this location. This is thought to have been previously identified within GCA's report of November 2005.

SE3 – It appears that the first soffit stone is partially supported at the corner of the Wing Wall.

- 407. Regarding SE3 we advise that the recommendations proposed in the GCA report of November 2005 remain applicable.
- 408. Regarding SWW1 we advise that the slope is battered back to a 1 in 2 gradient and inspected at regular intervals. Removal of trees and vegetation may require necessary approvals.

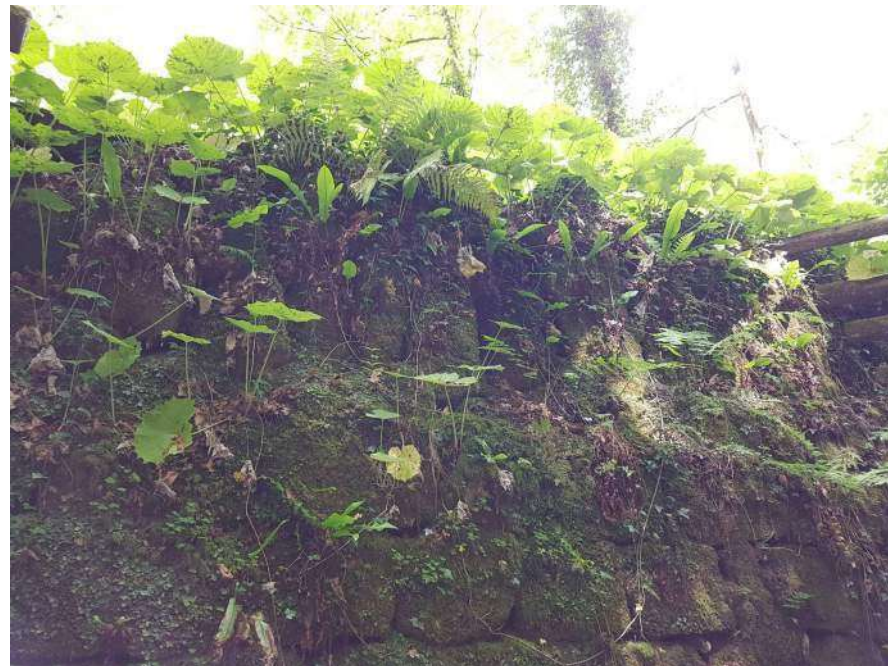
SE4 – There is evidence of stonework having fallen from the face of the wall. It was difficult to determine the extent of the fallen stone due to the extensive vegetation growing over the face of the wall.

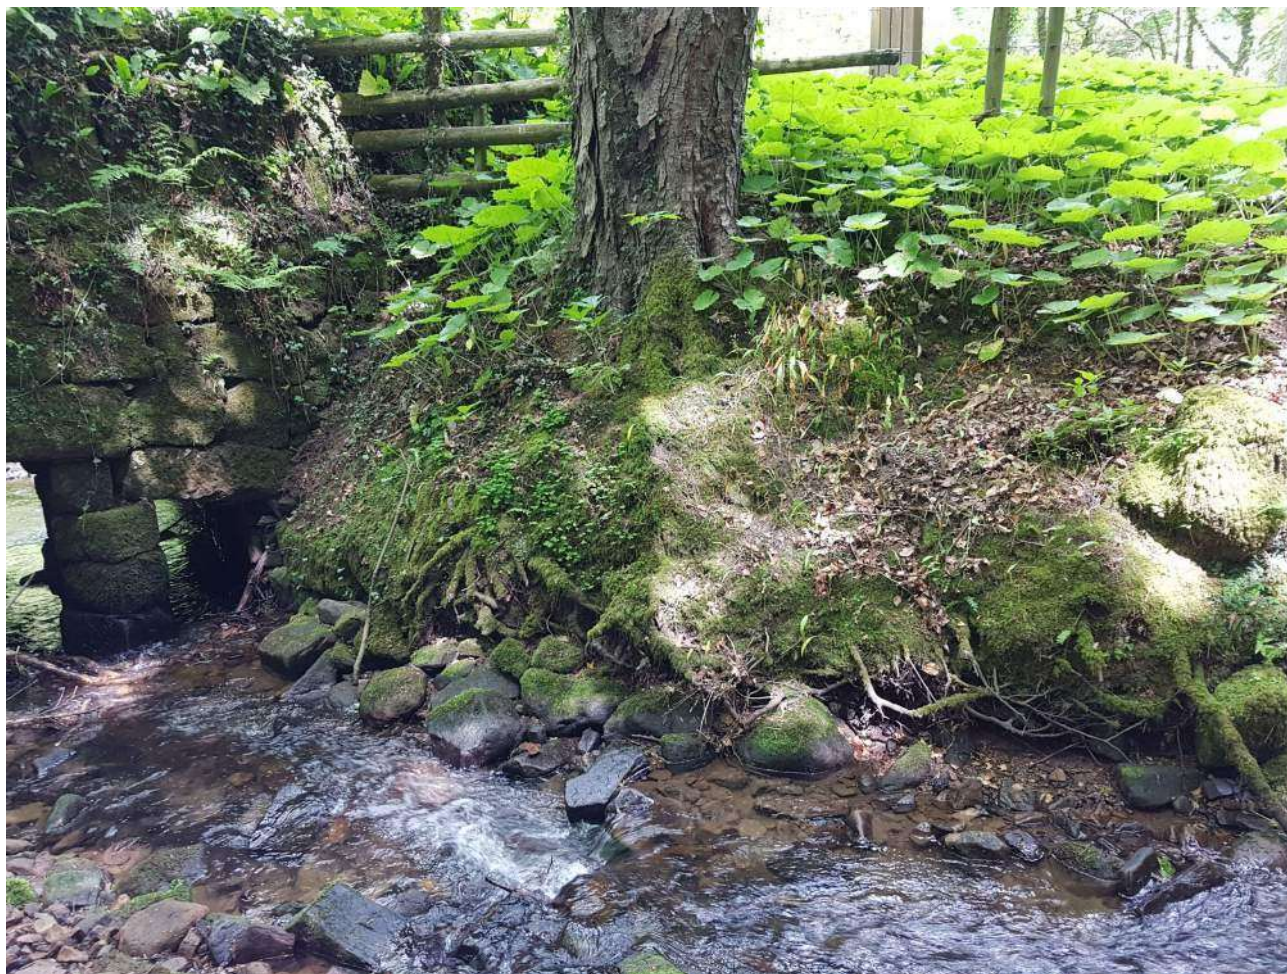
EWV1

EW1 – There is evidence of fallen stones at the edge of the stream. It is thought that a stone retaining structure may have existed at some point at this location. Above this location there is a large tree, circa 900mm diameter and estimated at 12-15m high.

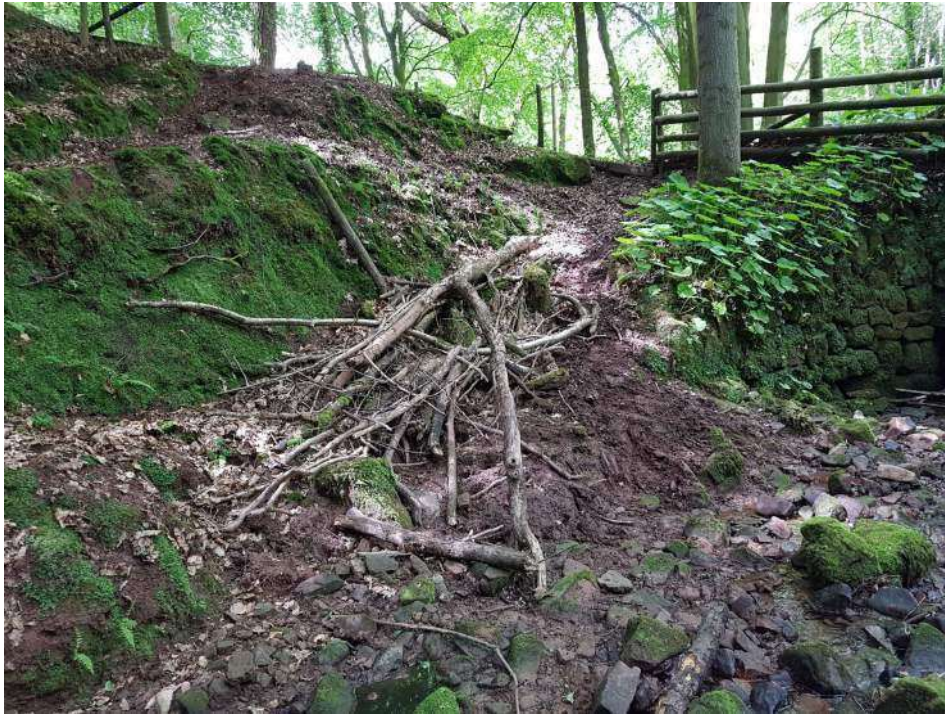
- 308. Regarding SWW1 there was evidence to suggest that a landslide had occurred. As the embankment is considered to remain relatively steep, we anticipate that there is further risk of potential landslides within this area.

SWW1 – There is evidence to suggest that the Wing Wall has undergone a significant collapse and a large landslide. It is thought that this has occurred between the time of the last survey in November 2005 and this inspection.

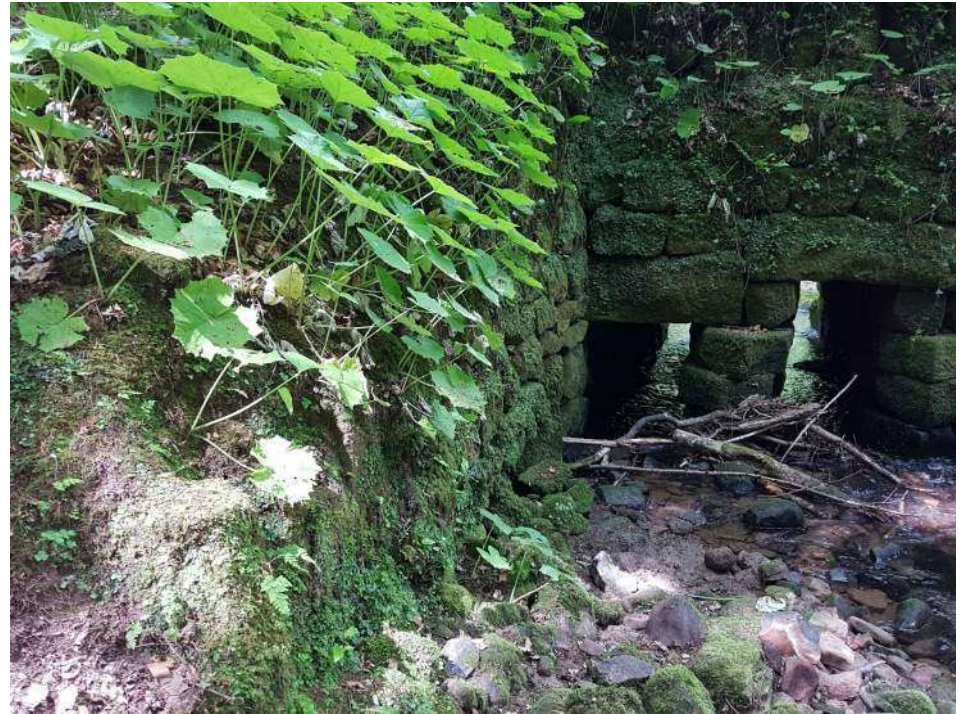
SWW2 – There is slight bulging of the remaining section of the Wing Wall within the vicinity of a tree. The tree is approximately 500mm in diameter and stands approximately 12-15m tall.

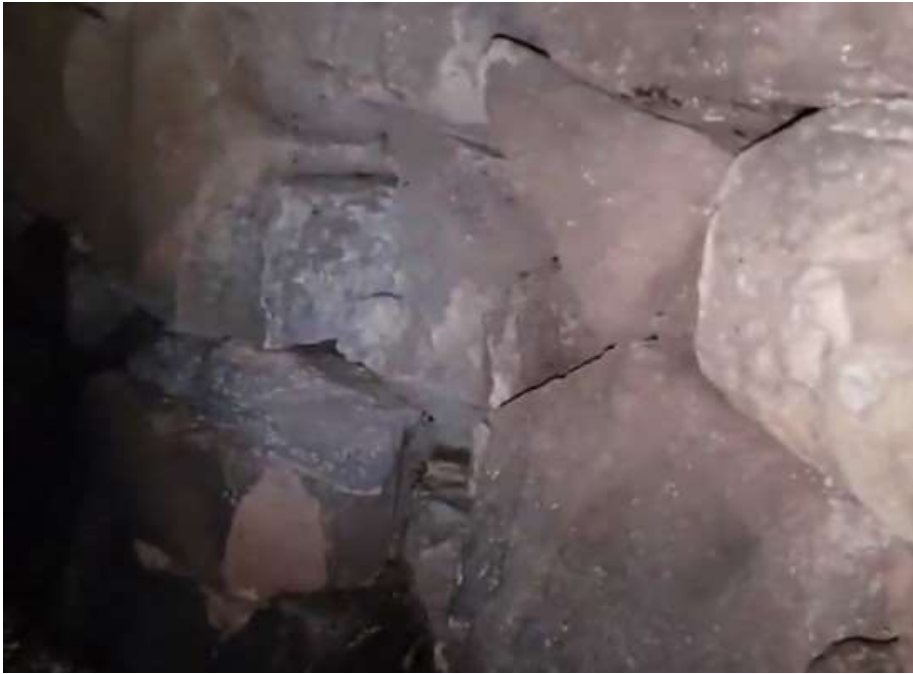
CA1 – Dislodged stonework was noted to the face of the wall.

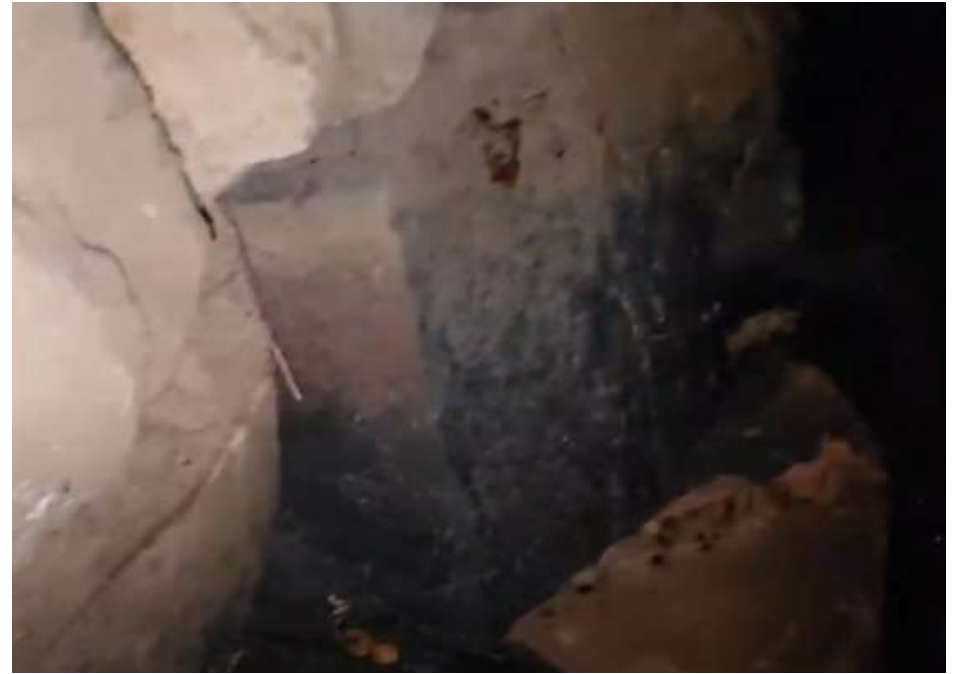
CA2 – Dislodged stonework was noted to the face of the wall.

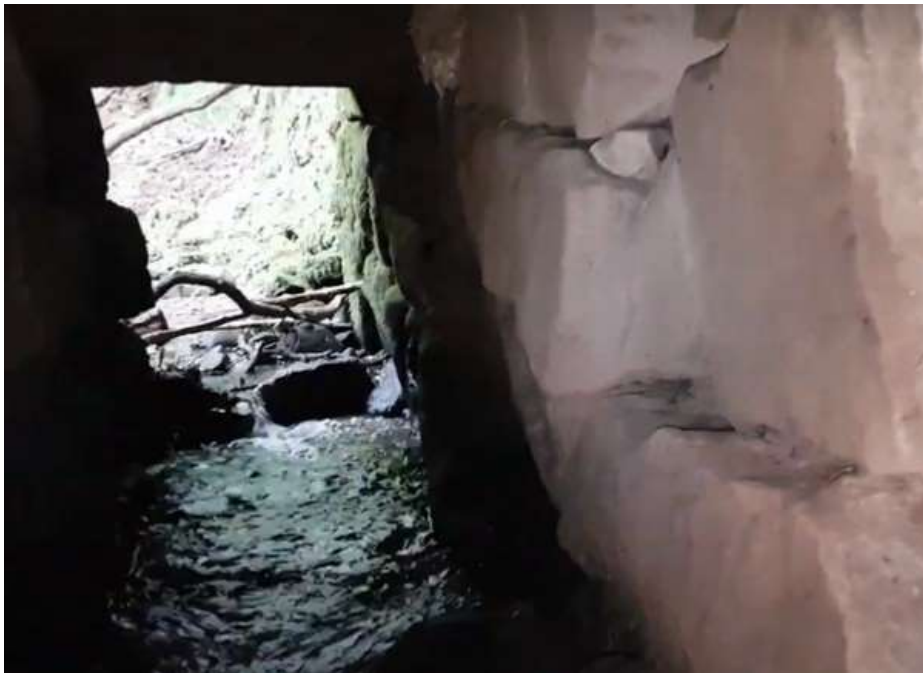
CA3 – The stonework appears to have become distorted and shows some signs of slight bulging.

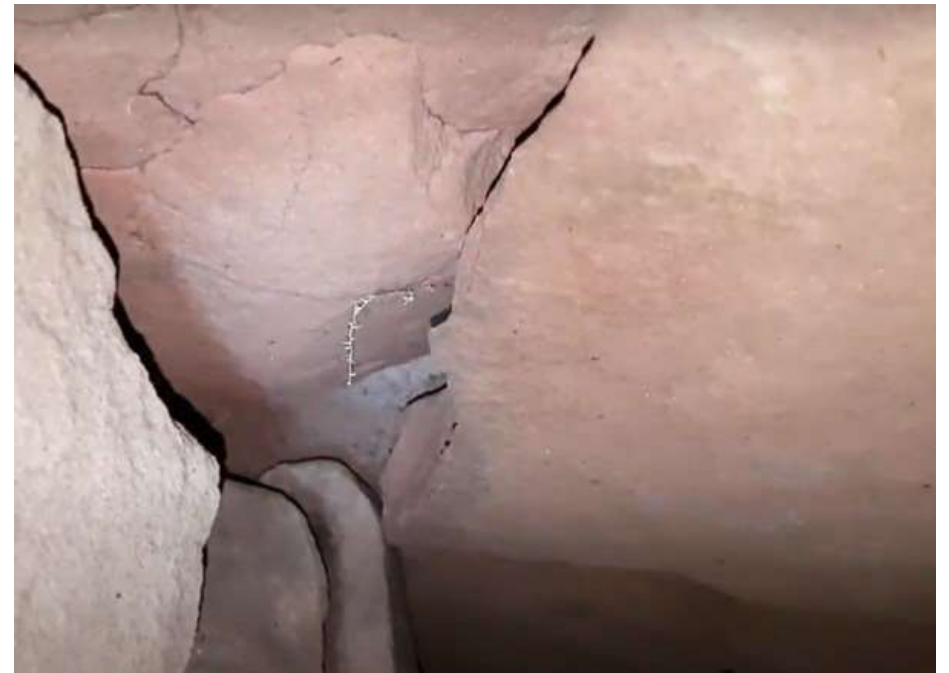
CA4 – There is a cracked soffit stone noted overhead.

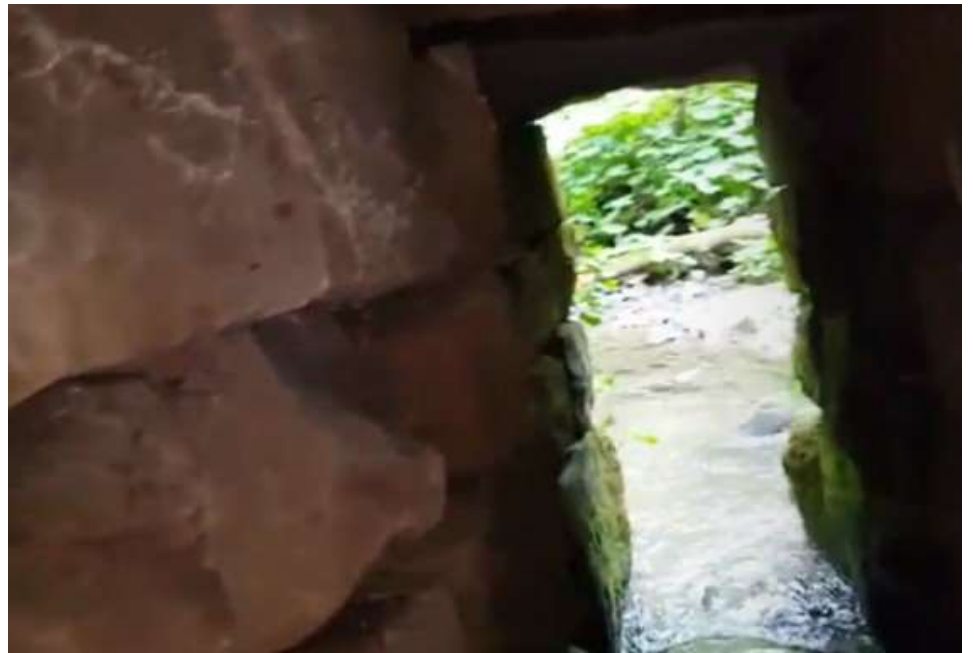
CB2 – There is evidence of a partially supported soffit slab overhead.

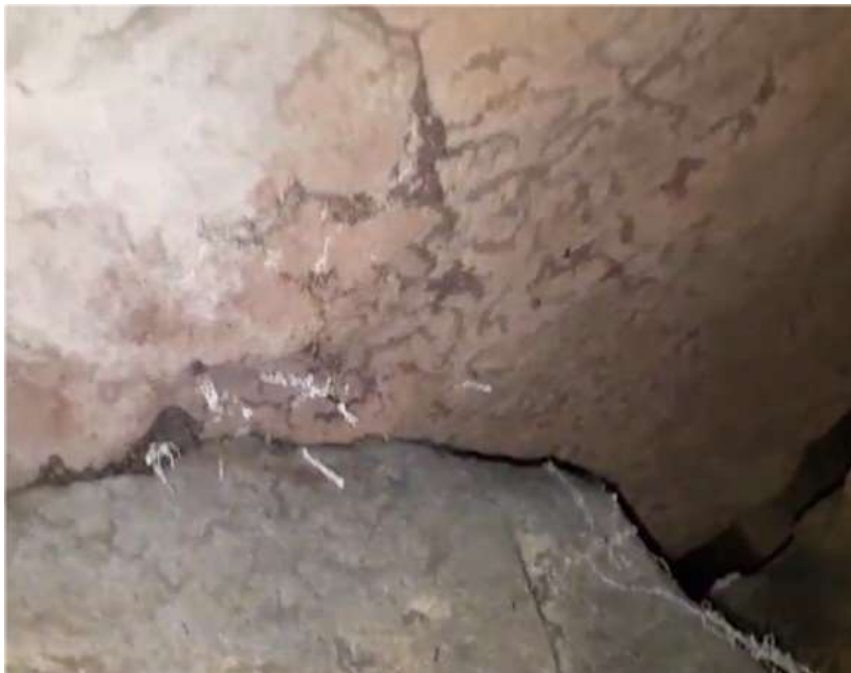
CB3 – The stone walls appear to display signs of slight curvature and belling inwards at this location. It is unclear whether the walls were originally constructed in this manner.

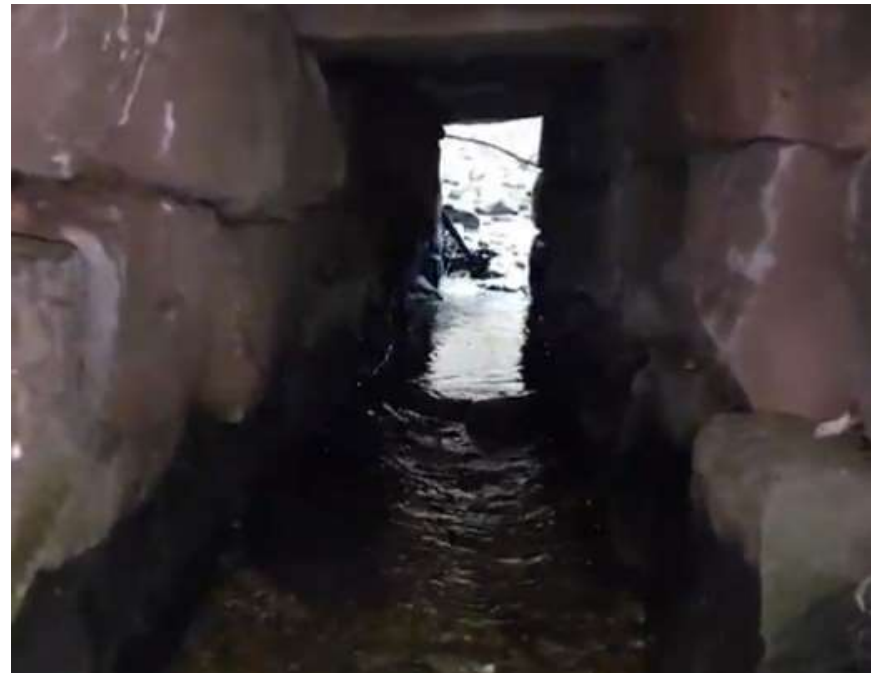
CC1 – access into Culvert C was not possible hence observations could only be made from the downstream end. No obvious signs of significant distortion were noted.

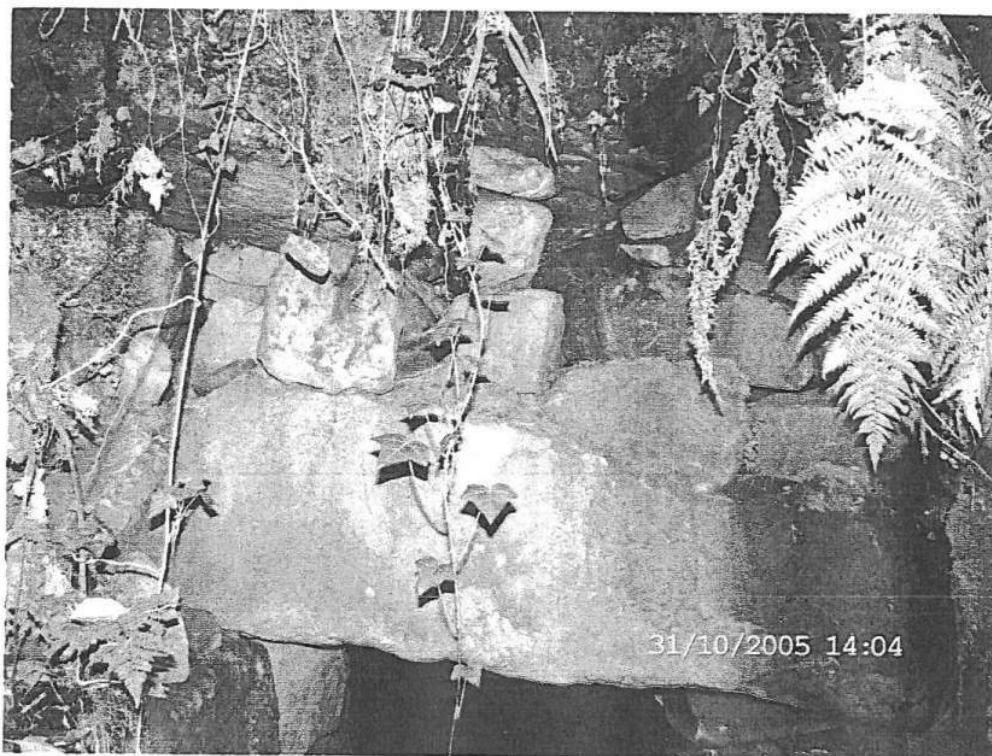
Photograph 2 – Downstream Collapsed Headwall, Culvert "A".

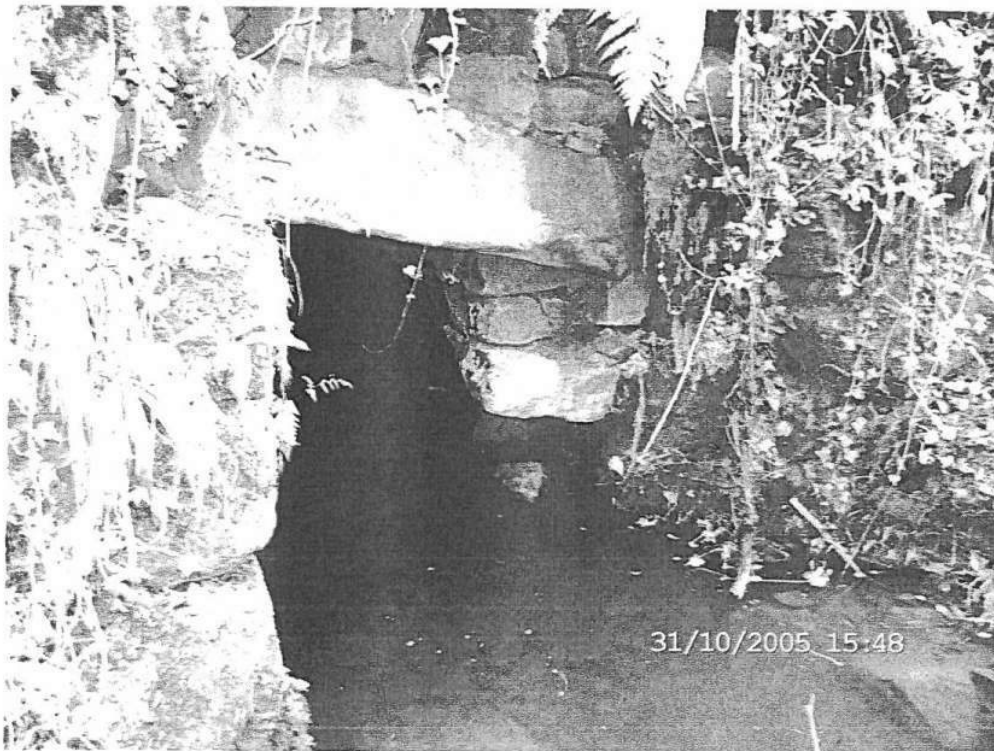
Photograph 9 – Scour at Downstream Entrance to Culvert "A".

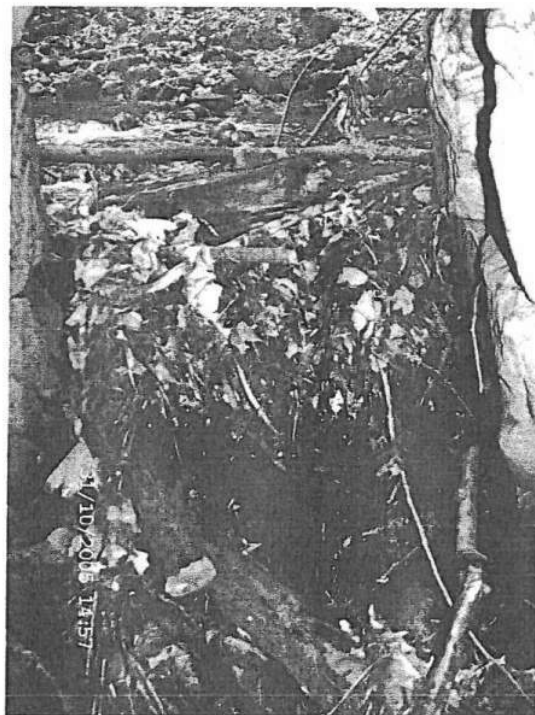
- 3.1 Schematic representation of the abutments, dividing walls and roof condition is shown on drawing 3/1499/03 in Appendix B.
- 3.2 There is much debris blocking the upstream entrance to Culverts 'A' and 'B'. The majority of the water flow is presently using Culvert 'C'. The depth of water dipped at the downstream exit was 360mm in Culvert 'C', 300mm in Culvert 'B', and 430mm in Culvert 'A'.

Photograph 12 – Culvert "B", Debris Blockage at Upstream Entrance.

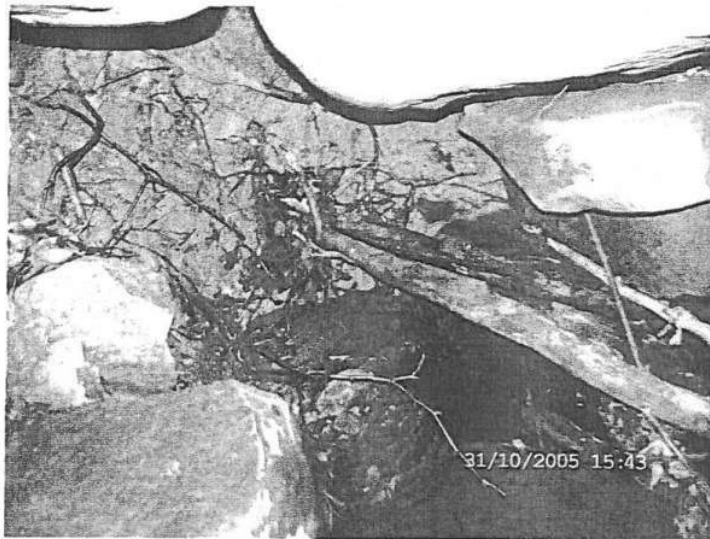
Photograph 14 – Culvert “A” at 4.2m, Right Hand Abutment, Deep Scour.

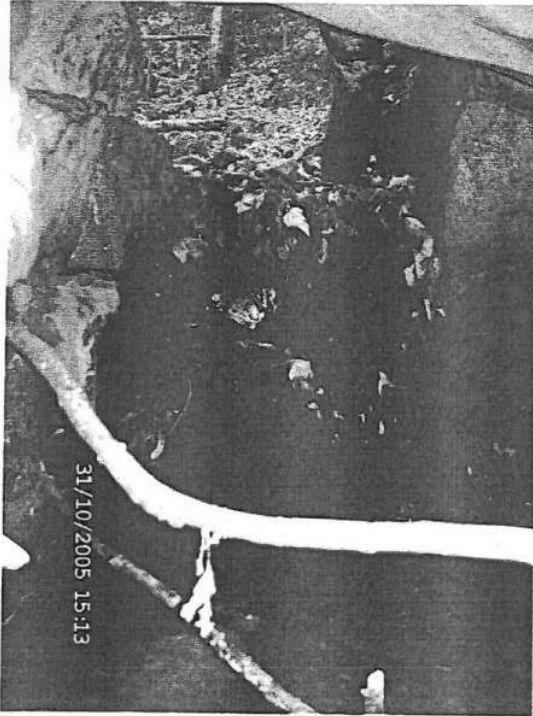
Photograph 16 – Culvert “A”, Debris Blockage at Upstream Entrance.

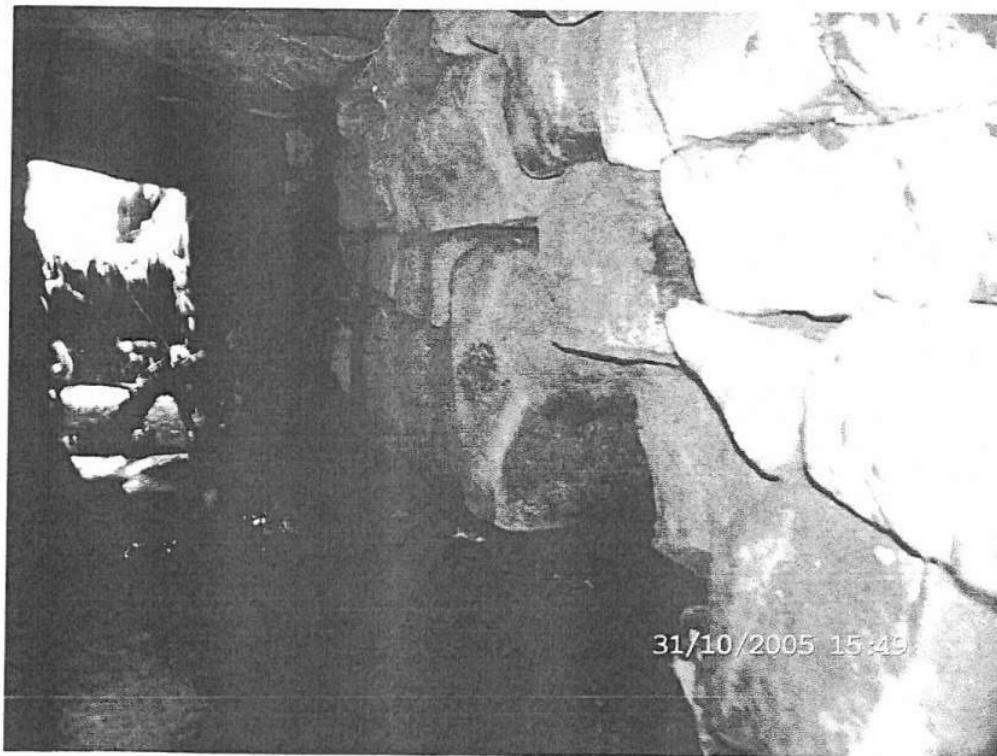
Photograph 18 – Culvert “A” at 1.0m to 3.0m, Right Hand Abutment Scour.

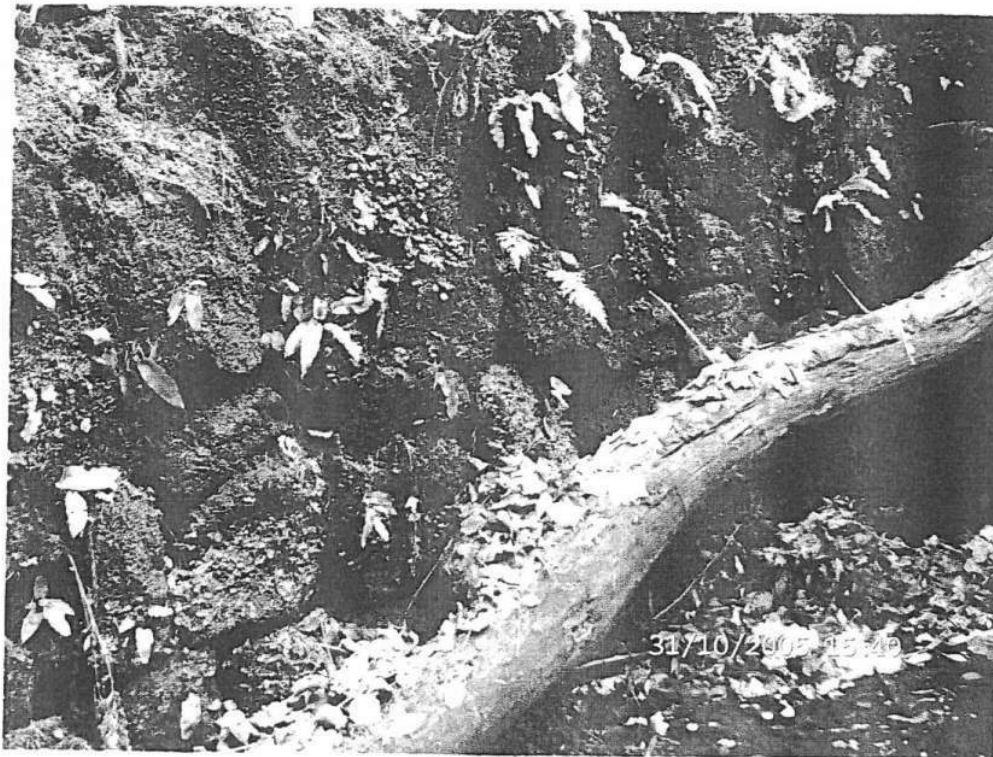
Photograph 22 – South East Wingwall Voids.
