Structural Appraisal

Cotton Dell Bridge Culverts

Staffordshire Wildlife Trust

Ref: 8968

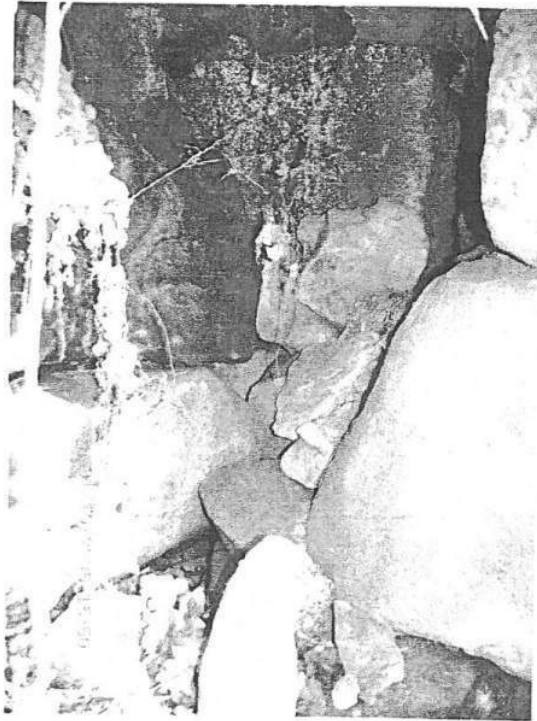
Photograph 34 – Back Face of Downstream (Missing) Headwall at Culvert "A".

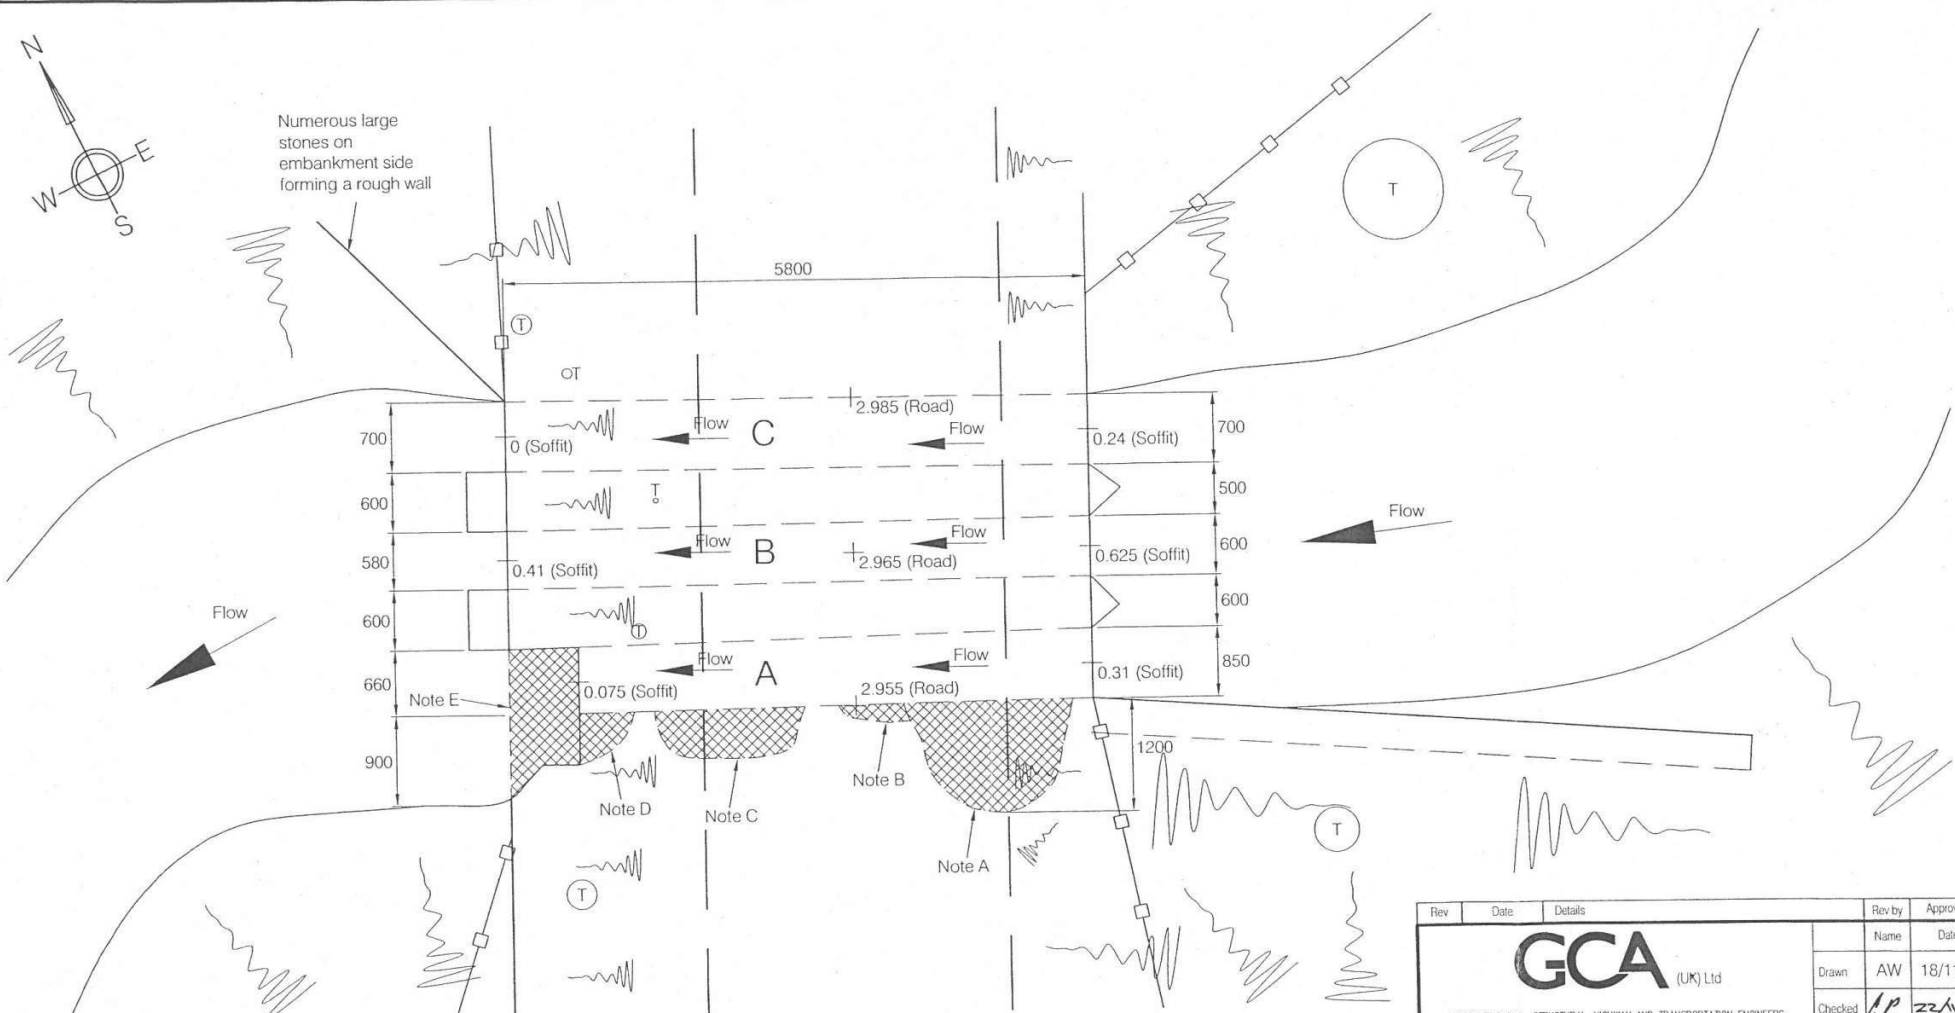
Note A
Abutment wall collapsed due to scour. SOFFIT NOT SUPPORTED. 3 No. large stones remaining, all others washed out. Soffit slabs slope down to missing support.

Note B
Partial scour to base of abutment wall with displaced stones. Soffit 50% supported

Note C
Scour to base of abutment wall extending 500mm back from wall face.

Note D
Abutment wall missing. Soffit slab has minimal support.

Note E
Spandrel wall missing. Soffit slab collapsed.
