Project Title: Ryde Town Council.

Site Address: Old National Westminster Bank
St. Thomas Square
Ryde
Isle of Wight

This report is to detail the testing and inspections to what used to be the National Westminster Bank located at St. Thomas Square, Ryde, Isle of Wight. The building is believed to be approx. 60 years old, the electrical installation is in excess of 45 years old.

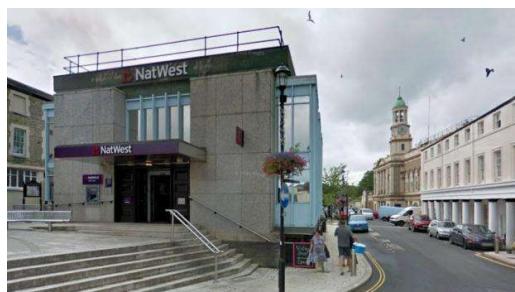
The incoming DNO supply, and switch fuse have not been verified for operational reasons. The building was in use at the time when testing was carried out. Supply tails emanate from the service head to the energy company's meter. It is unknown who the current providers are. Visual inspection of the supplies to and from the meter were satisfactory.

If the building is to be repurposed, consideration should be given to the incoming capacity which, given the size of the metering tails would be set to 100A or 69.28kVA. This figure is unverified. Tails from the TPN switch fuse to the bus bar chamber appears to be 25mm² and are in good condition.

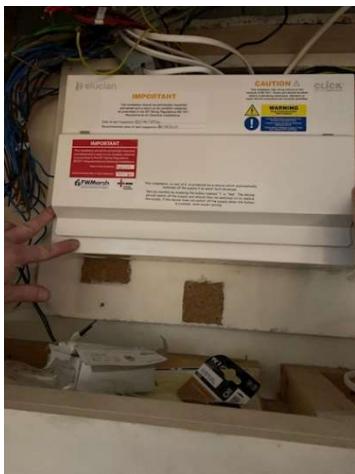
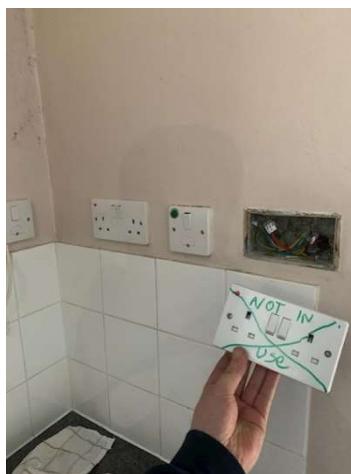
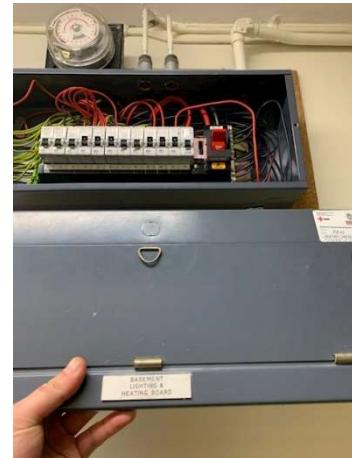
There have been several electrical alterations to the building. New distribution boards and consumer units have been recently installed. Many circuits to the first floor have been disconnected from the consumer unit and left coiled in the ceiling. Ideally, all old redundant cabling should be stripped back to its origin and the equipment at the end of the circuits removed. Several circuits are wired in MICC cable, although this cable is extremely robust it is susceptible to damage if altered or disturbed in any way.

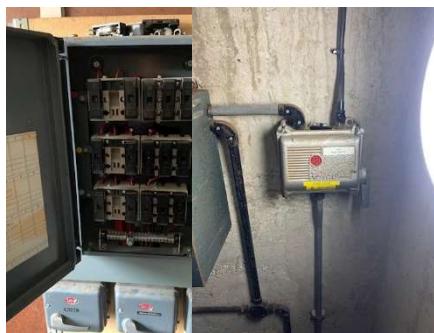
Wiring to the existing switchgear to the plant room located in the roof is outdated and is in need of upgrading. We were unable to test the isolators to the individual plant equipment due to Asbestos flash shields contained within them.

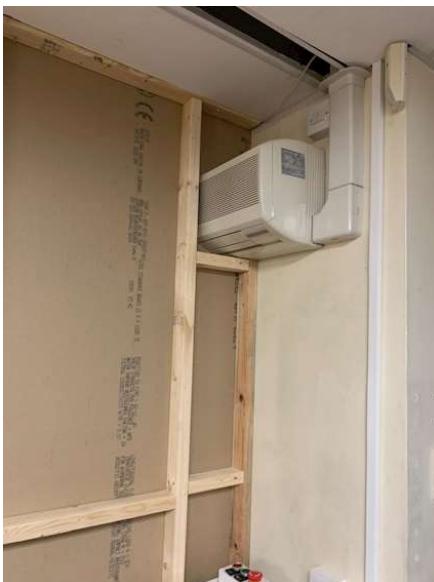
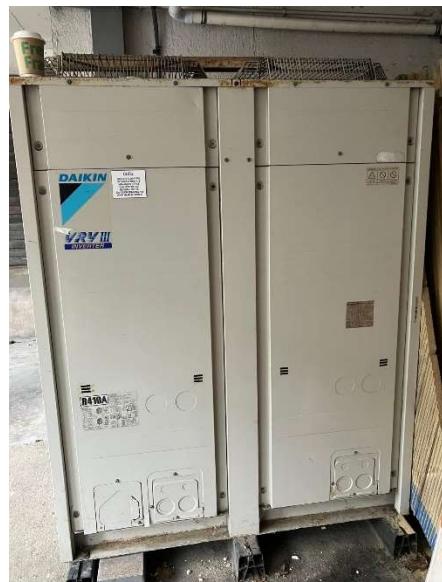
We have confirmed the supply to the VRV Daikin air conditioning unit located externally to the bottom of the vehicle ramp. Currently this is left in the 'off' position. This should not be energised until the unit has been serviced by a competent heating engineer.

We have verified the internal units are wired as a 'ring' final circuit and can be energised once a suitable MCB is sourced and live testing carried out. One of the units has been disconnected from this circuit due to a partition wall being constructed around it.

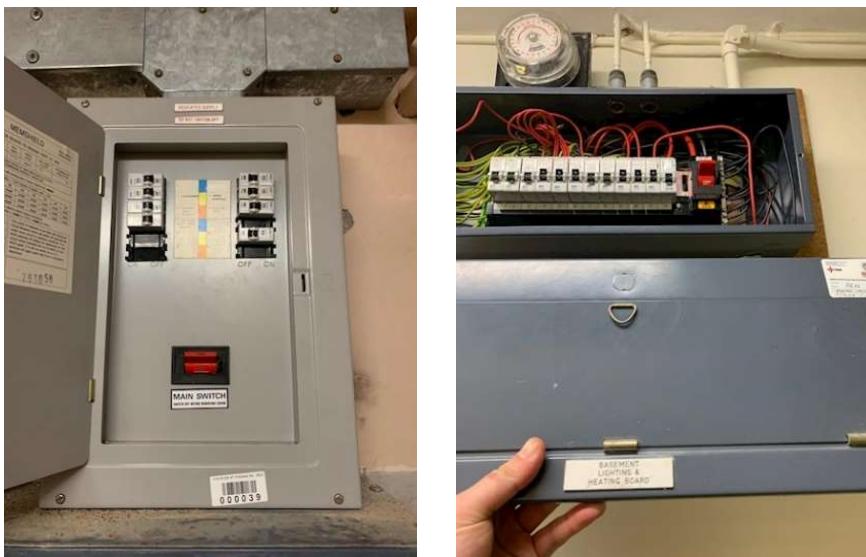
Sockets to the machine room sockets and counting room which are fed from distribution board DED1 have no RCD protection

Ring final circuit fed from the lighting and heating distribution board in the basement has no RCD protection to socket outlets.

This distribution board has no co-ordination or identification of conductors terminated in the neutral busbar terminal. Further investigation is required and affected circuits have been identified on page 18 of the certificate.

The origin for the 'DB CIR/1/2 feed RBP cabinet' could not be located. Details of the origin for this board have N/A entered into the fields on page 9 of the EICR

It is recommended the boards are replaced with new to provide circuit protection with BS EN 61009 RCBO's and Arc Fault Protection devices as recommended by current standards.

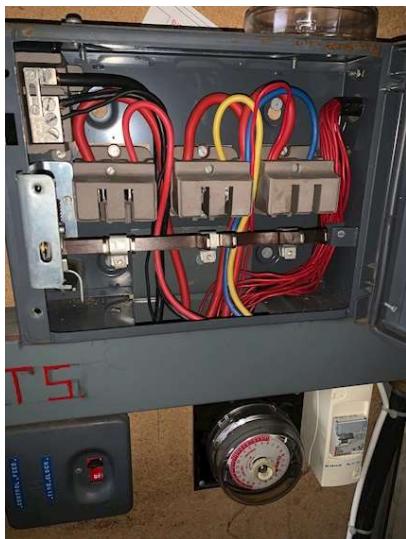
The switch fuse to the plant room DB has been used as a wireway into the trunking below. Although decommissioned, the supply to the contactor and time clock have been directly fed from the outgoing side of the isolator and not fused down and is currently fused at 63Amps from DB/1
