Report No **NACS/2945** for

Venn Court
Scott Avenue
Beeston

ASBESTOS SURVEY REPORT 2945

Name and Address of Client 650	Property Name ,Address & Ref No 4983
Broxtowe Borough Council Chief Executive Department Town Hall, Foster Avenue, Beeston Nottingham NG9 1AB	Venn Court Scott Avenue Beeston Notts
Type of Survey	Related Documents
Type 2 full survey	BS report 8244
Nature of Clients Request	Air report -
Carry Out Type 2 Surveys (communal To Residences)	Plan report 29276v1, 29277v1, 29278v1.
Name of surveyor(s)	Photo file 17553-17557, 20971-20975
SD Smith/I Haney	Register 4084
Survey Limitations	Priority One -
Communal areas	Misc documents
	Survey Date 22.6.2005 Report Date 30.6.2005

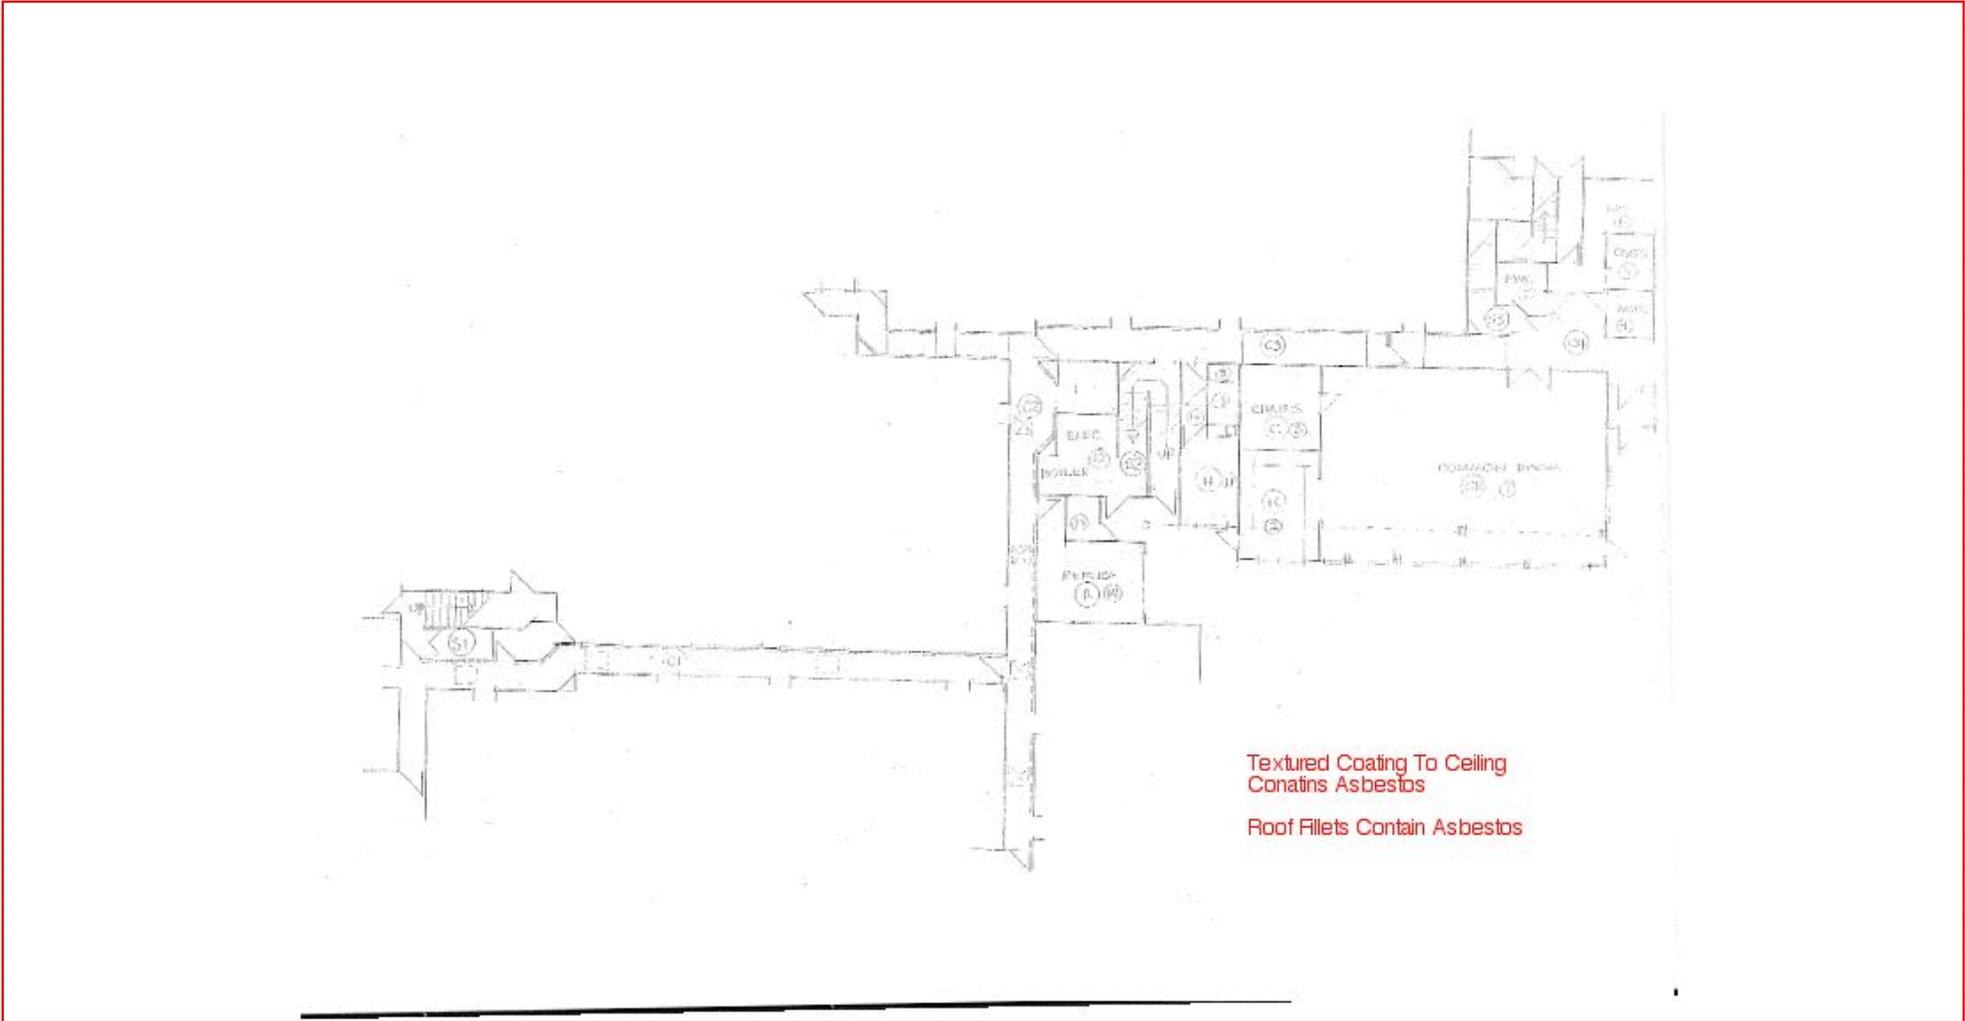
Plan Of Ground Floor With Acm's

Textured Coating To Ceiling
Conatins Asbestos
Roof Filets Contain Asbestos

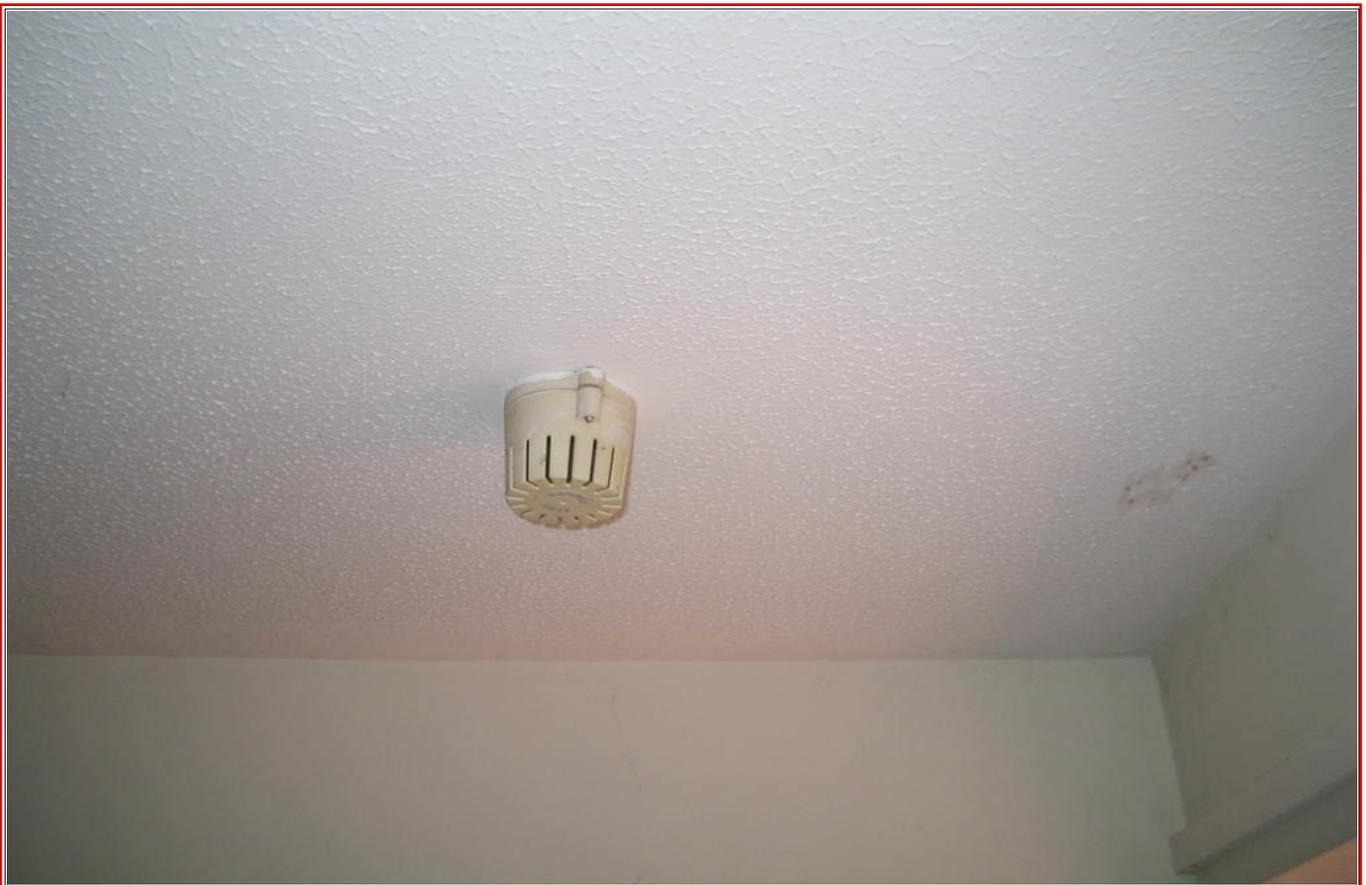
Textured Coating To Ceiling Store

Test No.	1331	score
* Component	artex	2
Condition		1
Acm Type		1
Asbestos type	Chrysotile	1
Material Risk Assessment Score		5
Accessibility	1	Priority: 3
Extent (m2)	8	
* 7= non asbestos (see registers)

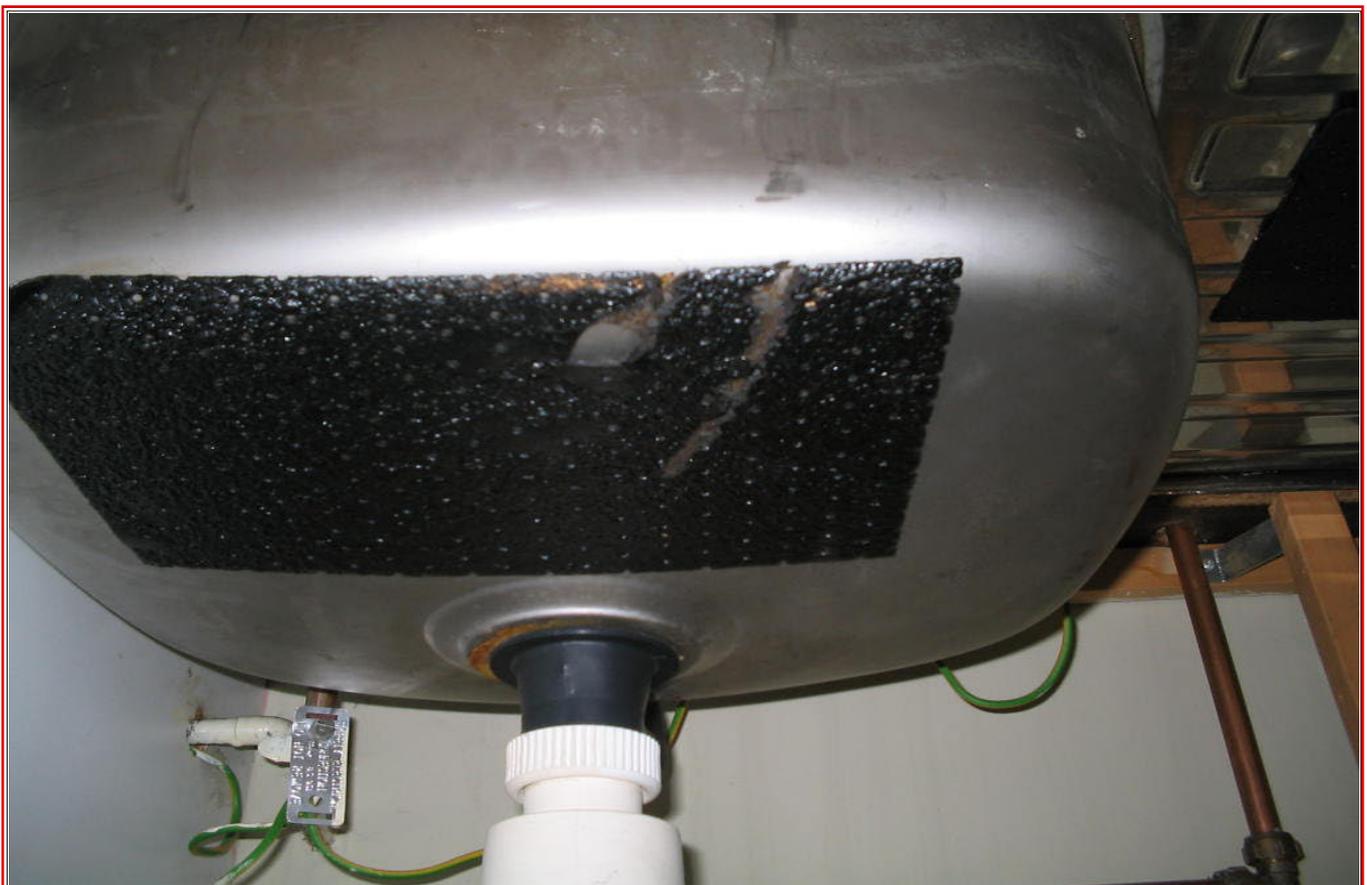
Sink Pad

Test No.	1333	score
* Component	7	
Condition		
Acm Type		
Asbestos type	Non Asbestos	0
Material Risk Assessment Score		0
Accessibility		Priority:
Extent (m2)		
* 7= non asbestos (see registers)

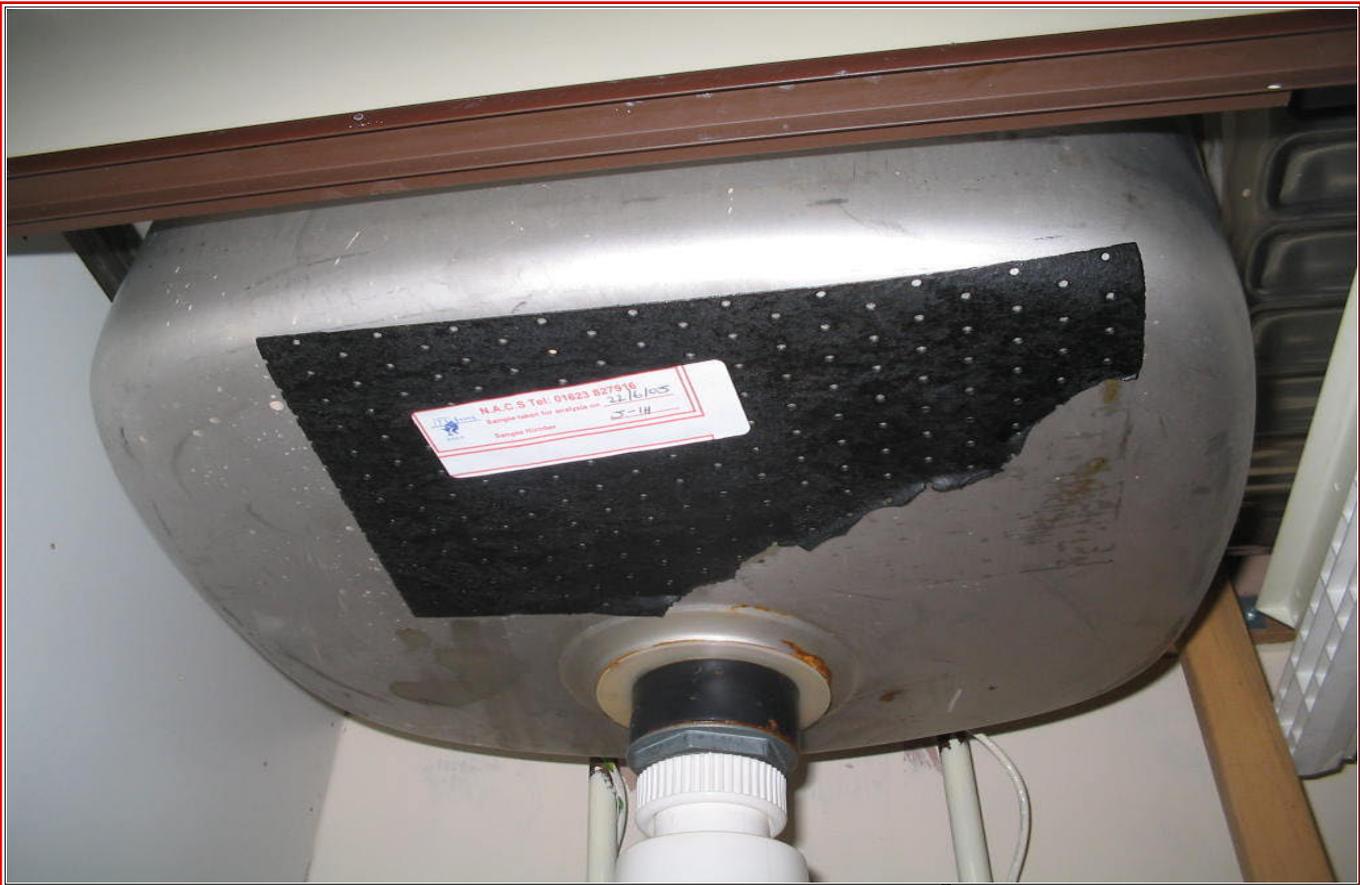
Sink Pad

Test No.	1335	score
* Component	7	
Condition		
Acm Type		
Asbestos type	Non Asbestos	0
Material Risk Assessment Score		0
Accessibility		Priority:
Extent (m2)		
* 7= non asbestos (see registers)

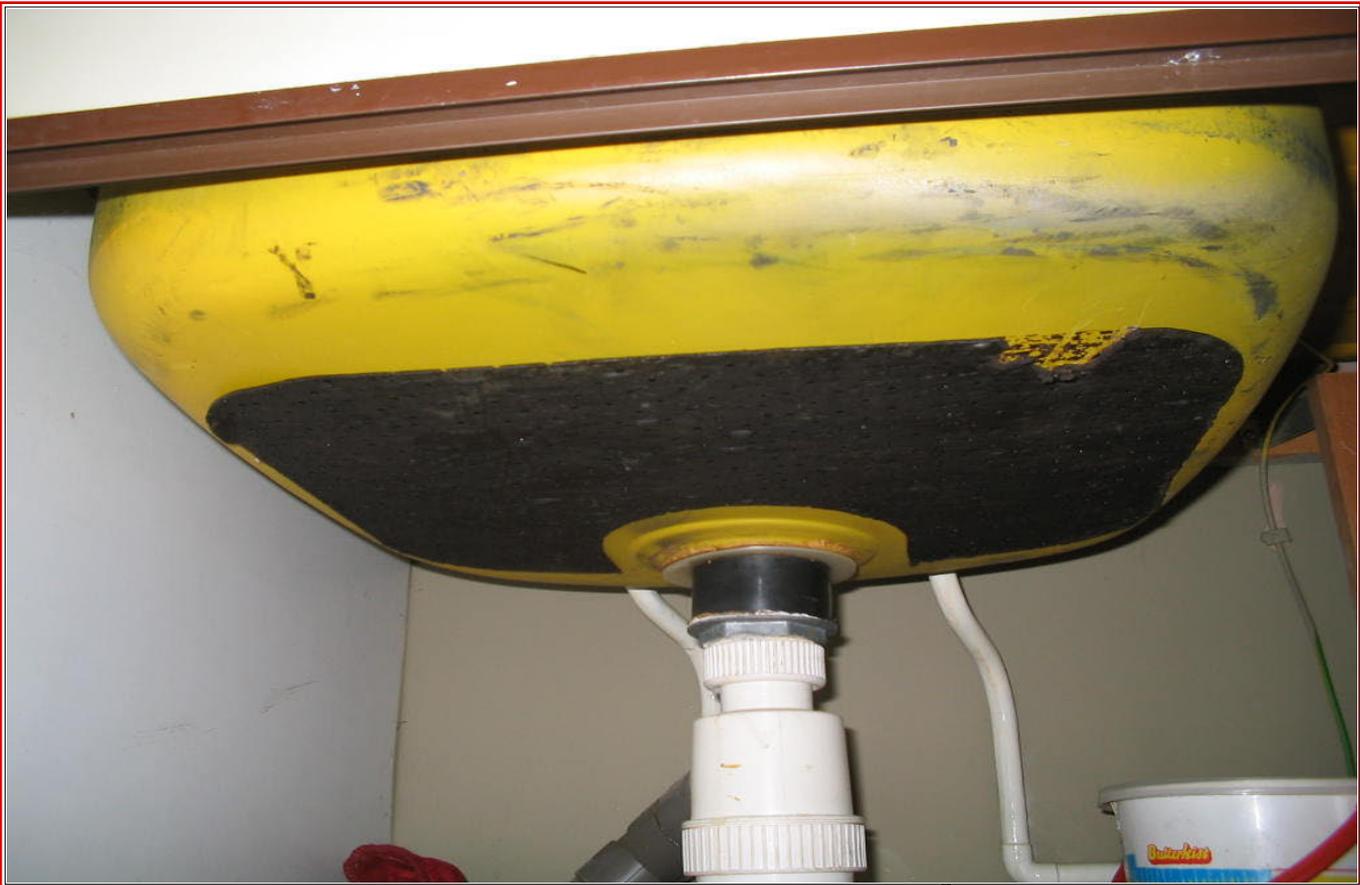
Sink Pad

Test No.	1337	score
* Component	7	
Condition		
Acm Type		
Asbestos type	Non Asbestos	0
Material Risk Assessment Score		0
Accessibility		Priority:
Extent (m2)		
* 7= non asbestos (see registers)

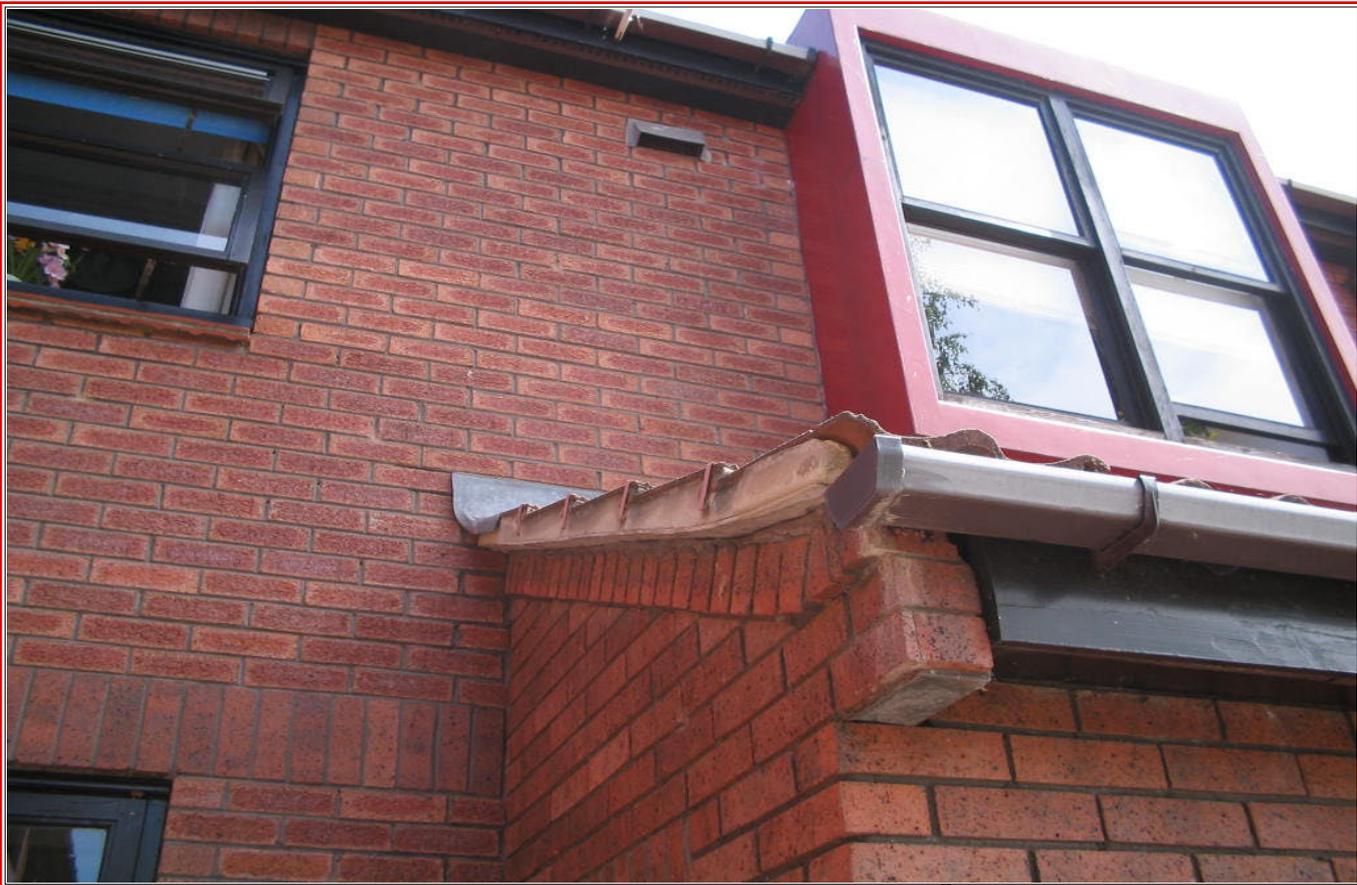
Roof Fillets

Test No.	1339	score
* Component	A/ C	1
Condition		1
Acm Type		1
Asbestos type	Chrysotile	1
Material Risk Assessment Score		4
Accessibility	1	Priority: 3
Extent (m2)	80	
* 7= non asbestos (see registers)

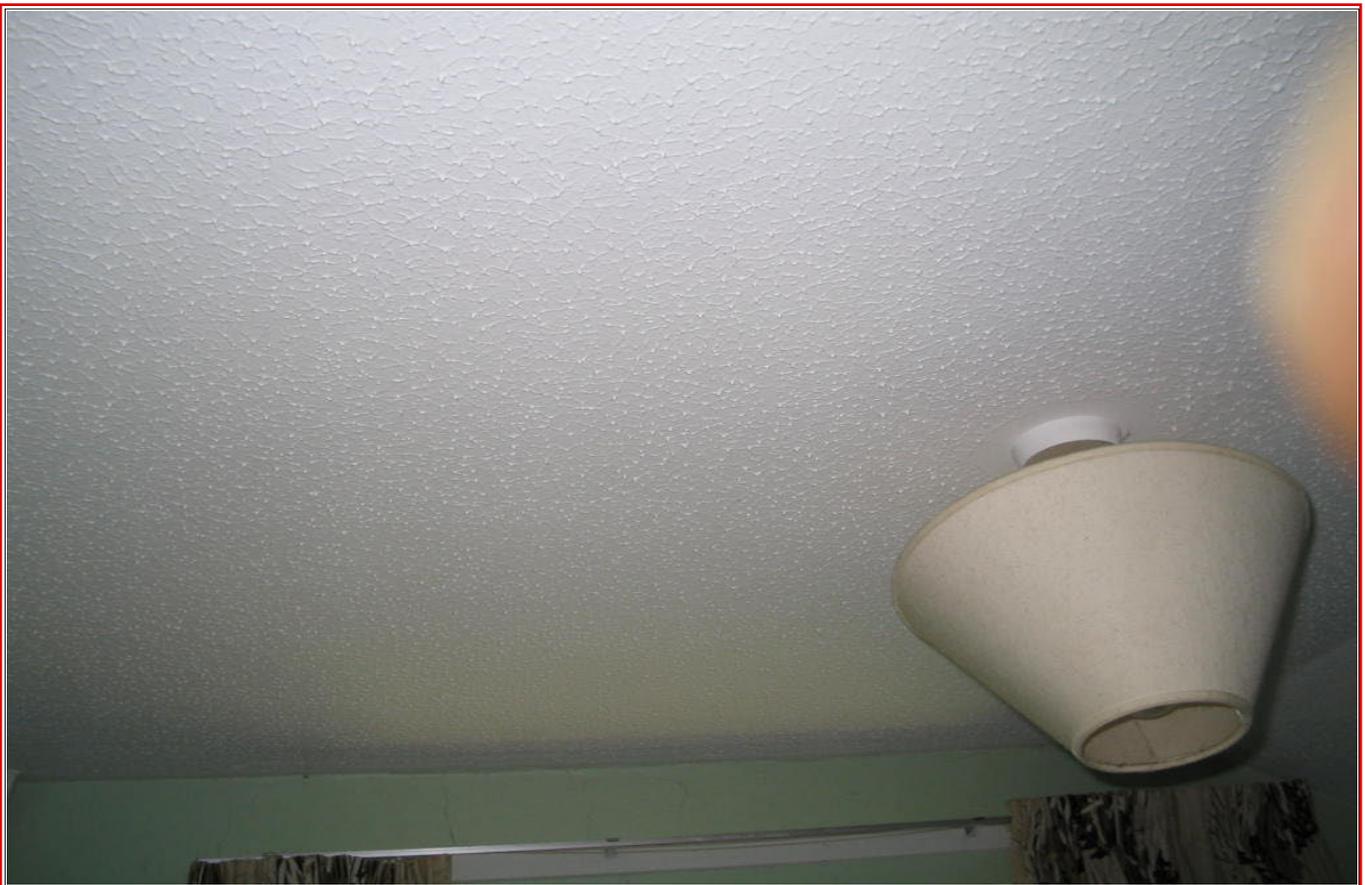
Textured Coating To Ceiling

Test No.	1332	score
* Component	artex	2
Condition		1
Acm Type		1
Asbestos type	Chrysotile	1
Material Risk Assessment Score		5
Accessibility	1	Priority: 3
Extent (m2)	60	
* 7= non asbestos (see registers)

Inc Phone Room And Lmr. Assume Same In Each Bedroom

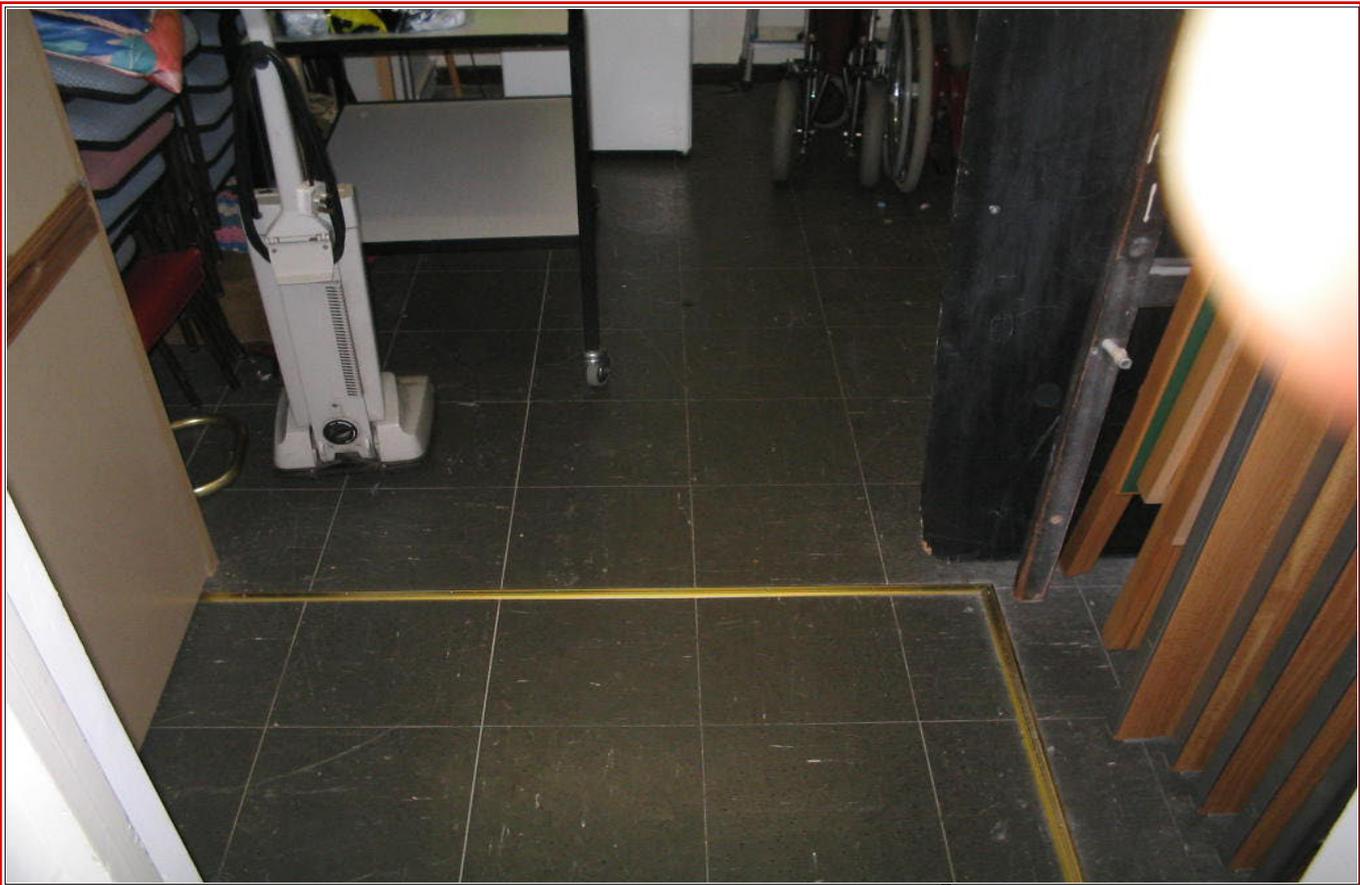
Floor Tiles

Test No.	1334	score
* Component	7	
Condition		
Acm Type		
Asbestos type	Non Asbestos	0
Material Risk Assessment Score		0
Accessibility		Priority:
Extent (m2)		
* 7= non asbestos (see registers)

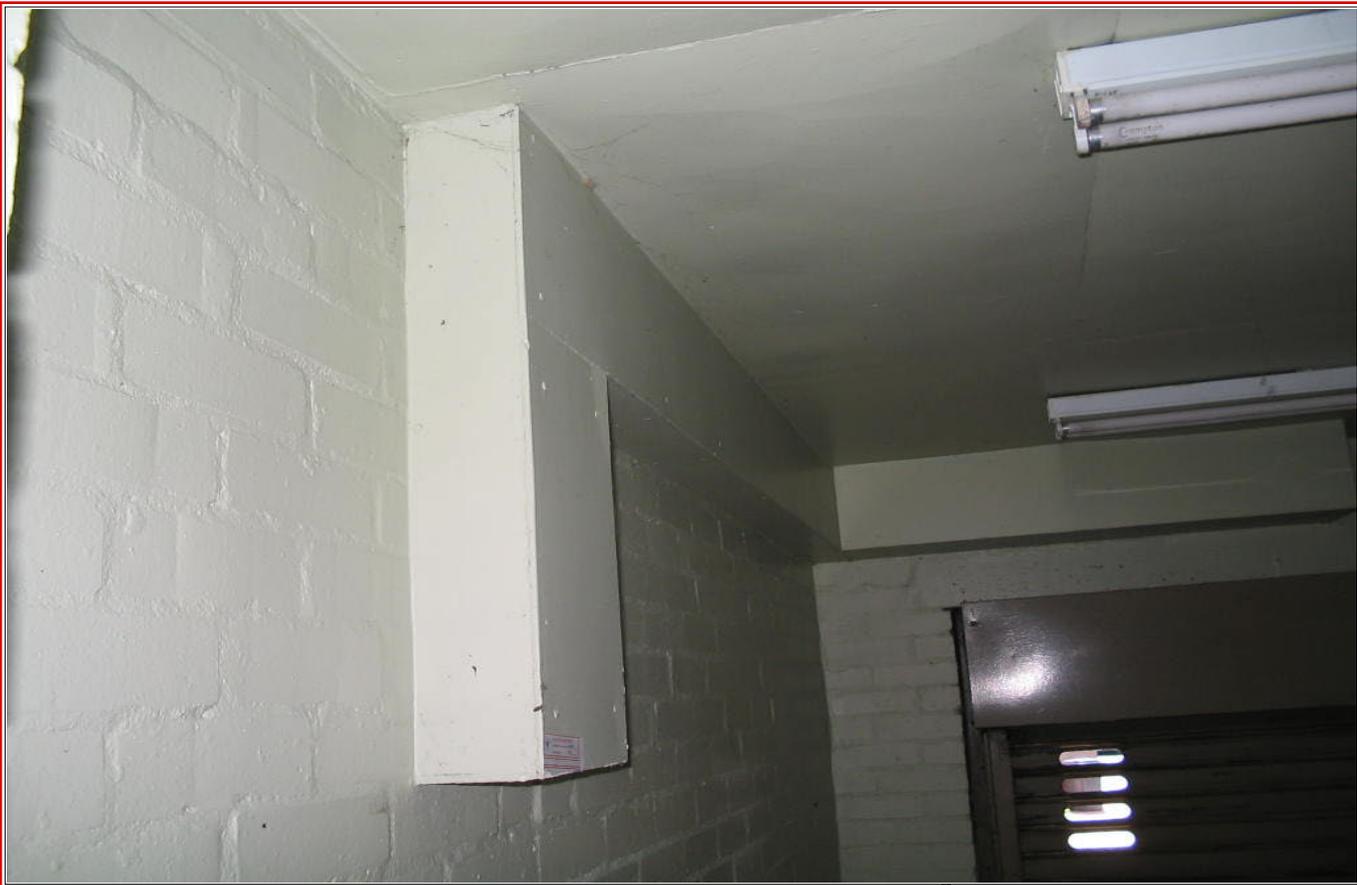
Boxing

Test No.	1336	score
* Component	7	
Condition		
Acm Type		
Asbestos type	Non Asbestos	0
Material Risk Assessment Score		0
Accessibility		Priority:
Extent (m2)		
* 7= non asbestos (see registers)

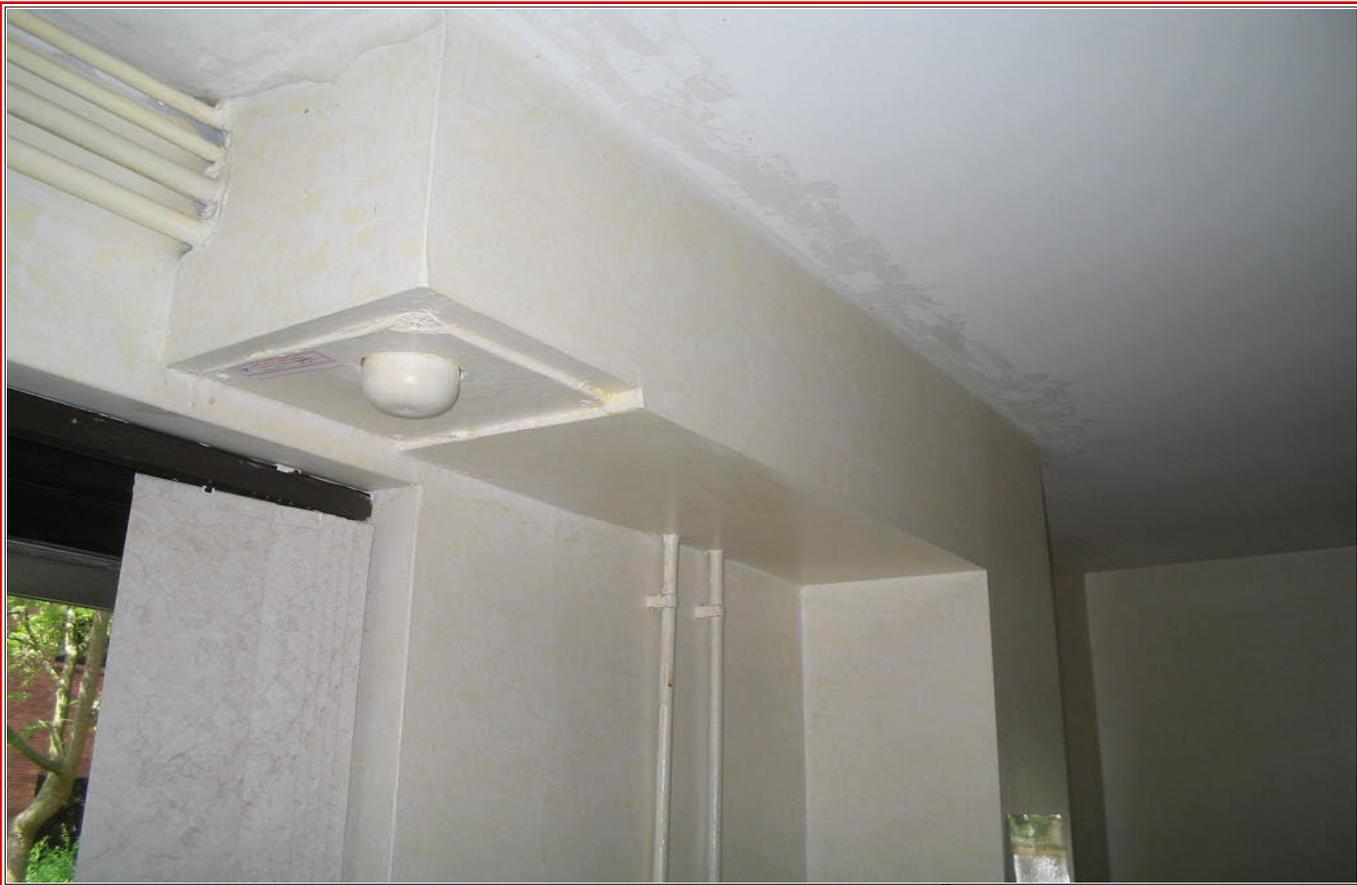
Panel To Boxing

Test No.	1338	score
* Component	7	
Condition		
Acm Type		
Asbestos type	Non Asbestos	0
Material Risk Assessment Score		0
Accessibility		Priority:
Extent (m2)		
* 7= non asbestos (see registers)

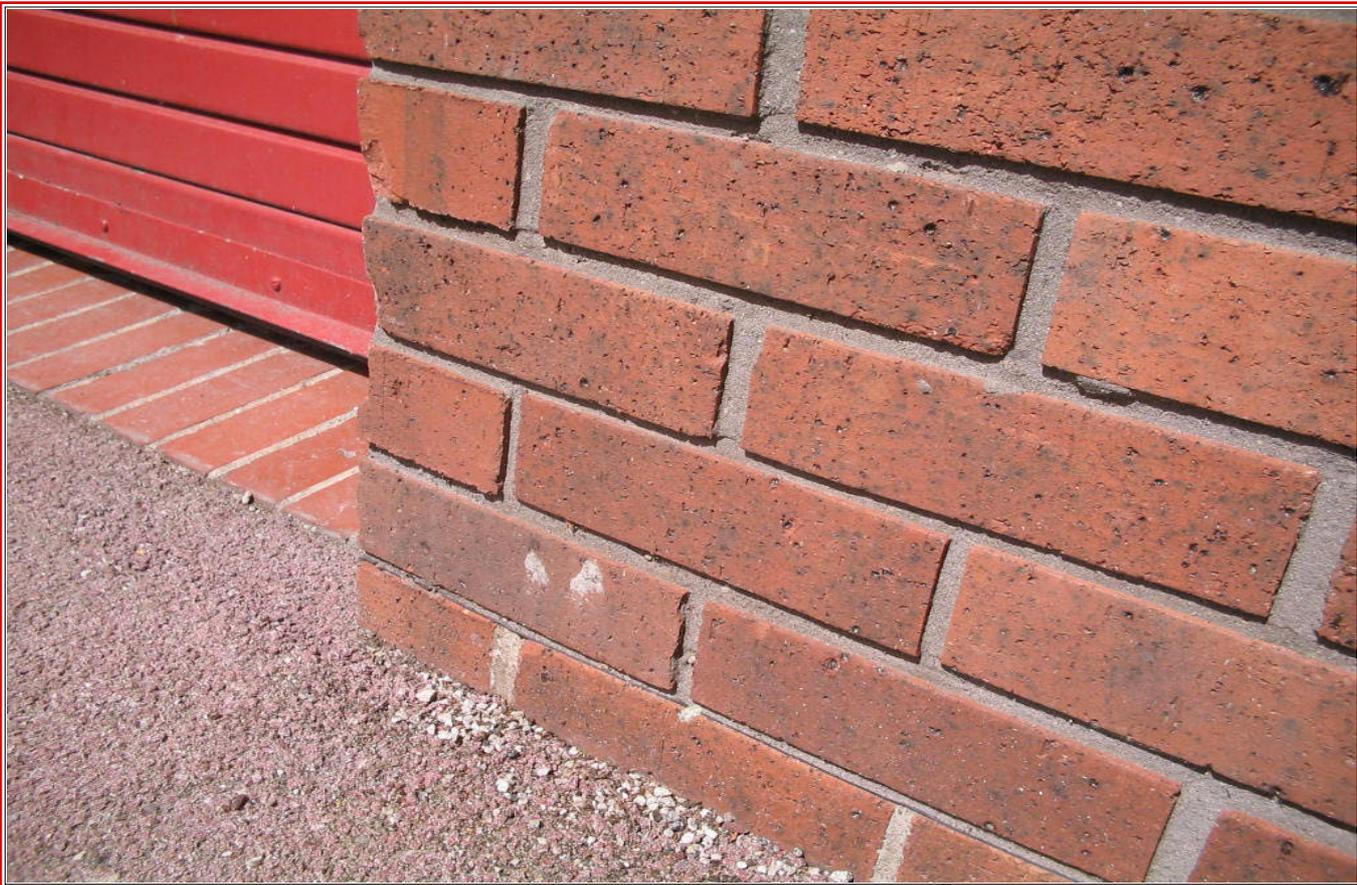
Dpm

Test No.	1340	score
* Component	7	
Condition		
Acm Type		
Asbestos type	Non Asbestos	0
Material Risk Assessment Score		0
Accessibility		Priority:
Extent (m2)		
* 7= non asbestos (see registers)
