NORTH FACING ELEVATION  
Refer to drawing 950-Q18 for full details of all stone repairs to this north elevation.

CLIENT: Ross-on-Wye Town Council  
PROJECT: North Elevation WF-06 Stone Repairs  
TITLE: WTS  
SCALE: 1:20 @ A3  
DATE: 11/04/22  
DRAWN BY: JRM  
CHECKED BY: JRM  
PROJECT NO: 950  
DRAWING NO: 034  
R.D.

CLIENT: Ross-on-Wye Town Council  
PROJECT: Market House  
TITLE: North Elevation WF-07 Stone Repairs  
SCALE: 1/10 (see sheet 950-018) 1/20 (see sheet 950-019)  
DATE: 13/04/2021 (sheet 950-018) 1/20 (see sheet 950-019)  
JOB/CLIENT NUMBER: 950 035  
DRAWN BY: RGT

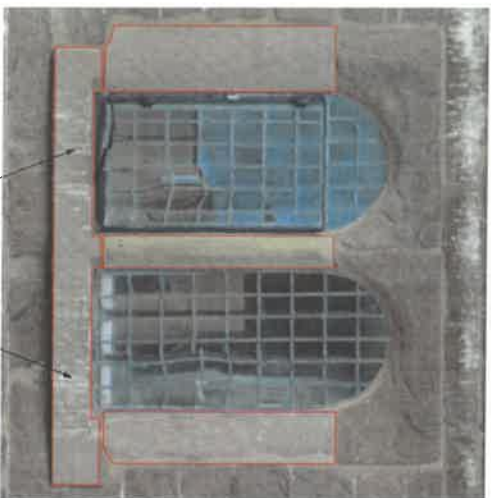
Existing Photographic Record of Window WF-03

Existing red sandstone sill to be retained and redressed.

Existing leaded lights. Individually sized to suit each individual window opening.  
The existing windows will need to be carefully removed and safely stored for later refitting. Allow for fully reconstructing the existing leaded lights to fit the new reveals with rebated glass lines.  
The repaired leaded lights and metal casements, (WF-03, WF-05, WF-07) are to be offered up and set within the rubble in a lime mortar bed.

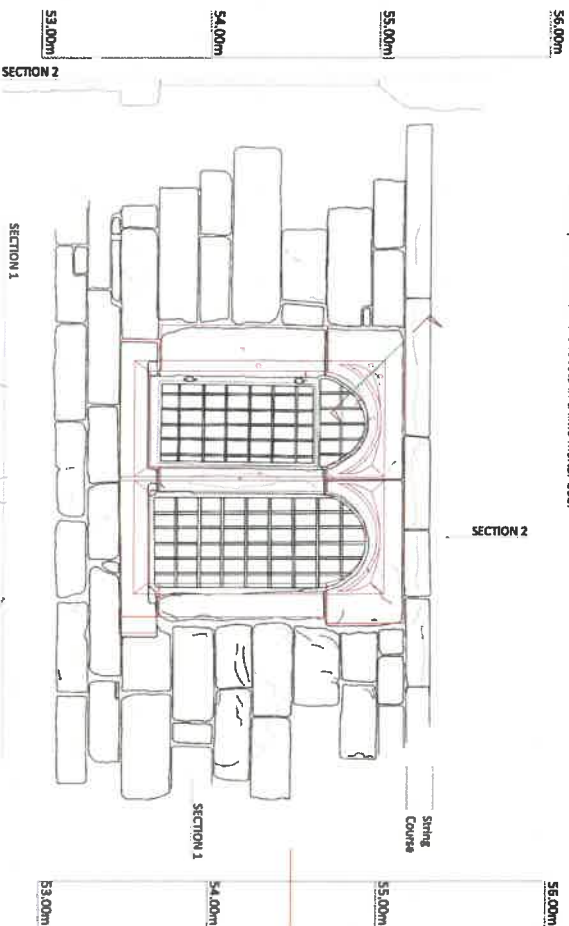
Surveyed drawing of window WF-03

Existing stone sections forming the window jambs, mullion, sills and window heads to be reassessed to determine extent of replacement. As most of the existing stone window reveals to the north elevation have now eroded up to and in parts beyond the glass line.  
The stone sections forming WF-03 are a mix of a Forest of Dean and Ross Red/Brown sandstone. All stone sections have eroded back to the existing glass line and will require replacement all with approved Ross red sandstone.

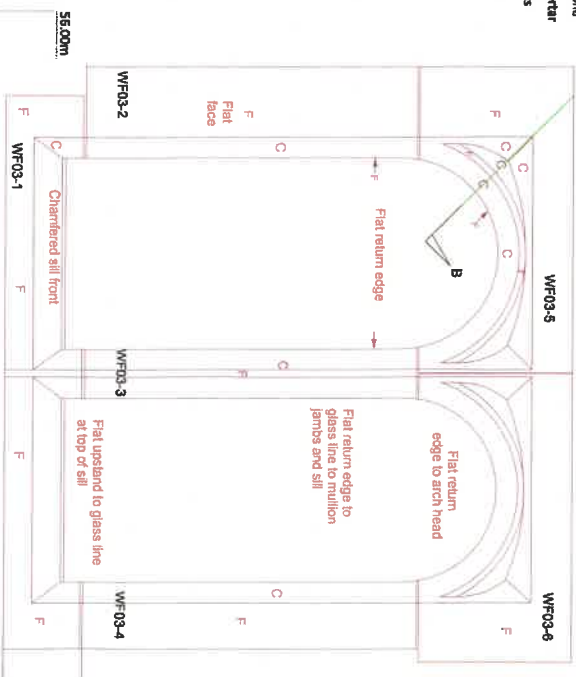
Window WF-03-External

Existing red sandstone sill to be retained and redressed. WF03-1 Existing Stone in-situ  
Remainder of stone sections forming the window jambs, mullion and window heads to be reassessed to determine extent of replacement. As most of the existing stone window reveals to the north elevation have now eroded up to and in parts beyond the glass line.  
The stone mullion to WF-03 is of a Forest of Dean stone and not the original sandstone.  
An earlier stone repair scheme has seen the insertion of a new red sandstone sill to this window which will require re-dressing to the approved profiles.  
The remaining 2 jambs and window head sections are also eroded to the glass line and require re-facing with rebated detail and profiles.

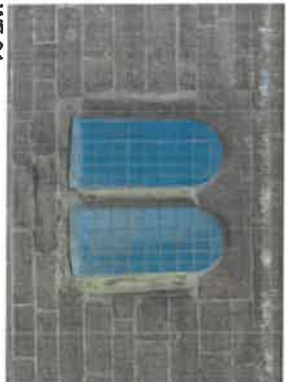
Photographic record of the existing condition of WF-04

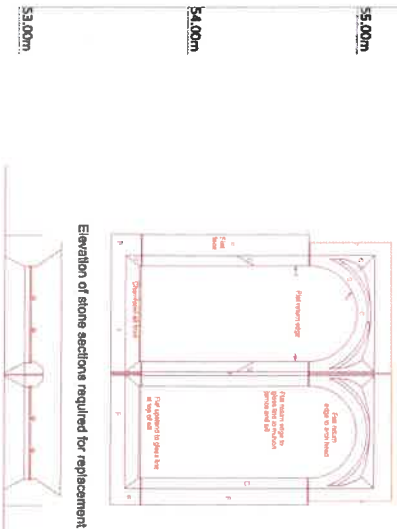
Window WF-05-External

Existing stone sections forming the window jambs, mullion, sills and window heads to be removed to determine extent of replacement. As most of the existing stone window reveals to the north elevation have now eroded up to and in parts beyond the glass line.

The stone sections forming WF-05 are a mix of a Forest of Dean and Rose Red/Brown sandstone. All stone sections have eroded back to the existing glass line and will require replacement all with approved Rose Brownstone.

Extent of stone replacements to return the window with functioning sills, window heads, jambs and mullion safely securing the leaded light and opening casement in a serviceable position.

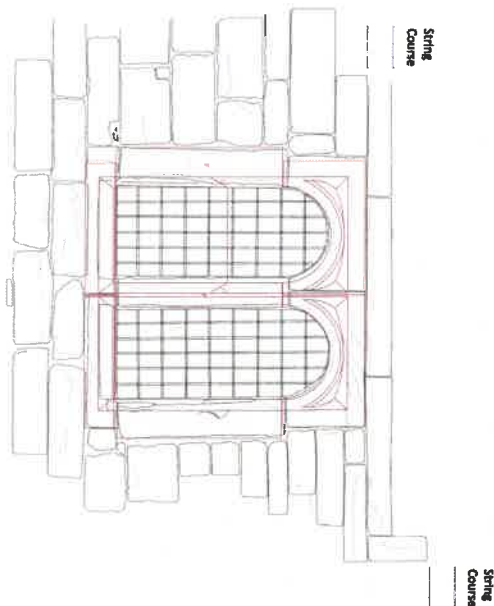
Window WF-06-External

Existing stone sections forming the window jambs, mullion, sills and window heads to be reassessed to determine extent of replacement. As most of the existing stone window reveals to the north elevation have now eroded up to and in parts beyond the glass line.

The stone sections forming WF-06 are a mix of a Forest of Dean and Rose Red/Brown sandstone. All stone sections have eroded back to the existing glass line and will require replacement all with approved Rose Brownstone, sandstone

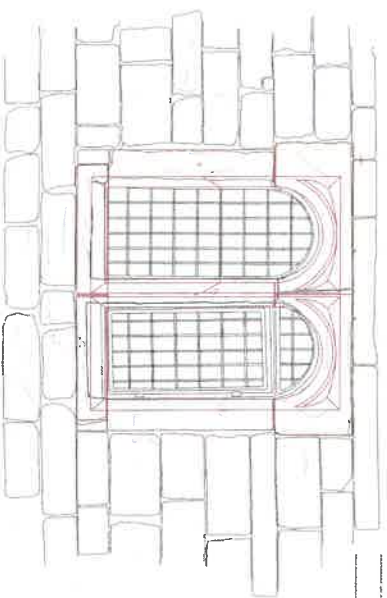
Window WF-07 stone sections identified for replacement

Existing stone sections forming the window jambs, mullion, sill and window heads to be reassessed to determine extent of replacement. As most of the existing stone window reveals to the north elevation have now eroded up to and in parts beyond the glass line.

The stone sections forming WF-07 are a mix of a Forest of Dean and Ross Red/Brown sandstone. All stone sections have eroded back to the existing glass line and will require replacement all with approved Ross red sandstone.

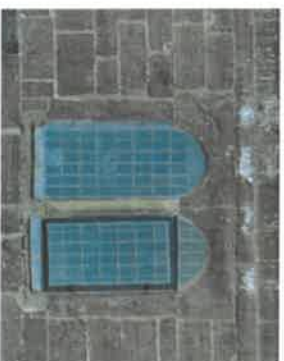
Photographic record of WF-07

Existing stone sections have eroded past the glass line.

All window stone replacements to be in Ross Brownstone to be carefully selected and approved by the Conservation Architect

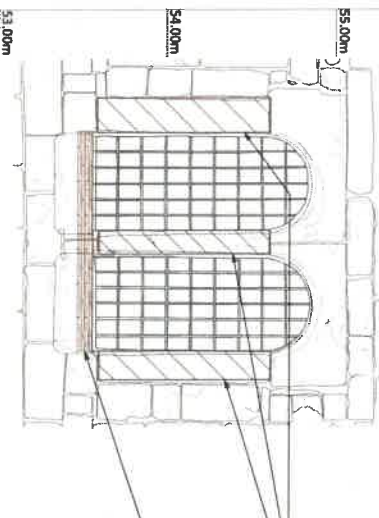
Window WF-01, WF-02

Vertical stone sections identified for some repair,  
all sections to be uncovered and assessed.

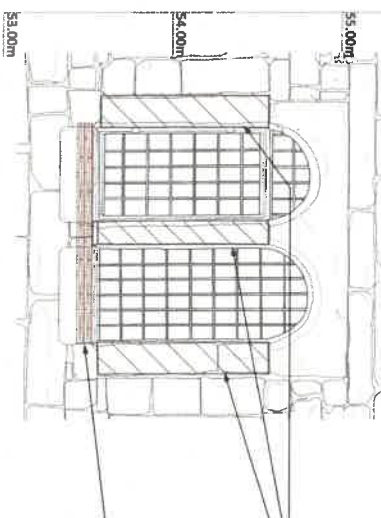
Window WF-02 External survey drawing.  
Elevation and section

Existing head stones appear to be less eroded and  
with a careful assessment

Existing stone sections forming the window jambs, mullion, sills  
to be reassessed to determine extent of repair.  
As most of the existing stone window reveals to the north elevation have  
now eroded up to and in parts beyond the glass line.

The stone sections forming WF-01 and WF-02 are of a Ross Red/Brown  
sandstone. All stone sections are heavily eroded, some back to the existing glass line.  
Repairs will be required, in parts with an approved suitable mortar mix to match the  
existing Ross red sandstone.

The existing sills are currently shielded by hand dressing to aid the  
shedding of rainwater, and arrest further erosion.  
Depending on their revealed current condition and further assessment  
allow for placing in clay tiles as shown to form the replacement sill.  
Form the sill in alternating the layers set in lime mortar with fine verticle  
joints, the leading edge extending slightly past the restoration line.  
Form a small verticle mortared upland to the existing glass line.

Left and right jambs, centre mullion to receive a sensitive  
mortar repair to bring the profile back and reform the edge  
to the glass line.  
The repair must be of the best quality, undertaken correctly  
in accordance to the specification to ensure compatibility with the  
existing existing host stone, matching the colour, texture and finish.  
The applied mortar mix will be approved by Historic England  
and the Conservation Architect and must be undertaken by a suitably  
qualified conservation craftsman familiar with such fine detailed  
plastic mortar applications and techniques.
