The NMRN have concerns regarding the condition of the cofferdam fill drainage and associated structures supported on the fill materials, being the Bow Platform and Forward bow access staircase. From previous surveys and inspection, the following SOR has been developed to address the long-term consequences of a poor drainage system to the cofferdam fill below HMS Alliance.

Background

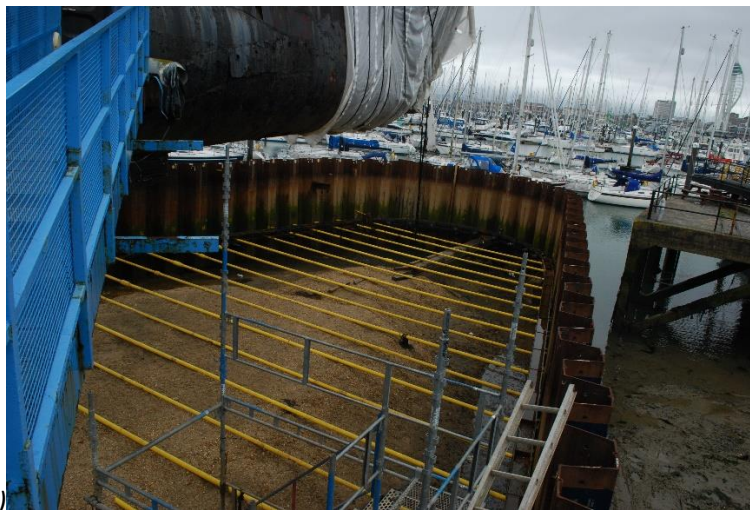
Photo during construction (pre capping beam/ drainage installation)

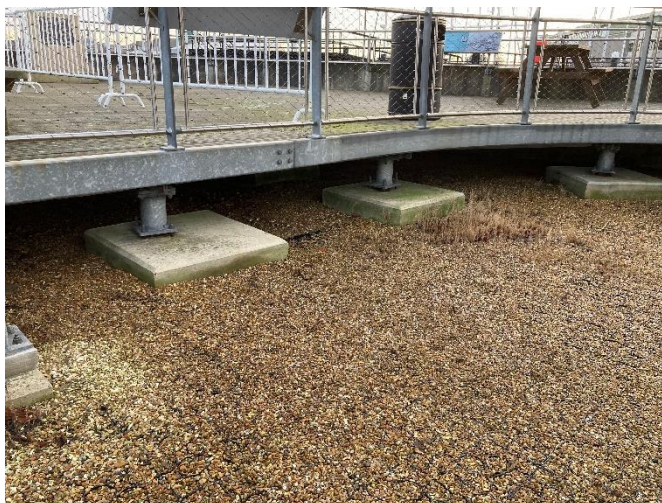
Photo of public viewing platform

To enable safe excavation and temporary shoring works required for the drainage system modifications, the existing public view platform shall be carefully disassembled as necessary, set to one side, then reinstated on completion of the works to which some foundation blocks shall be removed, and new structural steel beams installed to support the reinstated viewing platform.

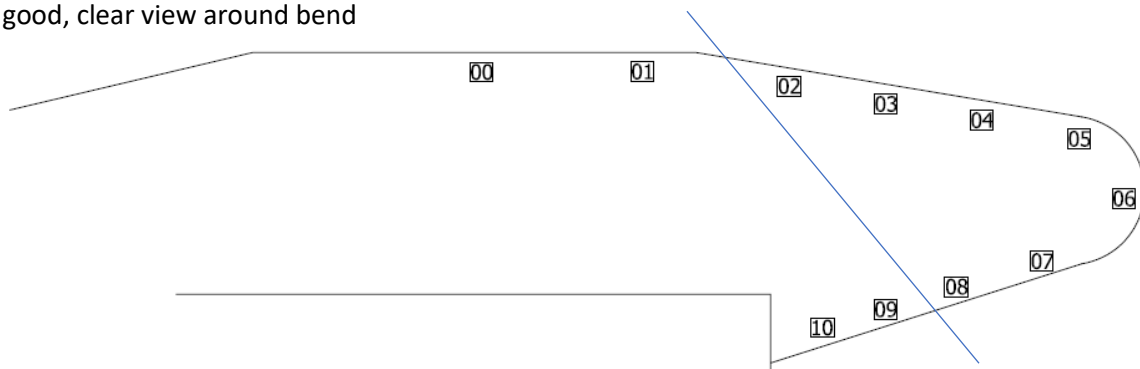
Drainage Condition position-

- 00 Very good, clear view around bend
- 01 Very good, clear view around bend
- 02 Good, clear view around bend, duct a little lower
- 03 Fair, clear view around bend, duct lower
- 04 Fair, clear view around bend, duct lower
- 05 Poor, plastic duct collapsed although still attached to flap housing
- 06 Poor, stainless steel mesh fitted over opening, duct collapsed behind
- 07 Fair, clear view around bend, duct a lot lower
- 08 Good, clear view around bend, duct a little lower
- 09 Very good, clear view around bend
- 10 Very good, clear view around bend

To each drainage flap point marked 02, 03, 04, 05, 06, 07 & 08, Markup sketch SK01.

- 1.1. Excavate cofferdam fill to expose installed drainage gabion baskets, Seagate flap valve housing and drainage duct at approx. 2.4m ACD. Noting current fill level in main basin area is at 4.9m ACD, 4.4m ACD under observation platform and substrates are tidal.

- 1.2. Once area fully exposed to each location, remove drainage 6a fill material, duct, and gabion mesh basket frames to enable access to the rear face of the flap valve.

- 1.3. Manufacture heavy duty 316 grade stainless steel cylindrical mesh filter basket 300mm long with end plate fabricated from perforated plate with 10mm holes on 15mm pitch, with flange face to suit flap valve bolt pitch. (*See details SK02*)

- 1.4. Install new valve drainage basket to each flap valve back by disconnecting Seagate flap valve and fit additional new flanged mesh basket on back face of flap valve on existing bolt pattern along with servicing, cleaning and reinstating the flap valves.

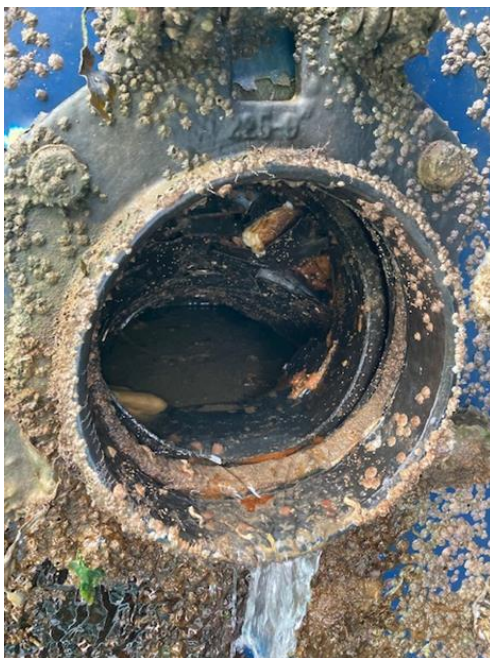
Typical poor condition flap

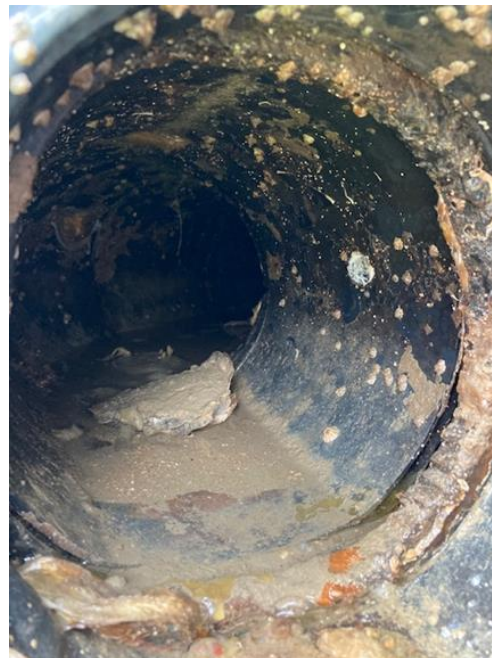
Typical good condition flap
