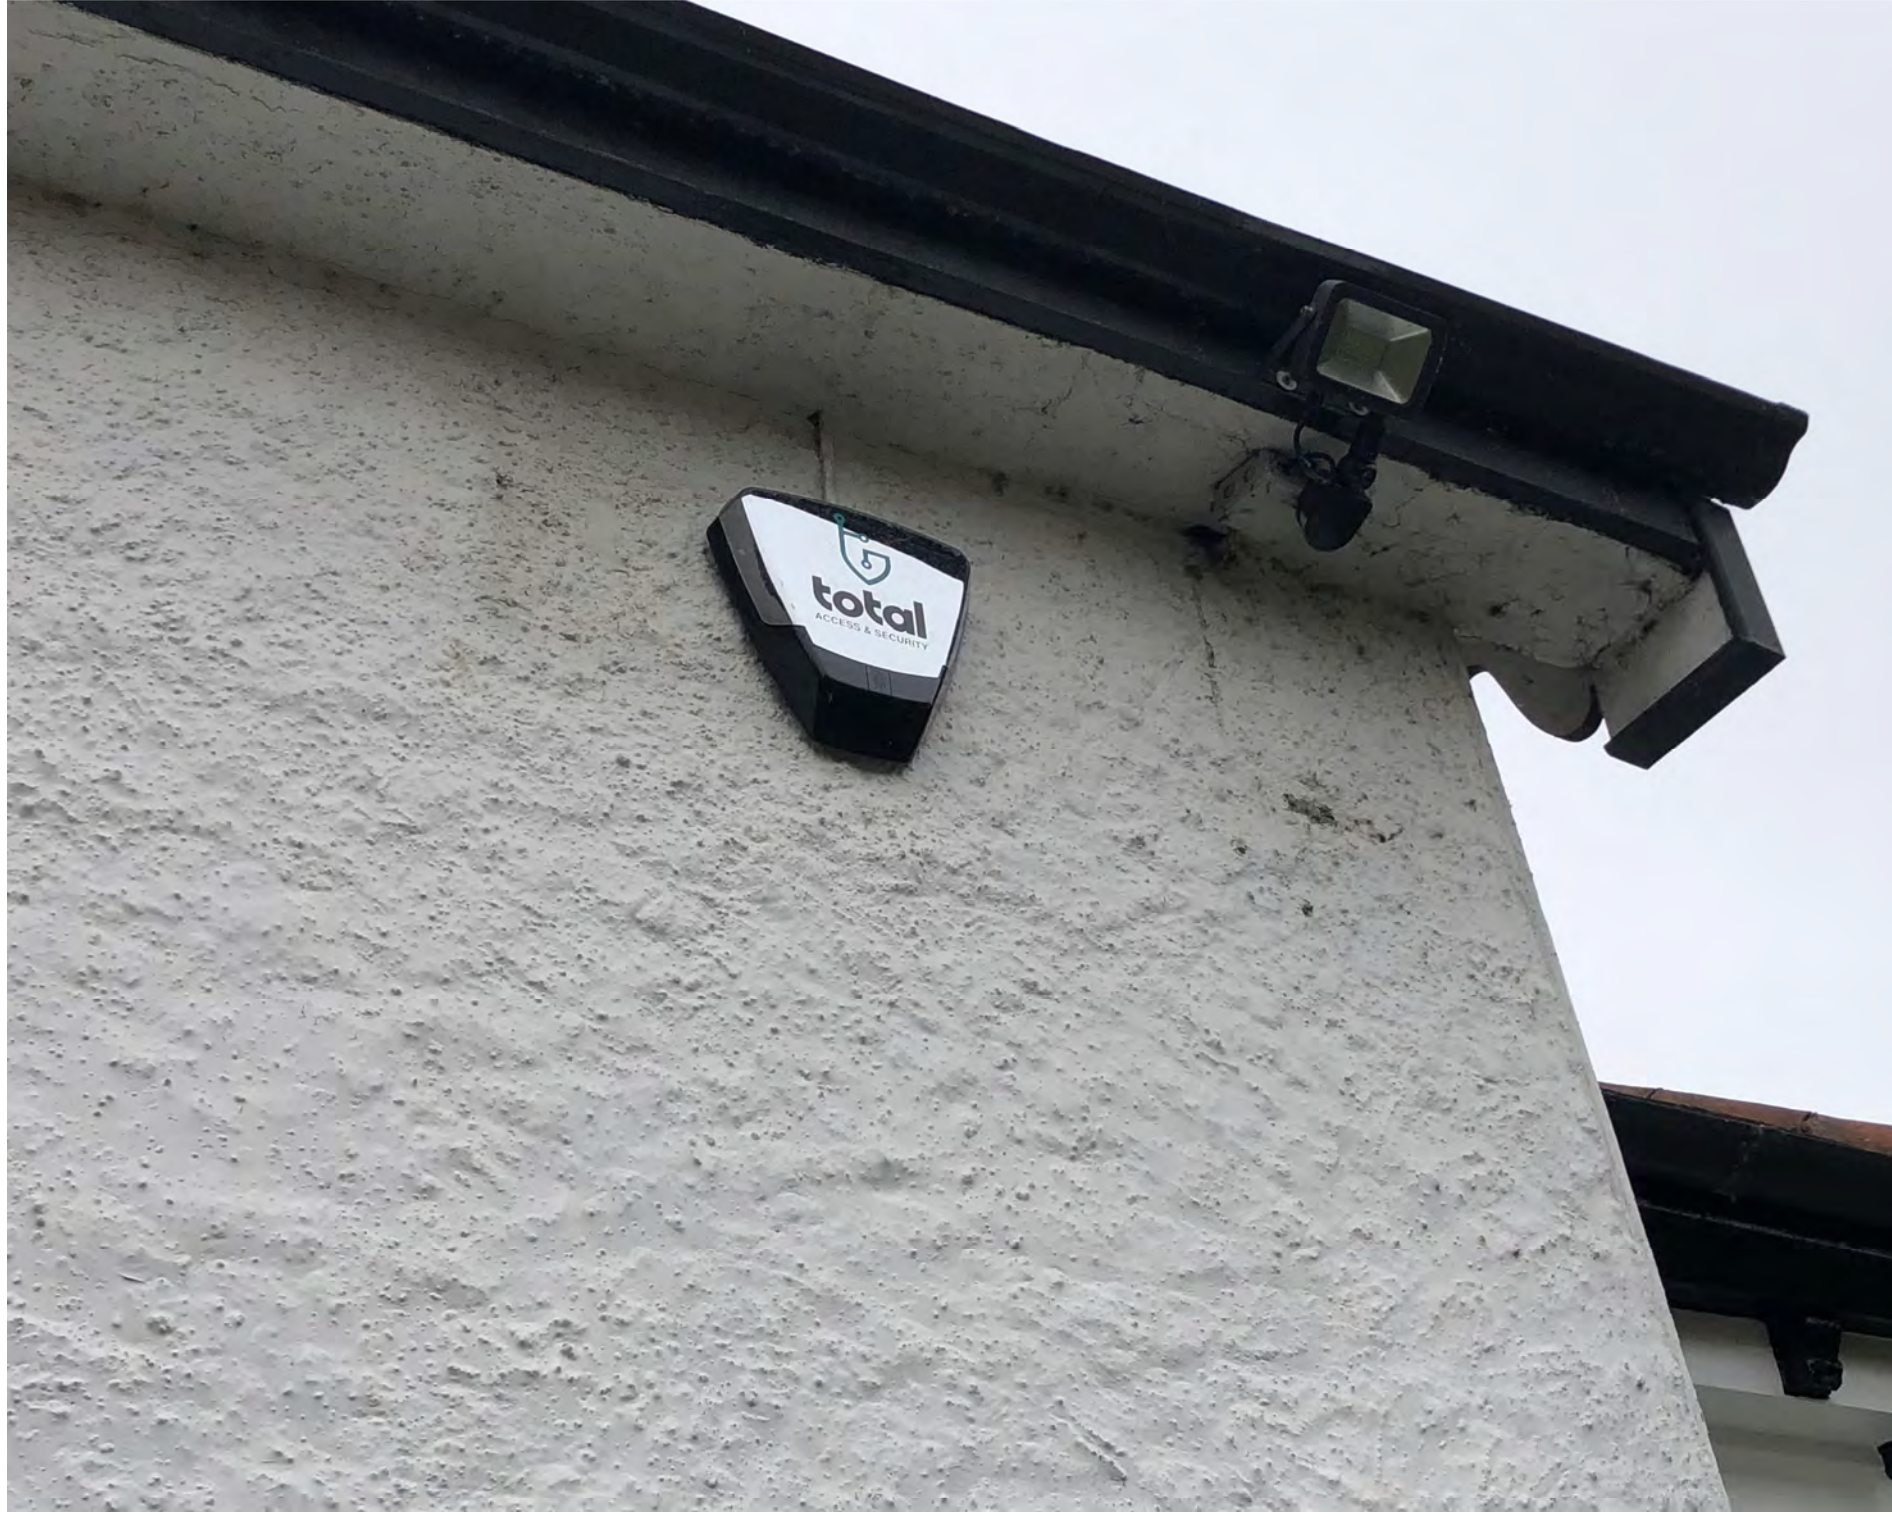
PHOTO 15 - SECURITY ALARM AND FLOODLIGHT TO BE RELOCATED, PROTECTED AND MAINTAINED DURING THE WORKS

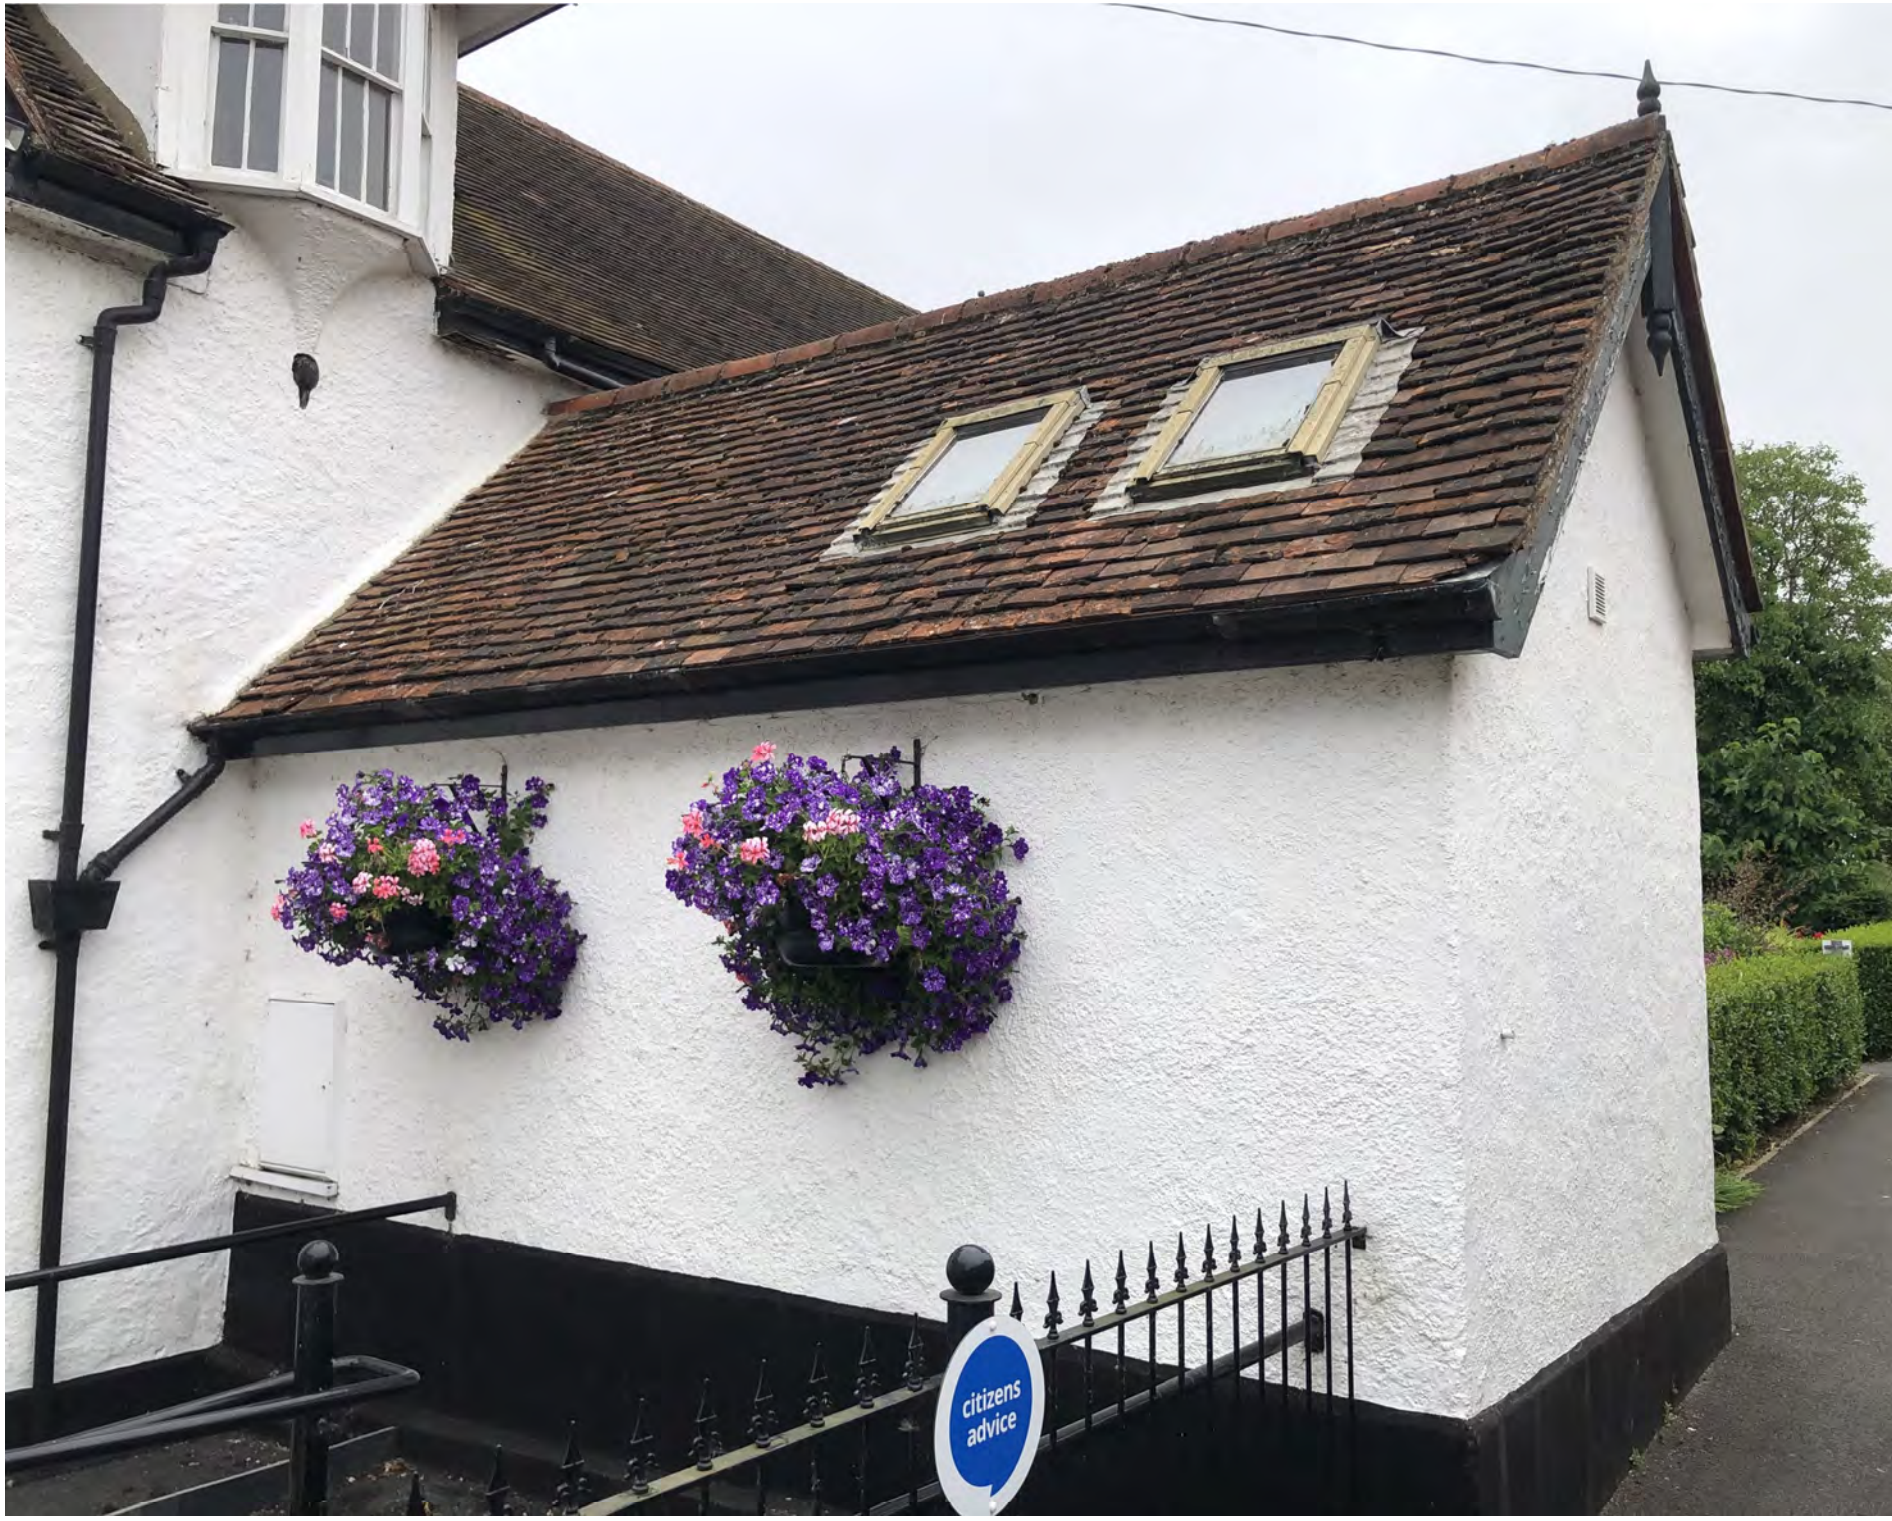
PHOTO 16 - WEST ELEVATION COUNCIL CHAMBER ROOF
ENTRANCE HALL ROOF AND ROOFLIGHTS

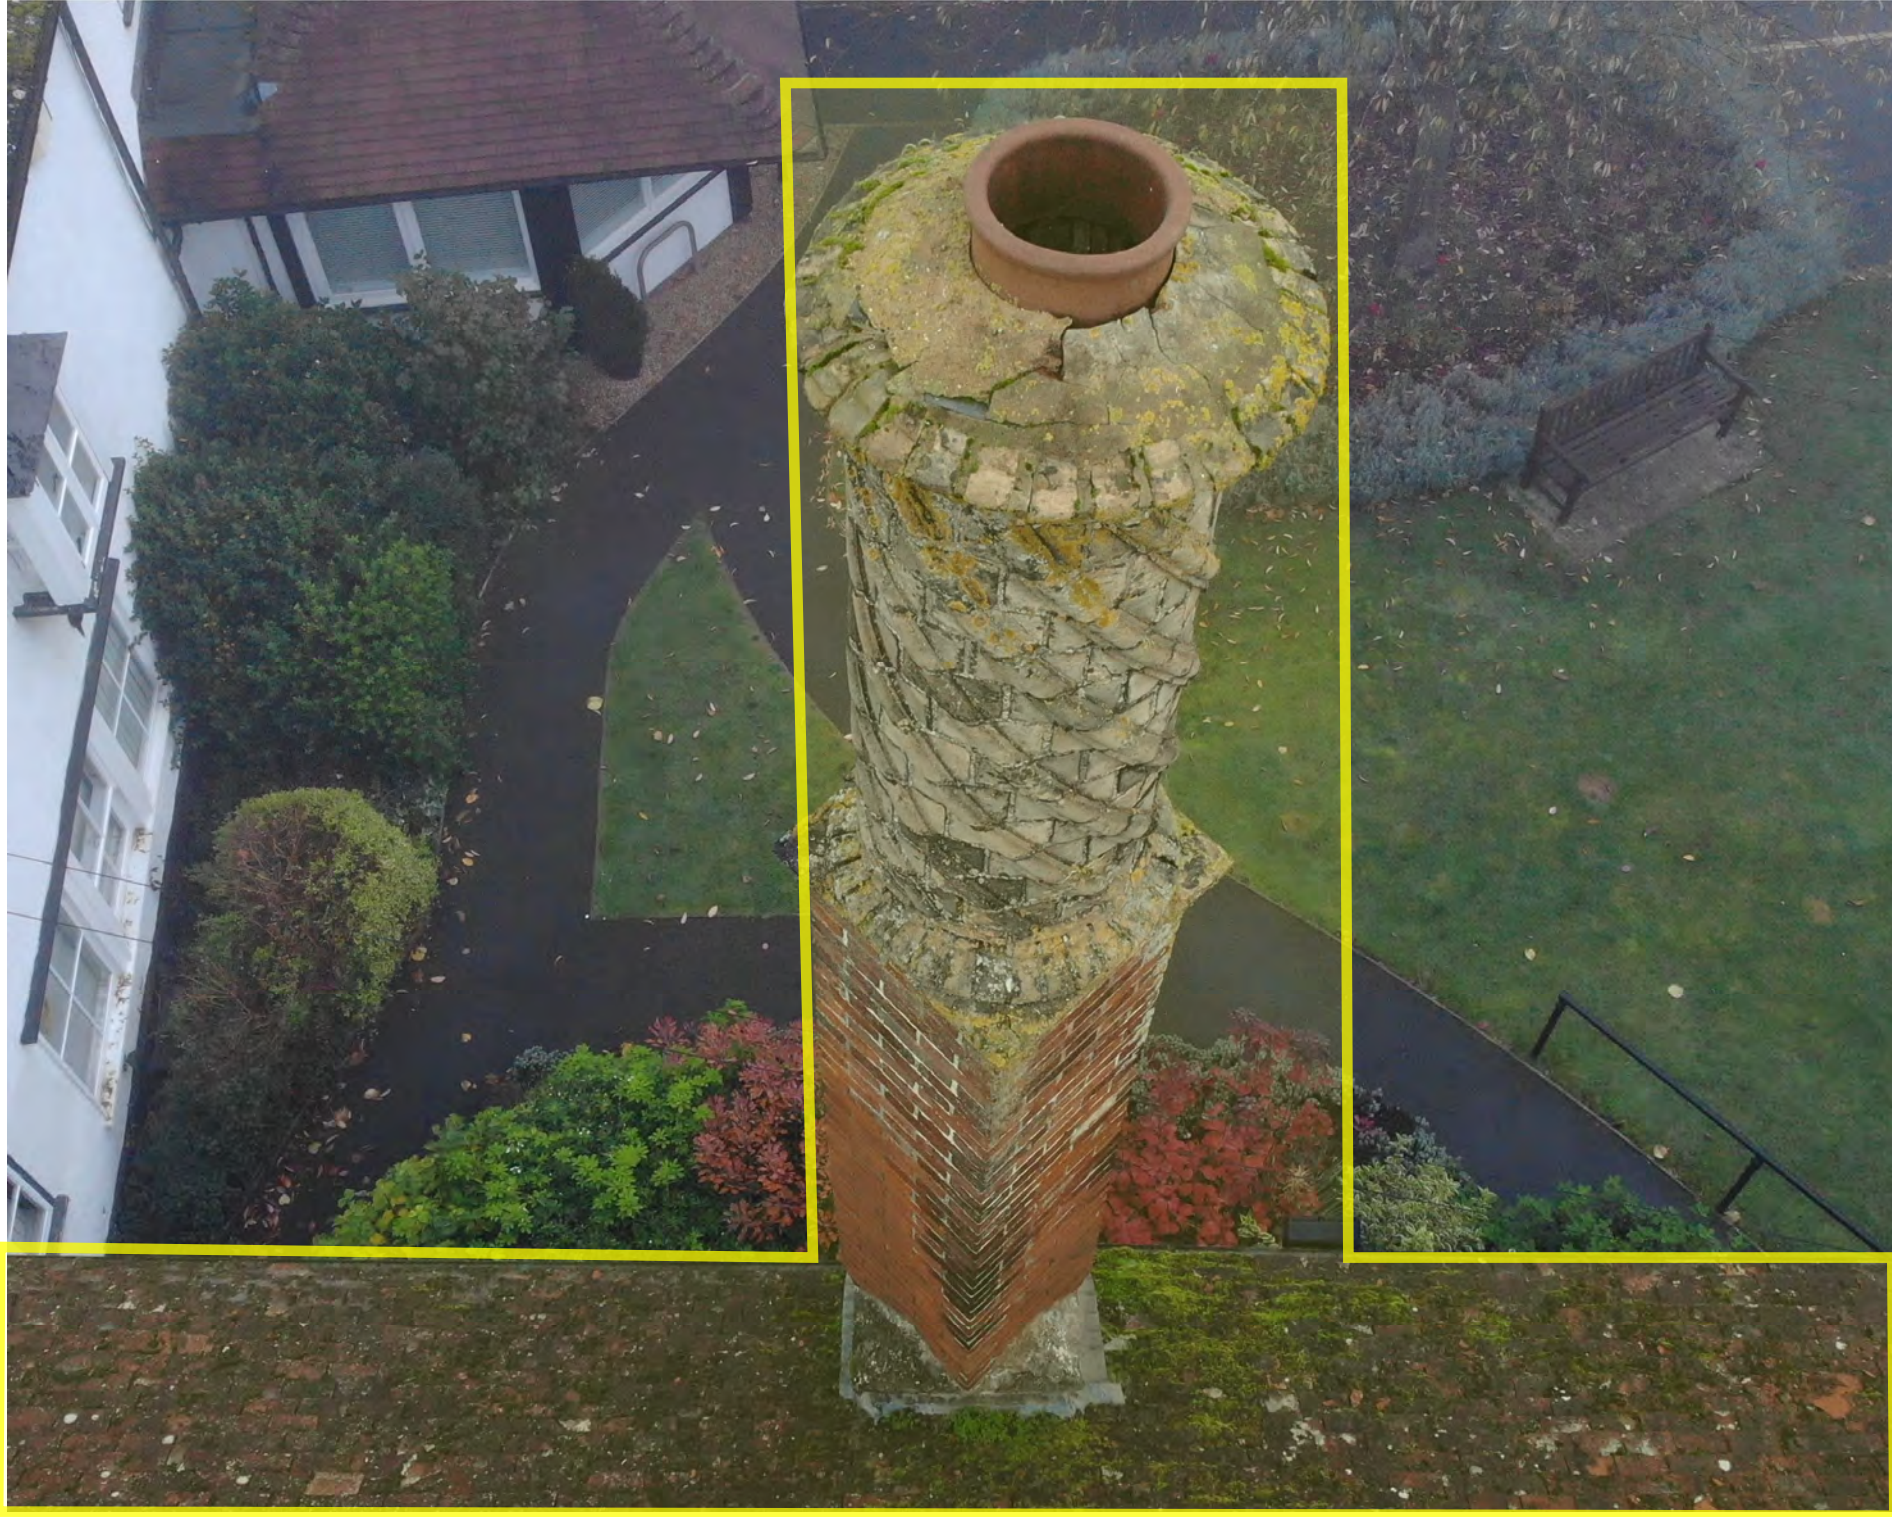
PHOTO 17 - EAST ELEVATION CHIMNEY TO BE RECONSTRUCTED

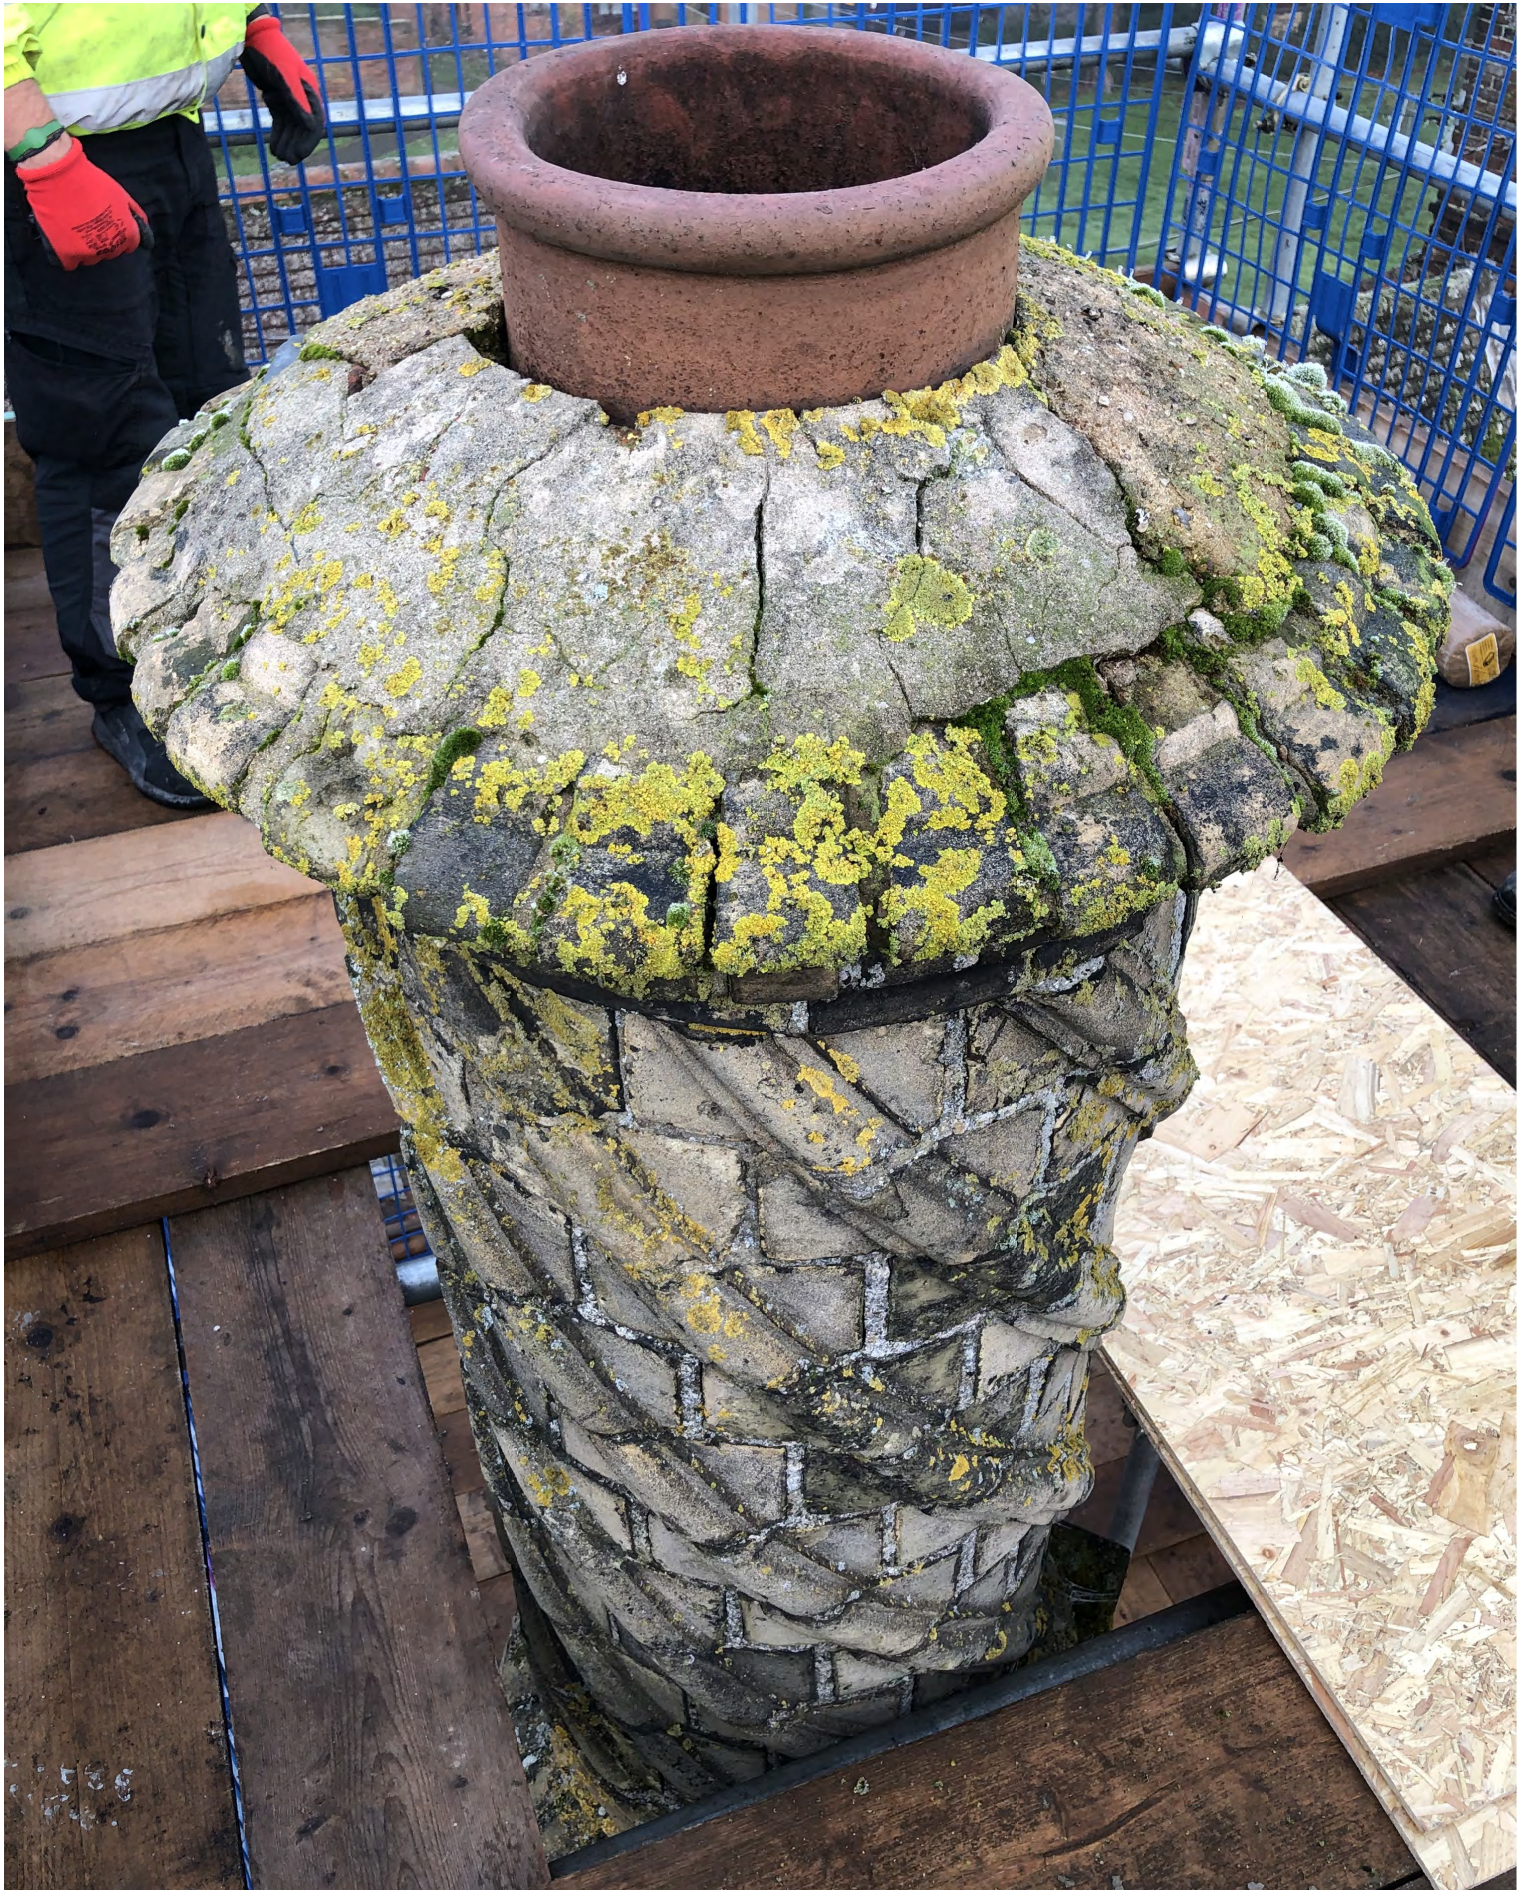
**PHOTO 18 - EAST COUNCIL CHAMBER CHIMNEY CAP AND
FLAUNCHING PRIOR TO DISMANTLING**

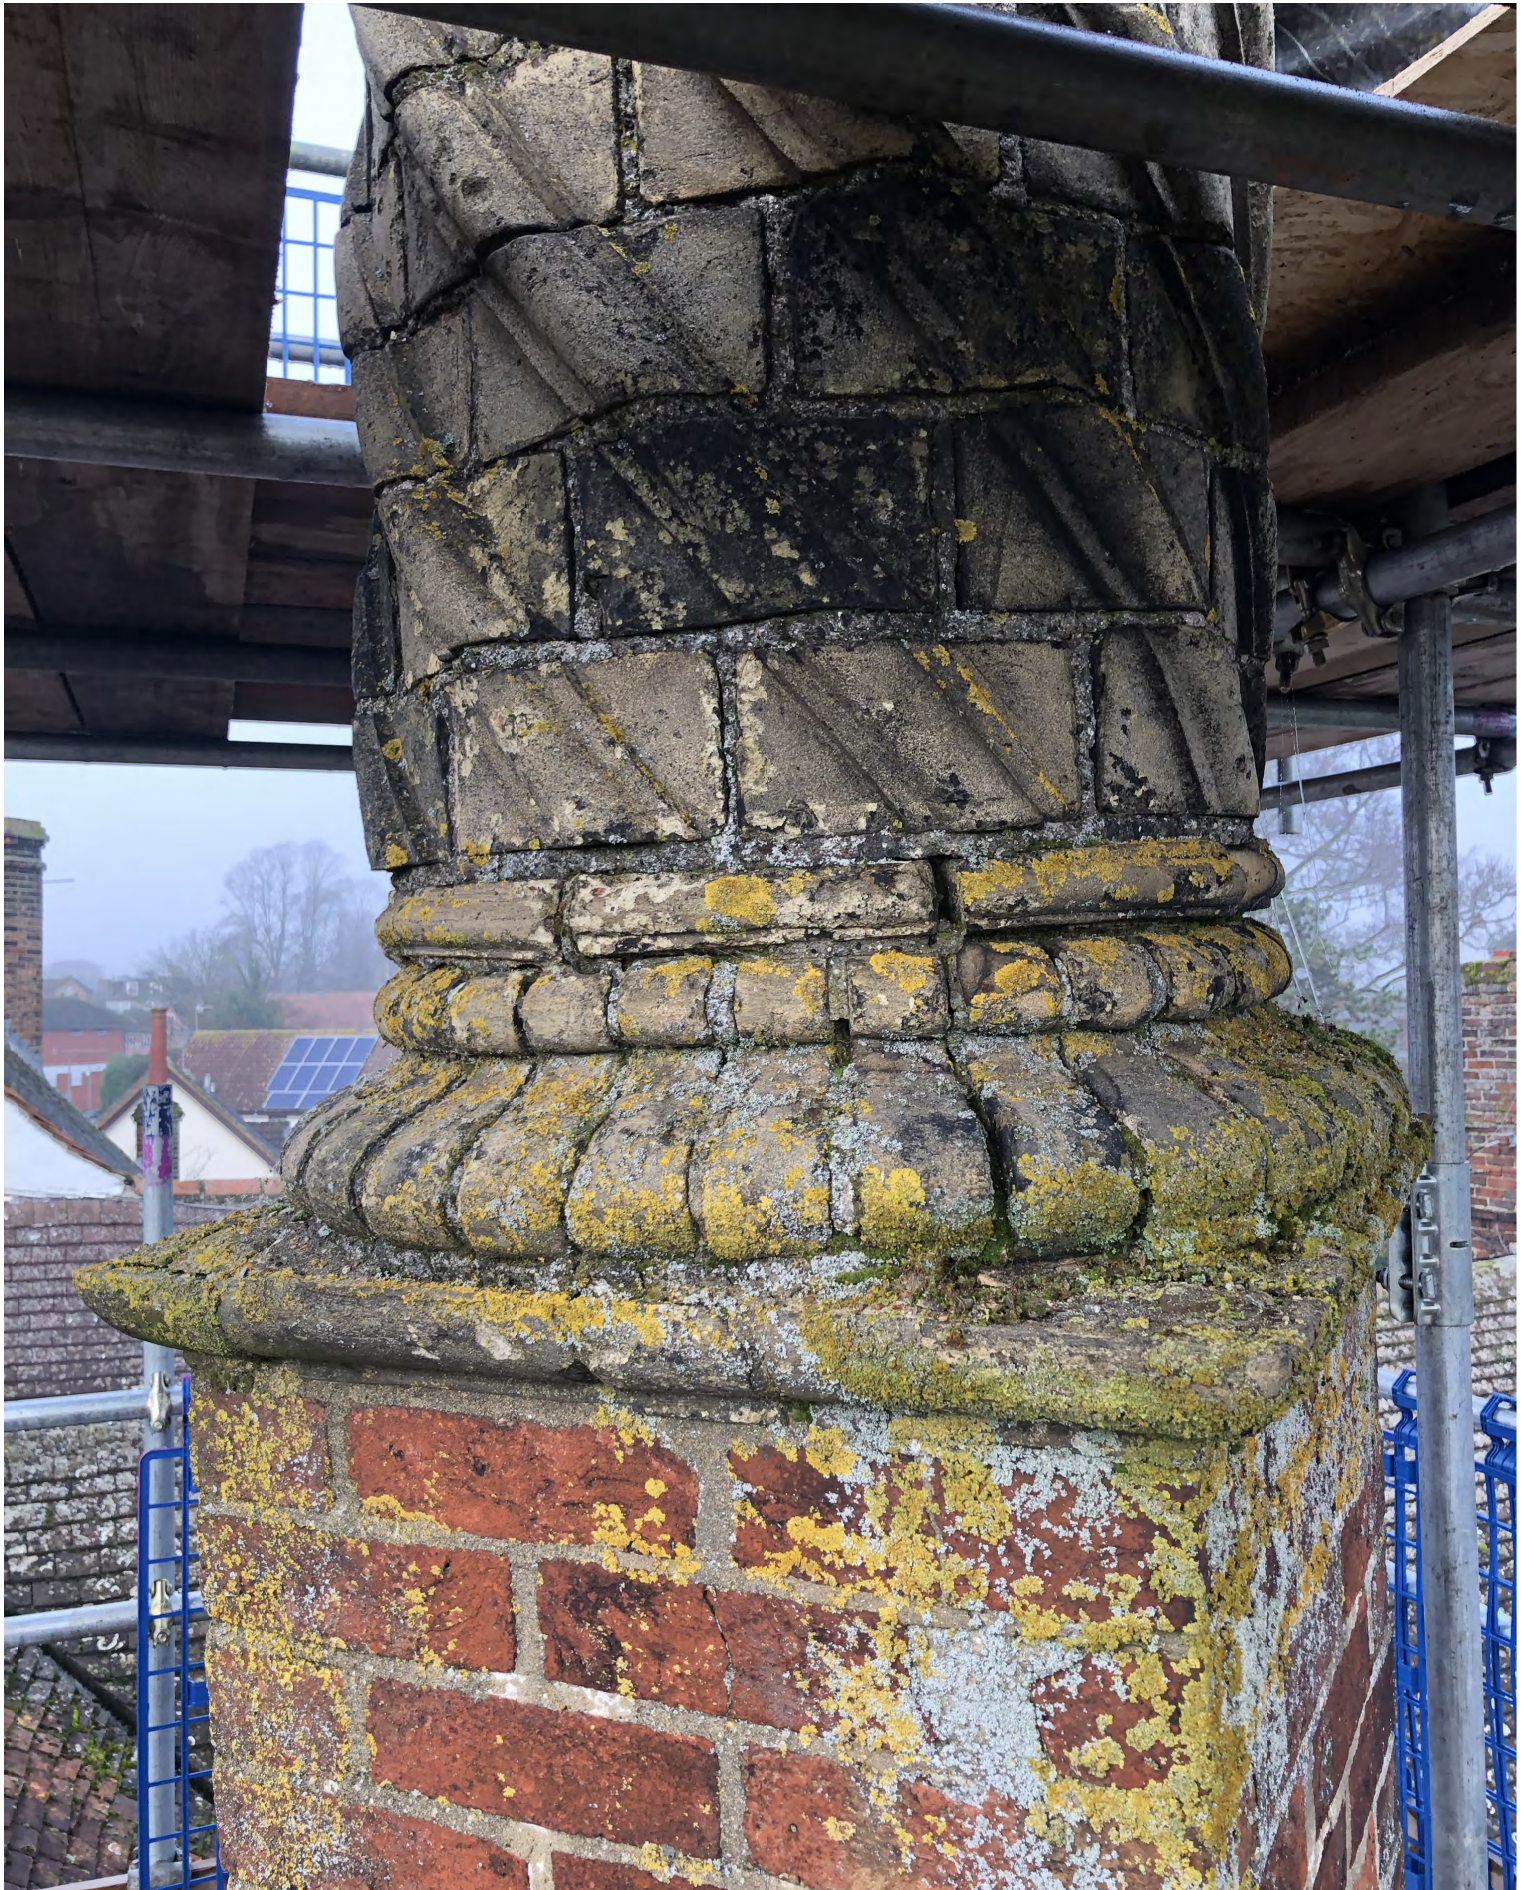
PHOTO 19 - EAST ELEVATION CHIMNEY PRIOR TO DISMANTLING

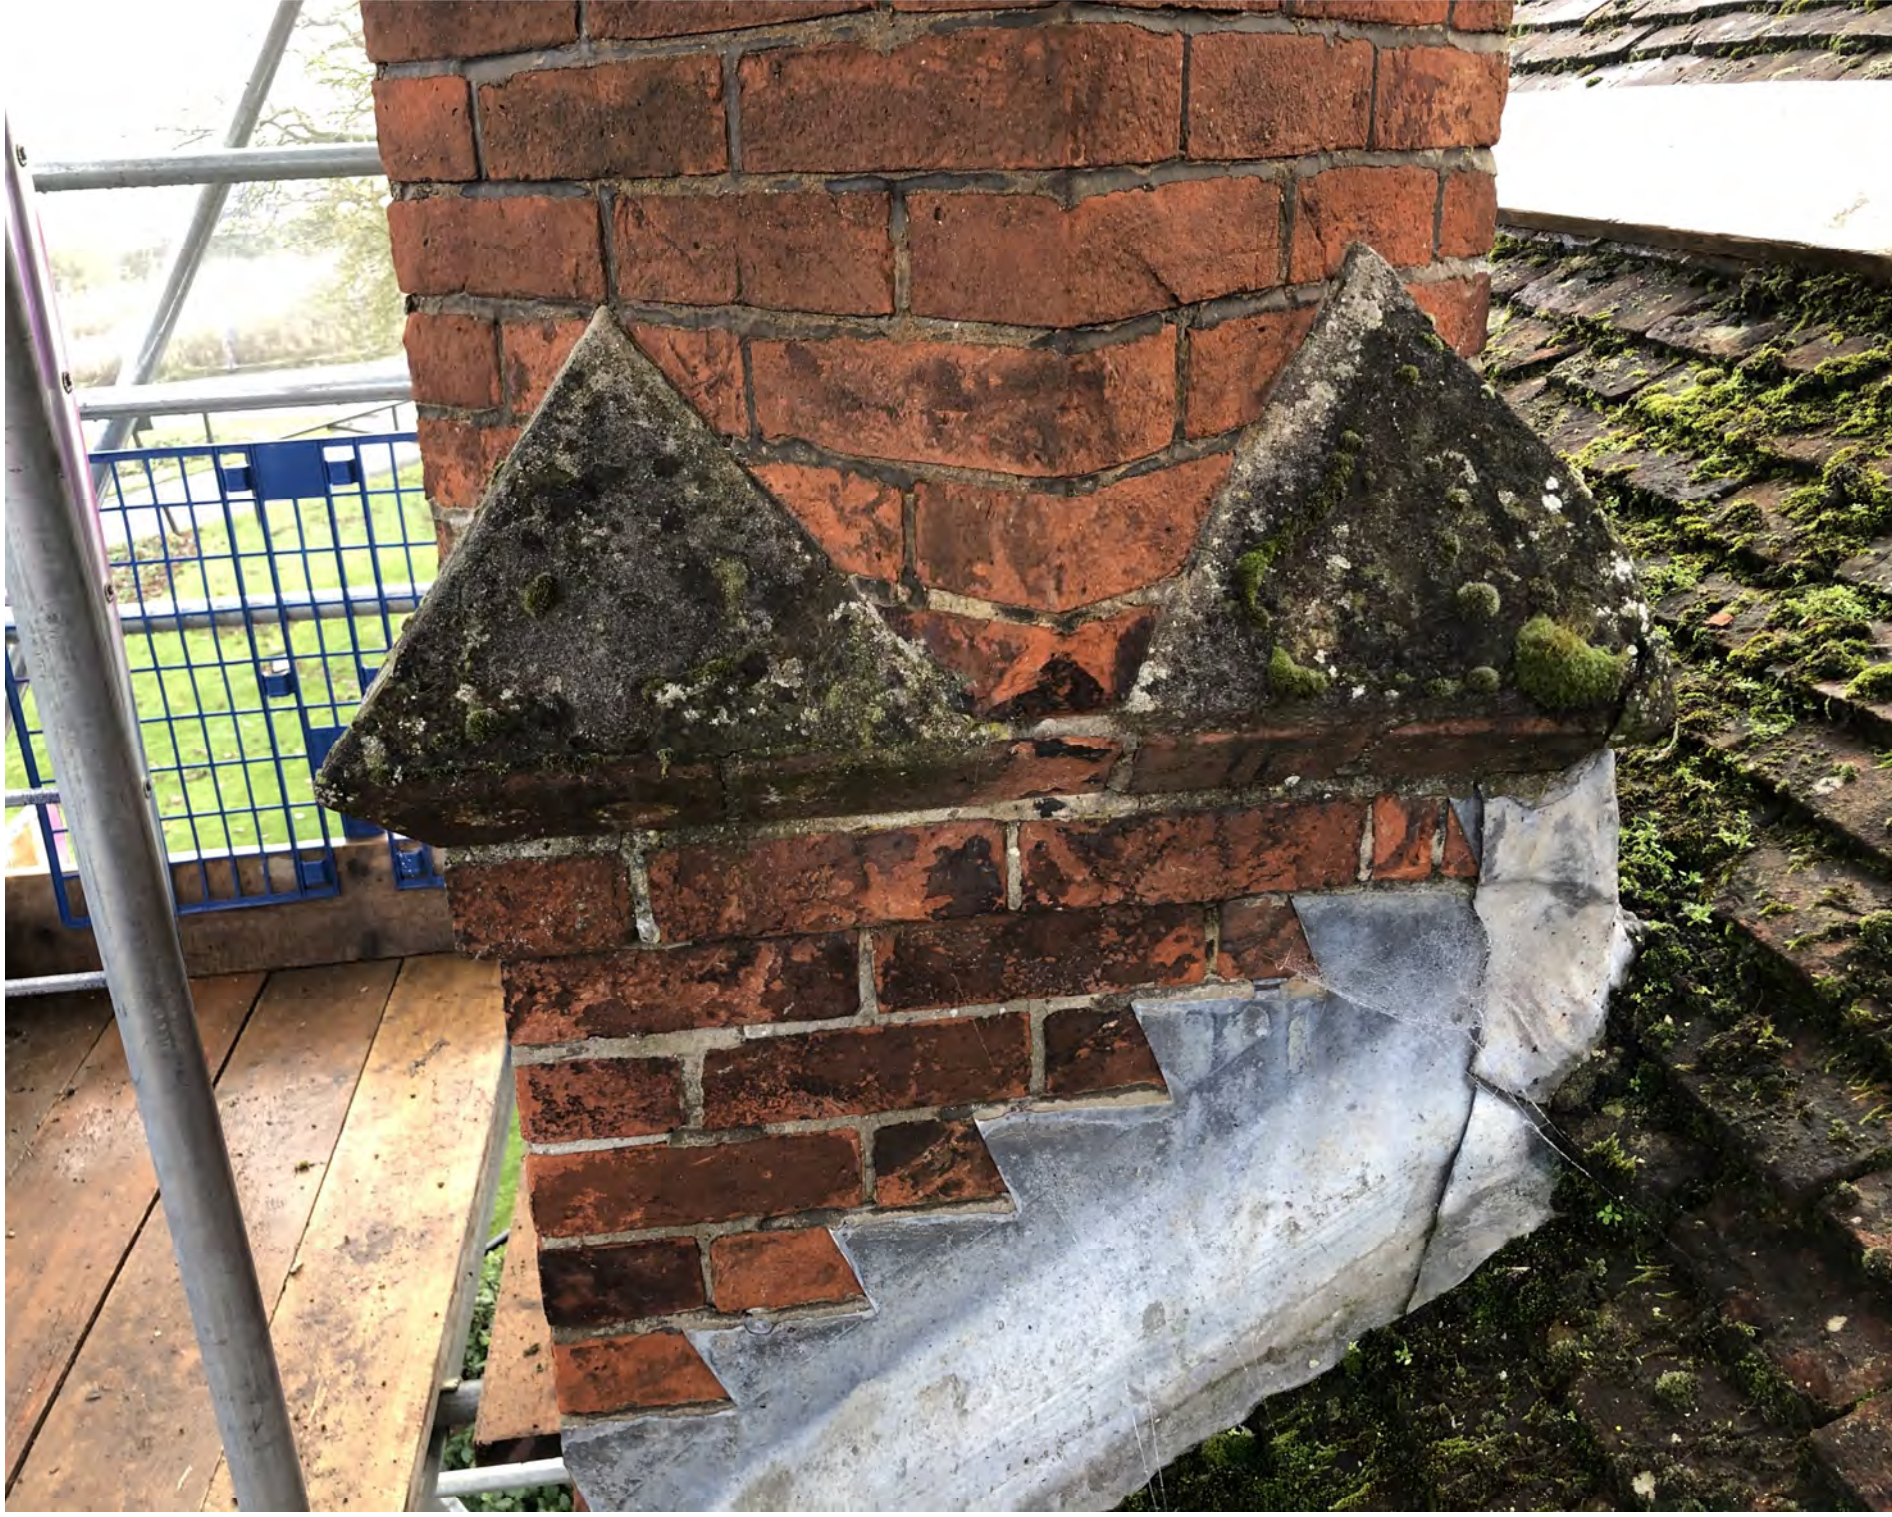
PHOTO 20 - BASE OF EAST CHIMNEY PRIOR TO DISMANTLING

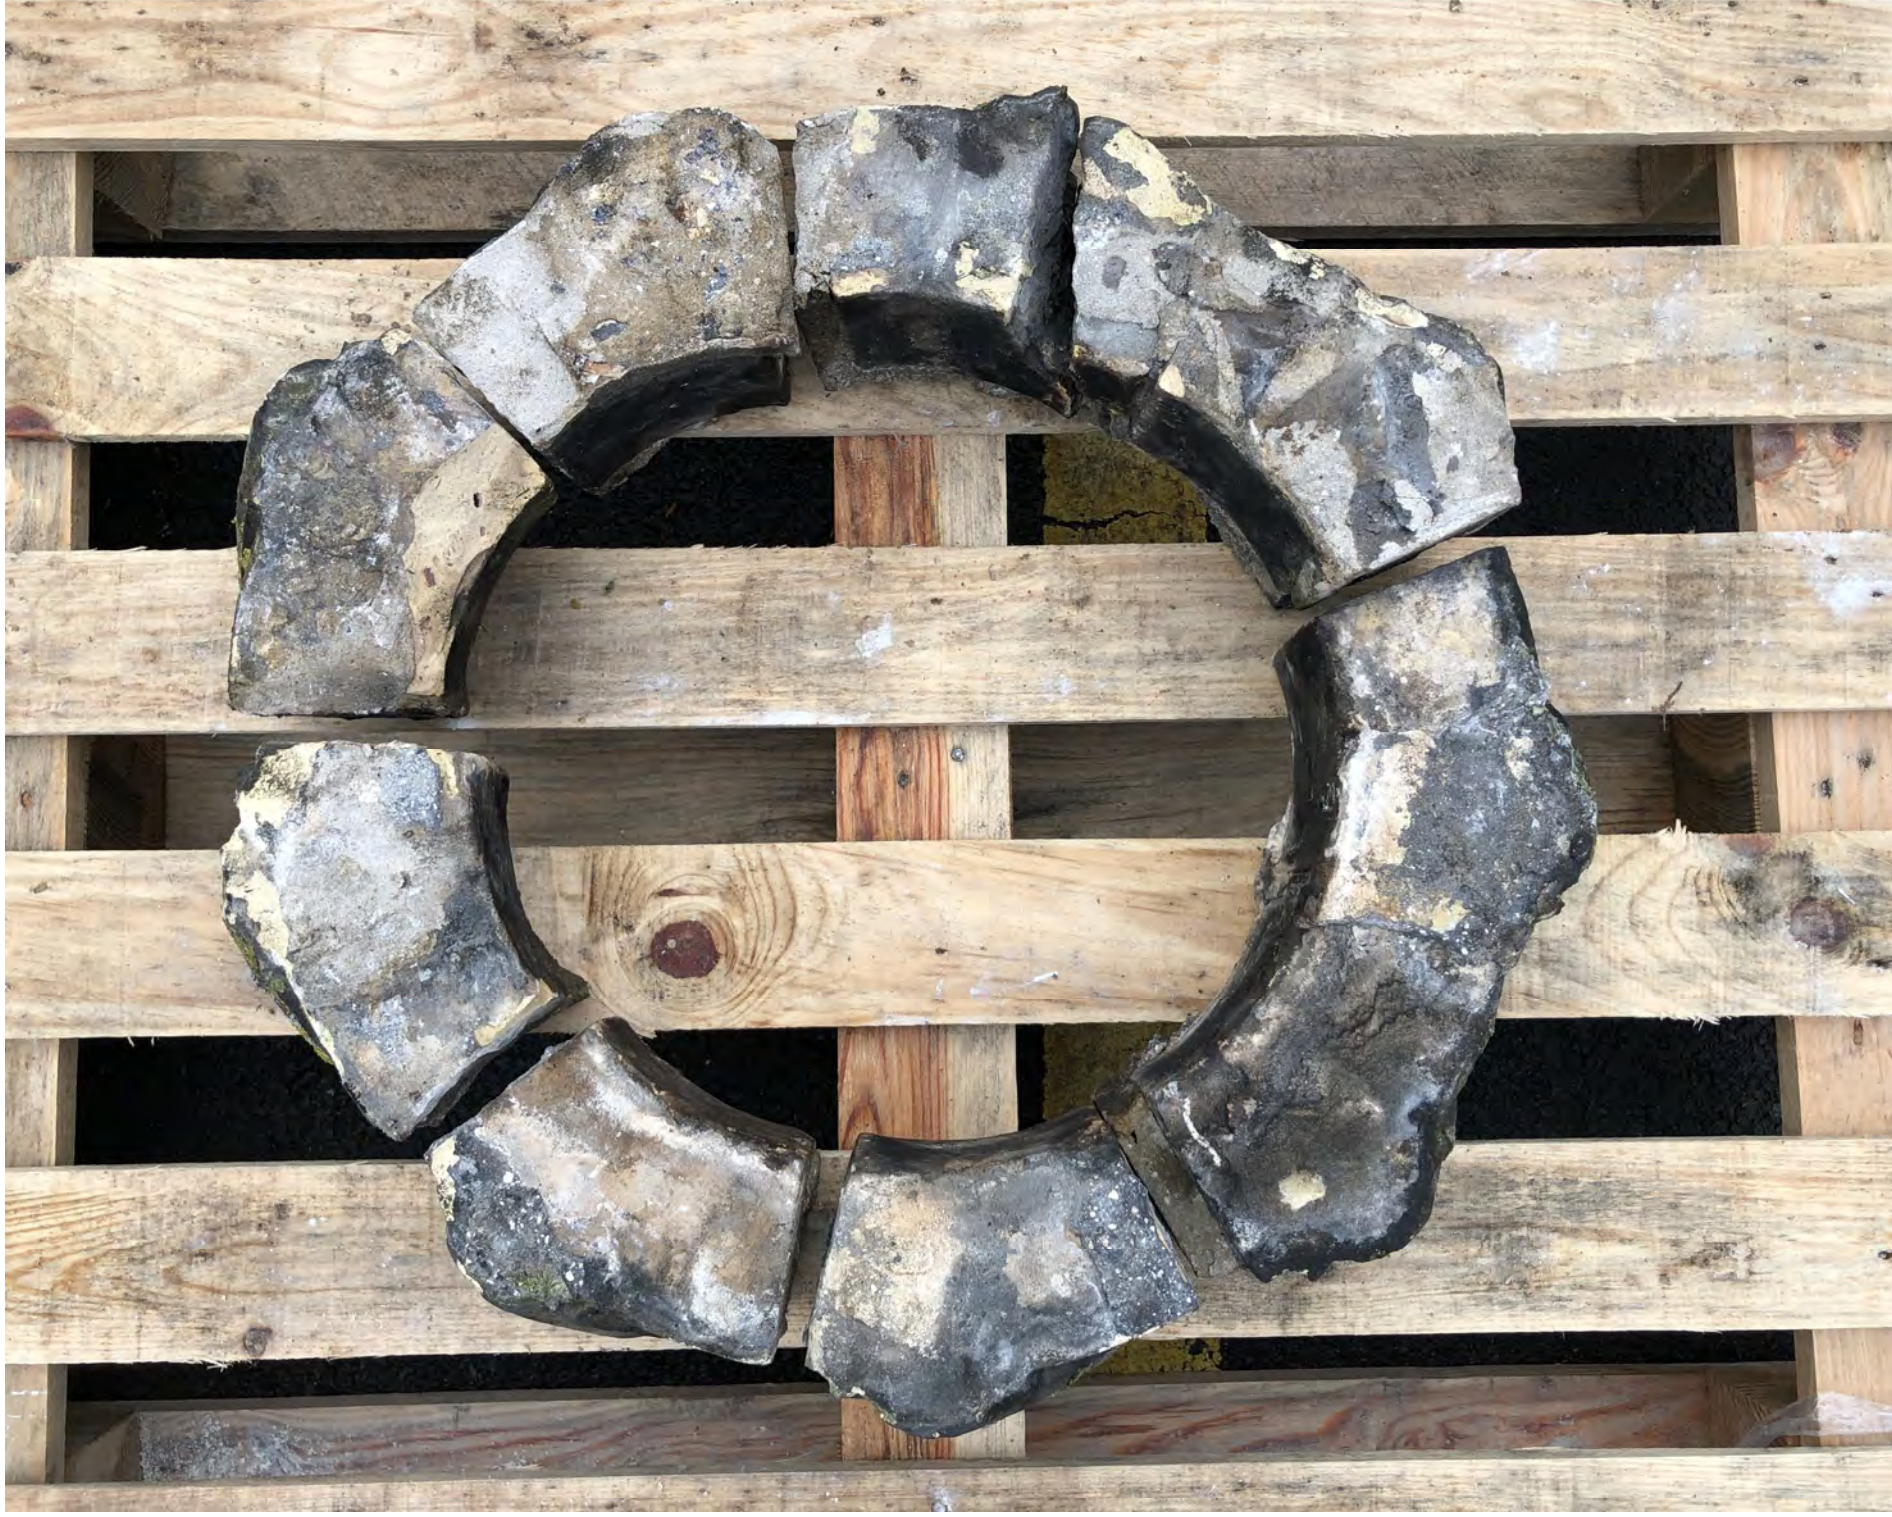
PHOTO 21 - RECLAIMED BRICKS FROM EAST CHIMNEY FLUE
STACKED FOR STORAGE AND REUSE AFTER DISMANTLING

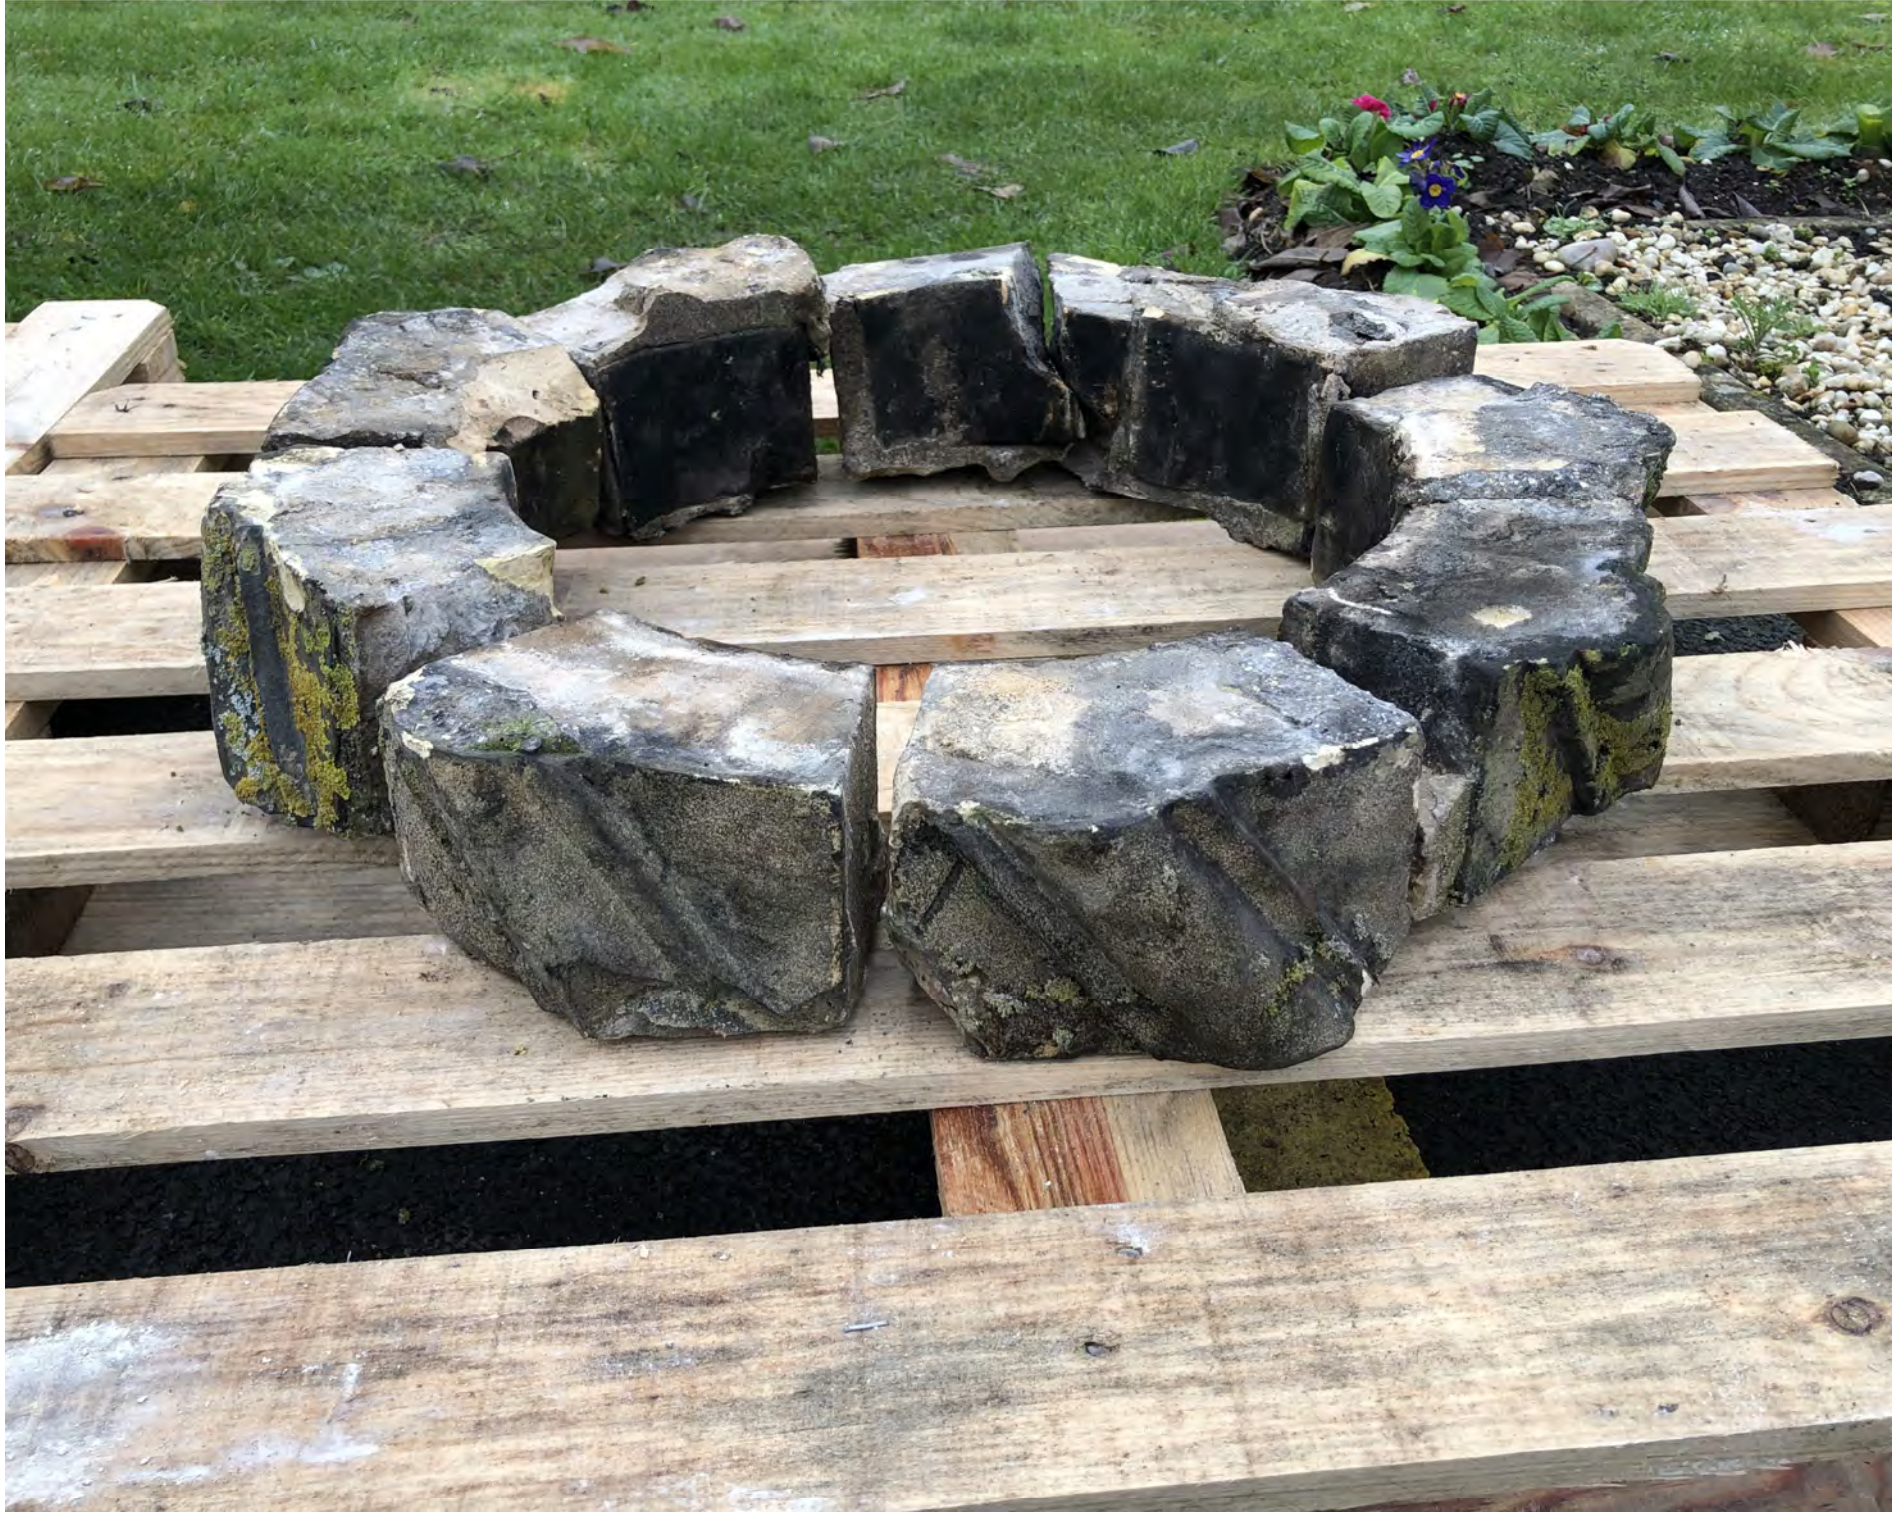
PHOTO 22 - STACK BRICK COURSES FROM EAST CHIMNEY
FOR STORAGE AND REUSE
