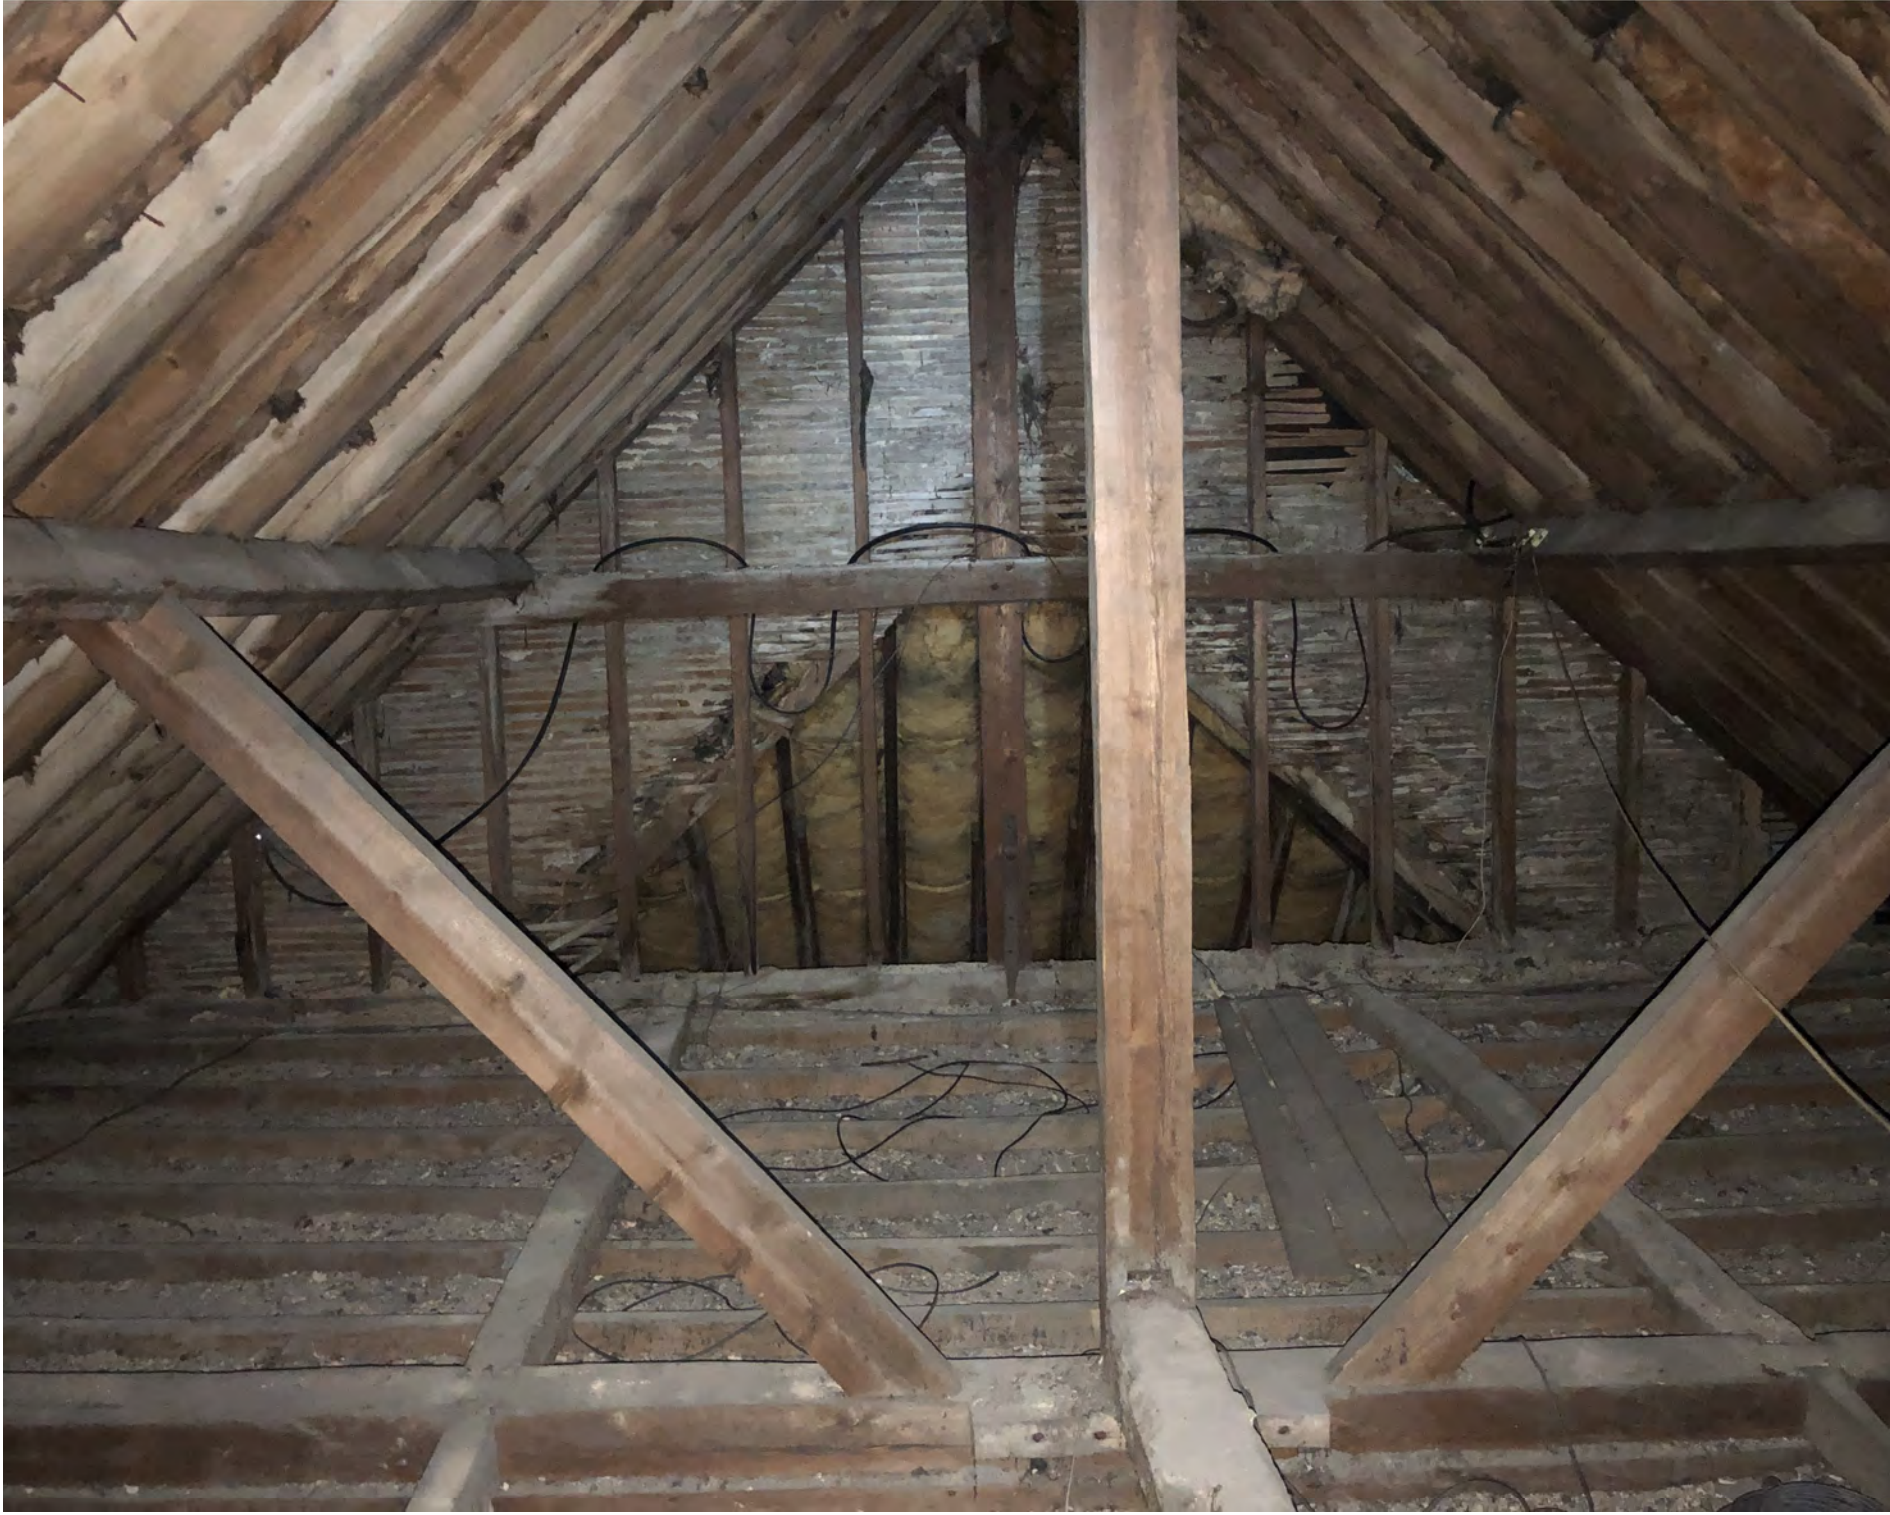
PHOTO 23 - TYPICAL ROOF TRUSS AND STRUCTURE OVER
COUNCIL CHAMBER

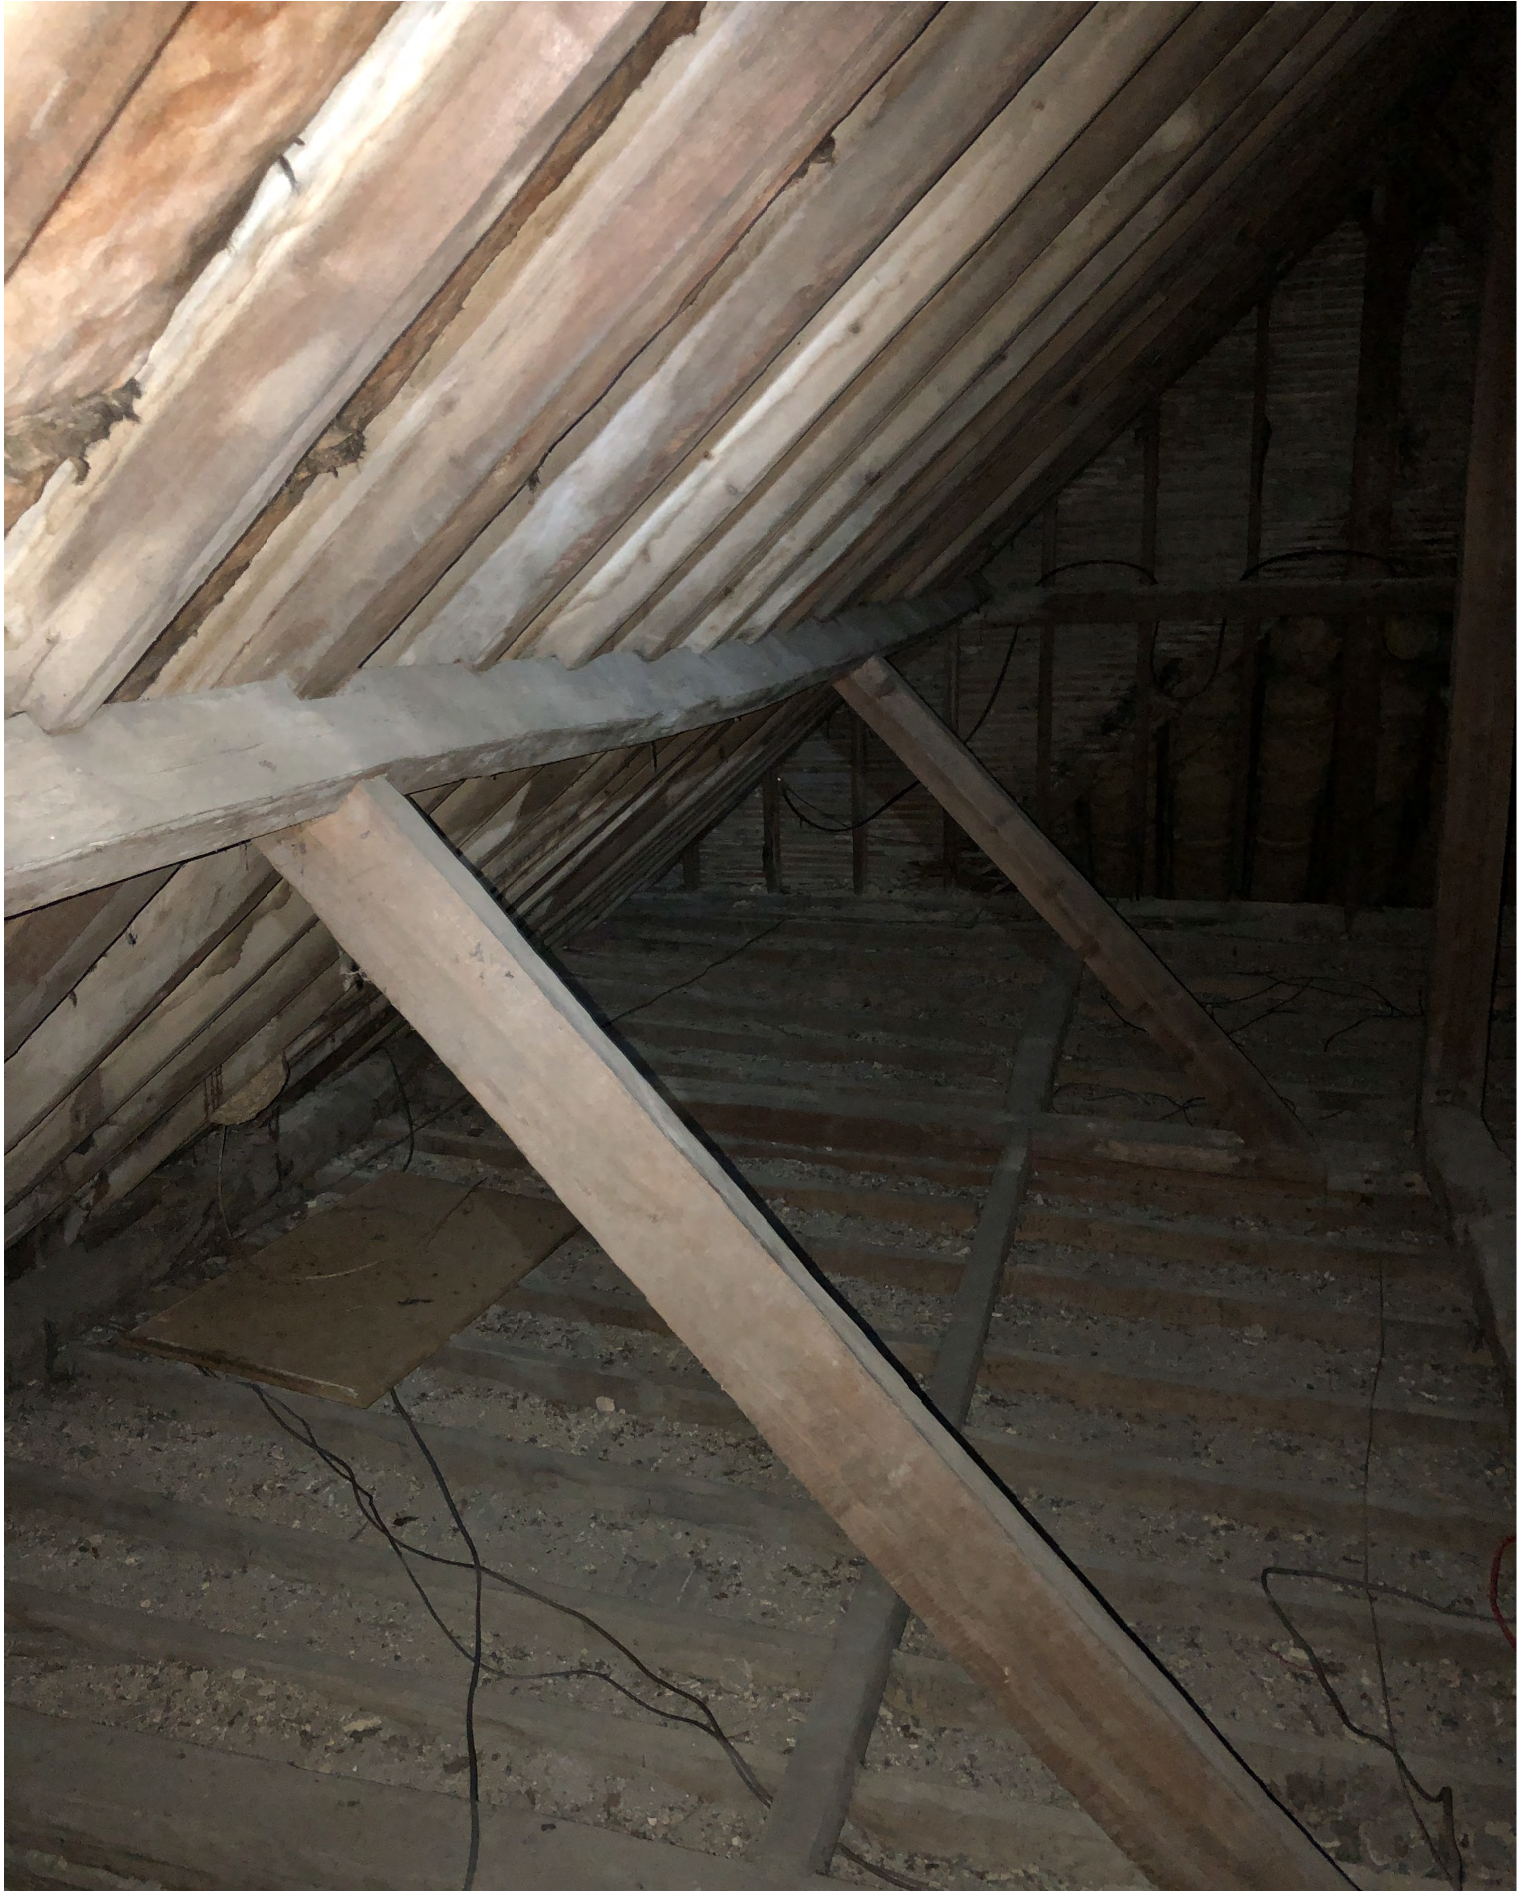
**PHOTO 24 - TYPICAL RAFTER, PURLIN AND PROP TO TRUSS
ARRANGMENT OVER COUNCIL CHAMBER**

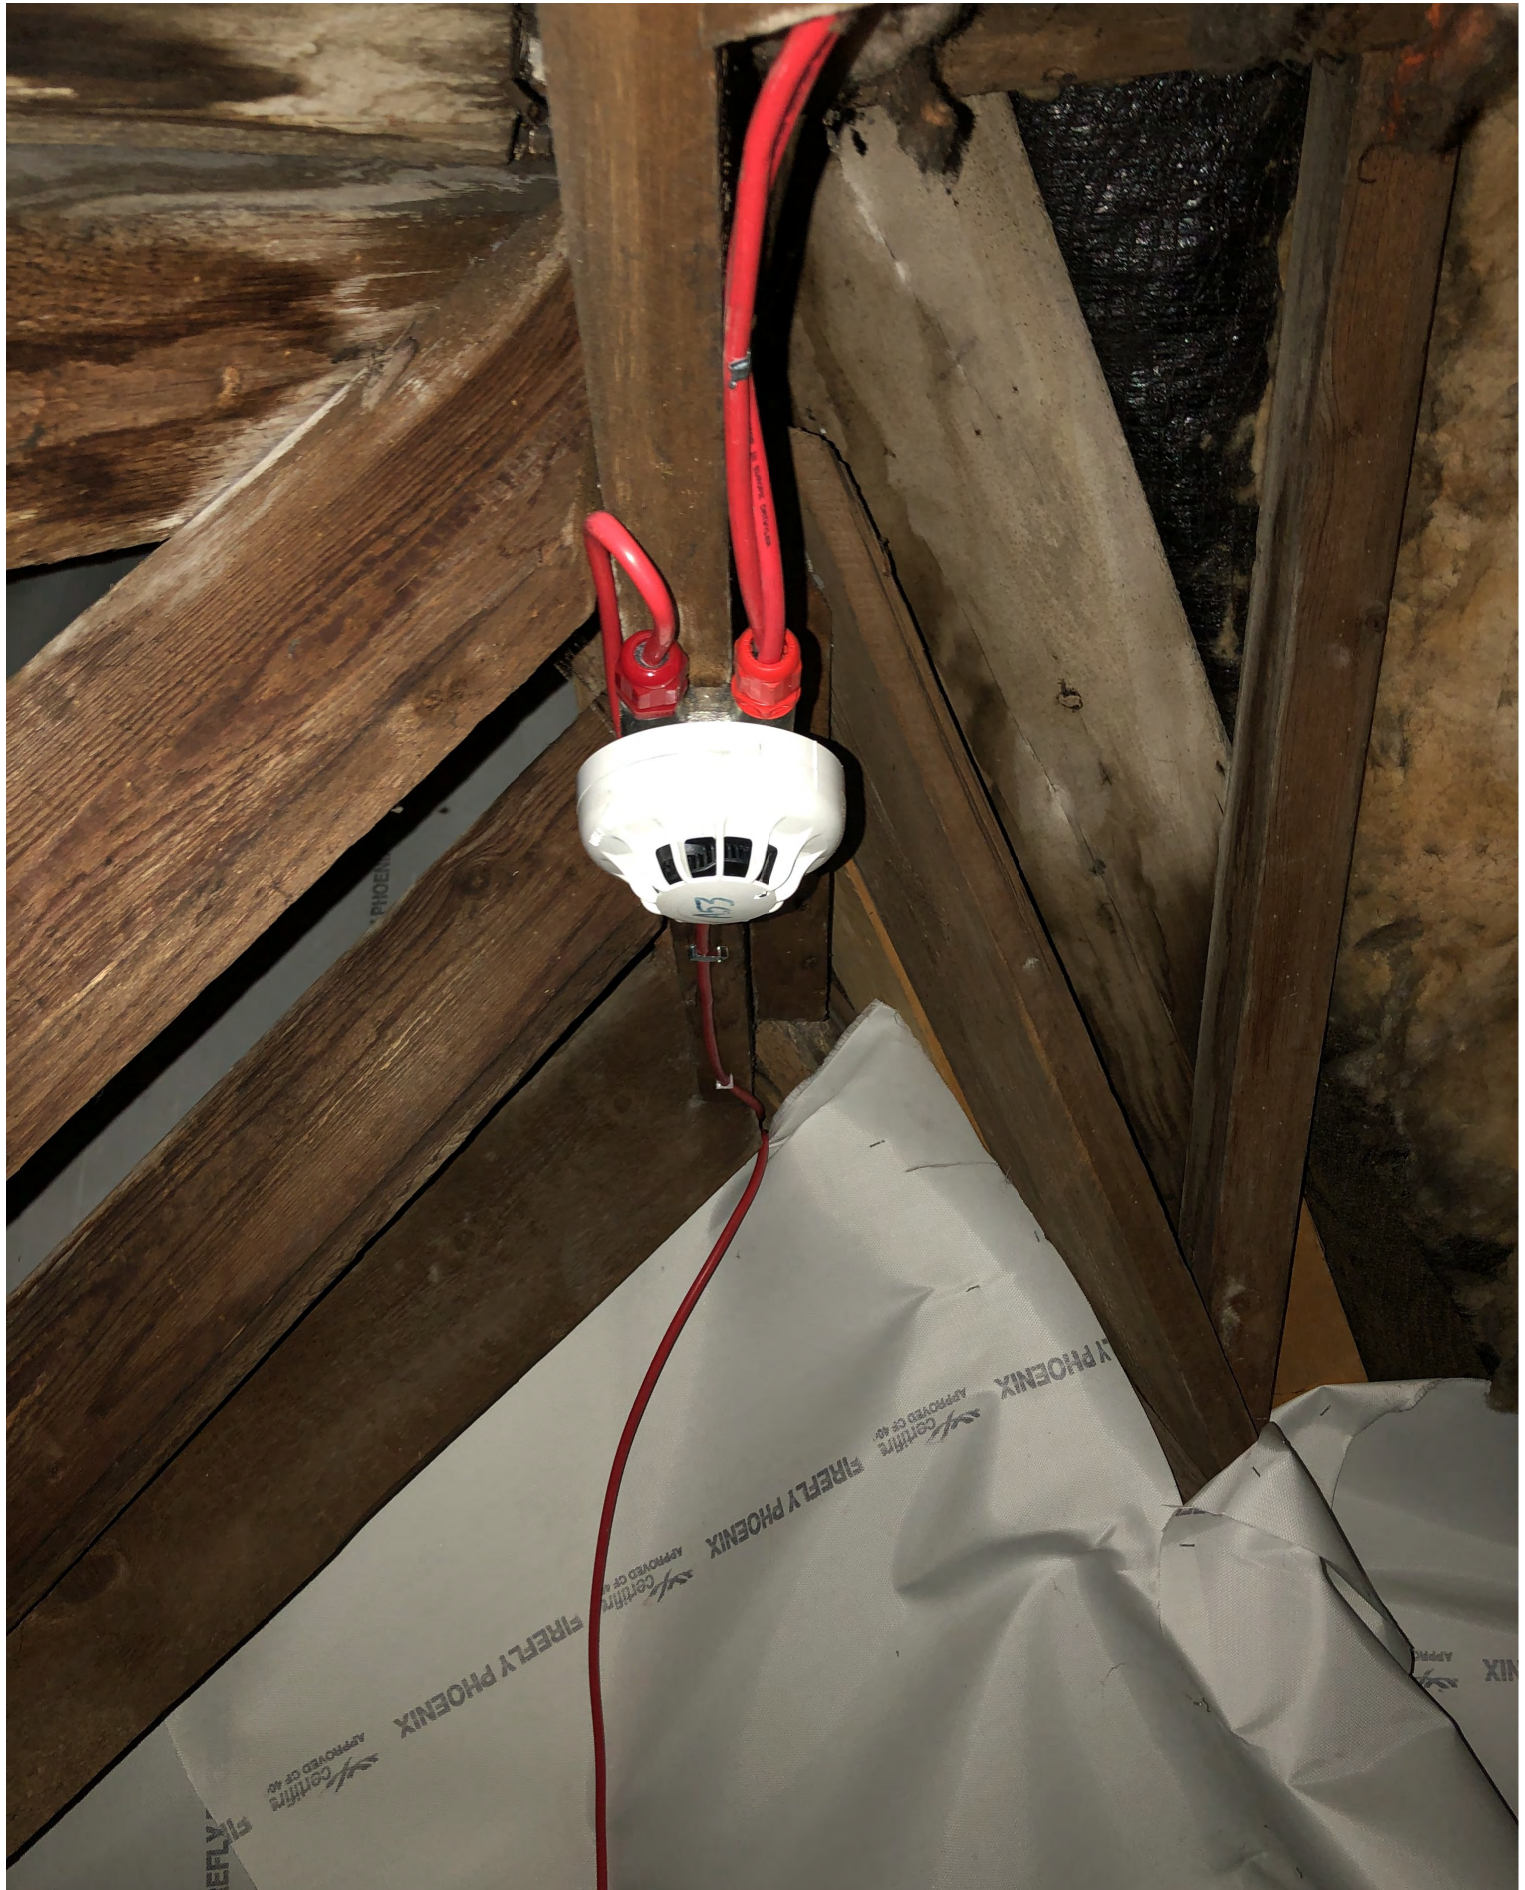
PHOTO 25 - SMOKE ALARM IN REGISTRAR'S OFFICE ROOF TO BE PROTECTED DURING WORKS

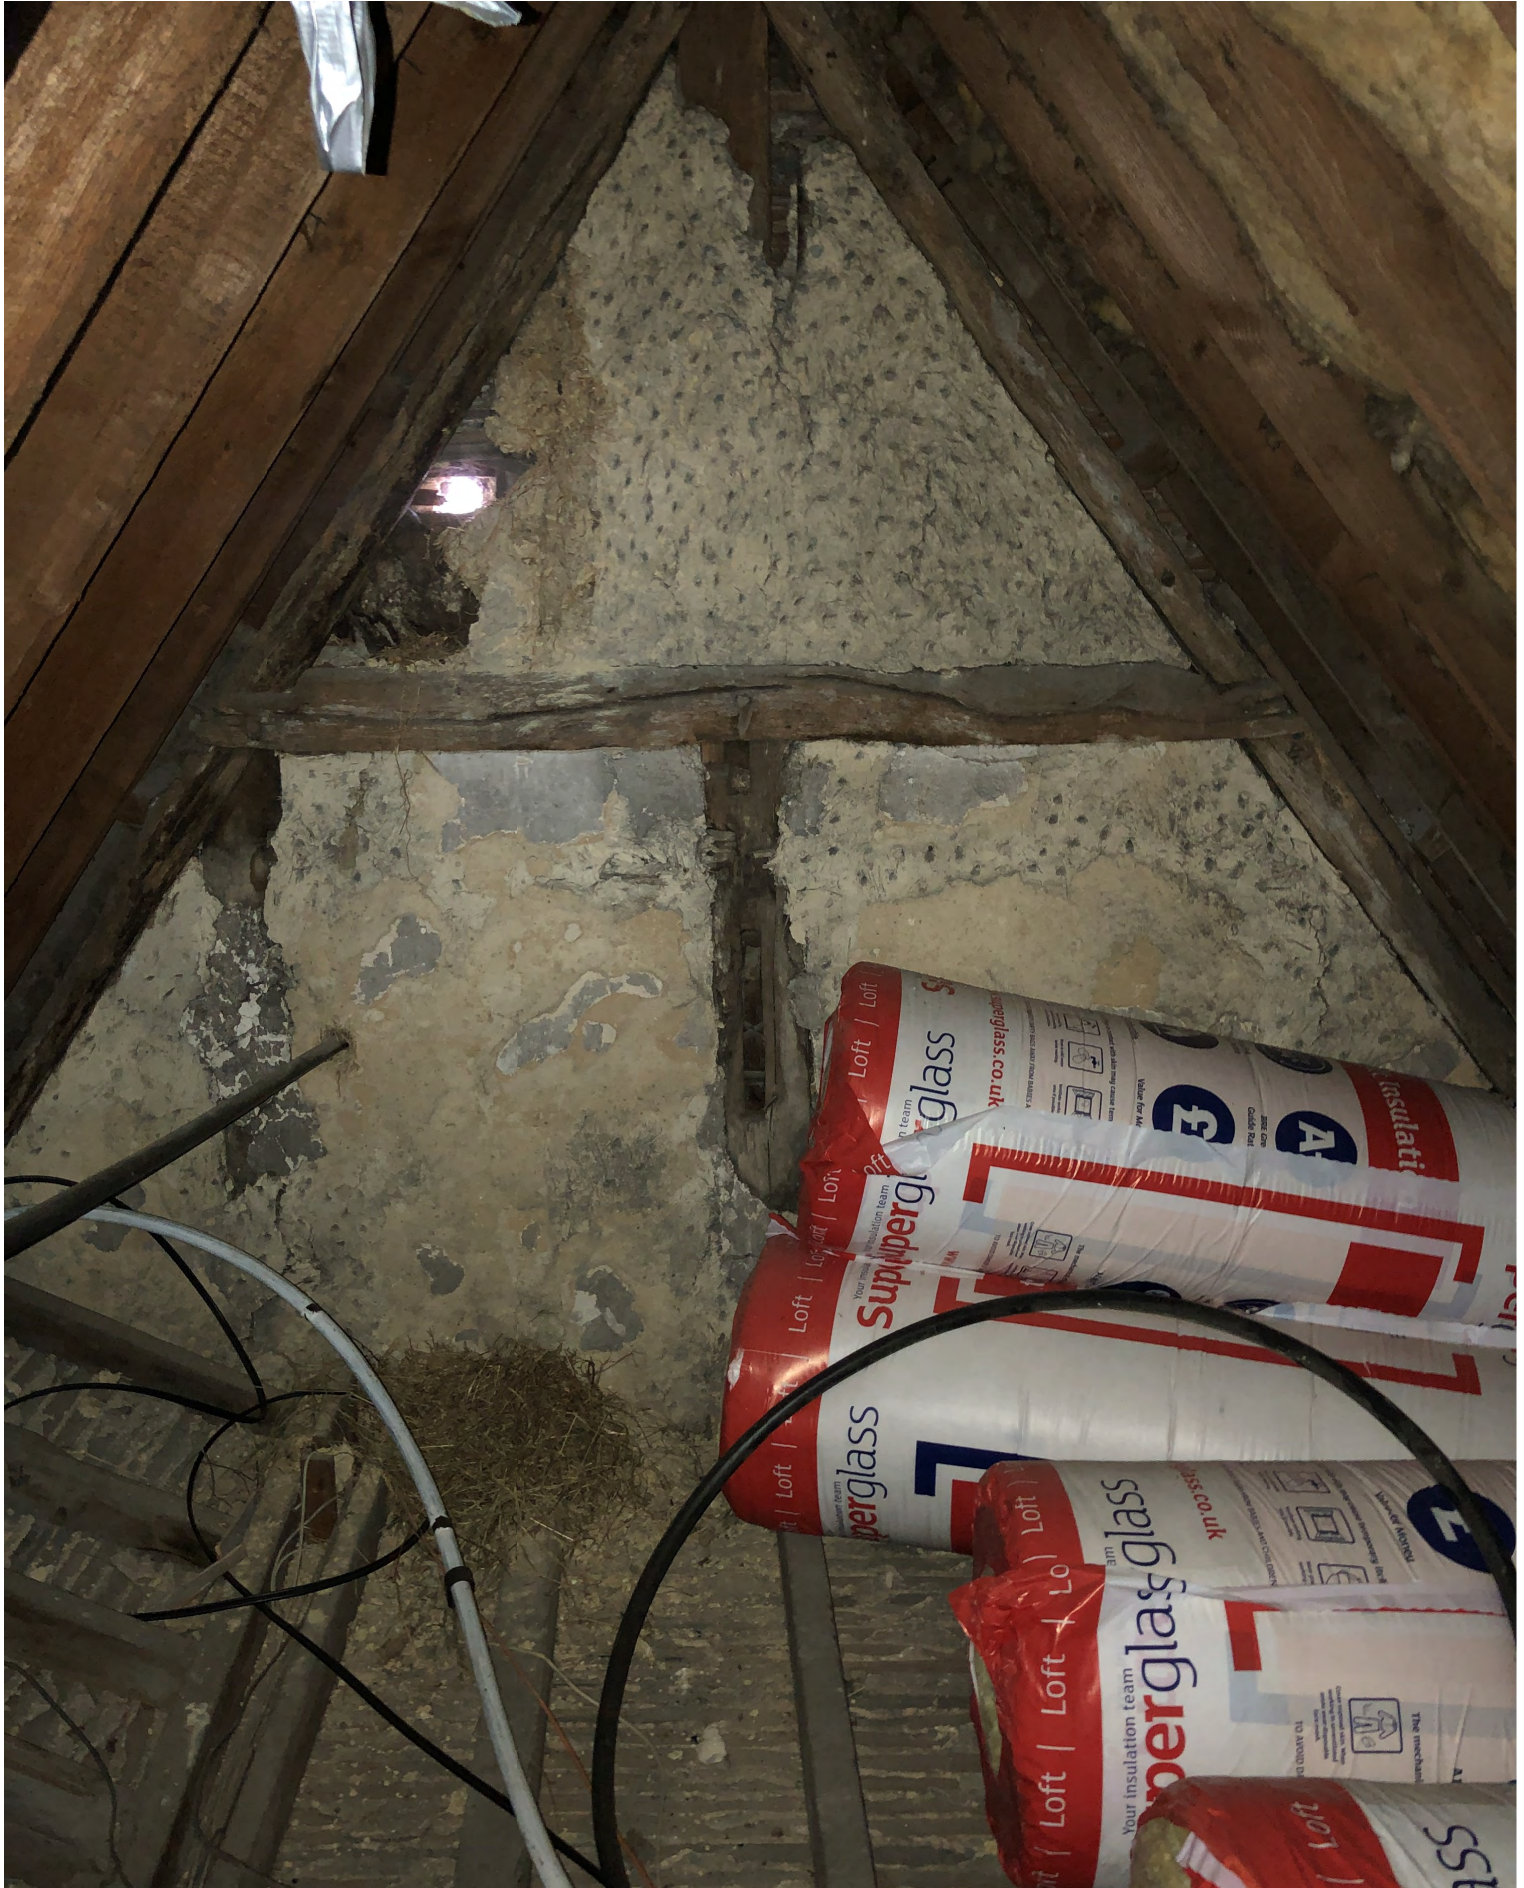
PHOTO 26 - TIMBER FRAME AND WATTLE & DAUB / COB INFILL TO WEST GABLE ELEVATION OVER REGISTRAR'S OFFICE TO BE REPAIRED

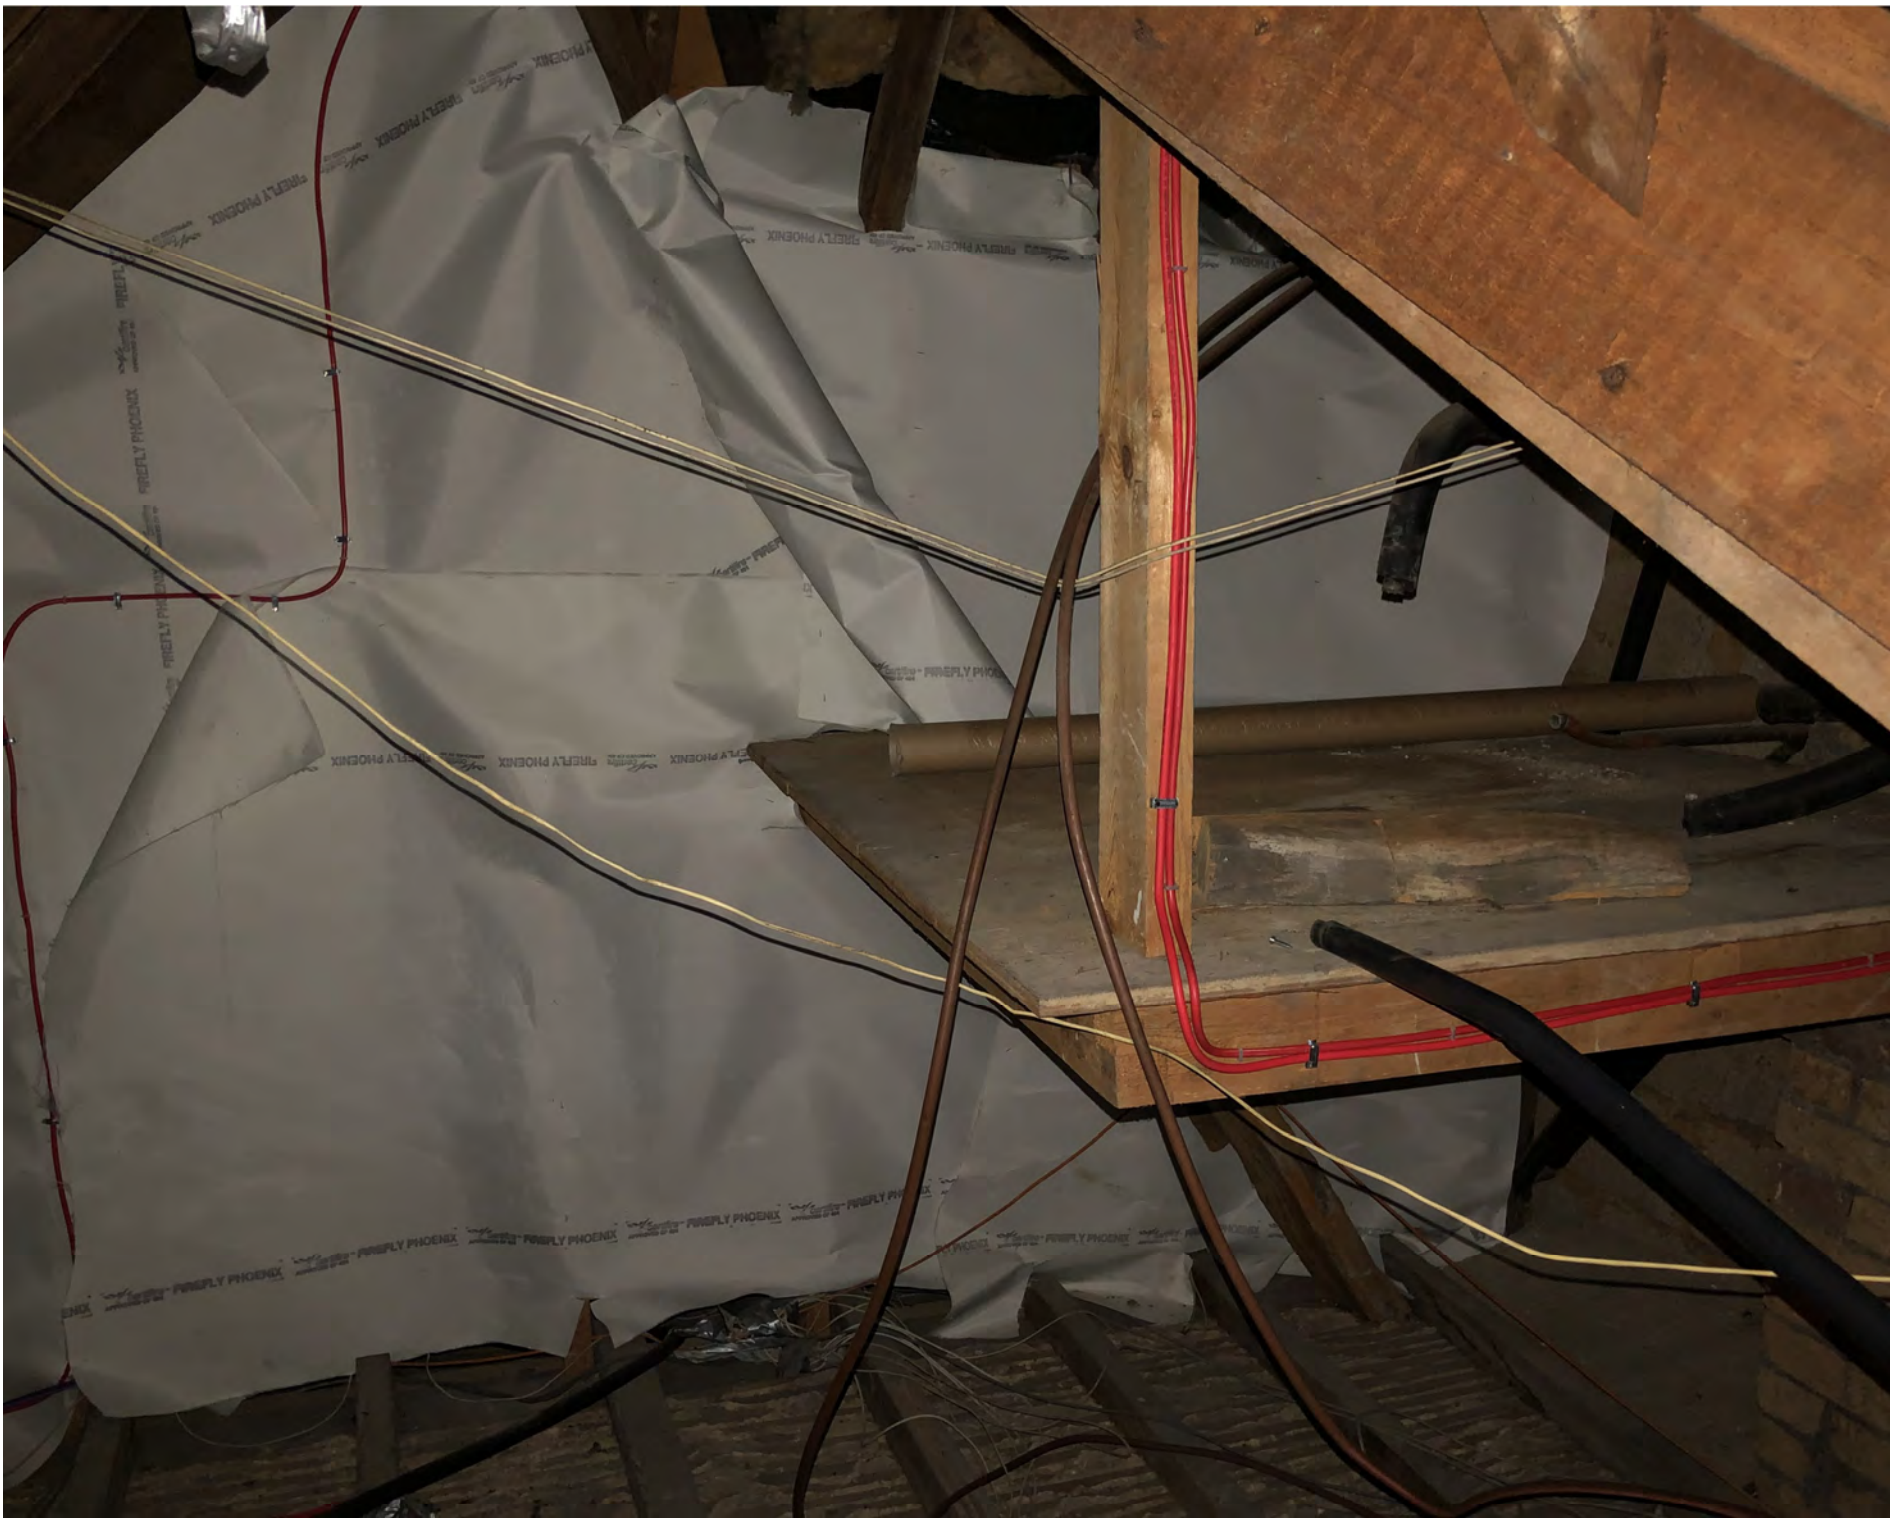
PHOTO 27 - MISC CABLES TO BE RE-ROUTED AND AND
REDUNDANT TIMBER PLATFORM OVER REGISTRAR'S OFFICE
TO BE REMOVED

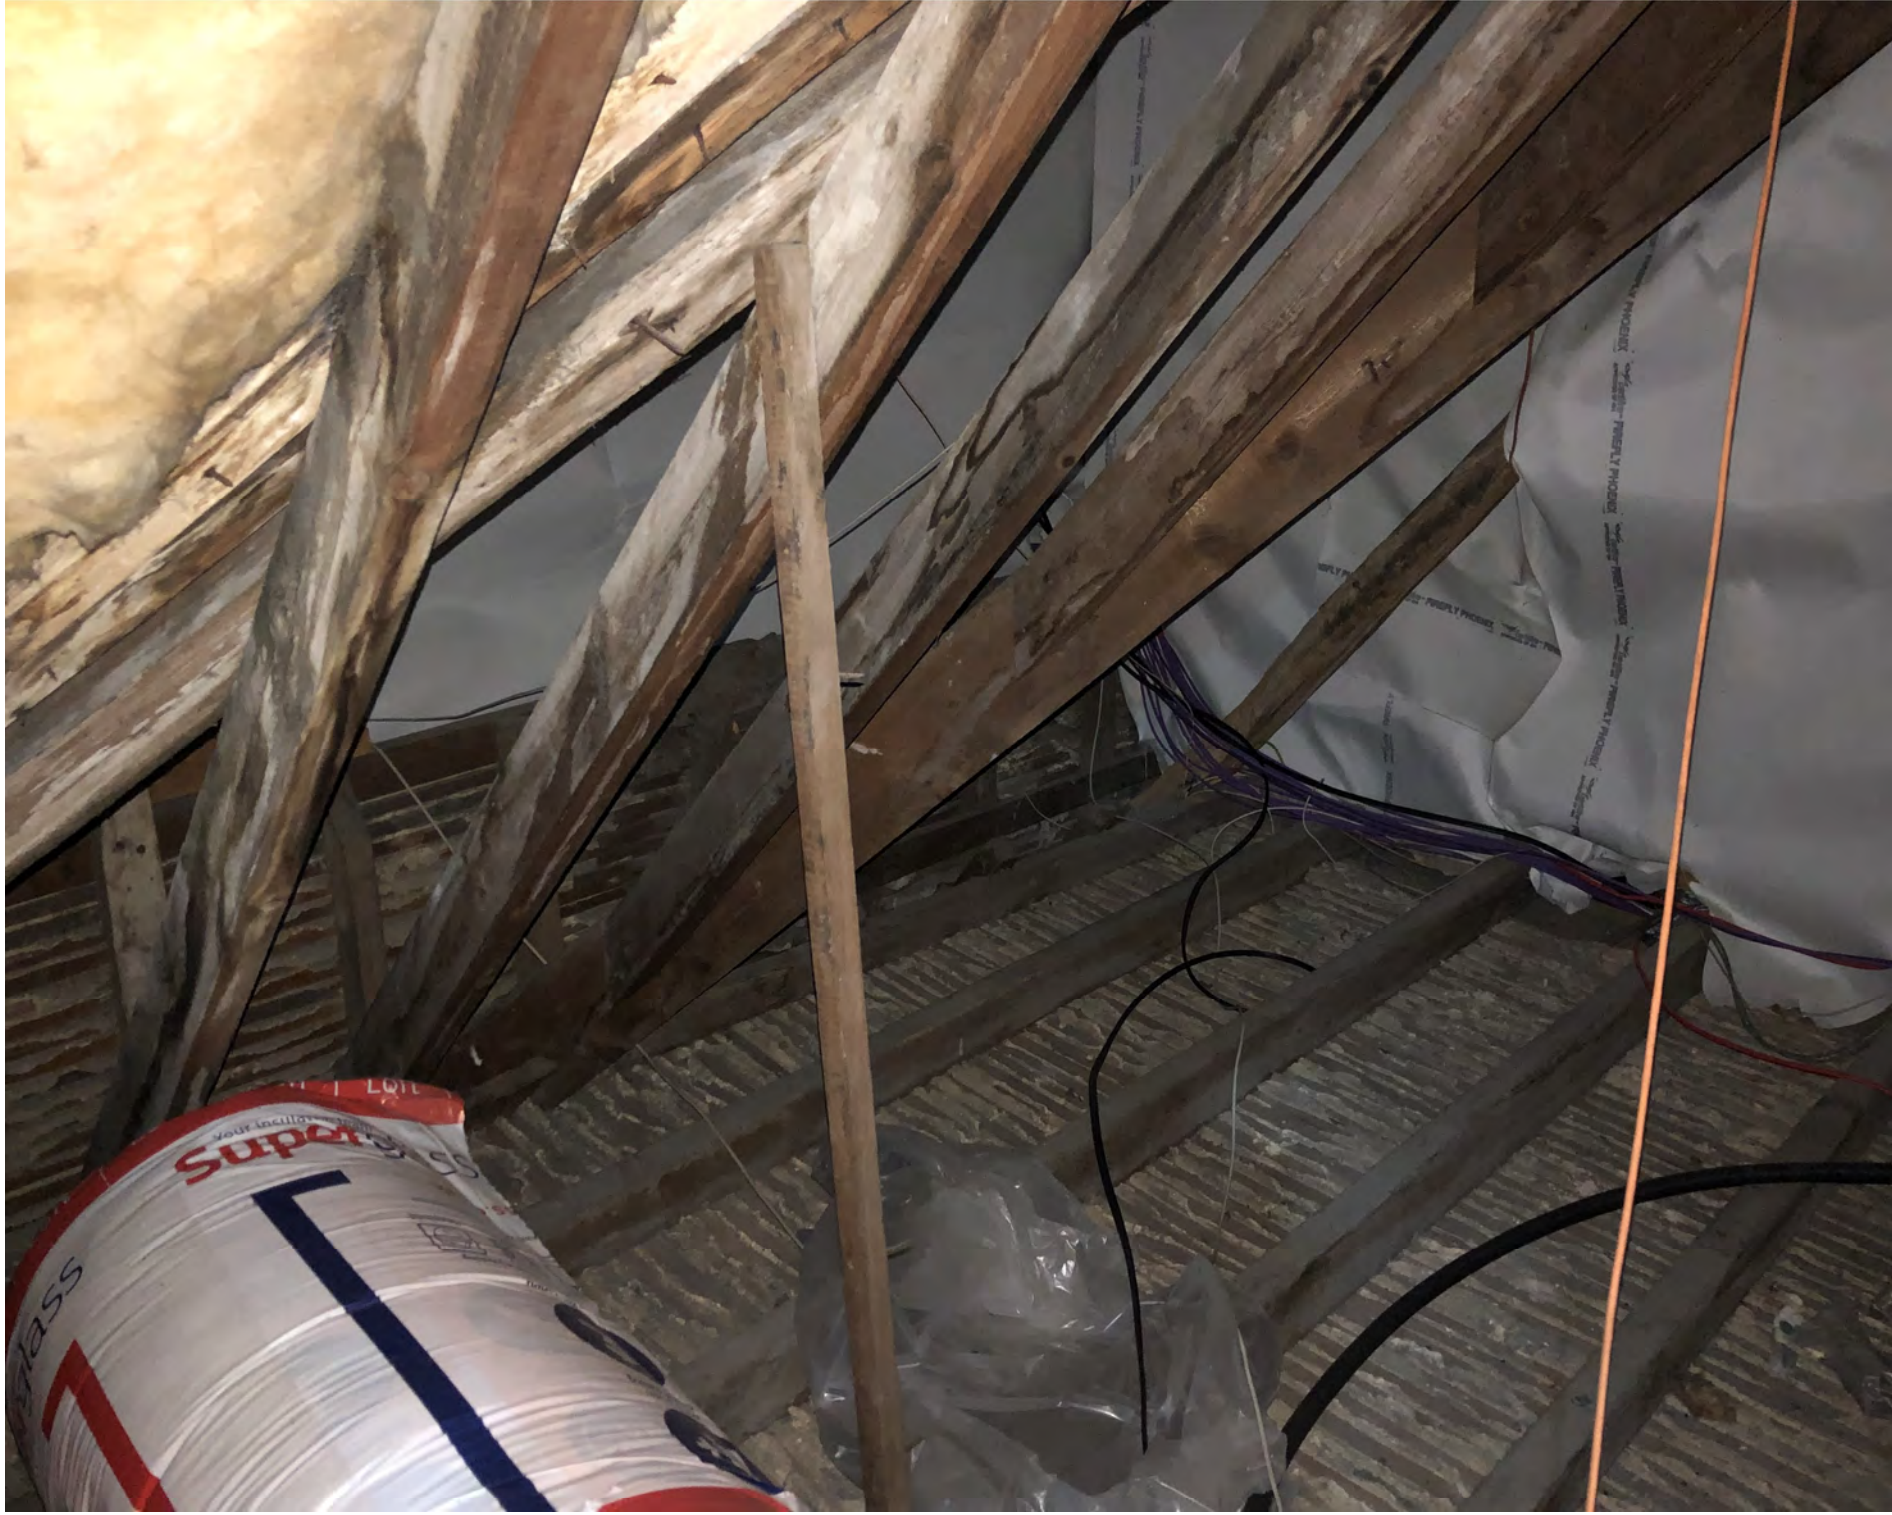
PHOTO 28 - EXPOSED CEILING TO REGISTRAR'S OFFICE TO BE INSULATED AS PART OF WORKS
