Annual Inspection

Central Swindon North Parish Council

Pembroke Gardens

Inspection Ref: 2248289

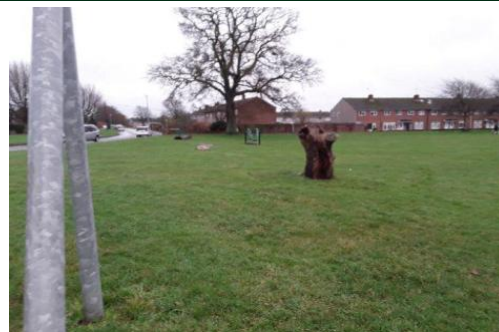
Item: Site General
Manufacturer: Owner/Operator
Surface Type: N/A
Item Quantity: 1
Equipment Compliance: N/A
Surface Area Compliance: N/A

It is recommended that signage, with information including the site address, contact information for maintenance issues and emergency contact details are provided for the facility - Provide in accordance with the recommendations

There is a rotten tree stump in the area - Remove

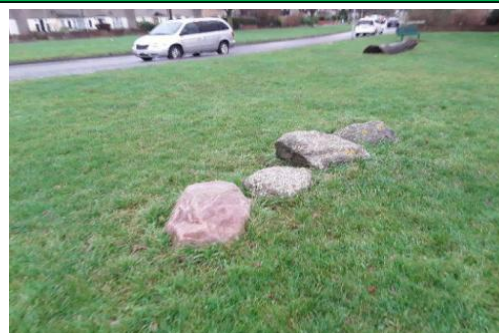
Item: Boulders
Manufacturer: Natural Feature
Surface Type: Grass
Item Quantity: 9
Equipment Compliance: N/A
Surface Area Compliance: N/A

The rocks and/or boulders have moss/algae growth apparent - Clean and maintain

The step between the items is quite large and users may not be able to complete the step without touching ground, the items could therefore be considered to be within the falling space of each other, however the intention of the play activity continuity is easily apparent and foreseeable to the user - Monitor - No remedial work recommended

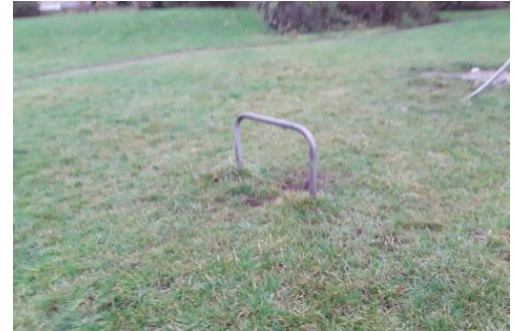
Item: Cycle Rack
Manufacturer: Not Identified
Surface Type: Grass
Item Quantity: 1
Equipment Compliance: N/A
Surface Area Compliance: N/A

There are trip hazards present - Reinstate surrounding surfaces to level to remove the trip points

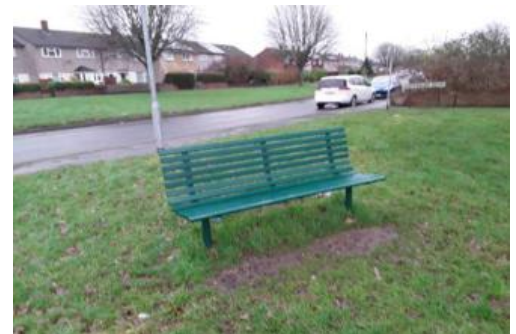
Item: Bench
Manufacturer: Not Identified
Surface Type: Grass
Item Quantity: 2
Equipment Compliance: N/A
Surface Area Compliance: N/A

This item is satisfactory - no work required -

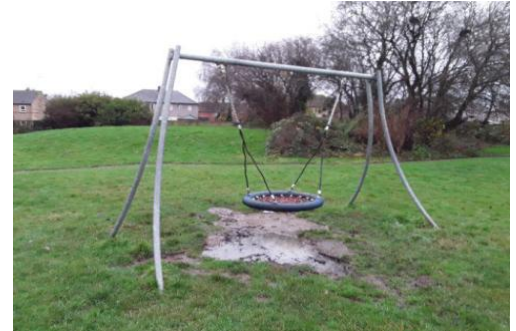
Item: Basket Swing - Type 1
Manufacturer: Kompan Ltd
Surface Type: Grass Matrix Tiles
Item Quantity: 1
Equipment Compliance: No
Surface Area Compliance: Yes

The surfacing is severely damaged - Repair damaged areas of surfacing

The connecting links are in excess of 8.6mm and less than 12mm and fail the requirements of BS EN 1176 Part 1; clause 4.2.13, Chains - Monitor - No remedial work recommended

There is/are bolt cap covers missing or damaged on the item - Replace missing or damaged bolt cap covers

The shackles are worn in excess of 40% and require renewing - Replace worn shackles

There is some notable evidence of chain wear - Monitor for any further deterioration and replace when 40% worn

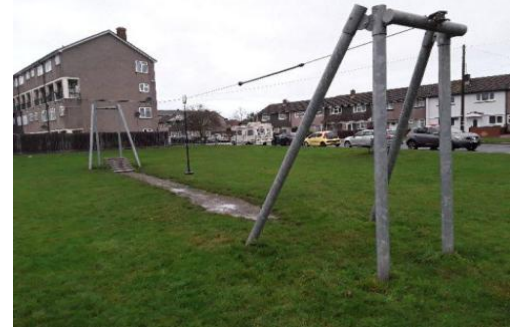
Item: Cable Runway
Manufacturer: Kompan Ltd
Surface Type: Grass Matrix Tiles
Item Quantity: 1
Equipment Compliance: Yes
Surface Area Compliance: Yes

We have completed a visual inspection of the suspension links, cable and fixing points from ground level, however it is not possible to fully inspect these areas without either hiring equipment to gain access or removing the cable and suspension and inspecting at ground level. We recommend that the main cable and fixing security is thoroughly inspected at least in accordance with the manufacturers recommendations to check for wear, damage, security or internal rusting; this will help to ensure the continued safe use of the equipment - Inspect in accordance with the manufacturers recommendations

The grass mats are silted up and the soil is compacted; this may have an effect on the impact absorbing properties of the surface. Consideration should be given to HIC testing the surface to verify impact attenuating properties (<https://playinspections.co.uk/inspection-services/safety-surface-testing/>) - Contact our office for a quotation for this service

The nylon inserts are worn or missing at the point the cable enters the traveller - Replace worn or missing inserts as required

Parts of the timber are rough or splintered - Remove all rough or sharp edges

There is or are fixings missing on the item - Replace all missing fixings

The seat connection cannot be inspected without dismantling the seat - Dismantle the seat to inspect the seat connection for wear

There is some notable evidence of chain wear - Monitor for any further deterioration and replace when 40% worn

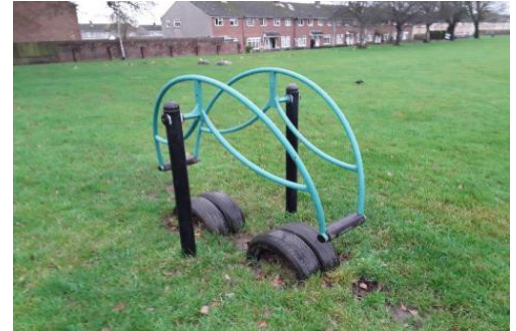
Item: See Saw
Manufacturer: Hags
Surface Type: Grass Matrix Tiles
Item Quantity: 1
Equipment Compliance: Yes
Surface Area Compliance: Yes

The rubber foot cover has been damaged - Monitor for any further deterioration and replace as required

There is/are bolt cap covers missing or damaged on the item - Replace missing or damaged bolt cap covers

The dampening tyre has been damaged - Monitor for any further deterioration and replace as required

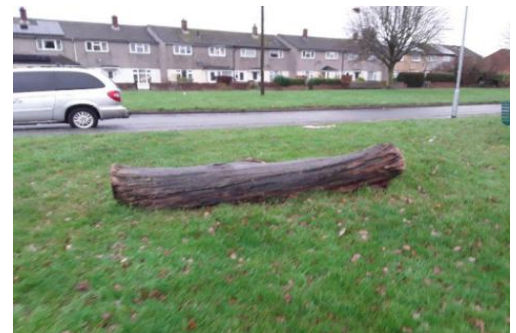
Item: Fallen Tree
Manufacturer: Natural Feature
Surface Type: Grass
Item Quantity: 1
Equipment Compliance: N/A
Surface Area Compliance: N/A

Parts of the timber are rough or splintered - Remove all rough or sharp edges

There are areas or parts of the timber on the structure that have rotted - Replace all affected timbers

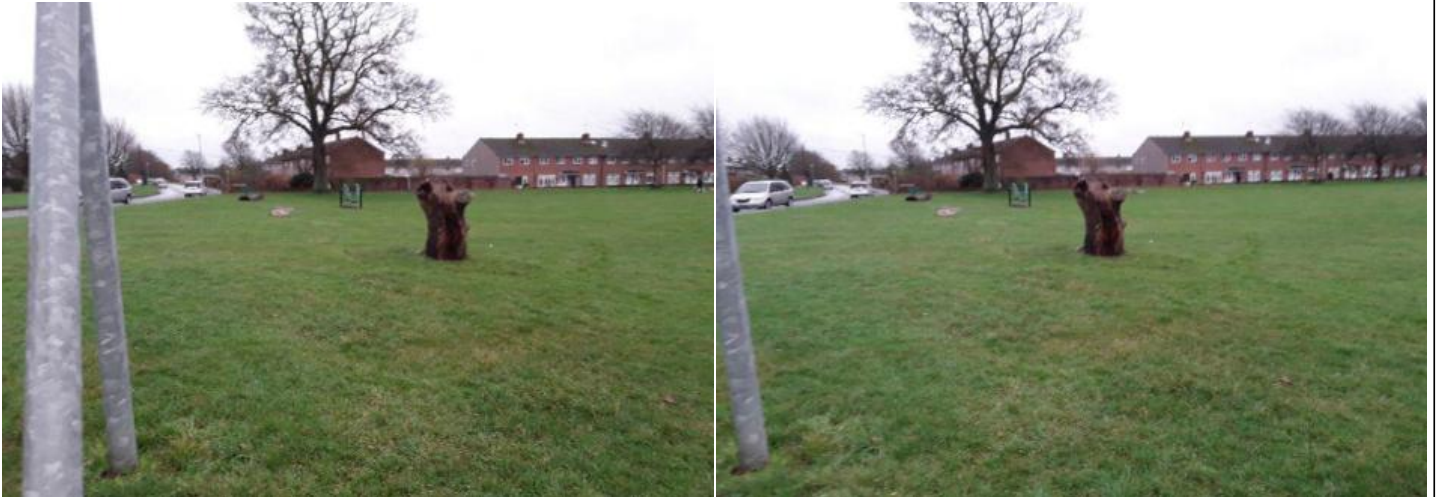
Item: Ancillary Items - Site General
Manufacturer: Owner/Operator

Finding: It is recommended that signage, with information including the site address, contact information for maintenance issues and emergency contact details are provided for the facility

Action: Provide in accordance with the recommendations

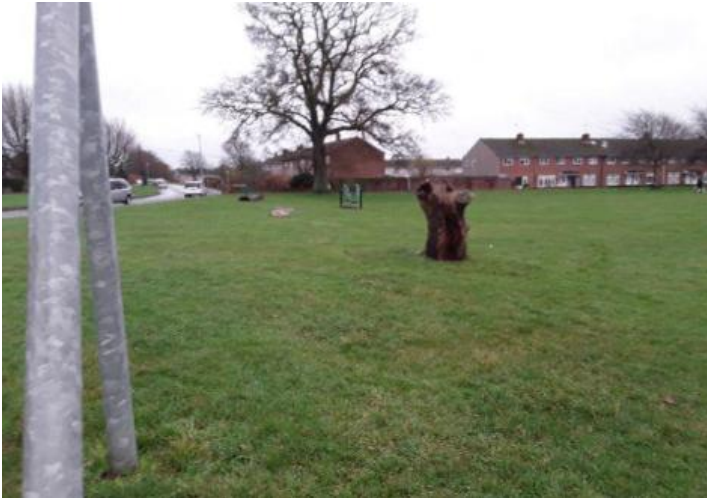
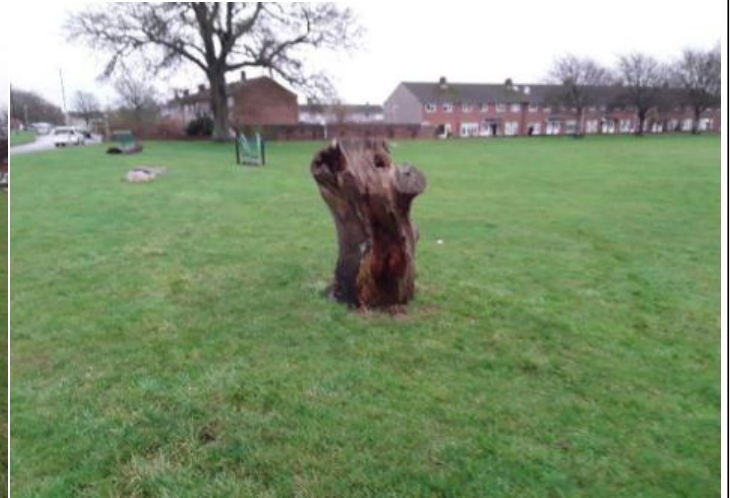
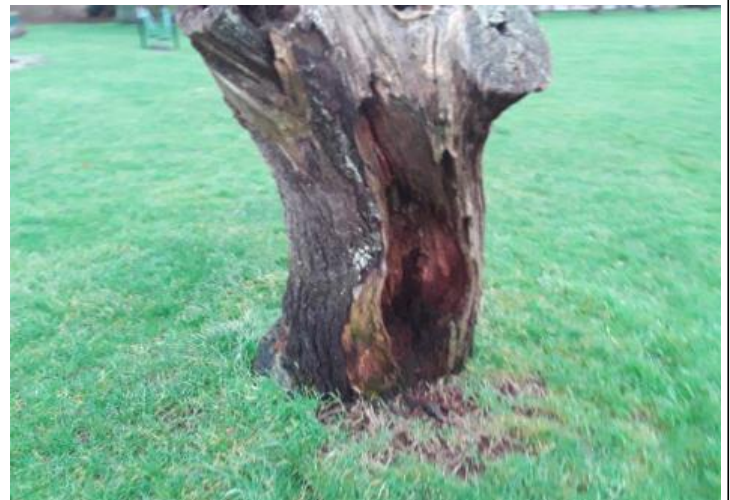
Item: Ancillary Items - Site General
Manufacturer: Owner/Operator

Finding: There is a rotten tree stump in the area

Action: Remove

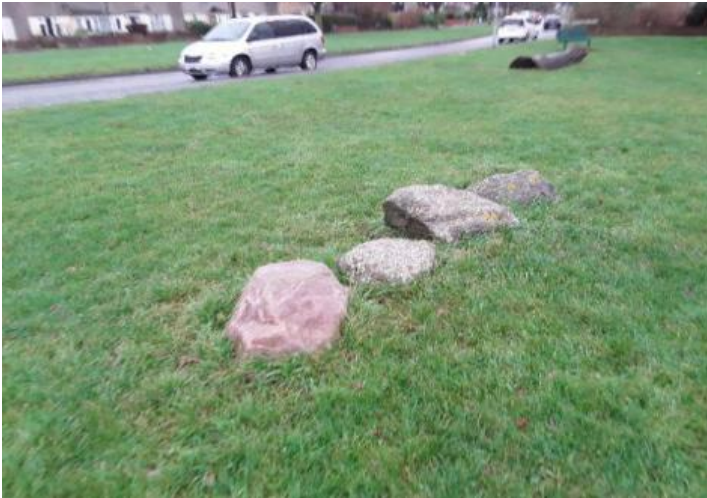
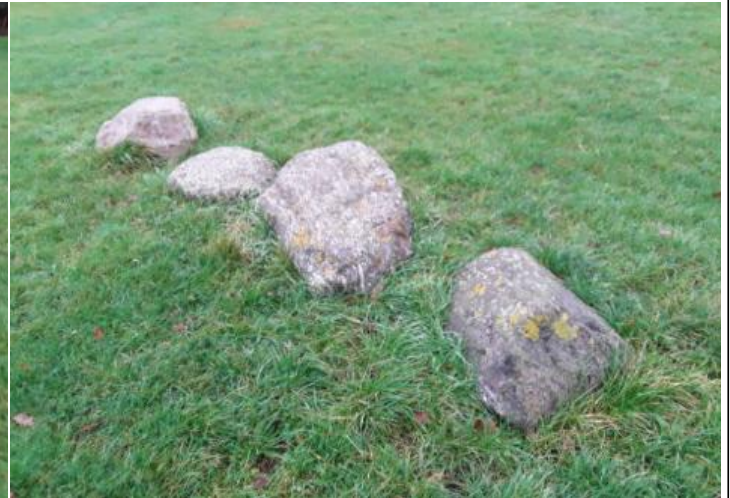
Item: Other - Boulders
Manufacturer: Natural Feature

Finding: The rocks and/or boulders have moss/algae growth apparent

Action: Clean and maintain

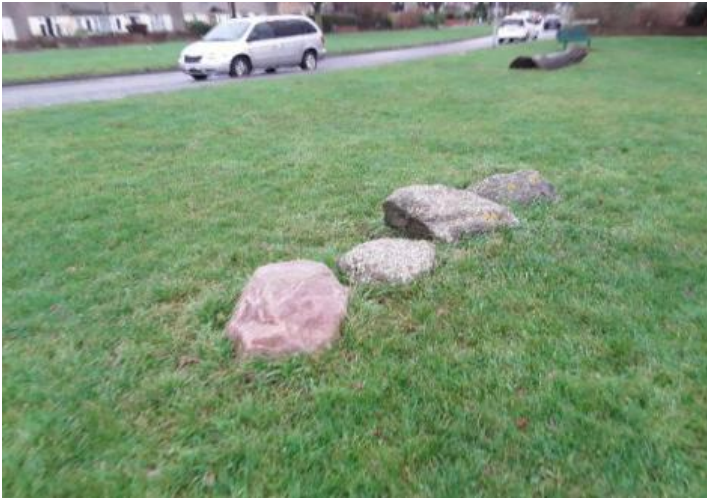
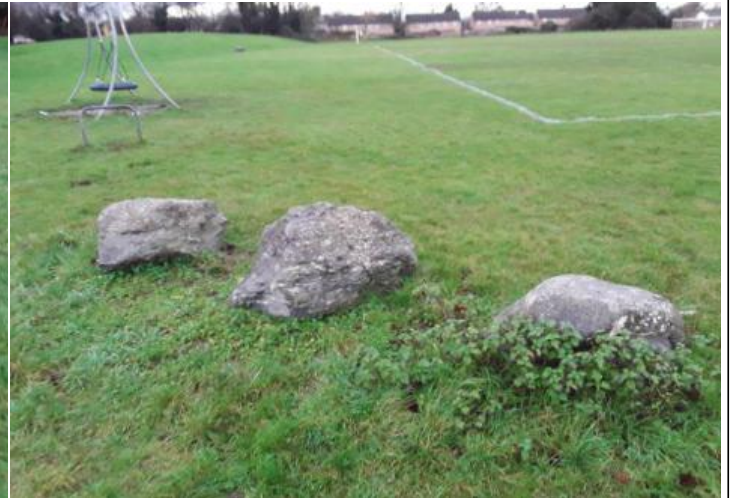
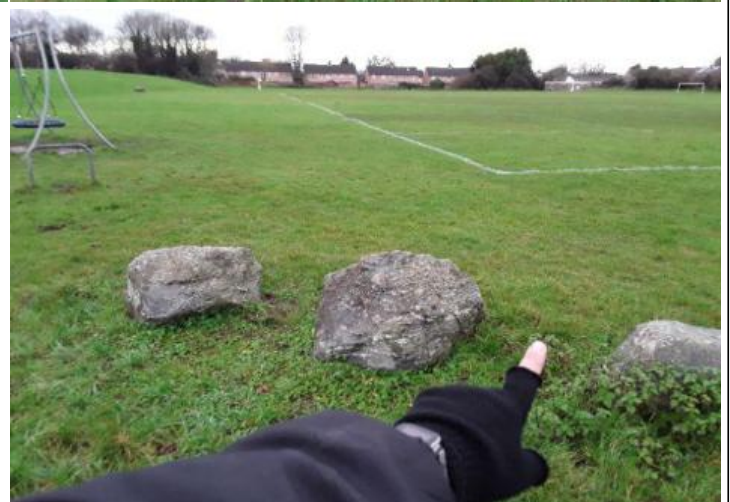
Item: Other - Boulders
Manufacturer: Natural Feature

Finding: The step between the items is quite large and users may not be able to complete the step without touching ground, the items could therefore be considered to be within the falling space of each other, however the intention of the play activity continuity is easily apparent and foreseeable to the user

Action: Monitor - No remedial work recommended

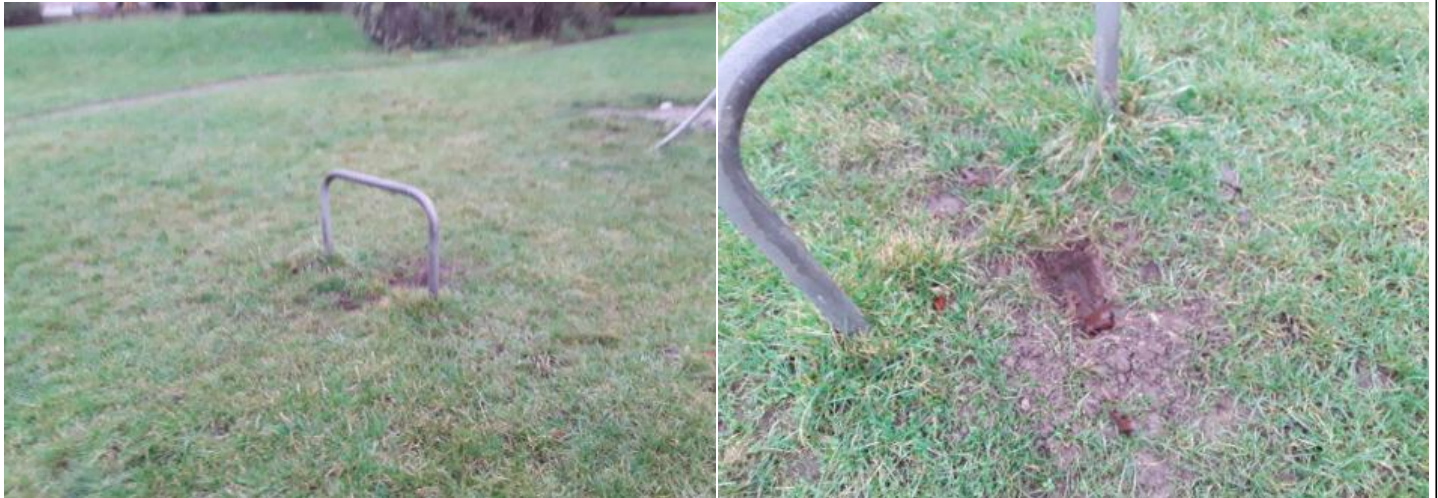
Item: Ancillary Items - Cycle Rack
Manufacturer: Not Identified

Finding: There are trip hazards present

Action: Reinstall surrounding surfaces to level to remove the trip points

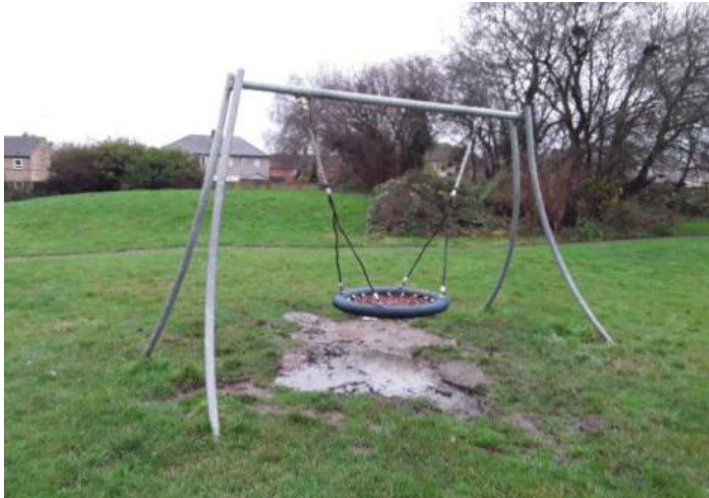
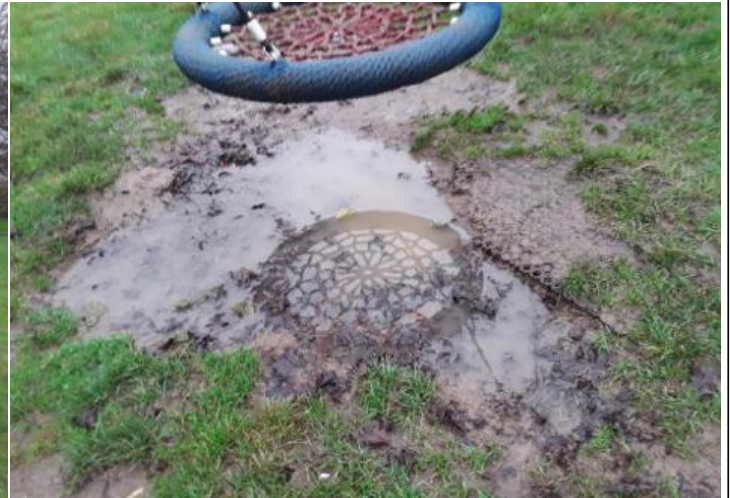
Item: Swings - Basket Swing - Type 1
Manufacturer: Kompan Ltd

Finding: The surfacing is severely damaged

Action: Repair damaged areas of surfacing

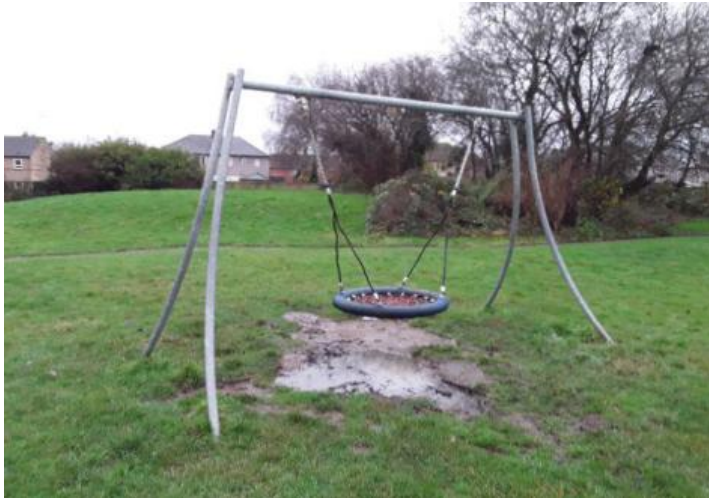
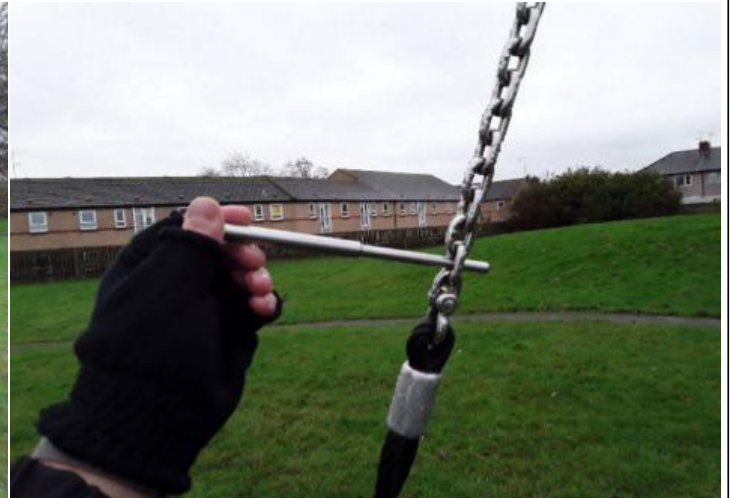
Item: Swings - Basket Swing - Type 1
Manufacturer: Kompan Ltd

Finding: The connecting links are in excess of 8.6mm and less than 12mm and fail the requirements of BS EN 1176 Part 1; clause 4.2.13, Chains

Action: Monitor - No remedial work recommended

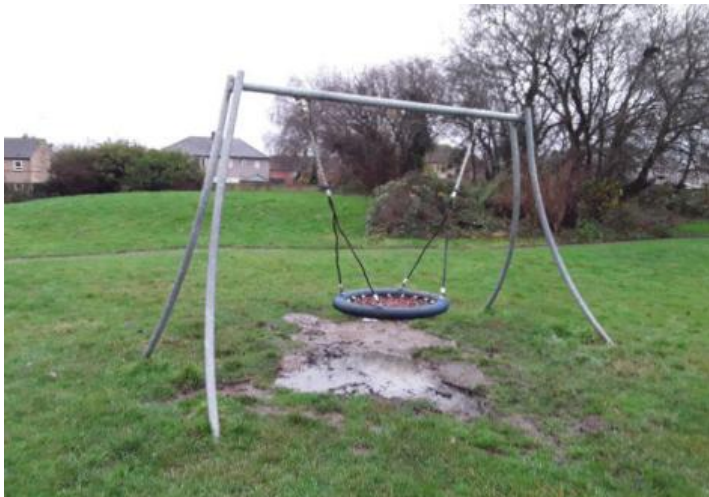
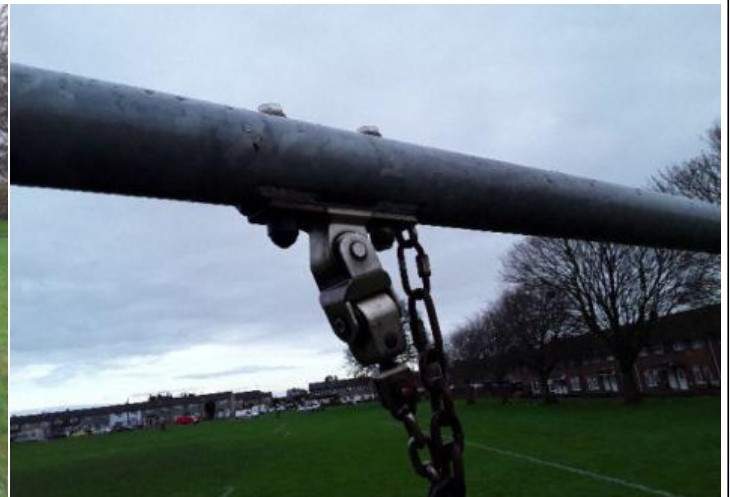
Item: Swings - Basket Swing - Type 1
Manufacturer: Kompan Ltd

Finding: There is/are bolt cap covers missing or damaged on the item

Action: Replace missing or damaged bolt cap covers

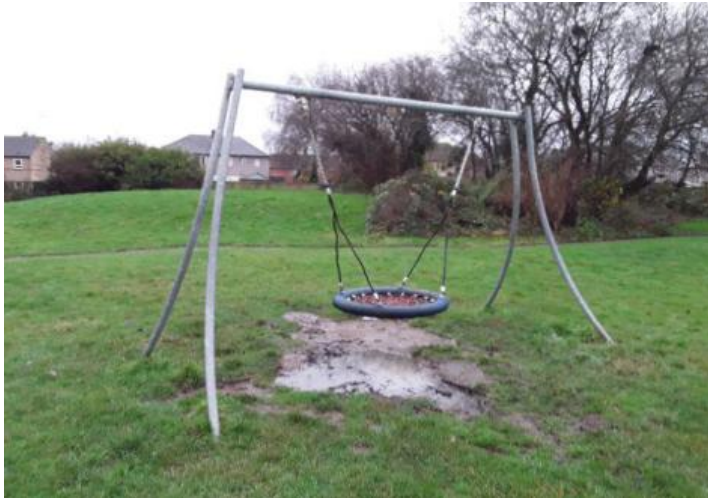
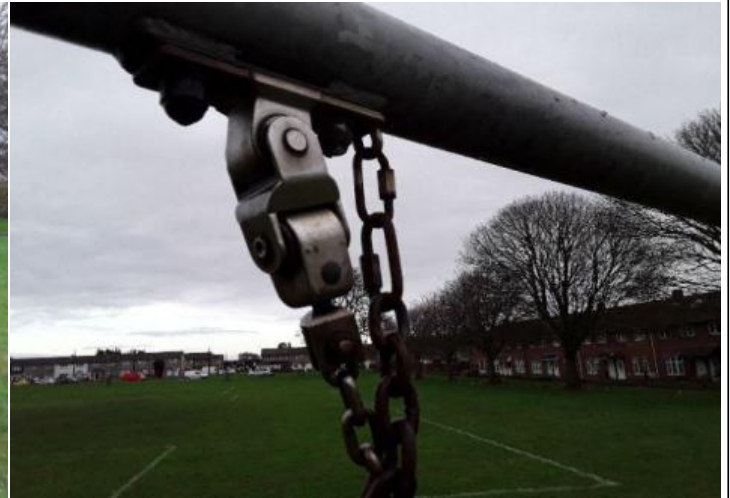
Item: Swings - Basket Swing - Type 1
Manufacturer: Kompan Ltd

Finding: The shackles are worn in excess of 40% and require renewing

Action: Replace worn shackles

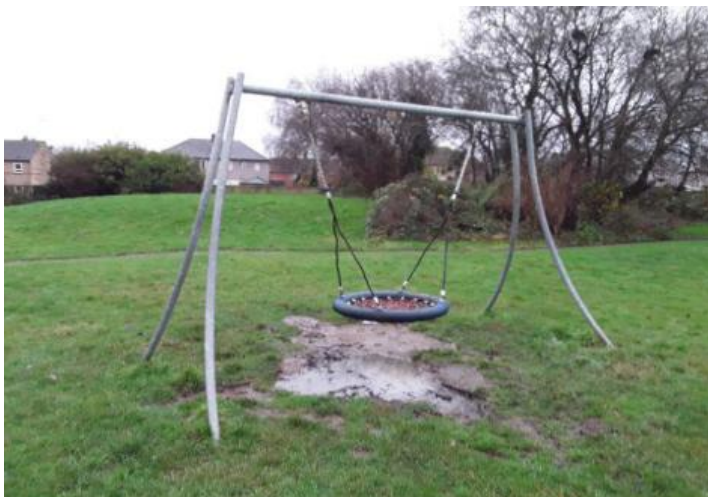
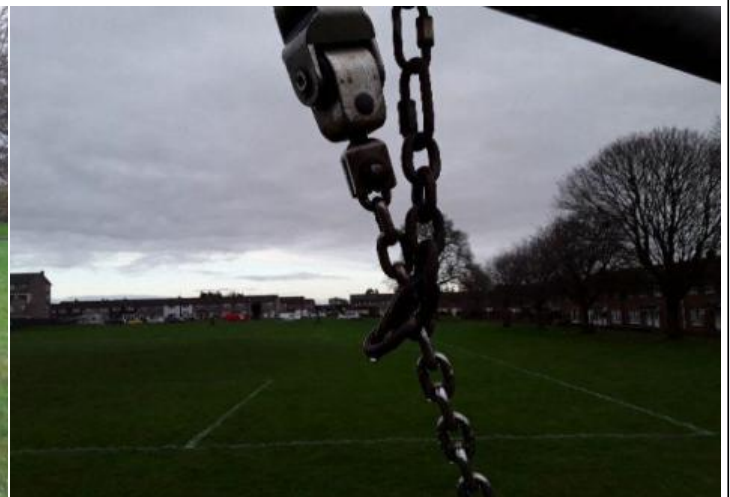
Item: Swings - Basket Swing - Type 1
Manufacturer: Kompan Ltd

Finding: There is some notable evidence of chain wear

Action: Monitor for any further deterioration and replace when 40% worn

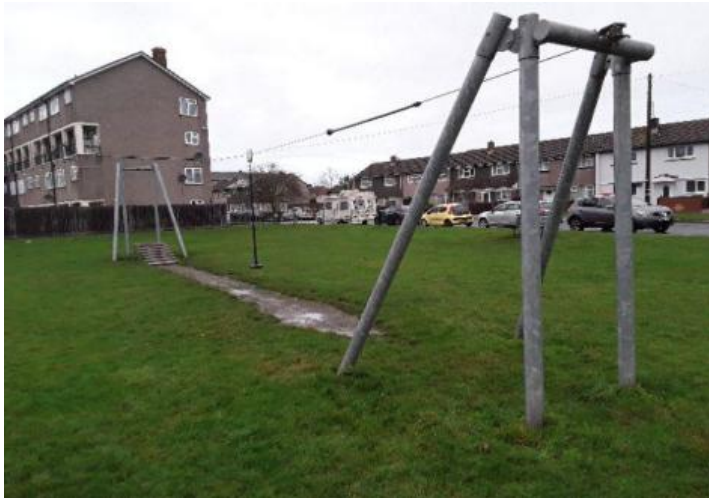
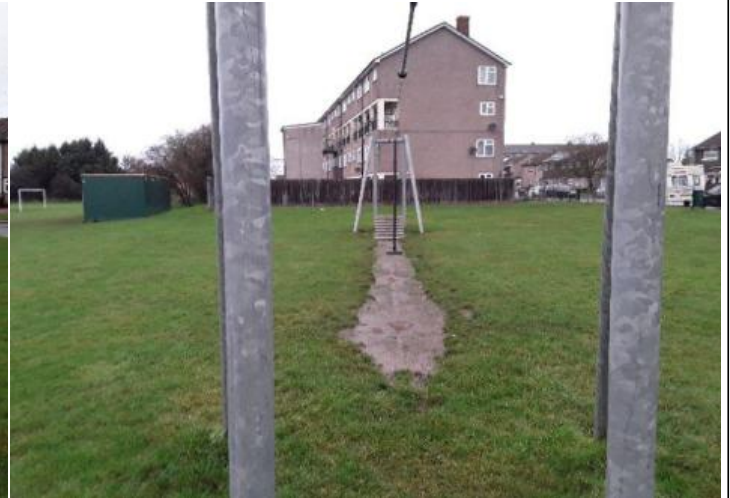
Item: Other - Cable Runway
Manufacturer: Kompan Ltd

Finding: We have completed a visual inspection of the suspension links, cable and fixing points from ground level, however it is not possible to fully inspect these areas without either hiring equipment to gain access or removing the cable and suspension and inspecting at ground level. We recommend that the main cable and fixing security is thoroughly inspected at least in accordance with the manufacturers recommendations to check for wear, damage, security or internal rusting; this will help to ensure the continued safe use of the equipment

Action: Inspect in accordance with the manufacturers recommendations

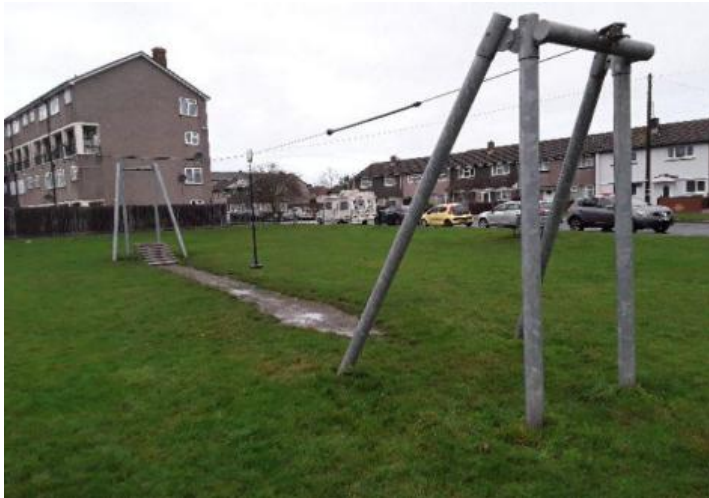
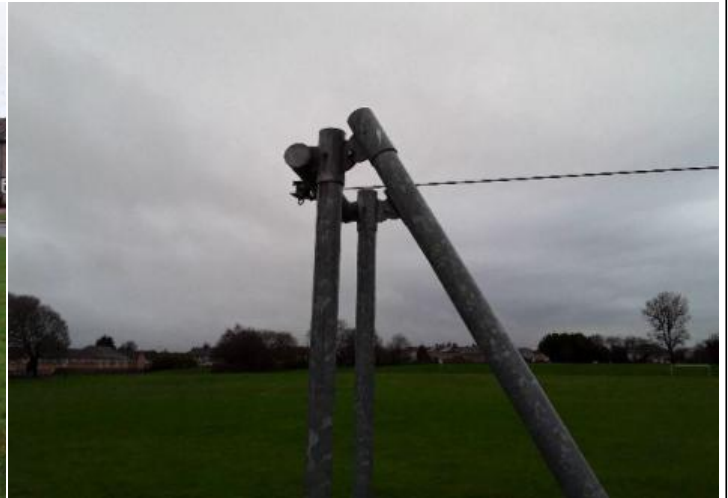
Item: Other - Cable Runway
Manufacturer: Kompan Ltd

Finding: There is or are fixings missing on the item

Action: Replace all missing fixings

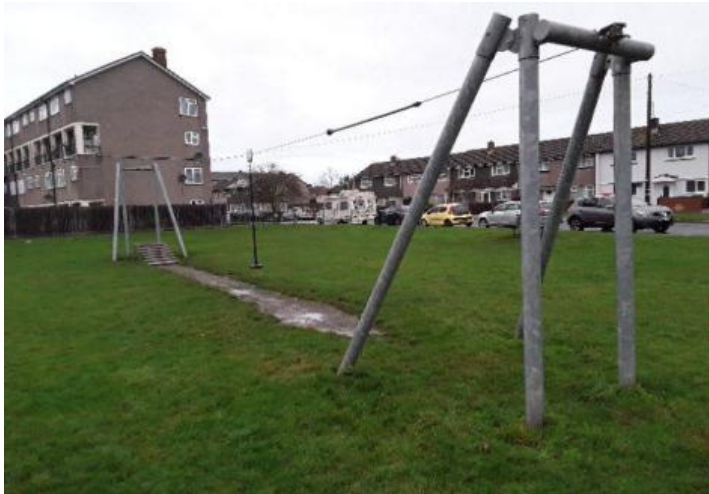
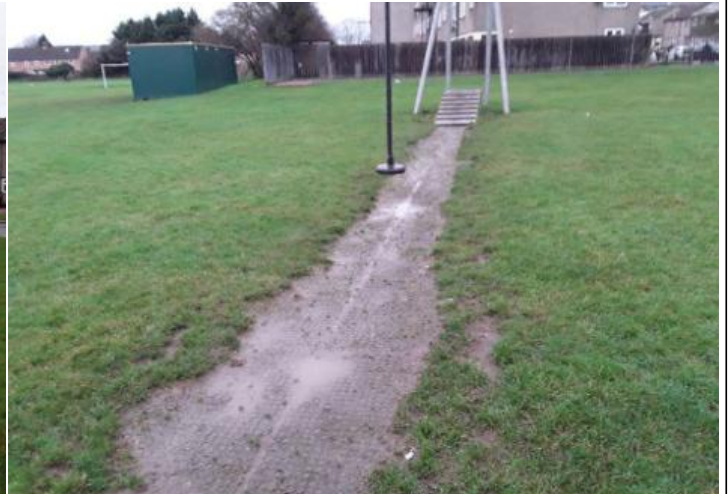
Item: Other - Cable Runway
Manufacturer: Kompan Ltd

Finding: The grass mats are silted up and the soil is compacted; this may have an effect on the impact absorbing properties of the surface. Consideration should be given to HIC testing the surface to verify impact attenuating properties (<https://playinspections.co.uk/inspection-services/safety-surface-testing/>)

Action: Contact our office for a quotation for this service

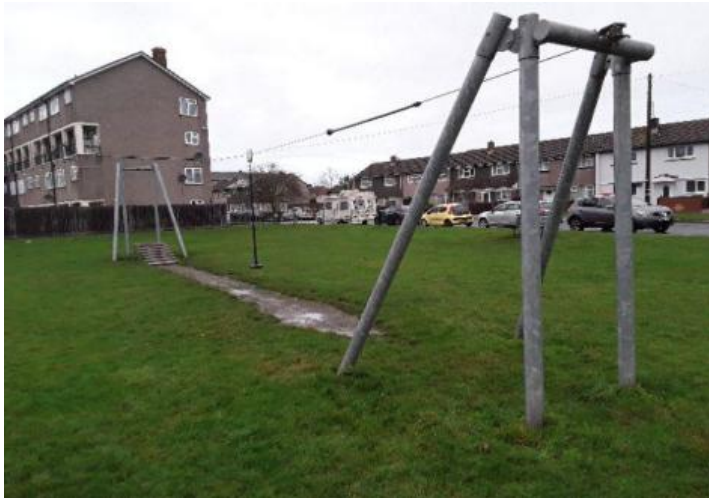
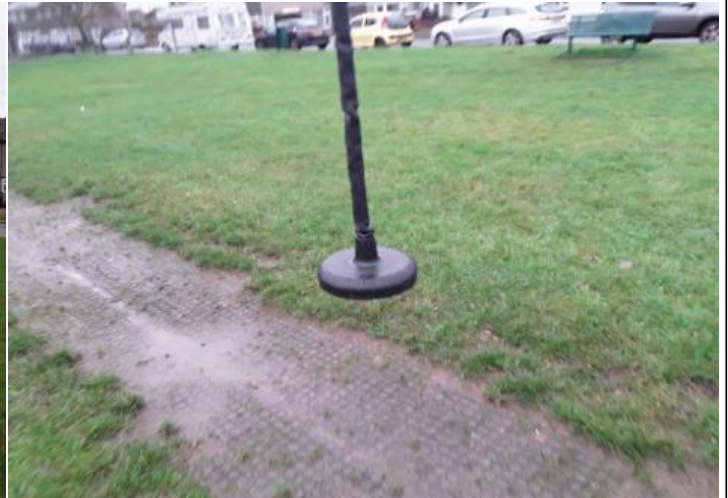
Item: Other - Cable Runway
Manufacturer: Kompan Ltd

Finding: The seat connection cannot be inspected without dismantling the seat

Action: Dismantle the seat to inspect the seat connection for wear

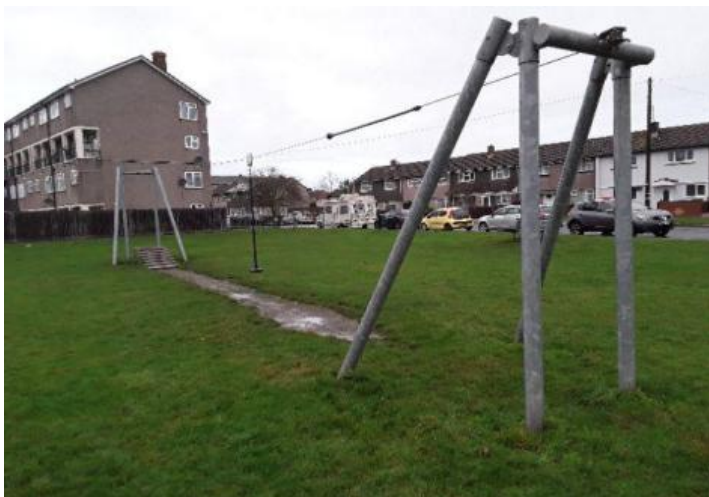
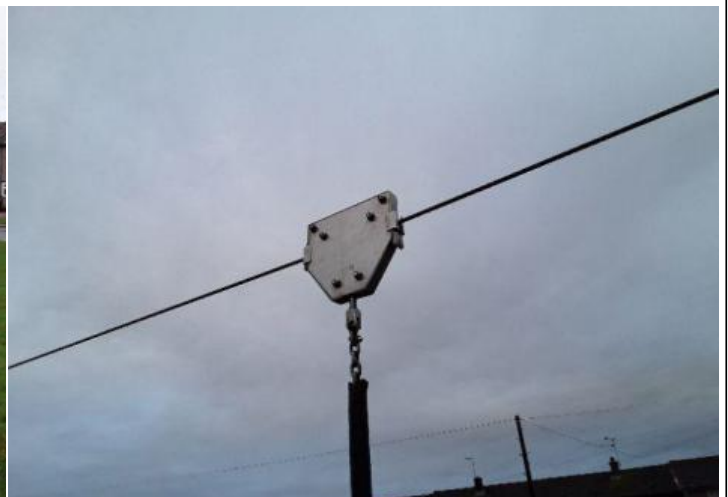
Item: Other - Cable Runway
Manufacturer: Kompan Ltd

Finding: The nylon inserts are worn or missing at the point the cable enters the traveller

Action: Replace worn or missing inserts as required

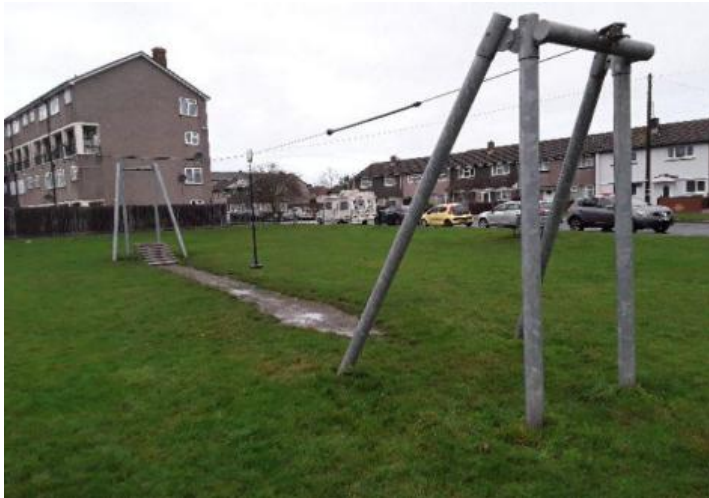
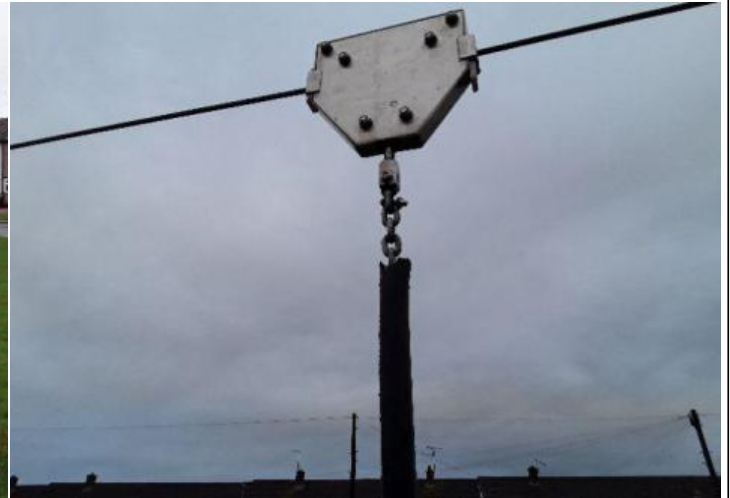
Item: Other - Cable Runway
Manufacturer: Kompan Ltd

Finding: There is some notable evidence of chain wear

Action: Monitor for any further deterioration and replace when 40% worn

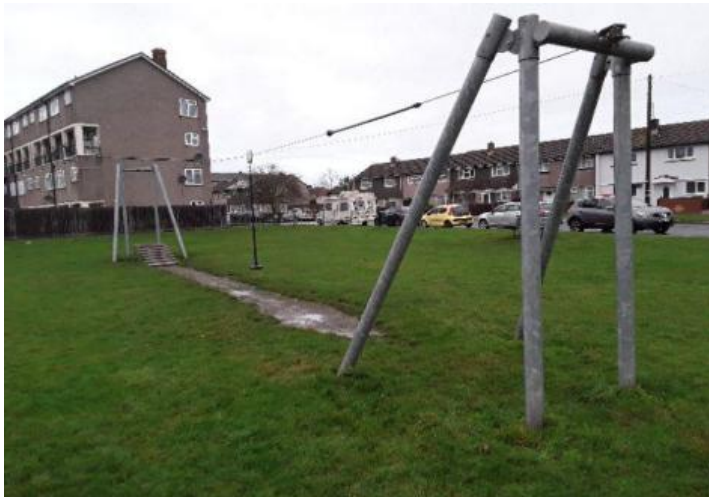
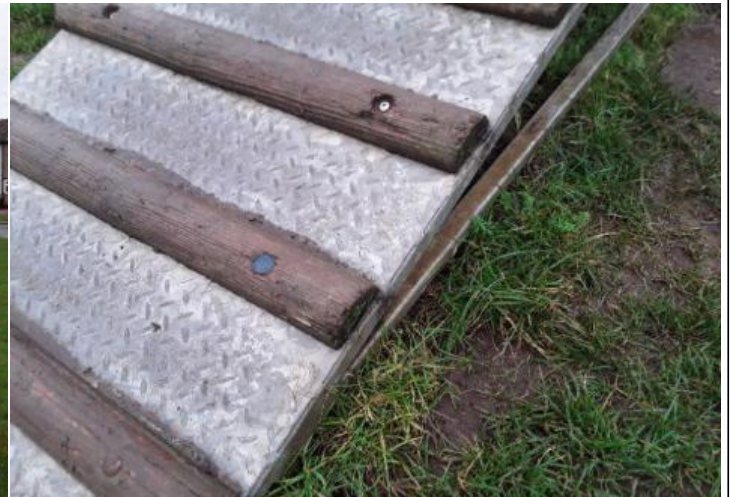
Item: Other - Cable Runway
Manufacturer: Kompan Ltd

Finding: Parts of the timber are rough or splintered

Action: Remove all rough or sharp edges

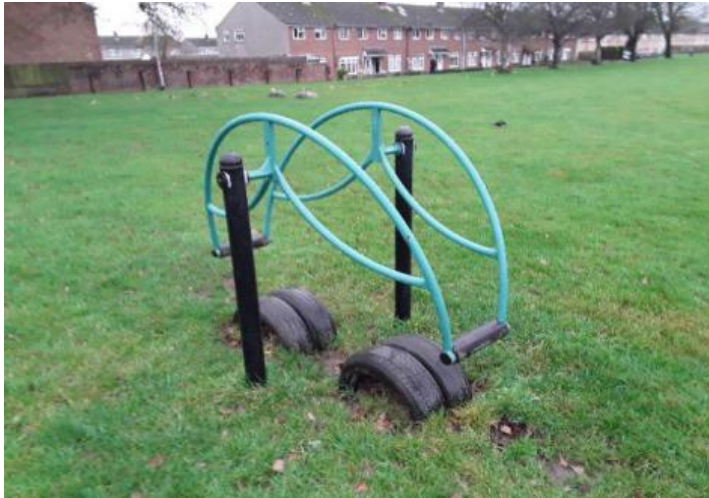
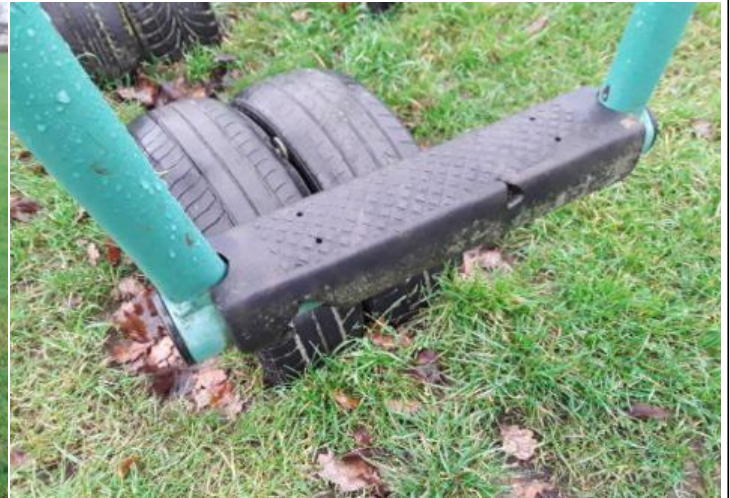
Item: Rocking Equipment - See Saw
Manufacturer: Hags

Finding: The rubber foot cover has been damaged

Action: Monitor for any further deterioration and replace as required

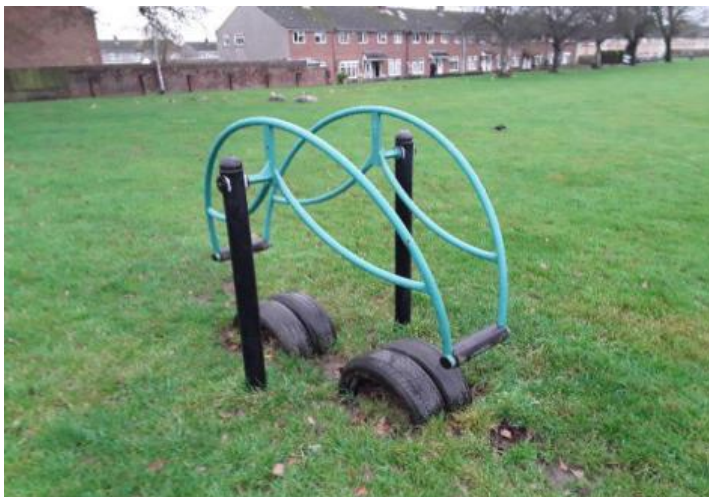
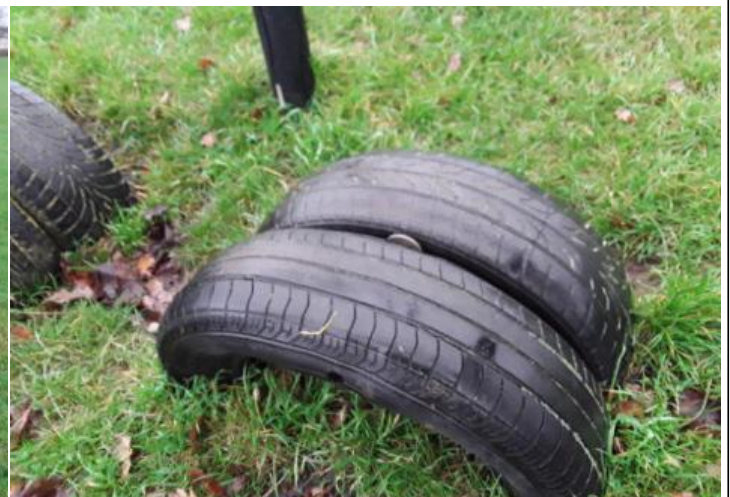
Item: Rocking Equipment - See Saw
Manufacturer: Hags

Finding: The dampening tyre has been damaged

Action: Monitor for any further deterioration and replace as required

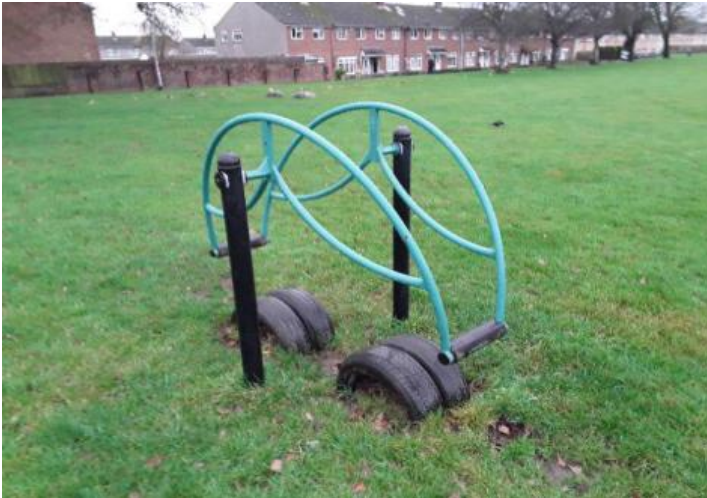
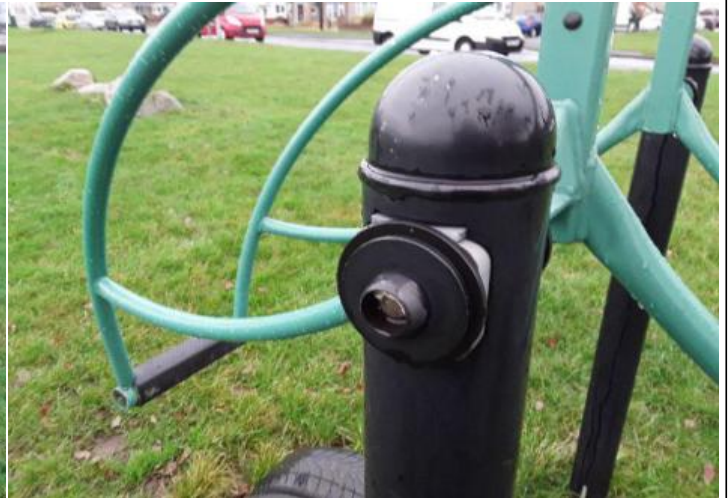
Item: Rocking Equipment - See Saw
Manufacturer: Hags

Finding: There is/are bolt cap covers missing or damaged on the item

Action: Replace missing or damaged bolt cap covers

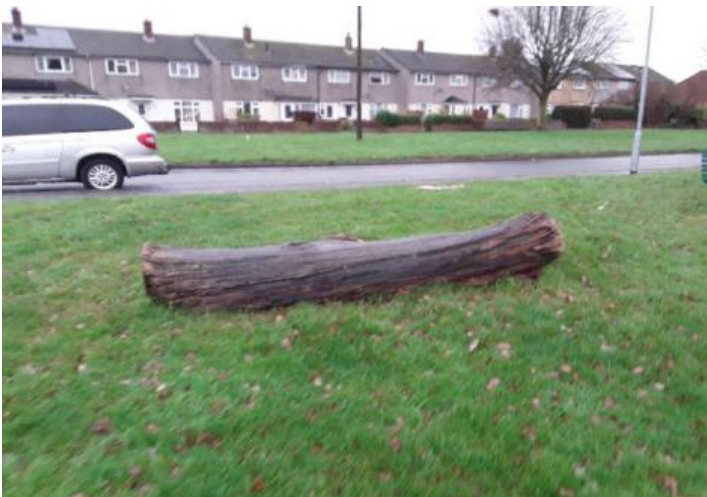
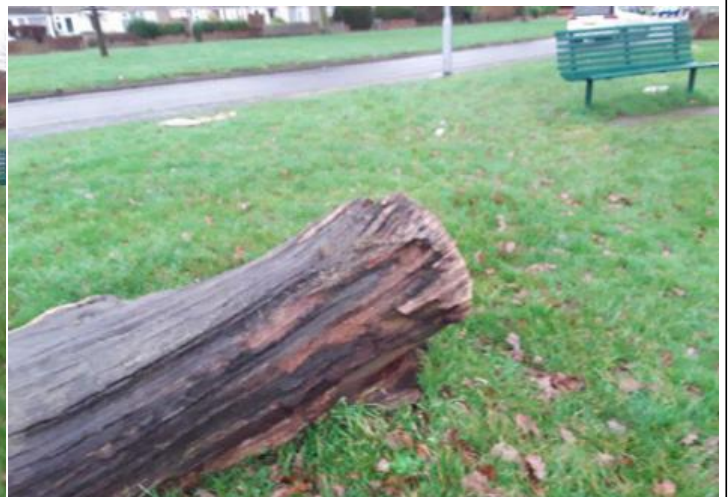
Item: Other - Fallen Tree
Manufacturer: Natural Feature

Finding: Parts of the timber are rough or splintered

Action: Remove all rough or sharp edges

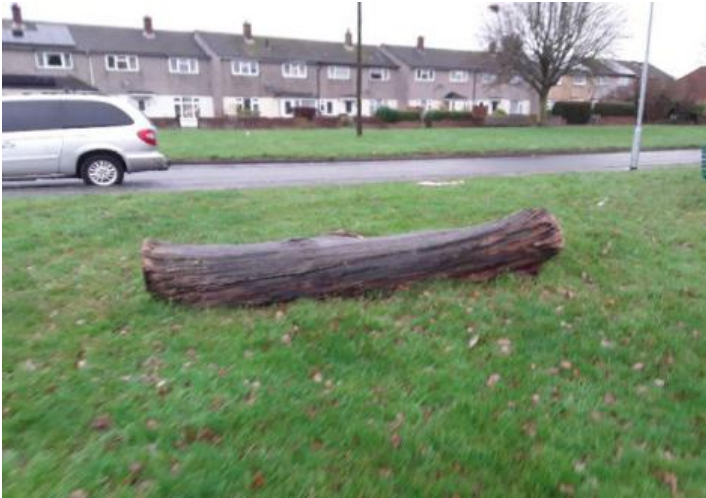
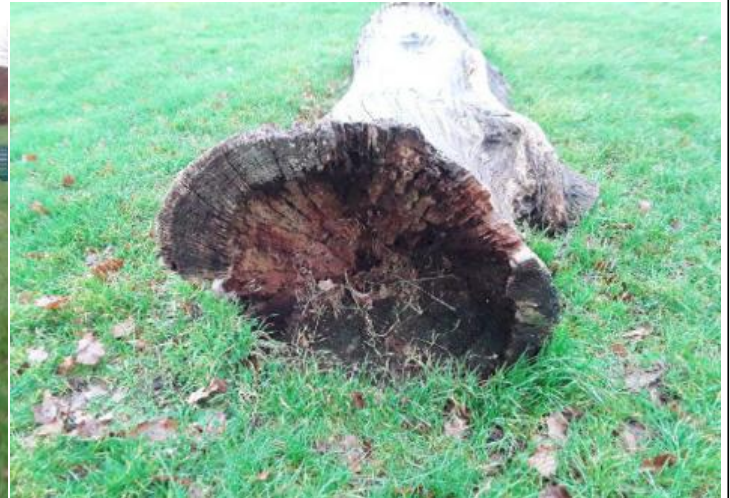
Item: Other - Fallen Tree
Manufacturer: Natural Feature

Finding: There are areas or parts of the timber on the structure that have rotted

Action: Replace all affected timbers
