**The Springfield Public House
Springfield Boulevard
Milton Keynes
MK6 3HR**

Structural Survey

Revision 0: March 2019

R-11461V-01-0

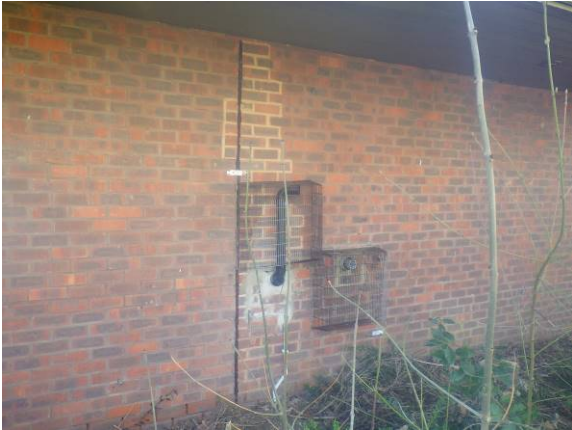
There is evidence of longstanding crack and movement damage to the northern end of this elevation suggesting a downward movement in foundations has occurred. Crack patterns include diagonal stepped and horizontal bed joint displacements with magnitudes up to 3mm. There is evidence of previous mortar repairs and in particular adjacent to a mastic vertical joint.

2. Wall 1 brickwork repairs adjacent to joint

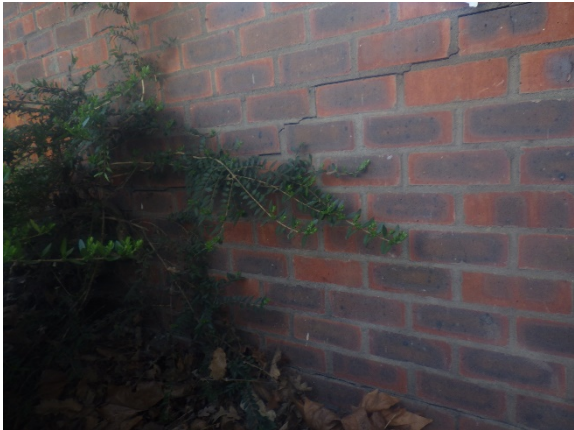
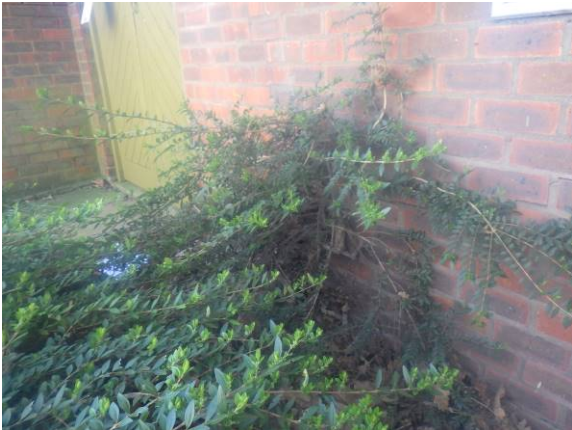
- 5.3 The nature of the crack and movement damage to this area is, in our opinion indicative of a rotational downward movement in the foundations. The potential variation in founding depths will have likely resulted in initial differential settlement shortly following construction, with tree root influence potentially exacerbating the normal seasonal variations in moisture content.

3. Wall 1 horizontal and diagonal stepped fracturing and adjacent shrubs

- Undertake intrusive investigations to establish the depth and nature of the foundations and sub-soils and to sample the soils and any tree root presence. This shall also include the foundations to the retaining walls and locally excavation to the rear face to establish the likely overall thickness.

- Due to the number and variety of trees and bushes in close proximity, that are a potential source of damage to the property we recommend a qualified Arboriculturist be appointed to advise on the most effective tree management scheme, in particular given their age in relation to the building.

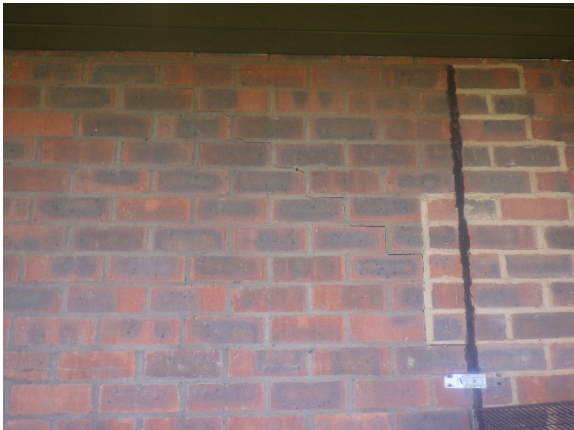
5. Wall 1 Stepped fracturing at high level adjacent to joint

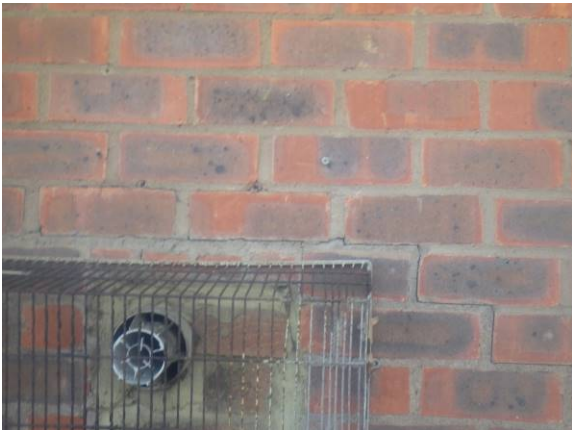
6. Wall 1 Stepped fracturing above vent grill

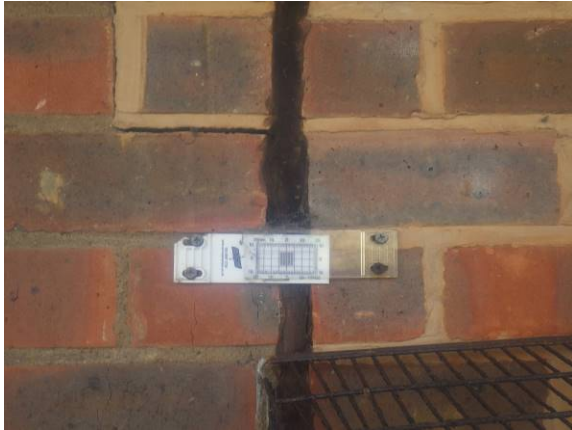
There are Avonguard crack monitoring gauges fitted across some of the fractures, also indicating the origin of the crack and movement damage to be longstanding. The gauges were typically fixed with the red cross hairs aligned on the 0-0 axis. You will note that vertical movement in the order of 4mm has taken place since fitting.

7. Wall 1 Crack monitoring gauge suggesting 4mm vertical movement

- Fit crack monitoring studs in accordance with BRE Digest 343 and carry out regular monitor readings with digital Vernier callipers to establish the rate and magnitude of the damage. This will be required should it be possible to remove any vegetation.

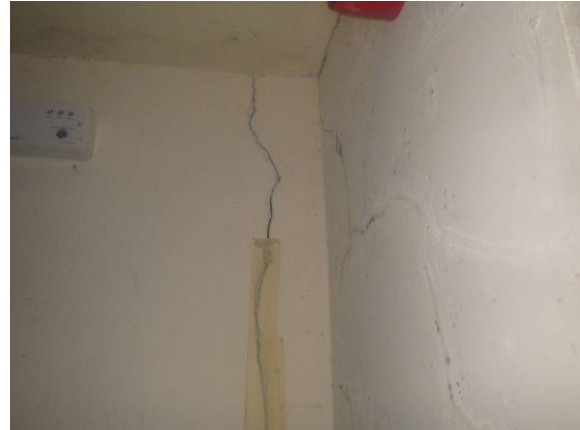
Internally, within the disabled toilet and old boiler room and adjacent rooms to the north eastern corner, there is evidence of a rotational movement having taken place towards wall 1, with tapering vertical fractures of 15mm at the top, diminishing towards the floor. Adjacent door frames have dropped, such that the top of the door binds on the frame.

8. Fracture to corner of Disabled WC dividing wall with Boiler room

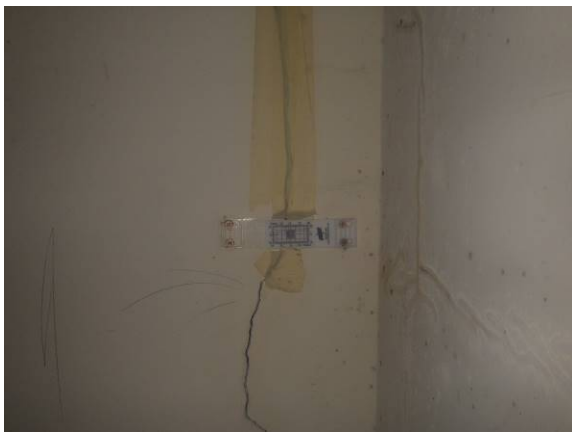
9. Fracture to corner of Disabled WC dividing wall with Boiler room indicating the wall to the left has lifted in the region of 4mm

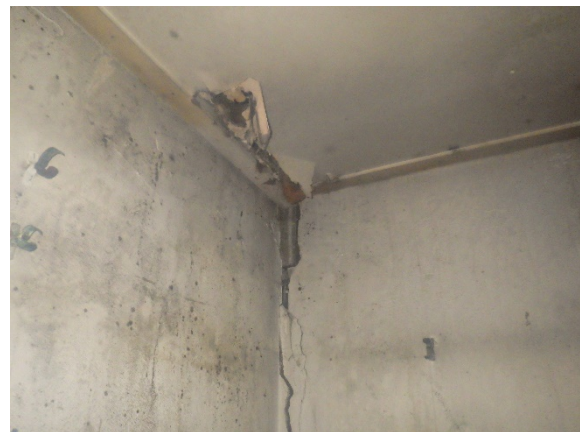
10. Fracture reflected within Boiler room dividing wall with Disabled WC at rear of stairwell, also showing beading at ceiling junction.

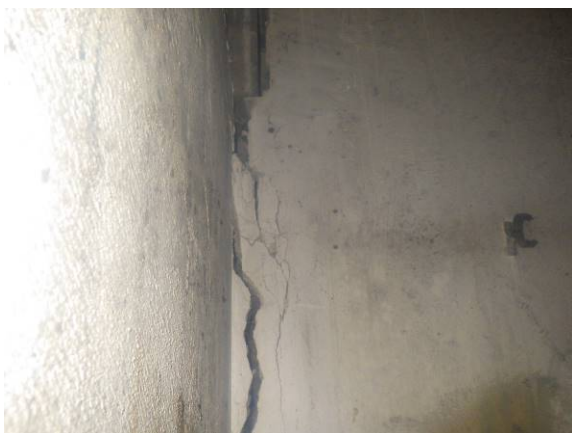
11. Continuation of fracture in 10. Above.

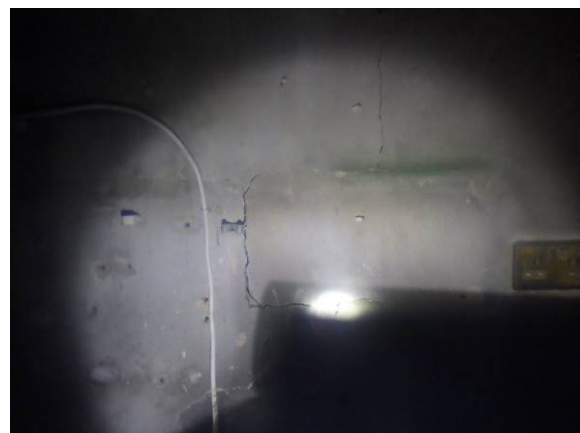
12. Fracturing to Wall 1 within Boiler room

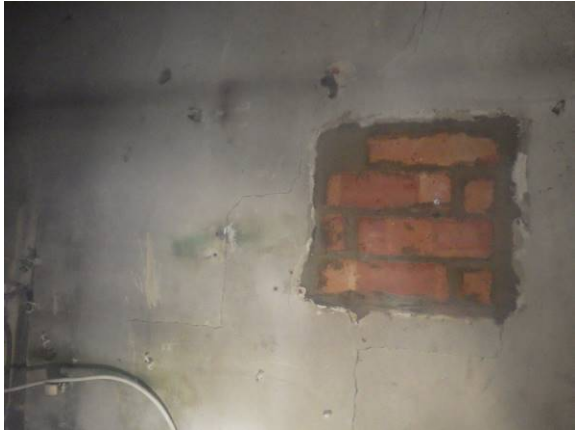
13. Wall 1 fracturing within Boiler room

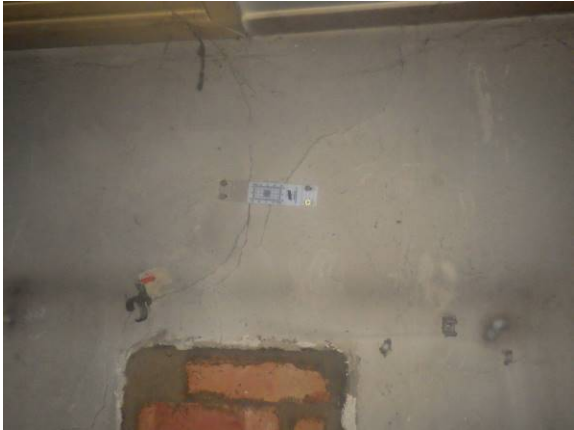
14. Crack monitor to Wall 1 suggesting no significant movement recorded

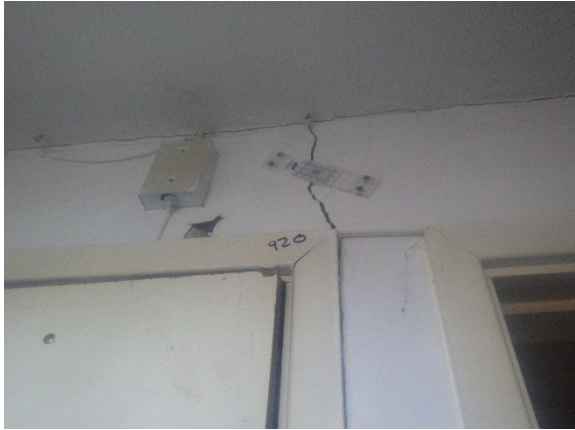
15. Top edge of door binding where frame has dropped

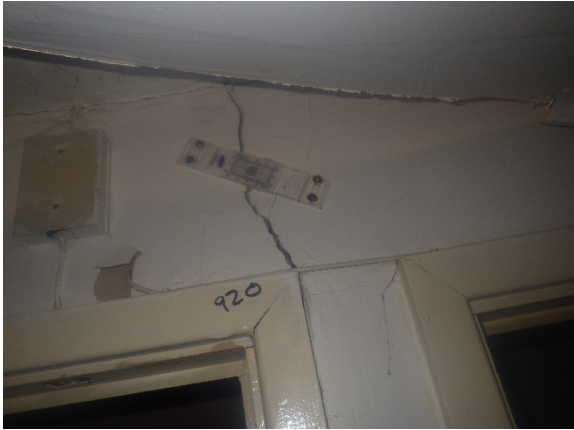
16. Crack monitor to adjacent room suggesting no significant movement recorded

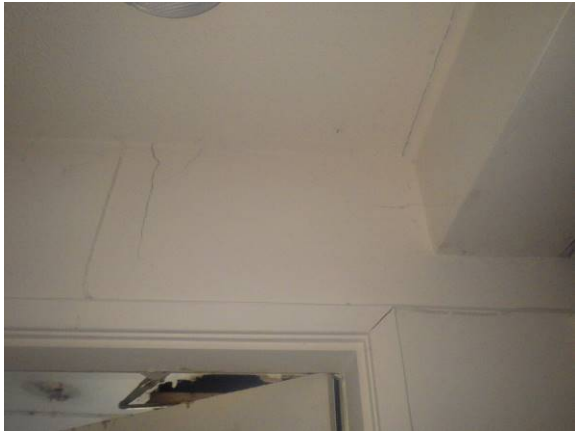
17. Fracturing above door

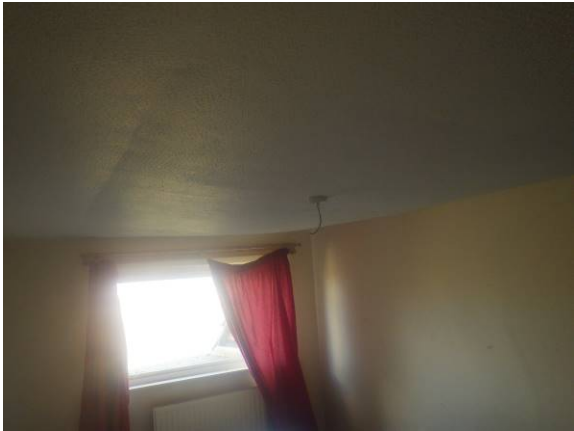
No significant structural defects generally, although a significant sag in the ceiling boarding to Bedroom 1, shown on drawing number 11461V/SK04. The sag in the ceiling appears to have created lateral displacement of the plaster finishes along the wall junctions.

18. Sagging ceiling to first floor Bed 1

- 6.2 Additionally, the ceiling in the first floor bedroom requires replacement.
- 6.3 Due to apparent roof/gutter leakage, remove all fascia cladding to allow inspection of the timber condition and replace/supplement decayed timber.

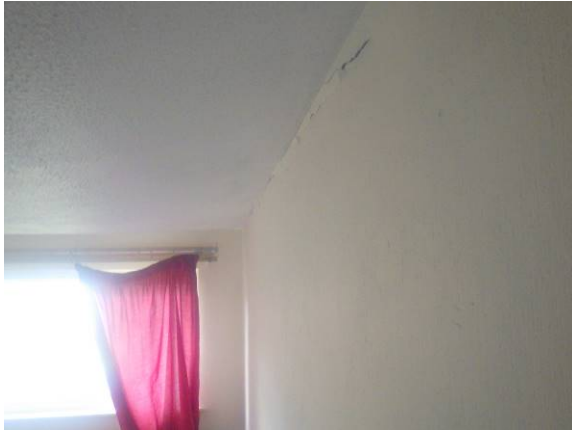
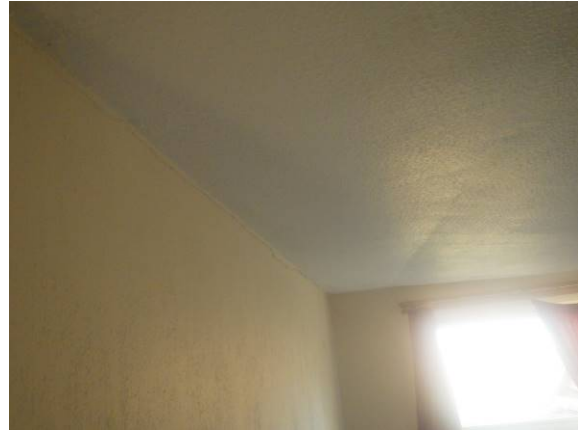
19. Laterally displaced plaster due to ceiling sag in Bed 1

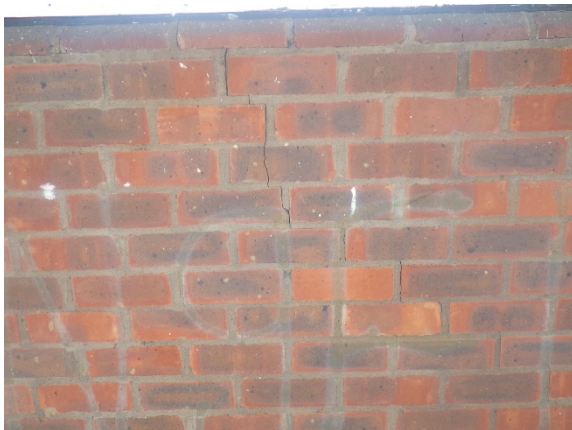
There is some evidence of stepped fracturing to this elevation, typically of magnitude 1.5mm tapering diminishing to hairline below the windows.

21. Wall 4 slightly tapering width vertical fracture

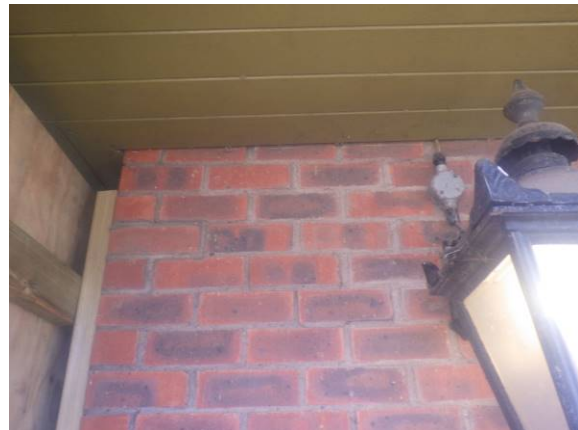
The fracture extends at high level adjacent to the front corner.

22. Wall 4 High level stepped fracturing adjacent to corner

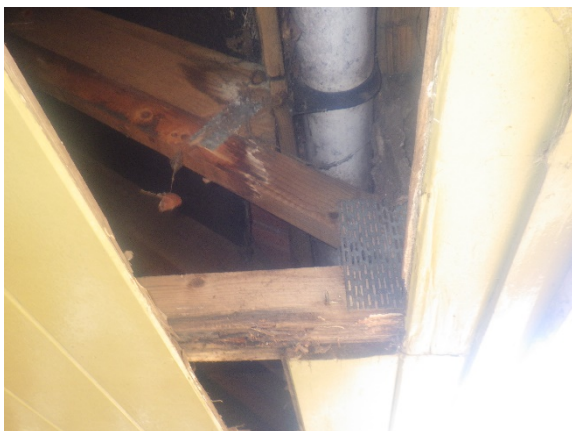
The eaves soffit overhang boarding is locally missing at this point. This reveals evidence of water damage to the roof and soffit support timbers, with the later exhibiting decay.

23. Wall 4 Water damage and decay to timbers

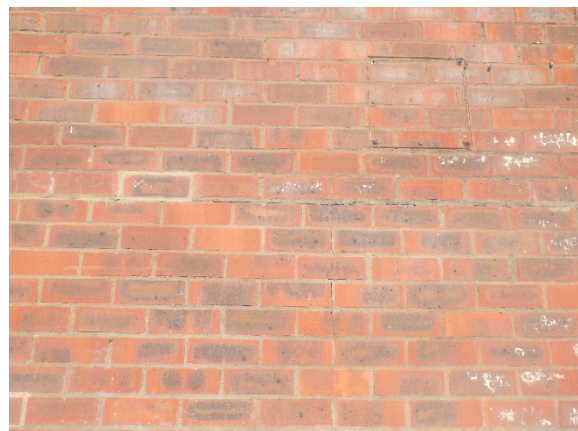
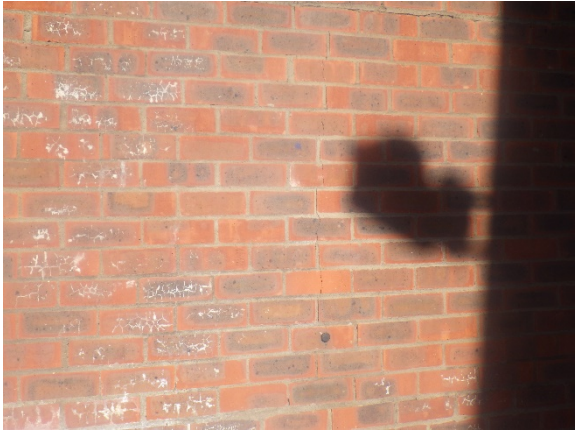
This elevation increases in height from damp proof course as ground levels slope down to the basement entrance doors, from 1.9 metres to 2.55m. There are two vertical fractures seemingly emanating from damp proof course level one extending down 525mm through bricks, the other extending down 975mm, again cracking the bricks. Both fractures are very slight in magnitude and in our opinion most likely the result of thermal movements.

24. Wall 7 Very slightly tapering vertical fracture

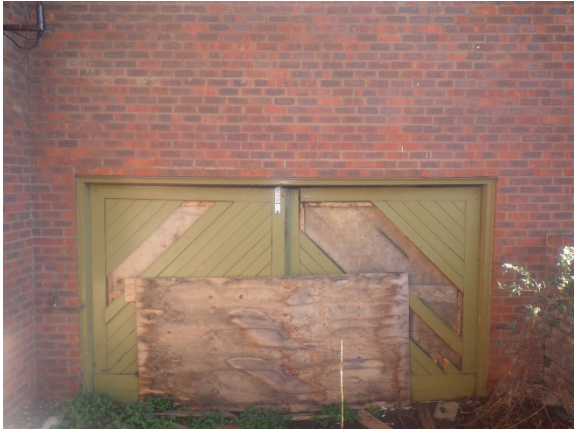
This elevation houses a double door entrance to the basement. There appears to be a concrete lintel with a steel plate supporting the outer leaf. The steel plate exhibits a very slight sag and appears to have tilted forward slightly. The bed joints in the brick courses immediately above have been repointed we suggest due to the deflection in the lintel. The panel above the opening has an area of repointed masonry particularly beneath the upper level window and there is a very slight diagonal stepped fracture above and to the right of the opening, possibly reflecting the very slight sag in the lintel.

26. Wall 8 showing very slight sag to door head

- 6.4 The brickwork over the double door opening to the basement in Wall 8 has been repointed but there is evidence of reopening. We suggest this is due to an over spanned lintel and recommend this is addressed. It may be possible to reinforce the brick panel above, this can be assessed and carried out by a specialist remedial repair company such as Helifx.

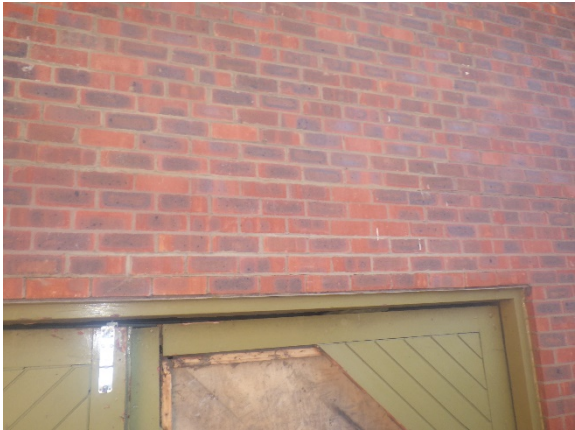
27. Wall 8 Panel over lintel has been repointed

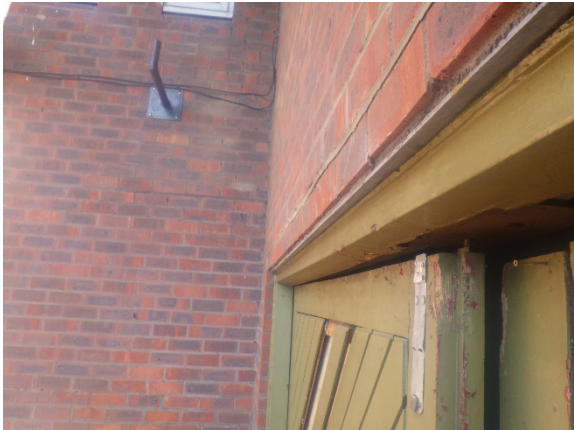
28. Wall 8 Slight lateral displacement in brickwork over

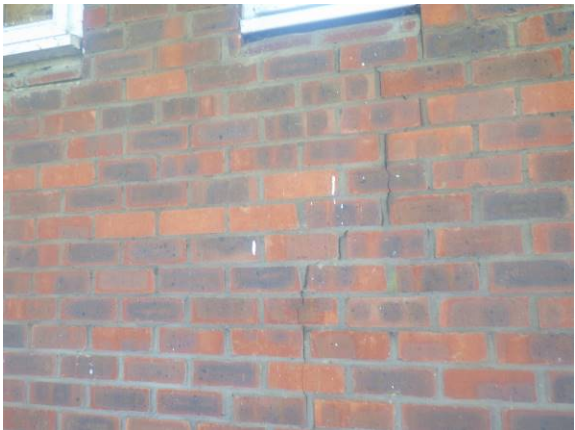
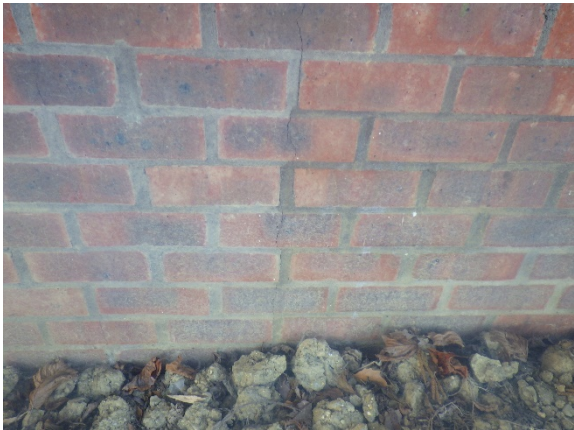
There is a vertical fracture extending below the right hand sill of the northern set of three windows. It is slightly tapering from approximately 1mm wide at the top diminishing to hairline at ground level.

29. Wall 12 Vertical slightly tapering fracture

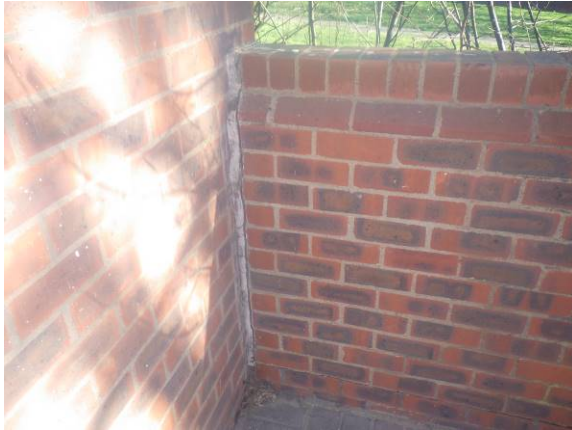
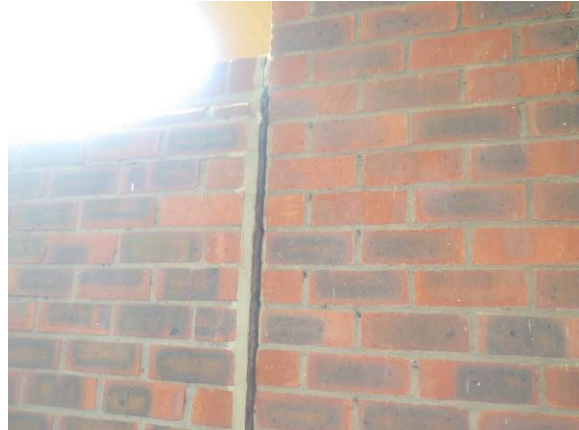
This wall comprises 1 metre high brickwork above the upper patio level and measures 280mm thickness. The wall extends a further 1.2m to 1.65m below the patio as a retaining structure to the adjacent ground levels. The wall has rotated away from its abutment with the building, our measurements suggest the retained element to be approximately 25mm out of vertical at its base with a generally curved profile. There are a number of vegetation clusters growing within 1.5 metres of the wall.

31. Wall A displacement

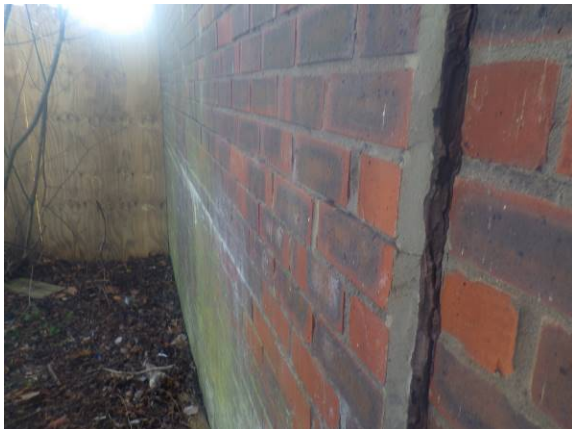
We also note the retaining wall does not have any weep holes to relieve water pressure build up behind the wall. There is also moss and damp staining to the wall at low level.

33. Wall A No weep holes

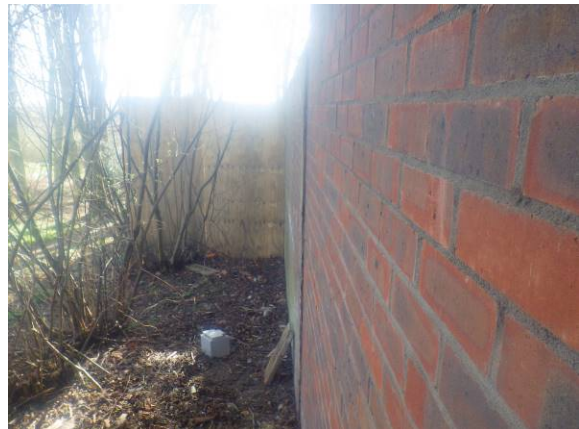
34. Wall A Adjacent vegetation

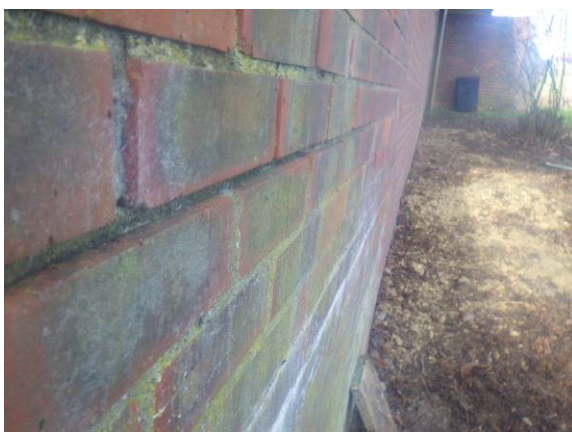
There is a 5mm lateral displacement at the damp proof course level in the brickwork below.

35. Wall A 5mm lateral displacement at dpc level

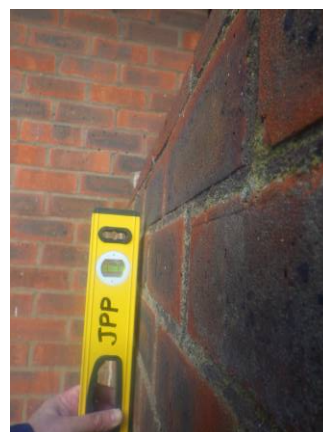
36. Wall A 6mm out of vertical

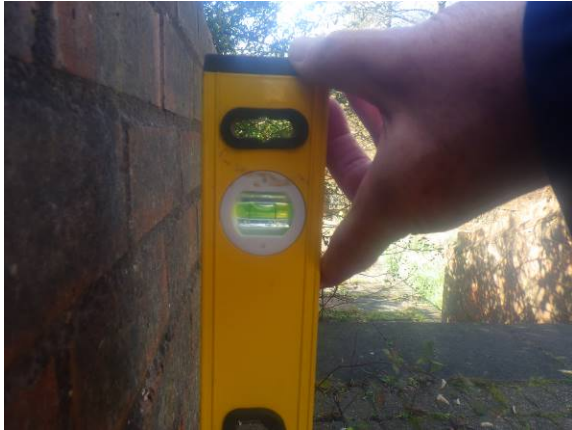
The retaining section of the wall is approximately 30mm out of vertical at its base.

37. Wall B Leaning out of vertical

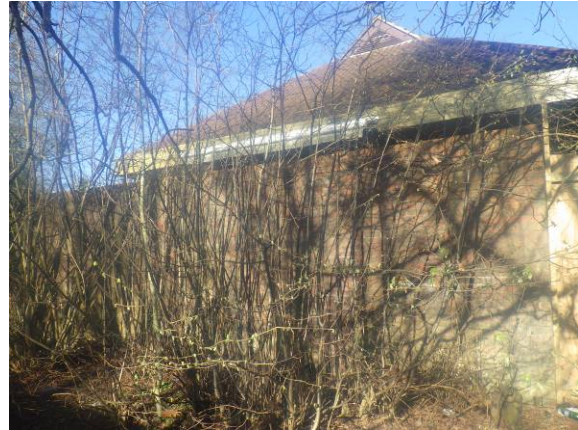
Adjacent to this wall is dense vegetation including brambles. Due to the time of year we are less able to offer suggestions as to their species, suffice to say they appear reasonably established.

38. Wall B Rear face also showing dense vegetation

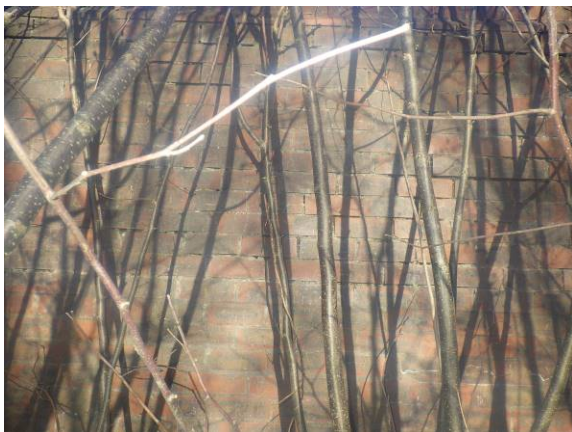
We also note the retaining wall does not have any weep holes to relieve water pressure build up behind the wall. There are also a number of open mortar joints.

39. Wall B Rear face open joints, no weep holes

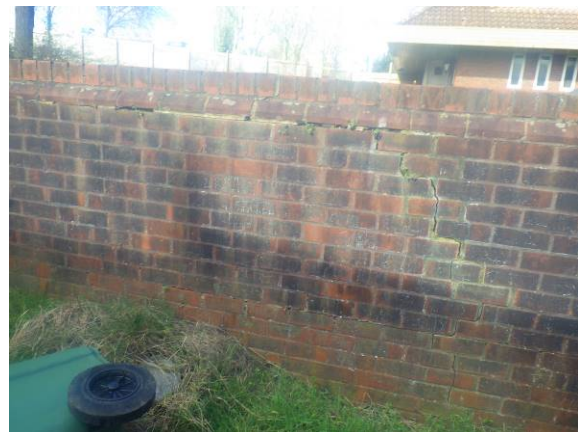
This wall has similar construction to the above, varying from 1.1 metres above ground level to 1.9 metres. At approximately 3.5 metres from the south western end there is a vertical stepped fracture of slightly tapering magnitude from 5mm to 3mm at the base. The wall also falls along its length from this fracture at 1 in 80, having broken its back. The wall also leans out of vertical at 1 in 53, but is still within its middle third.

40. Wall C Tapering stepped fracture

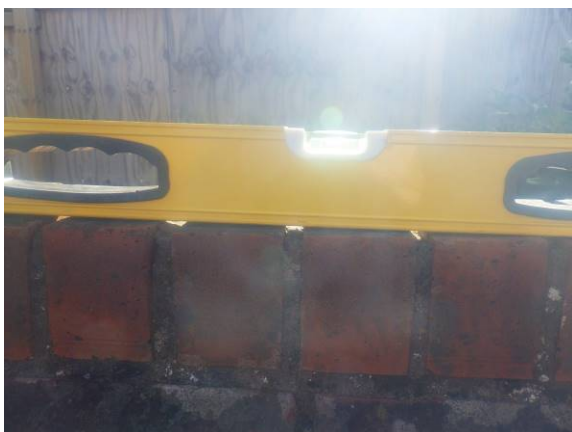
41. Wall C Top of wall falls at 1 in 80

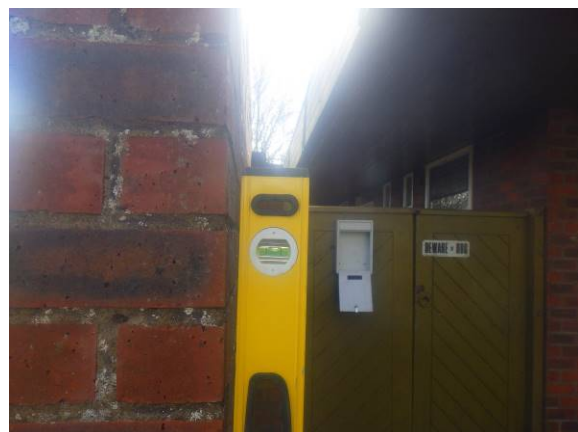
This is a 215mm thick generally freestanding wall, but becoming retaining towards its southern end. The wall has three buttress piers along its length. We noted that the wall leans out of vertical in the order of 35mm, which is on the limit of its stability. The buttress piers will enhance its stability, they appear to be consistent with the age of the wall itself and we therefore consider the whole structure to be leaning out of vertical. This is corroborated by a wide tapering mortar fillet at the southern return vertical abutment with the main building of approximately 65mm diminishing to 50mm.

42. Wall D out of vertical 1 in 61

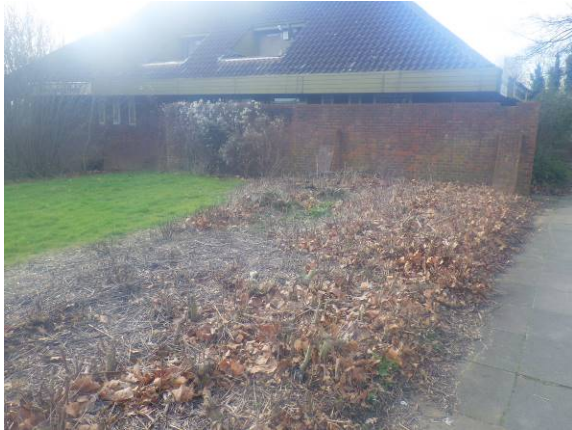
43. Wall D Buttresses and vegetation cut down prior to Spring

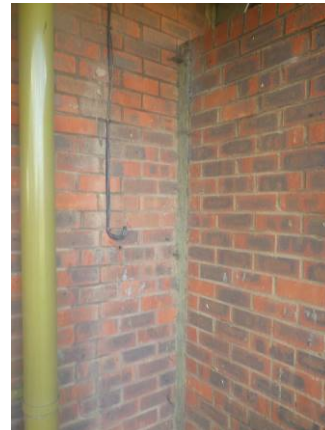
44. Wall D Wide tapering mortar fillet at abutment with building

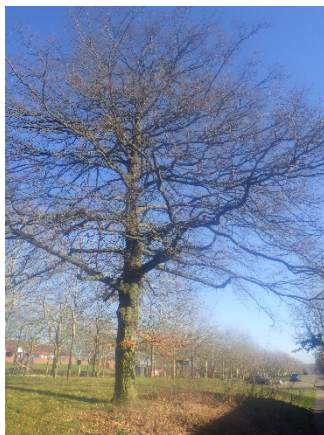
- 5.6 We consider that various of the trees and vegetation will be potentially extending root systems beneath foundation level. Taking the Oak tree for example, in accordance with the NHBC guidelines chapter 4.2 'Building near trees', a high water demand species the tree is located 9 metres away from the building and in theory will be extending roots to a radius of 1.25 x its height. Considering Ash trees to the south eastern corner outside the site boundaries. These are a moderate water demand species growing within 8 metres of the rear corner. In theory they will be extending roots to a distance of 0.75 x their height. Clearly, there are other sources of vegetation growing in closer proximity around the building.

45. Oak tree within 9 metres of Wall 1

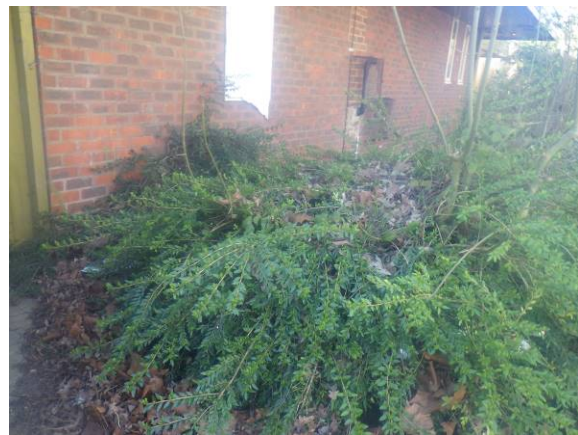
46. Ground covering shrubs adjacent to Wall 1

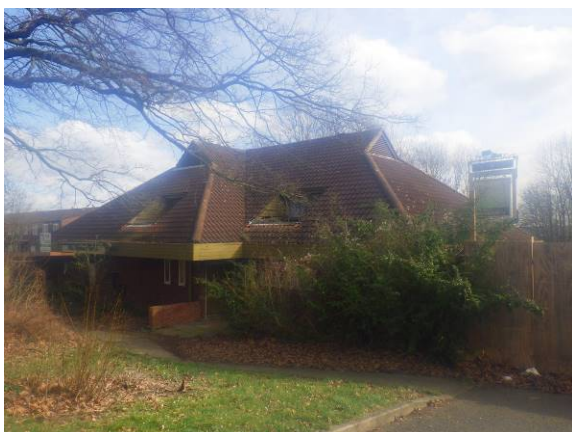
47. Bushes adjacent to Wall 3

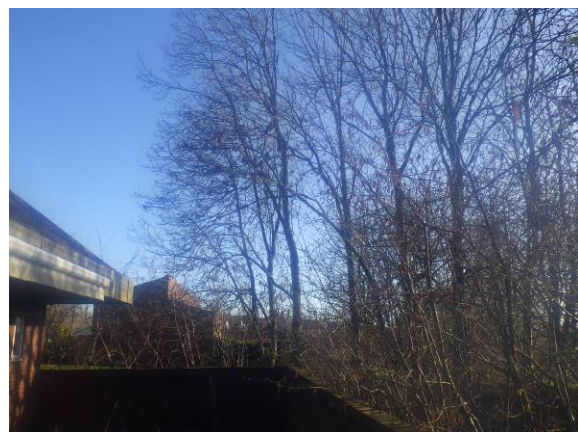
48. Copse of established trees adjacent to Wall A, B. 11 and 12

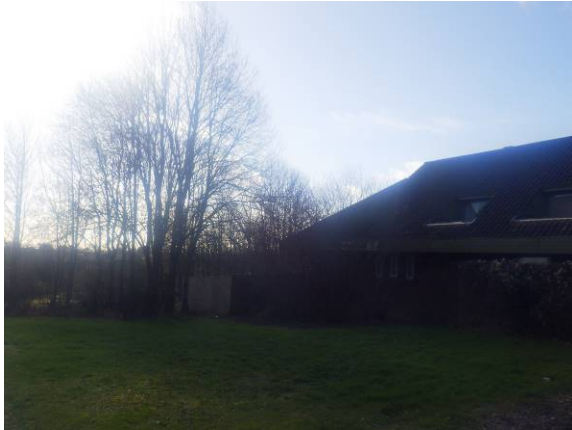
49. Copse of established trees and vegetation adjacent to Wall A, B, 11 and 12

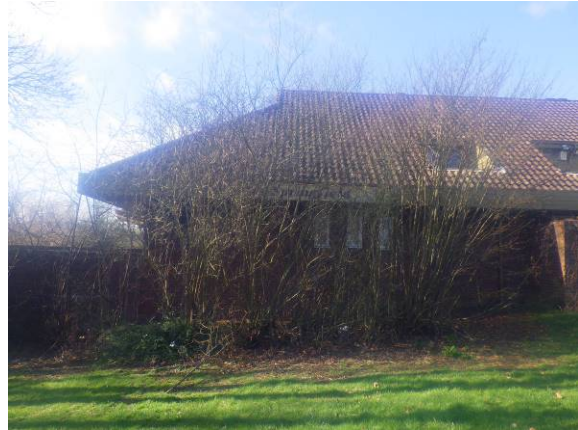
50. Established vegetation adjacent to Wall A and 12
