HIGHWAYS ENGLAND MONITORING RECORD SHEET

SCHEME: A30 Rawridge Hill 241/8 EB (Zone F)	Grid Reference: Start E319772, N104895 End E319844, N104979
--	---

Earthwork ID	6547	
Earthwork Type	Embankment	
Max slope Height (m)	4.3	
Max Slope Angle (°)	60°	
Drainage	Top	Kerb and Gullies and cross carriageway pipes over the edge
	Slope	None
	Base	None

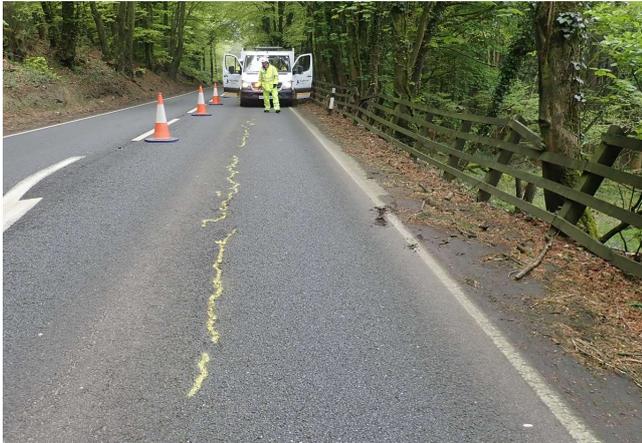
Date	HAGDMS ID	Inspection		Description	Classification	
		Type	Initials		Defect/Location	Risk
01/05/2019	613311	MI	PL/MM	The tension crack remains approximately 18m in length. There are three arcuate cracks less than 1m from the white edge line. These are 30m either side of the clearway sign and are 1m in length (to the West of the sign) and 2m in length (to the East of the sign). The verge is very soft and there are small diameter (<10mm) voids in the verge edge. There is no evidence of movement on the WB carriageway or upslope of EB defect.	1A/A	5

Photo 1 shows the extent of the cracking within the carriageway (looking West).

Date	Inspection Type		Recommendations
	Type	Initials	
05/09/2017	Reactive	EG/SB	Geotechnical Team to register the site as part of the geotechnical monitoring programme and visually monitor on a 6 monthly basis.
01/05/2019	MI	PL/MM	Continue to monitor on a 6 monthly basis. Remember to bring spirit level to measure deflection.

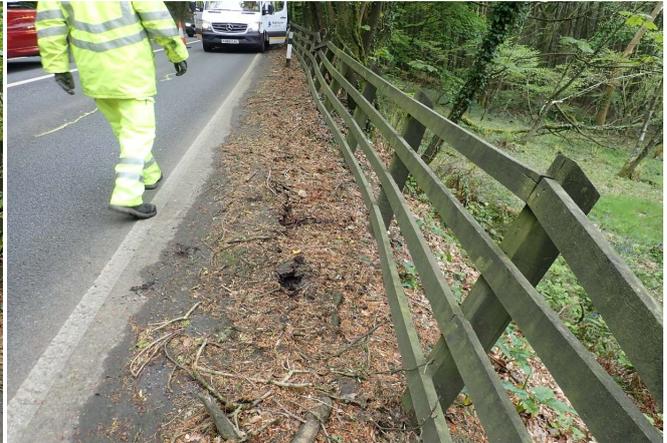
Photo 2 shows the soft verge edge and the fence leaning down slope.
