CLIENT
AFFINITY DESIGN AND
MANAGEMENT LTD

JOB
FABRIC REPAIRS AT
104 - 116 CHURCH STREET
STOKE-ON-TRENT

TITLE
ELEVATIONS AS EXISTING

dwg. no. A (0) 01
Date MARCH 2018
Status TENDER

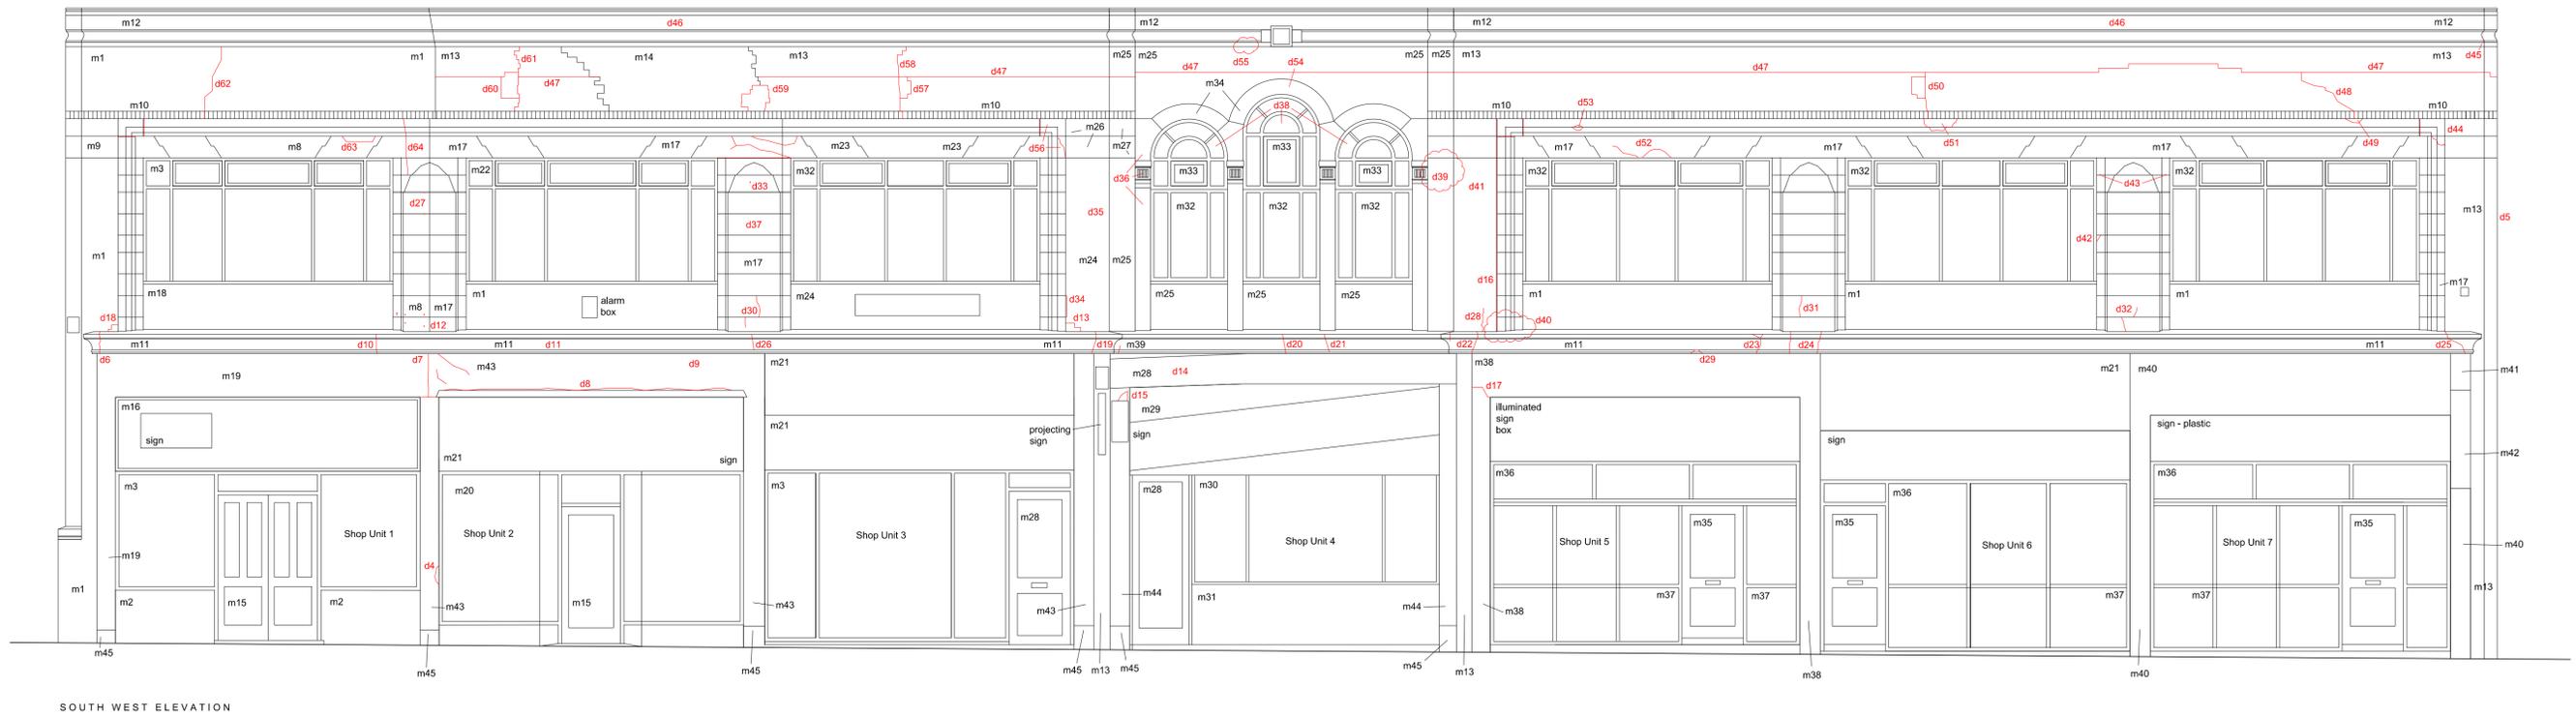
SOUTH WEST ELEVATION

| d1 Fine crack in precast concrete plinth. Action - Test and repair as required | d18 Fracture in brickwork already repaired. Action - Monitor. | d38 The timber framed glazed fanlights are in particularly poor condition. Action - Replace. | d50 Hole in brickwork formed to allow steel to be inspected. Action - Re-state as part of the works |
| d2 Graffiti on plaster. Action - remove or paint over. | d19 Cracks in precast concrete cornice. Action - Test and repair as required. | d39 Vegetation is growing out of the wall in this location and the pointing is poor. Action - Remove vegetation and re-point. | d51 Medium sized area of spalling to precast concrete component. Action - Repair |
| d3 Damaged window sill. Action - seal and redecorate. | d20 Crack in precast concrete cornice. Action - Test and repair as required. | d40 Vegetation is growing on the cornice in this location. Action - Remove vegetation and inspect. | d52 Significant area of cracking and spalling to precast concrete component. Action - Repair |
| d4 Peeling paint to pilaster. Action - repair as part of shop surround repair works. | d21 Crack in precast concrete cornice. Action - Test and repair as required. | d41 The first floor pier between Bay 4 and 5 is beginning to lean out from approximately 600mm below window head level. Action - Consider dismantling this pier and rebuilding with existing components. | d53 Small area of spalling to precast concrete component. Action - Repair |
| d5 Structural movement of this building may be damaging the granite cladding to the adjacent building. Action - Investigate and report to architect. | d22 Cracks in precast concrete cornice. Action - Test and repair as required. | d42 A mortar repair has been carried out to the left edge of the first floor pier between Bays 6 and 7. Action - Inspect and test soundness. | d54 Central arch in Bay 4 has been pushed forward circa 30mm. Action - Dismantle this area and re-build using the salvaged components. |
| d6 Crack in precast concrete cornice. Action - Test and repair as required. | d23 Crack in precast concrete cornice. Action - Test and repair as required. | d43 Screw holes in precast concrete components. Action - fill. | d55 Vegetation is growing on the ledge in this location. Action - Remove vegetation. |
| d7 Cracks at head of right hand pilaster to Shop Unit 1. Probably caused by change of material and/or loose render. Action - repair as part of shop surround repair works. | d24 Cracks in precast concrete cornice. Action - Test and repair as required. | d44 Severe fracture and structural movement to the precast concrete window surround at the top right hand corner of the first floor window to Bay 3. Action - Investigate further, repair and reseat. | d56 Severe fracture and structural movement to the precast concrete window surround at the top right hand corner of the first floor window to Bay 3. Action - Investigate further, repair and reseat. |
| d8 Loose paint, render and flashing to head of Shop Unit 2. Action - repair as part of shop surround repair works. | d25 Crack in precast concrete cornice. Action - Test and repair as required. | d45 Small crack to base of precast concrete capping stone at its corner. Action - Investigate further and repair. | d57 Hole in brickwork formed to allow steel to be inspected. Action - Re-state as part of the works |
| d9 Loose point and damaged render at head of Shop Unit 2. Action - repair as part of shop surround repair works. | d26 Fine crack in precast concrete cornice. Action - Test and repair as required. | d46 The pointing between the precast concrete capping components is generally poor. Action - Improve as part of the works | d58 Crack in brickwork. Action - Improve as part of the works |
| d10 Fine crack in precast concrete cornice. Action - Test and repair as required. | d27 Fine cracks in precast concrete components. Action - fill. | d47 There is a horizontal fracture in the parapet brickwork that lines up with the roof behind. The high level masonry has been pushed out forward of the parapet up to 30mm in places. It is believed that this has been caused by rusting steelwork. Action - carefully dismantle high level masonry as required and re-assemble using existing reclaimed bricks and concrete components. | d59 Hole in brickwork formed to allow steel to be inspected. Action - Re-state as part of the works |
| d11 Loose paint to precast concrete cornice generally. Action - repair as part of shop surround repair works. | d28 Fracture in brickwork. Action - cut out and replace broken bricks and re-point. | d48 Crack in brickwork. Action - Improve as part of the works | d60 Hole in brickwork formed to allow steel to be inspected. Action - Re-state as part of the works |
| d12 Screw holes in precast concrete components. Action - fill. | d29 Crack to underside of precast concrete cornice previously repaired. Action - Test and repair as required. | d49 Small area of spalling to precast concrete component. Action - Repair | d61 Crack in brickwork. Action - Improve as part of the works |
| d13 Fracture in brickwork. Action - cut out and replace broken bricks and re-point. | d30 Fine cracks in precast concrete component. Action - Test and repair as required. | | d62 Crack in brickwork that has been repaired. Previous structural movement is evident but does not appear to have reoccurred. Action - Improve as part of the works |
| d14 Fascia cladding dislodged. Action - replace as part of shop surround repair works. | d31 Fine cracks in precast concrete component. Action - Test and repair as required. | | d63 Area of spalling to precast concrete window surround that has been previously repaired. Action - Test and repair as required. |
| d15 Damaged render to left hand pilaster of Shop Unit 4 at high level. Action - replace as part of shop surround repair works. | d32 Fine cracks in precast concrete component. Action - Test and repair as required. | | d64 Crack to precast concrete window surround that has been previously repaired. Action - Test and repair as required. |
| d16 Widened joint caused by structural movement. Action - re-point and monitor | d33 Screw holes in precast concrete components. Action - fill. | | |
| d17 Damaged tiling to left hand pilaster of Shop Unit 5 at high level. Action - replace as part of shop surround repair works. | d34 Fill to opened up joint fallen away. Action - re-point. | | |
| | d35 Pointing to brickwork particularly bad in this area. Action - re-point. | | |
| | d36 Pointwork to arches in poor condition and obscuring detail. Action - remove paint and redecorate. | | |
| | d37 The first floor pier between Bay 2 and 3 leans significantly. Action - Consider dismantling this pier and rebuilding with existing components. | | |
