TASK NO.	TASK/DESCRIPTION	NOTES
	H4 EXTERNAL DOORS, OPENINGS AND HATCHES	
H4.01	<p>CASEVAC Hatch</p>

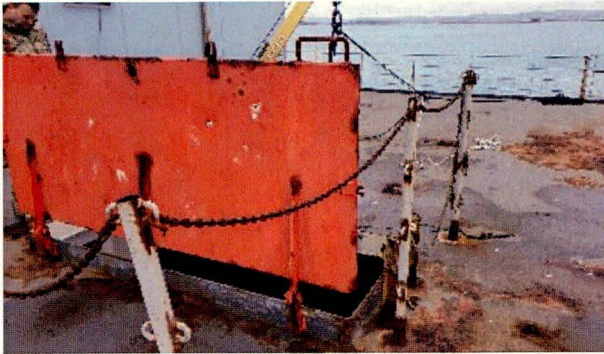
<p>The CASEVAC hatch located fwd on the vehicle deck is stiff to open and the hold-back facility inoperative. REMOVE and REFURBISH Vehicle deck CASEVAC hatch and hold back facility. REPRESENT all affected areas on completion. ALLOW for 4m² REPRESENTATION.</p>	<p>Hotwork Required – Appropriate precautions to be taken iaw General 8.4.</p> <p>IAW Paint scheme -General 12 and Annex B refer.</p> <p>To be completed in conjunction with H3.02.</p>

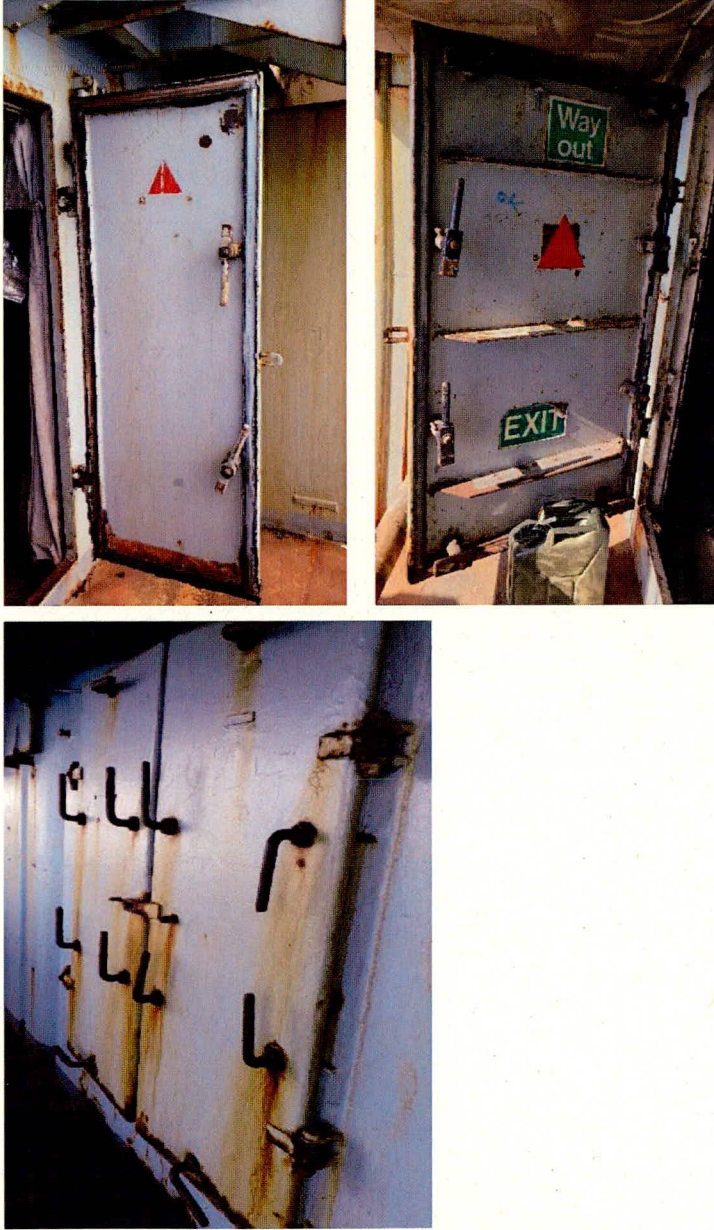
TASK NO.	TASK/DESCRIPTION	NOTES
	H4 EXTERNAL DOORS, OPENINGS AND HATCHES	
H4.03	<p>Upper Deck Doors</p>

<p>Many upper deck doors are seized or stiff to move with no ability to securely close. REFURBISH doors to include renewal of rubber seals and repair any excessively corroded areas. All clips to be freed up and greased, or RENEWED if beyond repair. Doors will be placed in priority order with list provided to the Contractor prior to RPSD. REPRESENTATION on completion of any required work.</p> <p>ALLOW for 30 doors. ALLOW for 60m² REPRESENTATION.</p>	<p>Awaiting Escape, Evacuation and Rescue report to aid priority listing.</p> <p>IAW Paint scheme -General 12 and Annex B refer.</p>

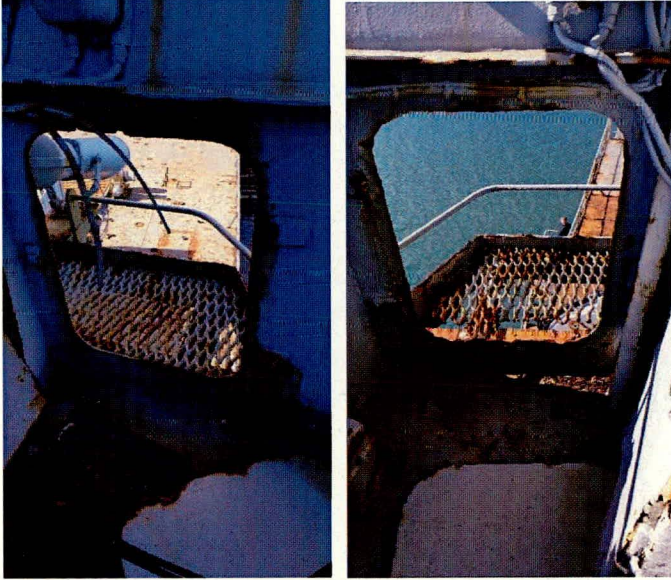
TASK NO.	TASK/DESCRIPTION	NOTES
	H4 EXTERNAL DOORS, OPENINGS AND HATCHES	
H4.04	<p>Bridge Wing Access Panels to Light Boom</p>

<p>Port and stbd bridge wing access doors to flight lighting booms have both suffered excessive corrosion on hinges resulting in doors becoming detached. RENEW door hinges and refit doors. REPRESENT on completion.</p> <p>ALLOW for 4m² REPRESENTATION.</p>	<p>Hotwork Required – Appropriate precautions to be taken iaw General 8.4.</p> <p>IAW Paint scheme -General 12 and Annex B refer.</p> <p>To be completed in conjunction with H2.15 and H3.05.</p>

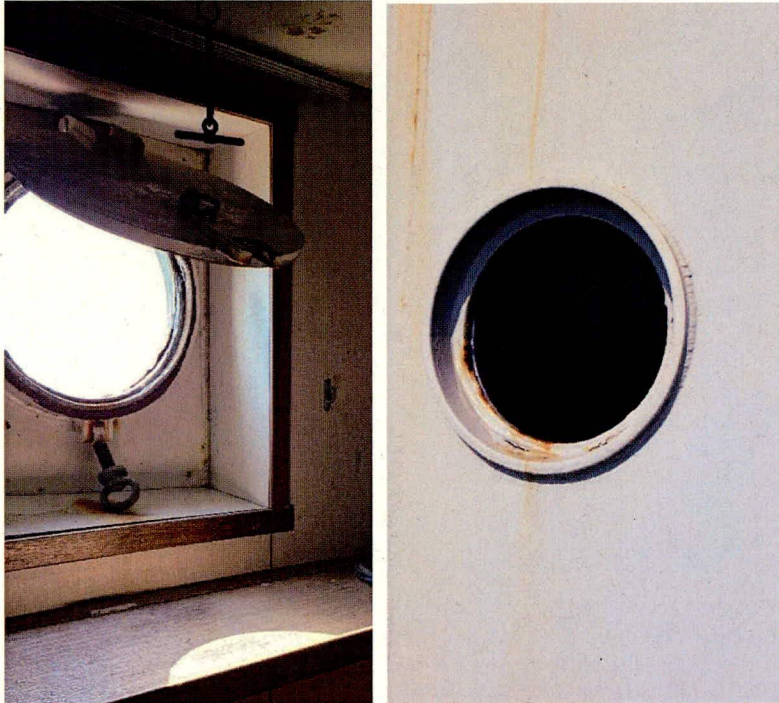
TASK NO.	TASK/DESCRIPTION	NOTES
	H4 EXTERNAL DOORS, OPENINGS AND HATCHES	
H4.05	<p>Cabin Porthole</p> <div data-bbox="406 436 1189 1137">

</div> <p>Cabin 01Z0 porthole flap is seized open and porthole glass has become detached leaving an opening for rain ingress. Hinged flap to be freed up and sealed shut with appropriate weatherproof sealant.</p>

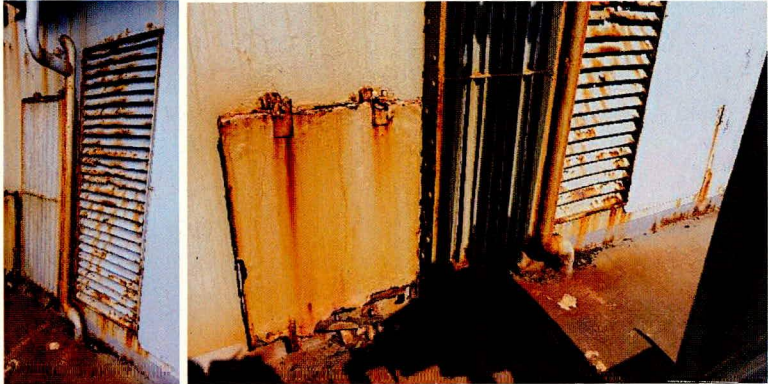
TASK NO.	TASK/DESCRIPTION	NOTES
	H4 EXTERNAL DOORS, OPENINGS AND HATCHES	
H4.06	<p>Upper Deck Intakes and Watertight Openings</p>

<p>Numerous upper deck vent grills and hinged watertight openings have corroded beyond repair. Steel blanks to be manufactured and used to REPLACE existing openings. Relevant openings will be identified prior to Refit start date. PRESERVE on completion.</p> <p>ALLOW for 15 openings. ALLOW for 45m² REPRESENTATION.</p>	<p>Hotwork Required – Appropriate precautions to be taken iaw General 8.4.</p> <p>Iaw Paint scheme -General 12 and Annex B refer.</p>

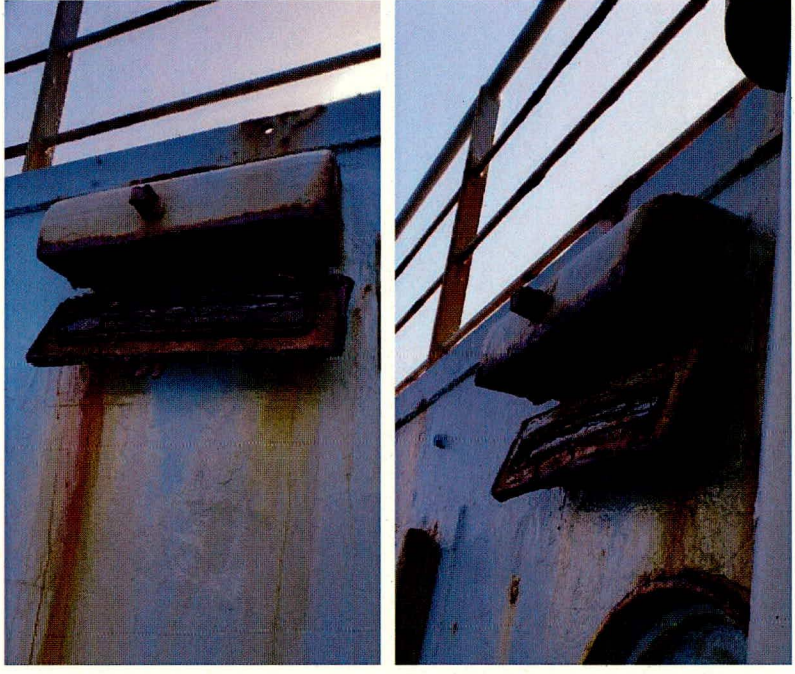
TASK NO.	TASK/DESCRIPTION	NOTES
	H4 EXTERNAL DOORS, OPENINGS AND HATCHES	
H4.07	<p>Natural Vent Covers</p>

<p>01 deck stbd side. 4 in number vent openings heavily corroded with full thickness rust penetration. All 4 openings to be REMOVED, with blanks welded in place. Area to be REPRESENTED on completion.</p> <p>ALLOW for 4m² REPRESENTATION.</p>	<p>Hotwork Required – Appropriate precautions to be taken iaw General 8.4.</p> <p>IAW Paint scheme -General 12 and Annex B refer.</p> <p>Contractor to dispose of removed items.</p>

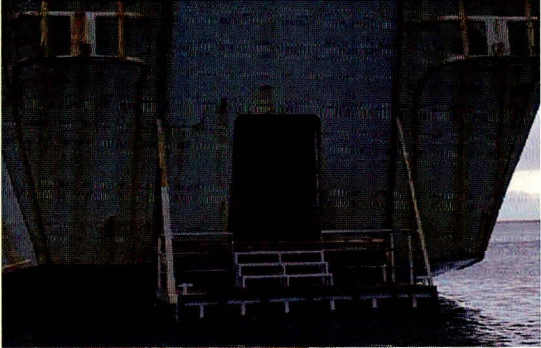
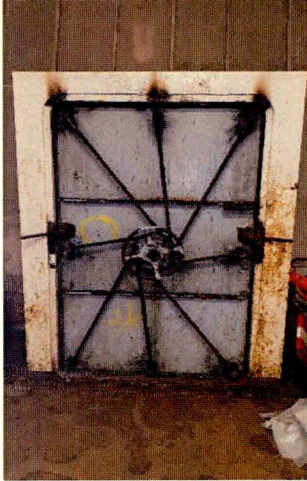
TASK NO.	TASK/DESCRIPTION	NOTES
	H4 EXTERNAL DOORS, OPENINGS AND HATCHES	
H4.08	<p data-bbox="400 389 842 418">Transom Access Door and Deck</p> <div data-bbox="400 432 943 777">

</div> <p data-bbox="400 1272 1214 1473">Transom door closing mechanism is worn and regularly seizes, door does not seal properly (daylight can be seen through sealing faces when closed). Remove and REFURBISH door – to include new door seal. Platform support brackets and door frame have paint coating breakdown with active corrosion evident. REPRESENT affected areas. Chalk test to be carried out once door is refitted and door adjusted accordingly.</p> <p data-bbox="400 1487 1214 1547">Note: Wooden blank to be manufactured and fitted in place of rear door whilst REFURBISHMENT of door taking place.</p> <p data-bbox="400 1561 842 1590">ALLOW for 10m² REPRESENTATION.</p>	<p data-bbox="1251 389 1437 533">Wooden blank to be fitted whilst door is being REFURBISHED.</p> <p data-bbox="1251 562 1449 734">Hotwork Required – Appropriate precautions to be taken iaw General 8.4.</p> <p data-bbox="1251 763 1449 875">IAW Paint scheme -General 12 and Annex B refer.</p>

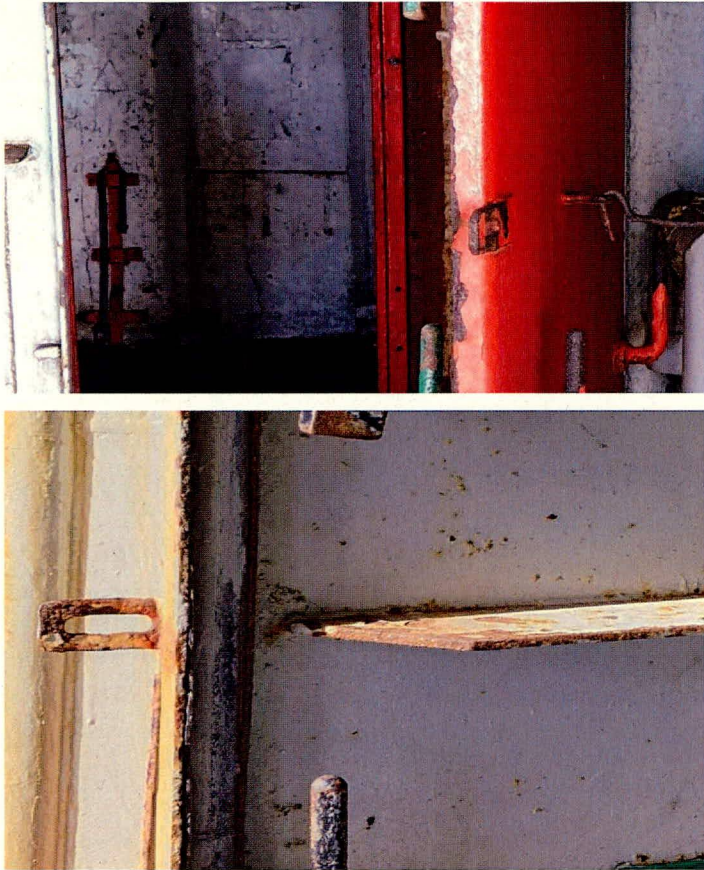
TASK NO.	TASK/DESCRIPTION	NOTES
	H4 EXTERNAL DOORS, OPENINGS AND HATCHES	
H4.09	<p>Door Locking Arrangements</p>

<p>Upper deck door locking arrangements are seized in numerous locations. Contractor is to free up /RENEW hasp and staple fittings on all associated doors as required. REPRESENT on completion.</p> <p>ALLOW for 7m² REPRESENTATION. ALLOW for 23 doors.</p>	<p>Hotwork Required – Appropriate precautions to be taken iaw General 8.4.</p> <p>IAW Paint scheme -General 12 and Annex B refer.</p>
