BELLS FIELD RECREATION AREA COLEFORD FOREST OF DEAN

Project:
BELLS FIELD, COLEFORD

ECOLOGICAL APPRAISAL

Tree Survey & Hazard Assessment COLEFORD, GLOUCESTERSHIRE:

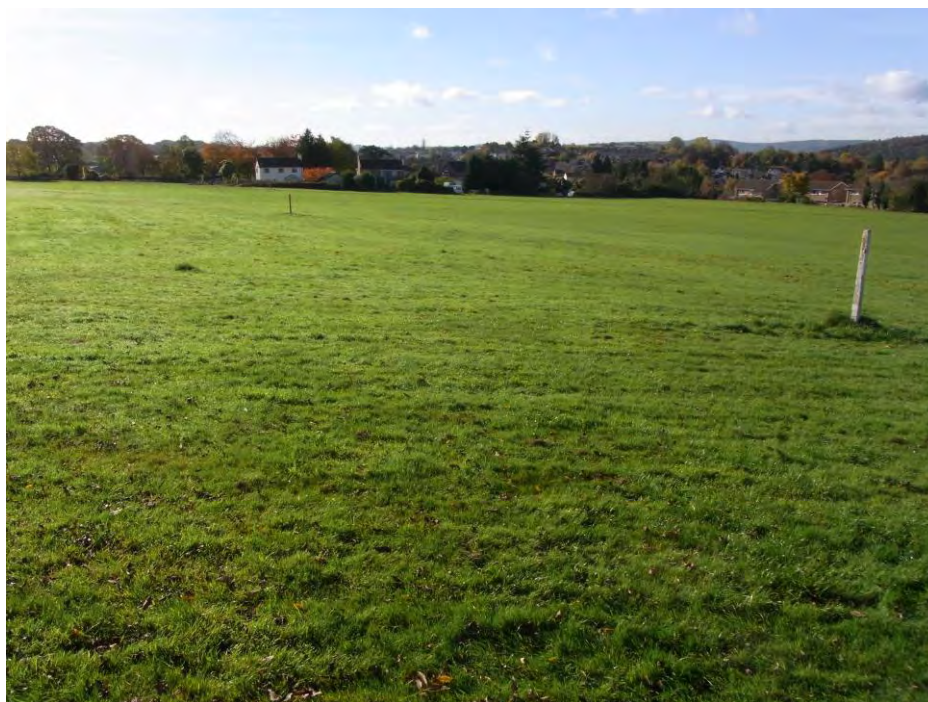
- 3.5 The site is occupied by grassland at [1] that was formerly used as a sports field. It consists of a species-poor sward over much of its area (Figure 1, overleaf), being dominated by perennial rye-grass *Lolium perenne* and red fescue *Festuca rubra* with dandelion *Taraxacum* agg., daisy *Bellis perennis* and greater plantain *Plantago major* being present along the more disturbed or heavily-worn pathways. The grassland is classified as semi-improved neutral grassland on account of the species present and the past use. The area is mown and cuttings left in situ.

Figure 1: Grassland at [1].

- 4.5 Where possible, it is recommended that examples of the sward in the eastern part of the site are retained and protected from disturbance and damage during the course of the works rather than removed and re-seeded after the works are complete. Longer term, it would be beneficial to manage the grassland by mowing and removing the arisings, either taking them off-site or creating a specific composting area in a location on the site boundary. Such a feature could provide a suitable egg-laying area for grass snake and provide habitat for other wildlife.

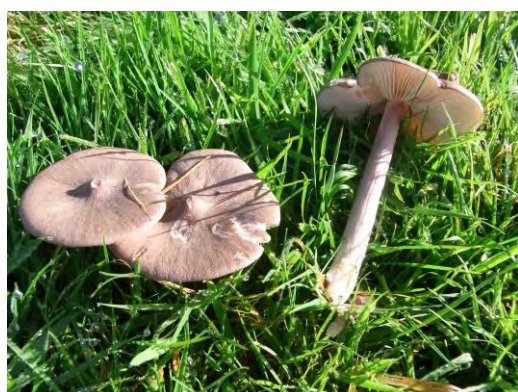
Holcus lanatus and the moss *Rhytidiadelphus squarrosus*. The waxcap *Hygrocybe virginea* and the agaric *Entoloma porphyrophaeum* (Figure 2) were also recorded, the latter in some abundance.

Figure 2: The fungus *Entoloma porphyrophaeum* in grassland at [1].

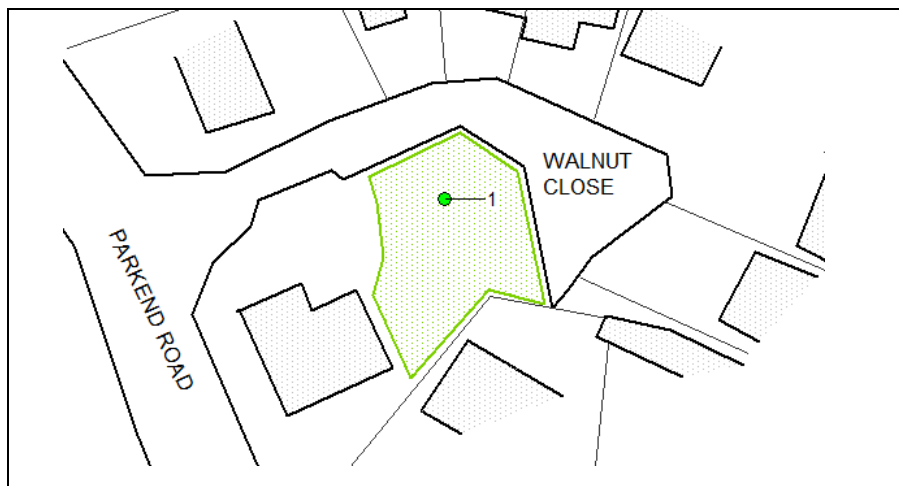
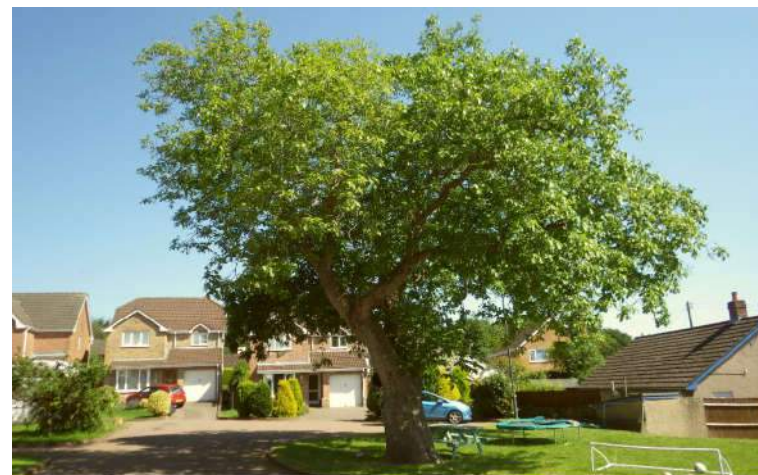
Walnut Close, Coalway

A single tree present:

D no.	Species	Height	Diameter	Maturity	Form	Target Status	Condition	General Notes &/or, Defect type <i>[If M or H]</i>	Hazard Magnitude	Probability of Failure	Recommended action	Priority
1	Walnut	M	L	LM	Std	3	M	This is an important, local landmark tree; healthy & vigorous but extensively hollow, in main stem and in certain limbs. As can be seen in the photo above, the area under is well used (in clement weather anyway). The tree currently appears to be generally stable but it must be appreciated that at some point a branch <i>will</i> fail. This is most likely to occur in bad weather when the land under is least likely to be occupied. However <i>absolute safety cannot be assured</i> . In view of the significance of the tree it is suggested that residents' opinions be sought regarding its future management.	3	2	Options: 1) Retain with due caution [avoid stormy conditions] 2) Carry out a 15-20% crown reduction. 3) Fell The planting of a replacement trees should be carried out at the first opportunity	2
