**Denver Sluice House/Denver Bungalow  
Denver Sluice/Denver Sluice  
Downham Market/Downham Market  
PE38 0EG/PE38 0EG**

**Environment Agency**

**External and Internal Building Repair Works**

**28 November 2022**

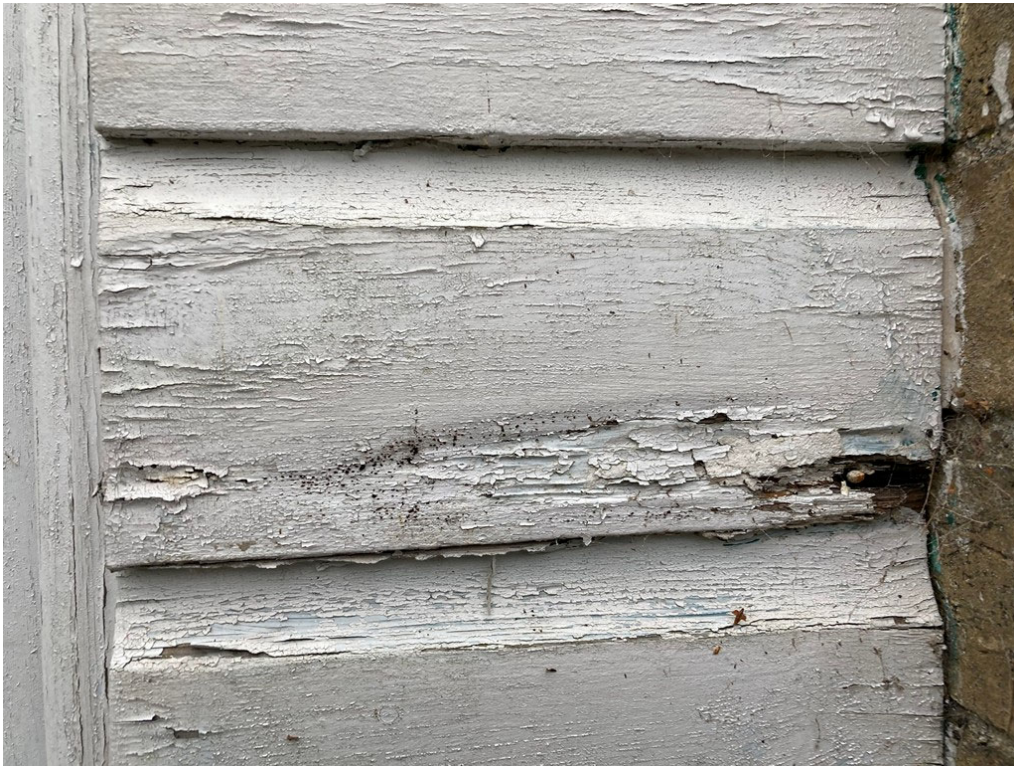
**Double timber doors and cladding surround (1)**

| Ref. | Description | £ | p |
|---|---|---|---|
| 4.2.3 | Carefully remove the double timber doors at the rear of the property. Remove any loose matter to the doors and the cladded area, rub down all to a smooth even surface. Fill all joints cracks and holes using exterior grade filler. Ensure surfaces are clean and dry to a sufficient depth. Any parts of the door/cladding that are affected with wet rot, should be carefully removed and repaired using an epoxy filler. The threshold bar which has decayed should be removed and discarded and replaced with a new hardwood threshold bar to match existing. Apply a single coat of Dulux Weathershield Stabilising Primer using a paintbrush, allow the primer to dry for four hours, before applying Dulux Weather Shield Satin wood (Colour to be agreed with the C.A). Allow for a minimum of two coats and apply according to the manufacturers instructions. Paintwork should not be applied in damp conditions. Finished paintwork must be a smooth surface with relevant finish, free from runs, debris or other blemishes. All in accordance with manufacturer's guidance. | | |

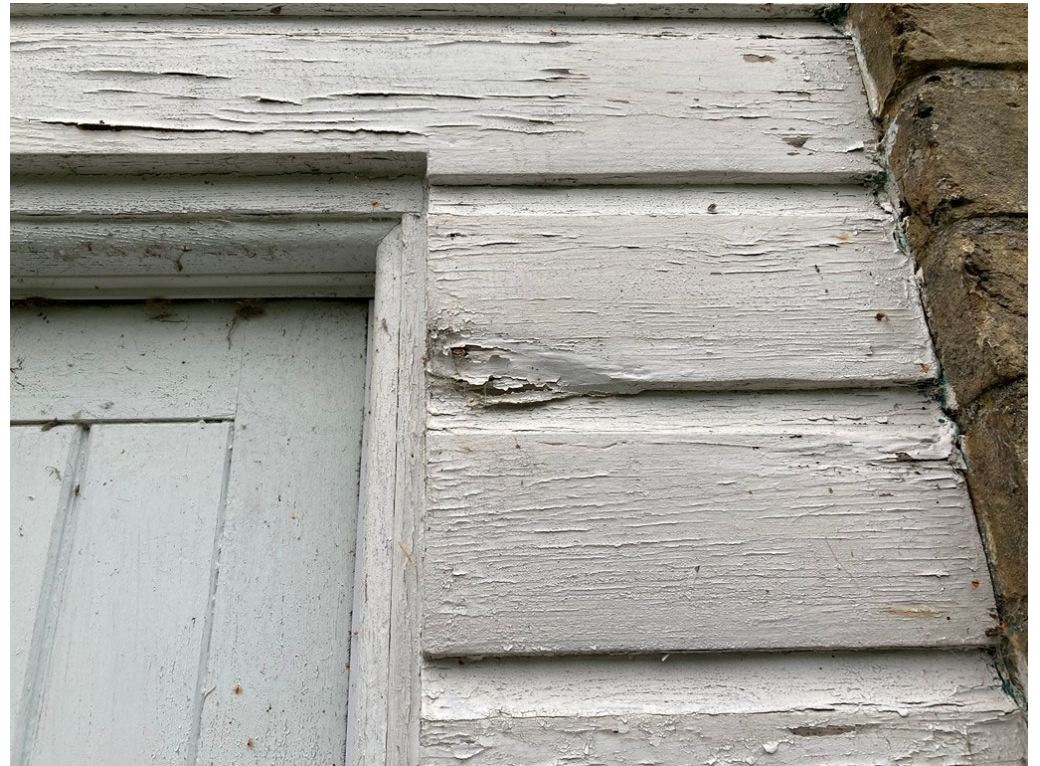
**Double timber doors and cladding surround (2)**

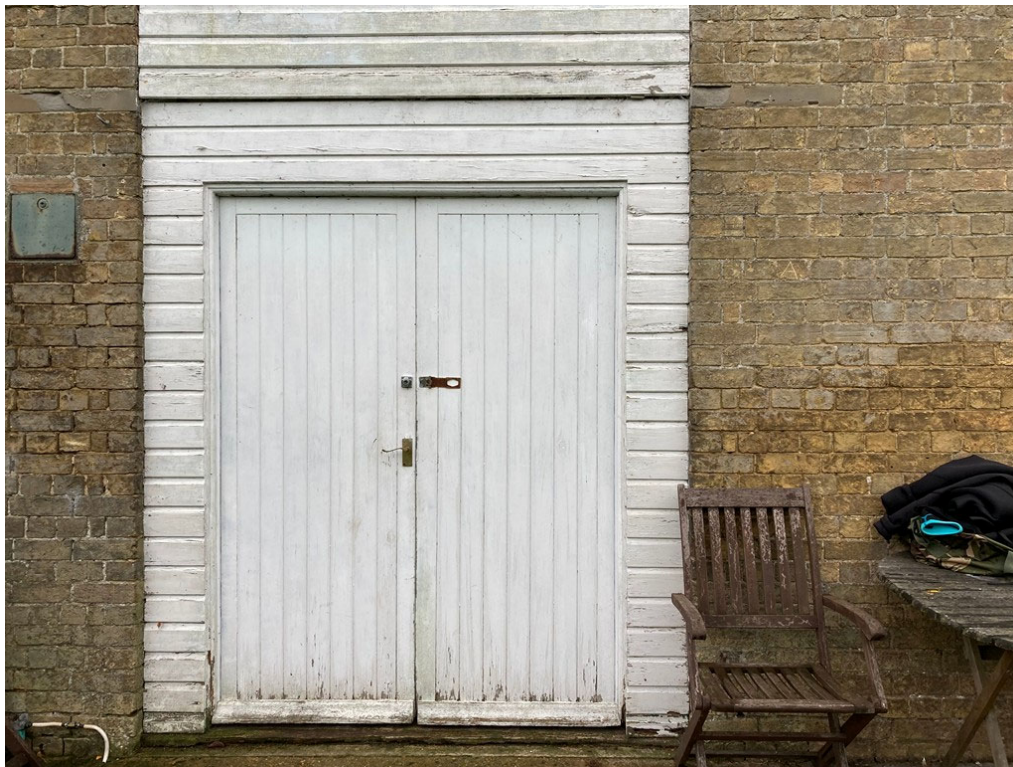
**Double timber doors and cladding surround**

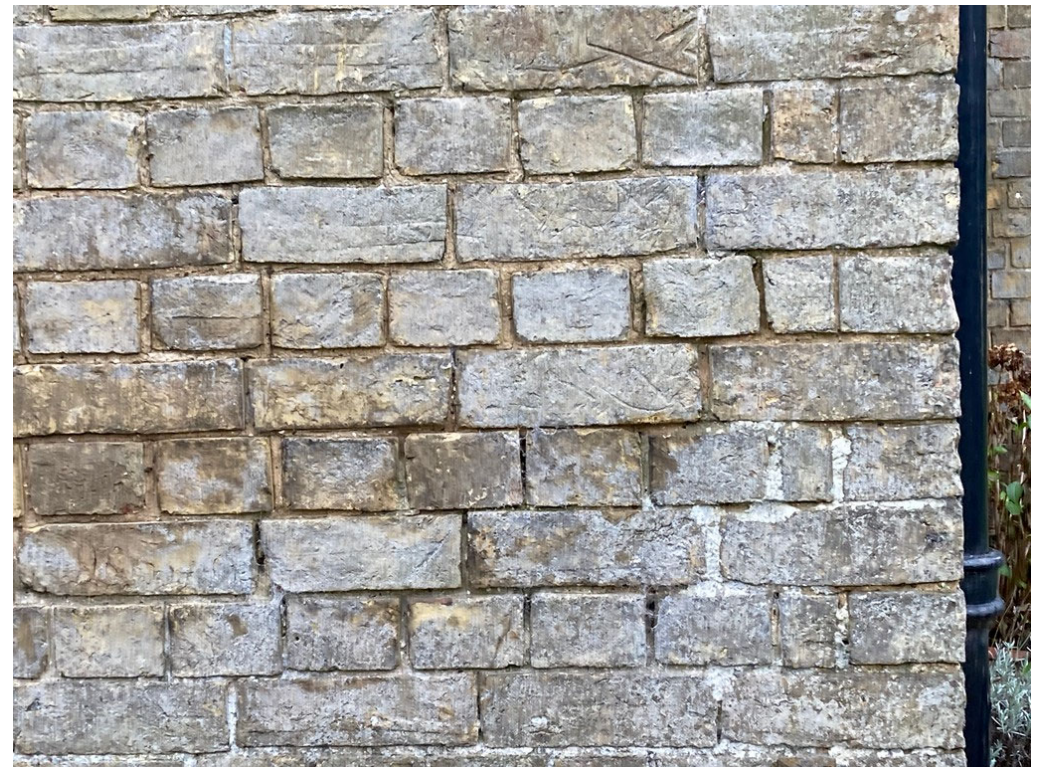
**Example of area in need of repointing**

| Ref. | Description | £ | p |
|---|---|---|---|
| 4.1.2 | Mortar bed joints and perps, at areas agreed with the C.A should be raked out to a minimum depth of 25mm (ensuring the depth is consistent) and the joints brushed out to remove dust and debris. All areas which have been raked out should be re-pointed to a bucket handle finish using the recommended mortar mix as per the Lime Centre guidance. Mortar should be well compacted, ensuring no voids are present. Lightly spray the wall with water prior to re-pointing. Ensure the newly re-pointed brickwork is brushed down with a soft brush at regular intervals. Allow for 50M2 of isolated areas of re-pointing. | | |

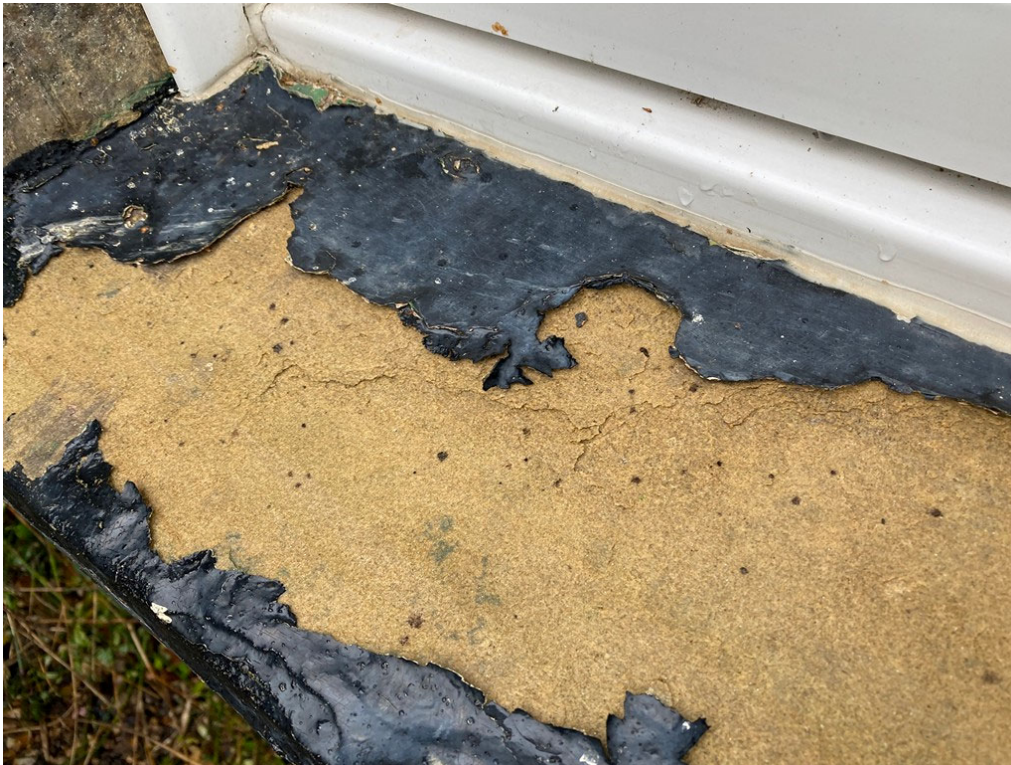
**Example of stone sill**

| Ref. | Description | £ | p |
|---|---|---|---|
| 4.2.2 | Remove all old flaking paint to the stone sills, sand down all stone sills using a coarse sandpaper and ensure that the sills are smooth. Fill any gaps or dents in the window sills using Toupret Exterior Masonry Repair Filler (or similar C.A approved), following the manufacturers instructions for use. If there are any areas of algae, lichen, mould or moss , use a suitable fungicidal wash and treat the area. Allow the treated area to dry before applying a single coat of Dulux Weathershield Stabilising Primer using a paintbrush, allow the primer to dry for four hours, before applying Dulux Weather Shield Smooth Masonry Paint (Colour to be agreed with the C.A). Allow for two coats and apply according to the manufacturers instructions. Once dry remove the masking tape. Finished paintwork must be a smooth surface with relevant finish, free from runs, debris or other blemishes. All in accordance with manufacturer's guidance | | |

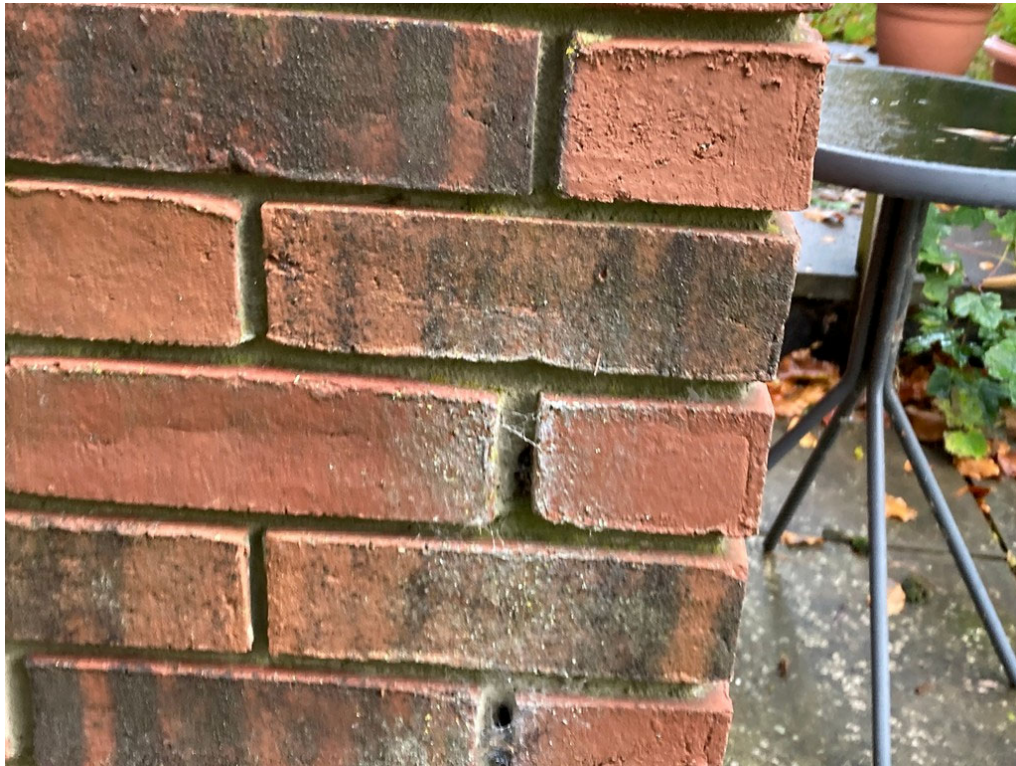
**Example of area in need of repointing**

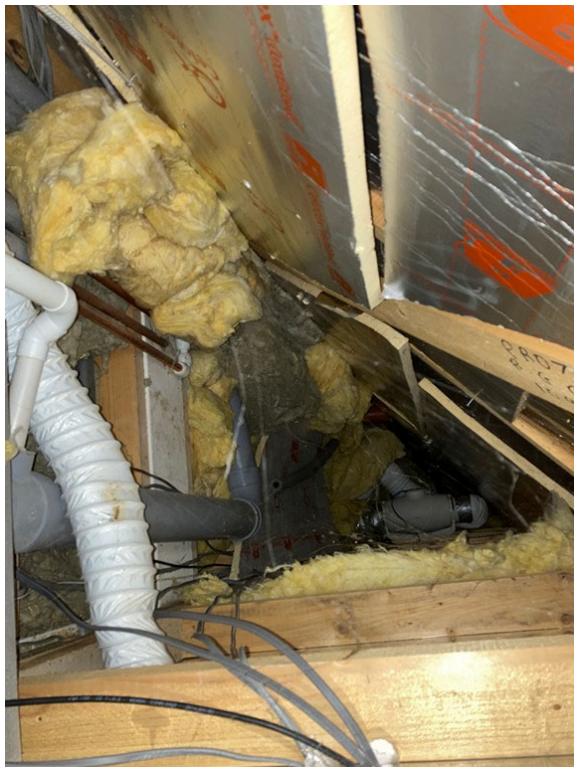
**Insulation in eaves space (2)**

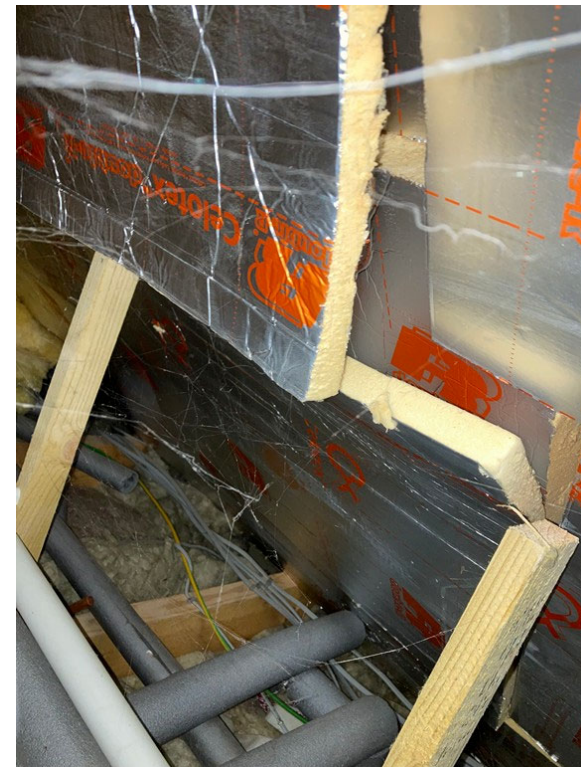
**Insulation in eaves space (3)**

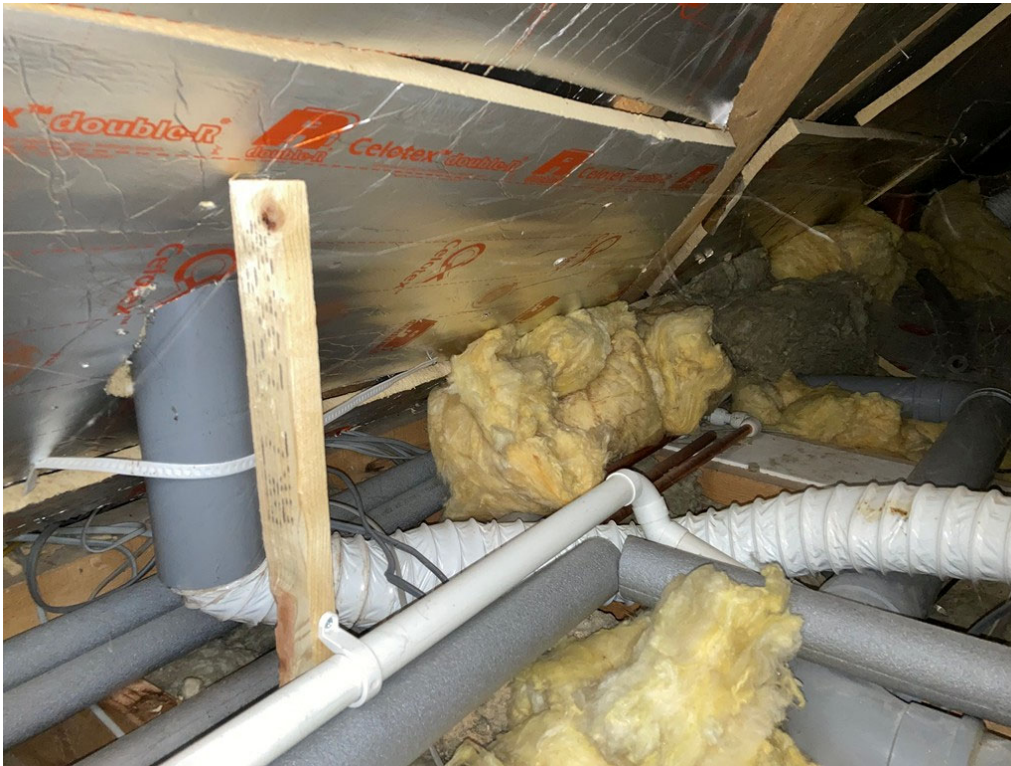
**Insulation in eaves space**

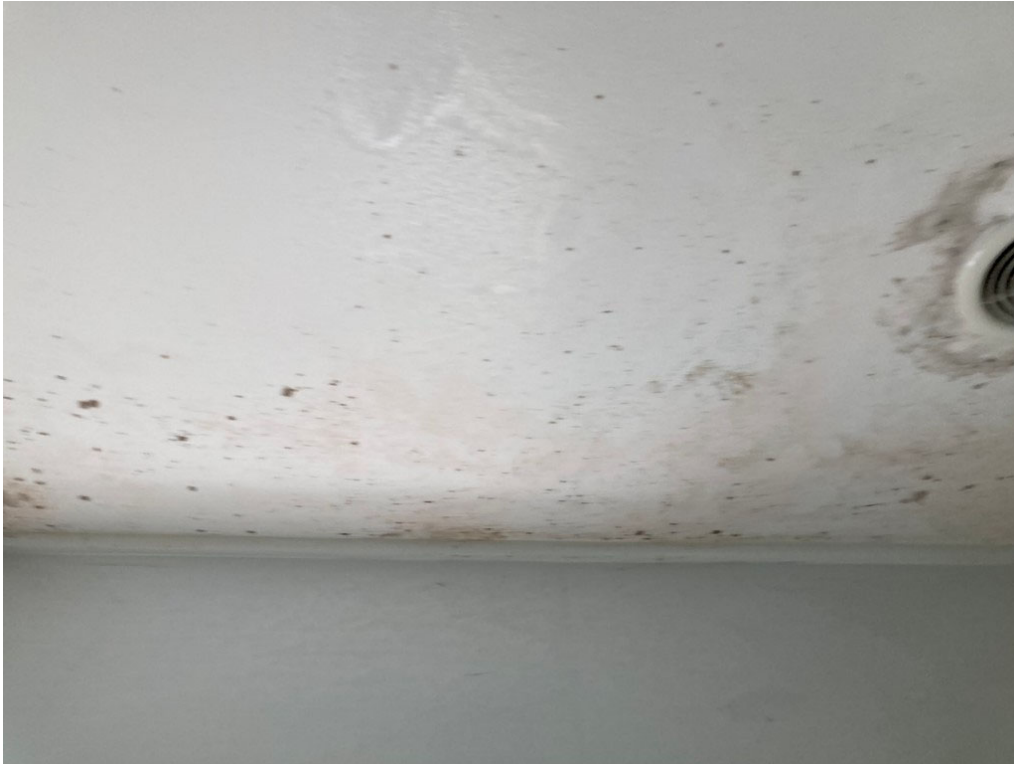
**Mould growth in bathroom (2)**

| Ref. | Description | £ | p |
|---|---|---|---|
| 4.3.1 | Prepare all bathroom and bedroom surfaces for decoration. Remove loose and flaking paint by scraping and brushing down, sanding where necessary. Clean down the mould affected areas with warm soapy water, using sparingly to ensure the areas are not saturated. Use an anti-fungal wash to clean down the mould affected areas and allow to dry. | | |

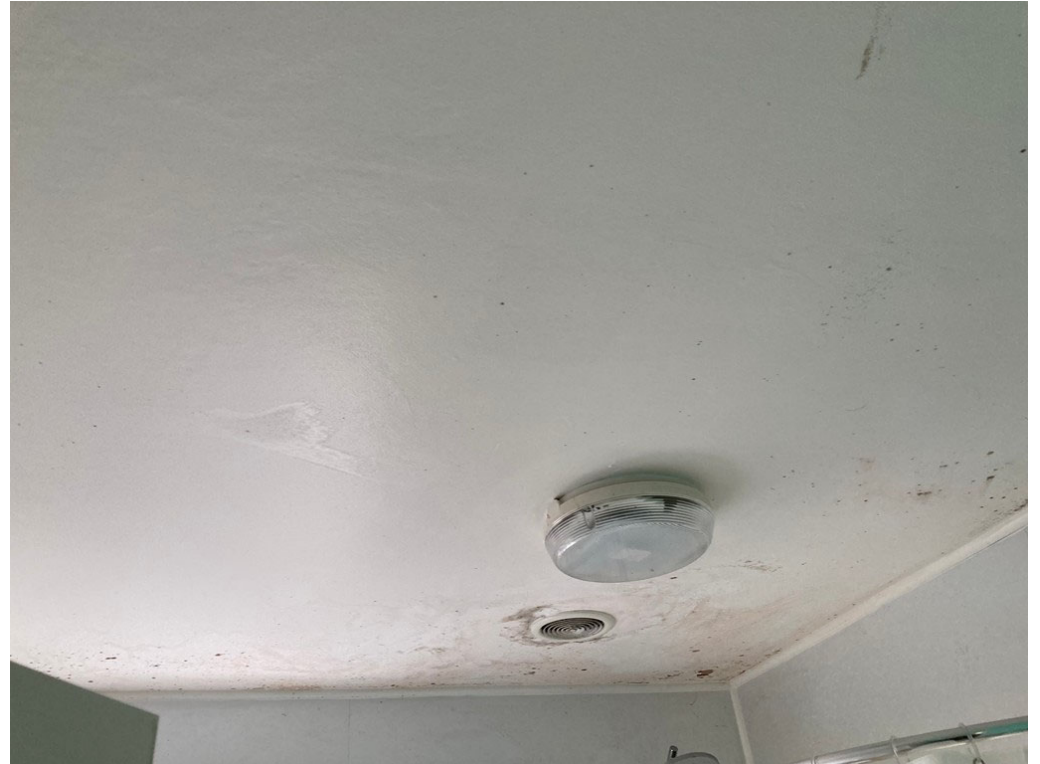
**Mould growth in bathroom (3)**

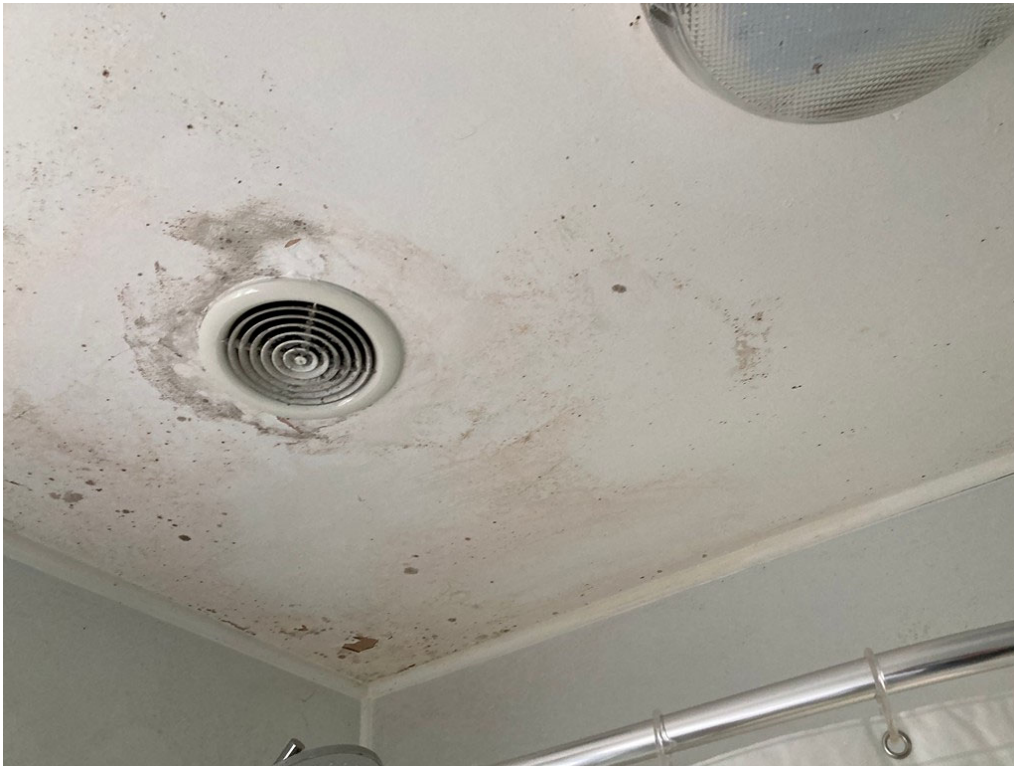
**Mould growth in bathroom**

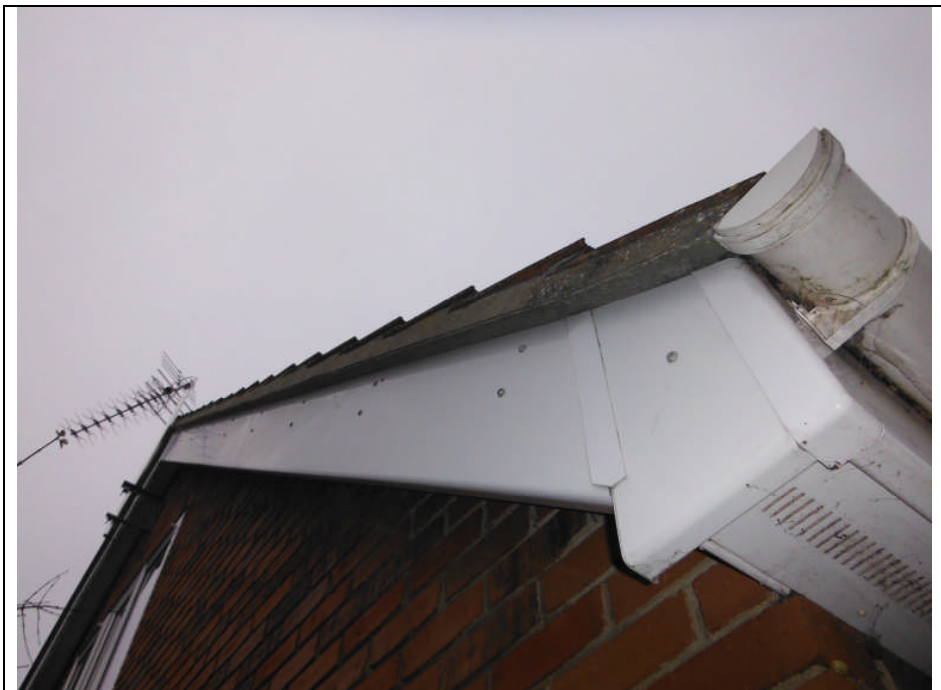
| Sample Number | Floor | Area / Room | Sample location | Extent - approx. |
|---|---|---|---|---|
| NGZ-1 | External | Gable End Roof Areas | Under-cloak below the roof tiles to the gable end roof areas, cement | 20 m length. |

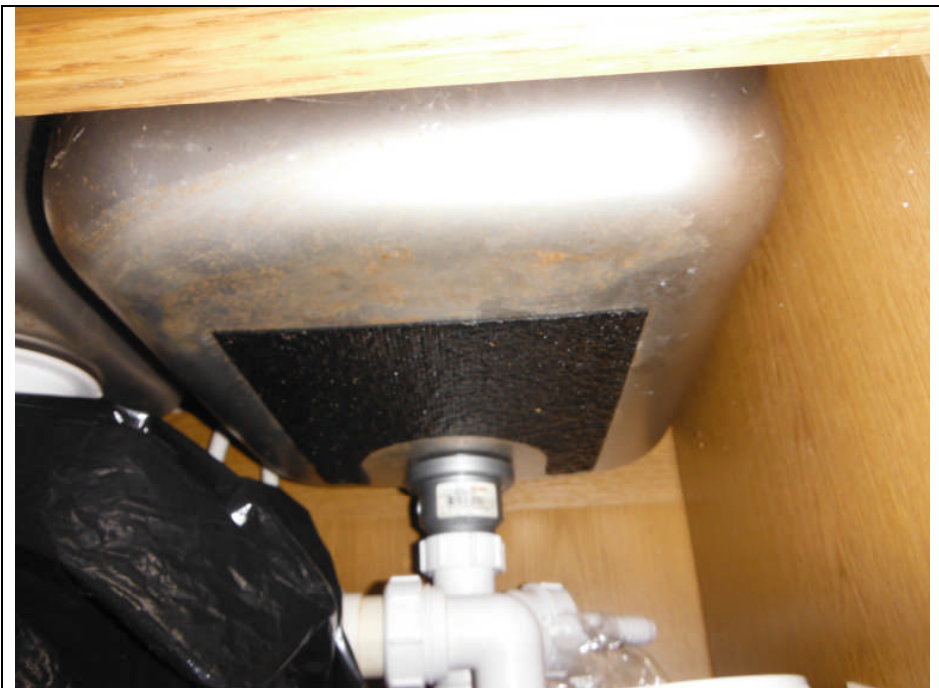
| Sample Number | Floor | Area / Room | Sample location | Extent - approx. |
|---|---|---|---|---|
| NGZ-1A | Ground | Kitchen | Acoustic under-sink pads are a modern non-asbestos type – not suspect, no sample taken | 0.2 m sq. |

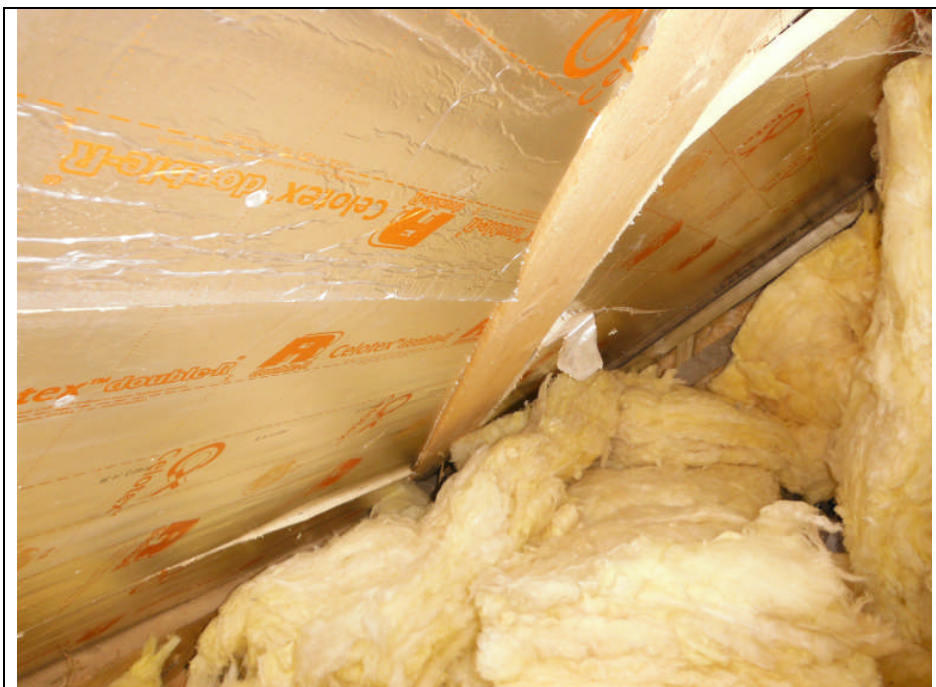
| Sample Number | Floor | Area / Room | Sample location | Extent - approx. |
|---|---|---|---|---|
| NGZ-1B | 1st | Eaves | Insulation to the eaves void is modern non-asbestos Celotex-type insulation and fibreglass – no suspect materials, no samples taken | Various. |

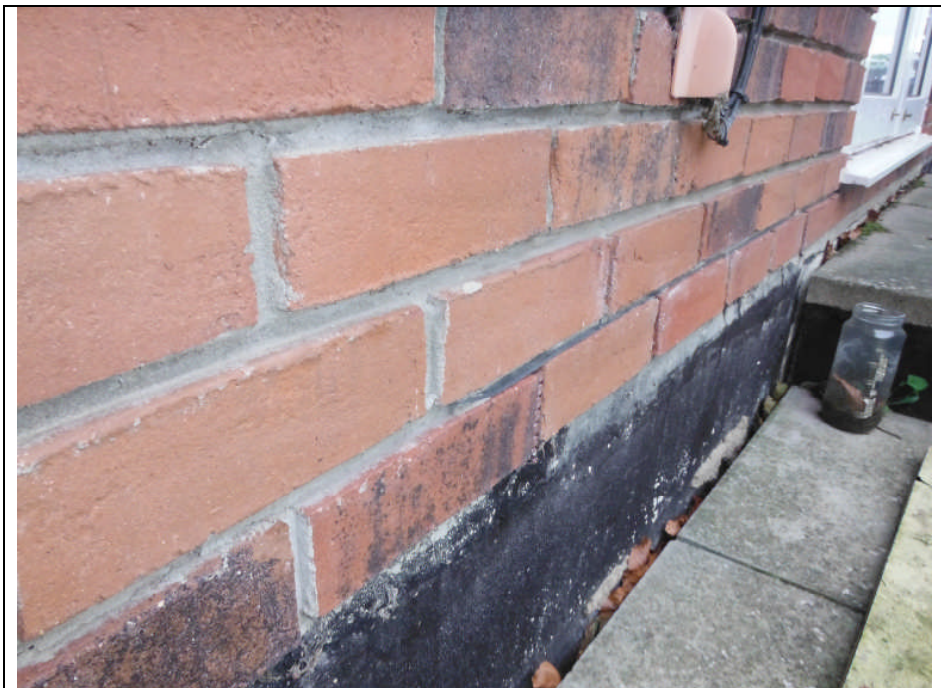
| Sample Number | Floor | Area / Room | Sample location | Extent - approx. |
|---|---|---|---|---|
| NGZ-1C | External | Perimeter Walls | Damp-proof coarse-layer is a modern non-asbestos type – not suspect, no sample taken | Perimeter walls. |

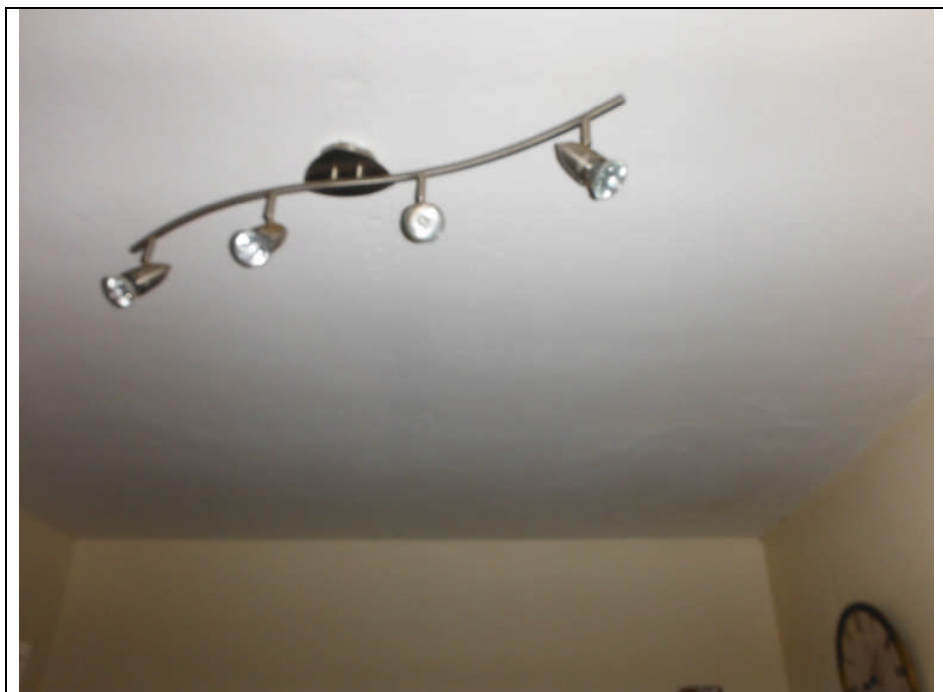
| Sample Number | Floor | Area / Room | Sample location | Extent - approx. |
|---|---|---|---|---|
| NHA-1 | Ground | Kitchen | Textured ceiling coating, artex | 15 m sq. |

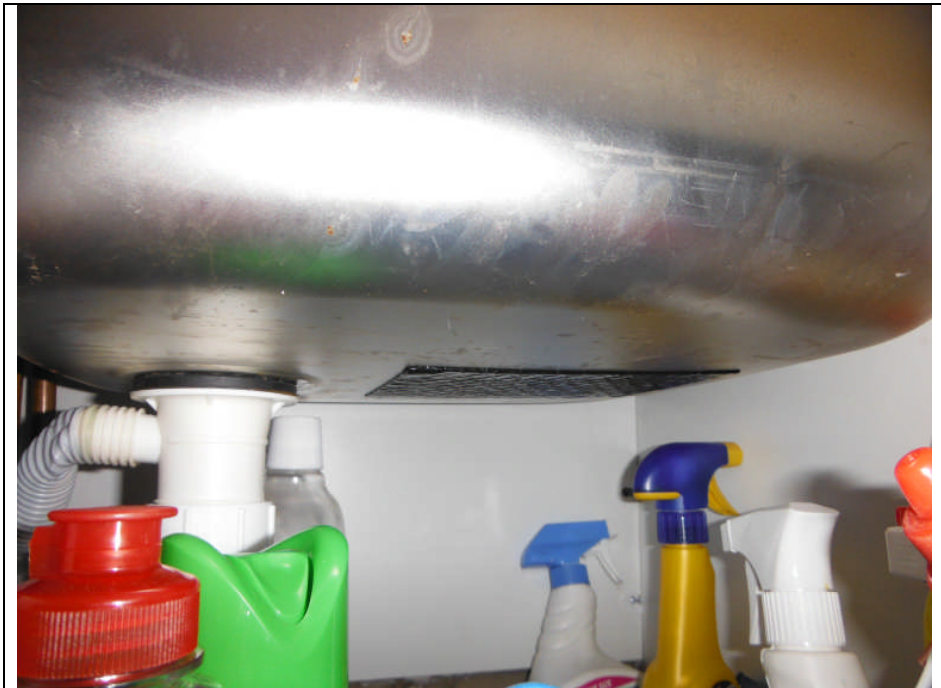
| Sample Number | Floor | Area / Room | Sample location | Extent - approx. |
|---|---|---|---|---|
| NHA-1A | Ground | Kitchen | Acoustic under-sink pads are a modern non-asbestos type – not suspect, no sample taken | 0.2 m sq. |

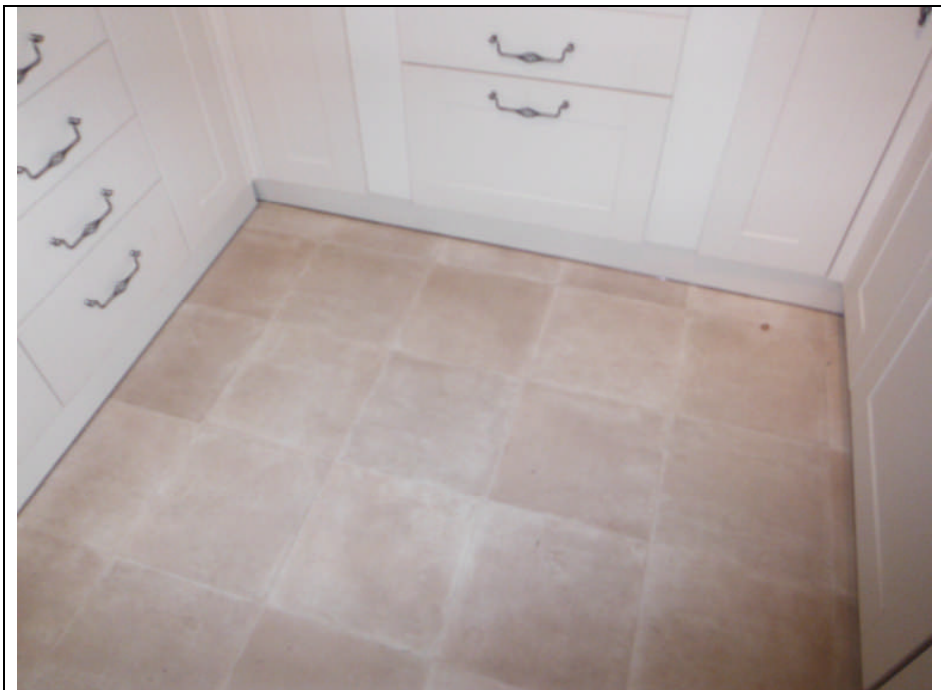
| Sample Number | Floor | Area / Room | Sample location | Extent - approx. |
|---|---|---|---|---|
| NHA-1B | Ground | Kitchen | Floor lining is a modern non-asbestos type – not suspect, no sample taken | 12 m sq. |

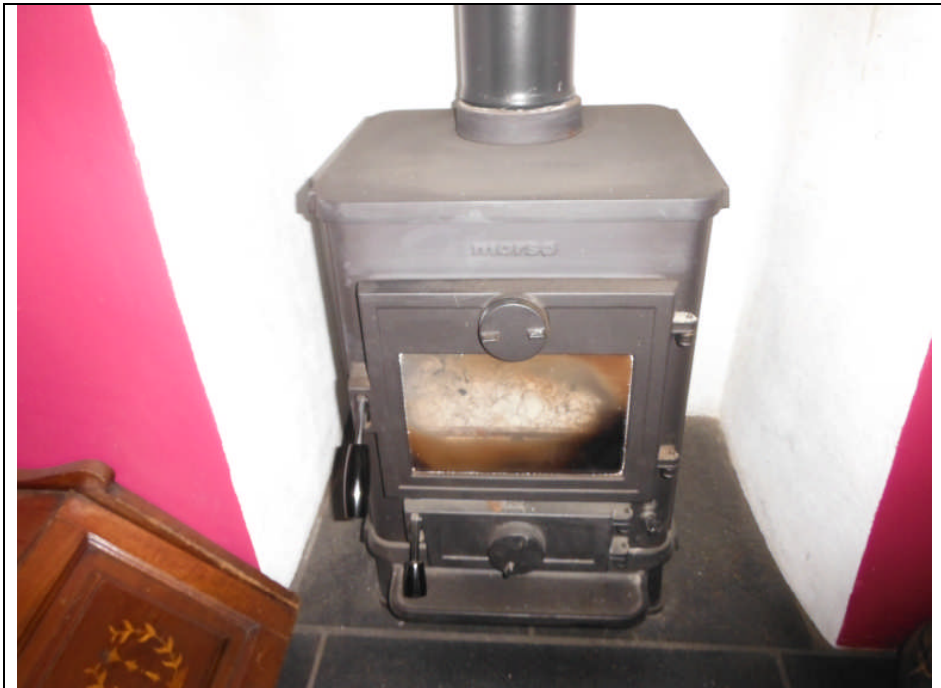
| Sample Number | Floor | Area / Room | Sample location | Extent - approx. |
|---|---|---|---|---|
| NHA-1C | Ground | Lounge | Rope gasket to the wood-burner is a modern fibreglass-type – not suspect, no sample taken | <0.5 m length. |

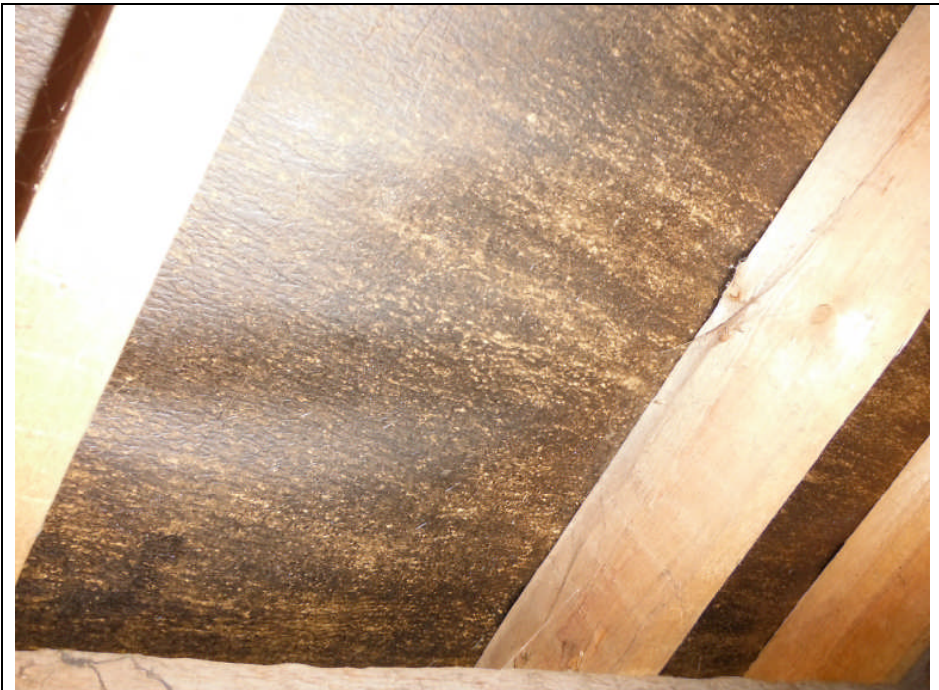
| Sample Number | Floor | Area / Room | Sample location | Extent - approx. |
|---|---|---|---|---|
| NHA-2 | Loft | Loft Areas | Bituminous roof felt below the roof tiles | All loft areas. |

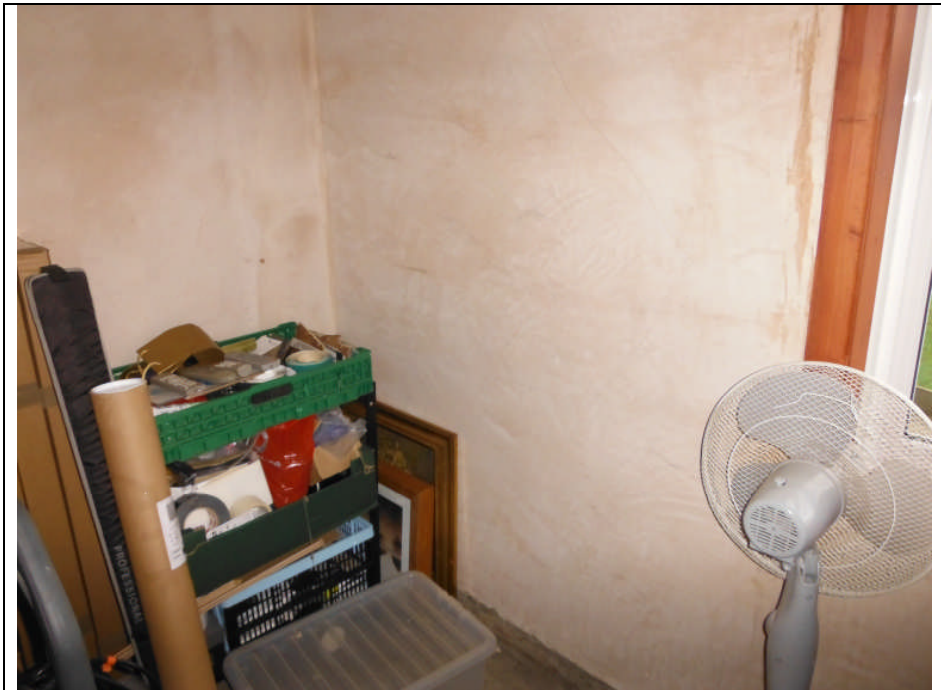
| Sample Number | Floor | Area / Room | Sample location | Extent - approx. |
|---|---|---|---|---|
| NHA-3 | Basement | All Basement Wall Areas | Plaster wall linings | All wall areas. |

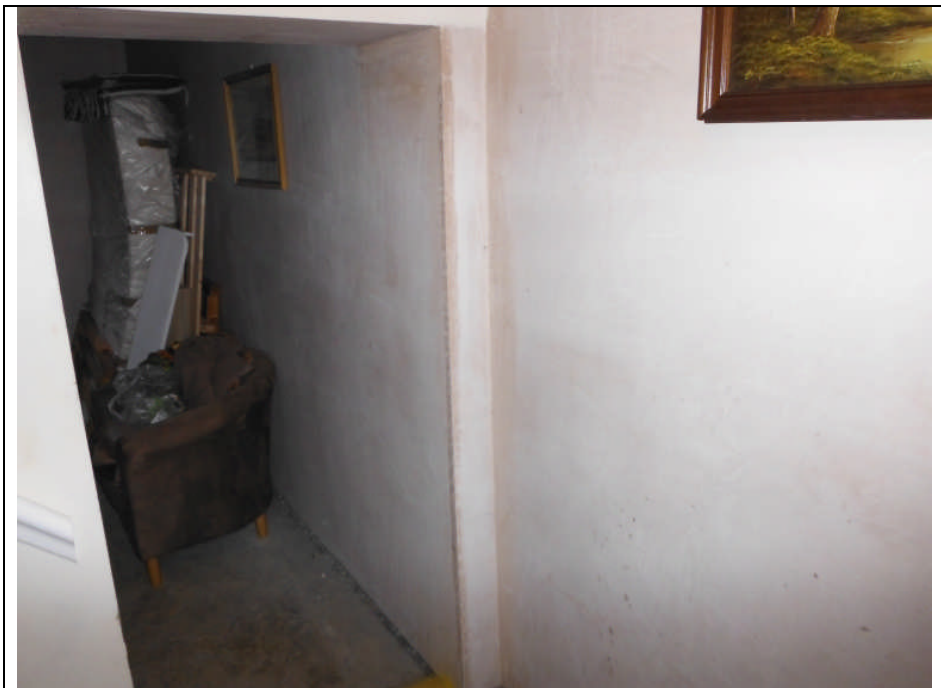
| Sample Number | Floor | Area / Room | Sample location | Extent - approx. |
|---|---|---|---|---|
| NHA-3A | Basement | Front Wall Area | Front basement wall is plasterboard with a modern celotex-type insulation to the wall cavity – not suspect, no sample taken | Front wall areas. |

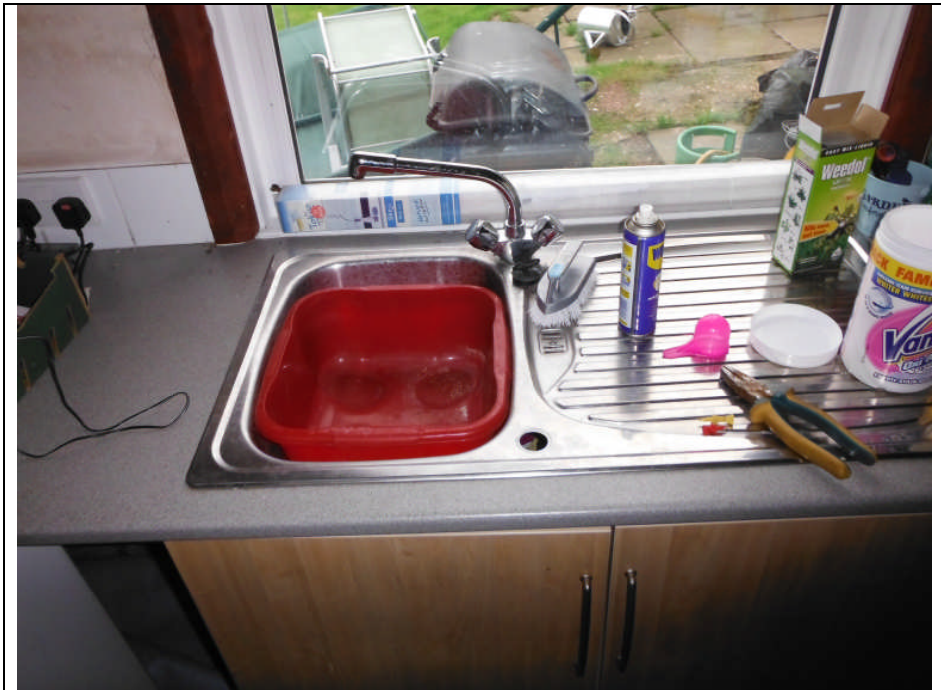
| Sample Number | Floor | Area / Room | Sample location | Extent - approx. |
|---|---|---|---|---|
| NHA-3B | Basement | Utility | Acoustic under-sink pads are a modern non-asbestos type – not suspect, no sample taken | 0.2 m sq. |

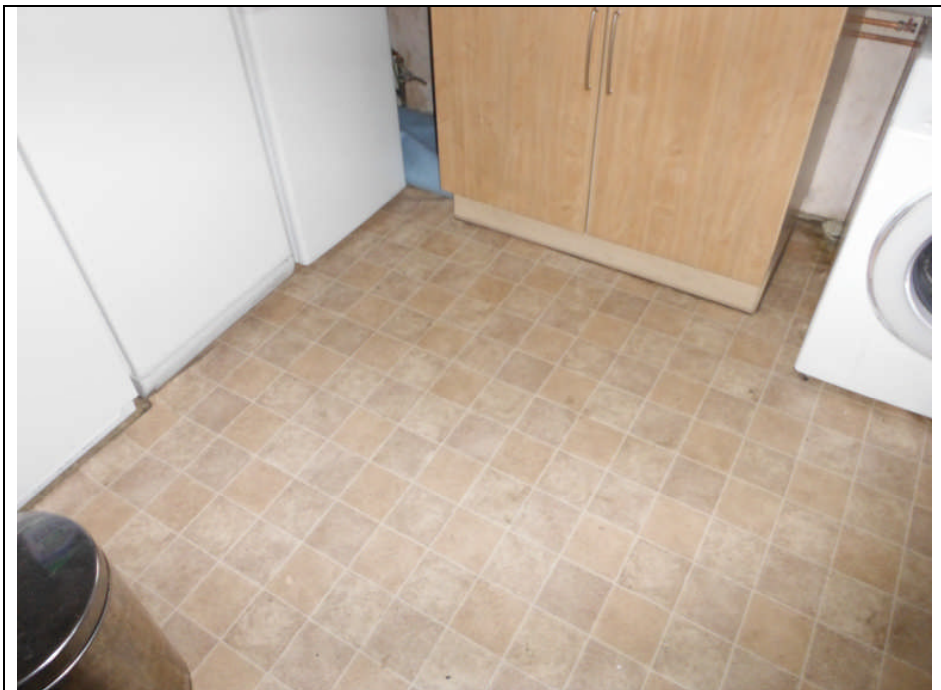
| Sample Number | Floor | Area / Room | Sample location | Extent - approx. |
|---|---|---|---|---|
| NHA-3C | Basement | Utility | Floor lining is a modern non-asbestos type – not suspect, no sample taken | 12 m sq. |

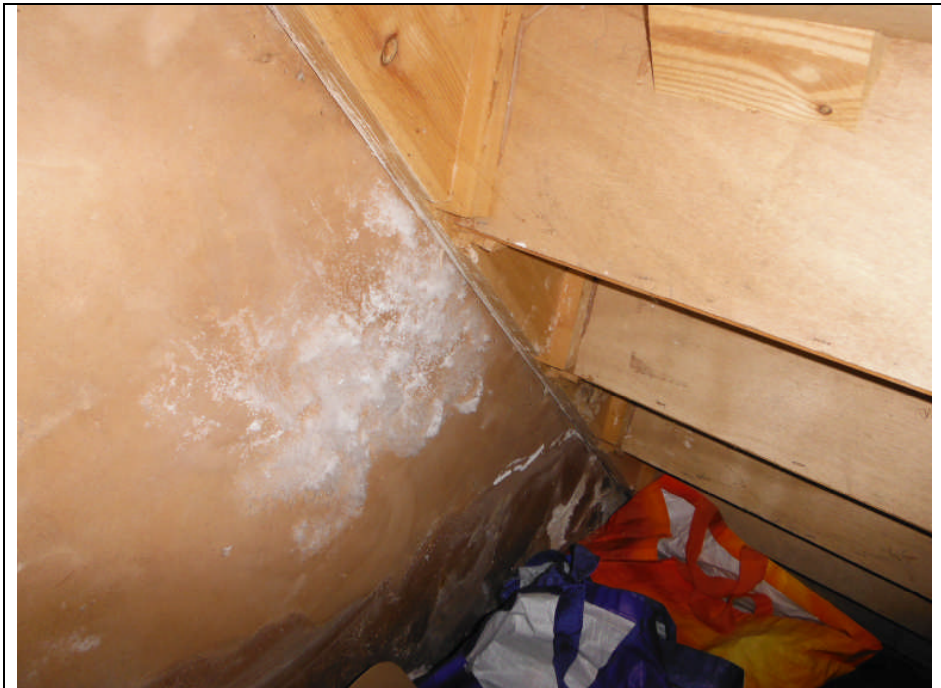
| Sample Number | Floor | Area / Room | Sample location | Extent - approx. |
|---|---|---|---|---|
| NHA-3D | Basement | Various Basement Wall Areas | White residue to wall areas is non-asbestos saltpetre – not suspect, no samples taken | Various. |
