**Jubilee Hall
Station Road
Anstey
Leicestershire
LE7 7AY**

Job Number: 9675

Anstey Parish Council

CCTV Inspection Report

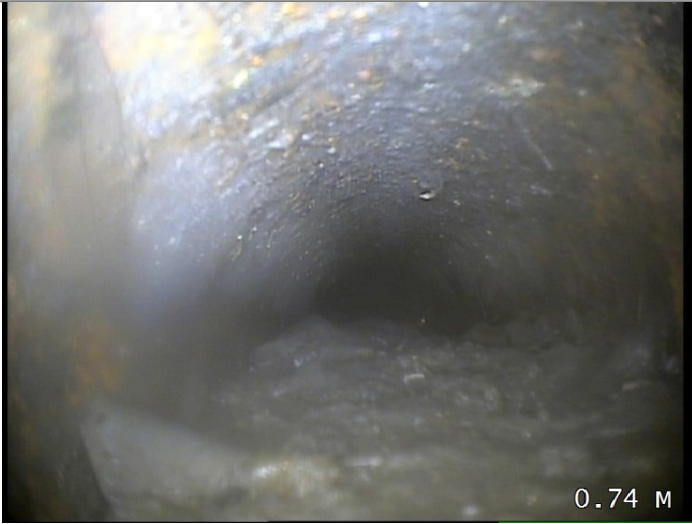
<p>0.74 M</p> <p>Settled deposits cause 25% cross-sectional area loss</p>

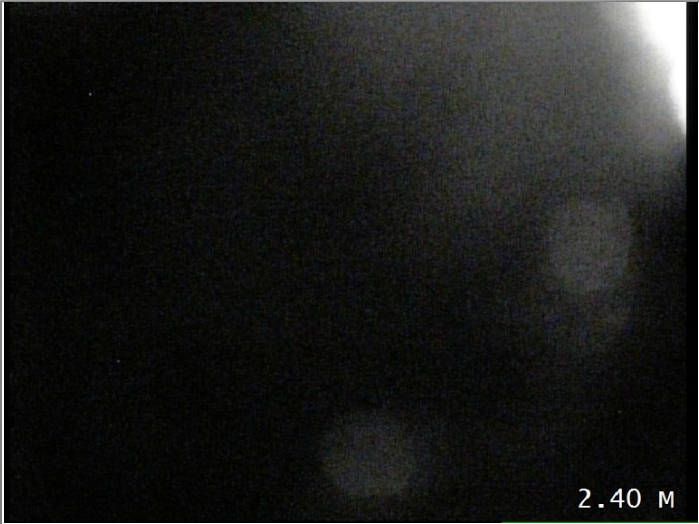
<p>1.14 M</p> <p>Settled deposits fine 25% cross-sectional area loss</p>

<p>2.40 M</p> <p>Survey abandoned - Remark: Due to debris (G)</p>
