Asbestos Survey Report & Register

Survey Type:	Asbestos Management Survey
Site:	Justinian House, Spitfire Close, Huntingdon, PE29 6XY
Surveyor(s):	Mr David Bond & Mr Kyle Johnson
Contract:	C06670
Survey Date:	17 th October 2016
Report Date:	19 th October 2016
Client:	Praxis Real Estate Management 13 Police Street, Manchester, M2 7LQ

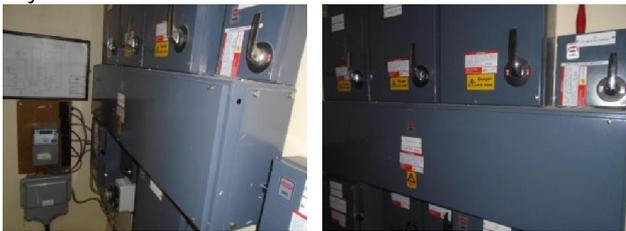
No:	Room / Area:	No access and restriction details:
1	Justinian House Ground Floor Electrics Cupboard	No access to electrics due to being live at the time of survey.

5.4 The client and or duty holder must presume that asbestos containing materials are present within all restricted or non accessed areas until proven otherwise and take appropriate precautionary asbestos management measures.

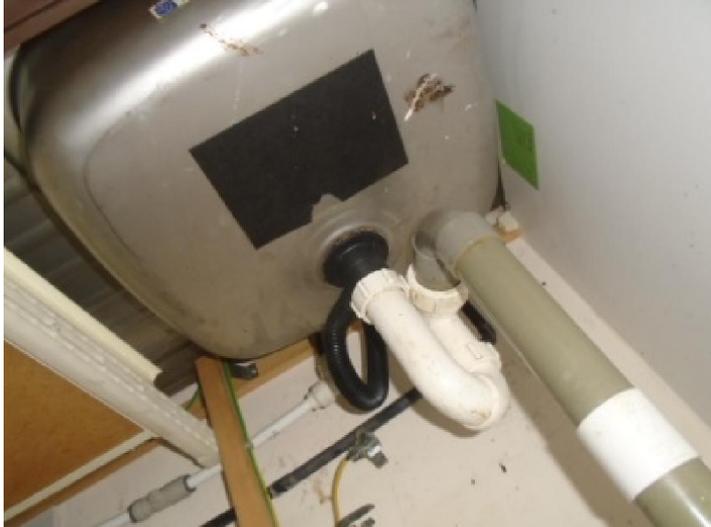
Contract No: C06670	Client: Praxis Real Estate Management	Location Ref OSL: 001	
Site: Justinian House, Spitfire Close, Huntingdon, PE29 6XY		Survey Date: 17/10/16	
Building:	Justinian House

Floor:	Ground		
Room Area:	Kitchen		
Description:	Bitumen Sink Pads		
Quantity:	2 units		
Accessibility:	Easy		
Product Type:	(Score 1,2,3 = 1) Bitumen		
Damage Extent:	(Score 0,1,2,3 = 1) Low		
Surface Treatment:	(Score 0,1,2,3 = 0) Composite	Re-inspection Due:	N/A
Asbestos Type:	(Score 1,2,3 = N/A) No Asbestos Detected	Sample Ref:	Sampled - S01
Material Assessment:	No Asbestos Detected		
Comments: - This product, although noted as 'No Asbestos Detected' was suspected to contain asbestos or was sampled to avoid confusion and has therefore been detailed within an asbestos register sheet.			
Recommendations: - N/A – No asbestos fibre types were detected within the sample collected and as such no further action is required.

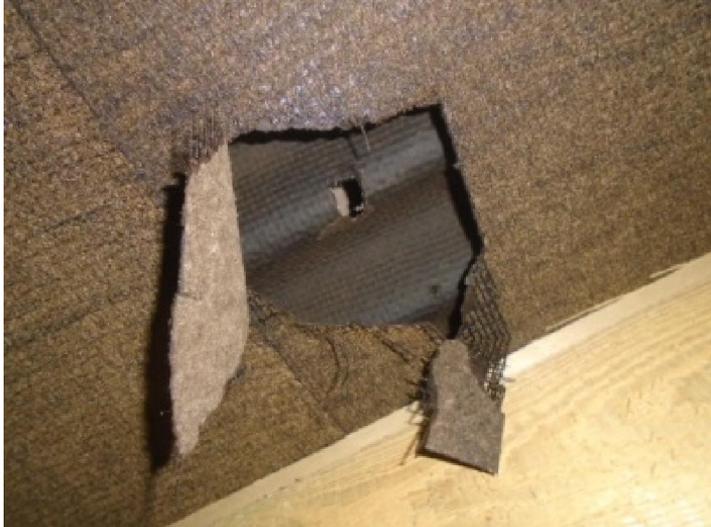
Contract No: C06670	Client: Praxis Real Estate Management		Location Ref OSL: 002
Site: Justinian House, Spitfire Close, Huntingdon, PE29 6XY			Survey Date: 17/10/16
Building:	Justinian House

Floor:	First		
Room Area:	Ceiling Void		
Description:	Felt Lining to Pitched Roof		
Quantity:	280 m ²		
Accessibility:	Medium		
Product Type:	(Score 1,2,3 = 1) Felt		
Damage Extent:	(Score 0,1,2,3 = 1) Low		
Surface Treatment:	(Score 0,1,2,3 = 0) Composite	Re-inspection Due:	N/A
Asbestos Type:	(Score 1,2,3 = N/A) No Asbestos Detected	Sample Ref:	Sampled - S02
Material Assessment:	No Asbestos Detected		
<p>Comments: - This product, although noted as 'No Asbestos Detected' was suspected to contain asbestos or was sampled to avoid confusion and has therefore been detailed within an asbestos register sheet.</p>			
<p>Recommendations: - N/A – No asbestos fibre types were detected within the sample collected and as such no further action is required.</p>

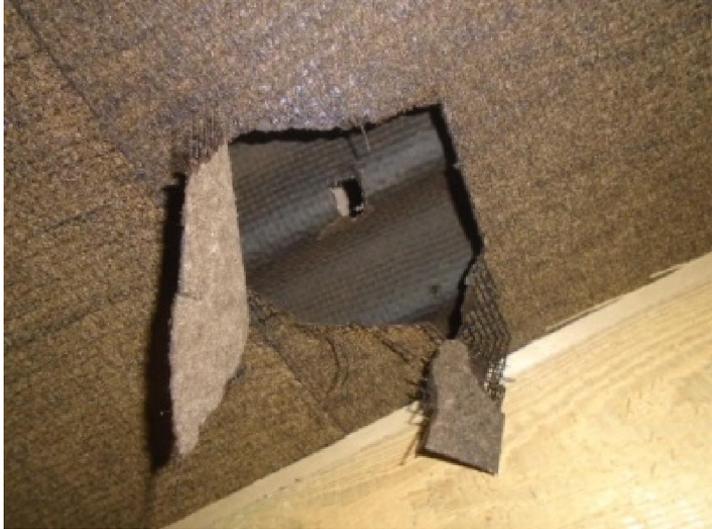
Contract No: C06670	Client: Praxis Real Estate Management		Location Ref OSL: 003
Site: Justinian House, Spitfire Close, Huntingdon, PE29 6XY			Survey Date: 17/10/16
Building:	Justinian House

Floor:	First		
Room Area:	Ceiling Void		
Description:	Bitumen Corrugated Bitumen Panels		
Quantity:	280 m ²		
Accessibility:	Difficult		
Product Type:	(Score 1,2,3 = 1) Bitumen		
Damage Extent:	(Score 0,1,2,3 = 1) Low		
Surface Treatment:	(Score 0,1,2,3 = 0) Composite	Re-inspection Due:	N/A
Asbestos Type:	(Score 1,2,3 = N/A) No Asbestos Detected	Sample Ref:	Sampled - S03
Material Assessment:	No Asbestos Detected		
<p>Comments: - This product, although noted as 'No Asbestos Detected' was suspected to contain asbestos or was sampled to avoid confusion and has therefore been detailed within an asbestos register sheet.</p>			
<p>Recommendations: - N/A – No asbestos fibre types were detected within the sample collected and as such no further action is required.</p>

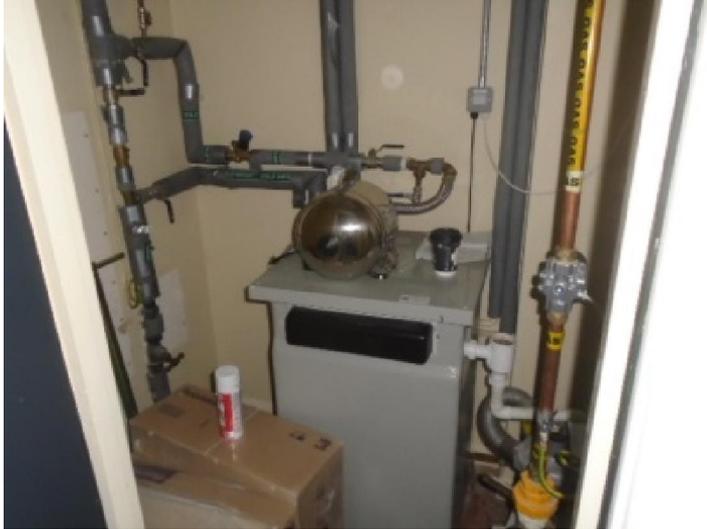
Contract No: C06670	Client: Praxis Real Estate Management	Location Ref OSL: 004	
Site: Justinian House, Spitfire Close, Huntingdon, PE29 6XY		Survey Date: 17/10/16	
Building:	Justinian House

Floor:	First		
Room Area:	Plant Room		
Description:	Rope Seal to Boiler Unit		
Quantity:	4 lm		
Accessibility:	Easy		
Product Type:	(Score 1,2,3 = 2) Rope		
Damage Extent:	(Score 0,1,2,3 = 1) Low		
Surface Treatment:	(Score 0,1,2,3 = 2) Unsealed	Re-inspection Due:	N/A
Asbestos Type:	(Score 1,2,3 = N/A) No Asbestos Detected	Sample Ref:	Sampled - S04
Material Assessment:	No Asbestos Detected		
Comments: - This product, although noted as 'No Asbestos Detected' was suspected to contain asbestos or was sampled to avoid confusion and has therefore been detailed within an asbestos register sheet.			
Recommendations: - N/A – No asbestos fibre types were detected within the sample collected and as such no further action is required.
