Woodbridge Town Council

Structural Report on Woodbridge Art Club Building, Tide Mill Way, Woodbridge

May 2022

01-05-112552 NPS-R-S-001

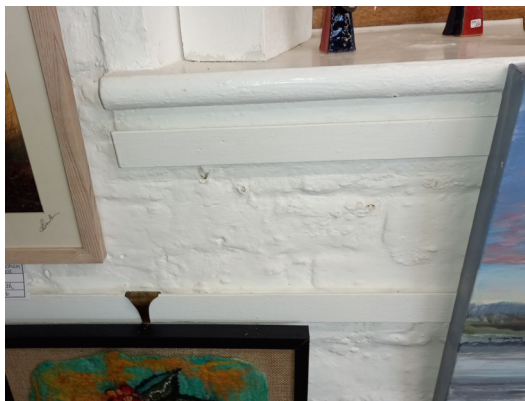
Photograph No. 05

The walls to the building comprise load bearing brick masonry which are typically in the order of 300mm thickness, but thicker immediately above ground level where the wall thickness steps out externally. These are painted white throughout. Inspection of these did not reveal any evidence of structural distress or damage, with areas observed appearing to be functioning satisfactorily as required.

Photograph No.'s 05 and 06 show a typical view of the internal load bearing brick masonry wall, which is predominantly covered by art displays, and the cracking damage to the blockwork respectively.

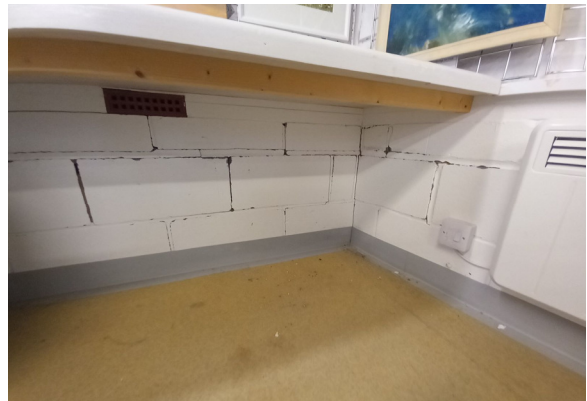
Photograph No. 06

There is an area of more recent blockwork masonry in the NW corner of the Studio, beneath a low level display shelf where storage crates are kept, where cracking damage to the blockwork is apparent. This wall appears to only support the display shelving and it is likely that the damage observed is caused by impact from the storage crates.

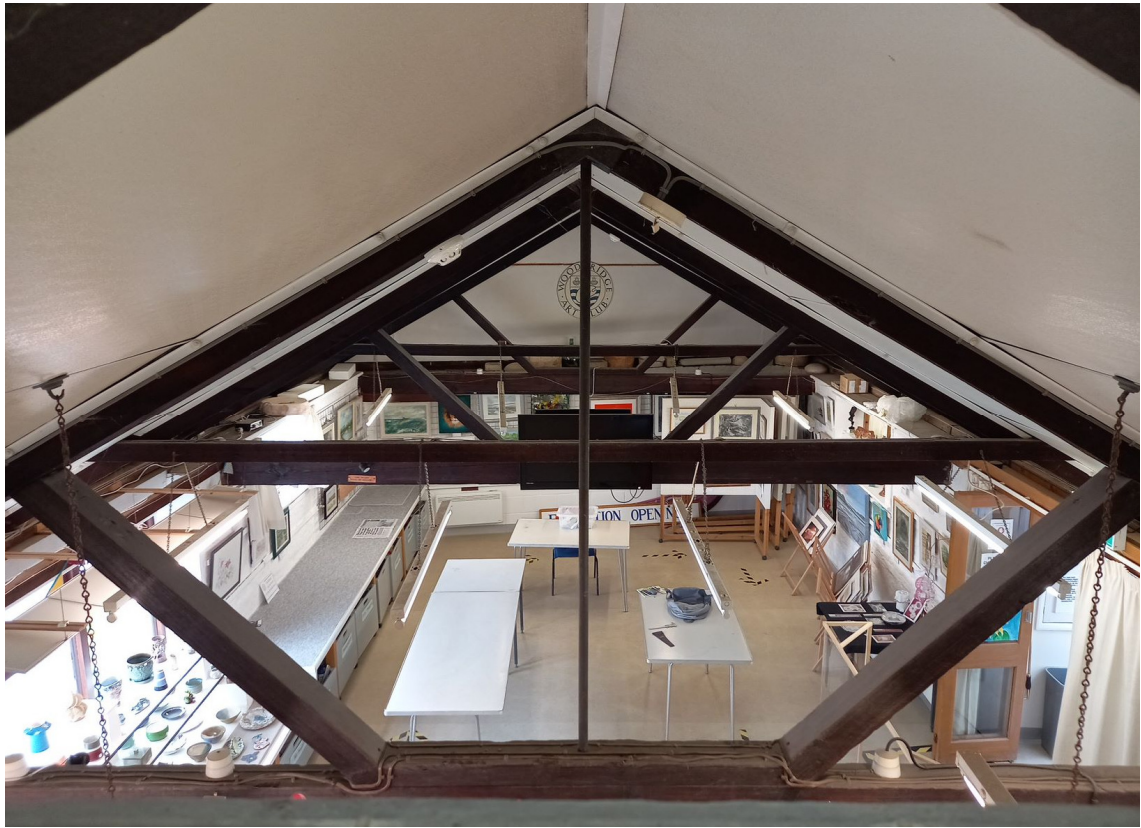
Photograph No. 07 below shows a general view of the Studio area roof trusses looking NW from the loft access area.

It appears that the Raised Collar trusses are a more modern addition to the building's roof structure, with the heavier section Queen Post trusses being the original roof structure. There is evidence to the Queen Post truss rafters that they originally supported a purlin at approximately mid height / at strut position along each rafter, due to the presence of unused notches / mortises. This can be seen on the Queen Post truss rafters within the loft space.

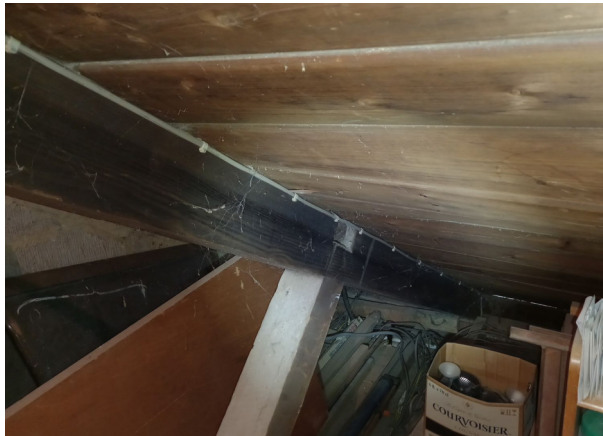
Photograph No. 08

Photograph No.'s 08 - 11 below show the purlin notch to a Queen Post truss rafter and boarding, the steel apex shoe to a Queen Post truss, storage within loft space with Raised Collar truss visible and collar approximately 400mm above floor level, and evidence of beetle infestation to truss rafter, respectively.

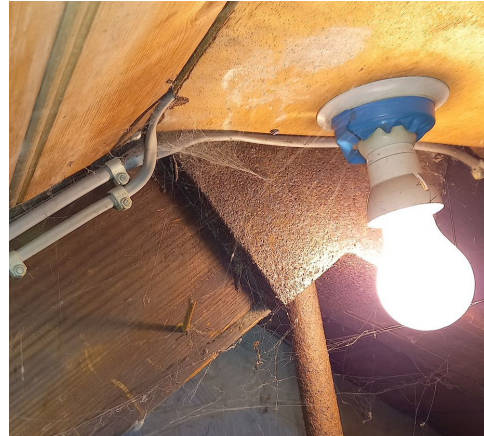
Photograph No. 09

Within the loft space the apex detail of the Queen Post trusses could be closely observed. This comprises a custom made steel shoe which the steel rod is connected to. Within the loft the steel shoes are suffering from moderate surface corrosion.

- Due to evidence of beetle infestation and damp damage to some primary structural members, we recommend that a timber treatment specialist is appointed for advice in treatment and long term protection of structural timber members.
- In the event of a roof refurbishment scheme going ahead, where existing primary roof structure is retained, further inspections of bearings and connections should be undertaken to confirm suitable structural condition. Items such as steel bolts, rods, nuts, washers, screws,

straps, ties, shoes, should be inspected for corrosion and repaired or treated as required to protect them and provide extended lifetime of the roof structure.

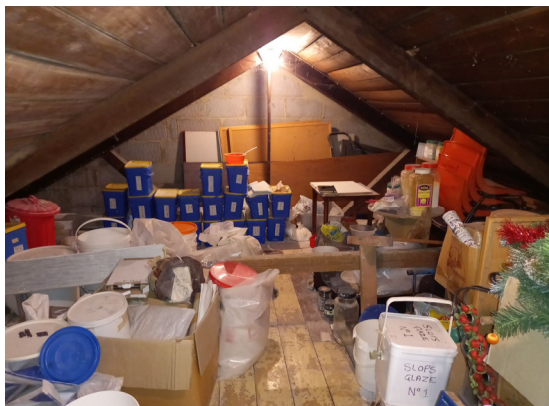
Photograph No. 10

Within the loft space there is a significant amount of storage. The loft floor joists could not be directly observed, however, these are thought to span between the heads of the blockwork walls that form the W.C. / Kitchen areas below, which are relatively short spans, and there was no evidence to suggest that the current storage is in excess of the loft floors structural capacity.

- Within the loft, there is storage of materials and this does not appear to be causing any distress to the loft floor structure of supporting walls. It should be noted however that storage weights should not be increased beyond what currently exists without undertaking structural assessment of the loft floor structure to confirm actual structural capacity.

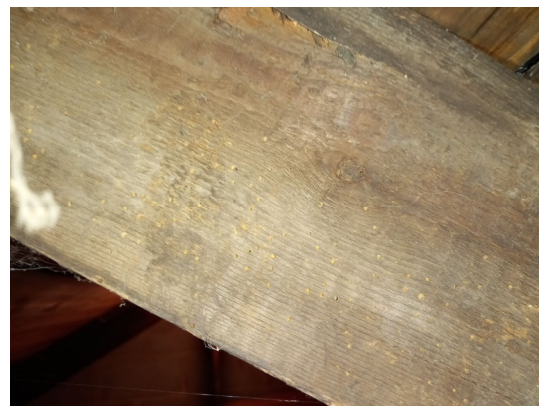
Photograph No. 11

Also noticeable in the loft space is evidence of beetle infestation to the Queen Post truss rafters. This appears only minor at the time of our inspection.

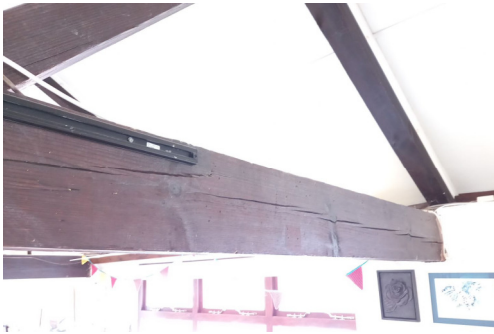
Photograph No. 12

General visual inspection of the timber trusses within the Studio area did not reveal any noticeable signs of structural distress. There is some evidence of splitting along the grain direction to the larger timber Chord members to the Queen post trusses. This is typical of shrinkage on larger timber sections and is not considered to be of structural significance. No visual evidence of noticeable deflection of truss members was apparent, with all truss joint nodes and bolted connections viewed appearing to function satisfactorily.

Photograph No.'s 12 – 13 below show a splitting bottom chord of a Queen Post truss and a general view of trusses with straight bottom chords and rafters / stuts, respectively.

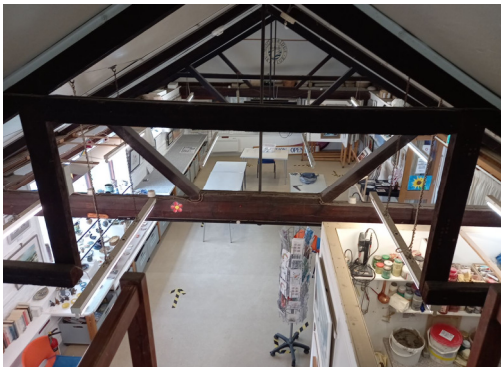
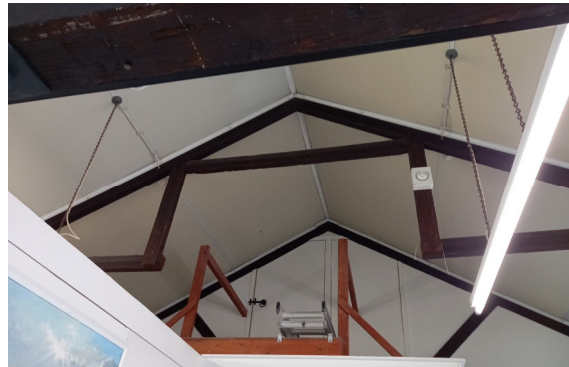
At the location where loft access is provided, to provide clear access, the bottom chord / collar, of the Raised Collar truss has been cut. This compromises the trusses ability to behave structurally as a truss, potentially making it unsafe depending on whether it, or other parts of the roof were locally strengthened to accommodate the trusses modification when originally altered. There does not appear to be any noticeable distress to this area of the roof however, so it is likely that the roof is managing to span between adjacent trusses, albeit in a way it was not originally intended to. Photograph No.'s 14 – 15 show the cut truss.

- The cut Raised Collar truss at the loft access doesn't appear to be causing an issue, however, this is not structurally correct, and should therefore be considered for strengthening / repair / replacement so that it functions as a structural roof truss as originally intended.

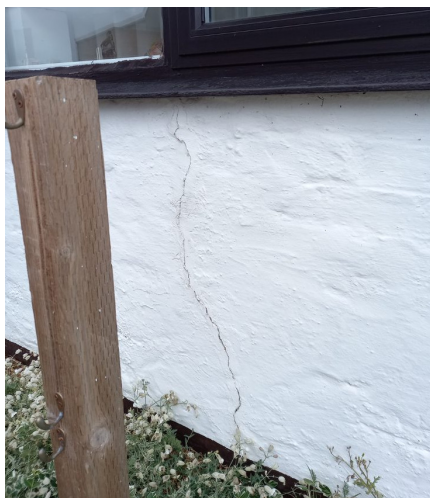
On the SW elevation on Tide Mill Way, there is a generally vertical crack below the window adjacent to the main entrance. Photograph No. 18 shows this crack which is in the order of 1 – 2mm width. The crack appears to have been re-pointed historically, and subsequently reopened since paint coating has been applied.

- Cracking observed to the original buildings brickwork is only minor / hairline, and is thought most likely to be attributed to thermal and natural movement of the building fabric. There are no movement joints in the masonry, and it is typical for movement joints to be provided at maximum 12m centres, or within 6m of a return wall for brick masonry. The building is approximately 15m length, and is therefore susceptible to cracking due to natural movement in lieu of movement joint provision. The cracking observed is not therefore considered to be structural and is only aesthetic in nature. The cracks could be monitored to check they are not progressive, but we do not feel this is necessary at this point in time unless more noticeable damage becomes apparent. Where cracking in masonry is present, masonry repairs such as full stitching of new brickwork, or installation of Helifix stainless steel rods could be considered to re-establish full strength of the masonry walls.

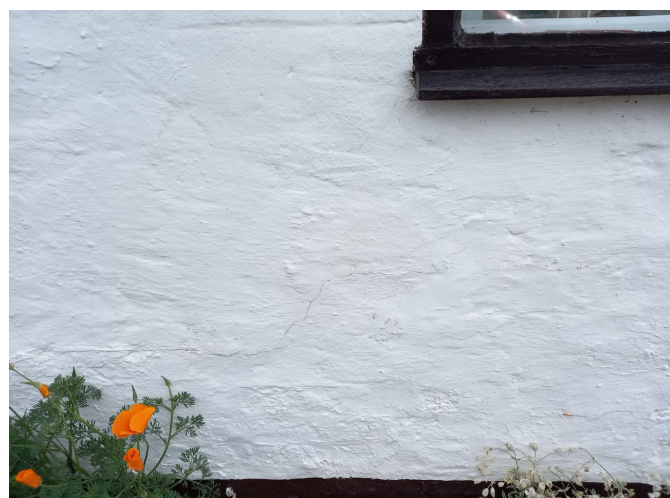
Photograph No. 19

A hairline stepped horizontal crack also exists to the bottom left corner of the same window, on the NW side, as shown in Photograph No. 19.

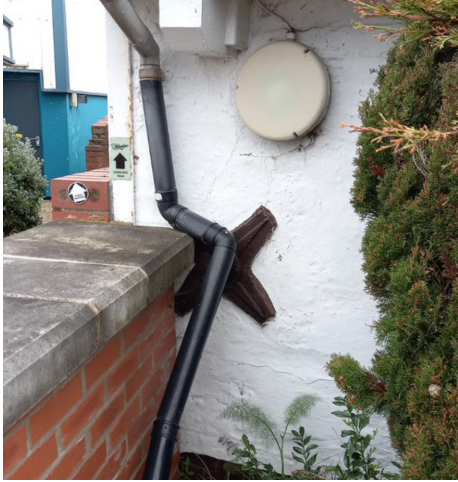
At the NW corner of the building, further minor horizontal cracking is present just below an 'x' shaped patress plate. There is also hairline cracking just above the patress plate, beneath the external wall light. Photograph No. 20 shows this area of the wall. Photograph No. 21 shows the opposite 'x' patress plate on the NE corner of the building. The patress plates and nuts to the tie rod appear to be functioning as intended with no evidence of damage or distress.

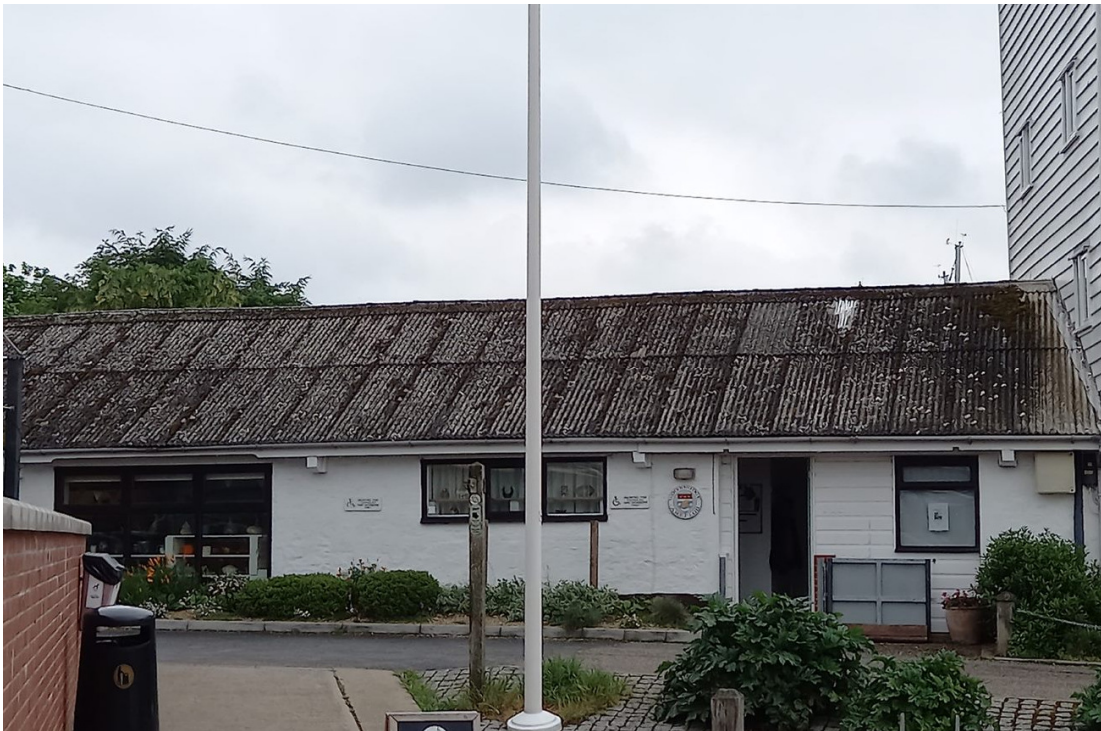
Photograph No. 22 shows the Western elevation view with the majority of the roof visible. Visual inspection of the roof did not reveal any noticeable deflection or deformation, suggesting the existing roof structure is functioning satisfactorily in its present condition.

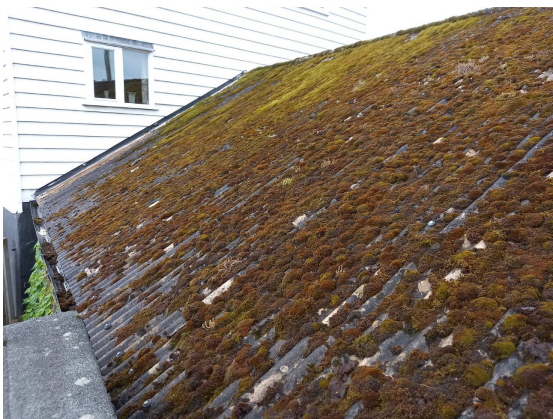
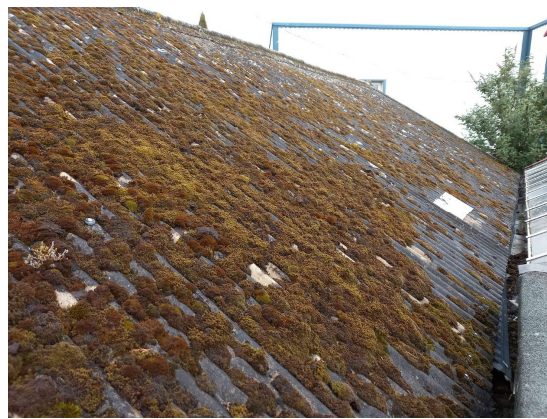
On the Eastern side of the roof, there is significant moss growth to the roof surface and areas of damaged roof sheeting. When saturated the moss will increase overall weight to the roof, however, as with the Western view of the roof, there is no evidence to suggest the roof is not functioning structurally as required.

Photograph No.'s 23 & 24 show the Eastern side roof views.
