MANAGEMENT ASBESTOS SURVEYS

Management Survey

Site: The Hub, Civic Approach, Uckfield, TN22 2AL
Client: Uckfield Town Council
Report No: J005397
Survey Date: 30th September 2015
Report Date: 2nd October 2015
Surveyors: Paul Veness
Report Produced By: **Report Authorised By:**

The Hub, Civic Approach, Uckfield

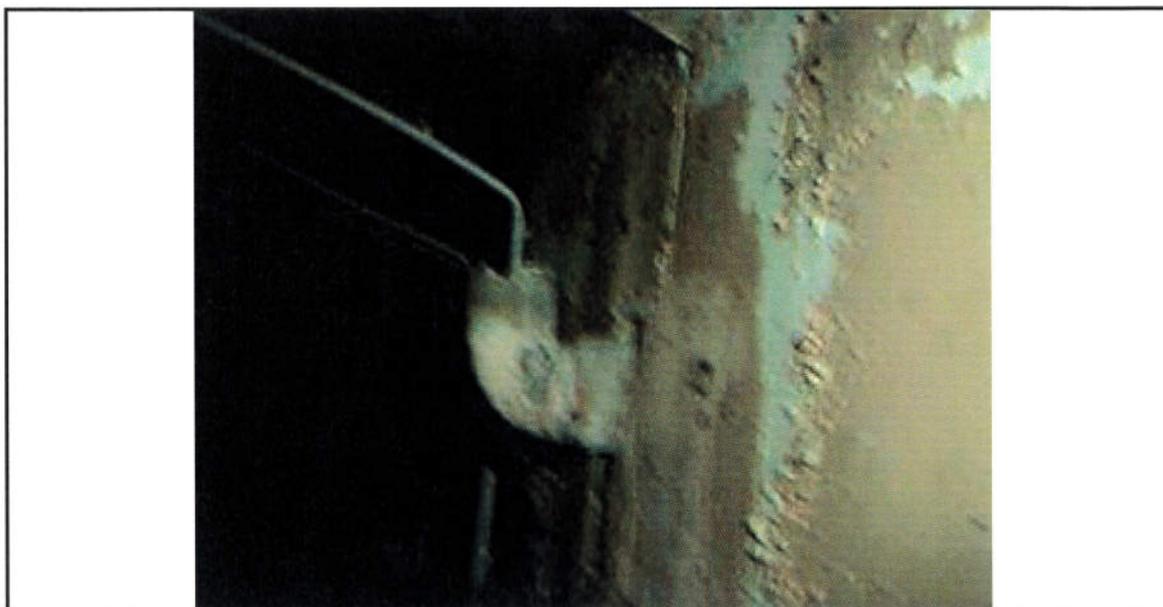
Picture 1

Sample ID	Building	Floor	Description	Room/Position	Extent (m2)	Fixing	Substrate	Asbestos Type Identified
Presumed	the hub, uckfield	Roof Void	disused cement flue pipe	roof void above rear lobby / to south wall	<1m	Bonded	Brick	(1) Chrysotile
Recommendations					Assessment Scores			Risk Code
					Material	Priority	Total	
Low risk ACM (Bound in matrix). Where appropriate label with warning signs. Undertake routine inspections for damage and deterioration. Work on this material does not require a license. Work on this material may be notifiable to the appropriate enforcing authority. Disposal of asbestos waste by a licensed contractor only. All work must conform to the 'Control of Asbestos Regulations 2012'.					4			D
Reinspection Due		12 months	Actions Taken		Time Scale			Action Completed Sign & Date

Sample No:	Presumed
Item No:	1
Survey Date:	30/09/15
Building:	the hub, uckfield
Floor:	Roof Void
Room No:	roof void above rear lobby
Position:	to south wall - disused cement flue pipe
Extent:	<1lm
Substrate:	Bonded, Brick
Material:	(1) Asbestos Cement
Accessibility:	(0) Usually inaccessible or unlikely to be disturbed
Asbestos Type:	(1) Chrysotile
Risk Category:	D
Recommended Action:	Low risk ACM (Bound in matrix). Where appropriate label with warning signs. Undertake routine inspections for damage and deterioration. Work on this material does not require a license. Work on this material may be notifiable to the appropriate enforcing authority. Disposal of asbestos waste by a licensed contractor only. All work must conform to the 'Control of Asbestos Regulations 2012'.

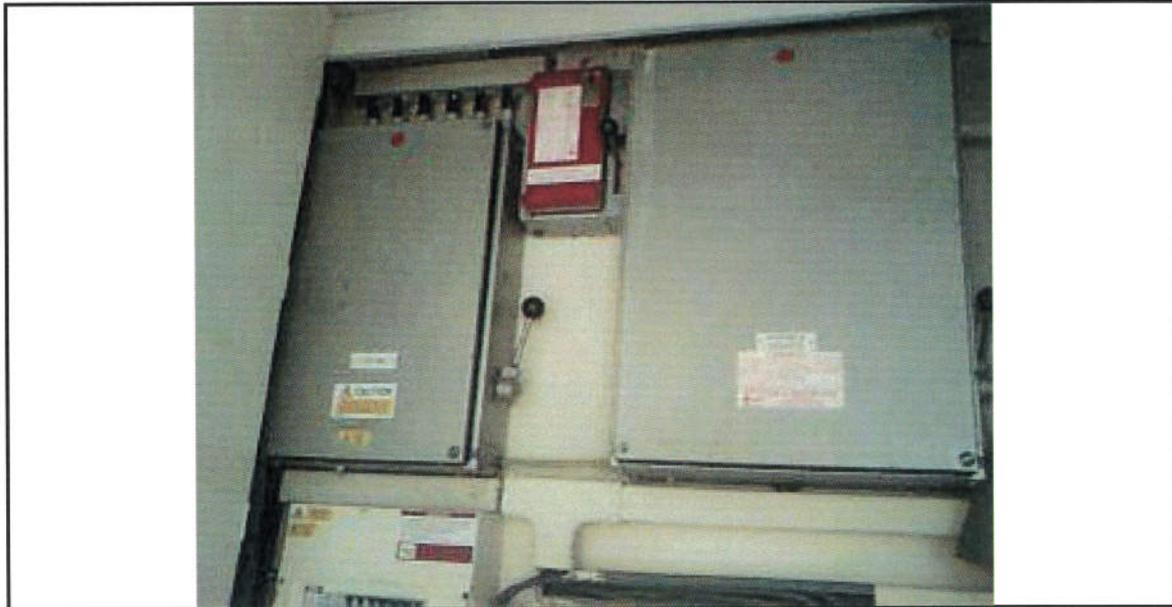
Picture 2

Sample ID	Building	Floor	Description	Room/Position	Extent (m2)	Fixing	Substrate	Asbestos Type Identified
Presumed	the hub, uckfield	Ground Floor	possible rope products	main office / within electrical switchgear	<1m	Bonded	Metal	(1) Chrysotile
Recommendations					Assessment Scores			Risk Code
					Material	Priority	Total	
Inaccessible further investigation is required. To determine the material, access, sampling and analysis would be required. Until this is carried out it must be presumed to be an ACM (Asbestos Containing Material).					5			C
Reinspection Due		12 months	Actions Taken		Time Scale			Action Completed Sign & Date

Sample No:	Presumed
Item No:	16
Survey Date:	30/09/15
Building:	the hub, uckfield
Floor:	Ground Floor
Room No:	main office
Position:	within electrical switchgear - possible rope products
Extent:	<1m
Substrate:	Bonded, Metal
Material:	(2) Asbestos Textiles/Paper
Accessibility:	(0) Usually inaccessible or unlikely to be disturbed
Asbestos Type:	(1) Chrysotile
Risk Category:	C
Recommended Action:	Inaccessible further investigation is required. To determine the material, access, sampling and analysis would be required. Until this is carried out it must be presumed to be an ACM (Asbestos Containing Material).

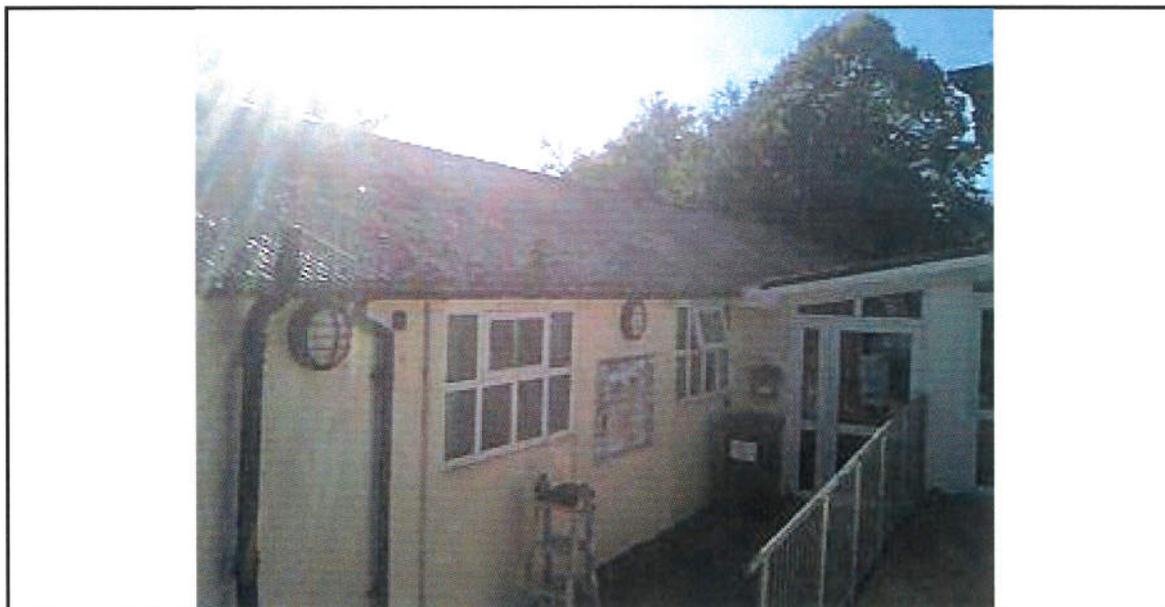
Picture 3

Sample ID	Building	Floor	Description	Room/Position	Extent (m2)	Fixing	Substrate	Asbestos Type Identified
BE003836	the hub, uckfield	External	cement profile sheets	external elements / roof	280m ²	Bolted	Concrete	(1) Chrysotile
Recommendations					Assessment Scores			Risk Code
Low risk ACM (Bound in matrix). Where appropriate label with warning signs. Undertake routine inspections for damage and deterioration. Work on this material does not require a license. Work on this material may be notifiable to the appropriate enforcing authority. Disposal of asbestos waste by a licensed contractor only. All work must conform to the 'Control of Asbestos Regulations 2012'.					3			D
Reinspection Due		12 months	Actions Taken		Time Scale			Action Completed Sign & Date

Sample No:	BE003836
Item No:	23
Survey Date:	30/09/15
Building:	the hub, uckfield
Floor:	External
Room No:	external elements
Position:	roof - cement profile sheets
Extent:	280m ²
Substrate:	Bolted, Concrete
Material:	(1) Asbestos Cement
Accessibility:	(0) Usually inaccessible or unlikely to be disturbed
Asbestos Type:	(1) Chrysotile
Risk Category:	D
Recommended Action:	Low risk ACM (Bound in matrix). Where appropriate label with warning signs. Undertake routine inspections for damage and deterioration. Work on this material does not require a license. Work on this material may be notifiable to the appropriate enforcing authority. Disposal of asbestos waste by a licensed contractor only. All work must conform to the 'Control of Asbestos Regulations 2012'.

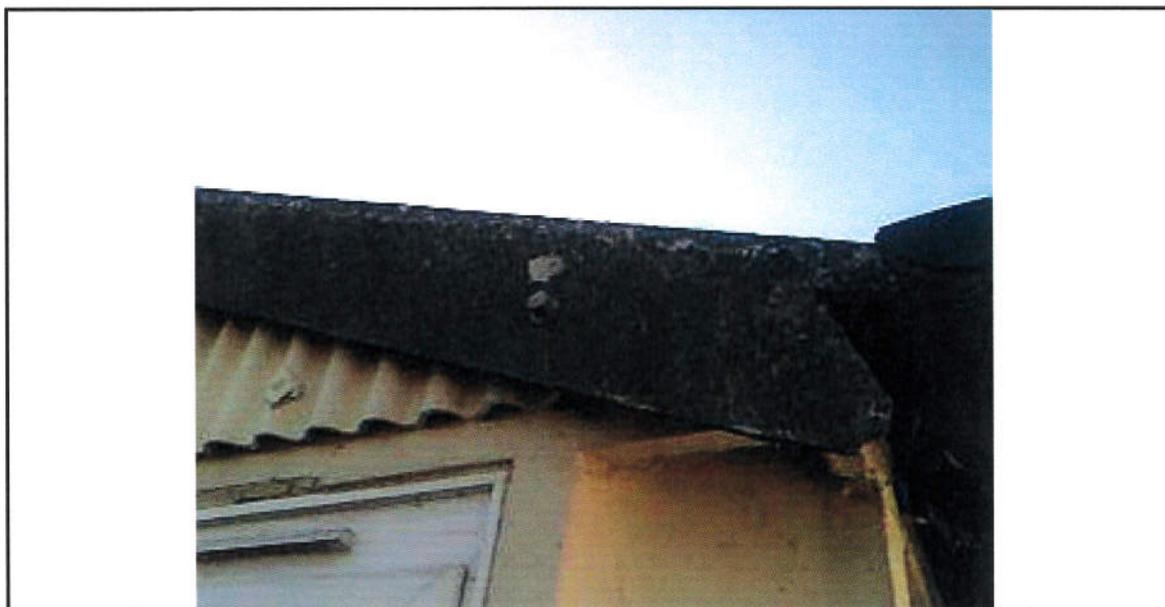
Picture 4

1.3 Sample BE003837 - Material: External cement verge plates. Location: external elements / to gable ends. – Recommendation: Where appropriate label with warning signs and re-inspect in 12 months.

Sample ID	Building	Floor	Description	Room/Position	Extent (m2)	Fixing	Substrate	Asbestos Type Identified
BE003837	the hub, uckfield	External	cement verge plates	external elements / to gable ends	161m	Bolted	Metal	(1) Chrysotile
Recommendations					Assessment Scores			Risk Code
Low risk ACM (Bound in matrix). Where appropriate label with warning signs. Undertake routine inspections for damage and deterioration. Work on this material does not require a license. Work on this material may be notifiable to the appropriate enforcing authority. Disposal of asbestos waste by a licensed contractor only. All work must conform to the 'Control of Asbestos Regulations 2012'.					4			D
Reinspection Due		12 months	Actions Taken		Time Scale			Action Completed Sign & Date

Sample No:	BE003837
Item No:	24
Survey Date:	30/09/15
Building:	the hub, uckfield
Floor:	External
Room No:	external elements
Position:	to gable ends - cement verge plates
Extent:	16lm
Substrate:	Bolted, Metal
Material:	(1) Asbestos Cement
Accessibility:	(0) Usually inaccessible or unlikely to be disturbed
Asbestos Type:	(1) Chrysotile
Risk Category:	D
Recommended Action:	Low risk ACM (Bound in matrix). Where appropriate label with warning signs. Undertake routine inspections for damage and deterioration. Work on this material does not require a license. Work on this material may be notifiable to the appropriate enforcing authority. Disposal of asbestos waste by a licensed contractor only. All work must conform to the 'Control of Asbestos Regulations 2012'.

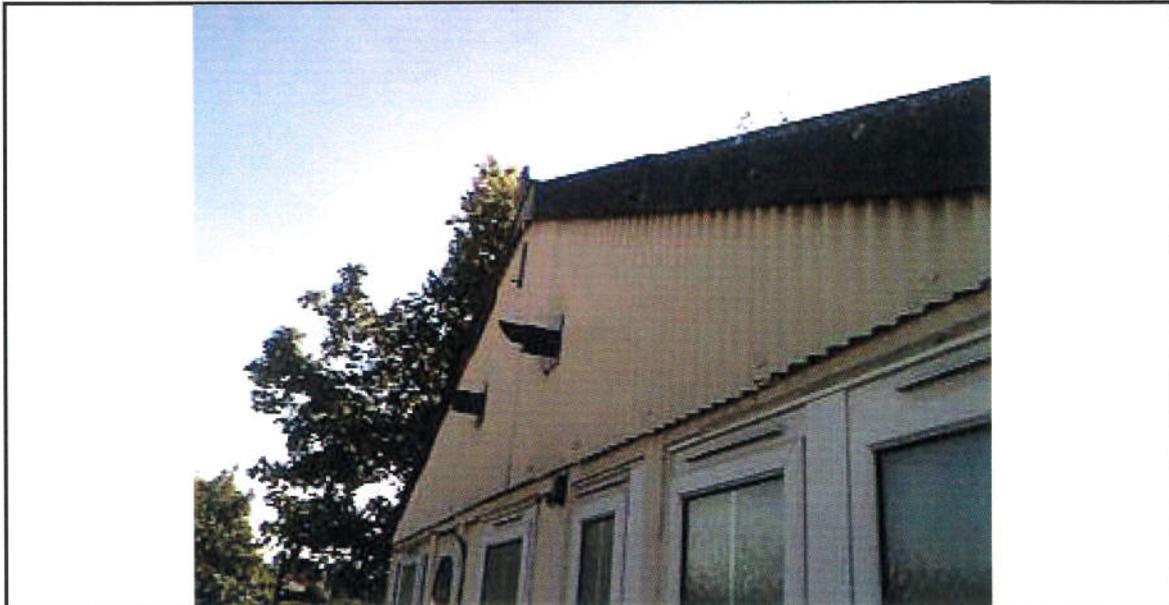
Picture 5

1.4 Sample BE003838 – Material: External cement profile sheets. Location: external elements / side cladding to gable ends. – Recommendation: Where appropriate label with warning signs and re-inspect in 12 months.

Sample ID	Building	Floor	Description	Room/Position	Extent (m2)	Fixing	Substrate	Asbestos Type Identified
BE003838	the hub, uckfield	External	cement profile sheets	external elements / side cladding to gable ends	22m ²	Bolted	Concrete	(1) Chrysotile
Recommendations					Assessment Scores			Risk Code
Low risk ACM (Bound in matrix). Where appropriate label with warning signs. Undertake routine inspections for damage and deterioration. Work on this material does not require a license. Work on this material may be notifiable to the appropriate enforcing authority. Disposal of asbestos waste by a licensed contractor only. All work must conform to the 'Control of Asbestos Regulations 2012'.					3			D
Reinspection Due	12 months	Actions Taken		Time Scale			Action Completed Sign & Date

Sample No:	BE003838
Item No:	25
Survey Date:	30/09/15
Building:	the hub, uckfield
Floor:	External
Room No:	external elements
Position:	side cladding to gable ends - cement profile sheets
Extent:	22m ²
Substrate:	Bolted, Concrete
Material:	(1) Asbestos Cement
Accessibility:	(0) Usually inaccessible or unlikely to be disturbed
Asbestos Type:	(1) Chrysotile
Risk Category:	D
Recommended Action:	Low risk ACM (Bound in matrix). Where appropriate label with warning signs. Undertake routine inspections for damage and deterioration. Work on this material does not require a license. Work on this material may be notifiable to the appropriate enforcing authority. Disposal of asbestos waste by a licensed contractor only. All work must conform to the 'Control of Asbestos Regulations 2012'.

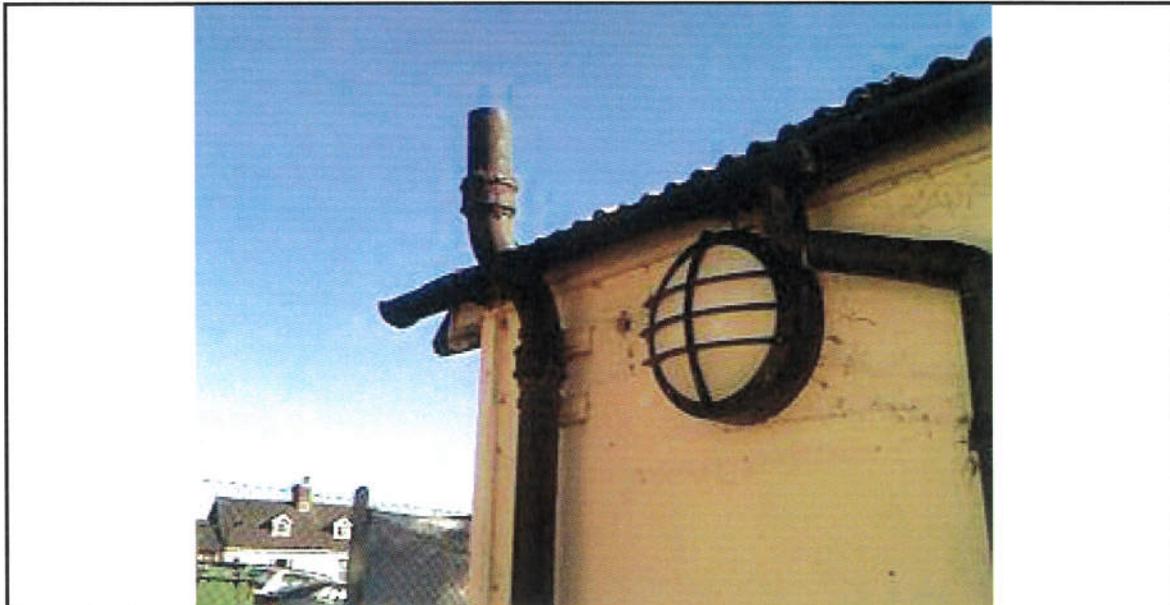
Picture 6

- 1.** The Hub: Five locations were identified as set out below:
 - 1.1** Sample BE003839 –Material : External cement soil pipe. Location: external elements / north elevation – Recommendation: Where appropriate label with warning signs and re-inspect in 12 months
 - 1.2** Sample BE003836 – Material: External cement profile sheets. Location: external elements / roof – Recommendation: Where appropriate label with warning signs and re-inspect in 12 months.

Sample ID	Building	Floor	Description	Room/Position	Extent (m2)	Fixing	Substrate	Asbestos Type Identified
BE003839	the hub, uckfield	External	cement soil pipe	external elements / north elevation	3m	Bolted	Concrete	(1) Chrysotile
Recommendations					Assessment Scores			Risk Code
Low risk ACM (Bound in matrix). Where appropriate label with warning signs. Undertake routine inspections for damage and deterioration. Work on this material does not require a license. Work on this material may be notifiable to the appropriate enforcing authority. Disposal of asbestos waste by a licensed contractor only. All work must conform to the 'Control of Asbestos Regulations 2012'.					3			D
Reinspection Due	12 months	Actions Taken		Time Scale			Action Completed Sign & Date

Sample No:	BE003839
Item No:	26
Survey Date:	30/09/15
Building:	the hub, uckfield
Floor:	External
Room No:	external elements
Position:	north elevation - cement soil pipe
Extent:	3lm
Substrate:	Bolted, Concrete
Material:	(1) Asbestos Cement
Accessibility:	(2) Easily disturbed
Asbestos Type:	(1) Chrysotile
Risk Category:	D
Recommended Action:	Low risk ACM (Bound in matrix). Where appropriate label with warning signs. Undertake routine inspections for damage and deterioration. Work on this material does not require a license. Work on this material may be notifiable to the appropriate enforcing authority. Disposal of asbestos waste by a licensed contractor only. All work must conform to the 'Control of Asbestos Regulations 2012'.

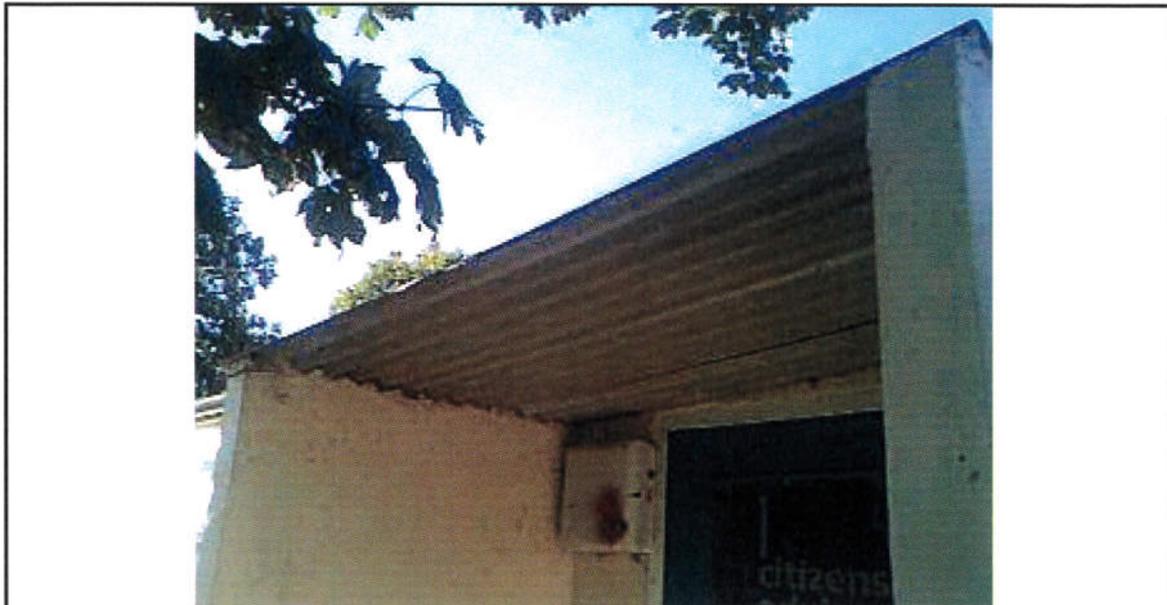
Picture 7

1.5 Sample BE003840 - Material: External cement profile sheet. Location: external elements / south canopy. Recommendation: Where appropriate label with warning signs and re-inspect in 12 months.

Sample ID	Building	Floor	Description	Room/Position	Extent (m2)	Fixing	Substrate	Asbestos Type Identified
BE003840	the hub, uckfield	External	cement profile sheet	external elements / south canopy	2m²	Bonded	Brick	(1) Chrysotile
Recommendations					Assessment Scores			Risk Code
<p>Low risk ACM (Bound in matrix). Where appropriate label with warning signs. Undertake routine inspections for damage and deterioration. Work on this material does not require a license. Work on this material may be notifiable to the appropriate enforcing authority. Disposal of asbestos waste by a licensed contractor only. All work must conform to the 'Control of Asbestos Regulations 2012'.</p>					Material	Priority	Total	
					3			D
Reinspection Due		12 months	Actions Taken		Time Scale	Action Completed Sign & Date

Sample No:	BE003840
Item No:	27
Survey Date:	30/09/15
Building:	the hub, uckfield
Floor:	External
Room No:	external elements
Position:	south canopy - cement profile sheet
Extent:	2m ²
Substrate:	Bonded, Brick
Material:	(1) Asbestos Cement
Accessibility:	(1) Occasionally likely to be disturbed
Asbestos Type:	(1) Chrysotile
Risk Category:	D
Recommended Action:	Low risk ACM (Bound in matrix). Where appropriate label with warning signs. Undertake routine inspections for damage and deterioration. Work on this material does not require a license. Work on this material may be notifiable to the appropriate enforcing authority. Disposal of asbestos waste by a licensed contractor only. All work must conform to the 'Control of Asbestos Regulations 2012'.
