**Ground & 1st Floors
'The Garth'
Launton Road
BICESTER
OX26 0JB**

Asbestos Survey Report

31st May 2012

BICESTER TOWN COUNCIL

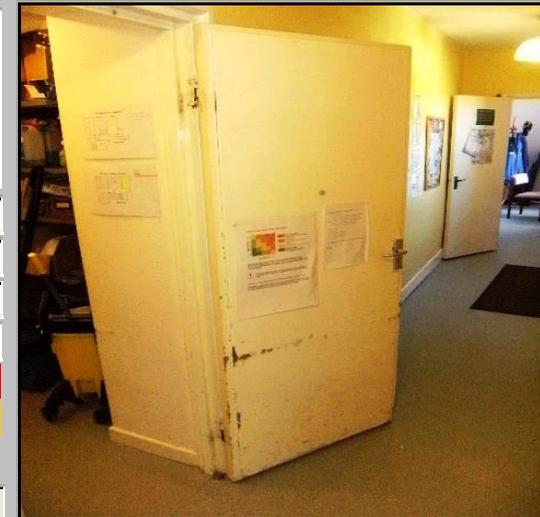
Sample 1- tested positive and contains predominantly brown asbestos fibres. This material is an area of board attached to the back of a door into a store room.

Currently it is in reasonable condition but I recommend that the door is repainted with a non water based paint to seal the surface and checked every three months for any new damage or deterioration.

Asbestos Type	<input type="text" value="Amosite (Brown)"/>	Maintenance (Type of)	<input type="text" value="Minor disturbance"/>

Material Assessment Score:	<input type="text" value="7"/>
Priority Assessment Score:	<input type="text" value="3"/>
TOTAL ASSESSMENT SCORE:	<input type="text" value="10"/>
Click here for notes on risk assessment and scores	
Proposed Action	<input type="text" value="Encapsulate"/>
Estimated Cost	<input type="text" value="£0.00"/>
Action Completed	<input type="text" value="Continue Monitoring"/>
Review Date	<input type="text" value="31-Aug-12"/>

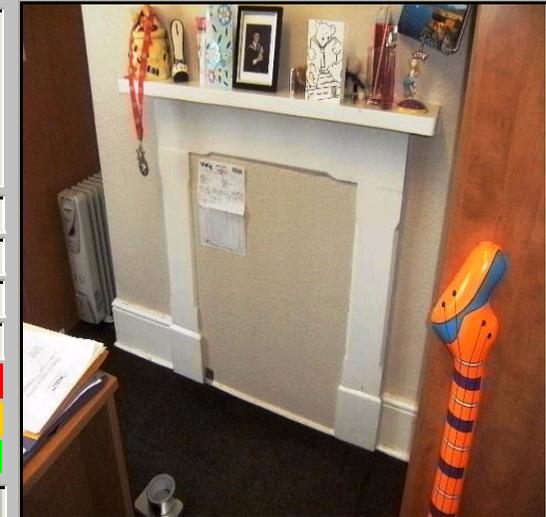
Sample 4- tested positive and contains predominantly brown asbestos fibres.

Currently the board is painted thus sealing in the fibres but due to its position it could be vulnerable to impact and fibre release.

I recommend the area is checked every three months for any new damage or deterioration.

Exposure (Freq of Use)	<input type="text" value="Infrequent"/>
Exposure (No of Occupants)	<input type="text" value="1 to 3"/>
Maintenance (Frequency of)	<input type="text" value="Unlikely to be disturbed"/>
Maintenance (Type of)	<input type="text" value="Minor disturbance"/>

Material Assessment Score:	<input type="text" value="6"/>
Priority Assessment Score:	<input type="text" value="3"/>
TOTAL ASSESSMENT SCORE:	<input type="text" value="9"/>
Click here for notes on risk assessment and scores

Proposed Action	<input type="text" value="Monitor"/>
Estimated Cost	<input type="text" value="£0.00"/>
Action Completed	<input type="text" value="Continue Monitoring"/>
Review Date	<input type="text"/>
