# **Cooper & Withycombe**

**The Harlington  
236 Fleet Road  
Fleet  
Hampshire  
GU51 4BY**

## **Condition Survey Report**

**January 2020**

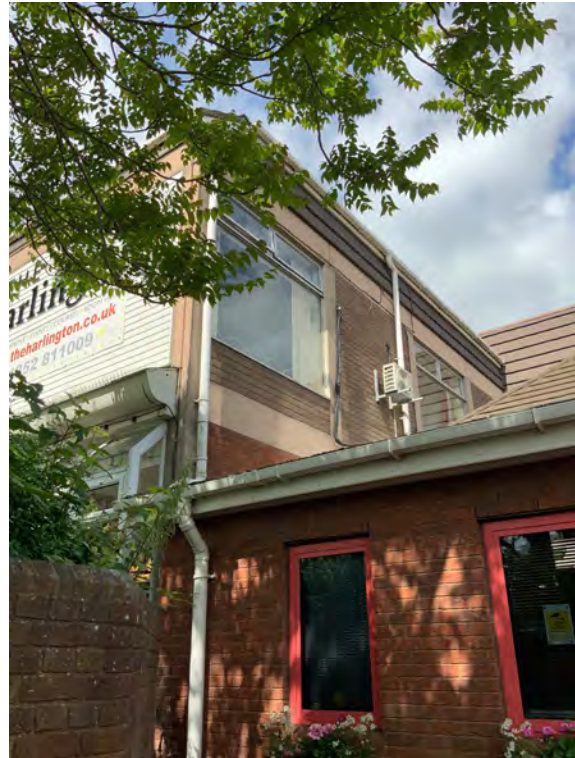
P5 Stained area of roof above function room, due to damaged gutter above

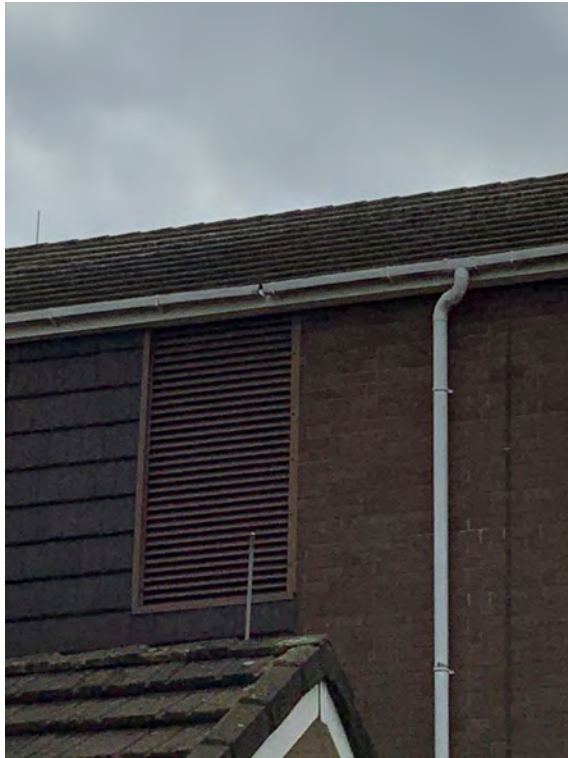
P8 North-east elevation of The Point. Damaged gutter to left hand side of front door.

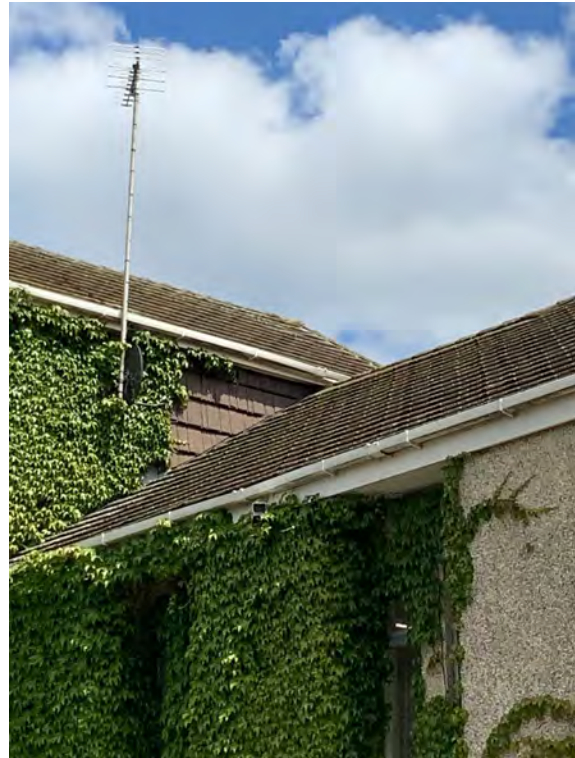
P9 Gap in gutter to north-east elevation of high level function room

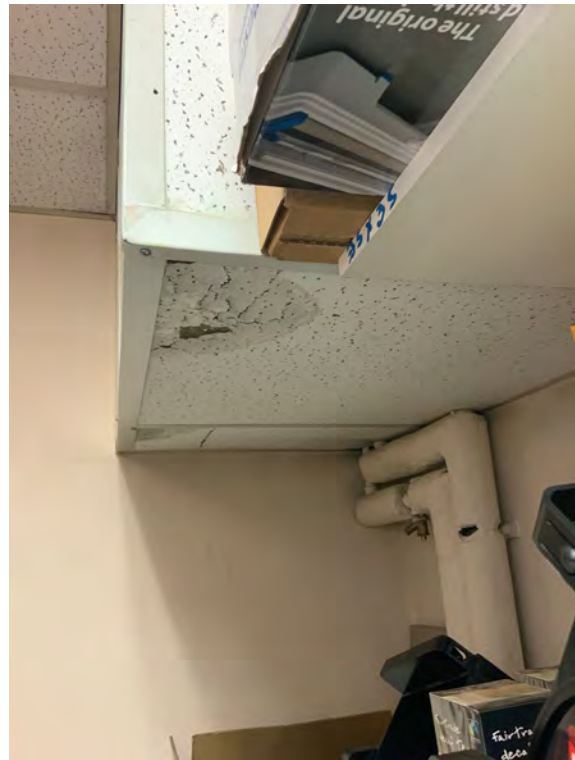
P37 Store Room adjacent RVS – L shaped crack around ceiling board

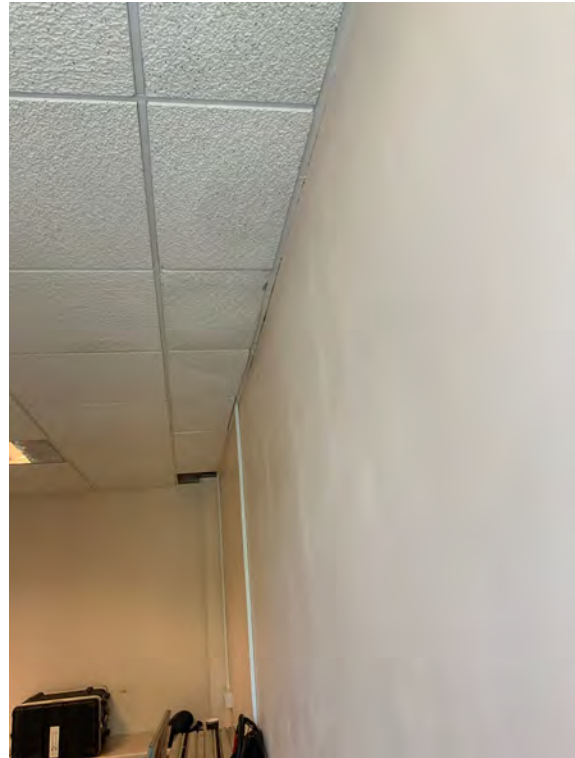
P50 First Floor, Meeting Room Corridor –  
Ceiling, stepped crack outside electrical  
cupboard

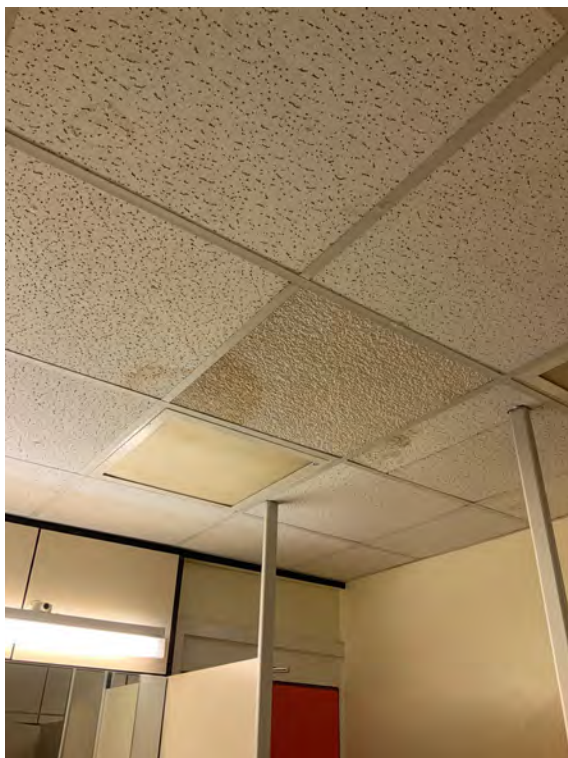
P51 Foot Clinic – Previous water leak

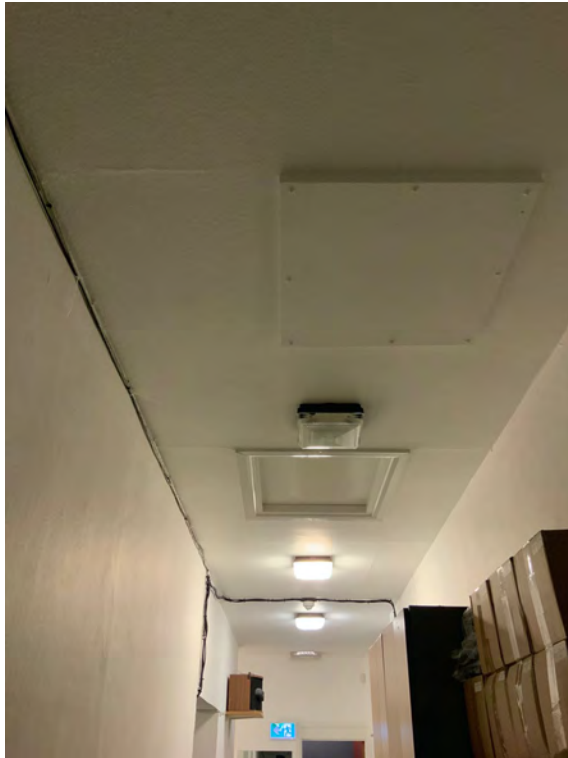
P53 Main Office – Joint cracking to edges of  
vaulted ceiling

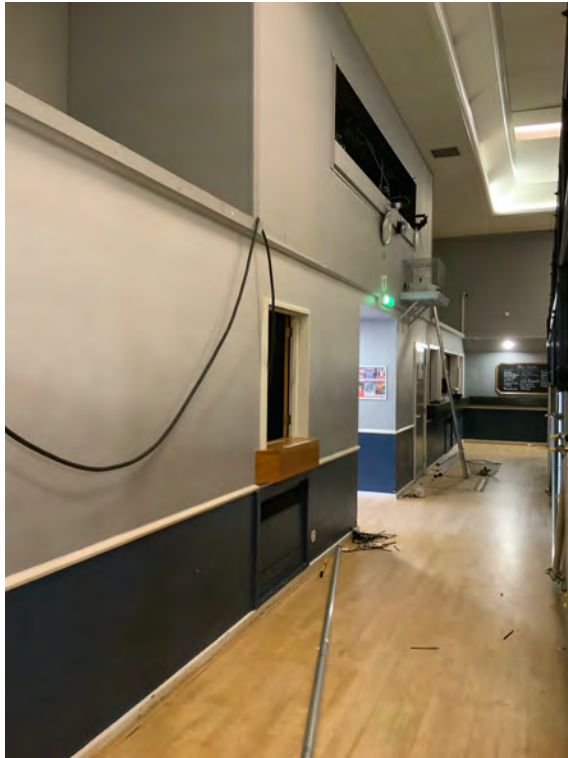
P61 Stage Store – Missing area of ceiling  
due to drainage

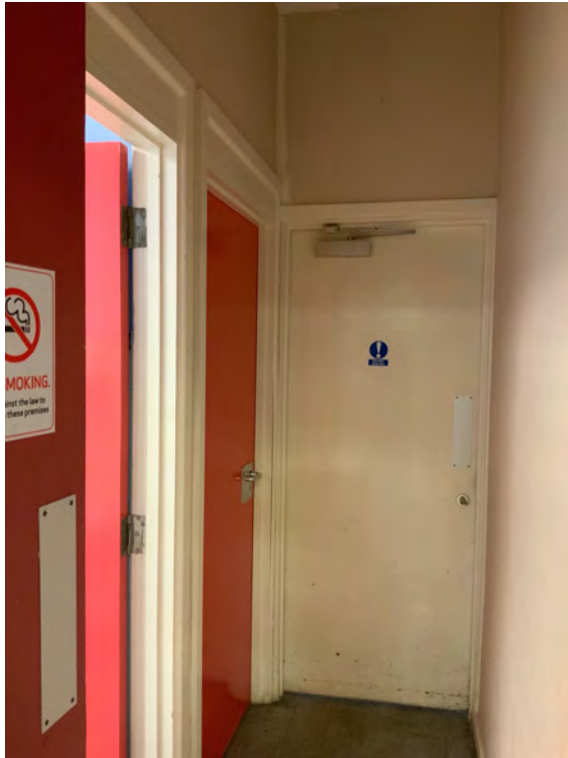
P65 RVS , Toilet Lobby – Crack from floor to ceiling.

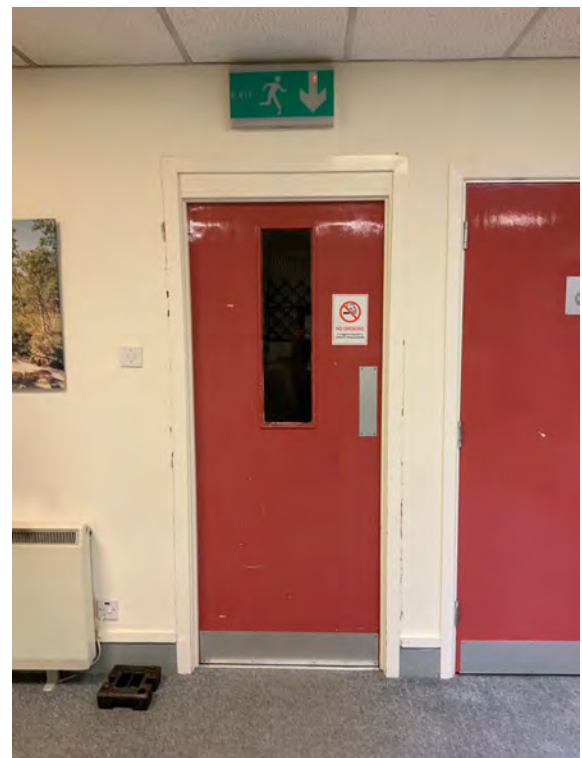
P68 RVS Main Dining Room – Vertical crack from ceiling to floor.

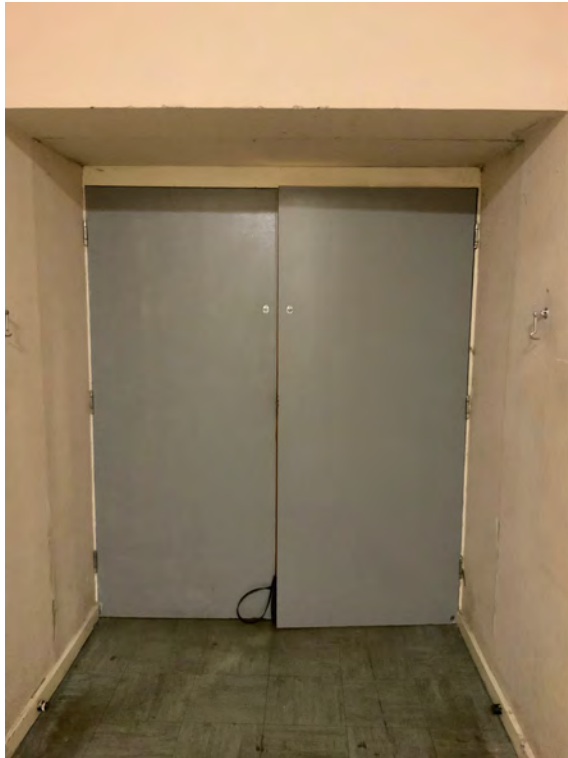
P69 RVS – Impact damage around door frame leading to toilet lobby

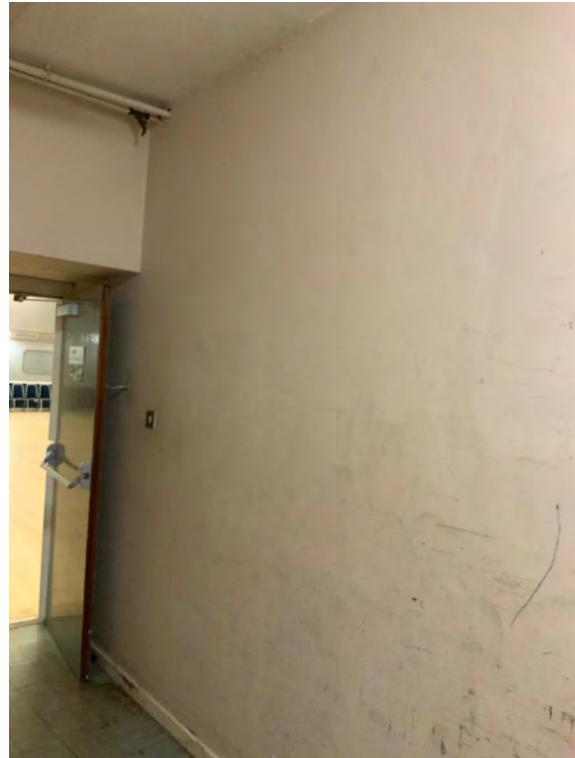
P70 Cracking either side of the access panel in bulkhead to the corridor leading to outside from the auditorium

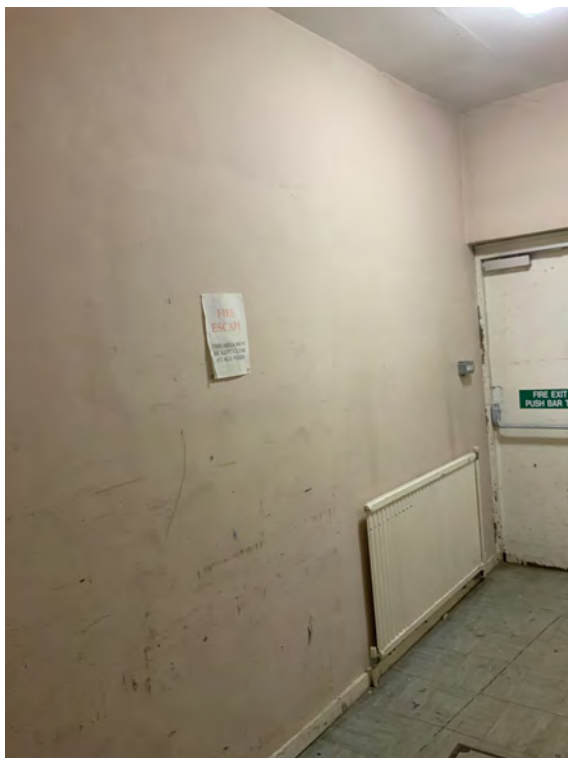
P71 Corridor from auditorium to outside – cracking on the left hand wall

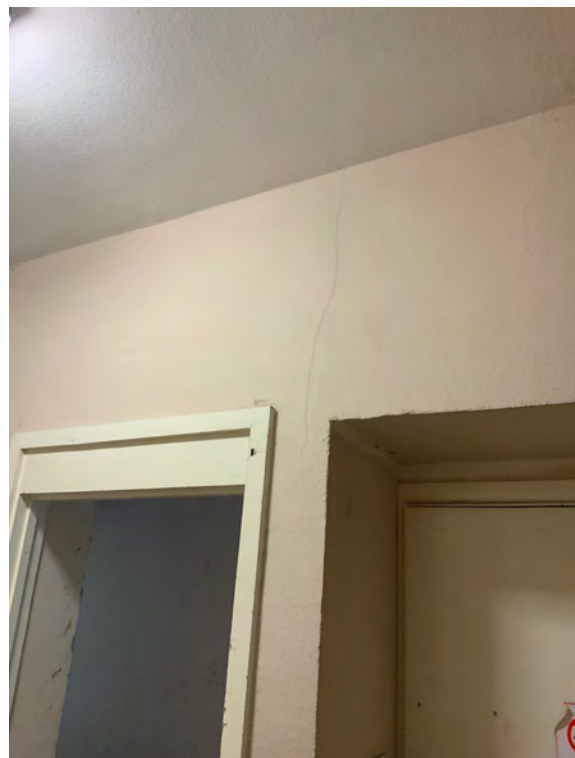
P72 Corridor from auditorium to outside – Cracking to left hand wall

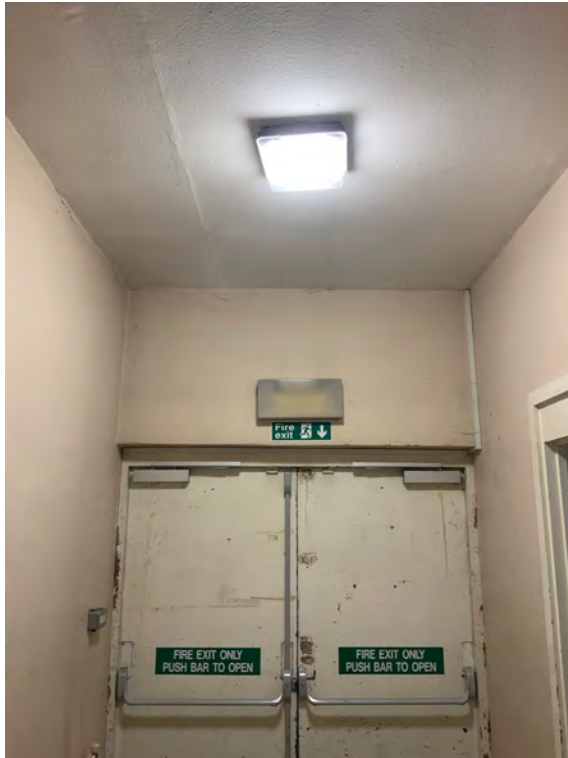
P73 Corridor from auditorium to outside - Crack to right hand wall between doors

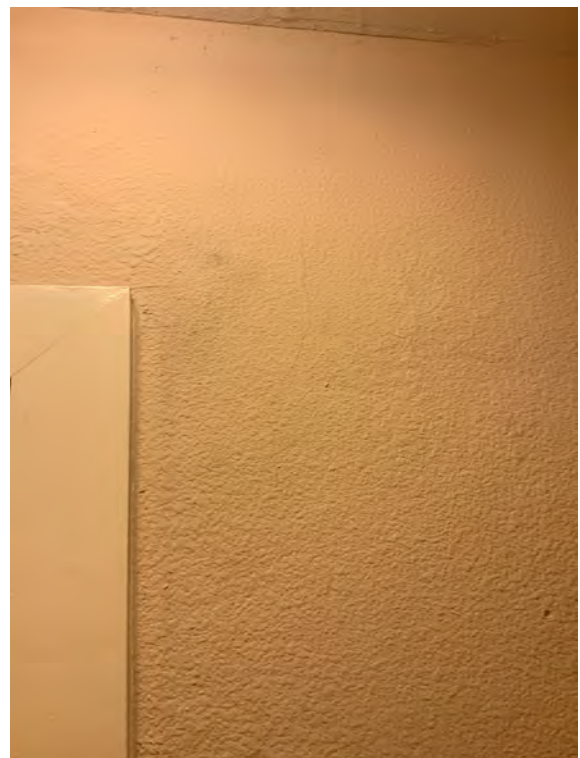
P80 First Floor Store – Hairline crack to wall to lobby

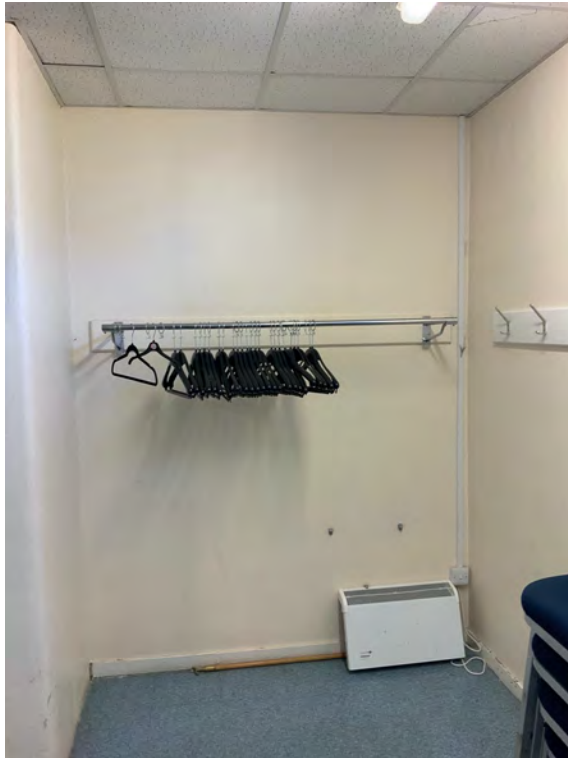
P102 Dressing Room 2 - Horizontal crack  
behind TV

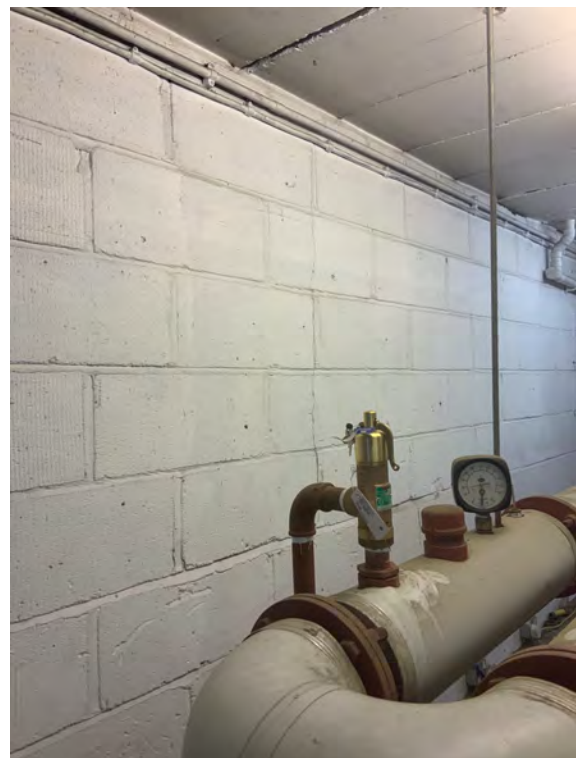
P105 Dressing Room Kitchenette – Running water staining to walls, likely due to lack of ventilation

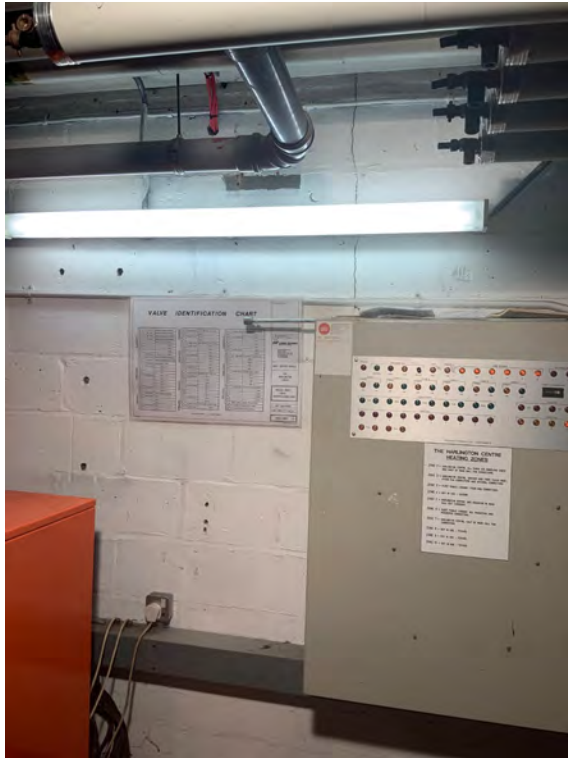
P106 Boiler Room – Hairline crack behind the boiler. These cracks are replicated at approx. 1m intervals along the wall

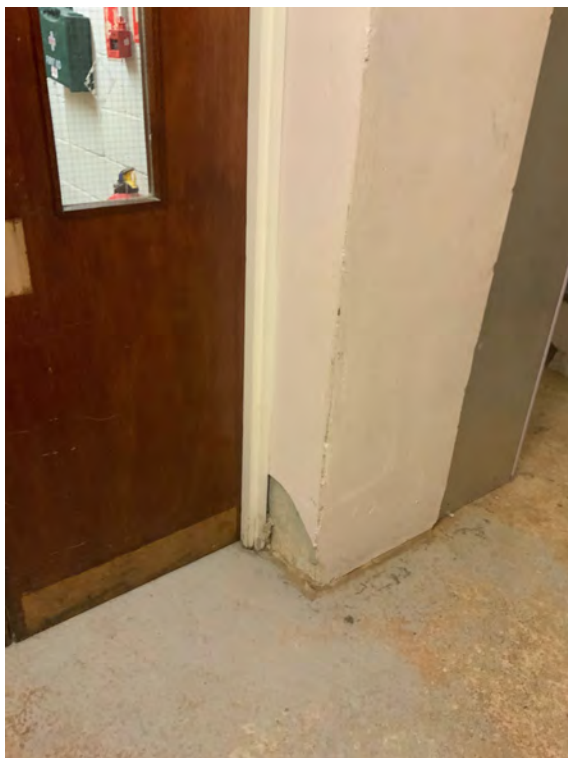
P108 Boiler Room – Ad hoc brickwork beneath door

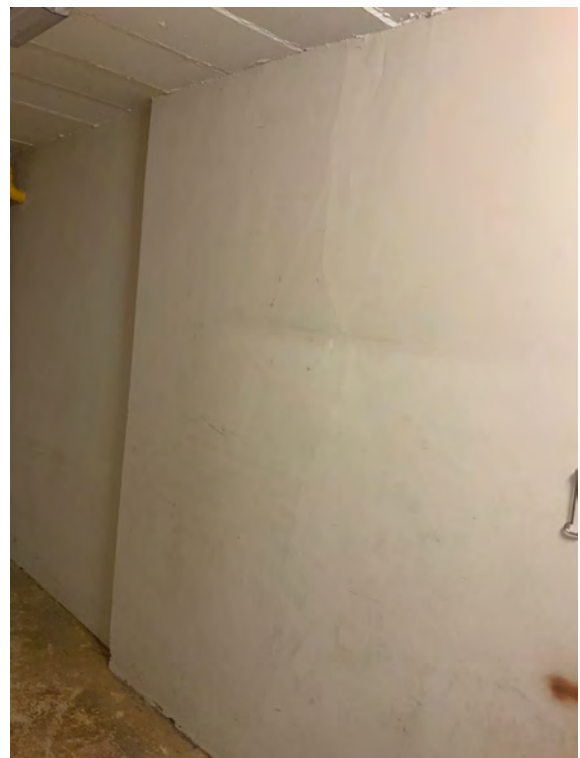
P109 Basement Main Lobby – Area of plaster missing from bottom of door and isolated areas of impact damage

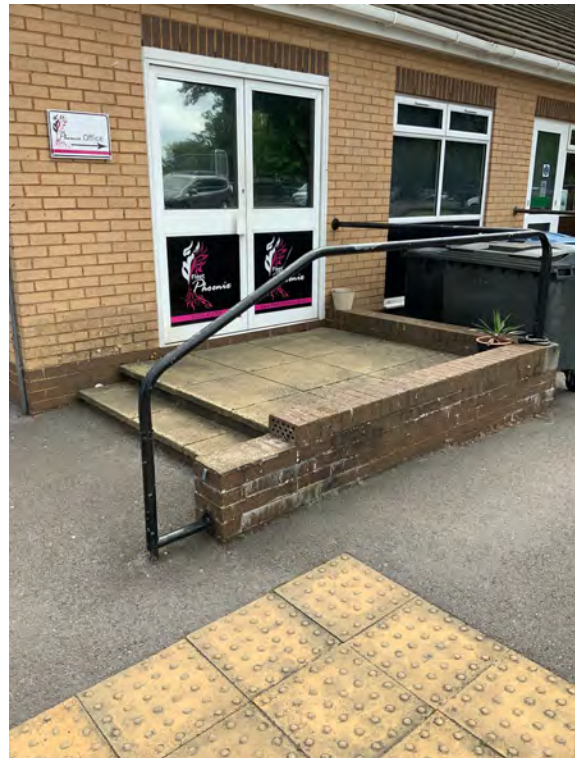
P195 Deteriorating concrete step to north-east elevation plant room, adjacent changing room. The gulley is filled with leaves

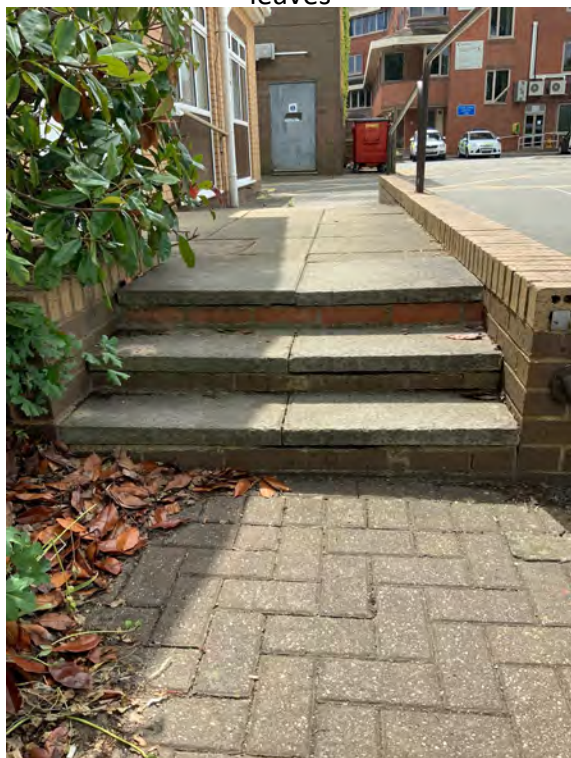
P196 North-west elevation steps to the rear of The Point. Six missing bricks and handrails would benefit from redecoration.
