the play inspection company

Annual Inspection

Central Swindon North Parish Council

St Marks Park

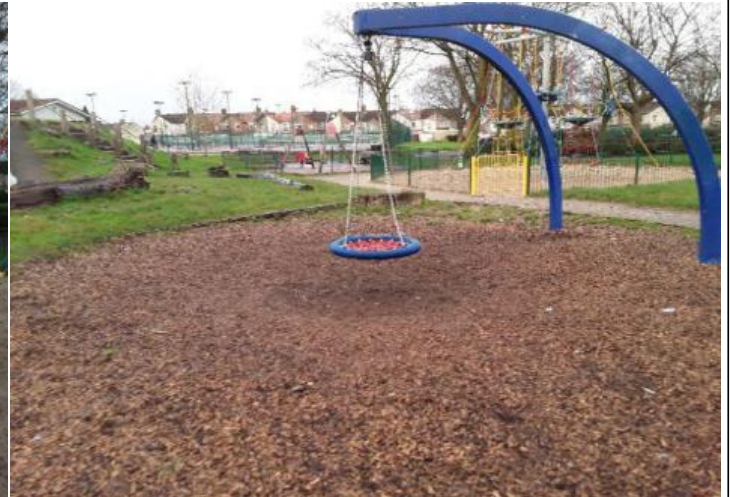
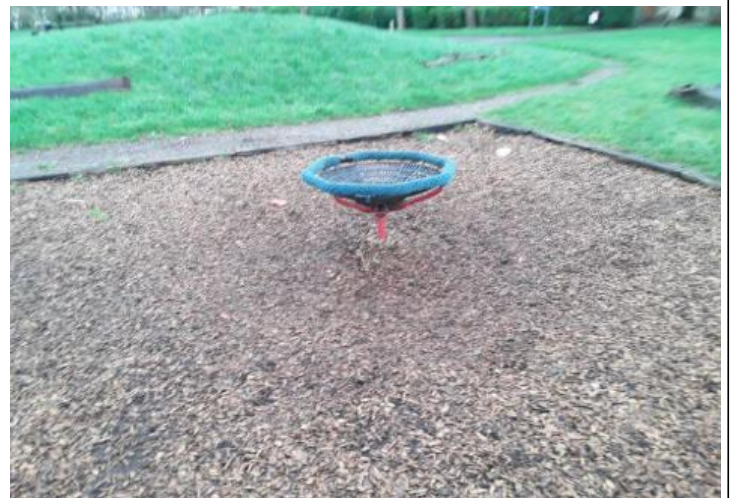
Finding: The loose fill surfacing has become displaced around some of the equipment

Action: Reinstall the surface

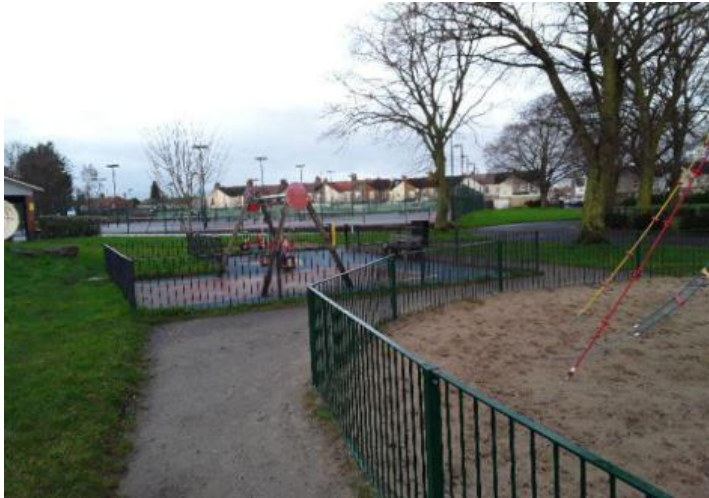
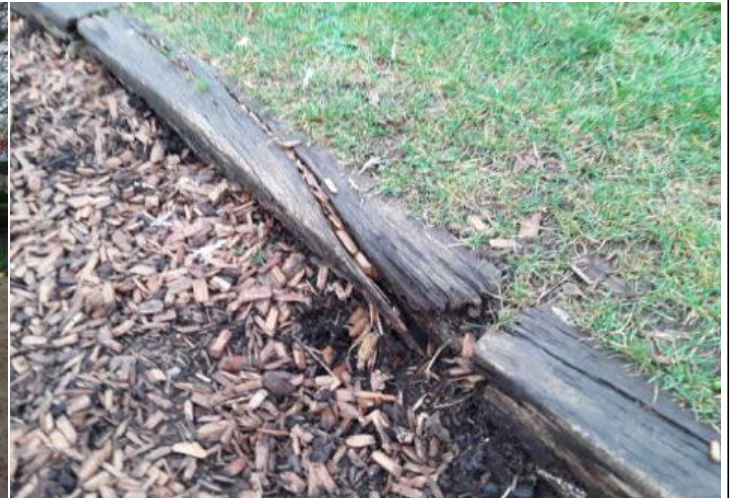
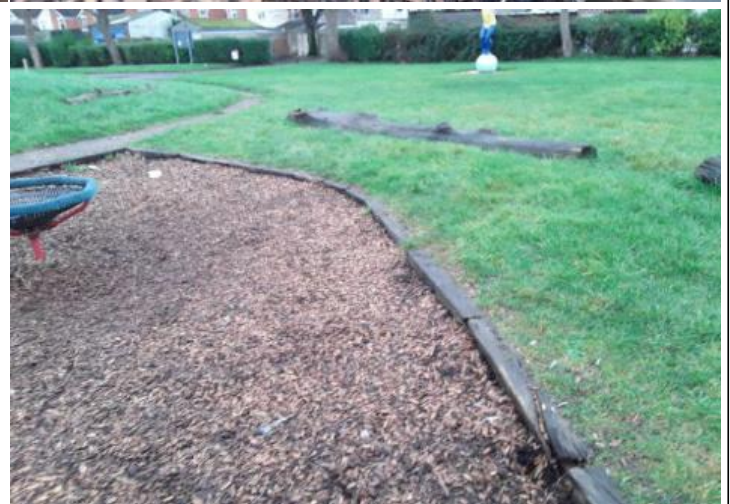
Finding: There are areas or parts of the timber edging that have rotted

Action: Replace all affected timbers

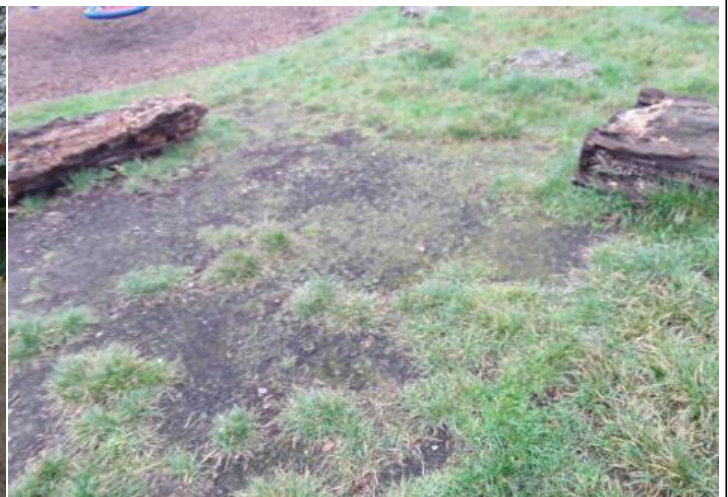
Finding: There is algae, silt or moss growth on the surface resulting in slippery conditions
Action: Clean and treat appropriately

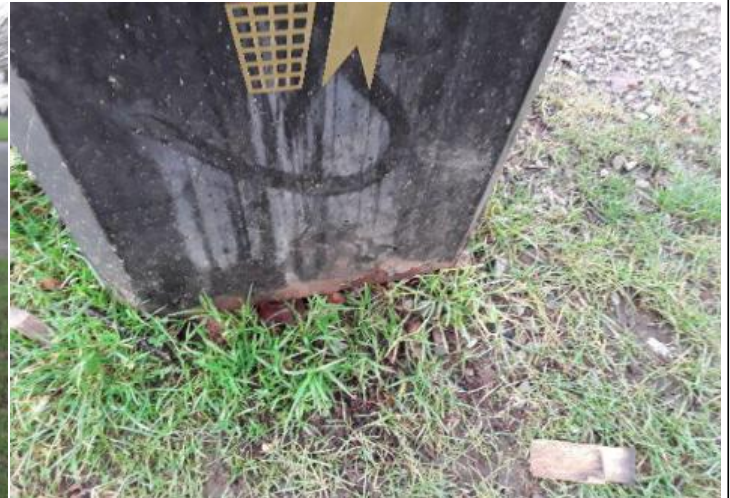
Finding: The paintwork on this item has been damaged or worn exposing the metal underneath which is rusting / corroding

Action: Treat affected areas and repaint

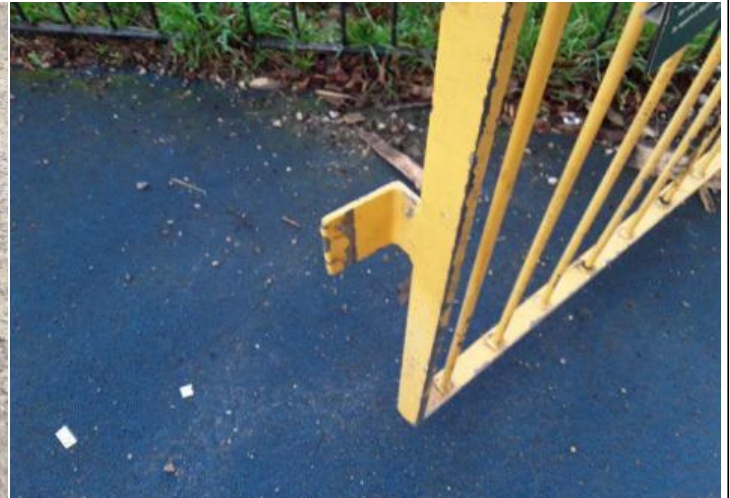
Finding: The rubber buffer is missing from the latch plate

Action: Replace rubber buffer

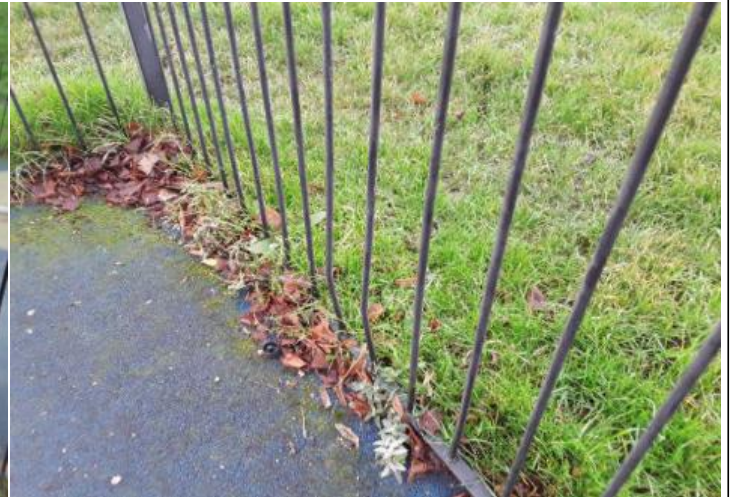
Finding: There is some damage to the fence sections

Action: Monitor for any further deterioration and repair as required

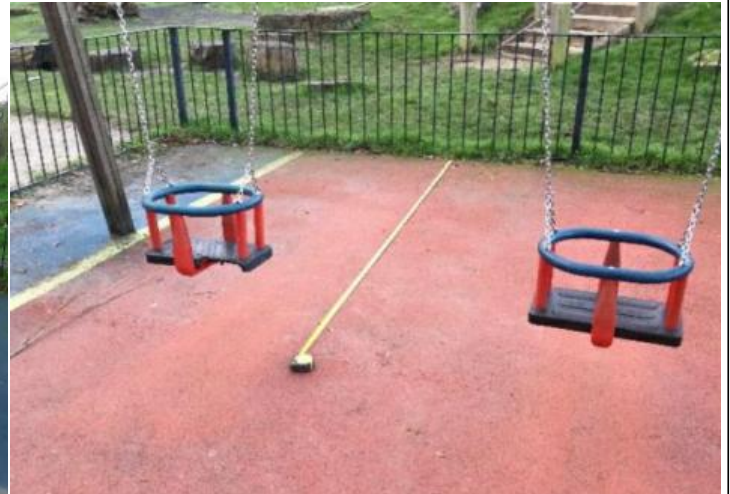
Finding: BS EN 1176 requires an additional 0.5m of unobstructed space at each end of the swing surfacing area. This is a relatively low risk finding and no remedial action is recommended at this point.

Action: Monitor - No remedial work recommended

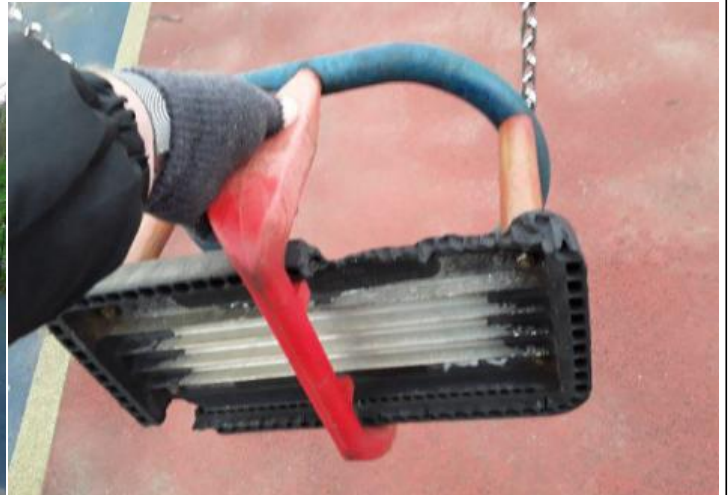
Finding: The seat is damaged and requires replacing

Action: Replace damaged seat

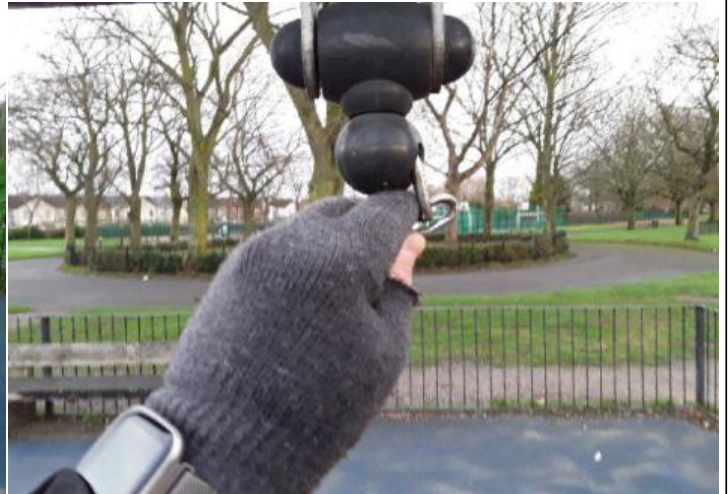
Finding: There is some notable evidence of chain wear

Action: Monitor for any further deterioration and replace when 40% worn

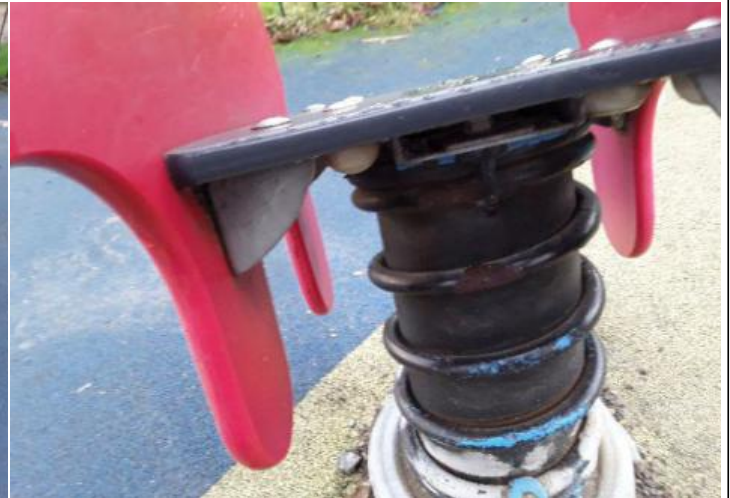
Finding: The paintwork on the spring has been damaged or worn exposing the metal underneath which is rusting
Action: Treat any rusting components and repaint

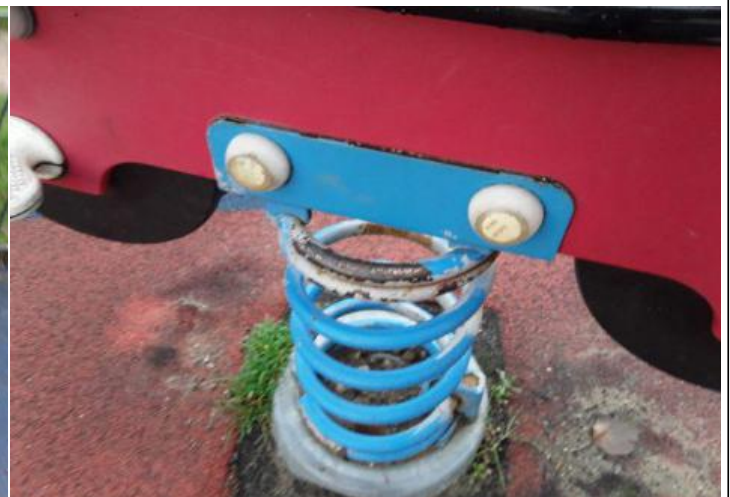
Finding: The paintwork on the spring has been damaged or worn exposing the metal underneath which is rusting
Action: Treat any rusting components and repaint

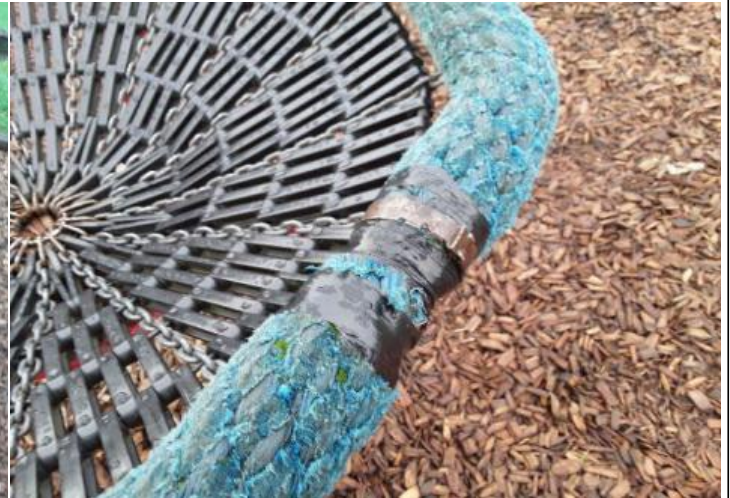
Finding: The rubber rim cover is missing exposing sharp edges

Action: Replace the rim cover

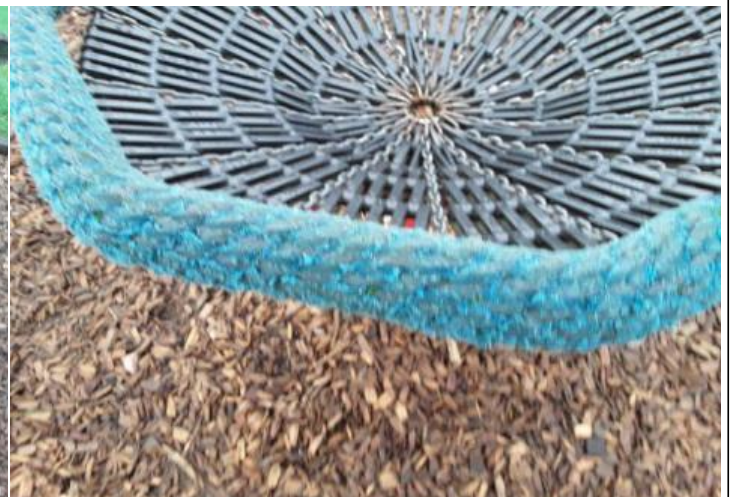
Finding: The ropes/nets are worn/damaged in places

Action: Monitor for any further deterioration and repair or replace as required

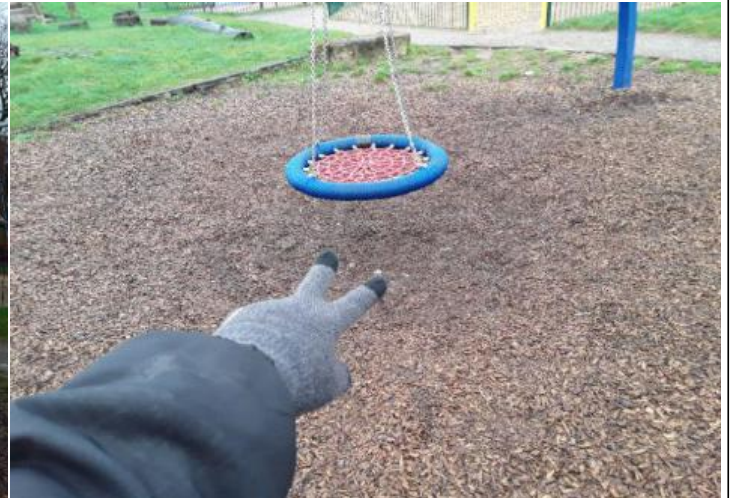
Finding: The exposed stone sub base forms a hard object within the impact area of the equipment in contravention of the requirements of BS EN 1176 Part 1

Action: Top up loose fill to correct levels to cover the sub base

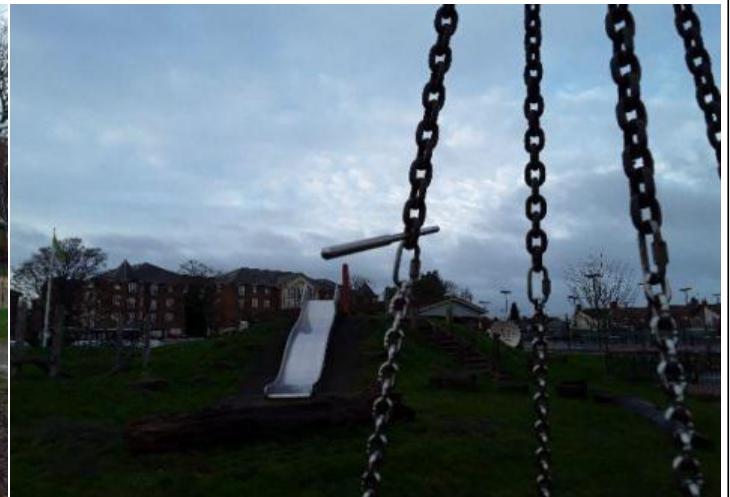
Finding: The connecting links are in excess of 8.6mm and less than 12mm and fail the requirements of BS EN 1176 Part 1; clause 4.2.13, Chains

Action: Monitor - No remedial work recommended

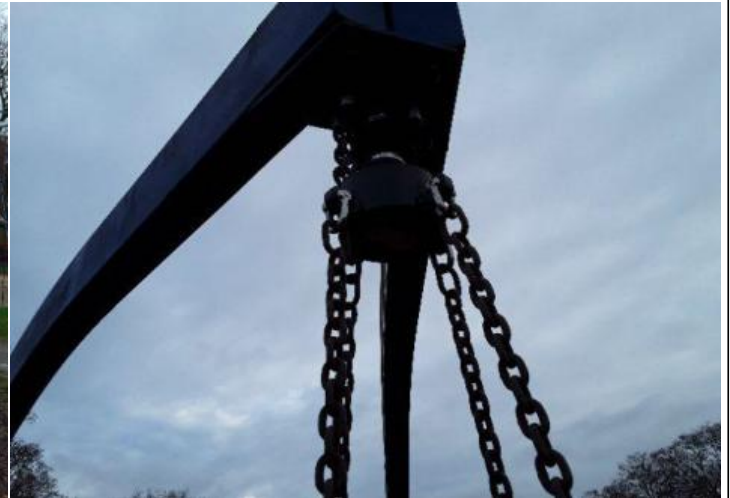
Finding: There is some notable evidence of chain wear

Action: Monitor for any further deterioration and replace when 40% worn

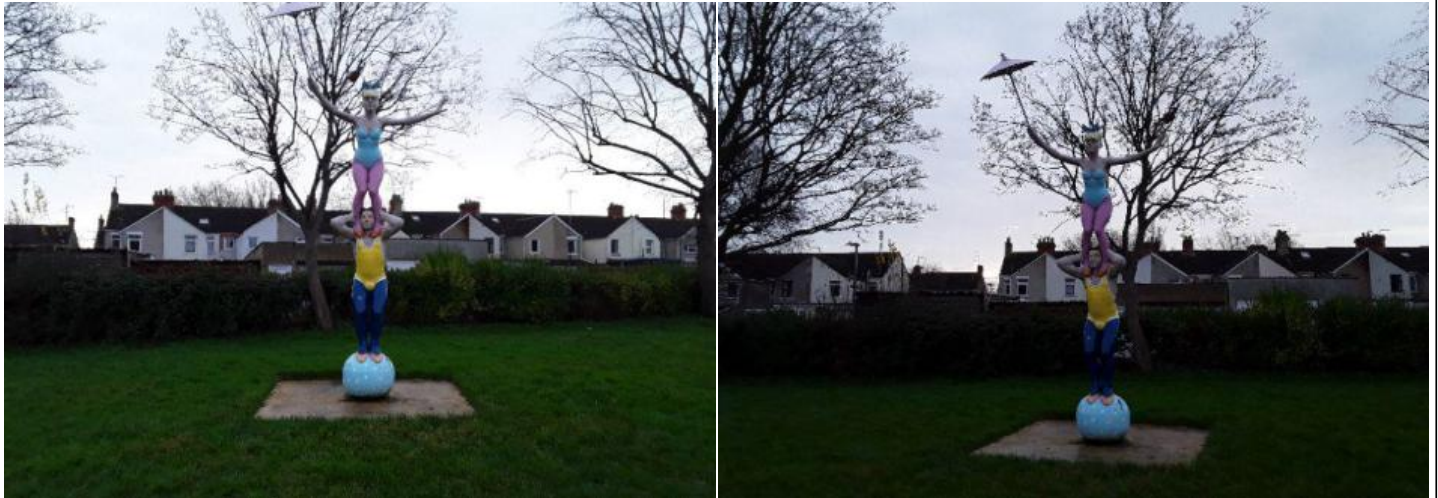
Finding: The fixings or components for this item were in excess of 2.5m above the standing surface and could not be fully accessed by the inspector. We have completed a visual inspection of the fixings from ground level but a maintenance inspection should be undertaken to assess the condition, security and wear of the components at intervals in accordance with the manufacturers recommendations.

Action: Inspect in accordance with the manufacturers recommendations

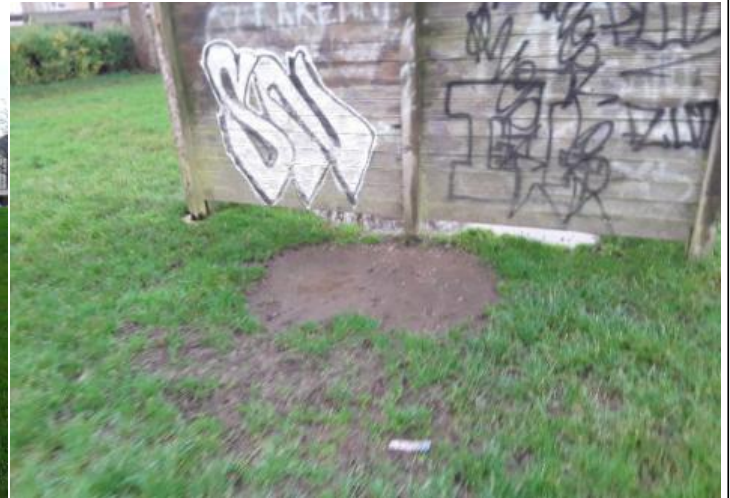
Finding: The surface has eroded in some areas and may be slippery in wet conditions
Action: Reinstate the surface

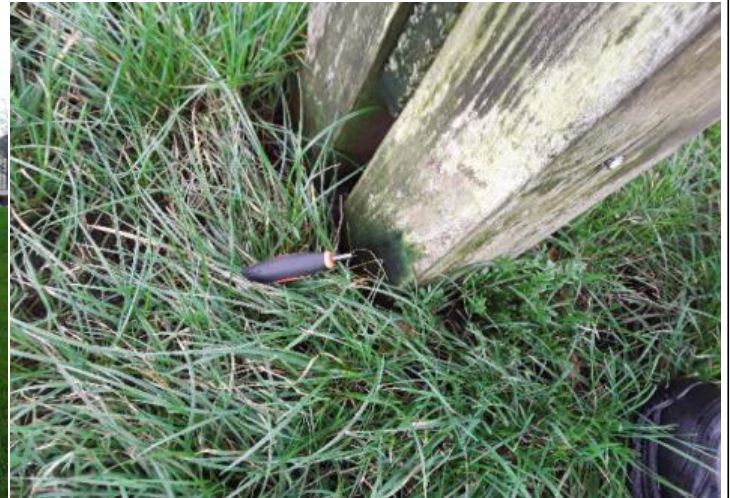
Finding: There is some evidence of rot in the timber

Action: Monitor for any further deterioration and replace as required

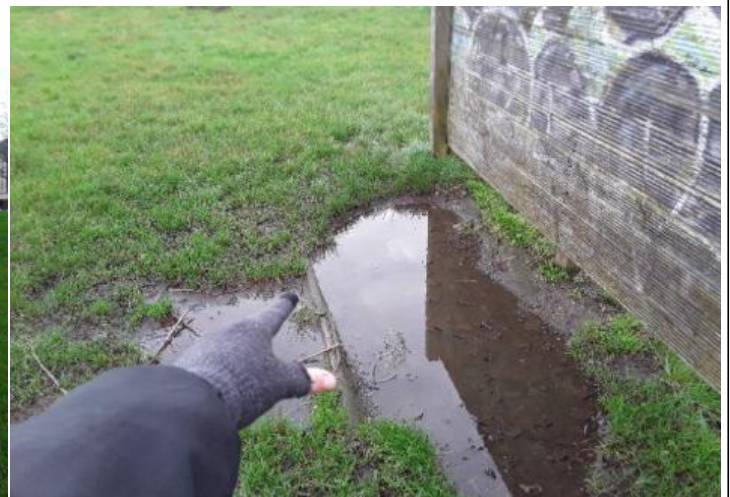
Finding: The surface is damaged and subsiding exposing timber edging

Action: Replace

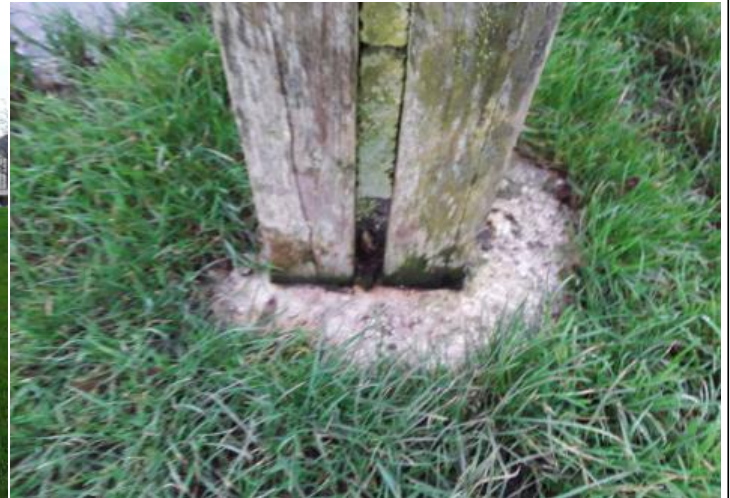
Finding: There is some strimmer / machinery damage apparent on the posts, this can penetrate the preservative applied to the timber and accelerate the rotting process

Action: Monitor for any deterioration (rot) and replace as required

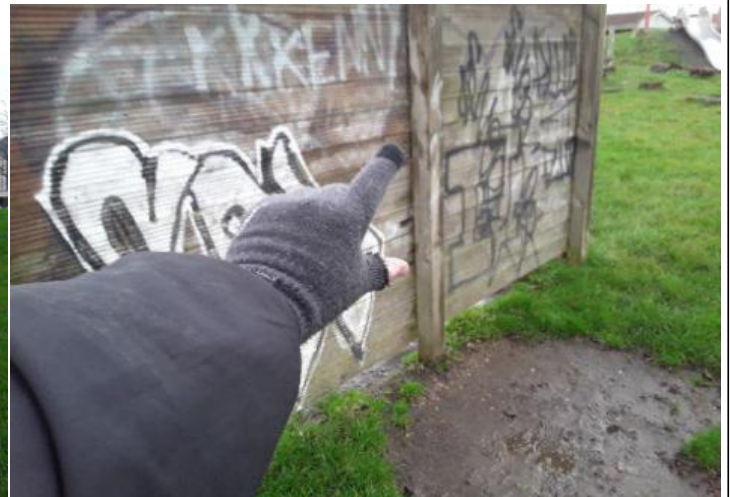
Finding: There is or are fixings missing on the item

Action: Replace all missing fixings

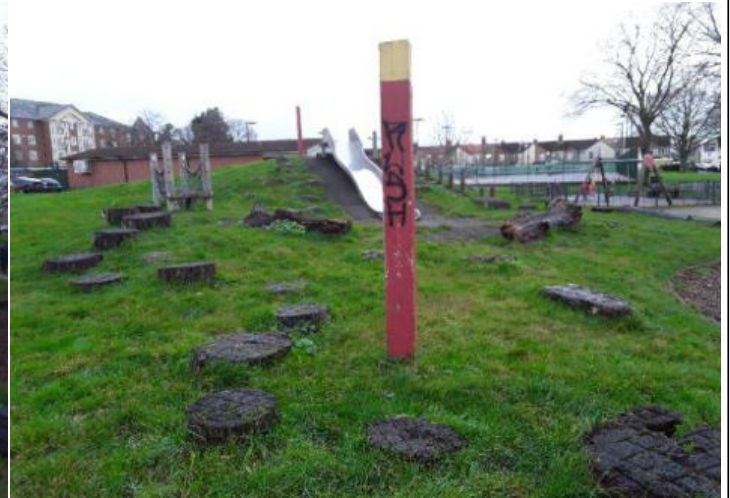
Finding: This item of equipment relies on a single post, or a line of posts, for stability and extra care needs to be taken with equipment of this nature to avoid the potential for catastrophic failure
Action: Ensure that regular detailed inspections are undertaken to assess for rot, corrosion and general stability

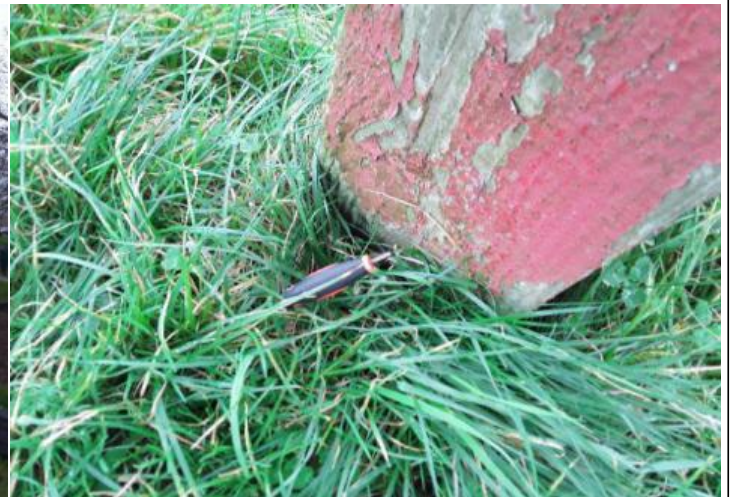
Finding: There is some evidence of rot in the timber
Action: Monitor for any further deterioration and replace as required

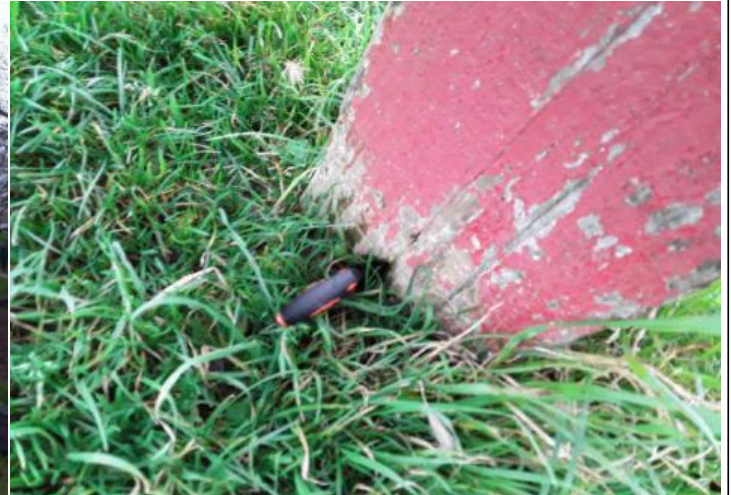
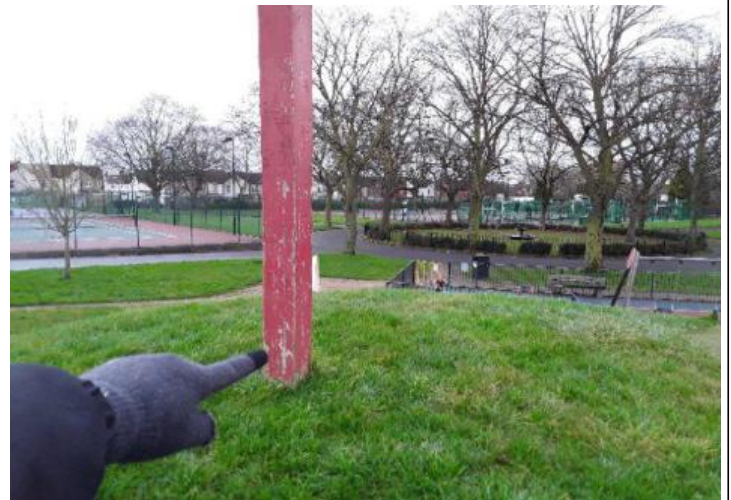
Finding: There are areas or parts of 1x timber post on the that have rotted

Action: Replace all affected timbers

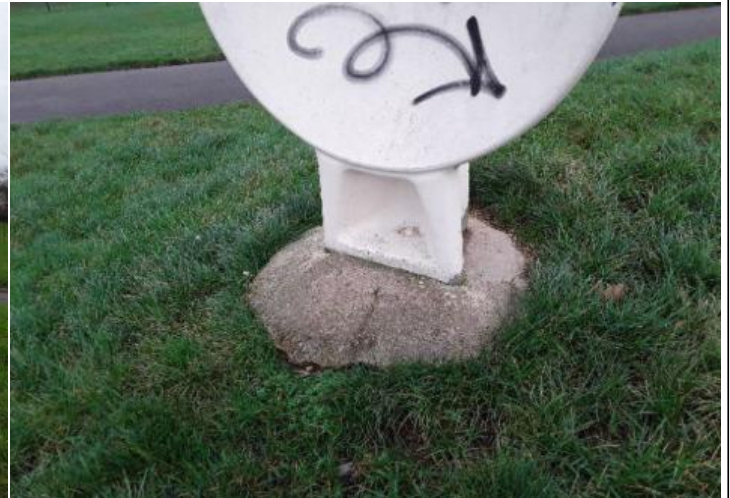
Finding: The surface has eroded and the foundations are exposed

Action: Reinstate surrounding surfaces to cover the foundations

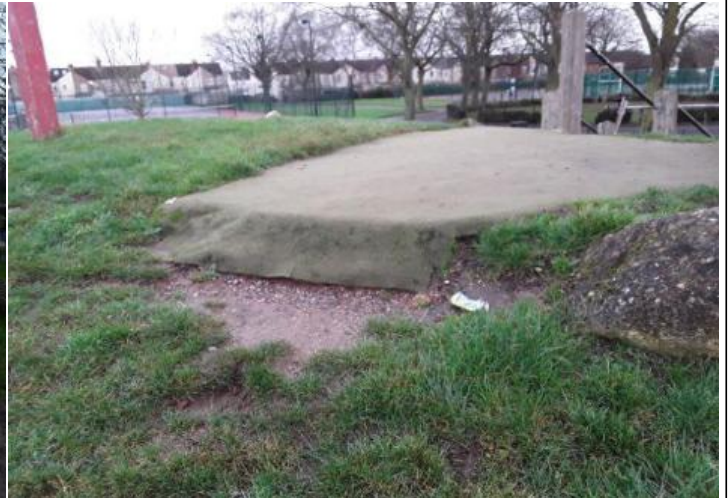
Finding: There are trip hazards at the edges of the surface

Action: Reinstate surrounding surface levels to remove the trip points

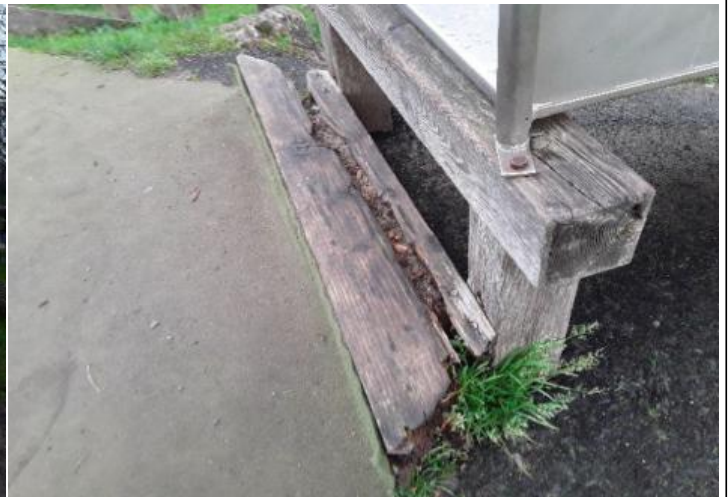
Finding: There are areas or parts of the timber on the structure that have rotted

Action: Replace all affected timbers

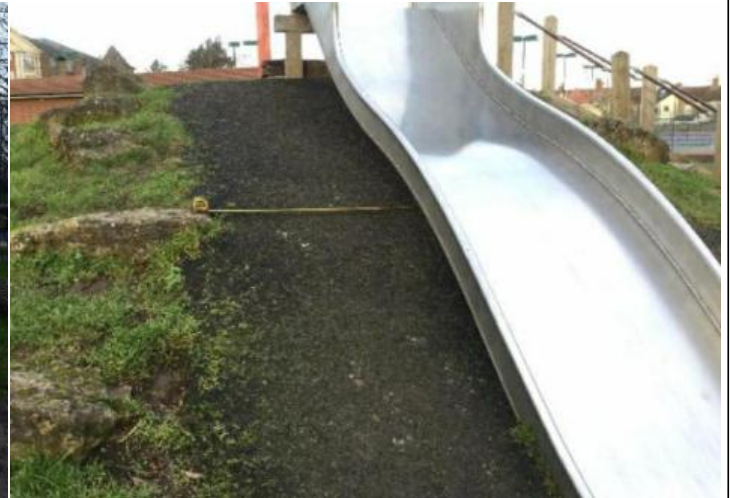
Finding: The boulder forms a hard object within the free space of the equipment in contravention of the requirements of BS EN 1176 Part 1

Action: Monitor - No remedial work recommended

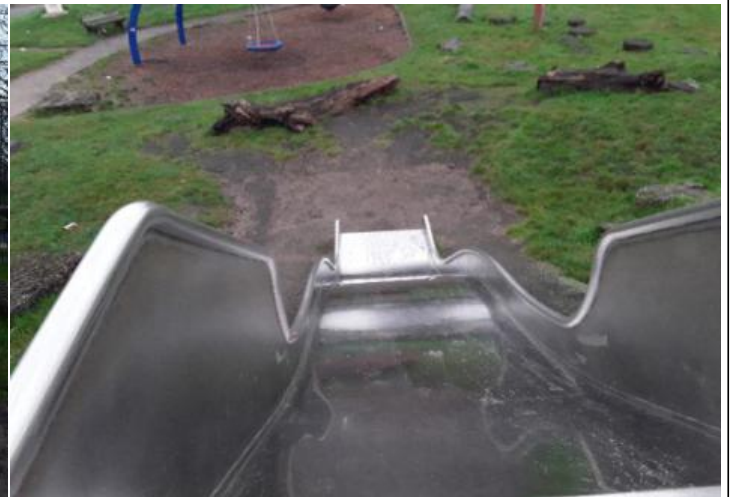
Finding: There are a number of dents in the slide surface

Action: Monitor for any further deterioration and repair as required

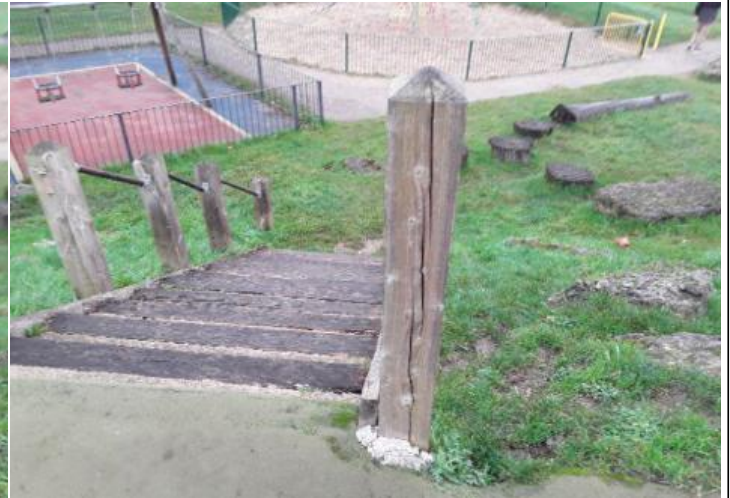
Finding: The timber has a number of splits/shakes or air cracks and this may affect the stability or allow water ingress which will accelerate the rotting process

Action: Monitor to ensure the splits do not cross through fixing points of the structure and/or cause any instability

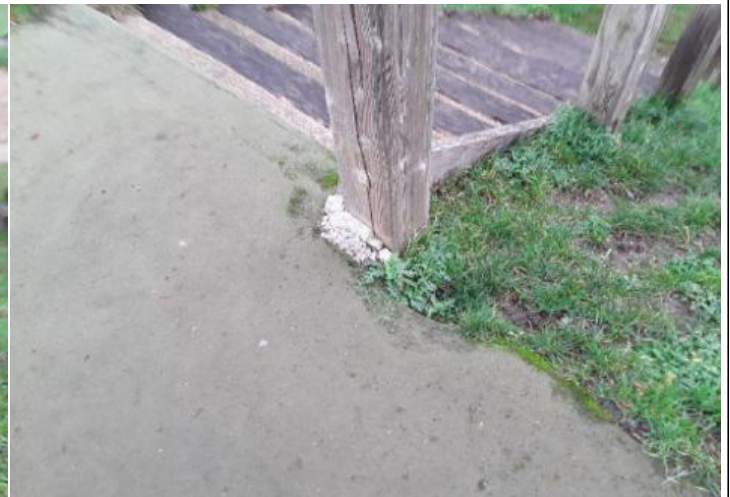
Finding: There are trip hazards present

Action: Reinstate surrounding surfaces to level to remove the trip points

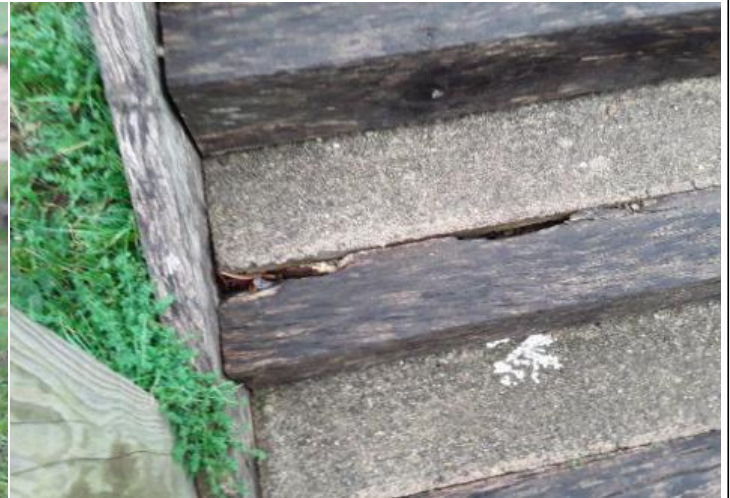
Finding: There is some evidence of rot in the timber

Action: Monitor for any further deterioration and replace as required

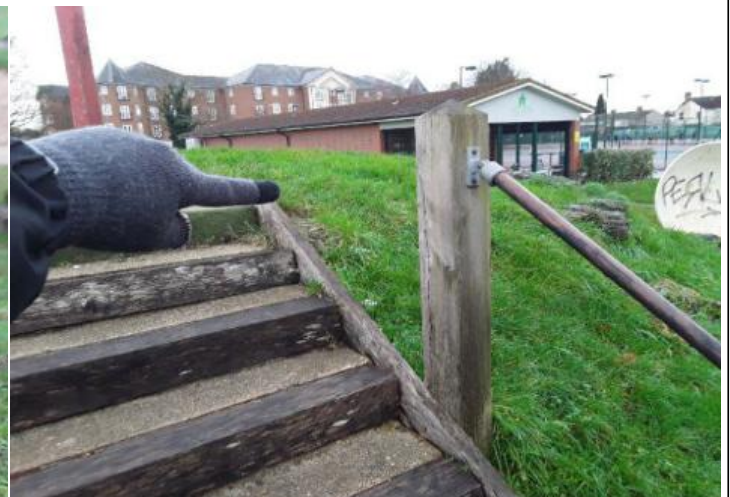
Finding: The item has missing component(s)

Action: Consider replacing missing components

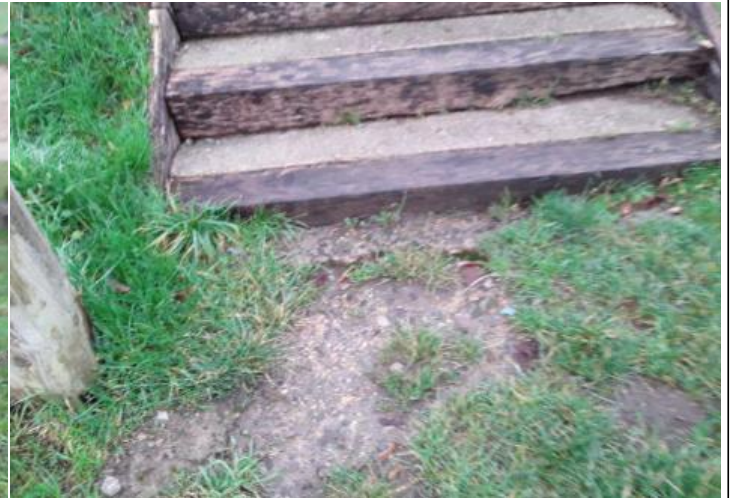
Finding: The surface has eroded and the foundations are exposed

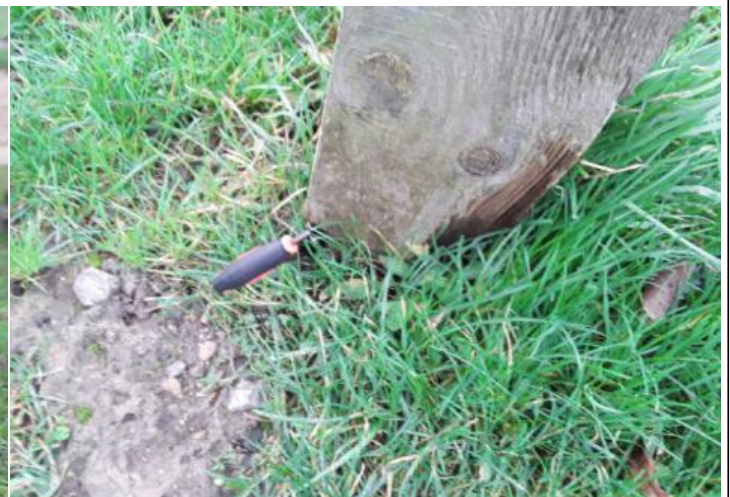
Finding: There is some evidence of rot in the timber posts

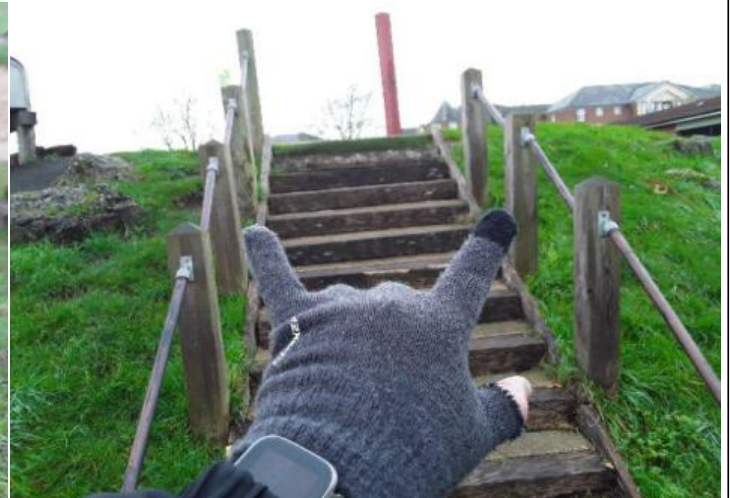
Finding: The item is slightly loose in its foundations

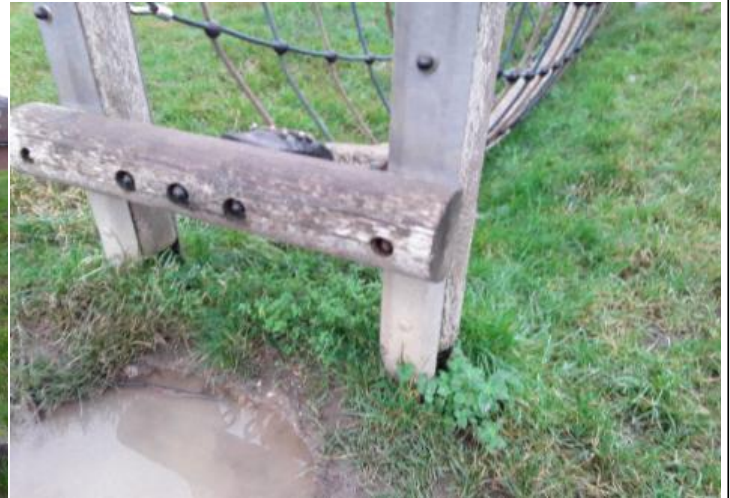
Finding: There is/are bolt cap covers missing or damaged on the item

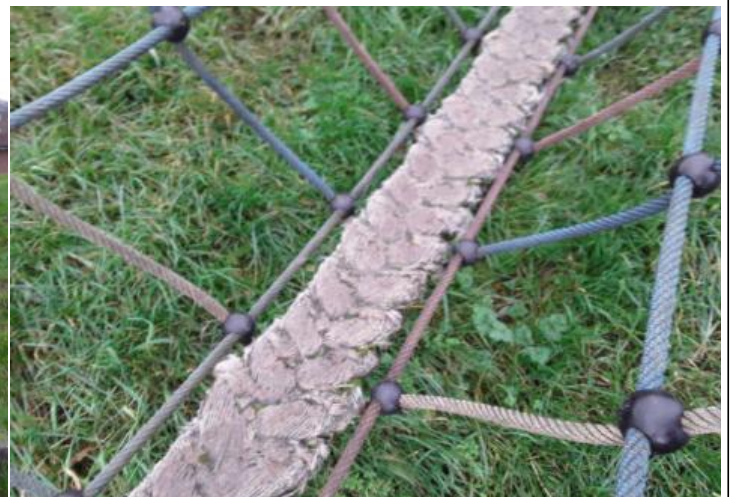
Finding: The ropes/nets are worn/damaged in places

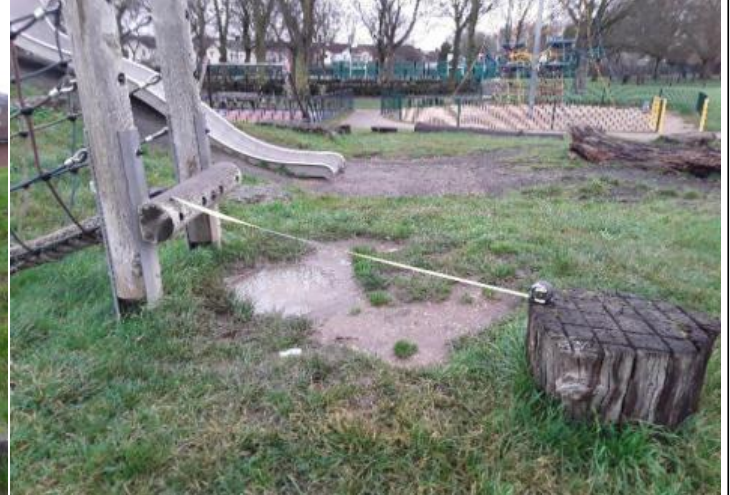
Finding: The adjacent item forms a hard object within the falling space of the equipment in contravention of the requirements of BS EN 1176 Part 1

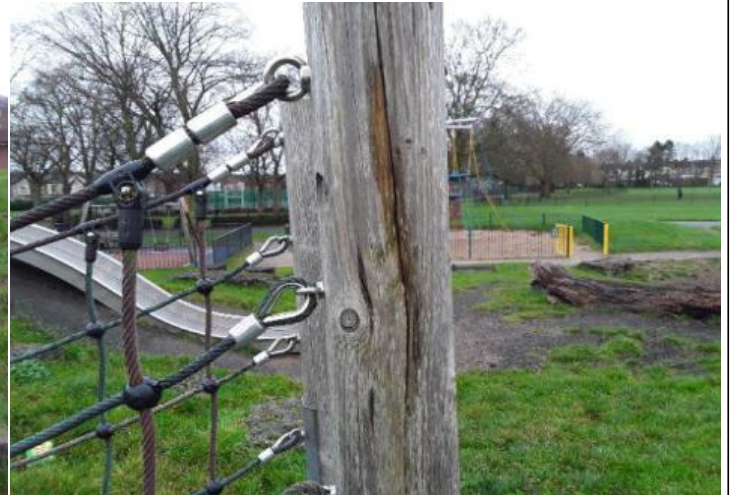
Finding: The timber has a number of splits/shakes or air cracks and this may affect the stability or allow water ingress which will accelerate the rotting process

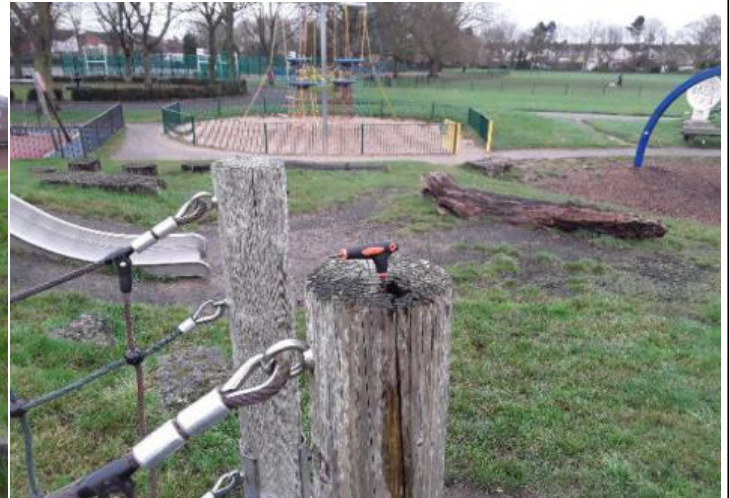
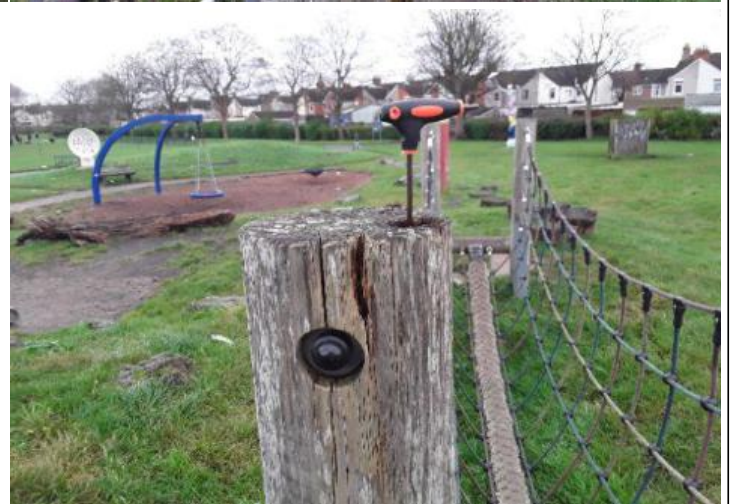
Finding: There are areas or parts of the timber post tops that have rotted

Action: Replace all affected timbers

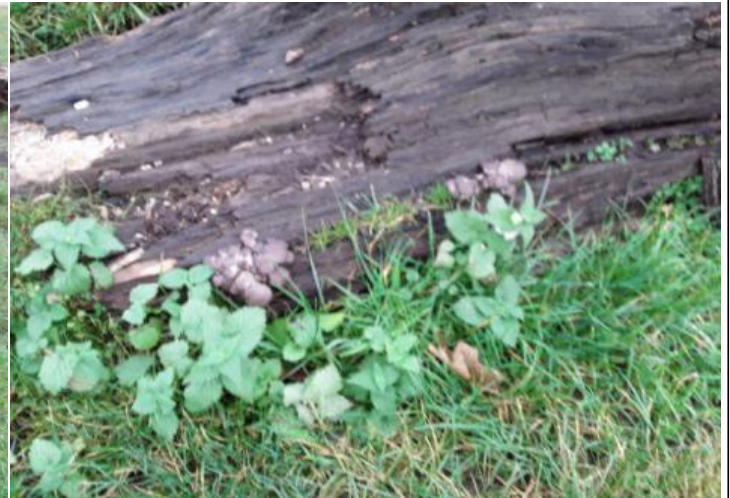
Finding: Fungus or algae was found on the equipment

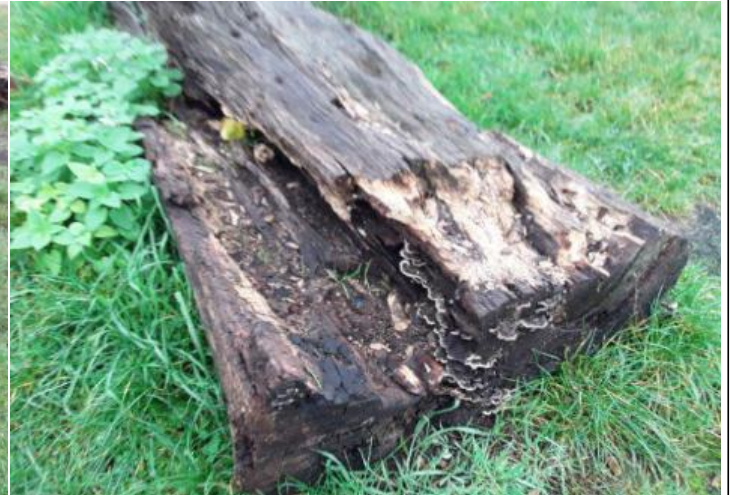
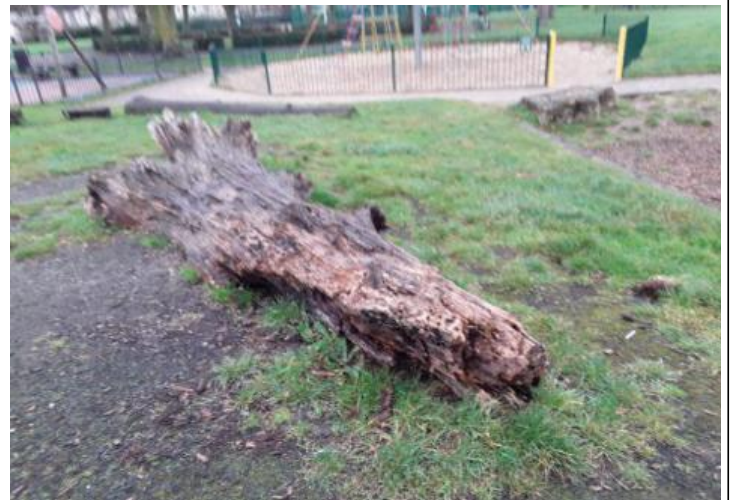
Finding: There are areas or parts of the timber on the structure that have rotted

Action: Replace all affected timbers

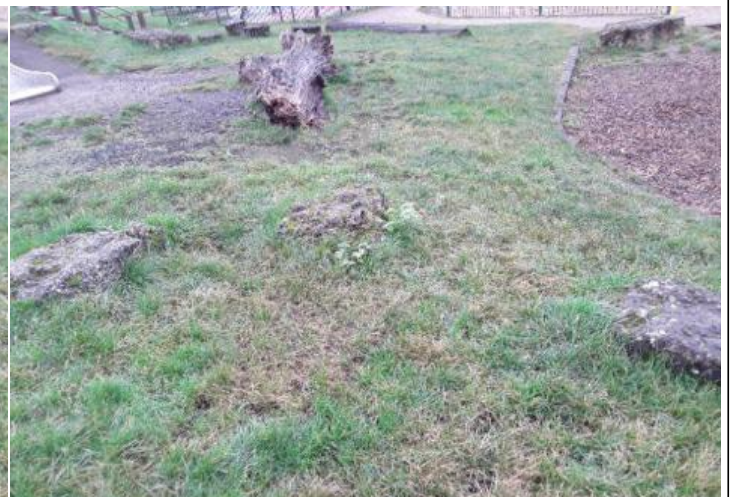
Finding: The step between the items is quite large and users may not be able to complete the step without touching ground, the items could therefore be considered to be within the falling space of each other, however the intention of the play activity continuity is easily apparent and foreseeable to the user

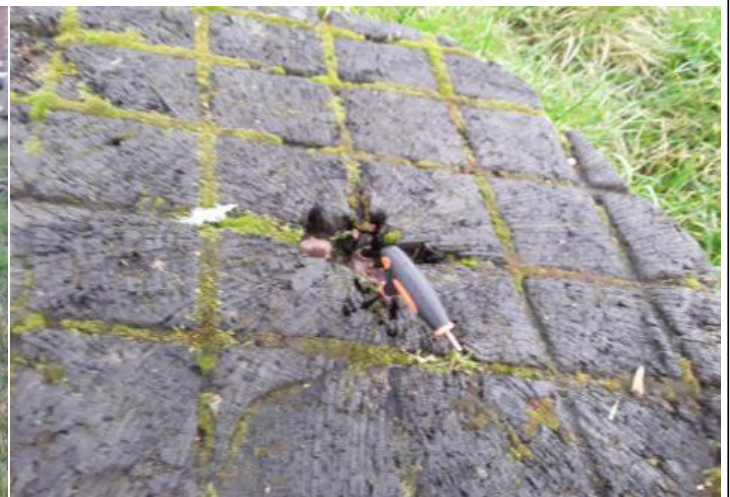
Finding: There are areas or parts of the timber on the structure that have rotted

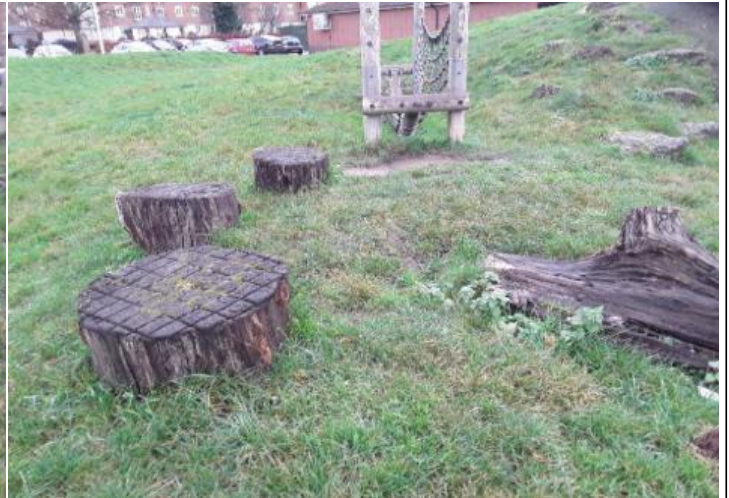
Finding: The adjacent item forms a hard object within the falling space of the equipment in contravention of the requirements of BS EN 1176 Part 1

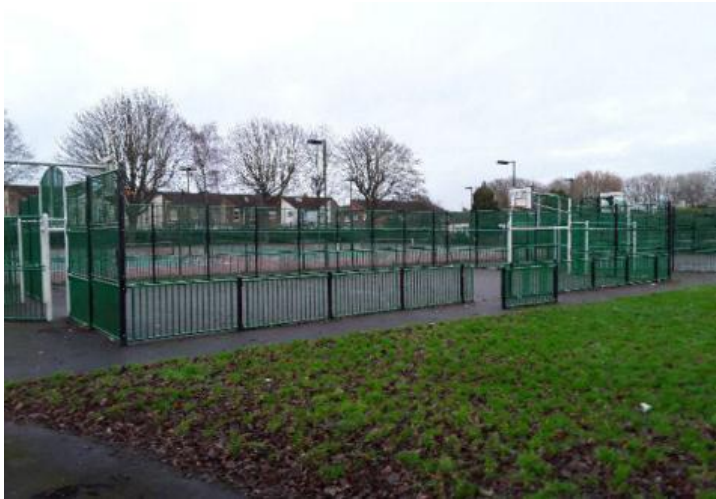
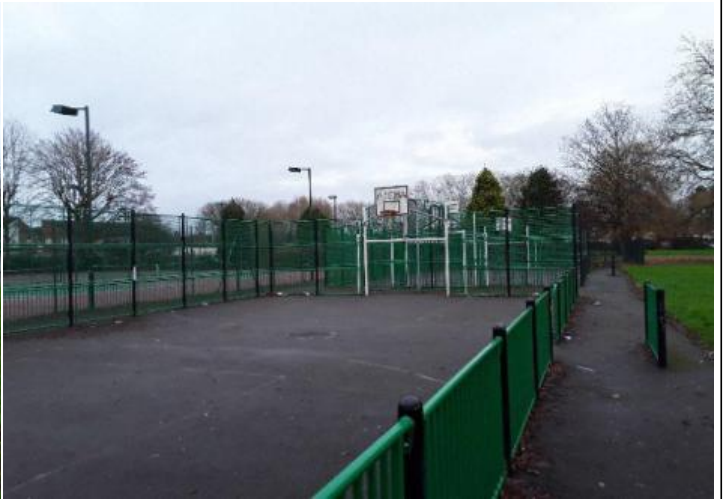
Finding: A clearly visible facility sign should be provided in a prominent position with the wording as detailed BS EN 15312- the equipment is not intended for children less than 3 years old- the warning - Do not climb on the framework or nets- the warning - Do not hang on the ring (if provided)- the warning - Do not wear rings or other jewellery- name and telephone number of the administrator- number to call in case of accident
Action: Provide signage to BS EN 15312

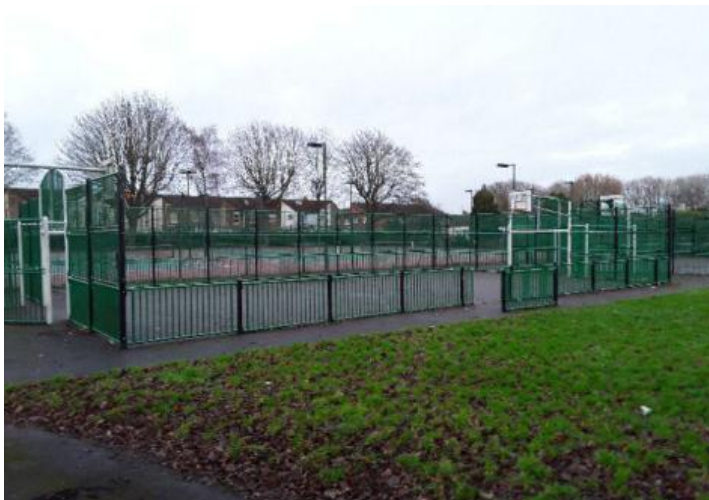
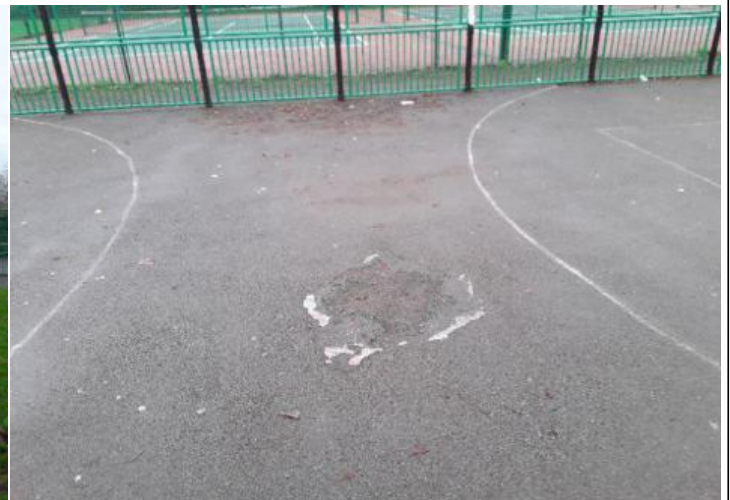
Finding: There is some evidence of fire damage to the surfacing
