the play inspection company

Annual Inspection

Central Swindon North Parish Council

St Marks Park

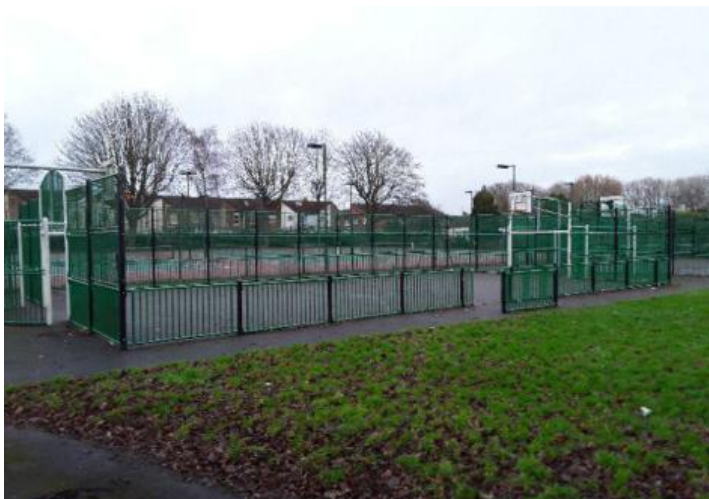
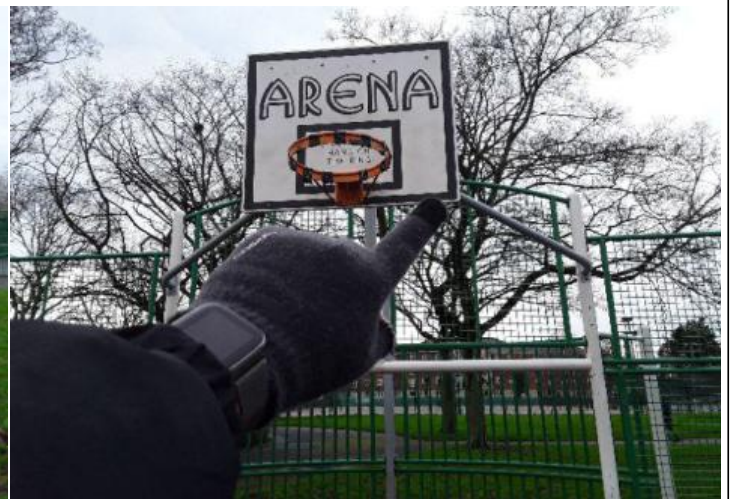
Finding: There is or are fixings missing on the backboard

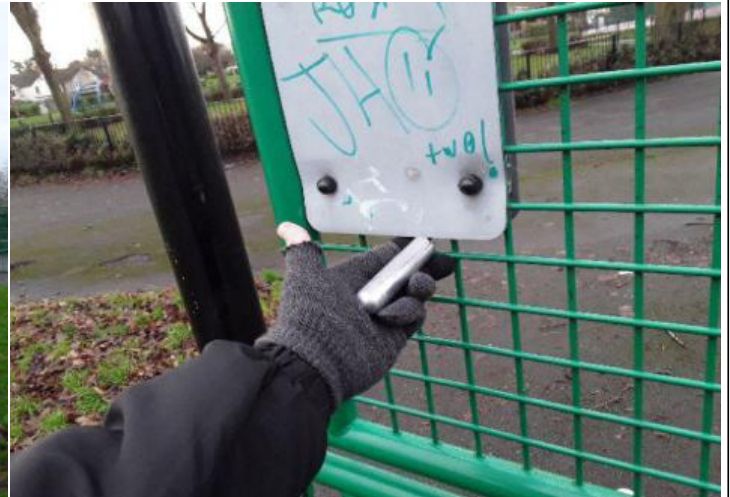
Finding: There is/are finger entrapments in the frame and the item fails to meet the requirements of BS EN 15312 Clause 4.4.2.2 Entrapment of fingers

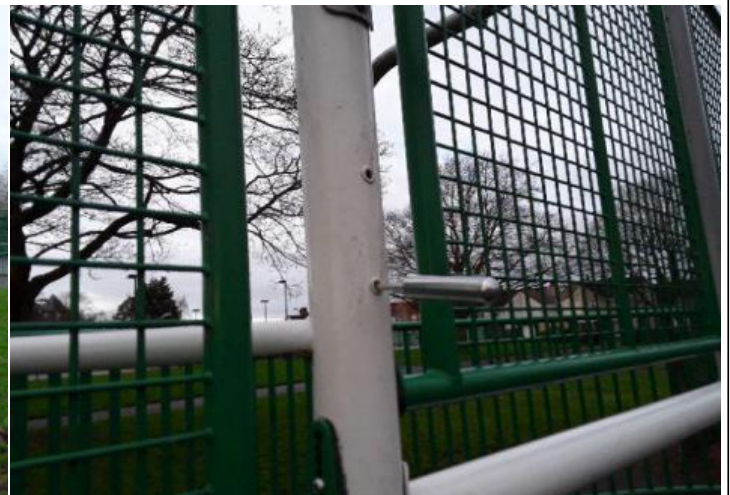
Finding: There is/are finger entrapments in the frame due to missing inserts and the item fails to meet the requirements of BS EN 15312 Clause 4.4.2.2 Entrapment of fingers

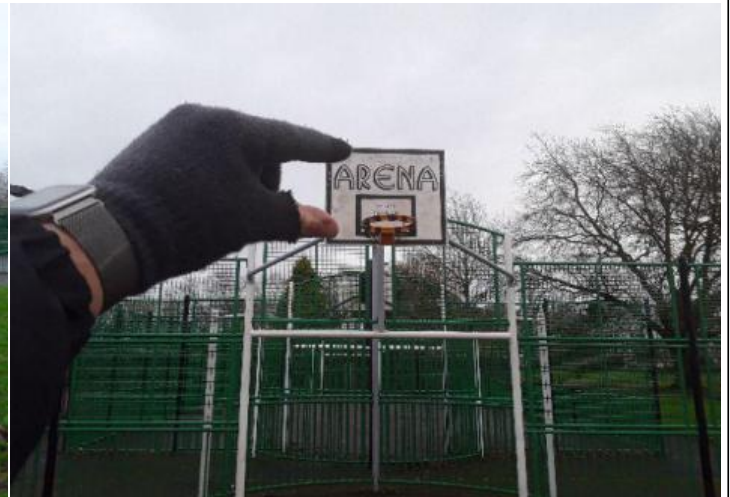
Finding: There is or are fixings missing on the backboard
Action: Replace all missing fixings

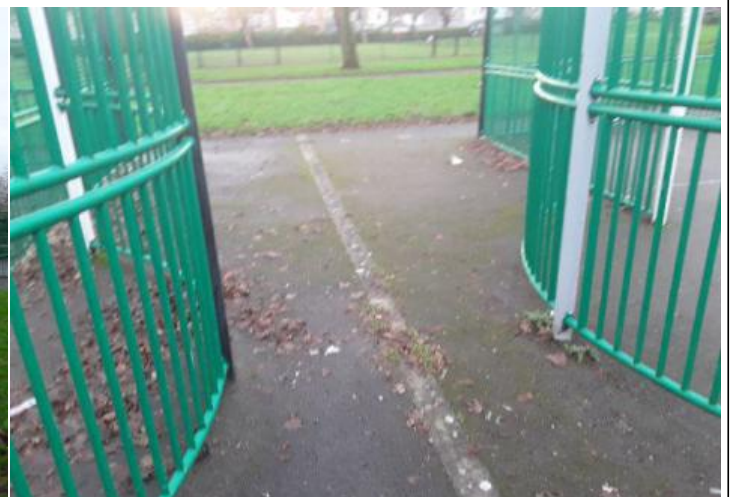
Finding: There is algae, silt or moss growth on the surface resulting in slippery conditions
Action: Clean and treat appropriately

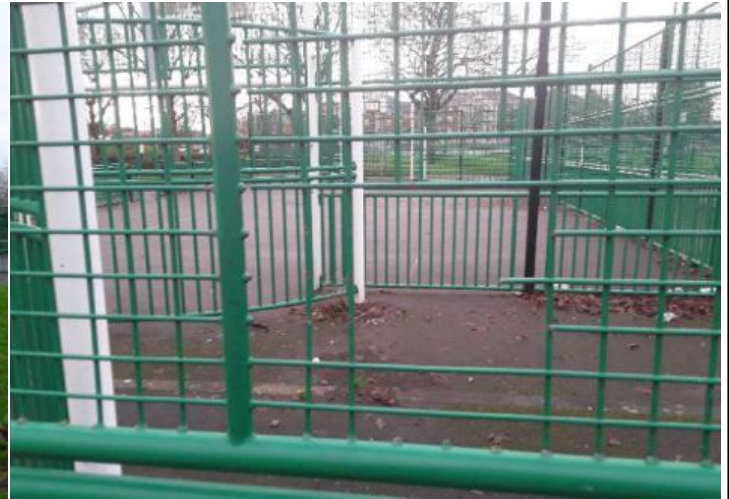
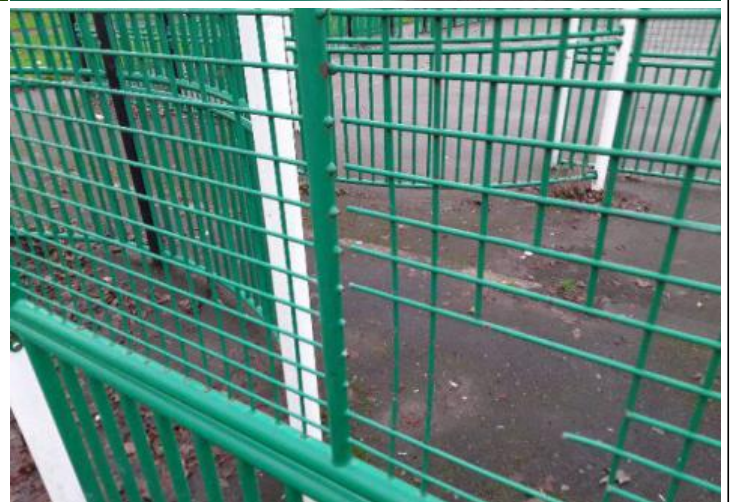
Finding: The fence is severely damaged in places

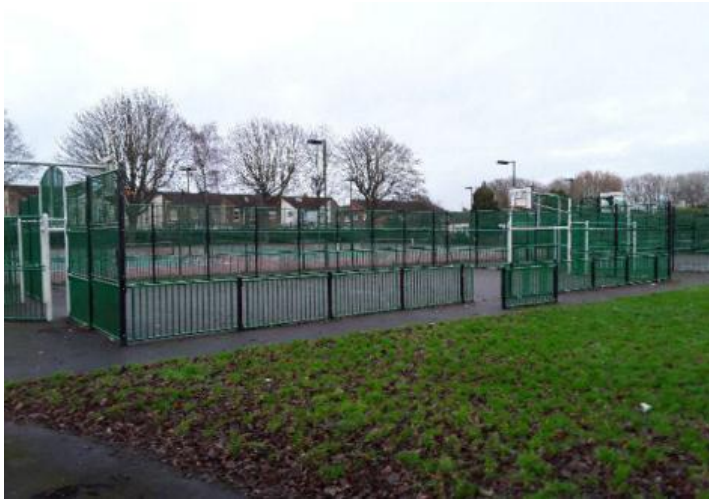
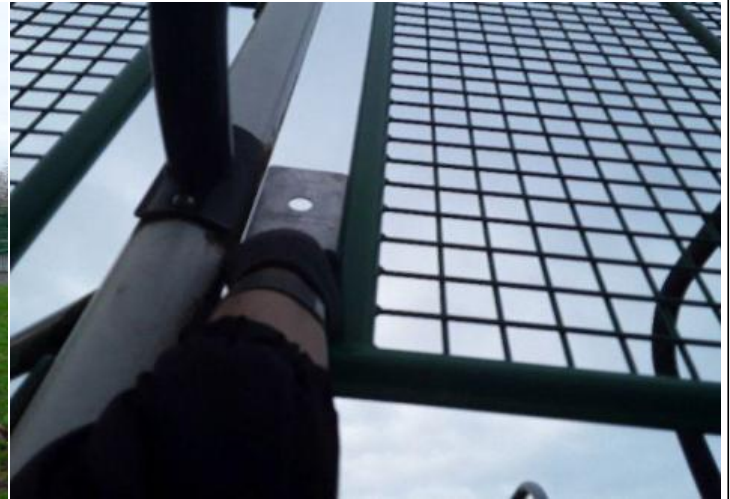
Finding: The item fails to meet the requirements of BS EN 15312 4.4.2.1 head and neck entrapment in the frame

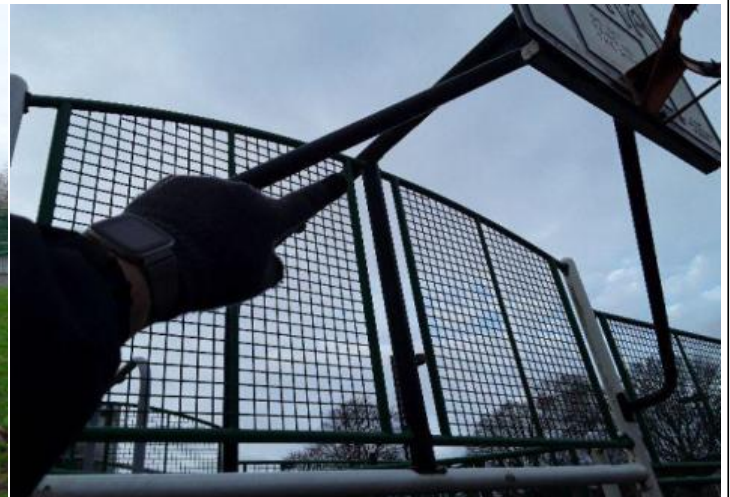
Finding: There is or are fixings missing on the item

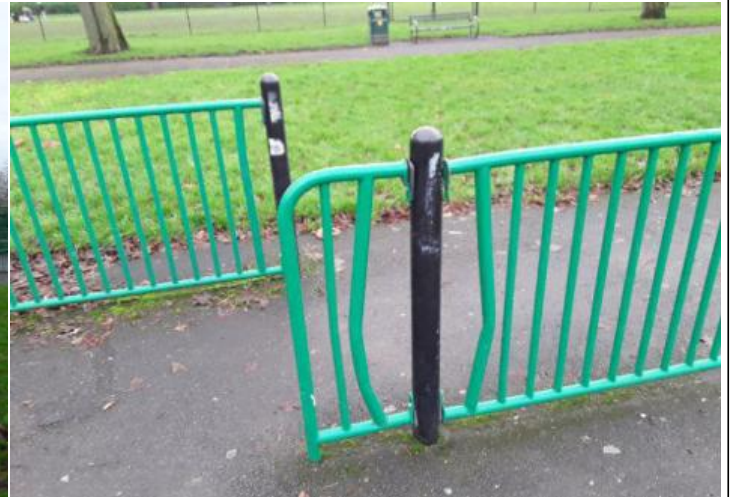
Finding: The fence is severely damaged in places

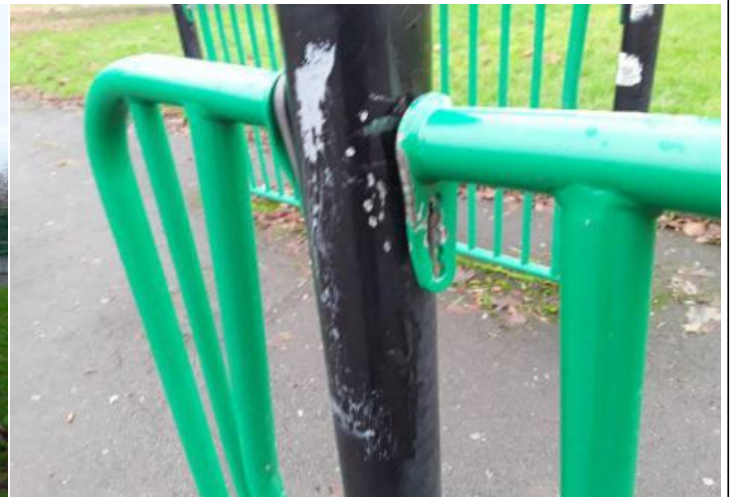
Finding: There are a number of fixings missing from the fence
