ASBESTOS REFURBISHMENT SURVEY REPORT

Site: Street Parish Rooms, 6 Leigh Road, Street, Somerset, BA16 0HA

Job Number: J104332

Survey Date: 10th December 2019

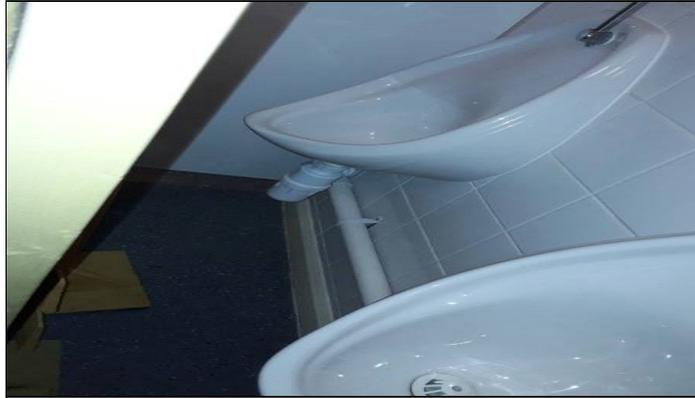
Sample No.	ZS002496	Description	Blue vinyl
-------------------	----------	--------------------	------------

Location ID	001	Position	to concrete floor.		
Building	01 Main Building	Floor	Ground Floor	Room/Area	Male WC (001)
Last Inspection Date	10/12/2019	Next Inspection Date	N/A

Product Type	Vinyl floor tile	Extent	8m ²
Surface Treatment	Composite (Self sealed)	HSE Notifiable	Non notifiable non licensed material
Damage Extent	Low Damage	Accessibility	Easily disturbed
Asbestos Type	No Asbestos Detected		
Material Risk No.	0	Certificate No.	J104332
Material Risk	NO ASBESTOS DETECTED

Comments	
Recommendations	No further action required

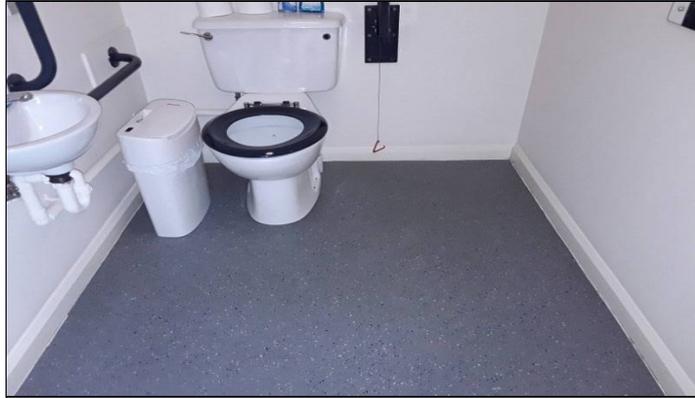
Sample No.	Ref ZS002496	Description	Blue vinyl
-------------------	--------------	--------------------	------------

Location ID	002	Position	to concrete floor		
Building	01 Main Building	Floor	Ground Floor	Room/Area	Disabled WC (002)
Last Inspection Date	10/12/2019	Next Inspection Date	N/A

Product Type	Vinyl floor tile	Extent	6m ²		
Surface Treatment	Composite (Self sealed)	HSE Notifiable	Non notifiable non licensed material		
Damage Extent	Low Damage	Accessibility	Easily disturbed		
Asbestos Type	No Asbestos Detected				
Material Risk No.	0	Certificate No.	J104332		
Material Risk	NO ASBESTOS DETECTED

Comments	
Recommendations	No further action required

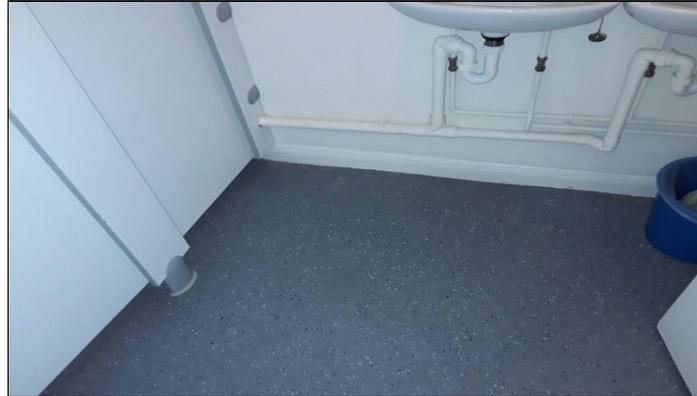
Sample No.	Ref ZS002496	Description	Blue vinyl
-------------------	--------------	--------------------	------------

Location ID	003	Position	to concrete floor		
Building	01 Main Building	Floor	Ground Floor	Room/Area	Female WC (003)
Last Inspection Date	10/12/2019	Next Inspection Date	N/A

Product Type	Vinyl floor tile	Extent	6m ²
Surface Treatment	Composite (Self sealed)	HSE Notifiable	Non notifiable non licensed material
Damage Extent	Low Damage	Accessibility	Easily disturbed
Asbestos Type	No Asbestos Detected		
Material Risk No.	0	Certificate No.	J104332
Material Risk	NO ASBESTOS DETECTED

Comments	
Recommendations	No further action required

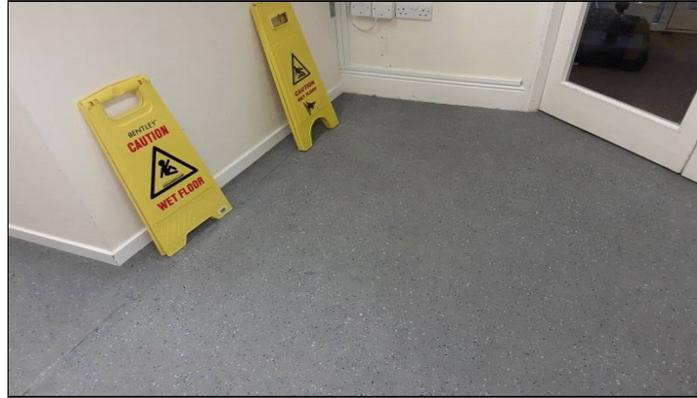
Sample No.	Ref ZS002496	Description	Blue vinyl
-------------------	--------------	--------------------	------------

Location ID	004	Position	to concrete floor		
Building	01 Main Building	Floor	Ground Floor	Room/Area	Reception (004)
Last Inspection Date	10/12/2019	Next Inspection Date	N/A

Product Type	Vinyl floor tile	Extent	20m ²
Surface Treatment	Composite (Self sealed)	HSE Notifiable	Non notifiable non licensed material
Damage Extent	Low Damage	Accessibility	Easily disturbed
Asbestos Type	No Asbestos Detected		
Material Risk No.	0	Certificate No.	J104332
Material Risk	NO ASBESTOS DETECTED

Comments	
Recommendations	No further action required

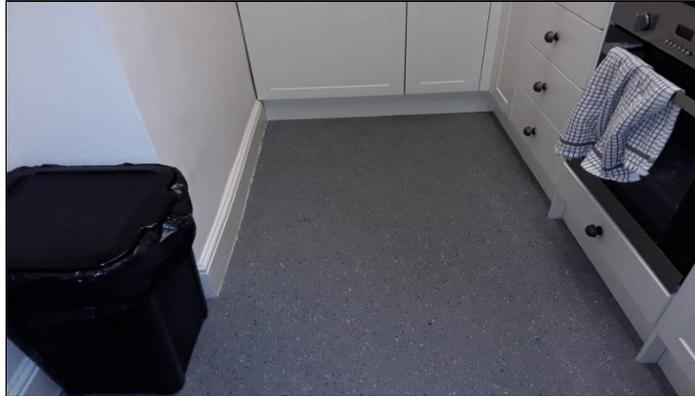
Sample No.	Ref ZS002496	Description	Blue vinyl
-------------------	--------------	--------------------	------------

Location ID	005	Position	to concrete floor		
Building	01 Main Building	Floor	Ground Floor	Room/Area	Kitchen (005)
Last Inspection Date	10/12/2019	Next Inspection Date	N/A

Product Type	Vinyl floor tile	Extent	8m ²
Surface Treatment	Composite (Self sealed)	HSE Notifiable	Non notifiable non licensed material
Damage Extent	Low Damage	Accessibility	Easily disturbed
Asbestos Type	No Asbestos Detected		
Material Risk No.	0	Certificate No.	J104332
Material Risk	NO ASBESTOS DETECTED

Comments	
Recommendations	No further action required

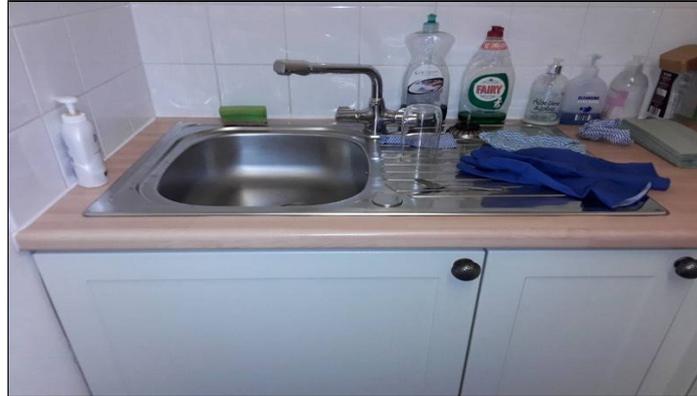
Sample No.	ZS002497	Description	Mastic pad
-------------------	----------	--------------------	------------

Location ID	005	Position	to underside of metal sink		
Building	01 Main Building	Floor	Ground Floor	Room/Area	Kitchen (005)
Last Inspection Date		10/12/2019	Next Inspection Date	N/A

Product Type	Mastic pad	Extent	2no.		
Surface Treatment	Composite (Self sealed)	HSE Notifiable	Non notifiable non licensed material		
Damage Extent	Low Damage	Accessibility	Usually inaccessible or unlikely to be disturbed		
Asbestos Type	No Asbestos Detected				
Material Risk No.	0	Certificate No.	J104332		
Material Risk	NO ASBESTOS DETECTED

Comments	
Recommendations	No further action required

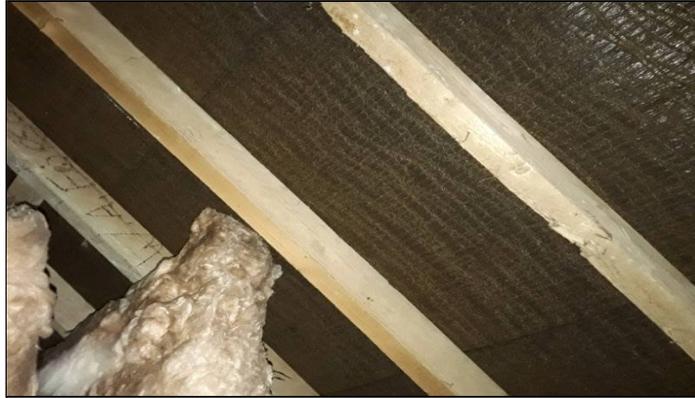
Sample No.	ZS002498	Description	Felt lining
-------------------	----------	--------------------	-------------

Location ID	006	Position	to the roof within the ceiling void		
Building	01 Main Building	Floor	Ground Floor	Room/Area	Entrance Lobby (006)
Last Inspection Date	10/12/2019	Next Inspection Date	N/A

Product Type	Bitumen / felt	Extent	10m ²		
Surface Treatment	Composite (Self sealed)	HSE Notifiable	Non notifiable non licensed material		
Damage Extent	Low Damage	Accessibility	Usually inaccessible or unlikely to be disturbed		
Asbestos Type	No Asbestos Detected				
Material Risk No.	0	Certificate No.	J104332		
Material Risk	NO ASBESTOS DETECTED

Comments	
Recommendations	No further action required

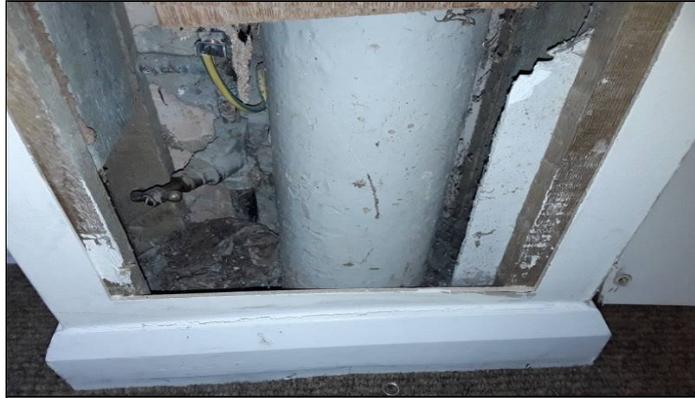
Sample No.	ZS002499	Description	Insulating board panel
-------------------	----------	--------------------	------------------------

Location ID	006	Position	to linings of the timber boxing		
Building	01 Main Building	Floor	Ground Floor	Room/Area	Entrance Lobby (006)
Last Inspection Date	10/12/2019	Next Inspection Date	N/A

Product Type	Insulating board	Extent	<1m ²
Surface Treatment	Unsealed	HSE Notifiable	Non notifiable non licensed material
Damage Extent	Low Damage	Accessibility	Usually inaccessible or unlikely to be disturbed
Asbestos Type	No Asbestos Detected		
Material Risk No.	0	Certificate No.	J104332
Material Risk	NO ASBESTOS DETECTED

Comments	
Recommendations	No further action required

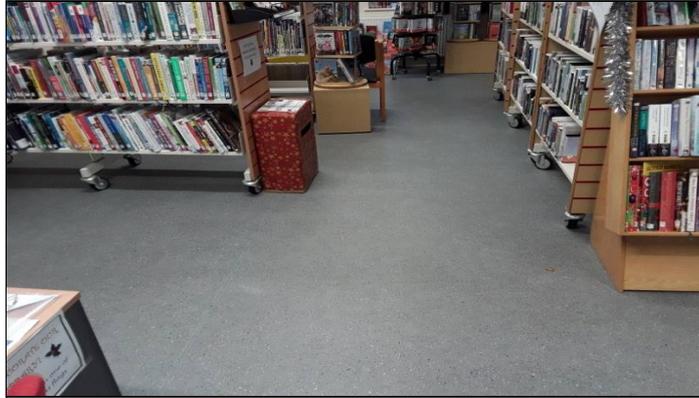
Sample No.	Ref ZS002496	Description	Blue vinyl
-------------------	--------------	--------------------	------------

Location ID	007	Position	to concrete floor		
Building	01 Main Building	Floor	Ground Floor	Room/Area	Library (007)
Last Inspection Date	10/12/2019	Next Inspection Date	N/A

Product Type	Vinyl floor tile	Extent	60m ²		
Surface Treatment	Composite (Self sealed)	HSE Notifiable	Non notifiable non licensed material		
Damage Extent	Low Damage	Accessibility	Easily disturbed		
Asbestos Type	No Asbestos Detected				
Material Risk No.	0	Certificate No.	J104332		
Material Risk	NO ASBESTOS DETECTED

Comments	
Recommendations	No further action required

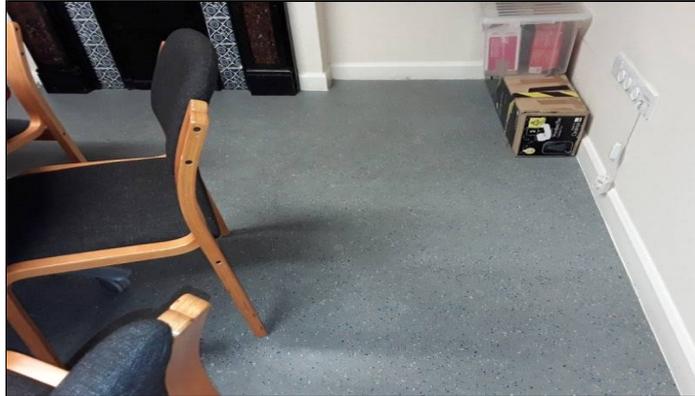
Sample No.	Ref ZS002496	Description	Blue vinyl
-------------------	--------------	--------------------	------------

Location ID	010	Position	to concrete floor		
Building	01 Main Building	Floor	Ground Floor	Room/Area	Clerks Office (010)
Last Inspection Date	10/12/2019	Next Inspection Date	N/A

Product Type	Vinyl floor tile	Extent	12m ²
Surface Treatment	Composite (Self sealed)	HSE Notifiable	Non notifiable non licensed material
Damage Extent	Low Damage	Accessibility	Easily disturbed
Asbestos Type	No Asbestos Detected		
Material Risk No.	0	Certificate No.	J104332
Material Risk	NO ASBESTOS DETECTED

Comments	
Recommendations	No further action required

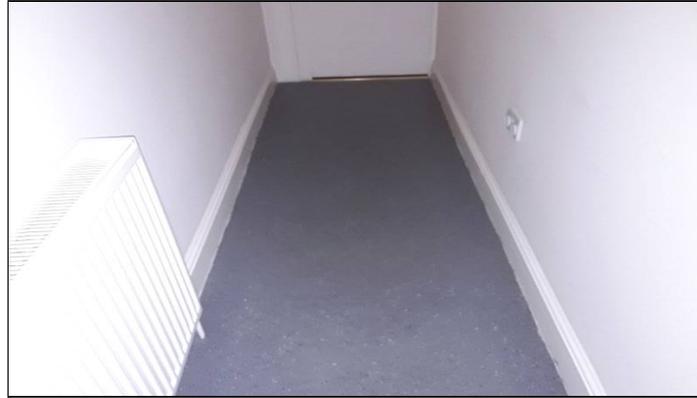
Sample No.	Ref ZS002496	Description	Blue vinyl
-------------------	--------------	--------------------	------------

Location ID	011	Position	to concrete floor		
Building	01 Main Building	Floor	Ground Floor	Room/Area	Lobby (011)
Last Inspection Date	10/12/2019	Next Inspection Date	N/A

Product Type	Vinyl floor tile	Extent	16m ²
Surface Treatment	Composite (Self sealed)	HSE Notifiable	Non notifiable non licensed material
Damage Extent	Low Damage	Accessibility	Easily disturbed
Asbestos Type	No Asbestos Detected		
Material Risk No.	0	Certificate No.	J104332
Material Risk	NO ASBESTOS DETECTED

Comments	
Recommendations	No further action required

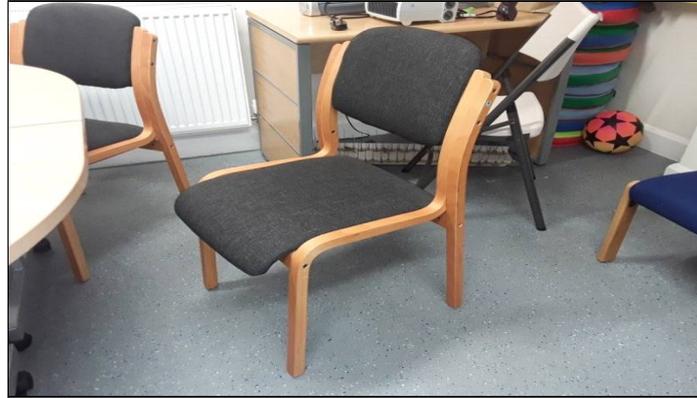
Sample No.	Ref ZS002496	Description	Blue vinyl
-------------------	--------------	--------------------	------------

Location ID	012	Position	to concrete floor		
Building	01 Main Building	Floor	Ground Floor	Room/Area	Training Room (012)
Last Inspection Date	10/12/2019	Next Inspection Date	N/A

Product Type	Vinyl floor tile	Extent	12m ²
Surface Treatment	Composite (Self sealed)	HSE Notifiable	Non notifiable non licensed material
Damage Extent	Low Damage	Accessibility	Easily disturbed
Asbestos Type	No Asbestos Detected		
Material Risk No.	0	Certificate No.	J104332
Material Risk	NO ASBESTOS DETECTED

Comments	
Recommendations	No further action required

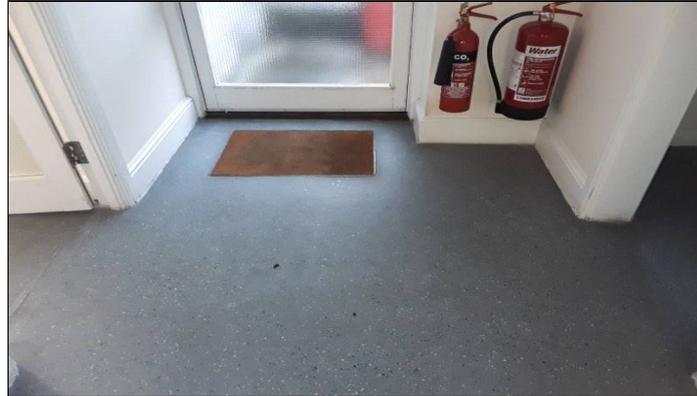
Sample No.	Ref ZS002496	Description	Blue vinyl
-------------------	--------------	--------------------	------------

Location ID	013	Position	to concrete floor		
Building	01 Main Building	Floor	Ground Floor	Room/Area	Lobby (013)
Last Inspection Date	10/12/2019	Next Inspection Date	N/A

Product Type	Vinyl floor tile	Extent	10m ²
Surface Treatment	Composite (Self sealed)	HSE Notifiable	Non notifiable non licensed material
Damage Extent	Low Damage	Accessibility	Easily disturbed
Asbestos Type	No Asbestos Detected		
Material Risk No.	0	Certificate No.	J104332
Material Risk	NO ASBESTOS DETECTED

Comments	
Recommendations	No further action required

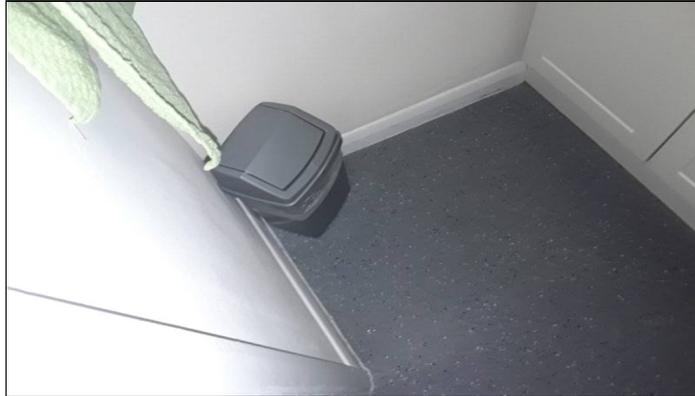
Sample No.	Ref ZS002496	Description	Blue vinyl
-------------------	--------------	--------------------	------------

Location ID	014	Position	to concrete floor		
Building	01 Main Building	Floor	Ground Floor	Room/Area	Kitchenette (014)
Last Inspection Date	10/12/2019	Next Inspection Date	N/A

Product Type	Vinyl floor tile	Extent	4m ²
Surface Treatment	Composite (Self sealed)	HSE Notifiable	Non notifiable non licensed material
Damage Extent	Low Damage	Accessibility	Easily disturbed
Asbestos Type	No Asbestos Detected		
Material Risk No.	0	Certificate No.	J104332
Material Risk	NO ASBESTOS DETECTED

Comments	
Recommendations	No further action required

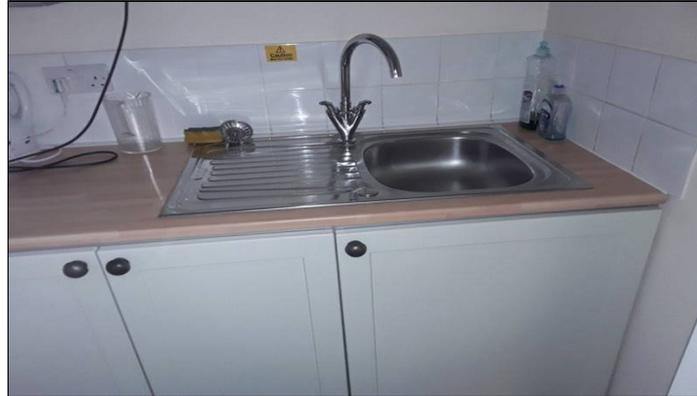
Sample No.	ZS002500	Description	Mastic pad
-------------------	----------	--------------------	------------

Location ID	014	Position	to the sink and drainer		
Building	01 Main Building	Floor	Ground Floor	Room/Area	Kitchenette (014)
Last Inspection Date	10/12/2019	Next Inspection Date	N/A

Product Type	Mastic pad	Extent	2no.
Surface Treatment	Composite (Self sealed)	HSE Notifiable	Non notifiable non licensed material
Damage Extent	Low Damage	Accessibility	Occasionally likely to be disturbed
Asbestos Type	No Asbestos Detected		
Material Risk No.	0	Certificate No.	J104332
Material Risk	NO ASBESTOS DETECTED

Comments	
Recommendations	No further action required

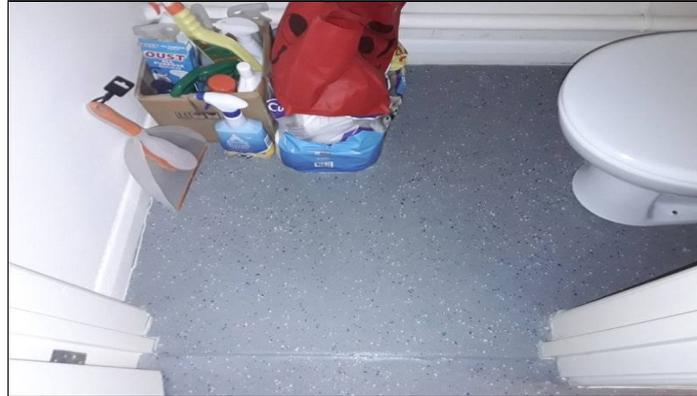
Sample No.	Ref ZS002496	Description	Blue vinyl
-------------------	--------------	--------------------	------------

Location ID	015	Position	to concrete floor		
Building	01 Main Building	Floor	Ground Floor	Room/Area	WC (015)
Last Inspection Date		10/12/2019	Next Inspection Date		N/A

Product Type	Vinyl floor tile	Extent	2m ²
Surface Treatment	Composite (Self sealed)	HSE Notifiable	Non notifiable non licensed material
Damage Extent	Low Damage	Accessibility	Easily disturbed
Asbestos Type	No Asbestos Detected		
Material Risk No.	0	Certificate No.	J104332
Material Risk	NO ASBESTOS DETECTED

Comments	
Recommendations	No further action required

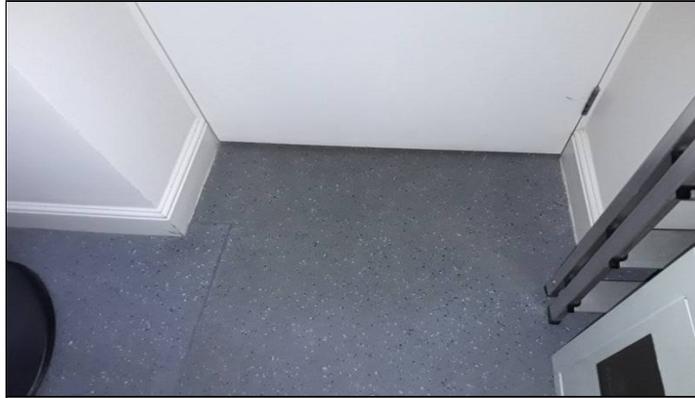
Sample No.	Ref ZS002496	Description	Blue vinyl
-------------------	--------------	--------------------	------------

Location ID	016	Position	to concrete floor		
Building	01 Main Building	Floor	Ground Floor	Room/Area	Lift Lobby (016)
Last Inspection Date	10/12/2019	Next Inspection Date	N/A

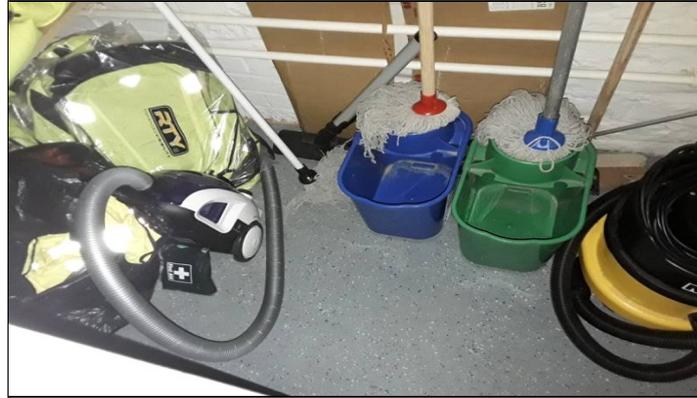
Sample No.	Ref ZS002496	Description	Blue vinyl
-------------------	--------------	--------------------	------------

Location ID	017	Position	to concrete floor		
Building	01 Main Building	Floor	Ground Floor	Room/Area	Store (017)
Last Inspection Date	10/12/2019	Next Inspection Date	N/A

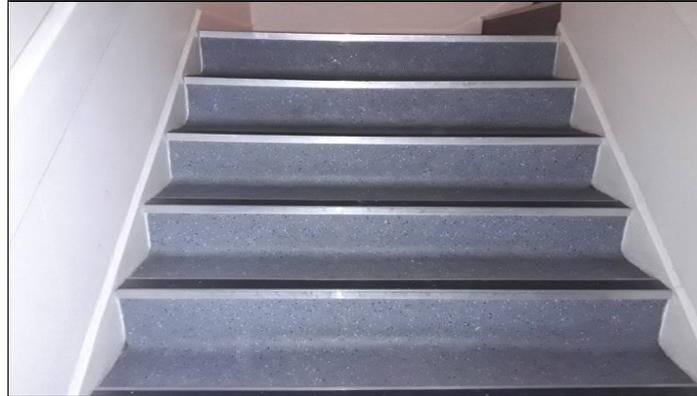
Sample No.	Ref ZS002496	Description	Blue vinyl
-------------------	--------------	--------------------	------------

Location ID	008	Position	to concrete floor		
Building	01 Main Building	Floor	Ground Floor	Room/Area	Stairwell (008)
Last Inspection Date	10/12/2019	Next Inspection Date	N/A
