MANAGEMENT SURVEY REPORT

Report Number: H5812

Petersfield Town Council

The Town & Festival Hall
Heath Road
Petersfield
Hampshire
GU31 4EA

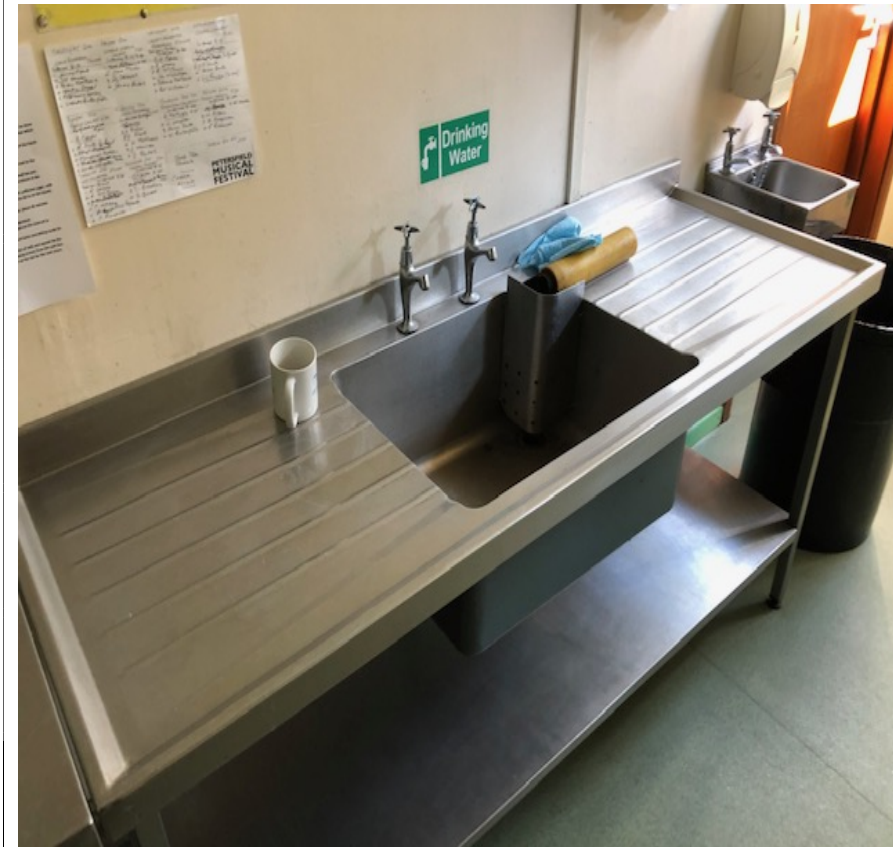
PHOTOPLATE 015

Location
G.29 – Kitchen
Item No.
08
Sample Reference (Bulk ID)
AA10922 B08
Product Details
Bitumen paint to sink unit
Analysis Result
NAD
Risk Level
-
Recommendation
-

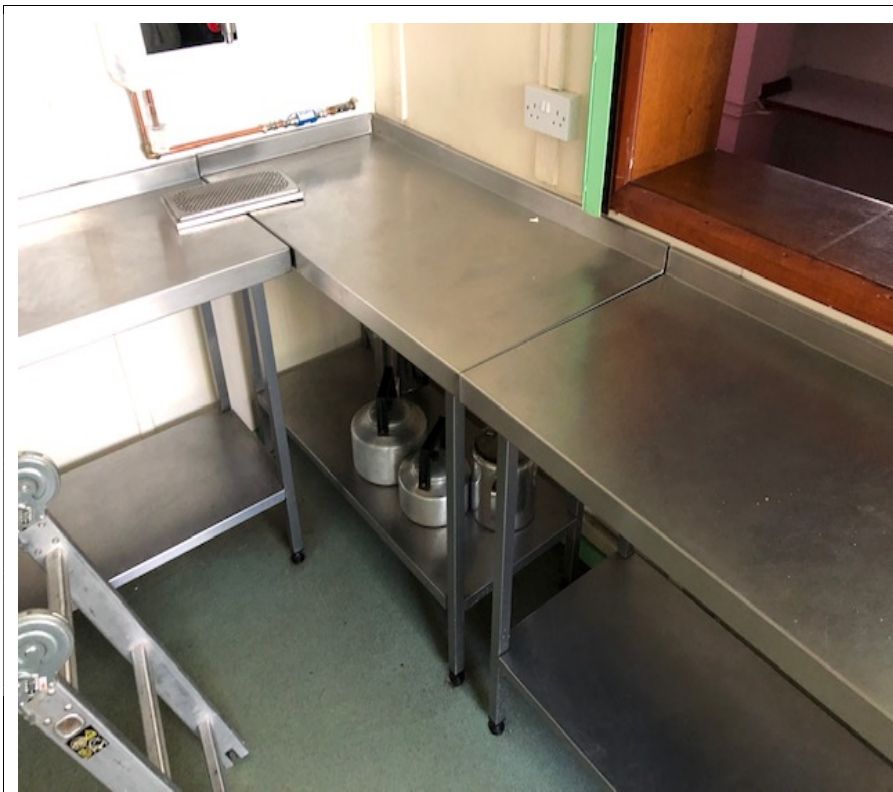
PHOTOPLATE 016

Location
G.29 – Kitchen
Item No.
08
Sample Reference (Bulk ID)
AA10922 B08
Product Details
Bitumen paint to work surfaces
Analysis Result
NAD
Risk Level
-
Recommendation
-

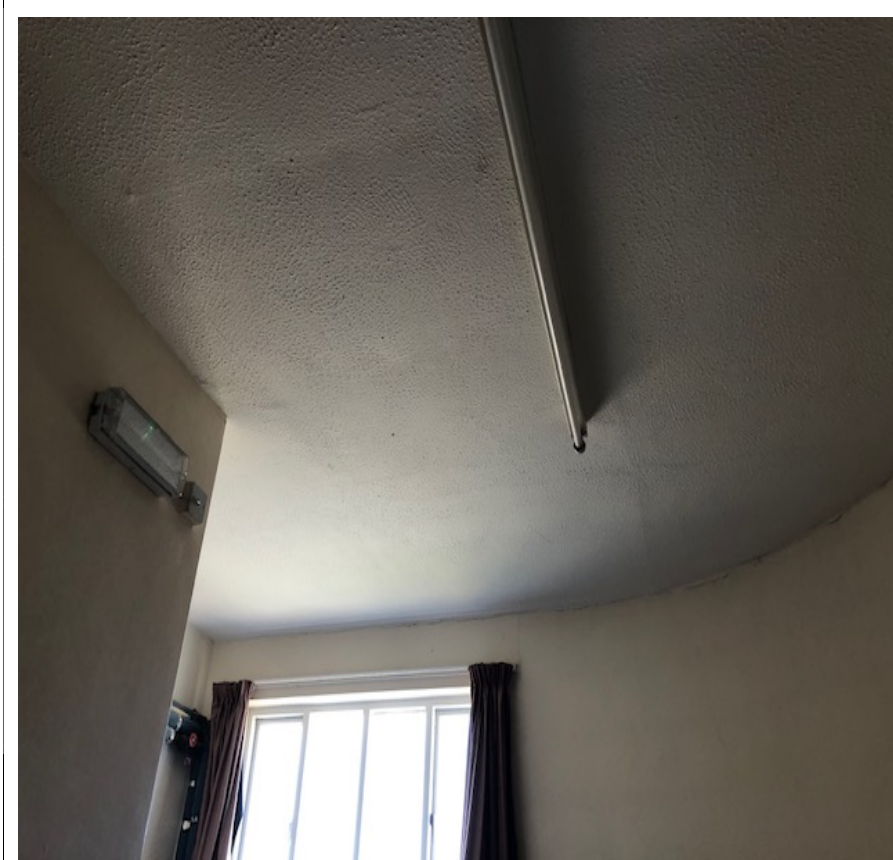
PHOTOPLATE 022

G.46 – Dressing Room 1 Textured coating to ceiling	12	AA16922 B12	21	1	0	0	NAD	-	1	12m ²	A
G.47 – Shower Textured coating to ceiling		Ref.12	22	1	0	0	NAD	-	1	5m ²	SP

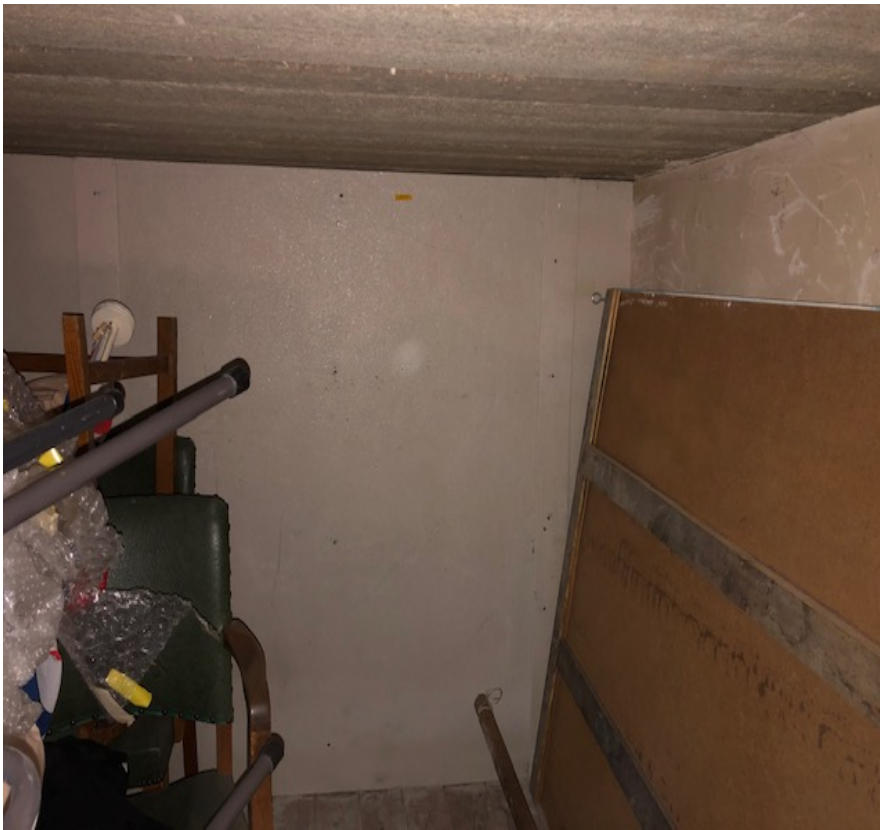
PHOTOPLATE 028

1.03 – Store Insulating board panelling	13	AA16922 B13	27	2	2	0	NAD	-	2	6m ²	A
1.04 – Store Bitumen adhesive to parquet flooring	14	AA16922 B14	28	1	0	0	NAD	-	3	4m ²	A

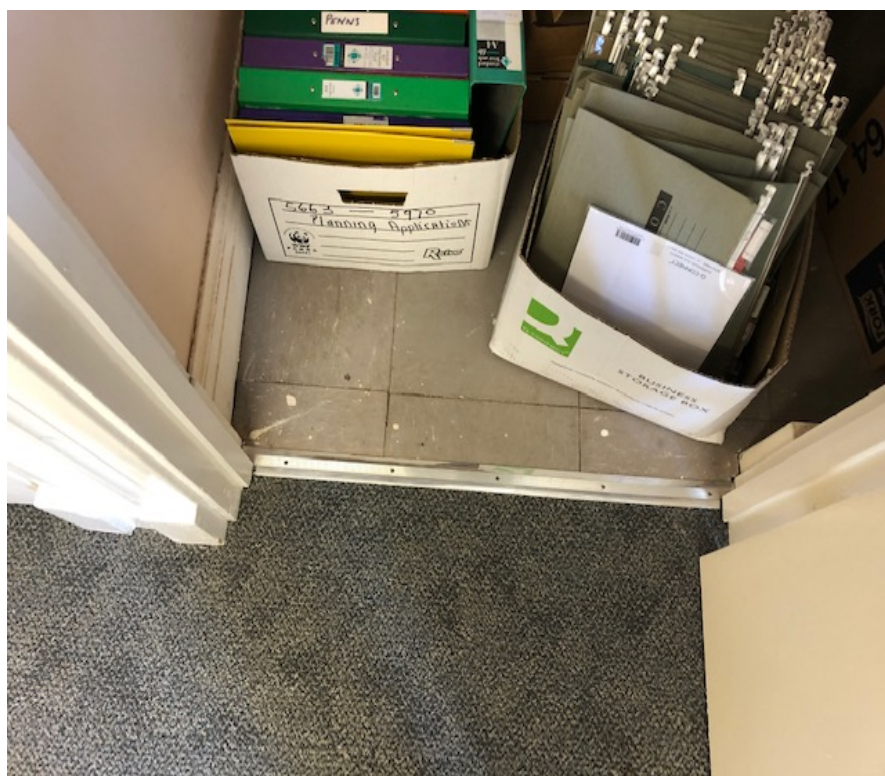
PHOTOPLATE 031

1.07 – Under Stairs Cupboard Insulating board ceiling		Ref.13	29	2	2	0	NAD	-	1	2.5m ²	SP
1.08 – Store Vinyl floor tiles	15	AA16922 B15	30	1	0	0	NAD	-	3	1.5m ²	A

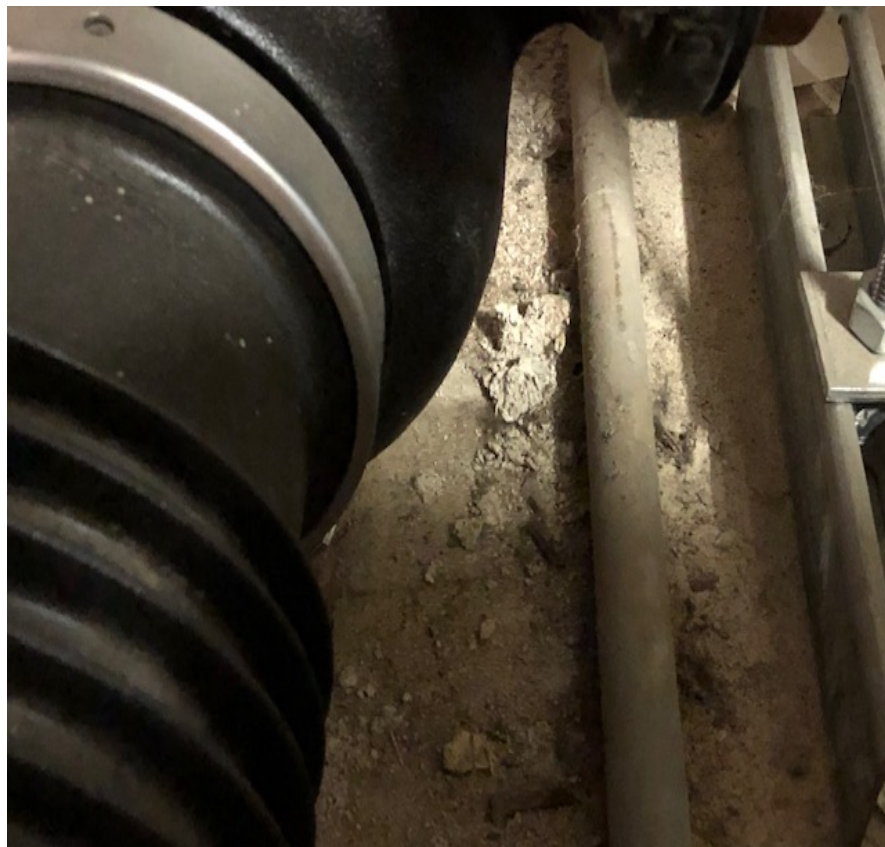
PHOTOPLATE 035

1.11 – Reception Insulating board door panel		Ref.04	31	2	1	1	NAD	-	2	2m ²	SP
1.18 – Gallery Insulating board panels		Ref.13	32	2	1	0	NAD	-	1	4m ²	SP
B.01 – Boiler Room Residue to wall & pipe brackets	16	AA16922 B16	33	3	3	3	NAD	-	2	>10m ²	A
B.01 – Boiler Room Residue to pipes	17	AA16922 B17	34	3	3	3	NAD	-	1	10m	A
B.01 – Boiler Room Residue to floor	18	AA16922 B18	35	3	3	3	NAD	-	3	>5m ²	A

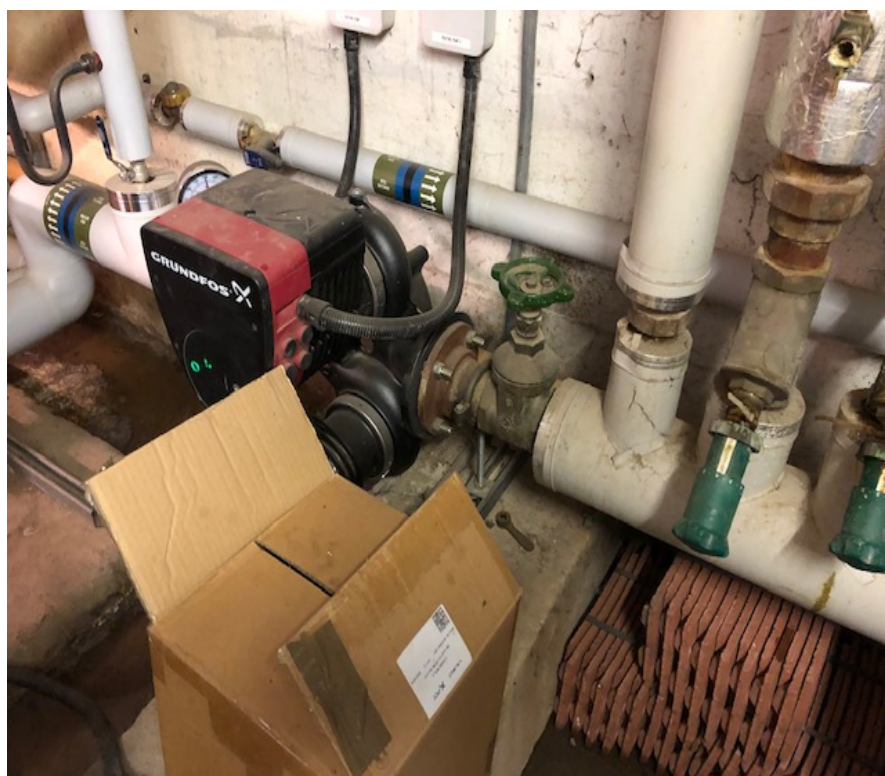
PHOTOPLATE 036

Building: Main					
Location	Item	Photo N°	Product Details	Finding	Recommended/ Action
B.01 – Boiler Room	VIS ID	36	Gaskets to pipe work	Is presumed to contain Crocidolite (Blue Asbestos)	Mark and manage

Room Number/ Name Product Details	Item No.	Bulk ID/ Vis ID	Photo No.	Product Type 1-3	Surface Treatment 0-3	Condition 0-3	Asbestos Type NAD, 1-3	Score	Possible Disturbance	Quantity M, M2,x?	ID A, SP, P	Rmd MM, E, R, Other
B.01 – Boiler Room Gaskets to pipe work		VIS ID	36	2	2	0	3	7	1	<1m ²	P	MM

Mark and manage
