Vehicle Restraint System
Work Required Job Details

Name:	Llangua Bridge Upstream End	Number:	BS9129
Eastings:	339538	Northings:	226544
Route Crossed:		Route Carried:	A465
In or near an area of ecological interest		SSSI (Sites of Special Scientific Interest)	
Description:			
Location Map:

Work Type:	Safety Barrier Works	Reference:	SB2400005
Works Identified by:	James Powell	Date:	04-03-2024
Work Description:	Full replacement of damaged Vehicle Restraint System (VRS) and the replacement damaged Bridge Parapet post and rail system behind the VRS (5 x posts and double tubular rail) It is likely that this work will require concrete repairs to the edge of the parapet beam and some access scaffold or edge protection. Full length of existing barrier is 53m and the most recent accident damaged 24m of beam and 6 x posts. The whole system needs to be replaced.		
Risk Likelihood:	7.5	Risk Consequence:	9
Risk Overall Score:		67.5

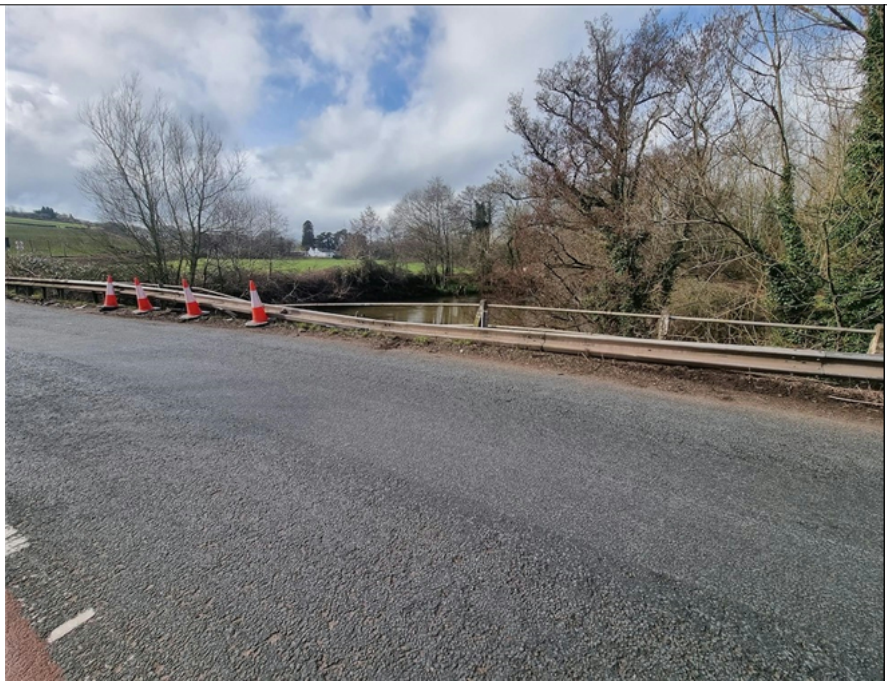
March 2024 vehicle
damage to VRS system

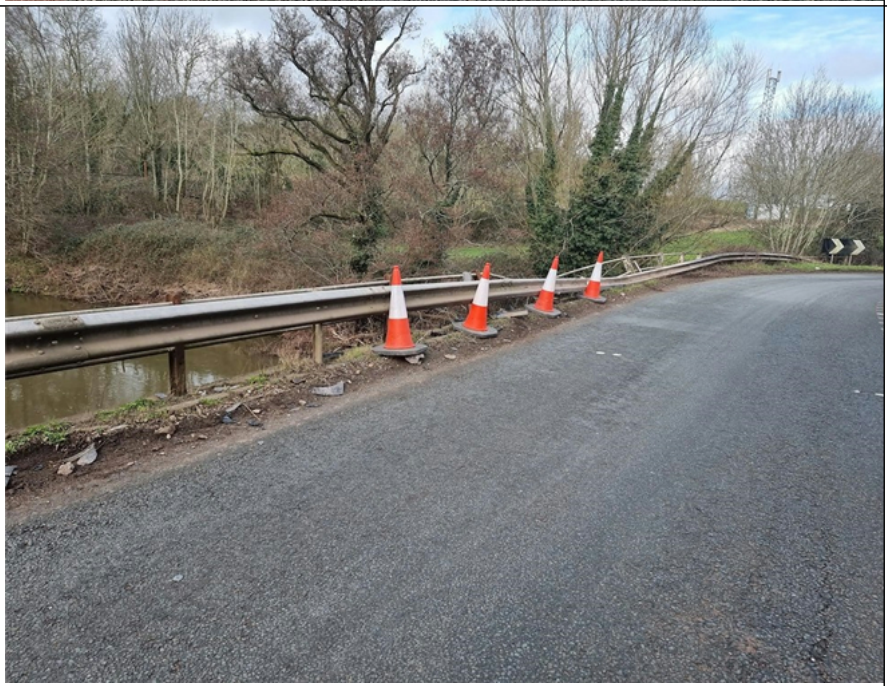
Damage upstream VRS

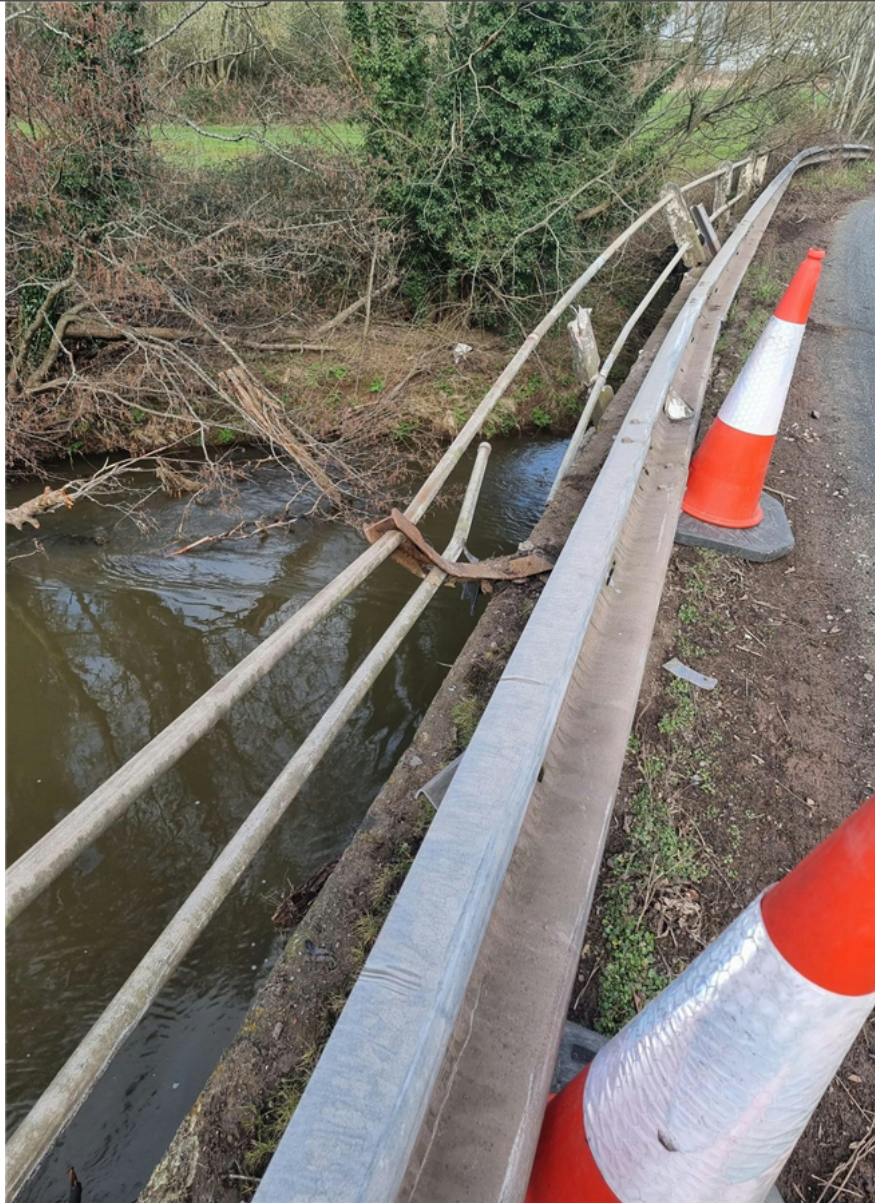
Damaged post and rail
bridge parapet to the
rear of the VRS

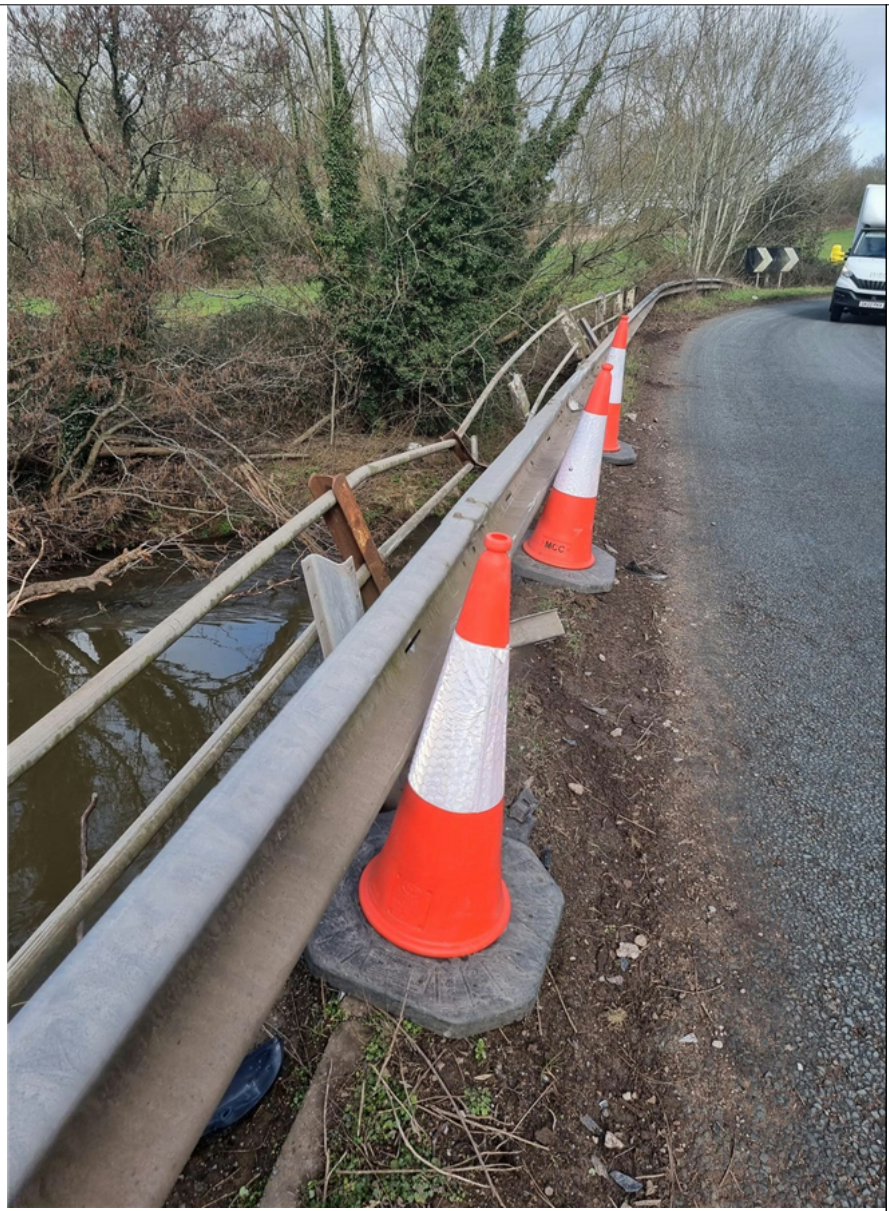
Damaged VRS with
post and rail bridge
parapet to the rear.
