REFURBISHMENT SURVEY FOR ASBESTOS-CONTAINING MATERIALS

CLIENT: DDS Environmental

SITE: Radford House, 18-20 Effingham Street, Ramsgate, Kent, CT11 9AT

TYPE OF SURVEY: Refurbishment

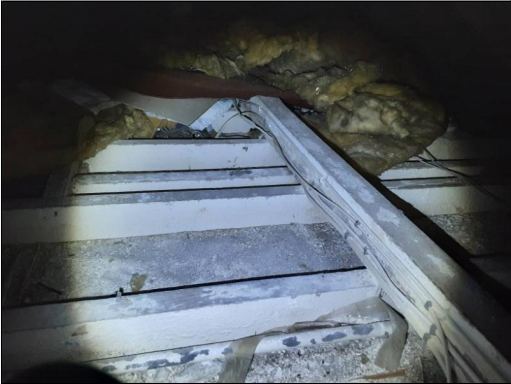
Building	Radford House	Floor/ room	Roof Void / 2.04 roof void		
Assessment no.	0002	Accessibility	Usually inaccessible or unlikely to be disturbed		
Material Risk					
Identification	Identified	Condition	Low Damage		
Extent	15m²	Asbestos Type	Chrysotile		
Location/ position	Cement lining to ceiling above 2.03 in roof void				
Surface treatment	Surface Sealed				
Product type	Cement				
Material risk	Very low	Material risk score	4		
Action	Remove

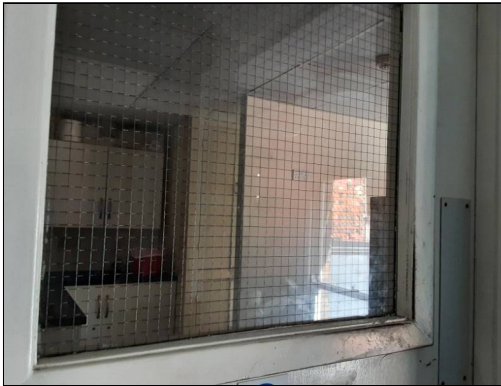
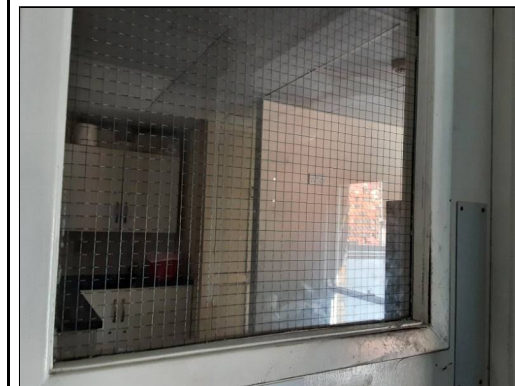
</div>
Building	Radford House	Floor/ room	1st Floor / 1.08		
Assessment no.	0008	Accessibility	Easily disturbed		
Material Risk					
Identification	Identified	Condition	Low Damage		
Extent	2lm	Asbestos Type	Amosite		
Location/ position	Board door beading to window between rooms 1.08 and 1.09				
Surface treatment	Surface Sealed				
Product type	Board				
Material risk	Low	Material risk score	6		
Action	Remove

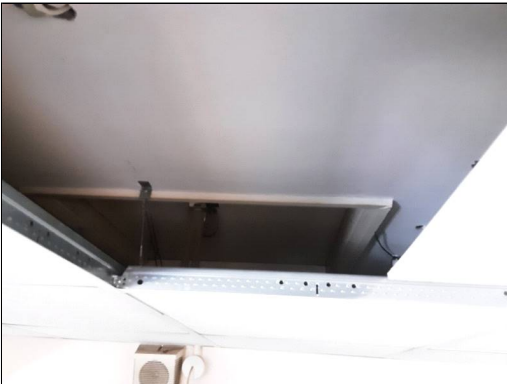
Assessment details				Comments	Photograph
Building	Radford House	Floor/ room	1st Floor / 1.09	No access to ceiling void - ceiling grid prevents access. This hatch covers ceiling void to rooms 1.09-1.11

Assessment no.	0011	Accessibility			
Material Risk					
Identification	Inaccessible (Presumed)	Condition	n/a		
Extent		Asbestos Type	n/a		
Location/ position	No access to ceiling void				
Surface treatment	n/a				
Product type	n/a				
Material risk		Material risk score			
Action	Inspect Prior to Disturbance

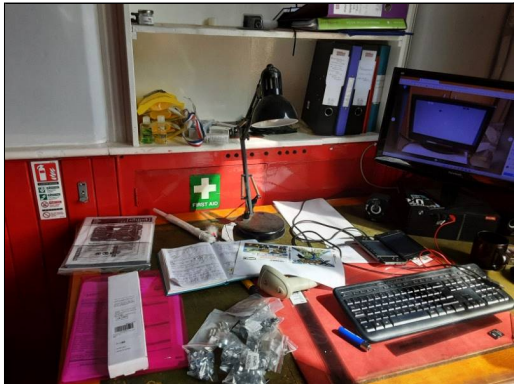
Assessment details				Comments	Photograph
Building	Radford House	Floor/ room	Ground Floor / G.03	No access to cupboard - desk position prevents access

Assessment no.	0017	Accessibility			
Material Risk					
Identification	Inaccessible (Presumed)	Condition	n/a		
Extent		Asbestos Type	n/a		
Location/ position	No access to cupboard				
Surface treatment	n/a				
Product type	n/a				
Material risk		Material risk score			
Action	Inspect Prior to Disturbance

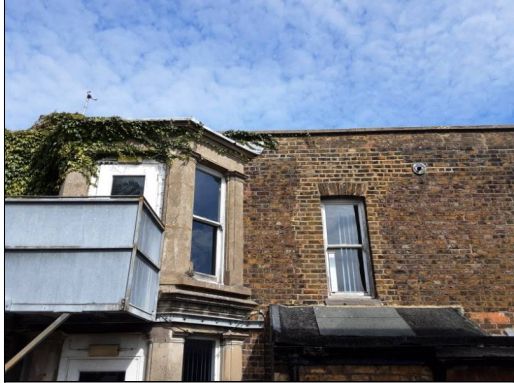
Assessment details				Comments	Photograph
Building	Radford House	Floor/ room	External / Externals	No access to main roof - high level access required

Assessment no.	0020	Accessibility			
Material Risk					
Identification	Inaccessible (Presumed)	Condition	n/a		
Extent		Asbestos Type	n/a		
Location/ position	No access to main roof				
Surface treatment	n/a				
Product type	n/a				
Material risk		Material risk score			
Action	Inspect Prior to Disturbance

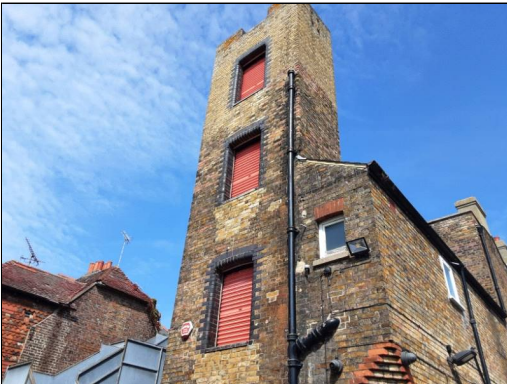
Assessment details				Comments	Photograph
Building	Radford House	Floor/ room	External / Externals	No access beyond roller doors to rear - unable to tie in ladders

Assessment no.	0024	Accessibility			
Material Risk					
Identification	Inaccessible (Presumed)	Condition	n/a		
Extent		Asbestos Type	n/a		
Location/ position	No access beyond roller doors to rear				
Surface treatment	n/a				
Product type	n/a				
Material risk		Material risk score			
Action	Inspect Prior to Disturbance

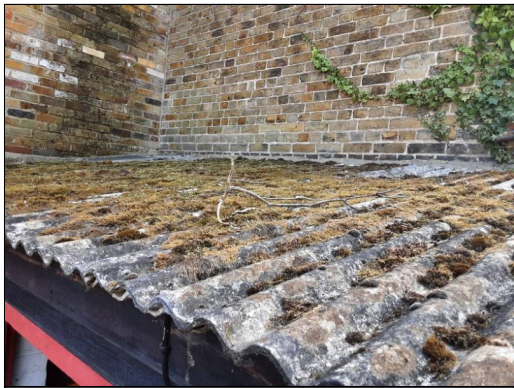
Assessment details				Comments	Photograph
Building	Radford House	Floor/ room	External / Outbuilding 1 externals

Assessment no.	0027	Accessibility	Usually inaccessible or unlikely to be disturbed		
Material Risk					
Identification	Identified	Condition	Low Damage		
Extent	12	Asbestos Type	Chrysotile		
Location/ position	Cement corrugated roof sheets				
Surface treatment	Surface Sealed				
Product type	Cement				
Material risk	Very low	Material risk score	4		
Action	Remove
