Asbestos Pre-Refurbishment Survey Report

Job Ref No: **140513**, Account Ref No: **18203**, Contract Ref No: **18463**

Horniman Museum and Gardens, 100 London Road, Forest Hill, London, SE23 3PQ

Title: Pre-Demolition Survey to Old Detached House, **Including:** Full demolition survey to old detached house

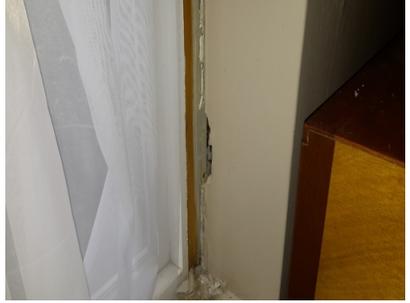
Building	Level	Location	Item / Product Examined	Sample No.	Material Description	Fibre Type	Material Score	Extent	Risk Level Assessment	Initial Control Recommendation	Photograph
Old detached house	0	004/ lounge	damp proof course	140513-8	Asbestos-containing bituminous product	Chrysotile	4	4 Lm.	R3	Remove

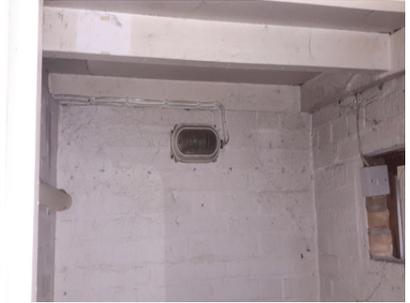
Old detached house	0	008/toilet	putty on light	140513-11	Asbestos-containing putty	Chrysotile	4	0.1 Sqm.	R3	Remove

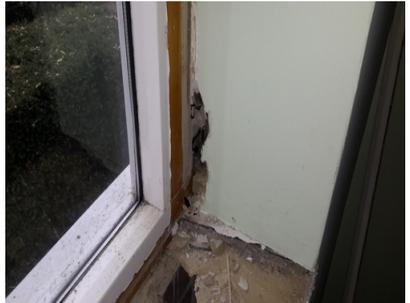
Old detached house	1	001/ bedroom	damp proof course	140513-2	Asbestos-containing bituminous product	Chrysotile	4	4 Lm.	R3	Remove

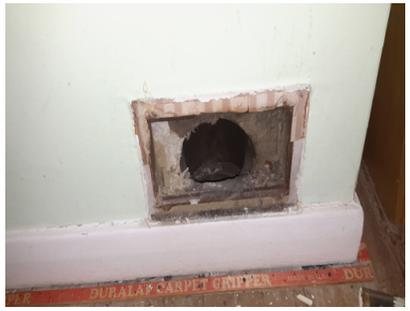
Building	Level	Location	Item / Product Examined	Sample No.	Material Description	Fibre Type	Material Score	Extent	Risk Level Assessment	Initial Control Recommendation	Photograph
Old detached house	1	001/ bedroom	flue	140513-3	Asbestos-containing cement	Chrysotile, Amosite	5	2 Lm.	R3	Remove

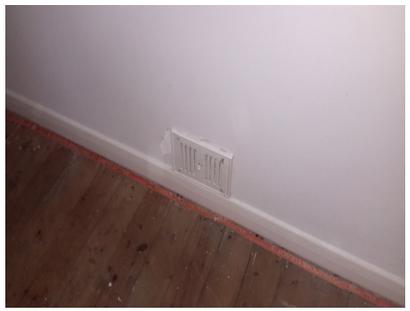
Old detached house	1	002/ bedroom	flue	140513-3	Asbestos-containing cement	Chrysotile, Amosite	5	2 Lm.	R3	Remove

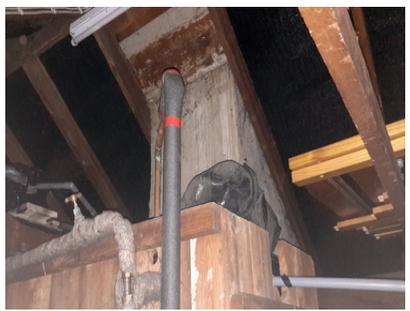
Old detached house	2	001/loft	flue		Asbestos-containing cement	Presume Chrysotile	4	2 Lm.	R3	Remove

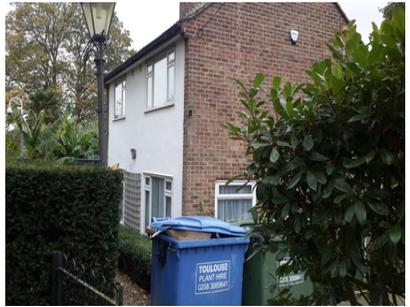
Building	Level	Location	Item / Product Examined	Sample No.	Material Description	Fibre Type	Material Score	Extent	Risk Level Assessment	Initial Control Recommendation	Photograph
Old detached house	9	999/externals	soffit	140513-13	Asbestos-containing insulating board	Amosite, Chrysotile	6	16 Lm.	R3	Remove

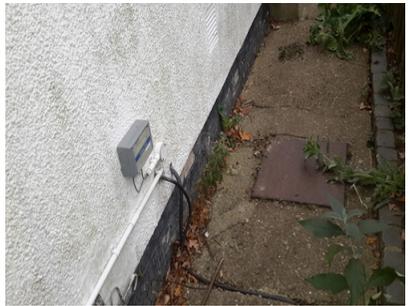
Old detached house	9	999/externals	damp proof course	140513-12	Asbestos-containing bituminous product	Chrysotile	4	50 Lm.	R3	Remove

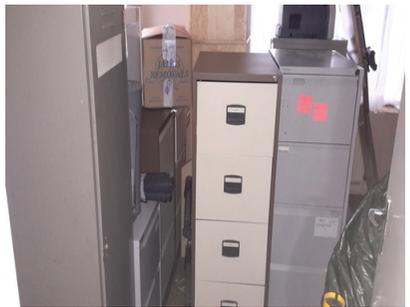
Building	Level	Location	Item / Product Examined	Accessibility	Access Comments	Photograph
Old detached house	0	004/lounge	Entire Location	Limited Access 💬 due to stored items	physically restricted space

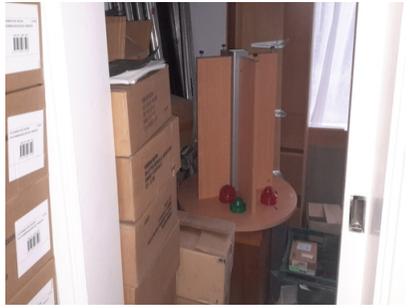
Building	Level	Location	Item / Product Examined	Accessibility	Access Comments	Photograph
Old detached house	0	005/kitchen	Entire Location	Limited Access	physically restricted space

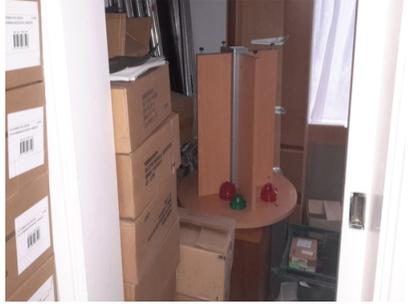
due to stored items		
Old detached house	0	006/dining room	Entire Location	Limited Access	physically restricted space

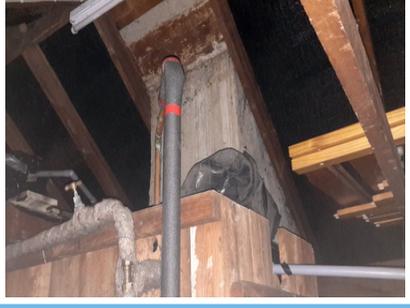
due to stored items		
Old detached house	2	001/loft	flue	No Access	reasons of health and safety

within chimney, no safe access
