Royal Cornwall Museum  
Truro, Cornwall

Bat and Nesting Bird Visual Survey and  
Detailed Bat Surveys

Ref:  
BE751a

Date:  
14<sup>th</sup> July 2022

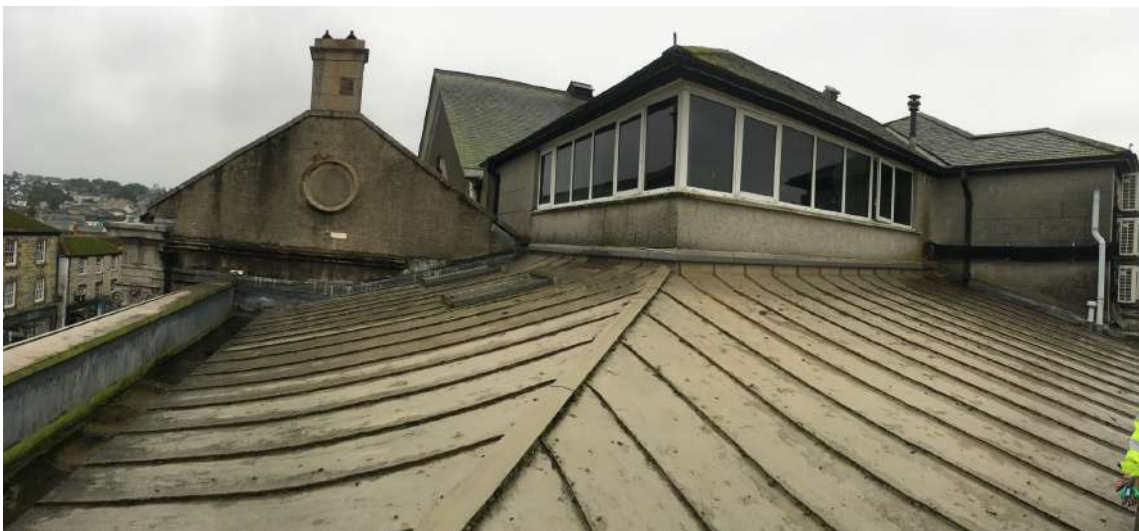
Roof No R1 is above the library and is a pitched gable roof. It has a granite front façade (Photograph 1) and granite gable (Photograph 3). There are granite cornices at the eaves (Photograph 4). These features do not allow any potential bat access points. The roof covering is natural slate with clay ridge tiles. The front roof slope was not visible from the ground. No obvious potential bat access points were observed in the rear roof slope. It was not possible to gain entry to the roof void as there was a non-weight bearing hanging ceiling. A single ceiling tile was removed so that the void could be seen. The underside of the roof covering has a fibrous insulation. This insulation is above the rafters but below the slates and is likely to block bat entry into the roof void. It is possible that bats could roost unseen beneath ridge tiles or behind slates in the void created by the battens (should potential bat access points be present). The presence or absence of bats in R1 could not be determined via a visual survey alone. R1 has been assessed as having low potential as a bat roost. Therefore, one emergence survey at dusk using two surveyors and 5 consecutive nights of remote monitoring in the roof void was recommended to prove absence of bats.

Photograph 3. Granite gable of Roof No R1 and southern parts of R4.

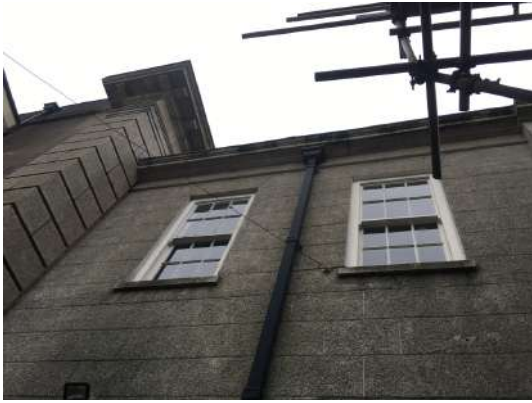
Photograph 4. Granite cornices of Roof No R1.

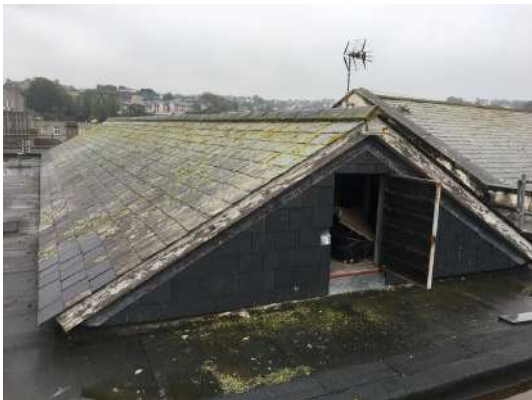
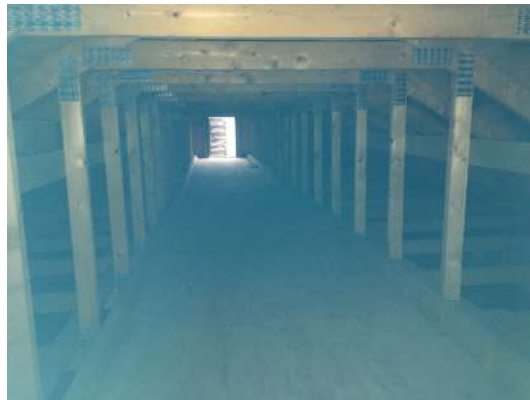
Roof No R2 is pitched gable roof. It has flat roof sections at the eaves (Roof No S2). It is therefore possible to walk entirely around Roof No R2 at the flat roof height. The roof covering is natural slate with clay ridge tiles. There is a foil type membrane present. No potential bat access points were observed to allow bats to the voids between the membrane and slates nor under the ridge tiles. At each gable is a louvred metal door which could potentially allow bat access to the walk-in void within. However, a thorough search of this void was achieved and no evidence of roosting bats was found. The hanging slates on the gables do not have any potential bat access points. A through search of all areas accessible to roosting bats was carried out and no evidence was found. Roof No R2 has been assessed as having negligible potential as a bat roost and no further surveys of this roof were required.

Photograph 5. Roof No R2 North and east elevations. Photograph 6. Roof No R2 internal.

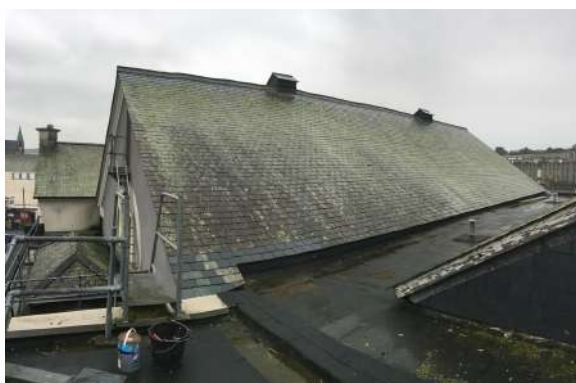
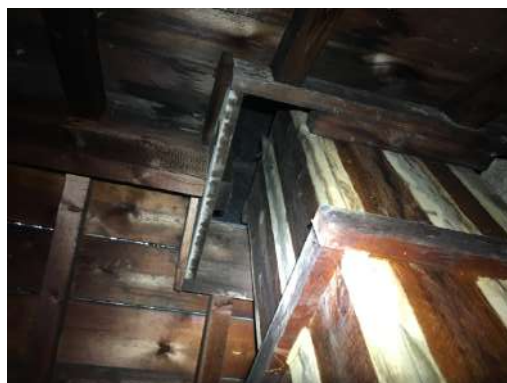
Roof No R3 is above the main gallery of the museum. This part of the museum has an arched vaulted vaulting. There is a large walk-in roof void above this ceiling. The access is via a wooden louvred door on the north gable. The large pitched gable roof has a covering of natural slate with clay ridge tiles. There are wooden sarking boards beneath the slates. There are two roof vents (see photographs 7 and 8) that have gaps that could potentially allow bats to enter the roof void. Bats may also potentially enter the void via the louvred door. However, no evidence of bats was found within the void.

Photograph 7. Roof No R3 North and west elevations. Photograph 8. Roof vent in No R3.

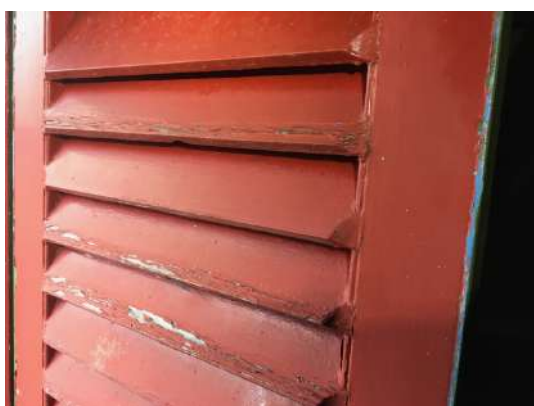
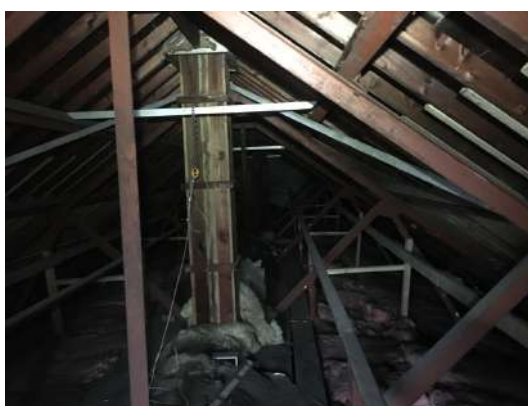
Photograph 9. Roof No R3 louvered door. Photograph 10. Roof void No R3.

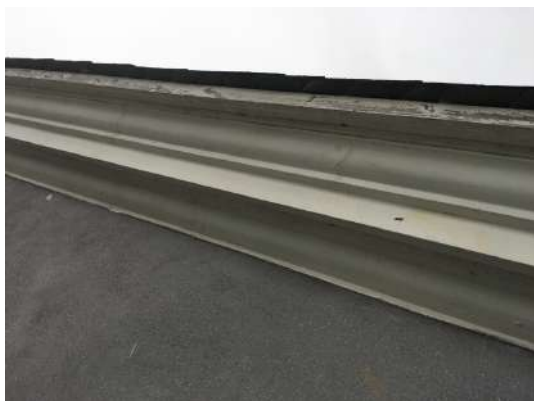
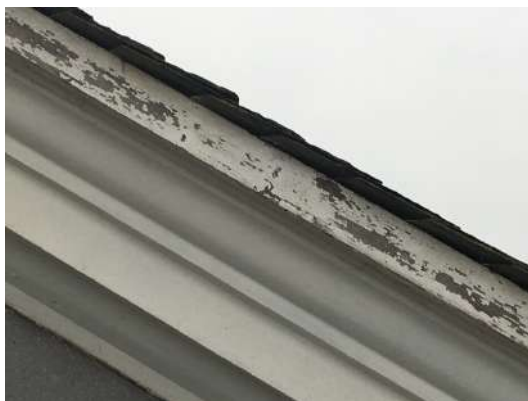
The soffits are tightly fitted to the render at the gables (Photograph 11), however there are gaps between the slates and the soffit that would allow bats to potentially gain access to the void between the slates and the sarking boards. There are also some lifted slates across the main part of the roof.

The presence or absence of bats in R3 could not be determined via a visual survey alone. R3 was assessed as having low potential as a bat roost. Therefore, one emergence survey at dusk using

Photograph 11. Tightly fitted soffit of R3. Photograph 12. Gaps between soffit and slates on R3.

two surveyors was recommended to prove absence of bats. Remote monitoring of the void was not required. R3 was surveyed at dusk from the flat roof sections.

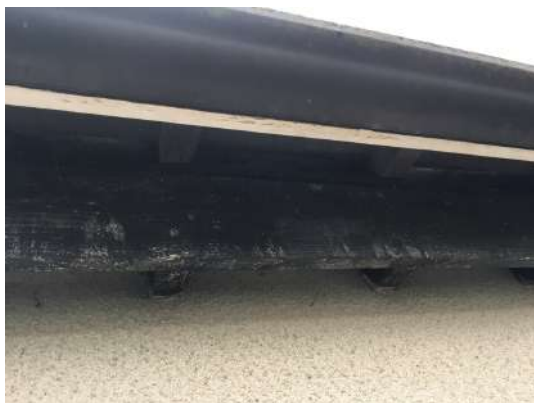
Roof No R4 is a complex design roof it is pitched with a gable at the north elevation, a hip at the south elevation and an intersecting roof section (see Photograph 3 and Figure 1). It has a roof covering of natural slate and clay ridges. Internally the ceiling is vaulted and there is no accessible roof void. Large gaps were observed between the rafters at the eaves (see Photograph 13). This would potentially allow bats to gain entry into the void between the roof and the vaulted ceiling.

The presence or absence of bats in R4 could not be determined via a visual survey alone. R4 was assessed as having low potential as a bat roost. Therefore, one emergence survey at dusk using two surveyors (a third surveyor covering R3 also covered the west roof slope of R4) was

Photograph 13. Gaps between the rafters at the eaves of R4.

recommended to prove absence of bats. Remote monitoring was not required. R4 was surveyed at dusk from the flat roof sections.

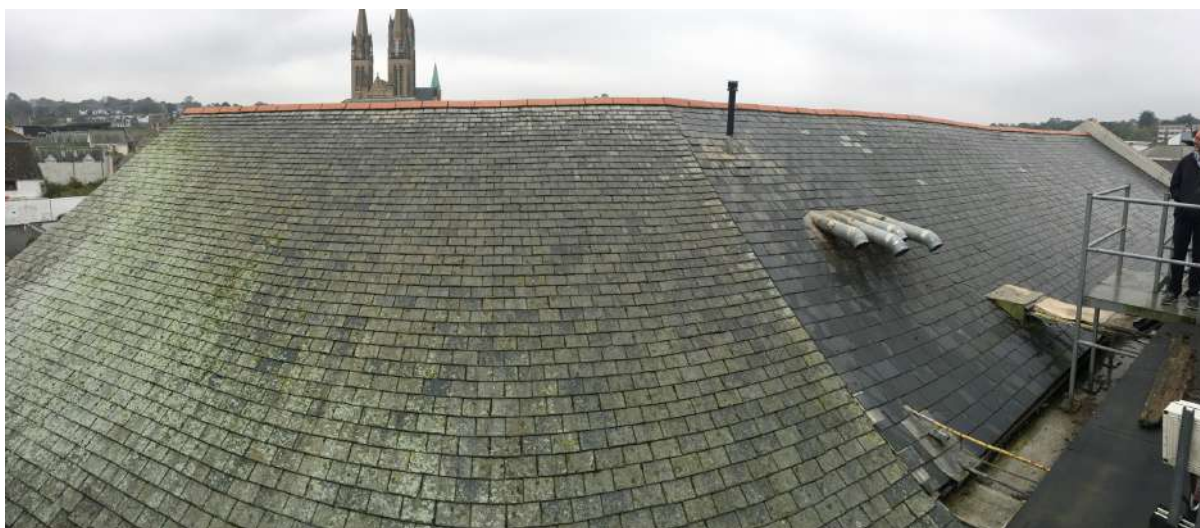
Roof No R5 is above the former chapel. There is a large walk-in roof void that houses the air circulation system for the museum. The roof covering is natural slate with bitumen felt. No evidence of bats was found within the void. The chapel roof has a stone gable at the south elevation. The soffit is tightly fitted to the render at the north gable, however there are gaps beneath the ridge tiles that may allow bats to gain entry to the ridge void.

The presence or absence of bats in R5 could not be determined via a visual survey alone. R5 was assessed as having low potential as a bat roost. Therefore, one emergence survey at dusk using two surveyors was recommended to prove absence of bats. Remote monitoring of the void was not required. R5 was surveyed at dusk with one surveyor on the flat roof and one on the road on the north elevation.

Photograph 14. West roof slope of R5.

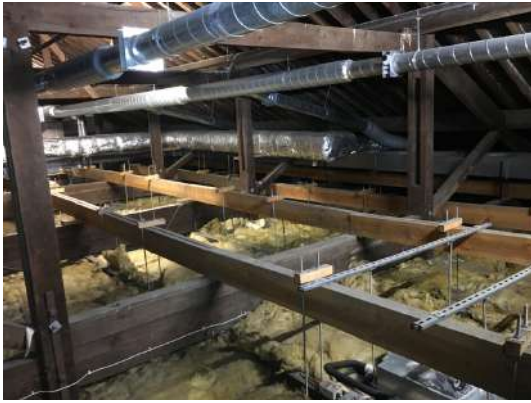
Photograph 15. Roof void of R5.

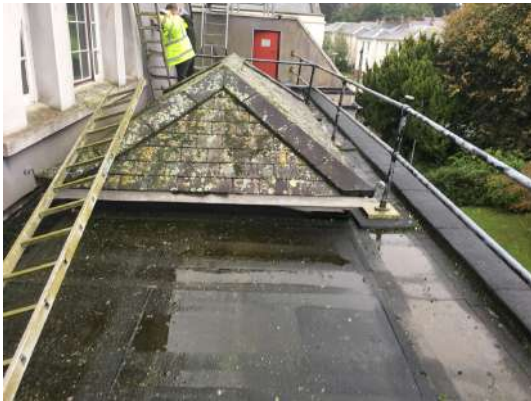
There is a small hipped roof within the flat roof (S4) to the north of R3 (see Photograph 16). It is possible that this was a former light-well that has been slated. It does not have any potential for roosting bats and no further surveys of S5 were required.

Photograph 16. Roof No S5.
