Dampness Inspection Report  
Brooklands Building  
Holmes Chapel Community Centre

Issue 1  
July 2021

Inspection Date 30 June 2021

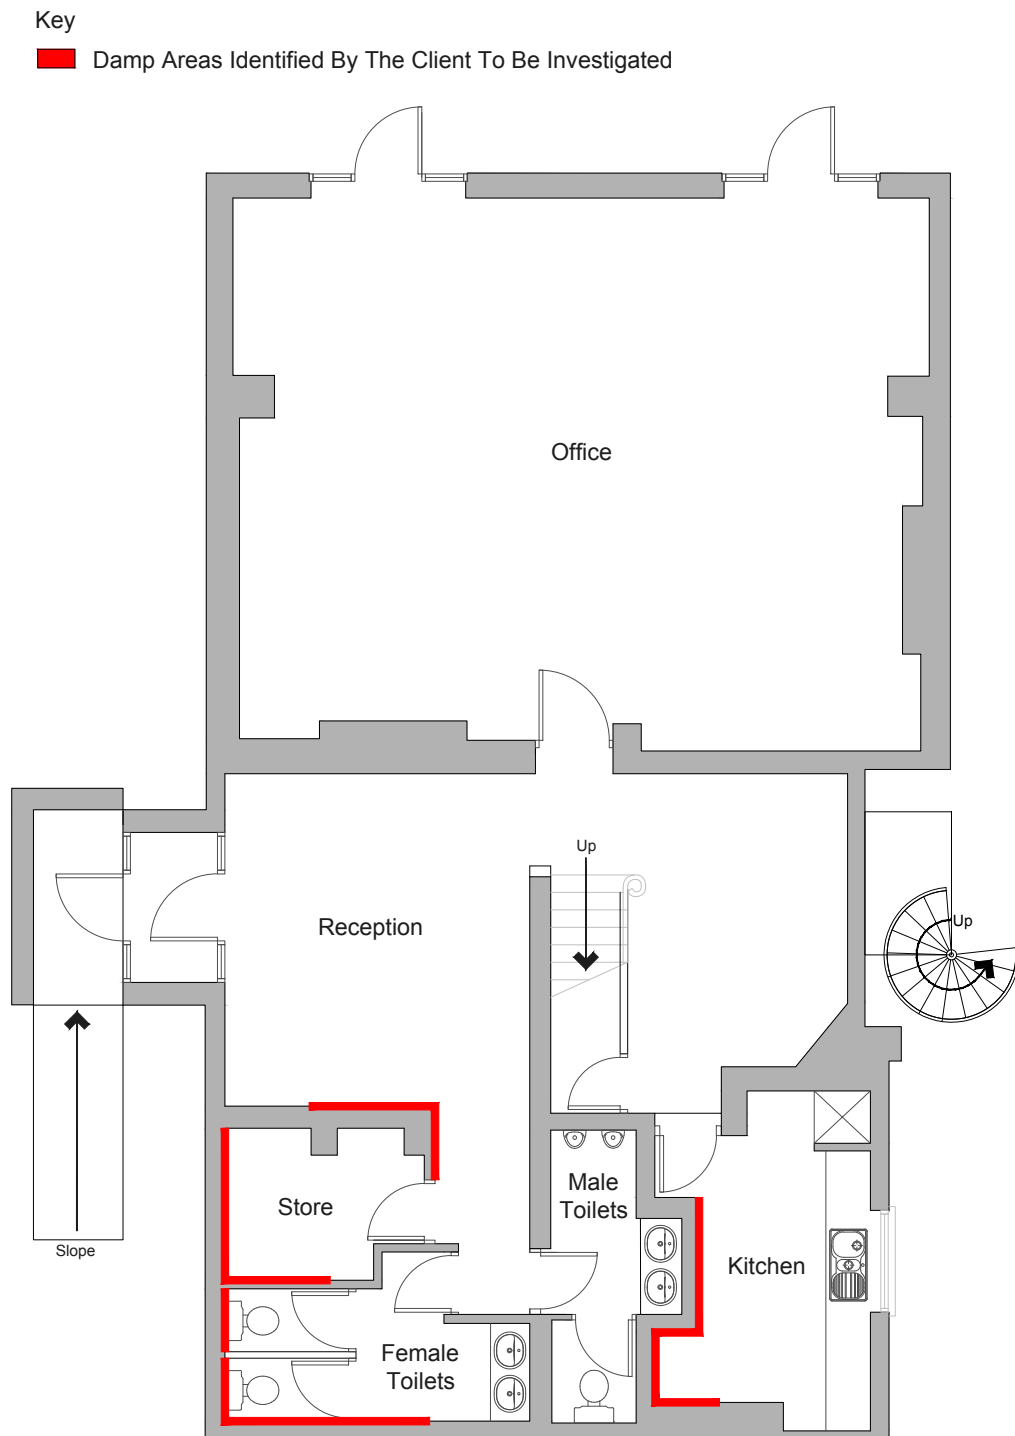
Figure 1 – Building Layout with Damp Areas requested by Client to be Investigated

The layout of the ground floor accommodation and general locations of dampness is shown in Figure 1.

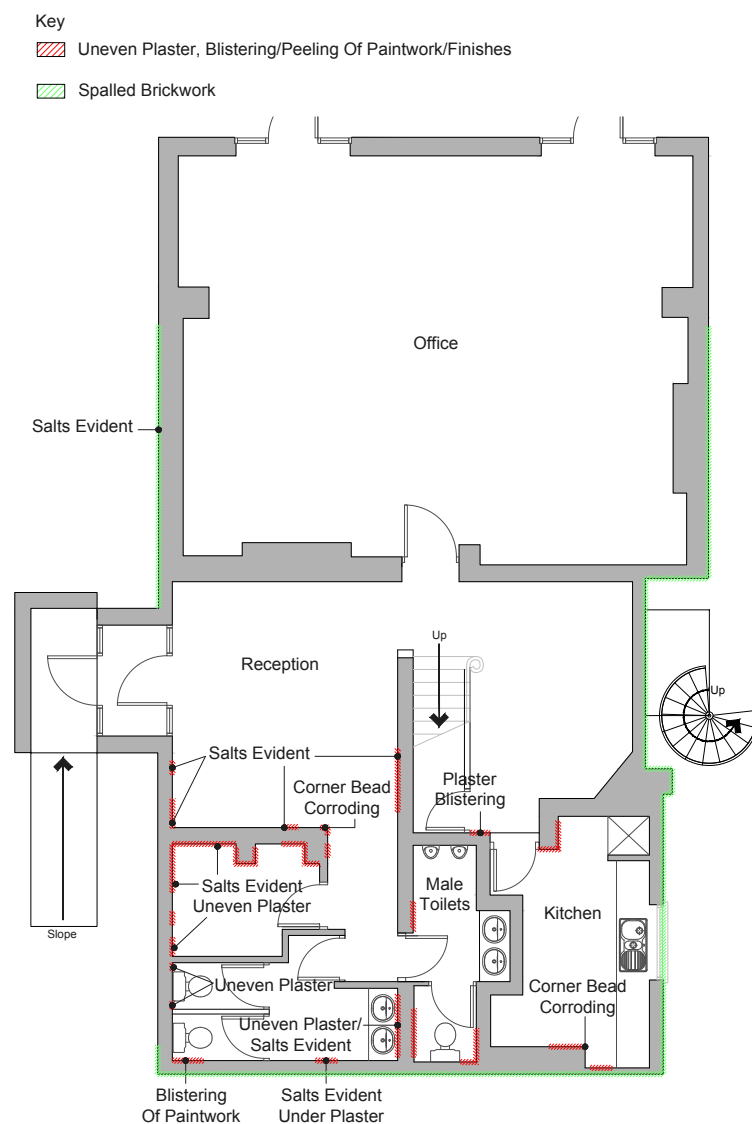
Figure 2 – Defect Locations

The following defects were noted during our inspection and are indicated on Figure 2 below:

1. Efflorescence and blistering / peeling of paint finish at low level to walls.
2. Rough / uneven plaster at low level.
3. Plaster corner beads were noted to be corroding.
4. Generally surface condition of all walls is consistent throughout.
5. Heavily spalled brickwork at low level externally with salt evident.

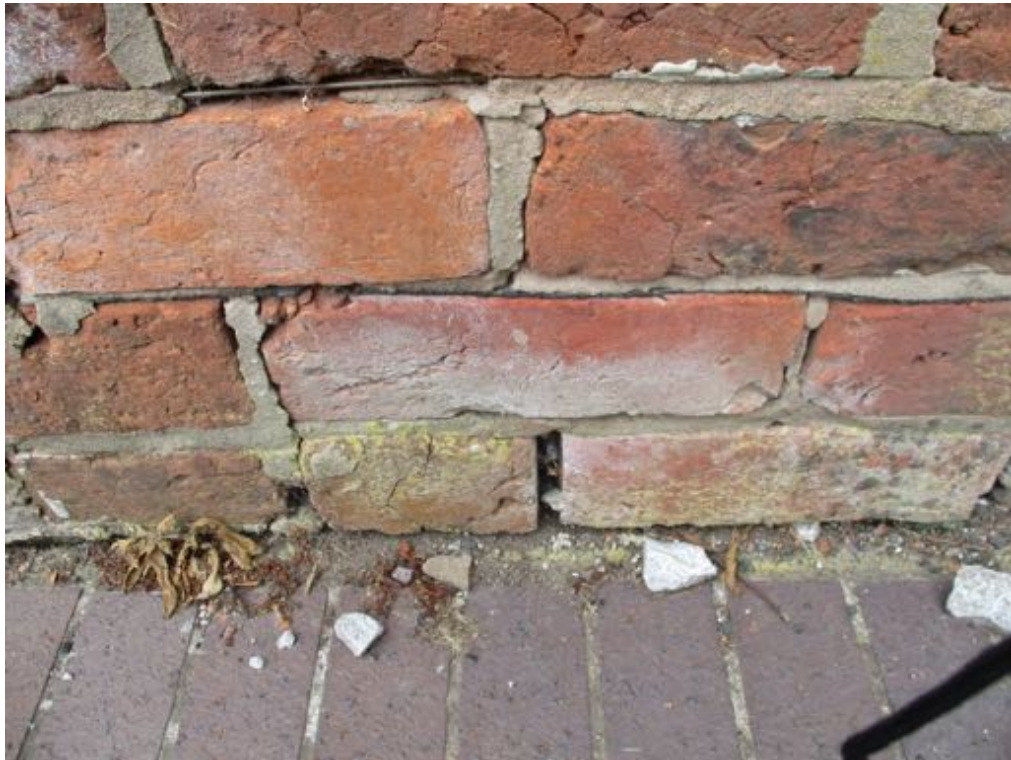
Externally a bitumen DPC was identified and was noted to be 75mm below the finished floor level of the building. The DPC was noted to be 150mm above ground levels.

Additionally an Electro-osmotic damp course appears to be present 75mm higher than the original DPC (titanium wire present behind mortar joint), suggesting past remedial works have been attempted to resolve historic damp issues. Due to the current condition of the walls, this system appears to be redundant or could be switched off. Further investigation of the installation and condition of this system should be undertaken before any intrusive remedial works are considered or undertaken.

Photograph of DPC / Electro-osmotic DPC

The installation of an electro-osmotic DPC highlights previous remedial works have been undertaken to attempt to resolve rising damp issues and considered to be redundant for the purposes of this report.

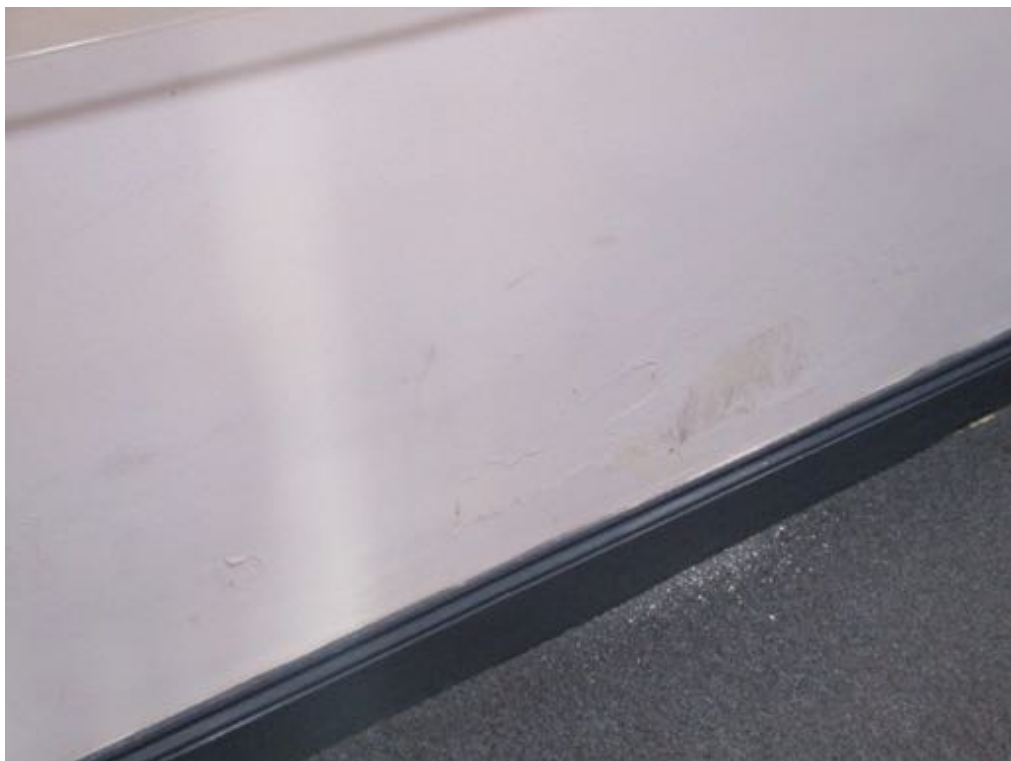
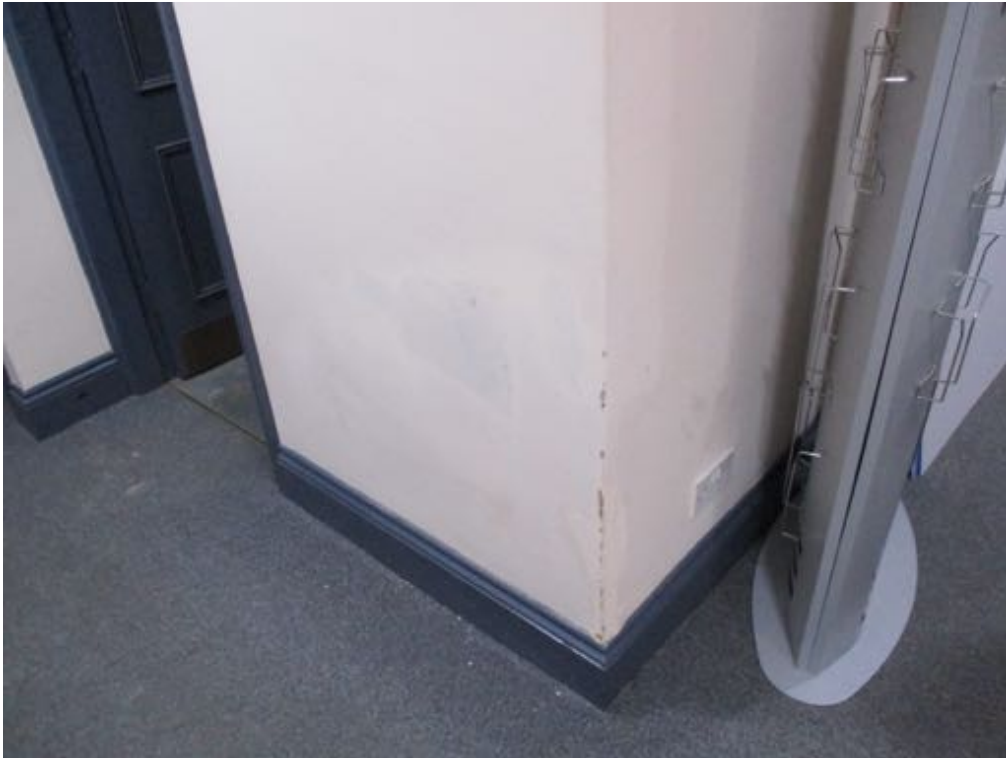
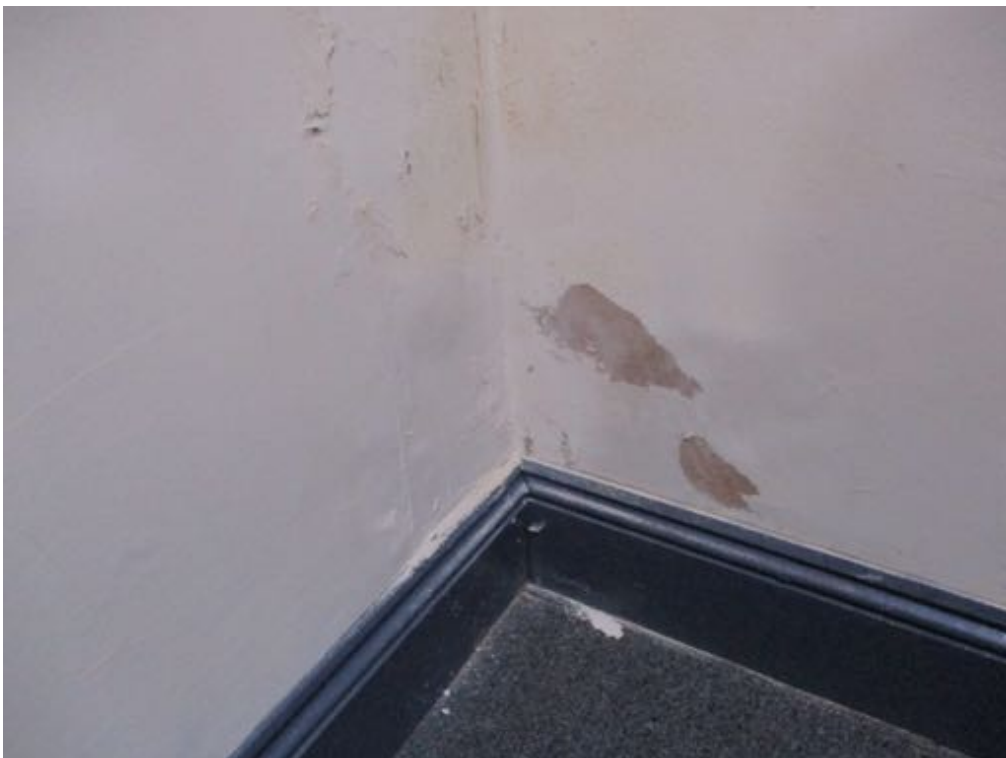
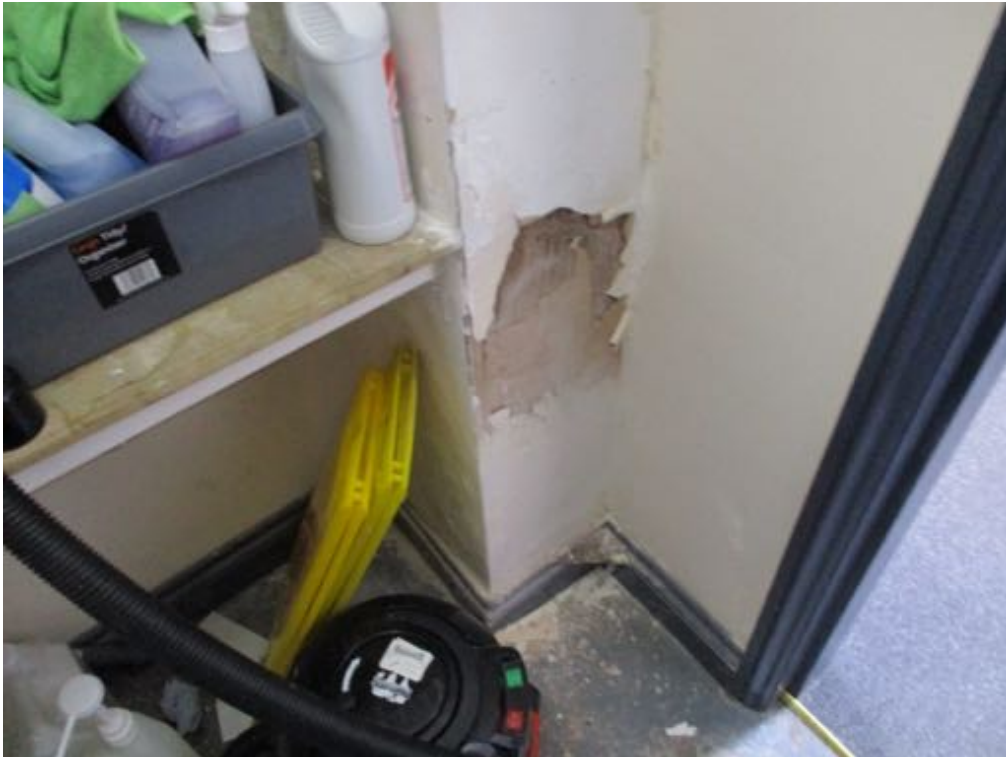
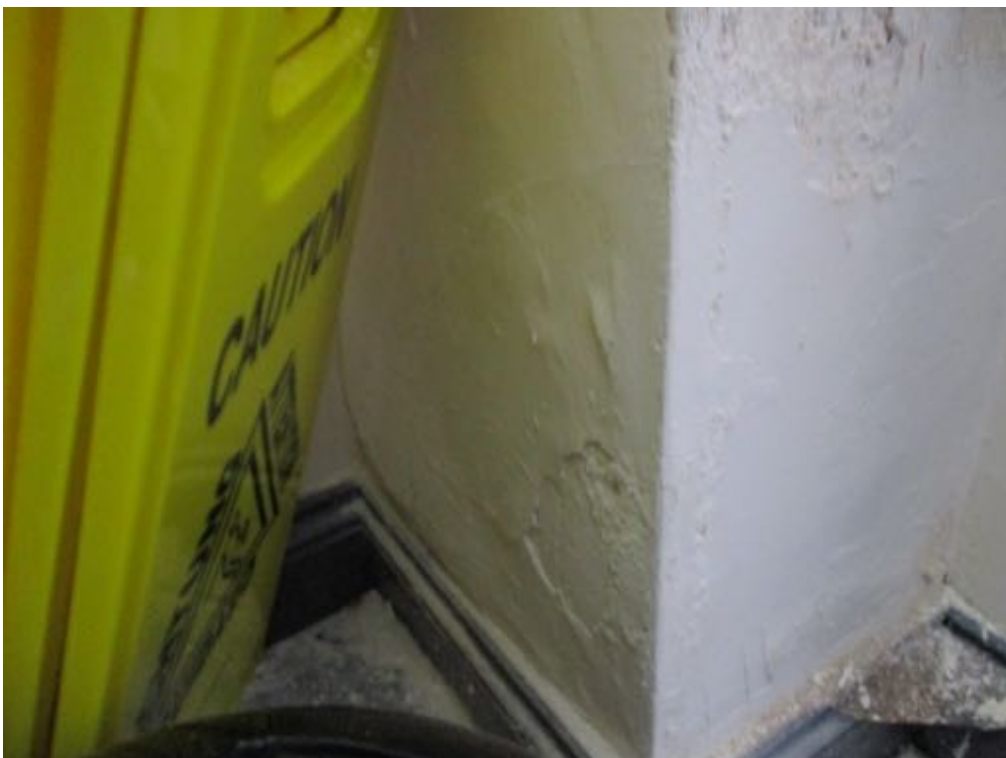
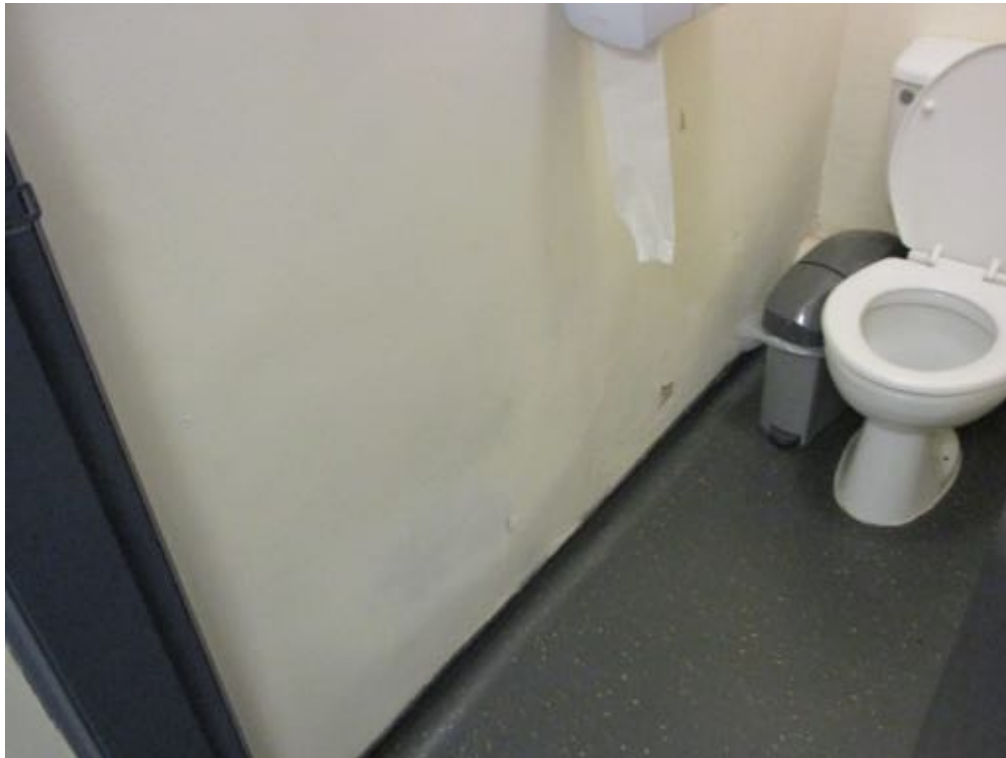
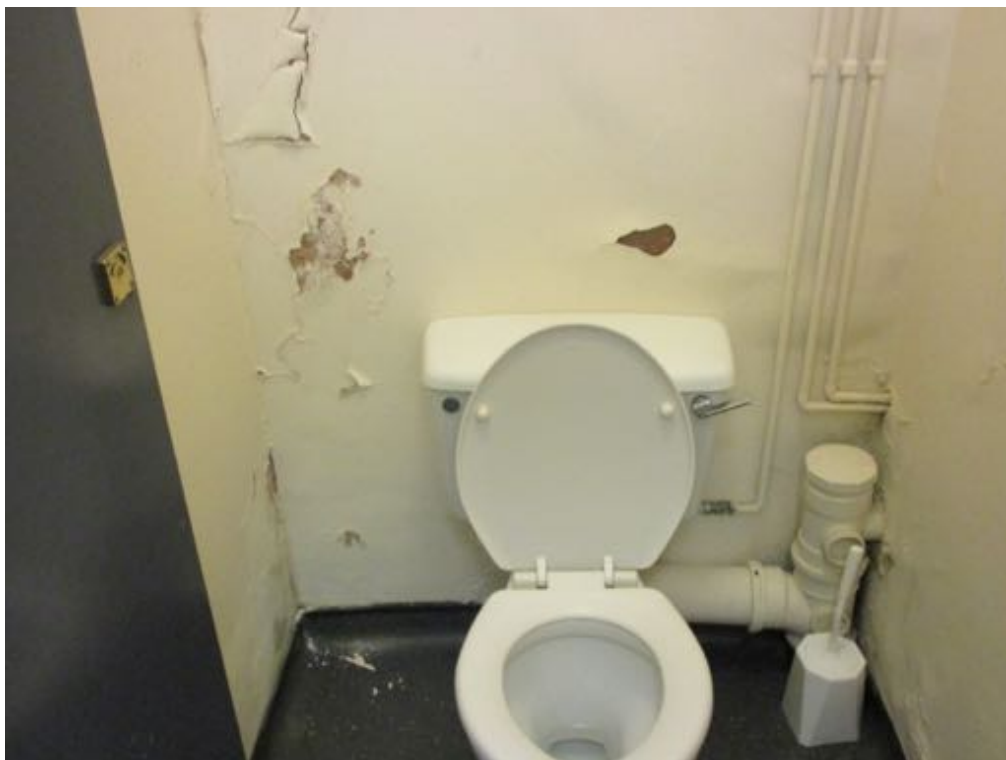
1. Very high moisture levels were consistent from finished floor level up to 1200mm above floor level.
2. Salts were evident to areas showing plaster defects.
3. Generally walls that appear dry on visual inspection still showed high damp readings at low level.
4. The moisture levels have a distinct absolute line where damp levels significantly decline to a safe % above the 1200-1500mm height.
5. No mould growth was noted.
6. High moisture content readings were present through the thickness of the wall where tested with the deep probes.
7. Timber skirtings have high moisture content readings around the defective areas but in a lot of instances were not showing any current signs of deterioration.
8. No signs of defects were noted to external rainwater goods and services.
9. Externally low-level bricks are heavily spalled with salts evident.

Photographs of Internal Dampness

Given the location of defects and general pattern of the damp readings of the walls the source of the moisture is considered to be caused by ground water rising up through the internal and external walls, due to the lack of adequate damp proof membranes with installation height of original DPC also being a contributing factor.

It is therefore recommended to install new chemical injection damp proof course.

Plaster should be removed to 1200mm above floor level and the wall re-plastered to finish above the level of the new injected damp proof course and first horizontal mortar joint above floor level. The new skirtings should be installed and high enough to cover the gap to the base of the wall where there is no plaster.

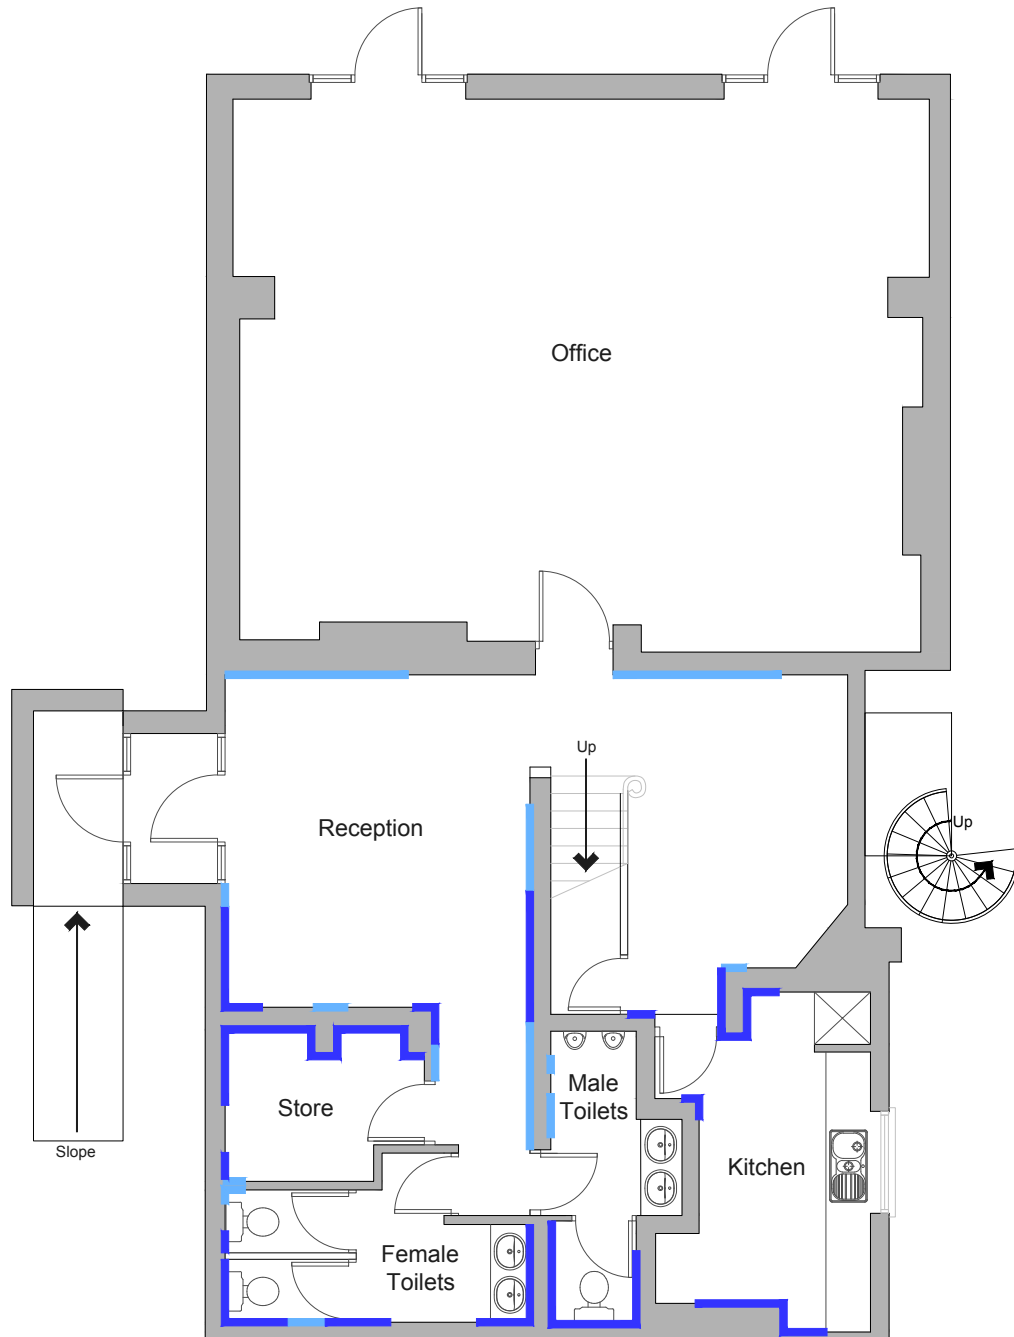
Figure 4 – Dampness Locations

Figure 4 indicates the extent of rising dampness identified. The pattern of moisture content readings do not support condensation as being a significant factor in the cause of the dampness, whilst the presence of salts, lack of mould and lack of defects to nearby services do not support penetrating dampness or pipe leaks as being a significant factor in the cause of dampness.
