Jewish Cemetery, Ponsharden

Proforma Condition and Repairs Schedule

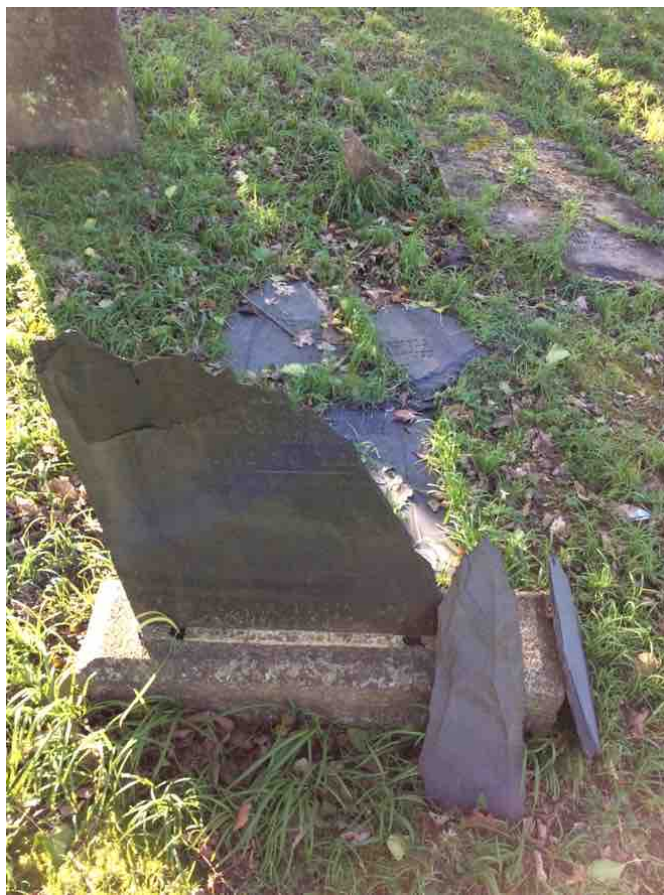
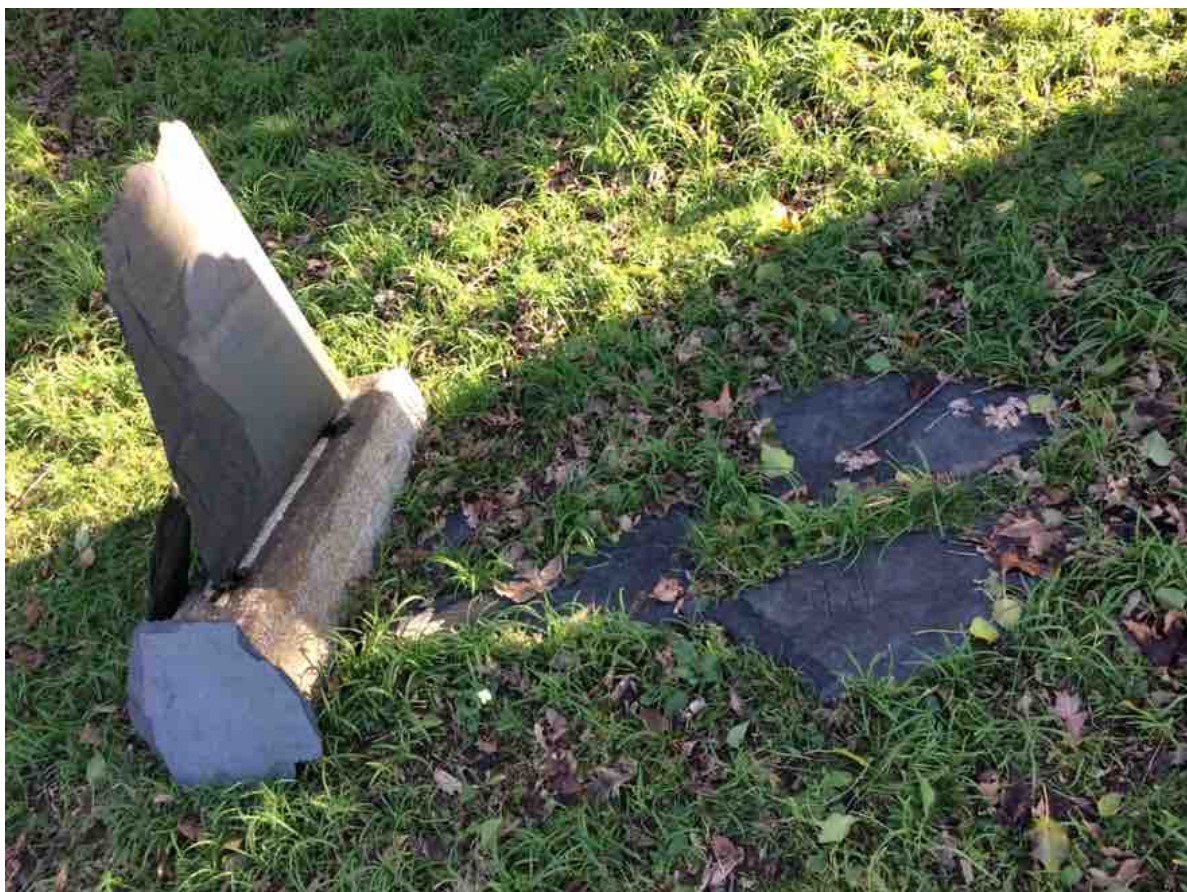
Headstone broken into 4 main pieces, with some sections missing

Granite base has since been re-erected, with broken headstone attached (see photo). High risk of further loss.

Clean off organic growth and dirt. Sink granite base into ground to original depth in original location. Pin surviving sections (4? no plus base) together to 25mm thick slate backing. Make good joints with mortar. Refix to granite base and re-erect headstone.

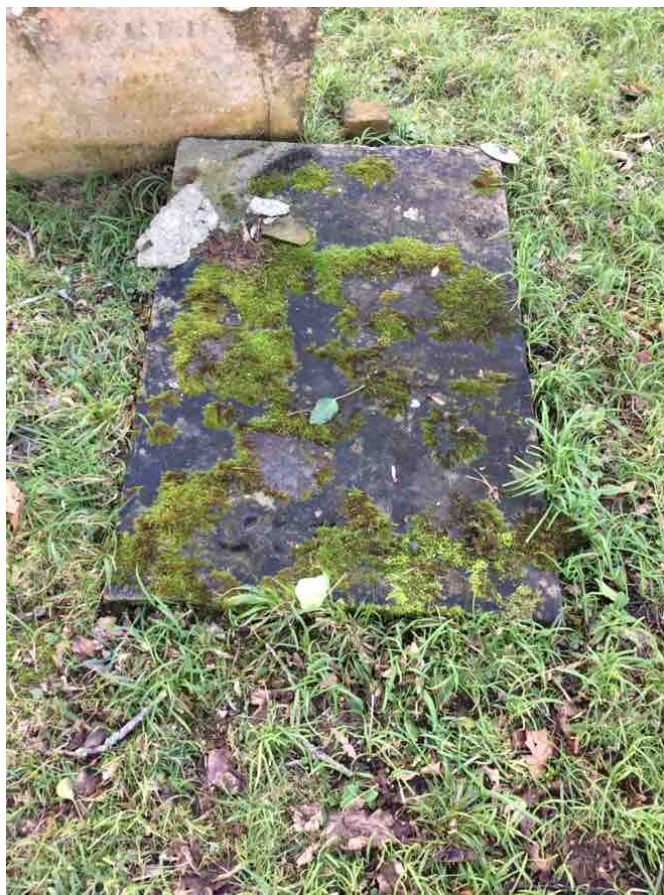
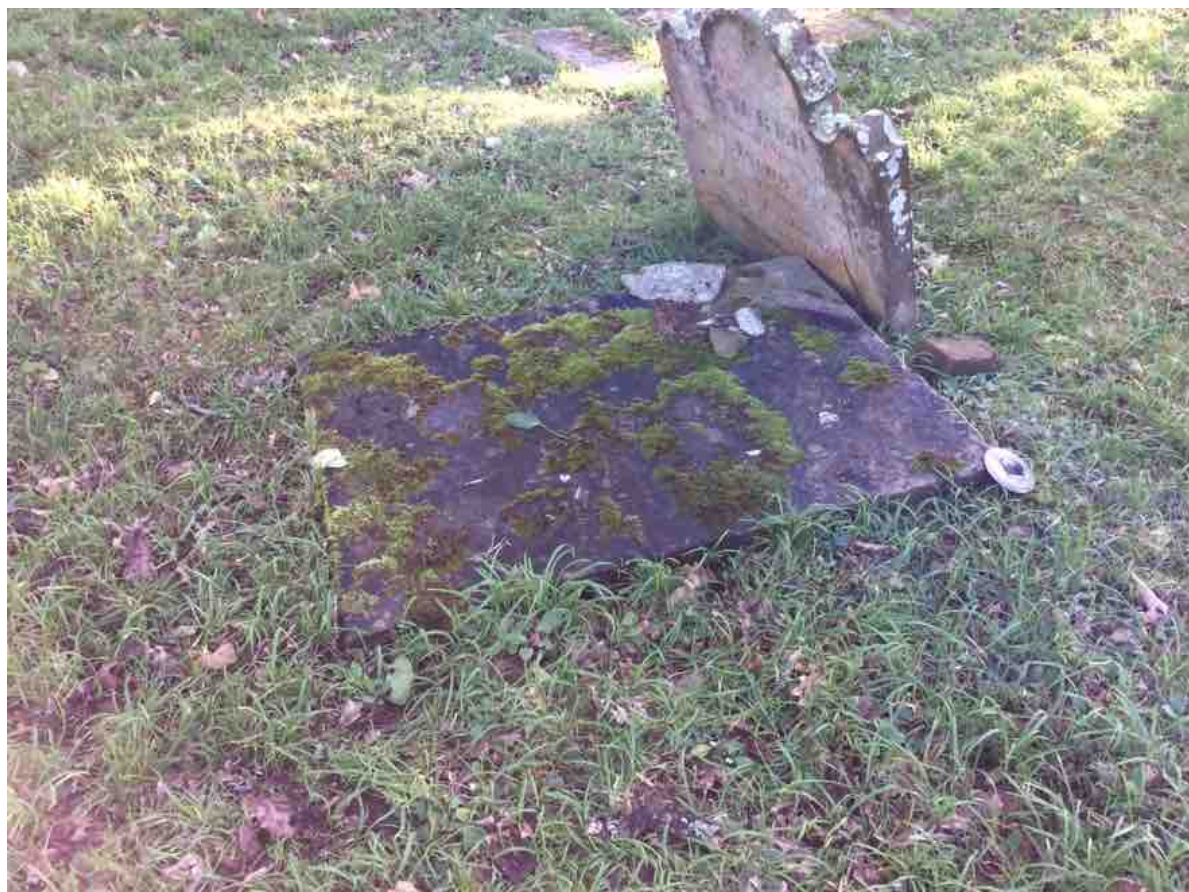
Broken off at base, but complete

Slate intact but lying face down, at risk of further damage if left in current location

Clean off organic growth and dirt. Excavate base and pin base and top of headstone to 25mm thick slate backing. Make good joints with mortar. Re-erect in original location of existing base.

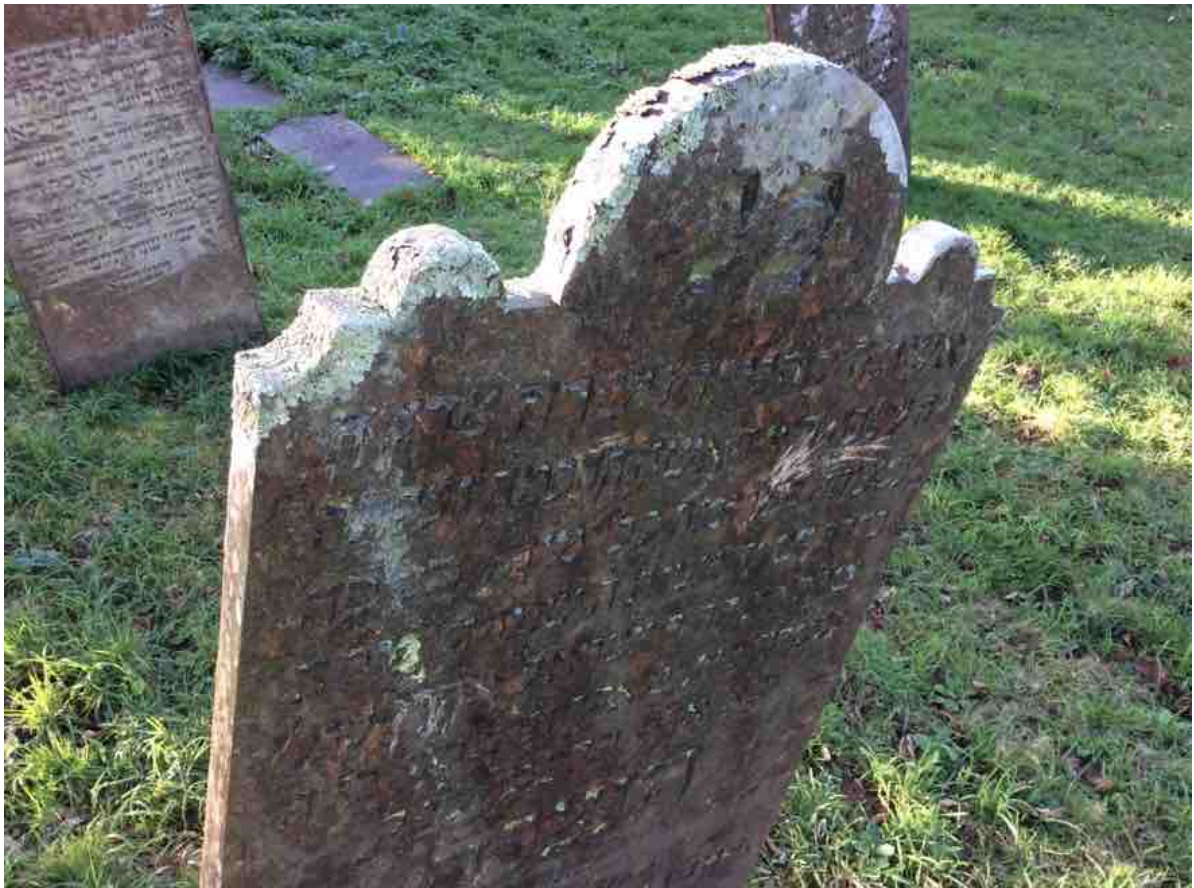
Lichen (see photo)

Sandstone with drastic lean, currently not unstable but may be advisable to deal with during any repair works to avoid need in the future

Carefully excavate headstone, and re-set vertically in the same location

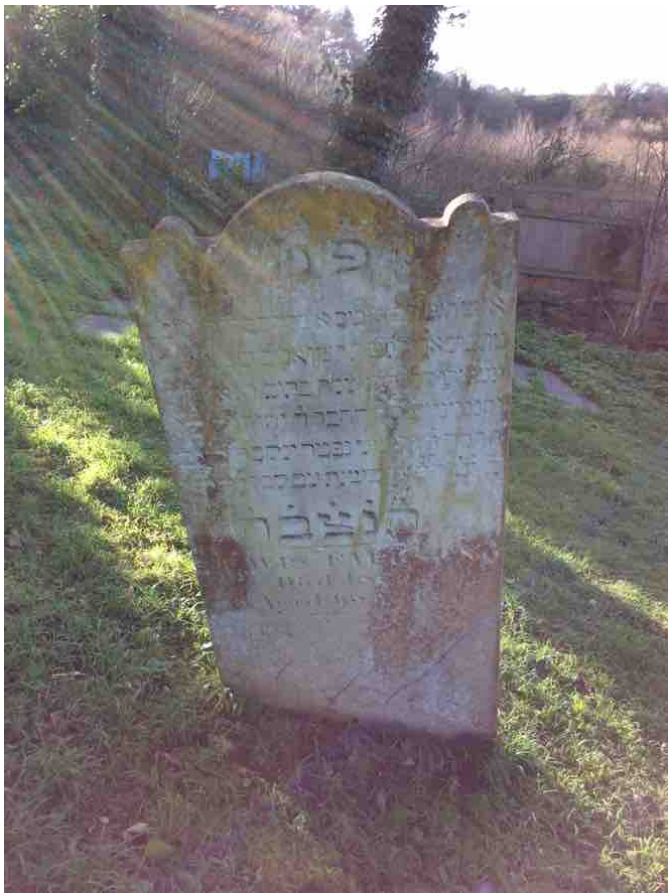
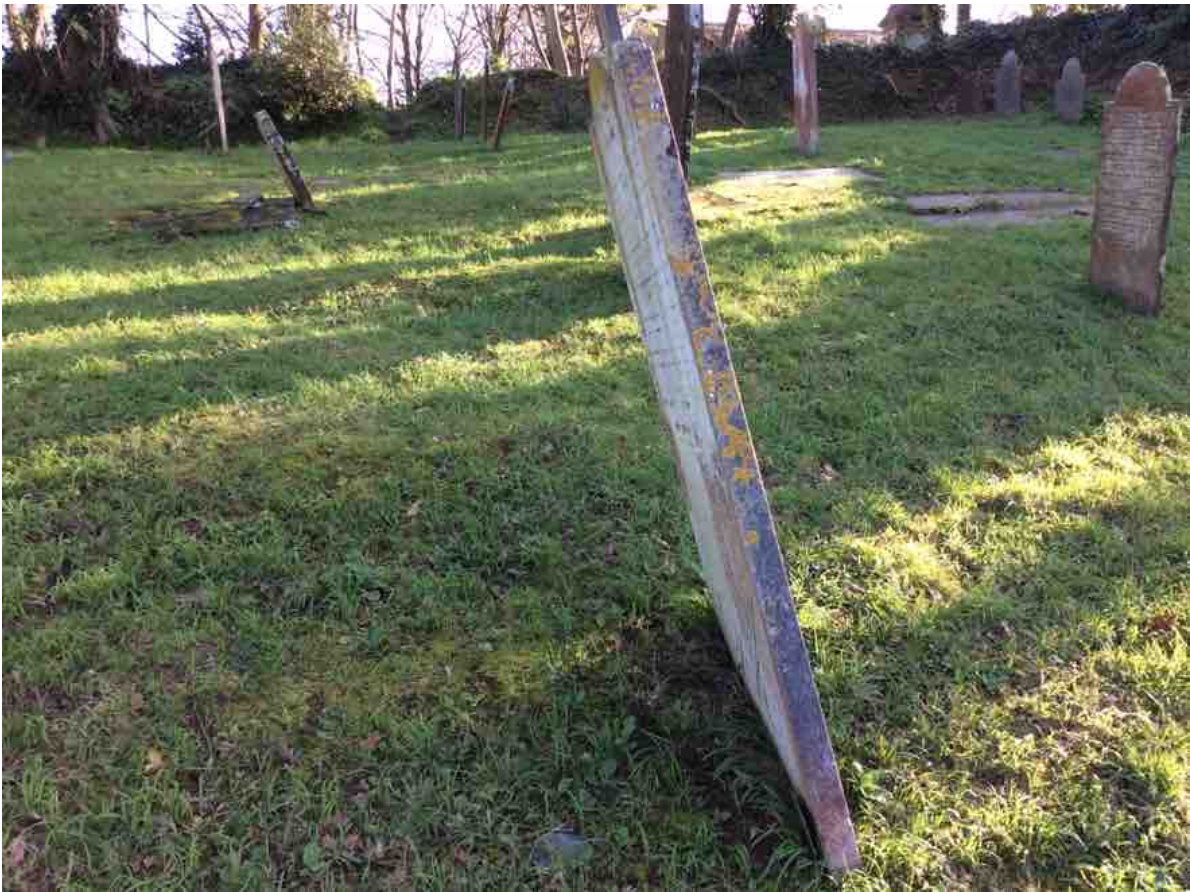
Overall structural condition:	Excessively tilted	Headstone drastically leaning towards north
Ground condition :	Other	Grass verge downhill
Impact of vegetation:	None	
Condition of foundation:	Not visible

Drastic lean, currently not unstable but may be advisable to deal with during any repair works to avoid need in the future.

Carefully excavate headstone, and re-set vertically in the same location

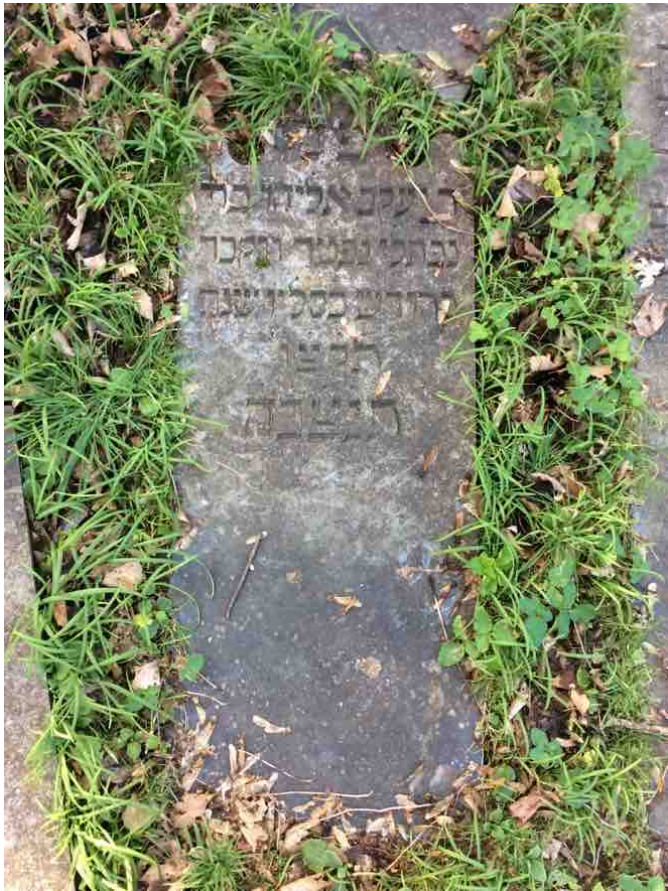
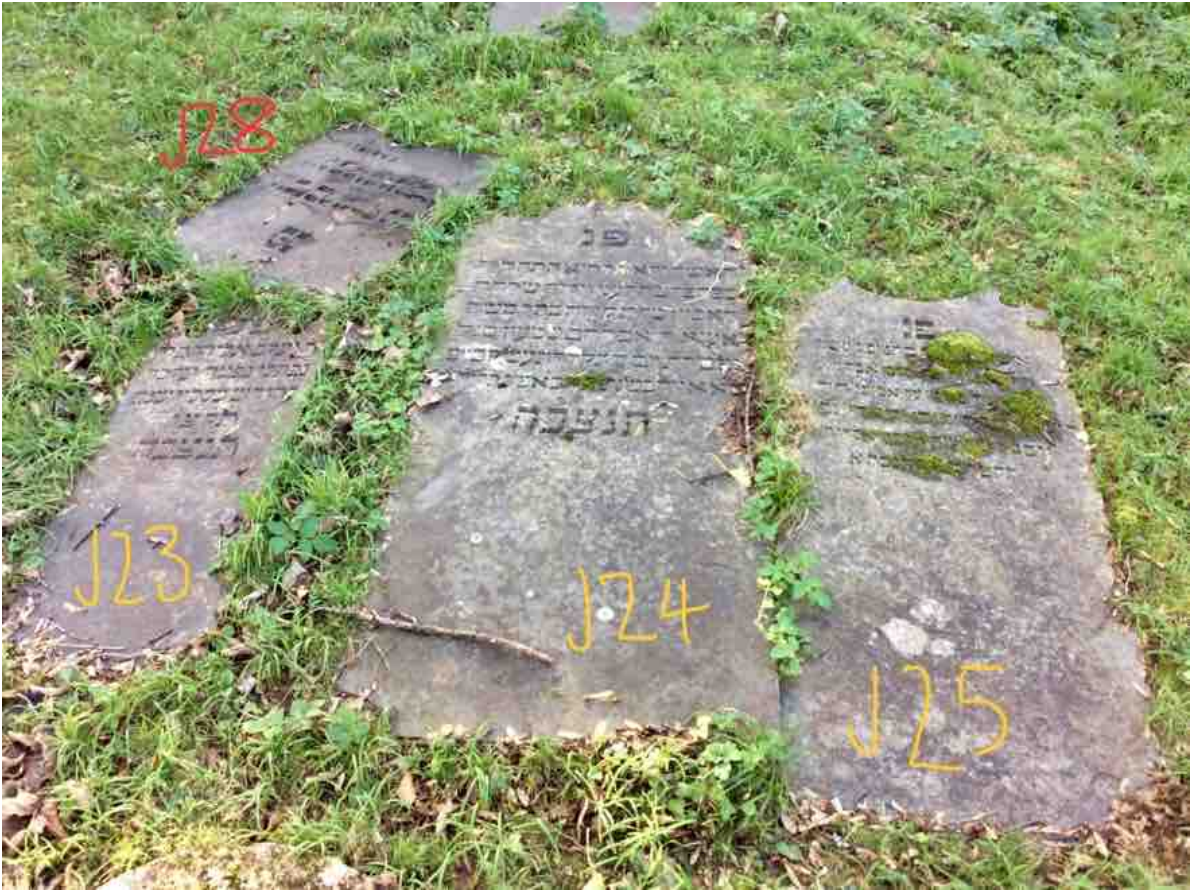
Good, slate lying on ground. Medium to high risk of further damage in current location.

Clean off organic growth and dirt. Re-erect in original location.

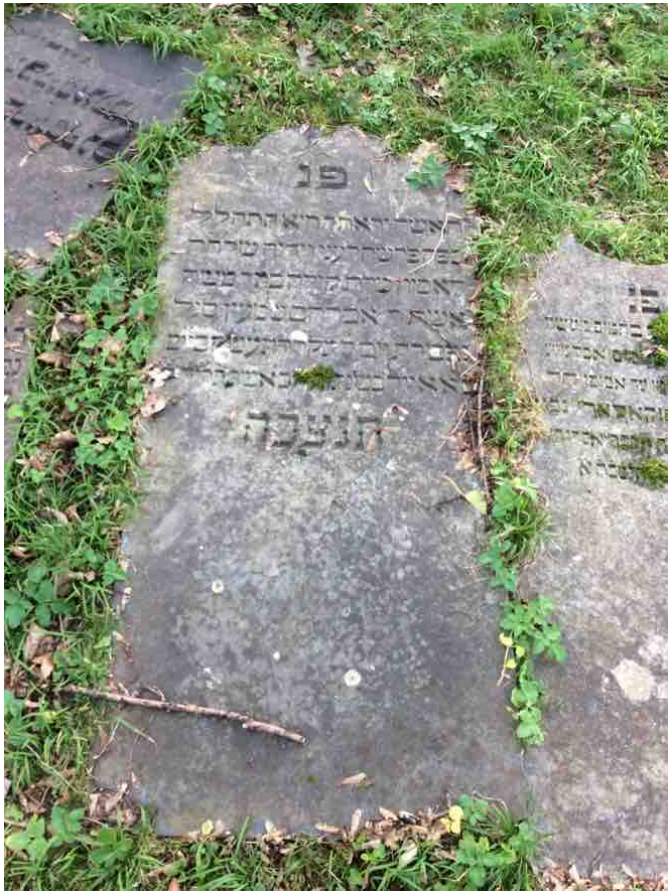
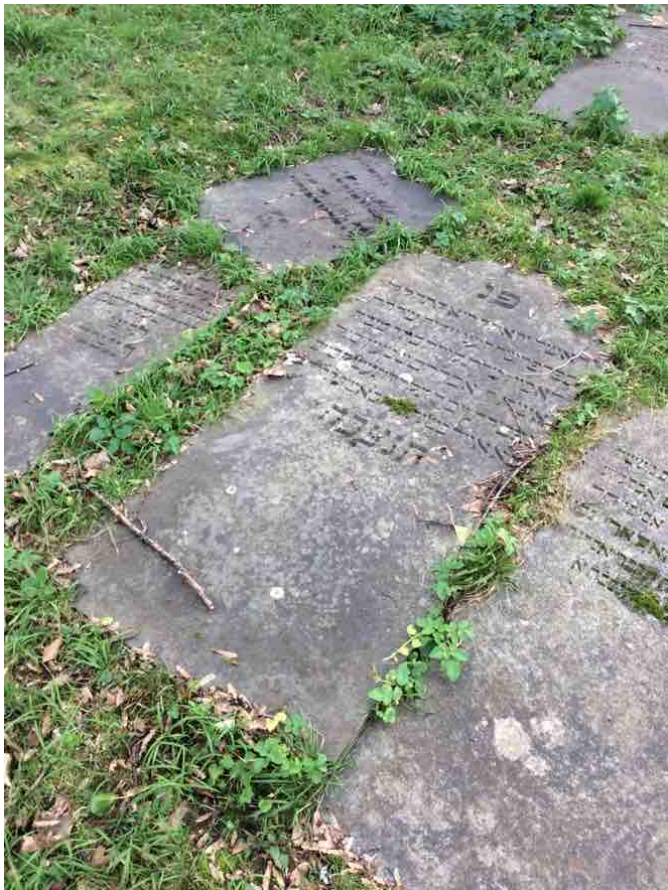
Good, slate lying on ground. Medium to high risk of further damage

Clean off organic growth and dirt. Re-erect in original location.

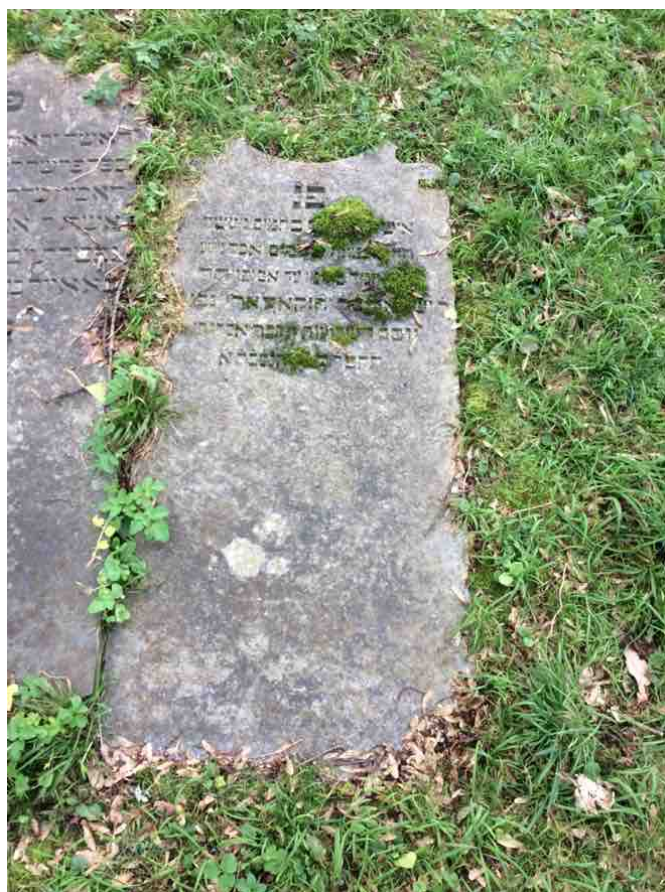
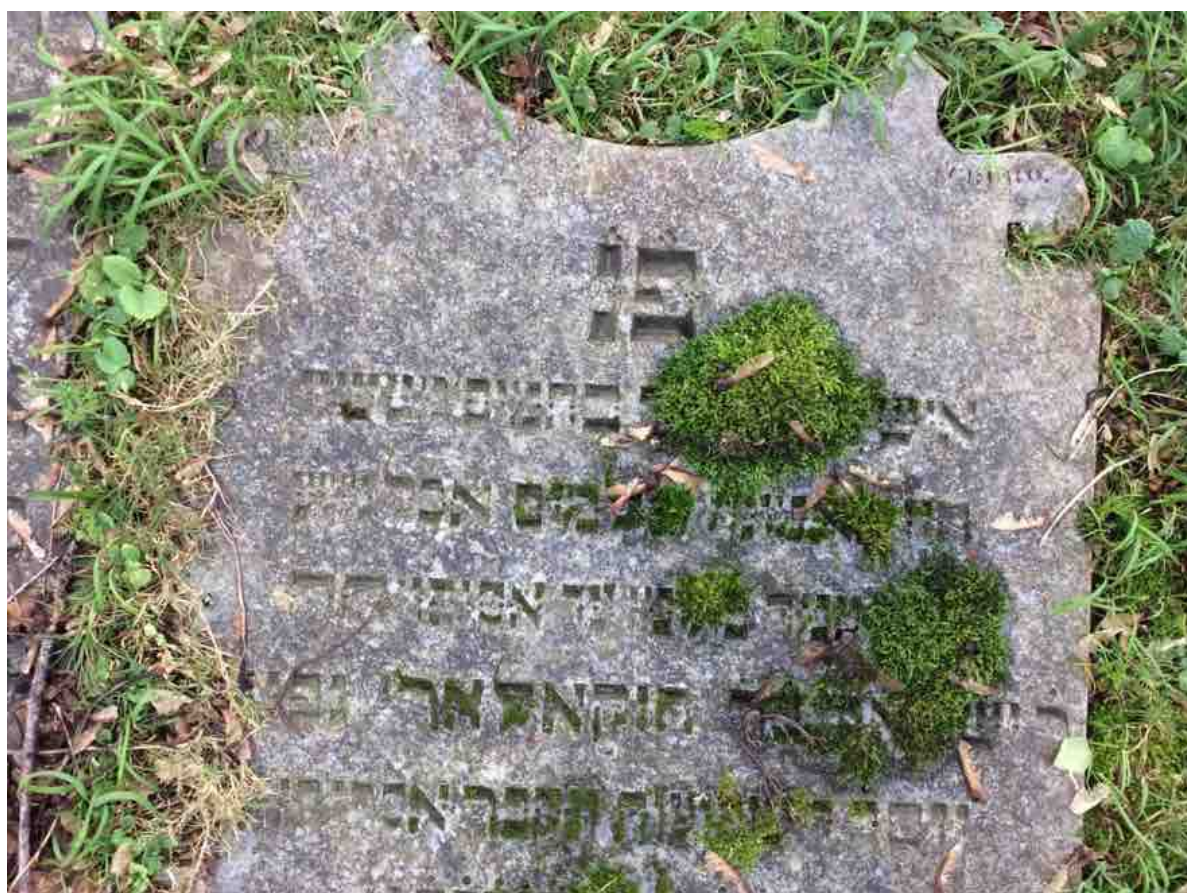
Good, slate lying on ground. Medium to high risk of further damage

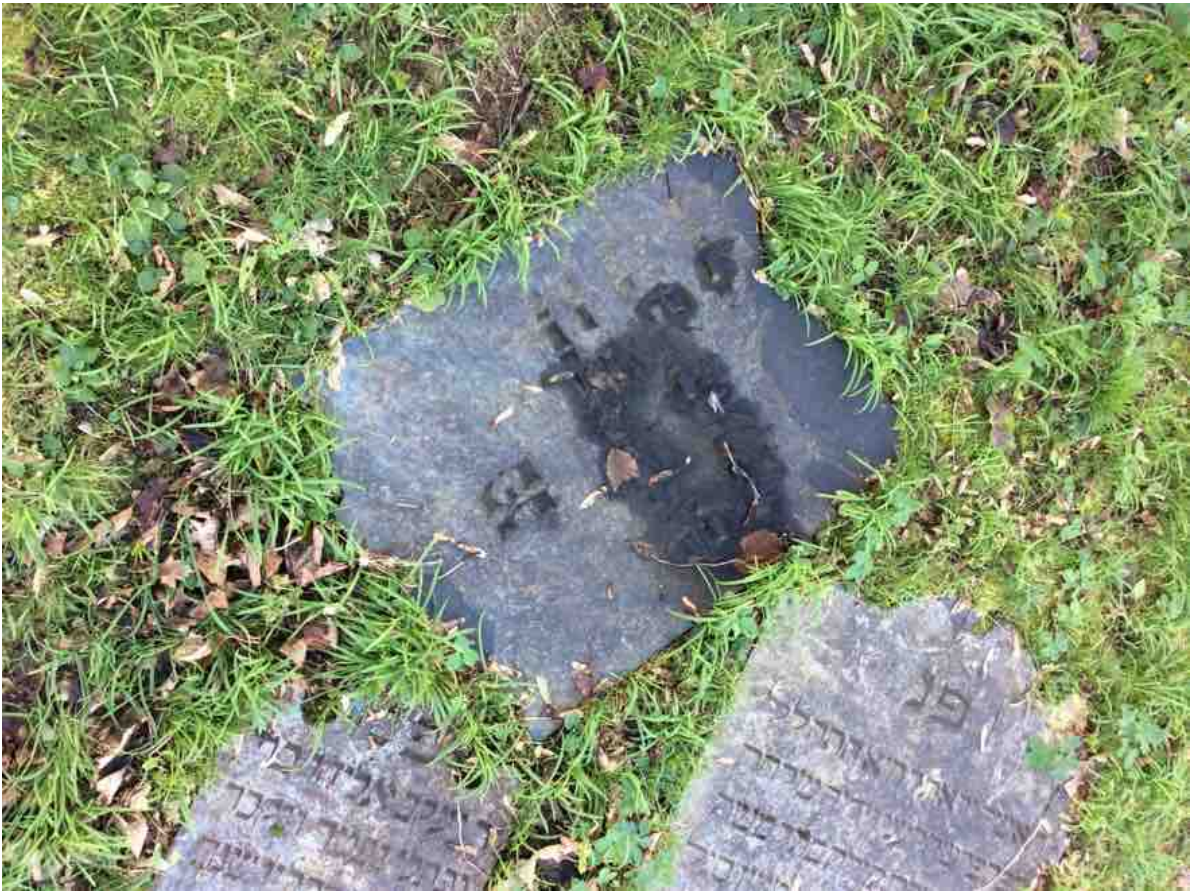
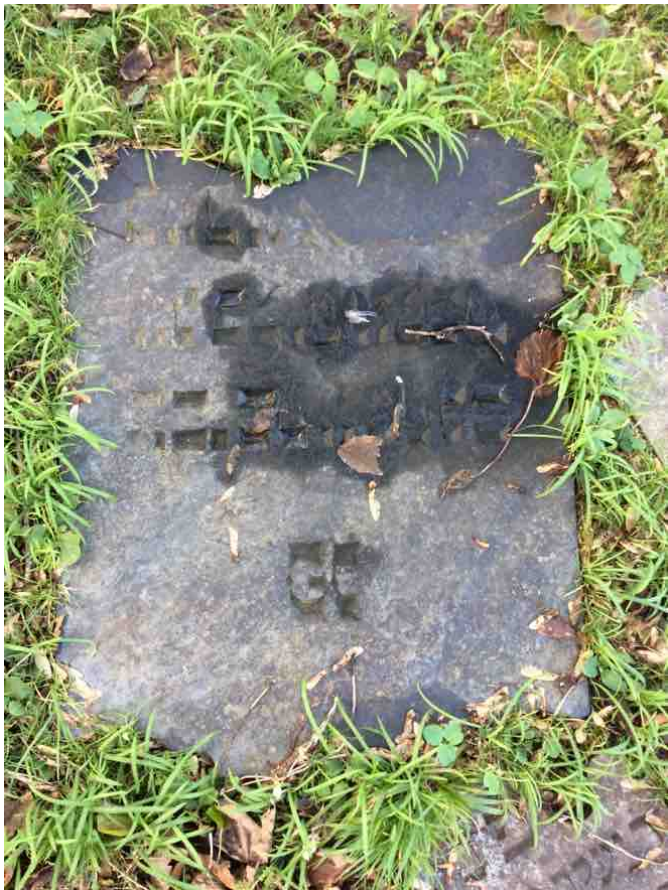
Broken headstone laid flat, only one large piece apparent, not large enough to re-erect. Not included in CMP schedule of monuments to be repaired

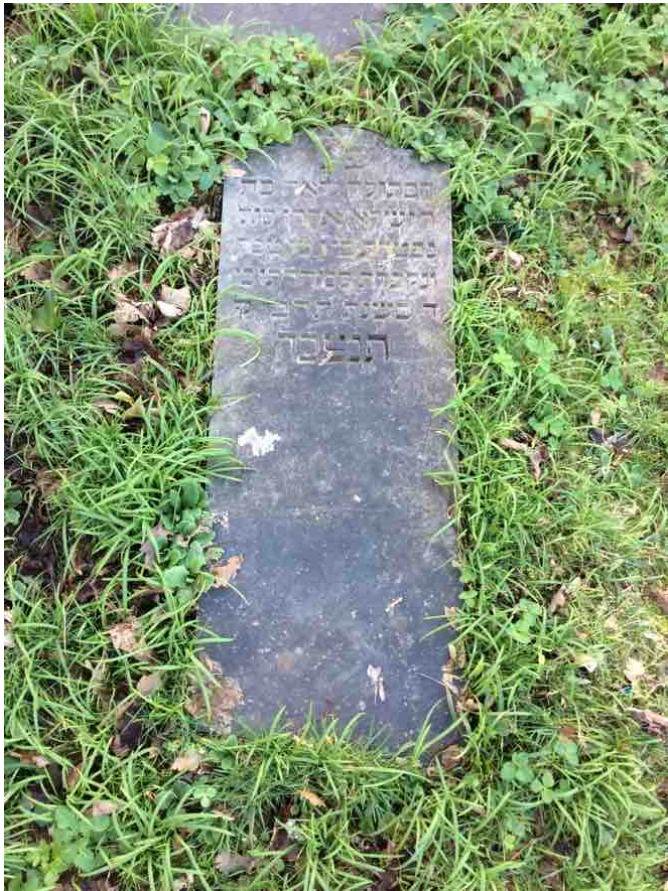
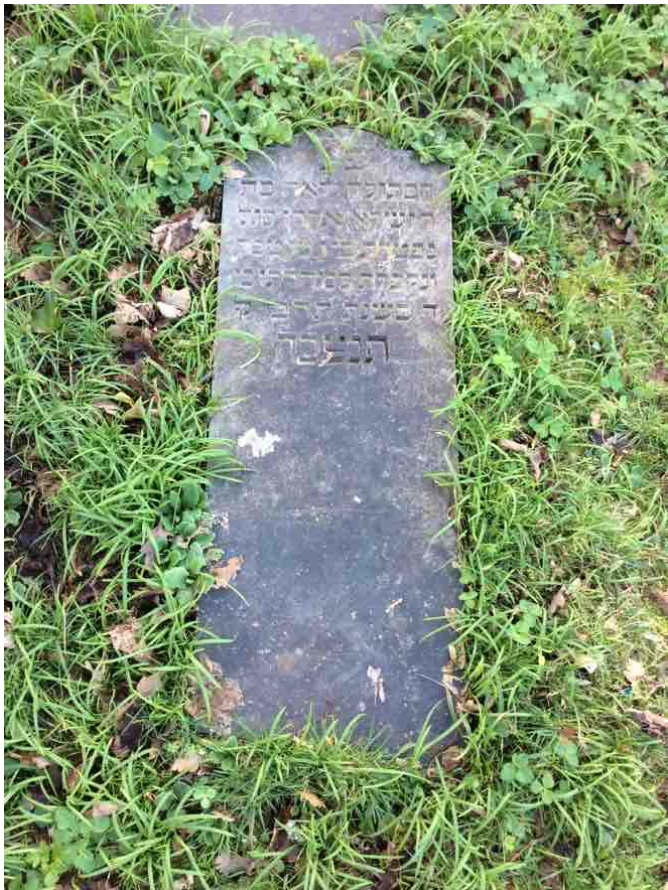
Fair / poor - slate lying on ground, belongs to broken base J14

Clean off organic growth and dirt. Excavate base J14 and pin base and main section J29 to 25mm thick slate backing with stainless steel dowels. Make good joints with mortar. Re-erect at position J14.

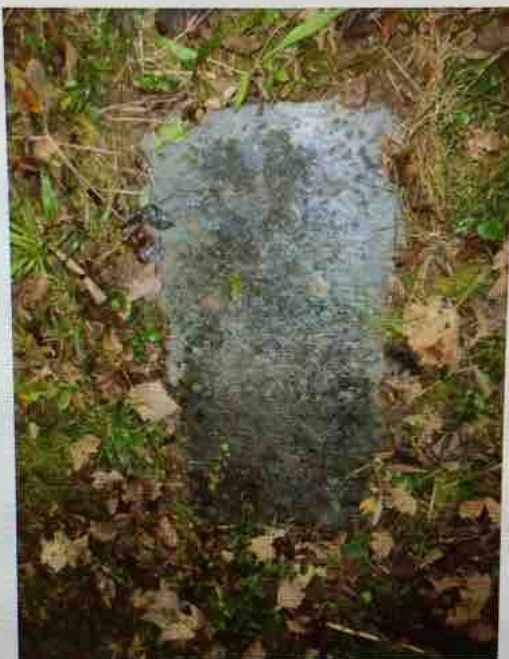
J30. NAME UNKNOWN

Slate, good condition, needs re-erecting.

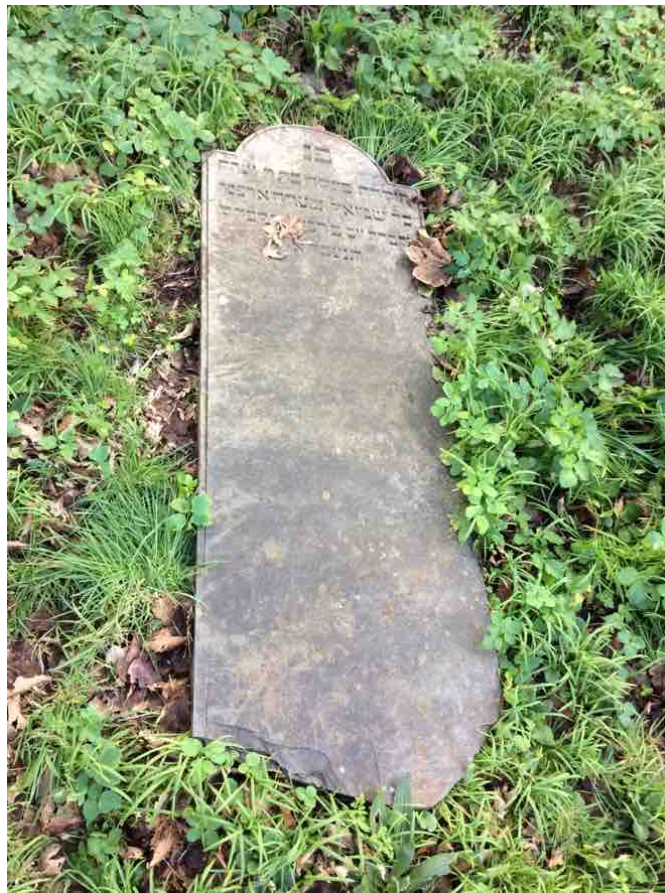
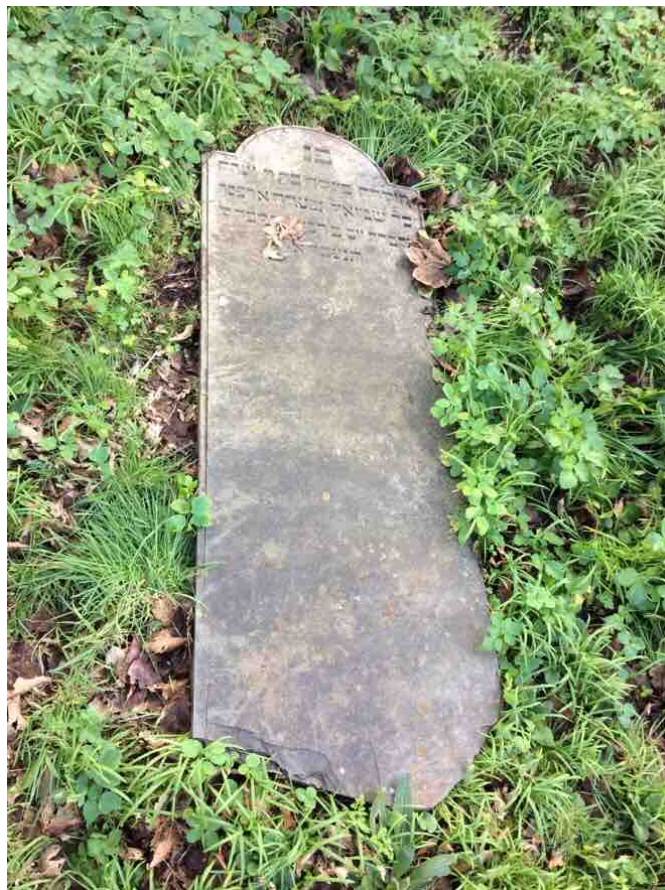
Slate headstone lying on ground, but in good condition. Medium to high risk of further damage

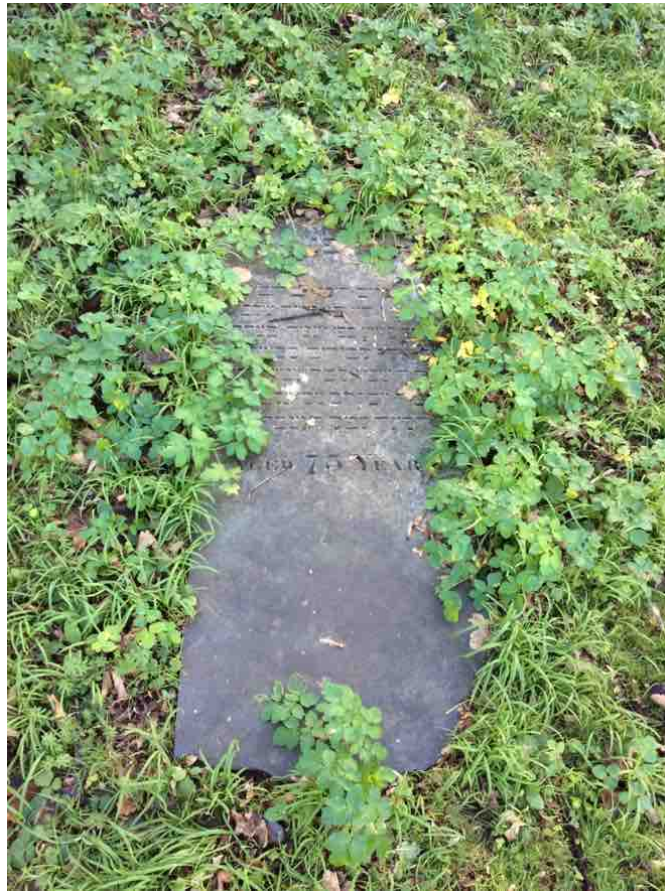
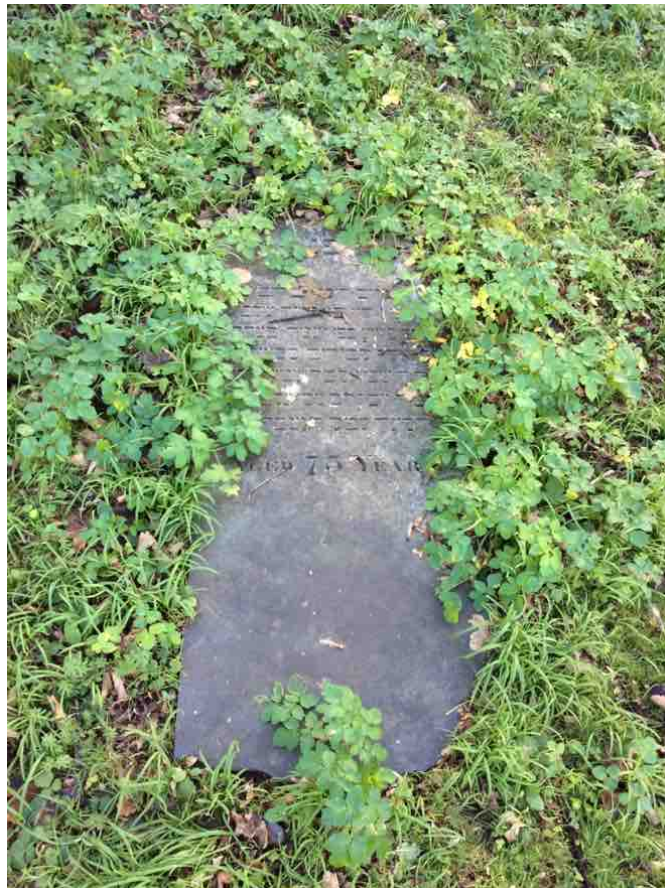
Slate lying on ground, but in good condition. Medium to high risk of further damage

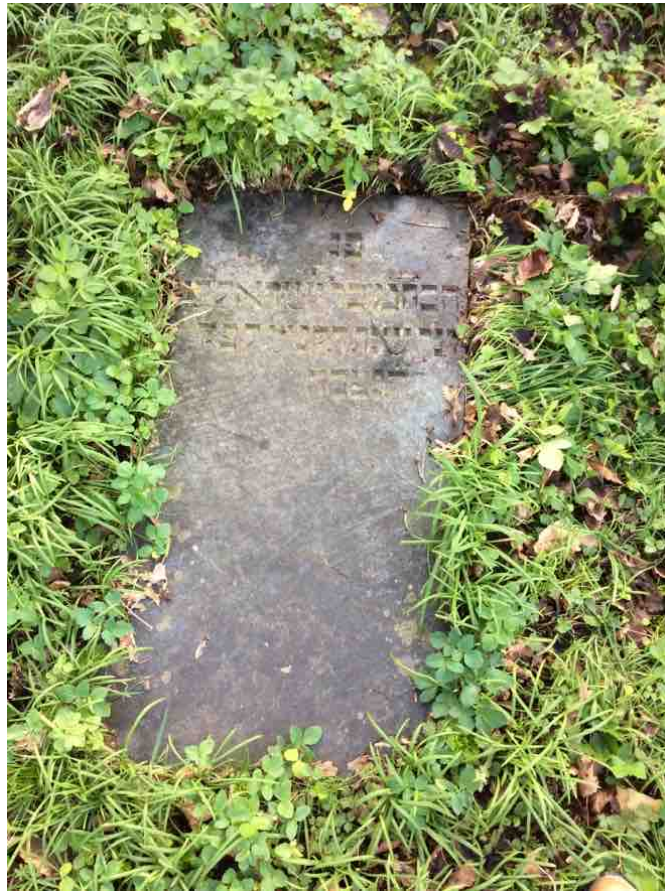
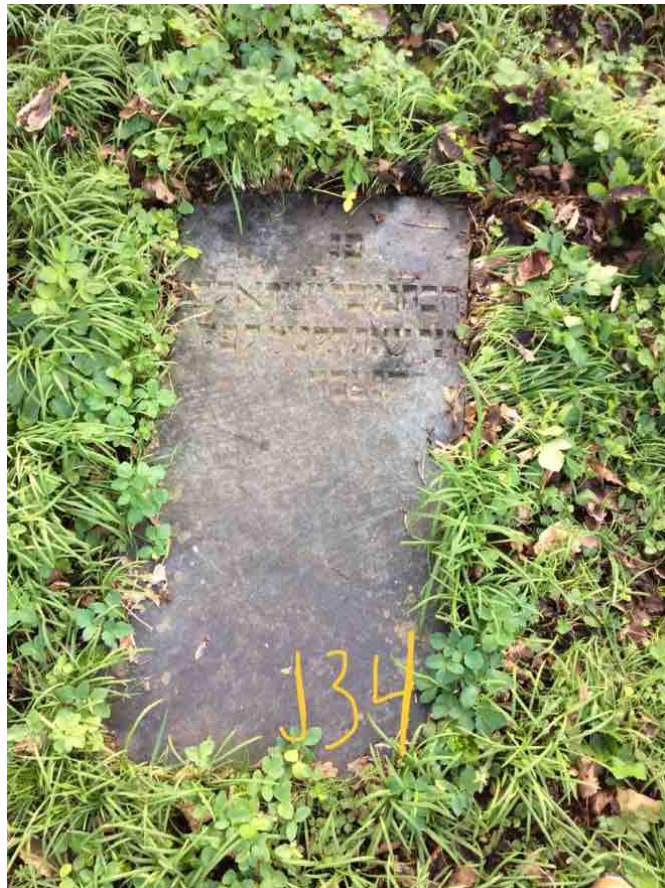
Slate lying on ground but in good condition. Medium to high risk of further damage

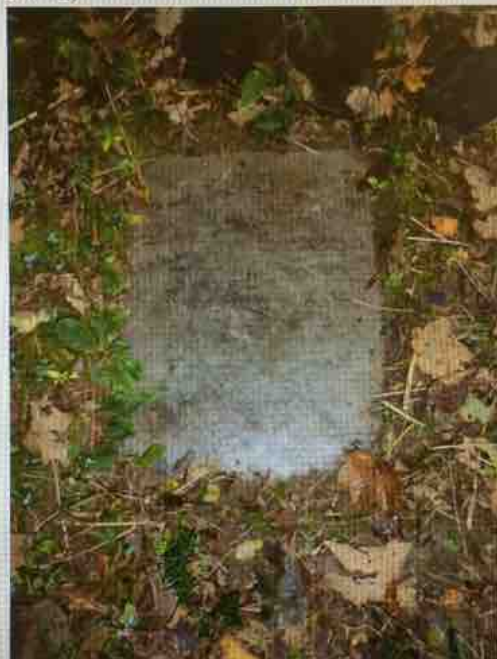
J30A. PHOEBE MOSES, d. 1804 (Feigele daughter of Moses, d. 5565)
(Recently uncovered, beneath J41)

Slate, very good condition, should be re-erected.

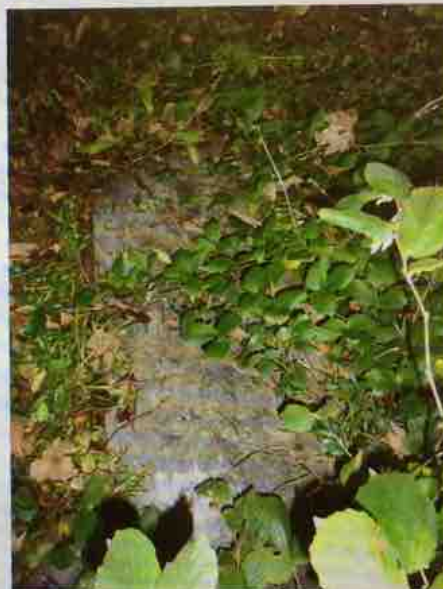
J42. NAME UNKNOWN

Slate, good condition, needs re-erecting.

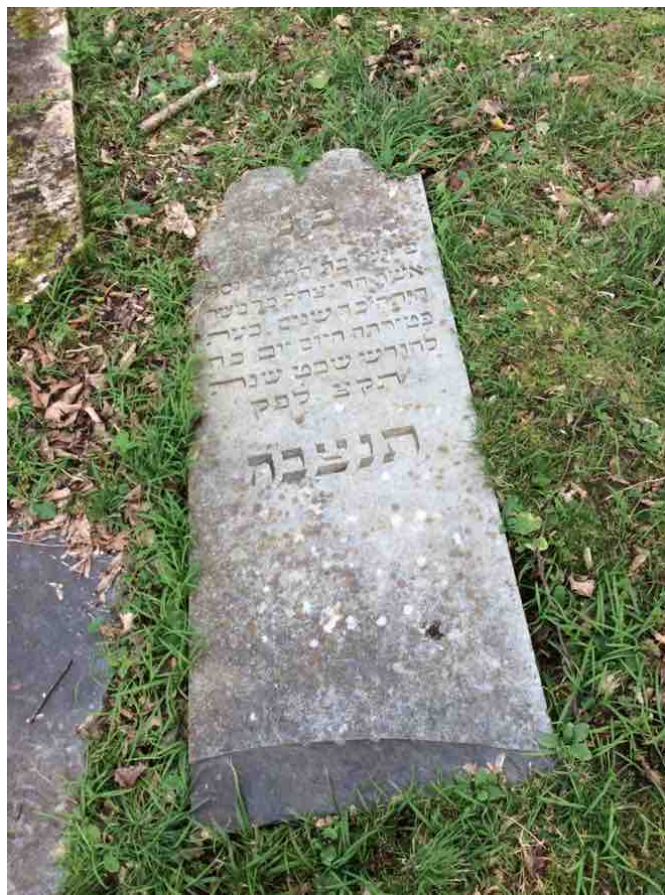
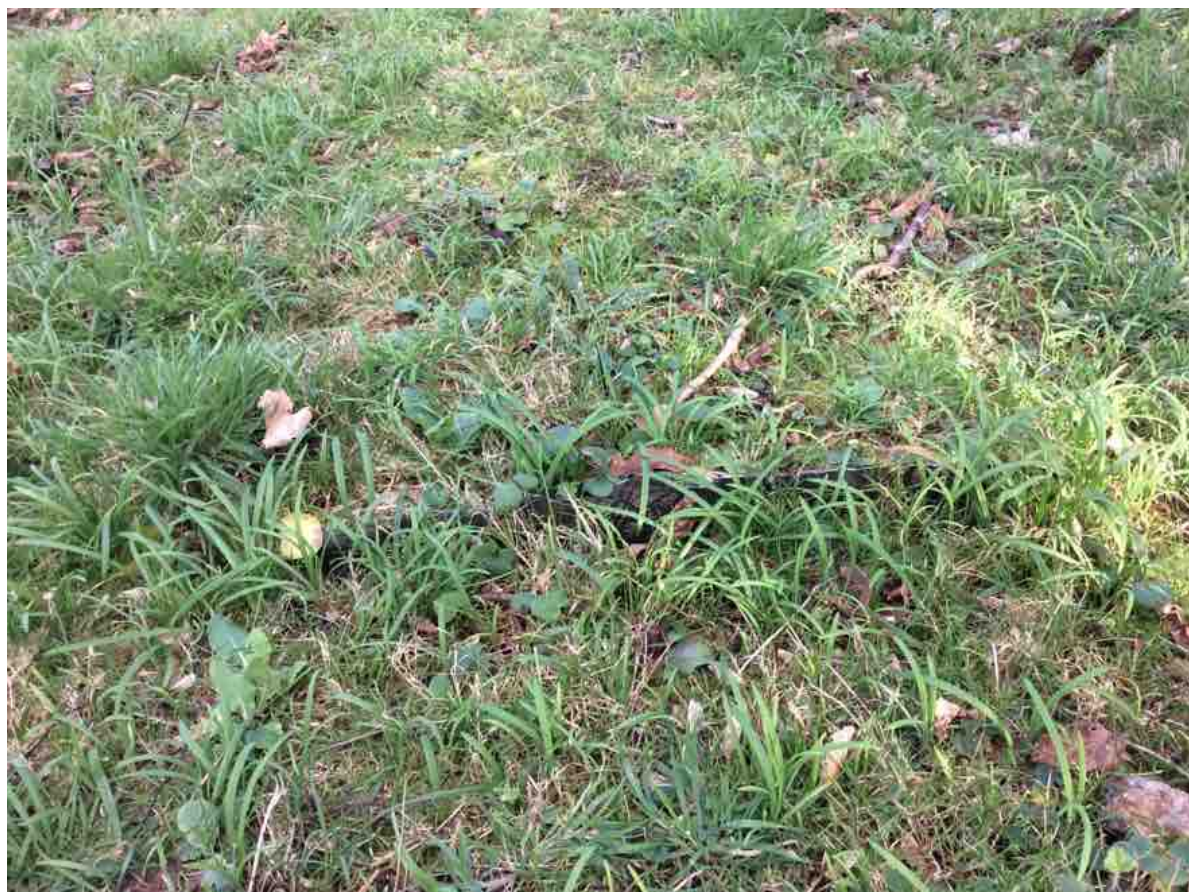
Fair/Poor, slate broken off at base. Main section of the broken base recorded as J21. Medium to high risk of further damage

Clean off organic growth and dirt. Excavate base of J21 and pin base and main section to 25mm thick slate backing with stainless steel pins. Make good joints with mortar. Re-erect in original location at J21.
