PD02/21
Asbestos R&D Survey

The Learning Warehouse
15-17 Union Street, Plymouth PL1 2SU

Asbestos Survey Data Sheet

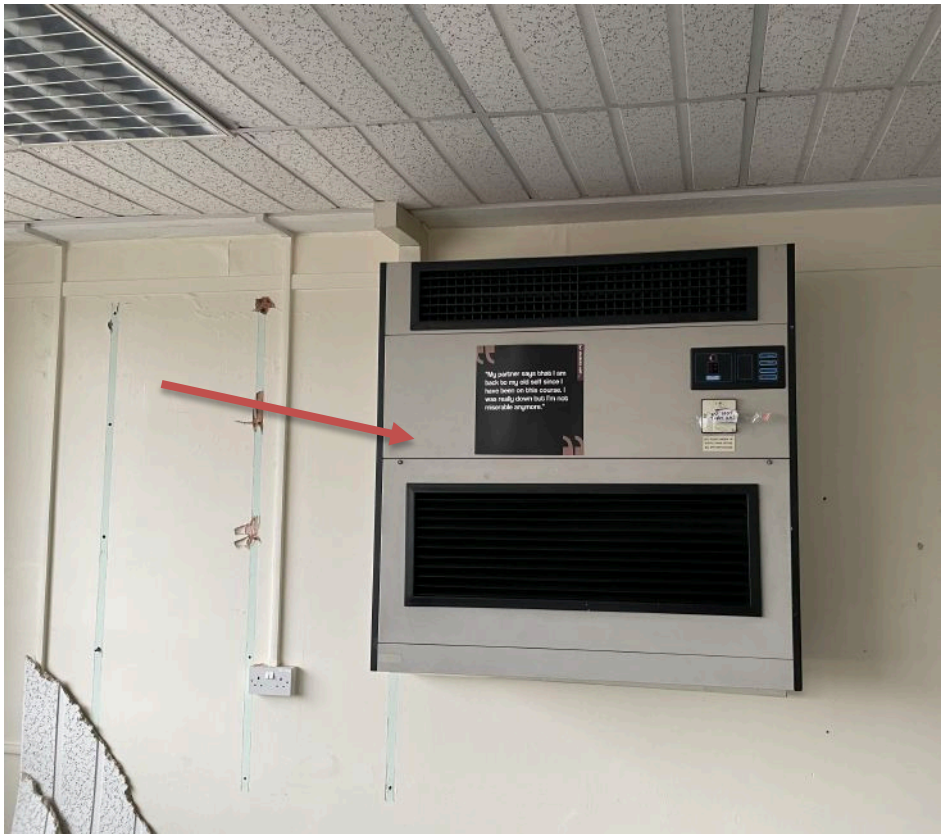
Photo 01

Plan Ref	Floor	Room	Location	Material	Quantity	Photo No.	Sampled	Condition	Risk	Comments
2F01	Second	Room 1 (PC26)	Air conditioning unit	No Access- Live	Unknown	01	Presumed	Good	Very Low	No Access. Refer to Recommendations
2F01	Second	Room 1 (PC26)	Fuse Boxes	No Access- Live	X2	02	Presumed	Good	Very Low	No Access. Refer to Recommendations
2F01	Second	Room 1 (PC26)	Switch	No Access. Live	x1	03	Presumed	Good	Very Low	No Access. Refer to Recommendations
2F01	Second	Room 1 (PC26)	Floor below carpet	Bitumen Adhesive		04	PD18012 1/01			No Asbestos Detected In Sample (N.A.D.I.S.). No Further Action Required
2F01	Second	Room 1 (PC26)	Floor in cupboard	Lino			PD18012 1/02			N.A.D.I.S. No Further Action Required
2F02	Second	Room 2 (PC27)	General View	No Asbestos Visually Detected (N.A.V.D.)						No Further Action Required
2F03	Second	Room 3 (PC28)	Floor below carpet	Lino			Ref: PD18012 1/02			N.A.D.I.S. No Further Action Required

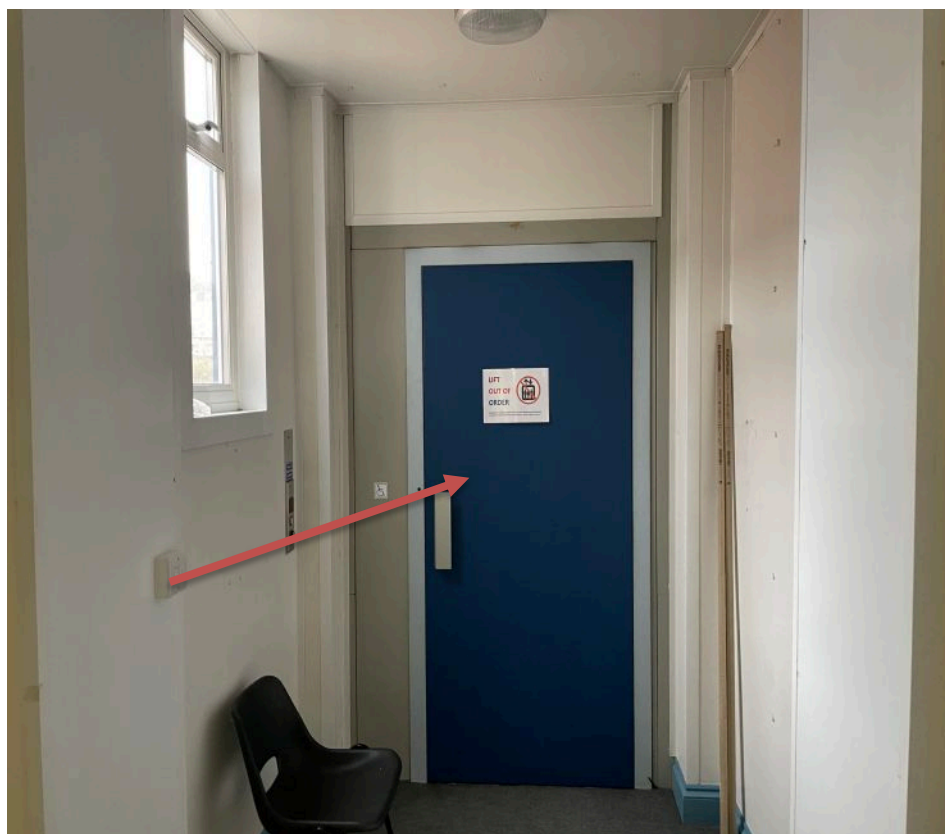
Photo 05

2F04	Second	Room 4 (PC22)	Lift	No Access Within	Unknown	05	Presumed	Good	Very Low	No Access. Refer to Recommendations
2F04	Second	Room 4 (PC22)	Floor below carpet	Lino			Ref: PD18012 1/02			N.A.D.I.S. No Further Action Required
2F05	Second	Kitchen	Sink	Mastic Pad	<1m ²	06	PD18012 1/03	Good	Very Low	Remove/ Monitor if outside of the scope of works. Non Licensable
2F05	Second	Kitchen	Floor below new lino	No Access Within	Unknown		Presumed	Good	Very Low	No Access. Refer to Recommendations
2F06	Second	Toilet	Water Heater	No Access Within	X1	07	Presumed	Good	Very Low	No Access. Refer to Recommendations
2F06	Second	Toilet	Service Void	No Access	Unknown		Presumed	Good	Low	No Access. Refer to Recommendations

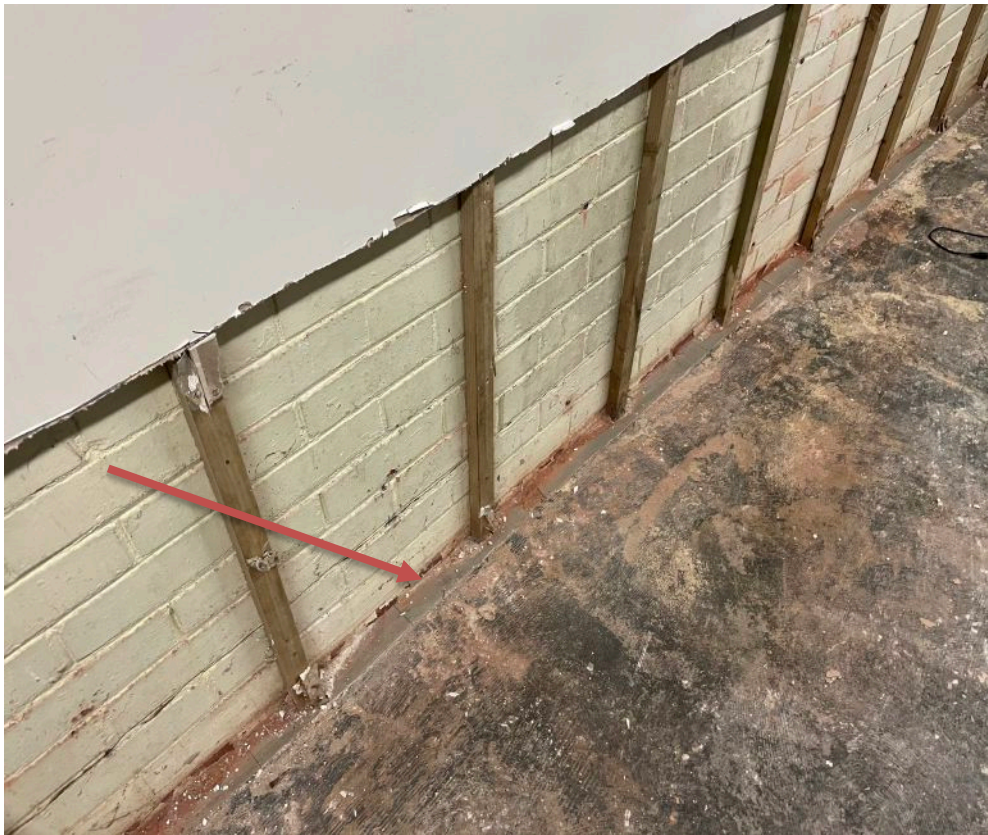
Photo 12

GF06	Ground	Bunker	Floor	Vinyl Floor Tiles & Associated Adhesive	19Lm	12	PD18012 1/05	Good	Very Low	Remove. Non Licensable
GF07	Ground	Boiler Room	Pipework	Gaskets	X2	13	Presumed	Good	Very Low	Not enough material visible to sample. Refer to Recommendations
GF07	Ground	Boiler Room	Damp Proof Course	Bitumen	Unknown	14	PD18012 1/06	Good	Very Low	Monitor. Outside of the scope of works. Non Licensable

- Vinyl Floor Tiles & the associated bitumen adhesive have been positively identified in this report in the bunker. It is strongly recommended that the vinyl floor tiles are removed, however if the scope of works means that the bitumen adhesive is not going to affect the works, then it would be recommended that the bitumen remains insitu and is sealed with a self levelling screed, as the works involved in removing the material is a laborious process, that causes lots of dust and so it would be safer to just leave it in situ. Both items are classed as very low grade, very low risk and non licensable.

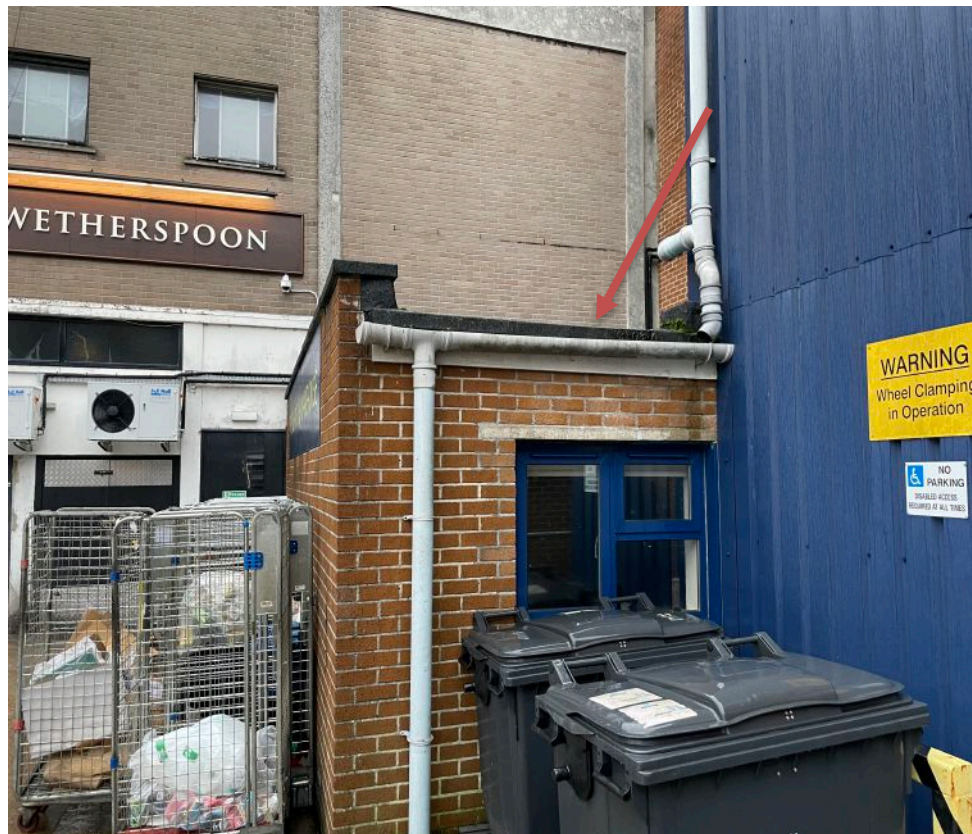
Photo 15

-	External	Flat Roof to bunker	Roof Felt	Bitumen	Throughout	15	Presumed	Good	Very Low	Monitor (outside scope of works). Refer to Recommendations

- The flat roof felt was not sampled at the time of the inspection, as it was outside of the scope of works and sampling the material would have damaged the integrity of the material. Visually it looks too new to contain asbestos, however it is recommended that in the future prior to commencing works, then it should be sampled so as to give a definitive answer. It is recommended that it should remain insitu and be monitored. If found to contain asbestos, the material is classed as very low grade, very low risk and non licensable.
- The damp proof course has been positively identified as containing asbestos and is classed as very low grade, very low risk and non licensable. The material is outside of the scope of works and so it is recommended that it should remain insitu and be monitored.
