Asbestos Management with Targeted Refurbishment Survey Front elevation windows/ Front Shop Fascia

Church Street Shops
Church Street
Stoke on Trent
ST4 1BU

Survey Report Reference:	P-245860
Client:	Karen Copeland
Survey Date:	29 March 2017

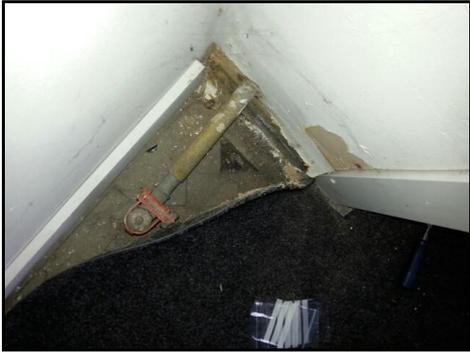
Item Description:	Adhesive beneath parquet flooring and carpet	
	Material description:	Bituminous products	
	Quantity / Extent:	N/A	
	Accessibility	Difficult Access	
	Analysis:	No asbestos detected	
	Conf. of Product Type:	Non-asbestos material	
Material Assessment Scoring:			
Product Type:	-	Condition:	-
Surface Treatment:	-	Asbestos Type:	-
Priority Assessment Scoring:			
Occupant Activity:	-	Disturbance:	-
Human Exposure:	-	Maintenance activity:	-
Total Scores:			
Material score:	-	Priority score	-
Total score:	-	Risk Cat.:	N/A
Recommended action:	-		
Recommendation comments:	-		
Surveyors Comments:	-

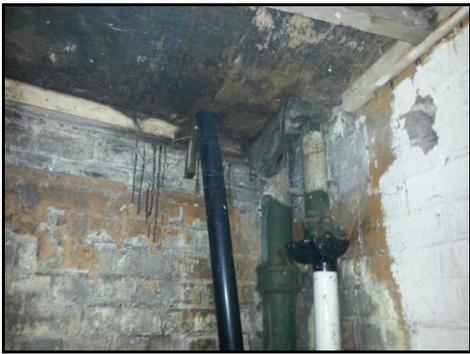
Item Description:	Felt to corner of room	
	Material description:	Bituminous products	
	Quantity / Extent:	N/A	
	Accessibility	Easy Access	
	Analysis:	No asbestos detected	
	Conf. of Product Type:	Non-asbestos material	
Material Assessment Scoring:			
Product Type:	-	Condition:	-
Surface Treatment:	-	Asbestos Type:	-
Priority Assessment Scoring:			
Occupant Activity:	-	Disturbance:	-
Human Exposure:	-	Maintenance activity:	-
Total Scores:			
Material score:	-	Priority score	-
Total score:	-	Risk Cat.:	N/A
Recommended action:	-		
Recommendation comments:	-		
Surveyors Comments:	-

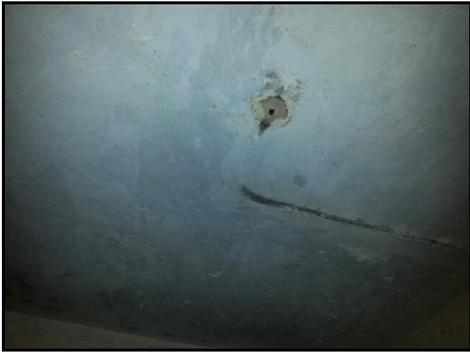
Item Description:	Textured coating to ceiling					
	Material description:	Textured coatings					
	Quantity / Extent:	N/A					
	Accessibility	Easy Access					
	Analysis:	No asbestos detected					
	Conf. of Product Type:	Non-asbestos material					
Material Assessment Scoring:							
Product Type:	-	Condition:	-	Surface Treatment:	-	Asbestos Type:	-
Priority Assessment Scoring:							
Occupant Activity:	-	Disturbance:	-	Human Exposure:	-	Maintenance activity:	-
Total Scores:							
Material score:	-	Priority score	-	Total score:	-	Risk Cat.:	N/A
Recommended action:	-						
Recommendation comments:	-						
Surveyors Comments:	-

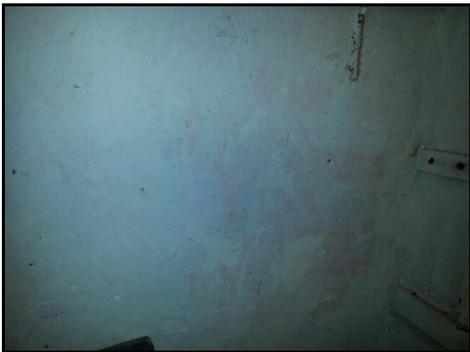
Item Description:	Textured coating to walls					
	Material description:	Textured coatings					
	Quantity / Extent:	N/A					
	Accessibility	Easy Access					
	Analysis:	No asbestos detected					
	Conf. of Product Type:	Non-asbestos material					
Material Assessment Scoring:							
Product Type:	-	Condition:	-	Surface Treatment:	-	Asbestos Type:	-
Priority Assessment Scoring:							
Occupant Activity:	-	Disturbance:	-	Human Exposure:	-	Maintenance activity:	-
Total Scores:							
Material score:	-	Priority score	-	Total score:	-	Risk Cat.:	N/A
Recommended action:	-						
Recommendation comments:	-						
Surveyors Comments:	-

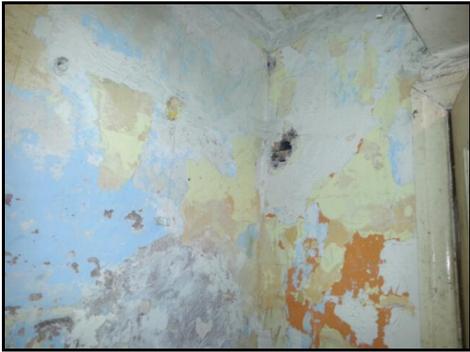
Item Description:	Textured coating to walls					
	Material description:	Textured coatings					
	Quantity / Extent:	N/A					
	Accessibility	Easy Access					
	Analysis:	Strongly Presumed No asbestos detected					
	Conf. of Product Type:	Strongly Presumed Non-asbestos material					
Material Assessment Scoring:							
Product Type:	-	Condition:	-	Surface Treatment:	-	Asbestos Type:	-
Priority Assessment Scoring:							
Occupant Activity:	-	Disturbance:	-	Human Exposure:	-	Maintenance activity:	-
Total Scores:							
Material score:	-	Priority score	-	Total score:	-	Risk Cat.:	N/A
Recommended action:	-						
Recommendation comments:	-						
Surveyors Comments:	-

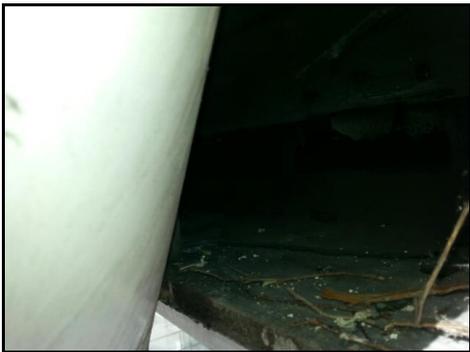
Item Description:	Felt behind plastic fascia					
	Material description:	Bituminous products					
	Quantity / Extent:	N/A					
	Accessibility	Difficult Access					
	Analysis:	No asbestos detected					
	Conf. of Product Type:	Non-asbestos material					
Material Assessment Scoring:							
Product Type:	-	Condition:	-	Surface Treatment:	-	Asbestos Type:	-
Priority Assessment Scoring:							
Occupant Activity:	-	Disturbance:	-	Human Exposure:	-	Maintenance activity:	-
Total Scores:							
Material score:	-	Priority score	-	Total score:	-	Risk Cat.:	N/A
Recommended action:	-						
Recommendation comments:	-						
Surveyors Comments:	-

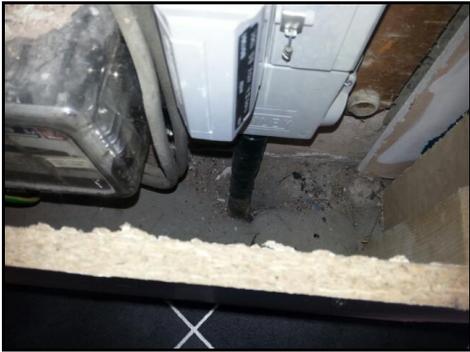
Item Description:	Floor tiles beneath modern vinyl					
	Material description:	Thermoplastic product					
	Quantity / Extent:	N/A					
	Accessibility	Medium Access					
	Analysis:	No asbestos detected					
	Conf. of Product Type:	Non-asbestos material					
Material Assessment Scoring:							
Product Type:	-	Condition:	-	Surface Treatment:	-	Asbestos Type:	-
Priority Assessment Scoring:							
Occupant Activity:	-	Disturbance:	-	Human Exposure:	-	Maintenance activity:	-
Total Scores:							
Material score:	-	Priority score	-	Total score:	-	Risk Cat.:	N/A
Recommended action:	-						
Recommendation comments:	-						
Surveyors Comments:	Floor tiles were identified around the electric meter

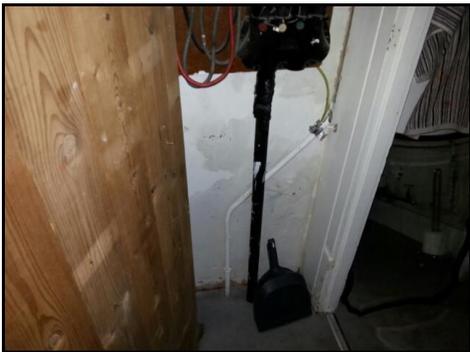
Item Description:	Wrap to cable					
	Material description:	Bituminous products					
	Quantity / Extent:	1 m linear					
	Accessibility	Easy Access					
	Analysis:	Presumed to contain asbestos					
	Conf. of Product Type:	N/A					
Material Assessment Scoring:							
Product Type:	1	Condition:	0	Surface Treatment:	0	Asbestos Type:	1
Priority Assessment Scoring:							
Occupant Activity:	0	Disturbance:	0	Human Exposure:	0	Maintenance activity:	0
Total Scores:							
Material score:	2	Priority score	-	Total score:	2	Risk Cat.:	Very Low
Recommended action:	Monitor condition.						
Recommendation comments:	-						
Surveyors Comments:	Bitumen wrap cable is live and can not be sampled without isolation.

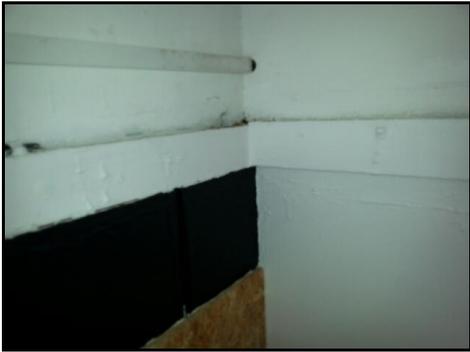
Item Description:	Suspect debris to timber rail next to lift					
	Material description:	Insulating board					
	Quantity / Extent:	N/A					
	Accessibility	Difficult Access					
	Analysis:	No asbestos detected					
	Conf. of Product Type:	Non-asbestos material					
Material Assessment Scoring:							
Product Type:	-	Condition:	-	Surface Treatment:	-	Asbestos Type:	-
Priority Assessment Scoring:							
Occupant Activity:	-	Disturbance:	-	Human Exposure:	-	Maintenance activity:	-
Total Scores:							
Material score:	-	Priority score	-	Total score:	-	Risk Cat.:	N/A
Recommended action:	-						
Recommendation comments:	-						
Surveyors Comments:	Suspect insulating board debris where a cable conduit has been installed/ drilled through a wall containing AIB

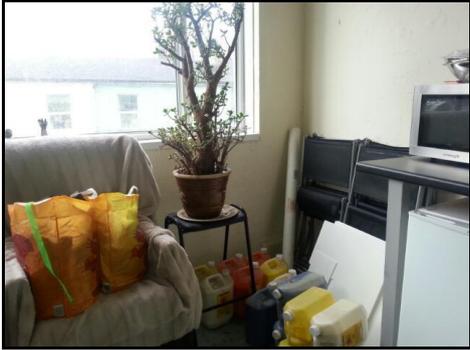
Item Description:	Textured coating to walls					
	Material description:	Textured coatings					
	Quantity / Extent:	N/A					
	Accessibility	Easy Access					
	Analysis:	No asbestos detected					
	Conf. of Product Type:	Non-asbestos material					
Material Assessment Scoring:							
Product Type:	-	Condition:	-	Surface Treatment:	-	Asbestos Type:	-
Priority Assessment Scoring:							
Occupant Activity:	-	Disturbance:	-	Human Exposure:	-	Maintenance activity:	-
Total Scores:							
Material score:	-	Priority score	-	Total score:	-	Risk Cat.:	N/A
Recommended action:	-						
Recommendation comments:	-						
Surveyors Comments:	Plaster applied as a textured coating

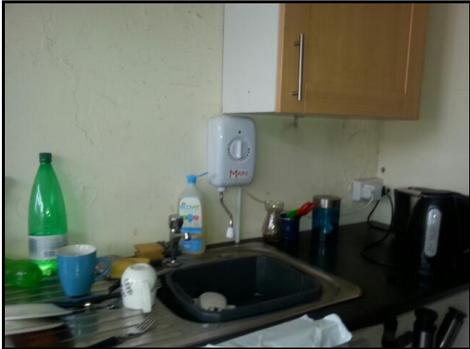
Item Description:	Sink pad					
	Material description:	Bituminous products					
	Quantity / Extent:	N/A					
	Accessibility	Medium Access					
	Analysis:	No asbestos detected					
	Conf. of Product Type:	Non-asbestos material					
Material Assessment Scoring:							
Product Type:	-	Condition:	-	Surface Treatment:	-	Asbestos Type:	-
Priority Assessment Scoring:							
Occupant Activity:	-	Disturbance:	-	Human Exposure:	-	Maintenance activity:	-
Total Scores:							
Material score:	-	Priority score	-	Total score:	-	Risk Cat.:	N/A
Recommended action:	-						
Recommendation comments:	-						
Surveyors Comments:	-

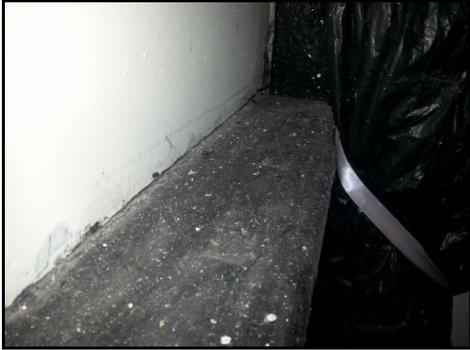
Item Description:	Suspect debris to ledge adjacent lift on stairs					
	Material description:	Insulating board					
	Quantity / Extent:	<1 m ²					
	Accessibility	Easy Access					
	Analysis:	Chrysotile Amosite					
	Conf. of Product Type:	Asbestos insulating board					
Material Assessment Scoring:							
Product Type:	2	Condition:	3	Surface Treatment:	2	Asbestos Type:	2
Priority Assessment Scoring:							
Occupant Activity:	0	Disturbance:	0	Human Exposure:	0	Maintenance activity:	0
Total Scores:							
Material score:	9	Priority score	-	Total score:	9	Risk Cat.:	Medium
Recommended action:	Remove.						
Recommendation comments:	-						
Surveyors Comments:	Debris on the shelf is likely to have originated from the drilling of the wall to the lift from the installation of a plastic pipe above it. Area should be vacuumed of any debris by LARC

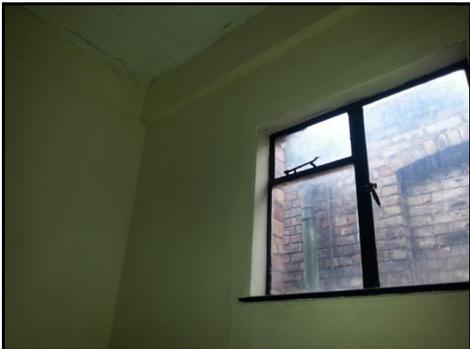
Item Description:	Mastics to windows					
	Material description:	Mastics					
	Quantity / Extent:	N/A					
	Accessibility	Medium Access					
	Analysis:	Strongly Presumed No asbestos detected					
	Conf. of Product Type:	Strongly Presumed Non-asbestos material					
Material Assessment Scoring:							
Product Type:	-	Condition:	-	Surface Treatment:	-	Asbestos Type:	-
Priority Assessment Scoring:							
Occupant Activity:	-	Disturbance:	-	Human Exposure:	-	Maintenance activity:	-
Total Scores:							
Material score:	-	Priority score	-	Total score:	-	Risk Cat.:	N/A
Recommended action:	-						
Recommendation comments:	-						
Surveyors Comments:	Mastics to rear window - windows to the front elevation are UPVC

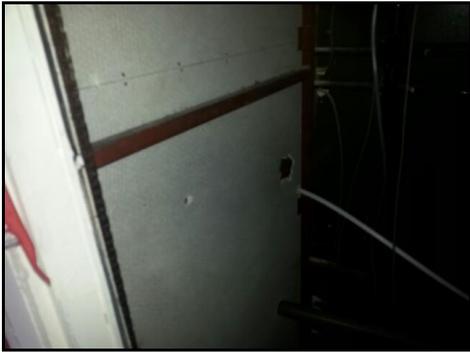
Item Description:	Panels lining the lift					
	Material description:	Insulating board					
	Quantity / Extent:	9 m ²					
	Accessibility	Easy Access					
	Analysis:	Amosite Chrysotile					
	Conf. of Product Type:	Asbestos insulating board					
Material Assessment Scoring:							
Product Type:	2	Condition:	2	Surface Treatment:	2	Asbestos Type:	2
Priority Assessment Scoring:							
Occupant Activity:	0	Disturbance:	0	Human Exposure:	0	Maintenance activity:	0
Total Scores:							
Material score:	8	Priority score	-	Total score:	8	Risk Cat.:	Medium
Recommended action:	Remedial – Encapsulate and then monitor condition.						
Recommendation comments:	-						
Surveyors Comments:	Panels lining the lift are unsealed and damaged in one area, it is recommended that the panels are encapsulated or access restricted to persons

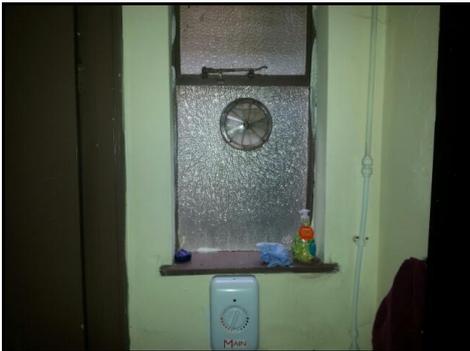
Item Description:	Mastics to windows					
	Material description:	Mastics					
	Quantity / Extent:	N/A					
	Accessibility	Medium Access					
	Analysis:	No asbestos detected					
	Conf. of Product Type:	Non-asbestos material					
Material Assessment Scoring:							
Product Type:	-	Condition:	-	Surface Treatment:	-	Asbestos Type:	-
Priority Assessment Scoring:							
Occupant Activity:	-	Disturbance:	-	Human Exposure:	-	Maintenance activity:	-
Total Scores:							
Material score:	-	Priority score	-	Total score:	-	Risk Cat.:	N/A
Recommended action:	-						
Recommendation comments:	-						
Surveyors Comments:	-

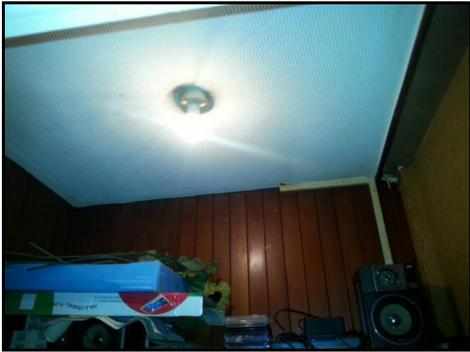
Item Description:	Textured coating to ceiling					
	Material description:	Textured coatings					
	Quantity / Extent:	N/A					
	Accessibility	Medium Access					
	Analysis:	No asbestos detected					
	Conf. of Product Type:	Non-asbestos material					
Material Assessment Scoring:							
Product Type:	-	Condition:	-	Surface Treatment:	-	Asbestos Type:	-
Priority Assessment Scoring:							
Occupant Activity:	-	Disturbance:	-	Human Exposure:	-	Maintenance activity:	-
Total Scores:							
Material score:	-	Priority score	-	Total score:	-	Risk Cat.:	N/A
Recommended action:	-						
Recommendation comments:	-						
Surveyors Comments:	-

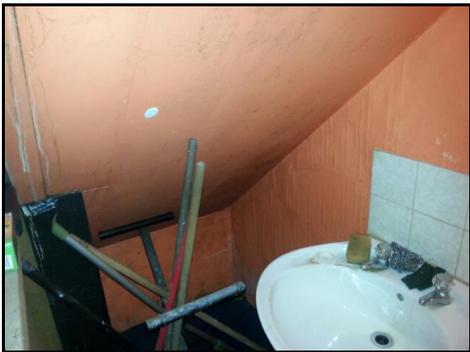
Item Description:	Panels lining stairs					
	Material description:	Insulating board					
	Quantity / Extent:	6 m ²					
	Accessibility	Easy Access					
	Analysis:	Chrysotile					
	Conf. of Product Type:	Asbestos insulating board					
Material Assessment Scoring:							
Product Type:	2	Condition:	0	Surface Treatment:	1	Asbestos Type:	1
Priority Assessment Scoring:							
Occupant Activity:	0	Disturbance:	0	Human Exposure:	0	Maintenance activity:	0
Total Scores:							
Material score:	4	Priority score	-	Total score:	4	Risk Cat.:	Very Low
Recommended action:	Monitor condition.						
Recommendation comments:	-						
Surveyors Comments:	Sample includes all panels lining stairs forming the underdrawing and the panel creating a wall to the base

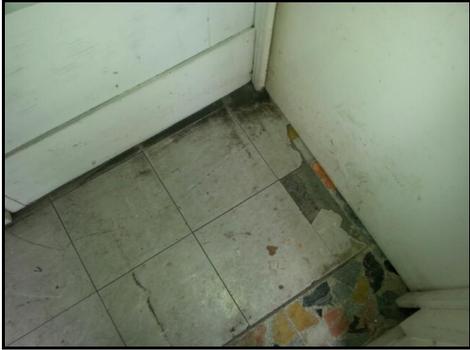
Item Description:	Floor tiles					
	Material description:	Thermoplastic product					
	Quantity / Extent:	1 m ²					
	Accessibility	Easy Access					
	Analysis:	Chrysotile					
	Conf. of Product Type:	Asbestos thermoplastic/adhesive					
Material Assessment Scoring:							
Product Type:	1	Condition:	1	Surface Treatment:	0	Asbestos Type:	1
Priority Assessment Scoring:							
Occupant Activity:	0	Disturbance:	0	Human Exposure:	0	Maintenance activity:	0
Total Scores:							
Material score:	3	Priority score	-	Total score:	3	Risk Cat.:	Very Low
Recommended action:	Monitor condition.						
Recommendation comments:	-						
Surveyors Comments:	-

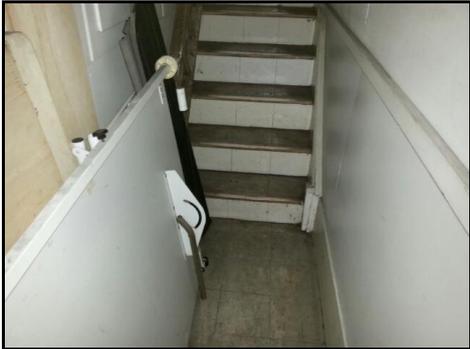
Item Description:	Floor tiles					
	Material description:	Thermoplastic product					
	Quantity / Extent:	8 m ²					
	Accessibility	Easy Access					
	Analysis:	Chrysotile					
	Conf. of Product Type:	Asbestos thermoplastic/adhesive					
Material Assessment Scoring:							
Product Type:	1	Condition:	0	Surface Treatment:	0	Asbestos Type:	1
Priority Assessment Scoring:							
Occupant Activity:	0	Disturbance:	0	Human Exposure:	0	Maintenance activity:	0
Total Scores:							
Material score:	2	Priority score	-	Total score:	2	Risk Cat.:	Very Low
Recommended action:	Monitor condition.						
Recommendation comments:	-						
Surveyors Comments:	-

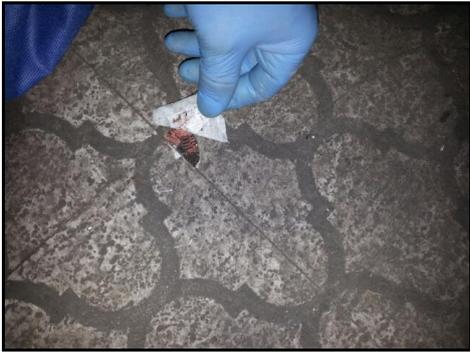
Item Description:	Floor screed beneath floor tiles					
	Material description:	Floor screed					
	Quantity / Extent:	60 m ²					
	Accessibility	Medium Access					
	Analysis:	Chrysotile					
	Conf. of Product Type:	Asbestos floor screed /adhesive					
Material Assessment Scoring:							
Product Type:	1	Condition:	0	Surface Treatment:	0	Asbestos Type:	1
Priority Assessment Scoring:							
Occupant Activity:	0	Disturbance:	0	Human Exposure:	0	Maintenance activity:	0
Total Scores:							
Material score:	2	Priority score	-	Total score:	2	Risk Cat.:	Very Low
Recommended action:	Monitor condition.						
Recommendation comments:	-						
Surveyors Comments:	-

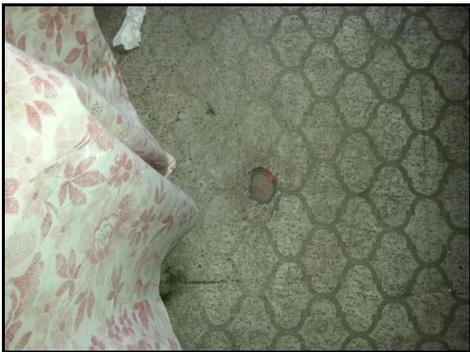
Item Description:	Floor screed beneath floor tiles					
	Material description:	Floor screed					
	Quantity / Extent:	40 m ²					
	Accessibility	Medium Access					
	Analysis:	Chrysotile					
	Conf. of Product Type:	Asbestos floor screed /adhesive					
Material Assessment Scoring:							
Product Type:	1	Condition:	0	Surface Treatment:	0	Asbestos Type:	1
Priority Assessment Scoring:							
Occupant Activity:	0	Disturbance:	0	Human Exposure:	0	Maintenance activity:	0
Total Scores:							
Material score:	2	Priority score	-	Total score:	2	Risk Cat.:	Very Low
Recommended action:	Monitor condition.						
Recommendation comments:	-						
Surveyors Comments:	-

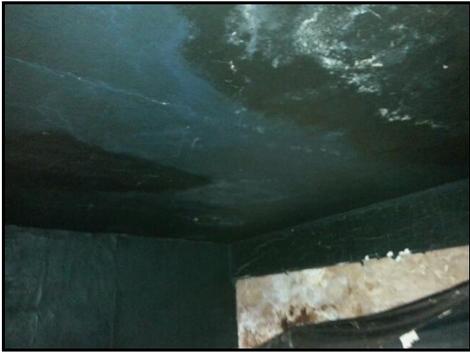
Item Description:	Sprayed coating to ceiling					
	Material description:	Sprayed coating					
	Quantity / Extent:	45 m ²					
	Accessibility	Medium Access					
	Analysis:	Chrysotile					
	Conf. of Product Type:	Asbestos sprayed coating					
Material Assessment Scoring:							
Product Type:	3	Condition:	1	Surface Treatment:	2	Asbestos Type:	1
Priority Assessment Scoring:							
Occupant Activity:	0	Disturbance:	0	Human Exposure:	0	Maintenance activity:	0
Total Scores:							
Material score:	7	Priority score	-	Total score:	7	Risk Cat.:	Medium
Recommended action:	Remove.						
Recommendation comments:	-						
Surveyors Comments:	Sprayed coating is beneath layers of paint but is water damaged is likely to become loose and exposed if untreated

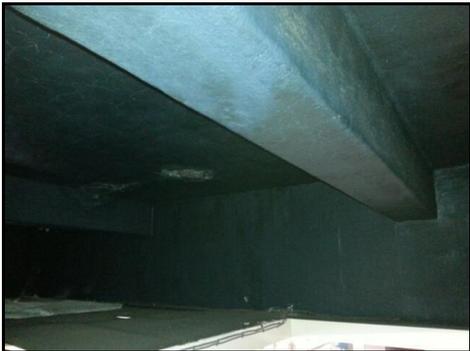
Item Description:	Sprayed coating to beams					
	Material description:	Sprayed coating					
	Quantity / Extent:	10 m linear					
	Accessibility	Medium Access					
	Analysis:	Chrysotile					
	Conf. of Product Type:	Asbestos sprayed coating					
Material Assessment Scoring:							
Product Type:	3	Condition:	0	Surface Treatment:	2	Asbestos Type:	1
Priority Assessment Scoring:							
Occupant Activity:	0	Disturbance:	0	Human Exposure:	0	Maintenance activity:	0
Total Scores:							
Material score:	6	Priority score	-	Total score:	6	Risk Cat.:	Low
Recommended action:	Monitor condition.						
Recommendation comments:	-						
Surveyors Comments:	Sprayed coating to beams is in relative good condition with no signs of cracks or damage.

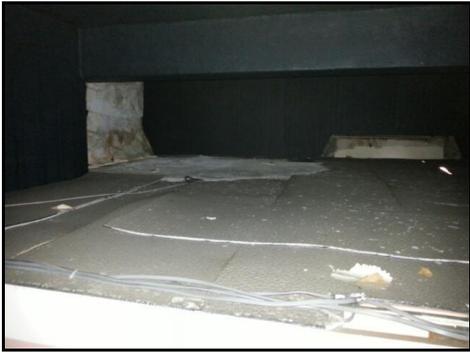
Item Description:	Sprayed coating debris on top of ceiling tiles					
	Material description:	Sprayed coating					
	Quantity / Extent:	10 m ²					
	Accessibility	Easy Access					
	Analysis:	Chrysotile					
	Conf. of Product Type:	Asbestos sprayed coating					
Material Assessment Scoring:							
Product Type:	3	Condition:	3	Surface Treatment:	3	Asbestos Type:	1
Priority Assessment Scoring:							
Occupant Activity:	0	Disturbance:	0	Human Exposure:	0	Maintenance activity:	0
Total Scores:							
Material score:	10	Priority score	-	Total score:	10	Risk Cat.:	High
Recommended action:	Remove.						
Recommendation comments:	-						
Surveyors Comments:	Around 10m2 of sprayed coating is resting on top of polystyrene ceiling tiles from a previous leak. Access should be prevented from this area until removed by LARC - all soft furnishings and fabrics should be removed as contaminated items and surfaces wiped clean where possible.

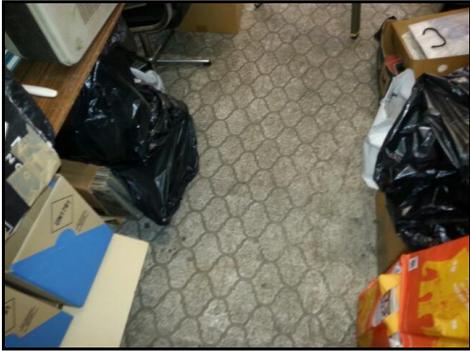
Item Description:	Floor tiles					
	Material description:	Thermoplastic product					
	Quantity / Extent:	45 m ²					
	Accessibility	Easy Access					
	Analysis:	Chrysotile					
	Conf. of Product Type:	Asbestos thermoplastic/adhesive					
Material Assessment Scoring:							
Product Type:	1	Condition:	0	Surface Treatment:	0	Asbestos Type:	1
Priority Assessment Scoring:							
Occupant Activity:	0	Disturbance:	0	Human Exposure:	0	Maintenance activity:	0
Total Scores:							
Material score:	2	Priority score	-	Total score:	2	Risk Cat.:	Very Low
Recommended action:	Monitor condition.						
Recommendation comments:	-						
Surveyors Comments:	-

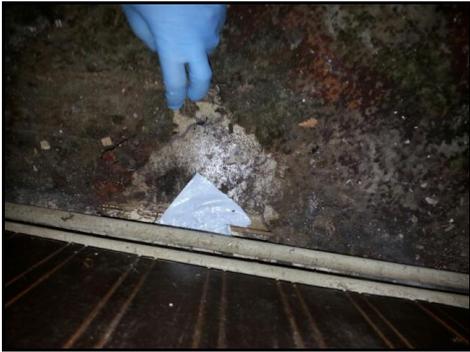
Item Description:	Paper backed linoleum beneath carpet					
	Material description:	Paper backed linoleum					
	Quantity / Extent:	N/A					
	Accessibility	Medium Access					
	Analysis:	No asbestos detected					
	Conf. of Product Type:	Non-asbestos material					
Material Assessment Scoring:							
Product Type:	-	Condition:	-	Surface Treatment:	-	Asbestos Type:	-
Priority Assessment Scoring:							
Occupant Activity:	-	Disturbance:	-	Human Exposure:	-	Maintenance activity:	-
Total Scores:							
Material score:	-	Priority score	-	Total score:	-	Risk Cat.:	N/A
Recommended action:	-						
Recommendation comments:	-						
Surveyors Comments:	-

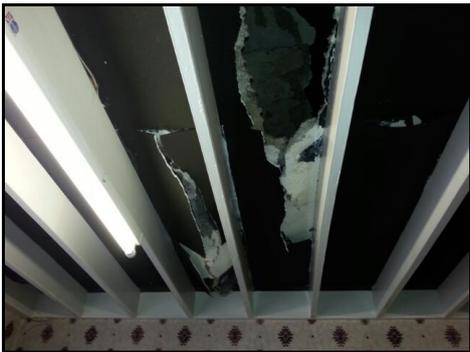
Item Description:	Sprayed coating debris on top of ceiling tiles					
	Material description:	Sprayed coating					
	Quantity / Extent:	1 m ²					
	Accessibility	Easy Access					
	Analysis:	Strongly Presumed Chrysotile					
	Conf. of Product Type:	Strongly Presumed Asbestos sprayed coating					
Material Assessment Scoring:							
Product Type:	3	Condition:	3	Surface Treatment:	3	Asbestos Type:	1
Priority Assessment Scoring:							
Occupant Activity:	0	Disturbance:	0	Human Exposure:	0	Maintenance activity:	0
Total Scores:							
Material score:	10	Priority score	-	Total score:	10	Risk Cat.:	High
Recommended action:	Remove.						
Recommendation comments:	-						
Surveyors Comments:	Exactly same material as reported in sample 035 - cross referenced made to show the poor condition and possible contamination

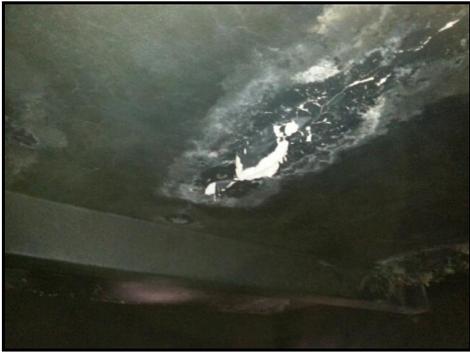
Item Description:	Sprayed coating to ceiling					
	Material description:	Sprayed coating					
	Quantity / Extent:	45 m ²					
	Accessibility	Medium Access					
	Analysis:	Chrysotile					
	Conf. of Product Type:	Asbestos sprayed coating					
Material Assessment Scoring:							
Product Type:	3	Condition:	2	Surface Treatment:	3	Asbestos Type:	1
Priority Assessment Scoring:							
Occupant Activity:	0	Disturbance:	0	Human Exposure:	0	Maintenance activity:	0
Total Scores:							
Material score:	9	Priority score	-	Total score:	9	Risk Cat.:	Medium
Recommended action:	Remove.						
Recommendation comments:	-						
Surveyors Comments:	Sprayed coating is exposed where layers of paint are peeling away from it - ceiling requires encapsulation as a minimum of ongoing asbestos management.

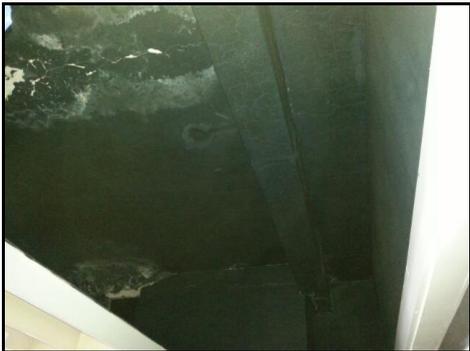
Item Description:	Sprayed coating to beams					
	Material description:	Sprayed coating					
	Quantity / Extent:	10 m linear					
	Accessibility	Medium Access					
	Analysis:	Chrysotile					
	Conf. of Product Type:	Asbestos sprayed coating					
Material Assessment Scoring:							
Product Type:	3	Condition:	0	Surface Treatment:	2	Asbestos Type:	1
Priority Assessment Scoring:							
Occupant Activity:	0	Disturbance:	0	Human Exposure:	0	Maintenance activity:	0
Total Scores:							
Material score:	6	Priority score	-	Total score:	6	Risk Cat.:	Low
Recommended action:	Monitor condition.						
Recommendation comments:	-						
Surveyors Comments:	Sprayed coating to beams is in relative good condition with no signs of cracks or damage.

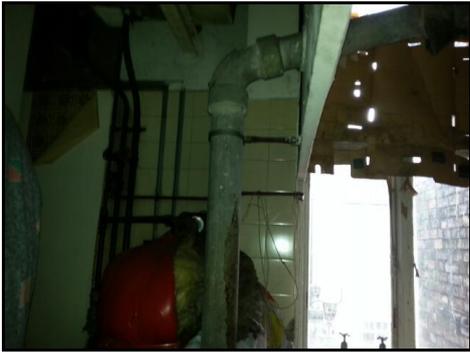
Item Description:	Flue pipe to boiler					
	Material description:	Cement product					
	Quantity / Extent:	3 m linear					
	Accessibility	Easy Access					
	Analysis:	Crocidolite Chrysotile					
	Conf. of Product Type:	Asbestos cement					
Material Assessment Scoring:							
Product Type:	1	Condition:	1	Surface Treatment:	1	Asbestos Type:	3
Priority Assessment Scoring:							
Occupant Activity:	0	Disturbance:	0	Human Exposure:	0	Maintenance activity:	0
Total Scores:							
Material score:	6	Priority score	-	Total score:	6	Risk Cat.:	Low
Recommended action:	Monitor condition.						
Recommendation comments:	-						
Surveyors Comments:	-

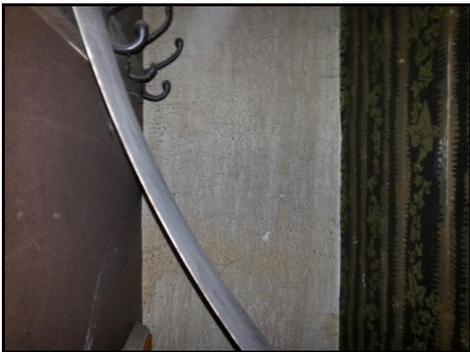
Item Description:	Textured coating to walls					
	Material description:	Textured coatings					
	Quantity / Extent:	N/A					
	Accessibility	Easy Access					
	Analysis:	No asbestos detected					
	Conf. of Product Type:	Non-asbestos material					
Material Assessment Scoring:							
Product Type:	-	Condition:	-	Surface Treatment:	-	Asbestos Type:	-
Priority Assessment Scoring:							
Occupant Activity:	-	Disturbance:	-	Human Exposure:	-	Maintenance activity:	-
Total Scores:							
Material score:	-	Priority score	-	Total score:	-	Risk Cat.:	N/A
Recommended action:	-						
Recommendation comments:	-						
Surveyors Comments:	-

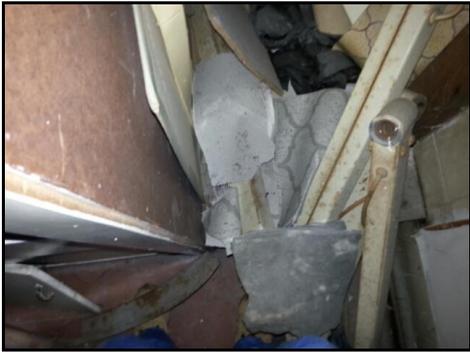
Item Description:	Floor tile debris					
	Material description:	Textured coatings					
	Quantity / Extent:	1 m ²					
	Accessibility	Easy Access					
	Analysis:	Chrysotile					
	Conf. of Product Type:	Asbestos thermoplastic/adhesive					
Material Assessment Scoring:							
Product Type:	1	Condition:	2	Surface Treatment:	0	Asbestos Type:	1
Priority Assessment Scoring:							
Occupant Activity:	0	Disturbance:	0	Human Exposure:	0	Maintenance activity:	0
Total Scores:							
Material score:	4	Priority score	-	Total score:	4	Risk Cat.:	Very Low
Recommended action:	Remove.						
Recommendation comments:	-						
Surveyors Comments:	-

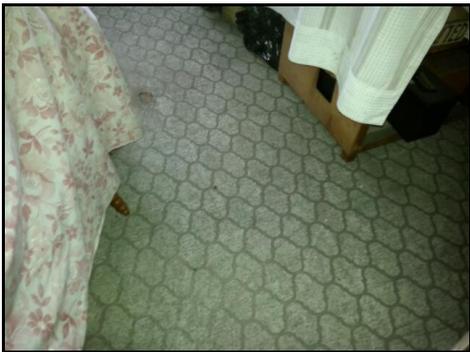
Item Description:	Floor tiles					
	Material description:	Thermoplastic product					
	Quantity / Extent:	N/A					
	Accessibility	Easy Access					
	Analysis:	No asbestos detected					
	Conf. of Product Type:	Non-asbestos material					
Material Assessment Scoring:							
Product Type:	-	Condition:	-	Surface Treatment:	-	Asbestos Type:	-
Priority Assessment Scoring:							
Occupant Activity:	-	Disturbance:	-	Human Exposure:	-	Maintenance activity:	-
Total Scores:							
Material score:	-	Priority score	-	Total score:	-	Risk Cat.:	N/A
Recommended action:	-						
Recommendation comments:	-						
Surveyors Comments:	-

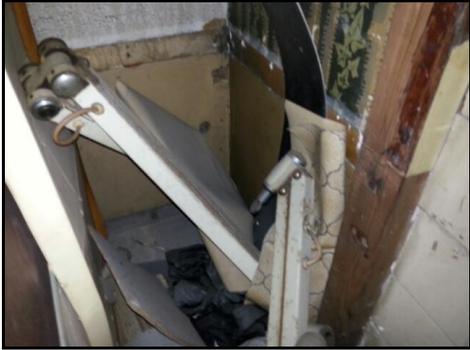
Item Description:	Cut offs of linoleum					
	Material description:	Paper backed linoleum					
	Quantity / Extent:	N/A					
	Accessibility	Easy Access					
	Analysis:	No asbestos detected					
	Conf. of Product Type:	Non-asbestos material					
Material Assessment Scoring:							
Product Type:	-	Condition:	-	Surface Treatment:	-	Asbestos Type:	-
Priority Assessment Scoring:							
Occupant Activity:	-	Disturbance:	-	Human Exposure:	-	Maintenance activity:	-
Total Scores:							
Material score:	-	Priority score	-	Total score:	-	Risk Cat.:	N/A
Recommended action:	-						
Recommendation comments:	-						
Surveyors Comments:	-

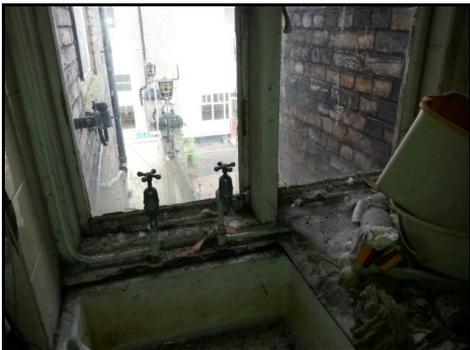
Item Description:	Mastics to rear windows					
	Material description:	Mastics					
	Quantity / Extent:	4 m linear					
	Accessibility	Medium Access					
	Analysis:	Chrysotile					
	Conf. of Product Type:	Asbestos mastic					
Material Assessment Scoring:							
Product Type:	1	Condition:	0	Surface Treatment:	0	Asbestos Type:	1
Priority Assessment Scoring:							
Occupant Activity:	0	Disturbance:	0	Human Exposure:	0	Maintenance activity:	0
Total Scores:							
Material score:	2	Priority score	-	Total score:	2	Risk Cat.:	Very Low
Recommended action:	Monitor condition.						
Recommendation comments:	-						
Surveyors Comments:	-

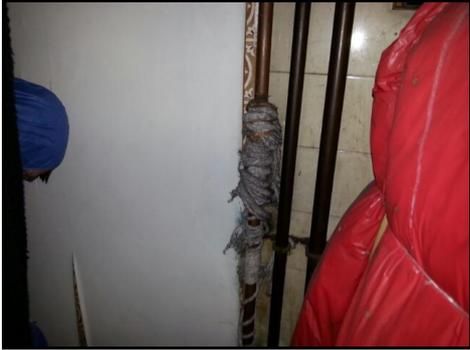
Item Description:	Rope to pipework behind boiler					
	Material description:	Woven product					
	Quantity / Extent:	2 m linear					
	Accessibility	Easy Access					
	Analysis:	Chrysotile					
	Conf. of Product Type:	Asbestos woven material					
Material Assessment Scoring:							
Product Type:	2	Condition:	1	Surface Treatment:	1	Asbestos Type:	1
Priority Assessment Scoring:							
Occupant Activity:	0	Disturbance:	0	Human Exposure:	0	Maintenance activity:	0
Total Scores:							
Material score:	5	Priority score	-	Total score:	5	Risk Cat.:	Low
Recommended action:	Remove.						
Recommendation comments:	-						
Surveyors Comments:	-

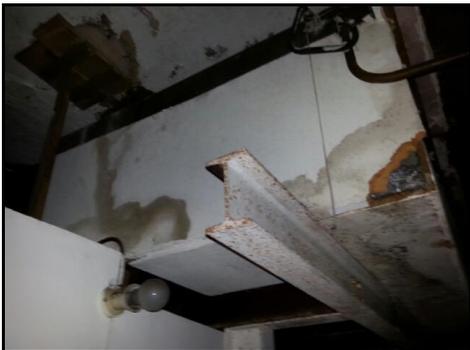
Item Description:	Panels to water tanks					
	Material description:	Insulating board					
	Quantity / Extent:	N/A					
	Accessibility	Medium Access					
	Analysis:	No asbestos detected					
	Conf. of Product Type:	Non-asbestos material					
Material Assessment Scoring:							
Product Type:	-	Condition:	-	Surface Treatment:	-	Asbestos Type:	-
Priority Assessment Scoring:							
Occupant Activity:	-	Disturbance:	-	Human Exposure:	-	Maintenance activity:	-
Total Scores:							
Material score:	-	Priority score	-	Total score:	-	Risk Cat.:	N/A
Recommended action:	-						
Recommendation comments:	-						
Surveyors Comments:	-

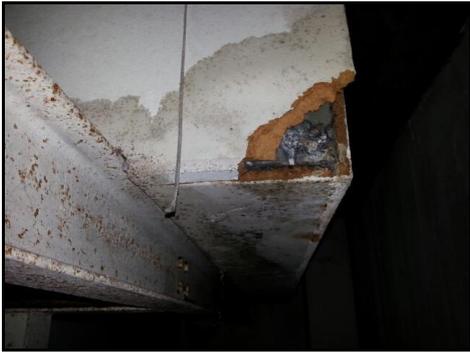
Item Description:	Mastic seals to fibreboard panels					
	Material description:	Mastics					
	Quantity / Extent:	N/A					
	Accessibility	Difficult Access					
	Analysis:	No asbestos detected					
	Conf. of Product Type:	Non-asbestos material					
Material Assessment Scoring:							
Product Type:	-	Condition:	-	Surface Treatment:	-	Asbestos Type:	-
Priority Assessment Scoring:							
Occupant Activity:	-	Disturbance:	-	Human Exposure:	-	Maintenance activity:	-
Total Scores:							
Material score:	-	Priority score	-	Total score:	-	Risk Cat.:	N/A
Recommended action:	-						
Recommendation comments:	-						
Surveyors Comments:	-

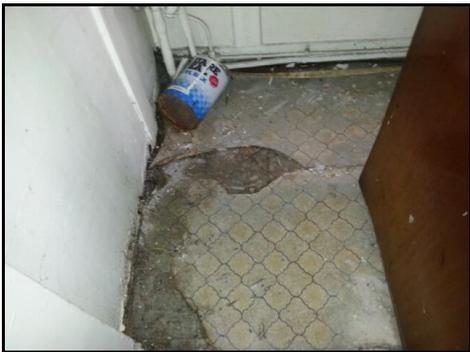
Item Description:	Linoleum					
	Material description:	Paper backed linoleum					
	Quantity / Extent:	N/A					
	Accessibility	Easy Access					
	Analysis:	No asbestos detected					
	Conf. of Product Type:	Non-asbestos material					
Material Assessment Scoring:							
Product Type:	-	Condition:	-	Surface Treatment:	-	Asbestos Type:	-
Priority Assessment Scoring:							
Occupant Activity:	-	Disturbance:	-	Human Exposure:	-	Maintenance activity:	-
Total Scores:							
Material score:	-	Priority score	-	Total score:	-	Risk Cat.:	N/A
Recommended action:	-						
Recommendation comments:	-						
Surveyors Comments:	-

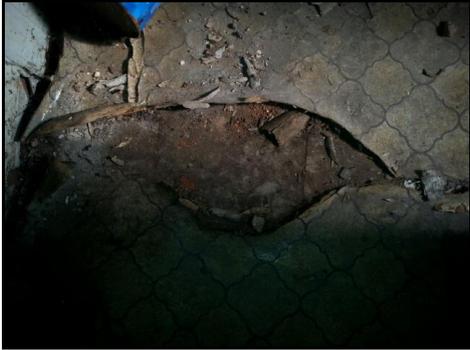
Item Description:	Floor tiles					
	Material description:	Thermoplastic product					
	Quantity / Extent:	4 m ²					
	Accessibility	Medium Access					
	Analysis:	Chrysotile					
	Conf. of Product Type:	Asbestos thermoplastic/adhesive					
Material Assessment Scoring:							
Product Type:	1	Condition:	1	Surface Treatment:	0	Asbestos Type:	1
Priority Assessment Scoring:							
Occupant Activity:	0	Disturbance:	0	Human Exposure:	0	Maintenance activity:	0
Total Scores:							
Material score:	3	Priority score	-	Total score:	3	Risk Cat.:	Very Low
Recommended action:	Monitor condition.						
Recommendation comments:	-						
Surveyors Comments:	-

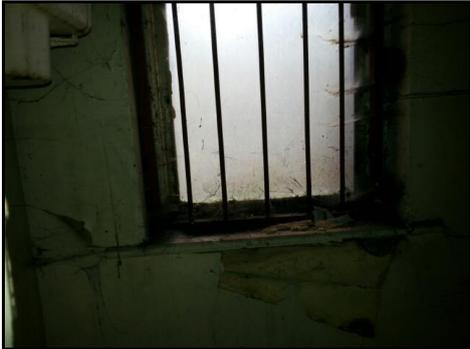
Item Description:	Mastics to window					
	Material description:	Mastics					
	Quantity / Extent:	2 m linear					
	Accessibility	Medium Access					
	Analysis:	Strongly Presumed Chrysotile					
	Conf. of Product Type:	Strongly Presumed Asbestos mastic					
Material Assessment Scoring:							
Product Type:	1	Condition:	0	Surface Treatment:	0	Asbestos Type:	1
Priority Assessment Scoring:							
Occupant Activity:	0	Disturbance:	0	Human Exposure:	0	Maintenance activity:	0
Total Scores:							
Material score:	2	Priority score	-	Total score:	2	Risk Cat.:	Very Low
Recommended action:	Monitor condition.						
Recommendation comments:	-						
Surveyors Comments:	-

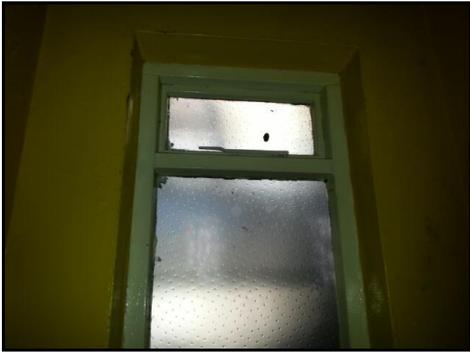
Item Description:	Mastics to window					
	Material description:	Mastics					
	Quantity / Extent:	2 m linear					
	Accessibility	Medium Access					
	Analysis:	Strongly Presumed Chrysotile					
	Conf. of Product Type:	Strongly Presumed Asbestos mastic					
Material Assessment Scoring:							
Product Type:	1	Condition:	0	Surface Treatment:	0	Asbestos Type:	1
Priority Assessment Scoring:							
Occupant Activity:	0	Disturbance:	0	Human Exposure:	0	Maintenance activity:	0
Total Scores:							
Material score:	2	Priority score	-	Total score:	2	Risk Cat.:	Very Low
Recommended action:	Monitor condition.						
Recommendation comments:	-						
Surveyors Comments:	-

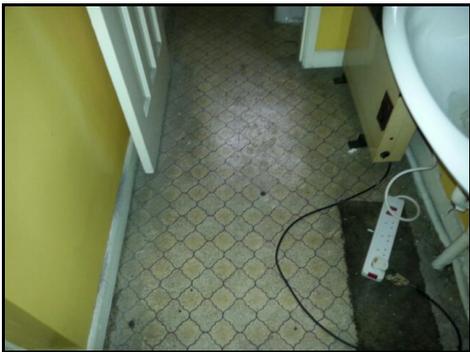
Item Description:	Linoleum					
	Material description:	Paper backed linoleum					
	Quantity / Extent:	N/A					
	Accessibility	Easy Access					
	Analysis:	Strongly Presumed No asbestos detected					
	Conf. of Product Type:	Strongly Presumed Non-asbestos material					
Material Assessment Scoring:							
Product Type:	-	Condition:	-	Surface Treatment:	-	Asbestos Type:	-
Priority Assessment Scoring:							
Occupant Activity:	-	Disturbance:	-	Human Exposure:	-	Maintenance activity:	-
Total Scores:							
Material score:	-	Priority score	-	Total score:	-	Risk Cat.:	N/A
Recommended action:	-						
Recommendation comments:	-						
Surveyors Comments:	-

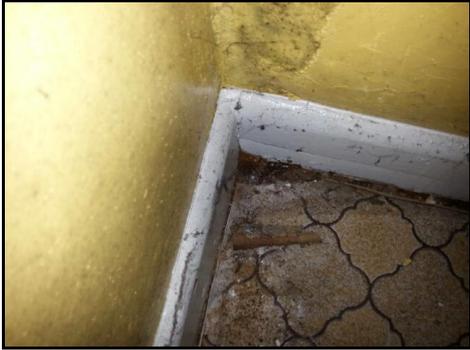
Item Description:	Floor tiles beneath linoleum					
	Material description:	Thermoplastic product					
	Quantity / Extent:	4 m ²					
	Accessibility	Medium Access					
	Analysis:	Strongly Presumed Chrysotile					
	Conf. of Product Type:	Strongly Presumed Asbestos thermoplastic/adhesive					
Material Assessment Scoring:							
Product Type:	1	Condition:	1	Surface Treatment:	0	Asbestos Type:	1
Priority Assessment Scoring:							
Occupant Activity:	0	Disturbance:	0	Human Exposure:	0	Maintenance activity:	0
Total Scores:							
Material score:	3	Priority score	-	Total score:	3	Risk Cat.:	Very Low
Recommended action:	Monitor condition.						
Recommendation comments:	-						
Surveyors Comments:	-

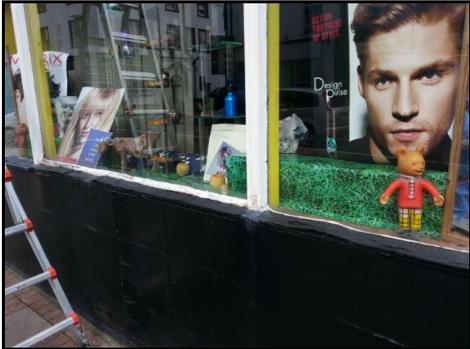
Item Description:	Mastics to windows					
	Material description:	Mastics					
	Quantity / Extent:	N/A					
	Accessibility	Medium Access					
	Analysis:	No asbestos detected					
	Conf. of Product Type:	Non-asbestos material					
Material Assessment Scoring:							
Product Type:	-	Condition:	-	Surface Treatment:	-	Asbestos Type:	-
Priority Assessment Scoring:							
Occupant Activity:	-	Disturbance:	-	Human Exposure:	-	Maintenance activity:	-
Total Scores:							
Material score:	-	Priority score	-	Total score:	-	Risk Cat.:	N/A
Recommended action:	-						
Recommendation comments:	-						
Surveyors Comments:	-

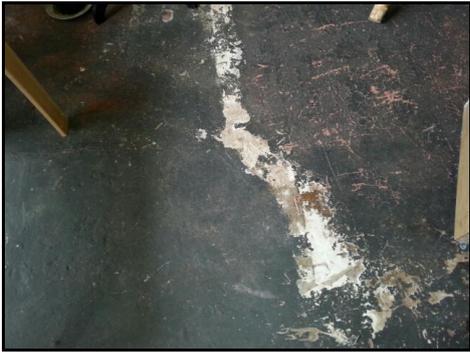
Item Description:	Adhesive to floor					
	Material description:	Bituminous products					
	Quantity / Extent:	N/A					
	Accessibility	Easy Access					
	Analysis:	No asbestos detected					
	Conf. of Product Type:	Non-asbestos material					
Material Assessment Scoring:							
Product Type:	-	Condition:	-	Surface Treatment:	-	Asbestos Type:	-
Priority Assessment Scoring:							
Occupant Activity:	-	Disturbance:	-	Human Exposure:	-	Maintenance activity:	-
Total Scores:							
Material score:	-	Priority score	-	Total score:	-	Risk Cat.:	N/A
Recommended action:	-						
Recommendation comments:	-						
Surveyors Comments:	-

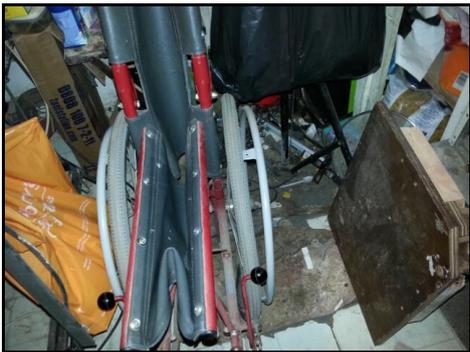
Item Description:	Floor tiles					
	Material description:	Thermoplastic product					
	Quantity / Extent:	N/A					
	Accessibility	Easy Access					
	Analysis:	No asbestos detected					
	Conf. of Product Type:	Non-asbestos material					
Material Assessment Scoring:							
Product Type:	-	Condition:	-	Surface Treatment:	-	Asbestos Type:	-
Priority Assessment Scoring:							
Occupant Activity:	-	Disturbance:	-	Human Exposure:	-	Maintenance activity:	-
Total Scores:							
Material score:	-	Priority score	-	Total score:	-	Risk Cat.:	N/A
Recommended action:	-						
Recommendation comments:	-						
Surveyors Comments:	-

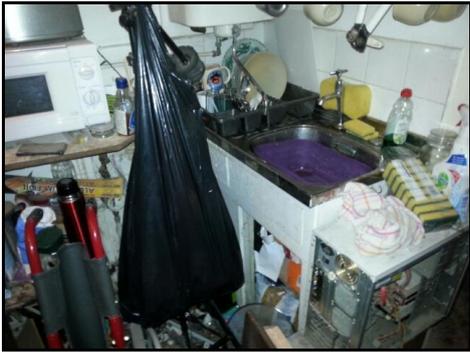
Item Description:	Sink pad					
	Material description:	Bituminous products					
	Quantity / Extent:	<1 m ²					
	Accessibility	Medium Access					
	Analysis:	Chrysotile					
	Conf. of Product Type:	Asbestos bitumen					
Material Assessment Scoring:							
Product Type:	1	Condition:	0	Surface Treatment:	0	Asbestos Type:	1
Priority Assessment Scoring:							
Occupant Activity:	0	Disturbance:	0	Human Exposure:	0	Maintenance activity:	0
Total Scores:							
Material score:	2	Priority score	-	Total score:	2	Risk Cat.:	Very Low
Recommended action:	Monitor condition.						
Recommendation comments:	-						
Surveyors Comments:	-

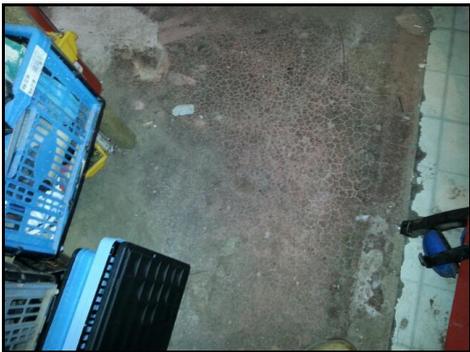
Item Description:	Adhesive to floor					
	Material description:	Bituminous products					
	Quantity / Extent:	N/A					
	Accessibility	Easy Access					
	Analysis:	Strongly Presumed No asbestos detected					
	Conf. of Product Type:	Strongly Presumed Non-asbestos material					
Material Assessment Scoring:							
Product Type:	-	Condition:	-	Surface Treatment:	-	Asbestos Type:	-
Priority Assessment Scoring:							
Occupant Activity:	-	Disturbance:	-	Human Exposure:	-	Maintenance activity:	-
Total Scores:							
Material score:	-	Priority score	-	Total score:	-	Risk Cat.:	N/A
Recommended action:	-						
Recommendation comments:	-						
Surveyors Comments:	-

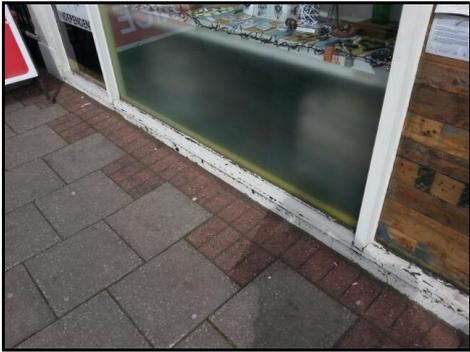
Item Description:	Mastics to windows					
	Material description:	Mastics					
	Quantity / Extent:	N/A					
	Accessibility	Medium Access					
	Analysis:	No asbestos detected					
	Conf. of Product Type:	Non-asbestos material					
Material Assessment Scoring:							
Product Type:	-	Condition:	-	Surface Treatment:	-	Asbestos Type:	-
Priority Assessment Scoring:							
Occupant Activity:	-	Disturbance:	-	Human Exposure:	-	Maintenance activity:	-
Total Scores:							
Material score:	-	Priority score	-	Total score:	-	Risk Cat.:	N/A
Recommended action:	-						
Recommendation comments:	-						
Surveyors Comments:	-

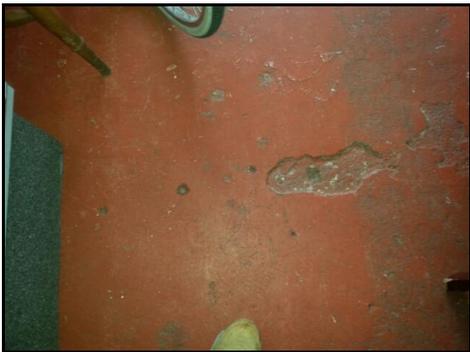
Item Description:	Floor screed					
	Material description:	Floor screed					
	Quantity / Extent:	N/A					
	Accessibility	Easy Access					
	Analysis:	No asbestos detected					
	Conf. of Product Type:	Non-asbestos material					
Material Assessment Scoring:							
Product Type:	-	Condition:	-	Surface Treatment:	-	Asbestos Type:	-
Priority Assessment Scoring:							
Occupant Activity:	-	Disturbance:	-	Human Exposure:	-	Maintenance activity:	-
Total Scores:							
Material score:	-	Priority score	-	Total score:	-	Risk Cat.:	N/A
Recommended action:	-						
Recommendation comments:	-						
Surveyors Comments:	-

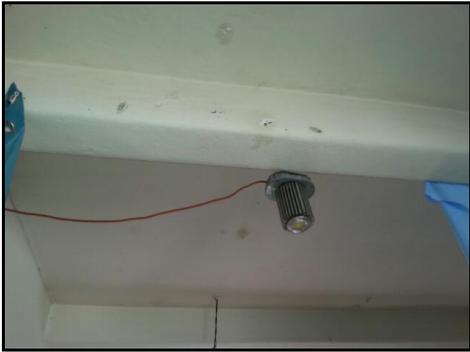
Item Description:	Sprayed coating to beam					
	Material description:	Sprayed coating					
	Quantity / Extent:	8 m linear					
	Accessibility	Medium Access					
	Analysis:	Amosite Crocidolite Chrysotile					
	Conf. of Product Type:	Asbestos sprayed coating					
Material Assessment Scoring:							
Product Type:	3	Condition:	3	Surface Treatment:	3	Asbestos Type:	3
Priority Assessment Scoring:							
Occupant Activity:	0	Disturbance:	0	Human Exposure:	0	Maintenance activity:	0
Total Scores:							
Material score:	12	Priority score	-	Total score:	12	Risk Cat.:	High
Recommended action:	Remove.						
Recommendation comments:	-						
Surveyors Comments:	Sprayed coating has been drilled by the tenant and requires encapsulation by LARC as a minimum of ongoing asbestos management

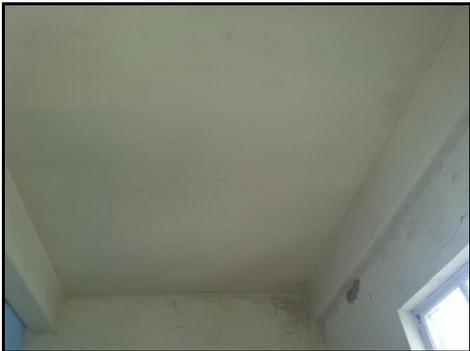
Item Description:	Sprayed coating to ceiling					
	Material description:	Sprayed coating					
	Quantity / Extent:	45 m ²					
	Accessibility	Medium Access					
	Analysis:	Crocidolite Chrysotile Amosite					
	Conf. of Product Type:	Asbestos sprayed coating					
Material Assessment Scoring:							
Product Type:	3	Condition:	1	Surface Treatment:	2	Asbestos Type:	3
Priority Assessment Scoring:							
Occupant Activity:	0	Disturbance:	0	Human Exposure:	0	Maintenance activity:	0
Total Scores:							
Material score:	9	Priority score	-	Total score:	9	Risk Cat.:	Medium
Recommended action:	Remedial – Encapsulate and then monitor condition.						
Recommendation comments:	-						
Surveyors Comments:	Hairline fracture within ceiling to rear window requires encapsulation, remainder of ceiling is in relative good condition

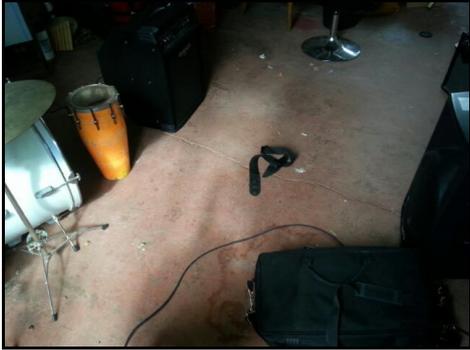
Item Description:	Floor screed					
	Material description:	Floor screed					
	Quantity / Extent:	N/A					
	Accessibility	Easy Access					
	Analysis:	No asbestos detected					
	Conf. of Product Type:	Non-asbestos material					
Material Assessment Scoring:							
Product Type:	-	Condition:	-	Surface Treatment:	-	Asbestos Type:	-
Priority Assessment Scoring:							
Occupant Activity:	-	Disturbance:	-	Human Exposure:	-	Maintenance activity:	-
Total Scores:							
Material score:	-	Priority score	-	Total score:	-	Risk Cat.:	N/A
Recommended action:	-						
Recommendation comments:	-						
Surveyors Comments:	-

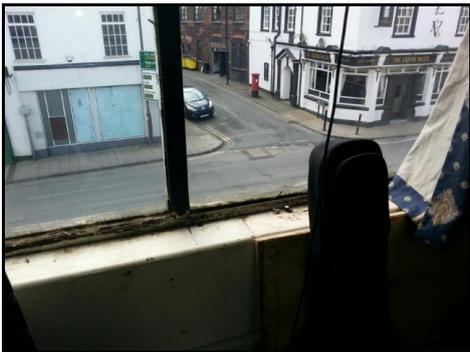
Item Description:	Mastics to window					
	Material description:	Mastics					
	Quantity / Extent:	N/A					
	Accessibility	Medium Access					
	Analysis:	No asbestos detected					
	Conf. of Product Type:	Non-asbestos material					
Material Assessment Scoring:							
Product Type:	-	Condition:	-	Surface Treatment:	-	Asbestos Type:	-
Priority Assessment Scoring:							
Occupant Activity:	-	Disturbance:	-	Human Exposure:	-	Maintenance activity:	-
Total Scores:							
Material score:	-	Priority score	-	Total score:	-	Risk Cat.:	N/A
Recommended action:	-						
Recommendation comments:	-						
Surveyors Comments:	-

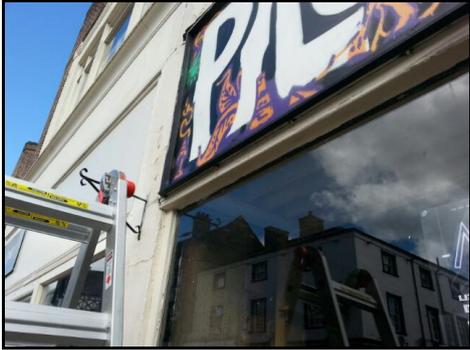
Item Description:	Mastics to windows					
	Material description:	Mastics					
	Quantity / Extent:	N/A					
	Accessibility	Medium Access					
	Analysis:	No asbestos detected					
	Conf. of Product Type:	Non-asbestos material					
Material Assessment Scoring:							
Product Type:	-	Condition:	-	Surface Treatment:	-	Asbestos Type:	-
Priority Assessment Scoring:							
Occupant Activity:	-	Disturbance:	-	Human Exposure:	-	Maintenance activity:	-
Total Scores:							
Material score:	-	Priority score	-	Total score:	-	Risk Cat.:	N/A
Recommended action:	-						
Recommendation comments:	-						
Surveyors Comments:	-

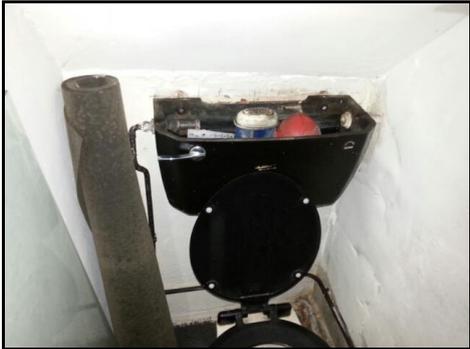
Item Description:	Toilet cistern					
	Material description:	Reinforced plastic					
	Quantity / Extent:	1 Number					
	Accessibility	Easy Access					
	Analysis:	Chrysotile					
	Conf. of Product Type:	Asbestos reinforced plastic					
Material Assessment Scoring:							
Product Type:	1	Condition:	0	Surface Treatment:	0	Asbestos Type:	1
Priority Assessment Scoring:							
Occupant Activity:	0	Disturbance:	0	Human Exposure:	0	Maintenance activity:	0
Total Scores:							
Material score:	2	Priority score	-	Total score:	2	Risk Cat.:	Very Low
Recommended action:	Monitor condition.						
Recommendation comments:	-						
Surveyors Comments:	-

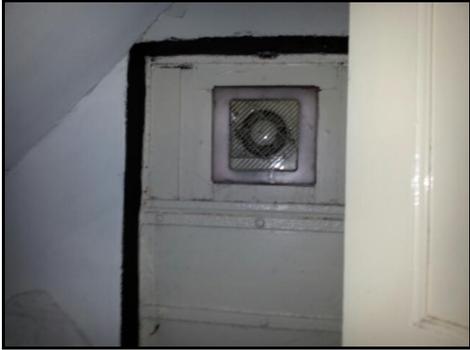
Item Description:	Mastic to window					
	Material description:	Mastics					
	Quantity / Extent:	N/A					
	Accessibility	Easy Access					
	Analysis:	No asbestos detected					
	Conf. of Product Type:	Non-asbestos material					
Material Assessment Scoring:							
Product Type:	-	Condition:	-	Surface Treatment:	-	Asbestos Type:	-
Priority Assessment Scoring:							
Occupant Activity:	-	Disturbance:	-	Human Exposure:	-	Maintenance activity:	-
Total Scores:							
Material score:	-	Priority score	-	Total score:	-	Risk Cat.:	N/A
Recommended action:	-						
Recommendation comments:	-						
Surveyors Comments:	-
