ASBESTOS MANAGEMENT PLAN

TOWN GARDENS, QUARRY ROAD, SWINDON, SN1 4EN

Asbestos Management Survey Report

Town Gardens, Quarry Road, Swindon, SN1 4EN

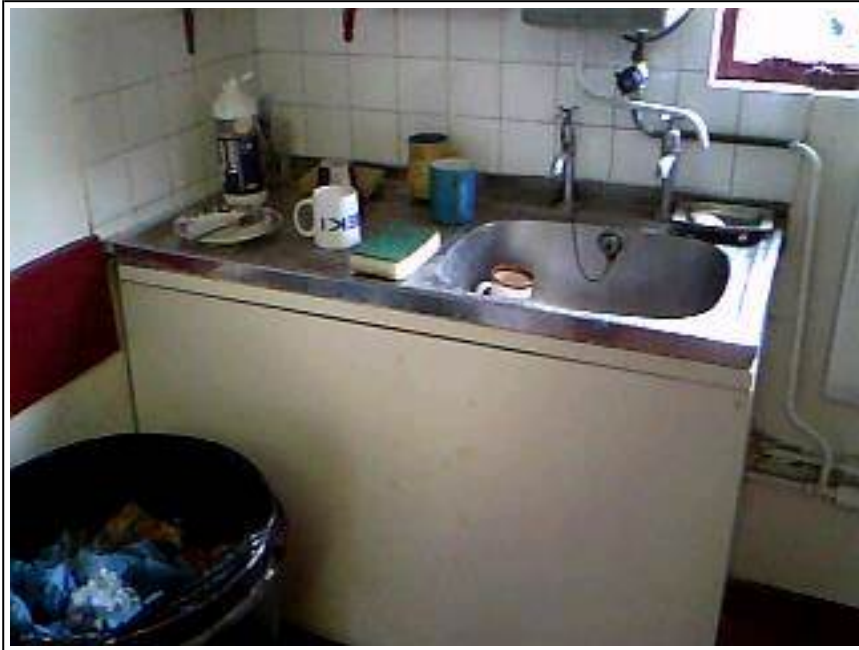
Sample Ref	Fl	Location	Description	Qty	Analysis Result	Total M.A.S	Licensed Material Y/N
AD005872	Ground Floor	Mess (mess area). 001	Sink - Acoustic pad - Well Bound Material	1no.	Chrysotile	2	N

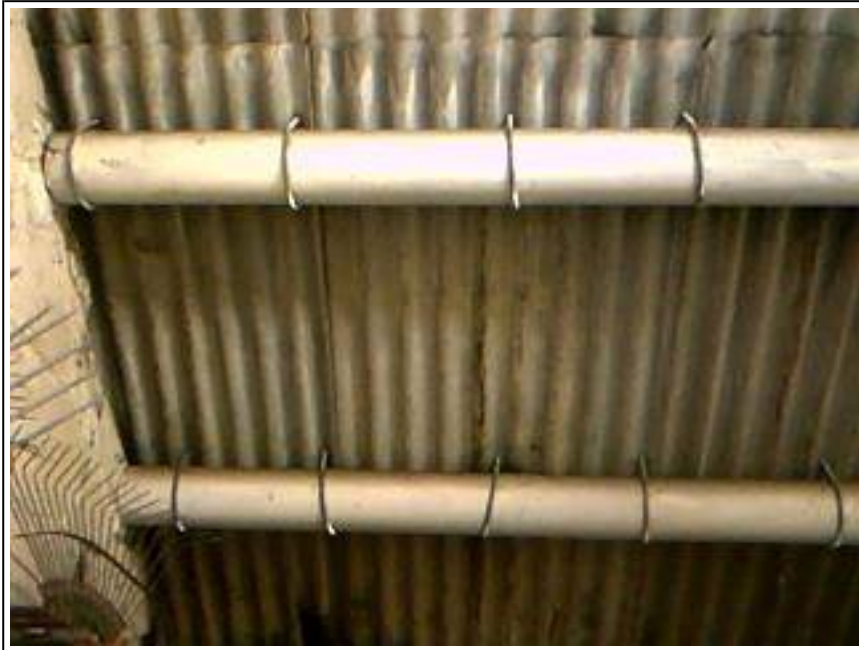
Sample Ref	Fl	Location	Description	Qty	Analysis Result	Total M.A.S	Licensed Material Y/N
ENS B07	Ground Floor	Store (mess area). 002	Roof supports - Cement surrounds - Cement	18lm	Chrysotile	3	N

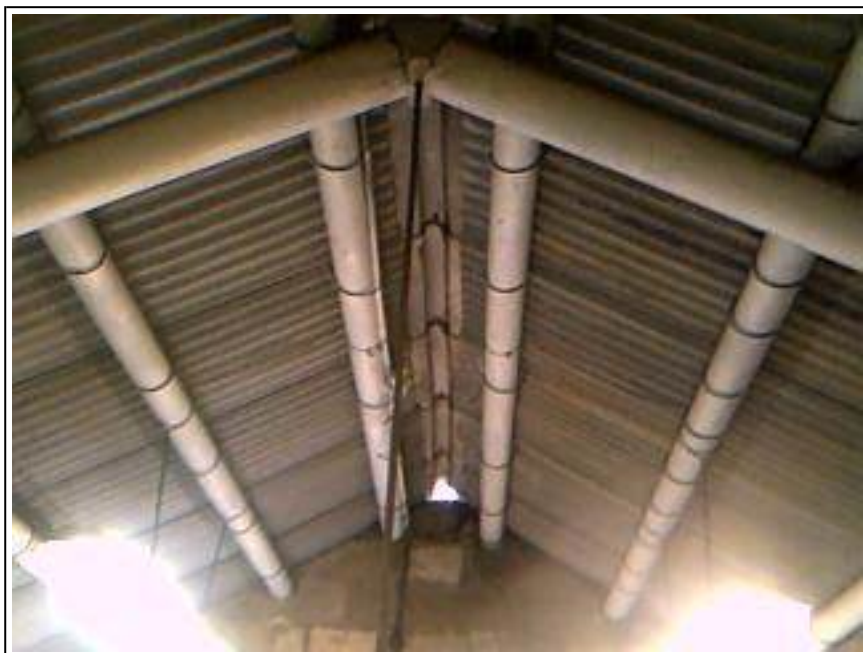
Sample Ref	FI	Location	Description	Qty	Analysis Result	Total M.A.S	Licensed Material Y/N
REFER (ENS B07)	Ground Floor	Garage (mess area). 003	Roof supports - Cement surrounds - Cement	56lm	Chrysotile	3	N

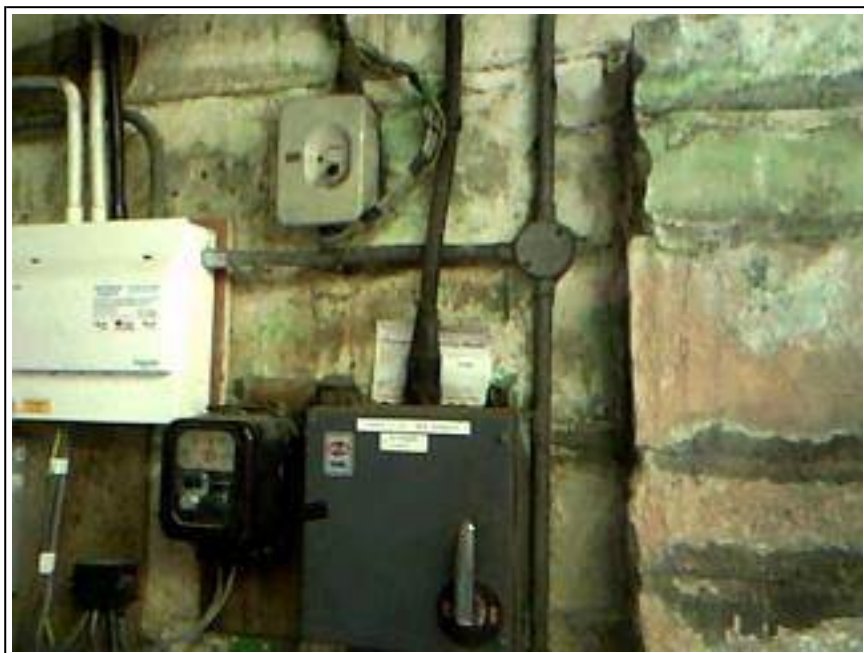
Sample Ref	FI	Location	Description	Qty	Analysis Result	Total M.A.S	Licensed Material Y/N
Presumed	Ground Floor	Garage (mess area). 003	Within MEM switchgear - Presumed textiles - Asbestos Textiles/Paper	<1m ²	Chrysotile	5	N

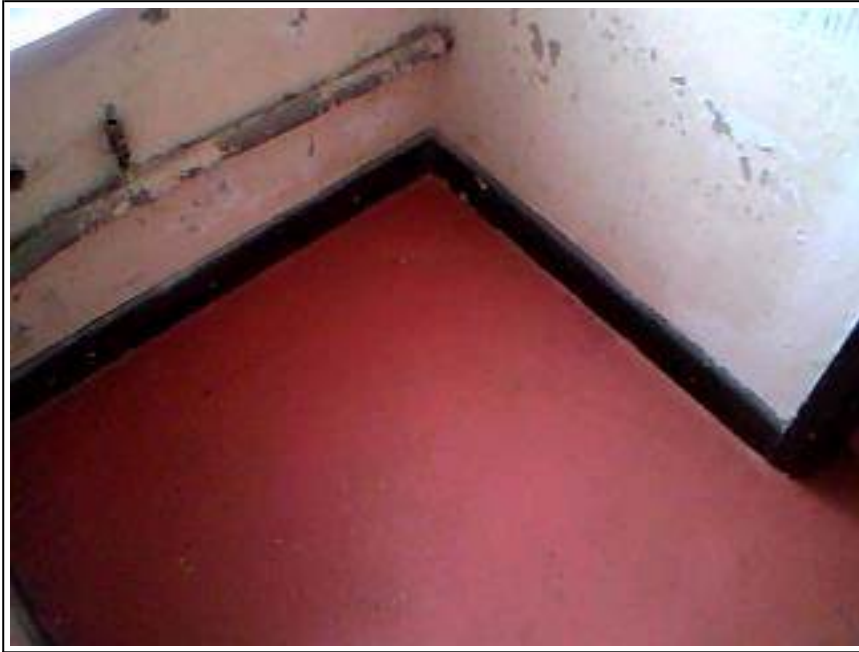
Sample Ref	FI	Location	Description	Qty	Analysis Result	Total M.A.S	Licensed Material Y/N
AD005873	Ground Floor	Toilet (mess area). 004	Floor (below lino) - Adhesive residue - Well Bound Material	6m ²	NADIS		N

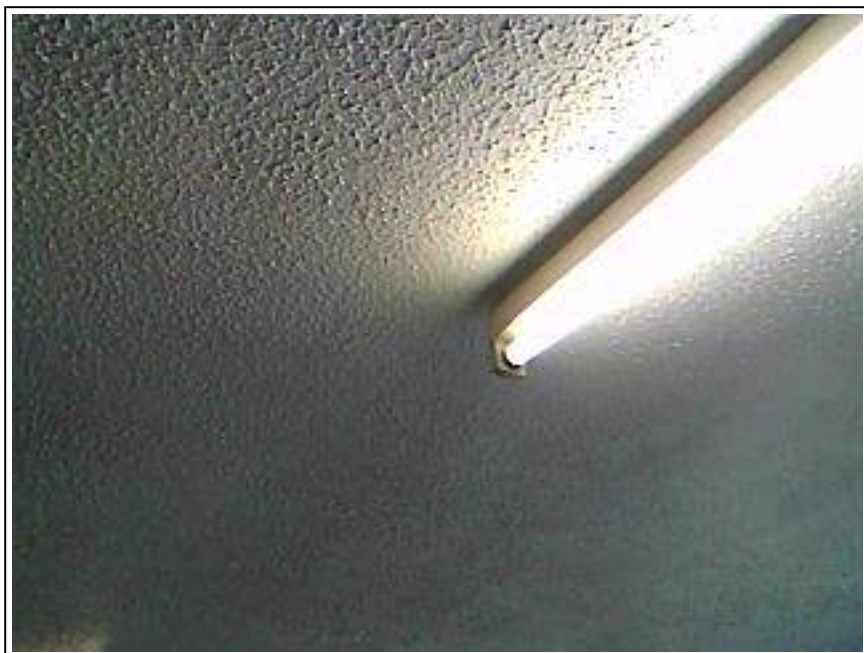
Sample Ref	FI	Location	Description	Qty	Analysis Result	Total M.A.S	Licensed Material Y/N
ENS B11	Ground Floor	Club Room (bowls pavillion). 006	Ceiling - Decorative coating - Textured Coating	30m ²	Chrysotile	2	N

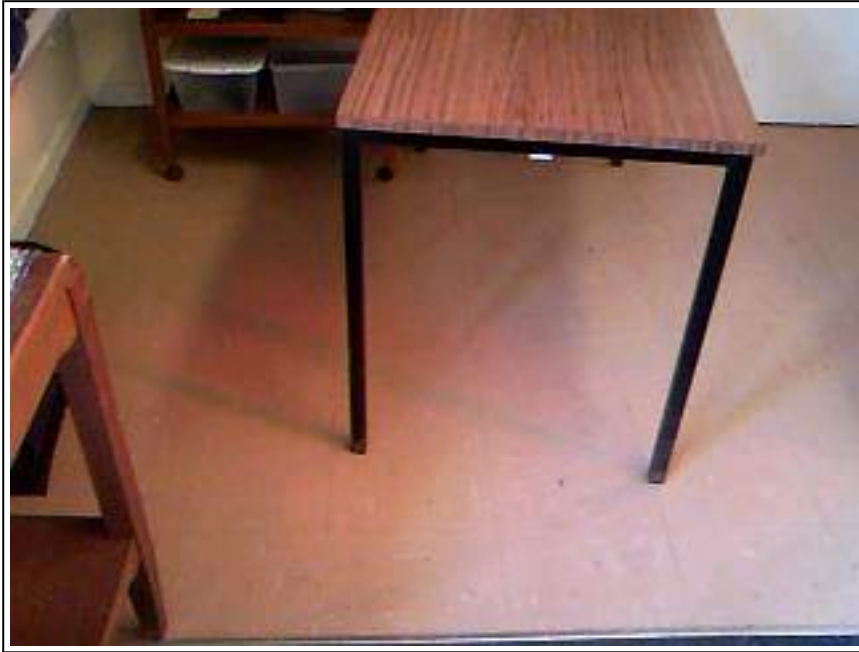
Sample Ref	FI	Location	Description	Qty	Analysis Result	Total M.A.S	Licensed Material Y/N
AD005879	Ground Floor	Club Room (bowls pavillion). 006	Part of floor - Vinyl floor tile and adhesive - Well Bound Material	6m ²	Chrysotile in bitumen	2	N

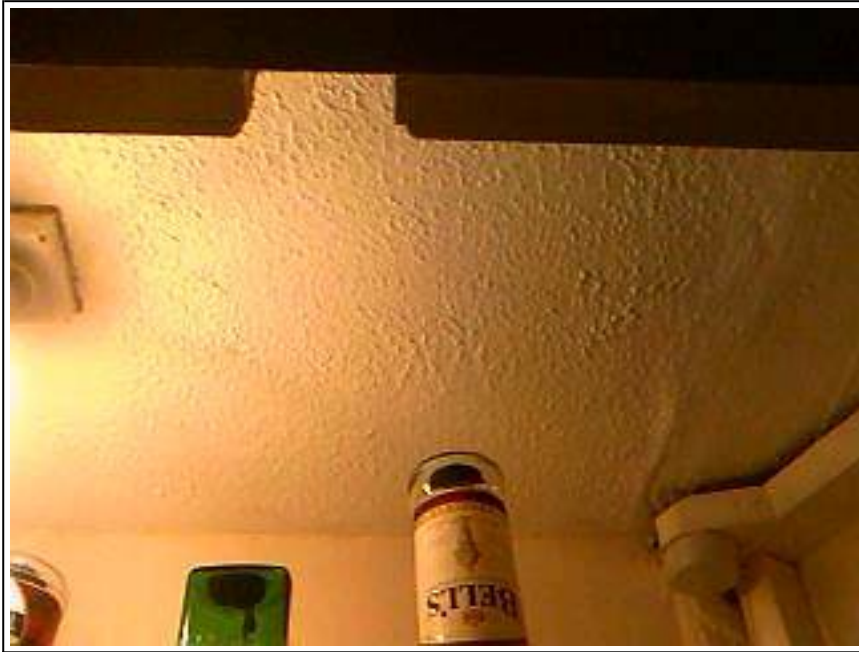
Sample Ref	FI	Location	Description	Qty	Analysis Result	Total M.A.S	Licensed Material Y/N
REFER (ENS B11)	Ground Floor	Store (bowls pavillion). 007	Ceiling - Decorative coating - Textured Coating	2m ²	Chrysotile	2	N

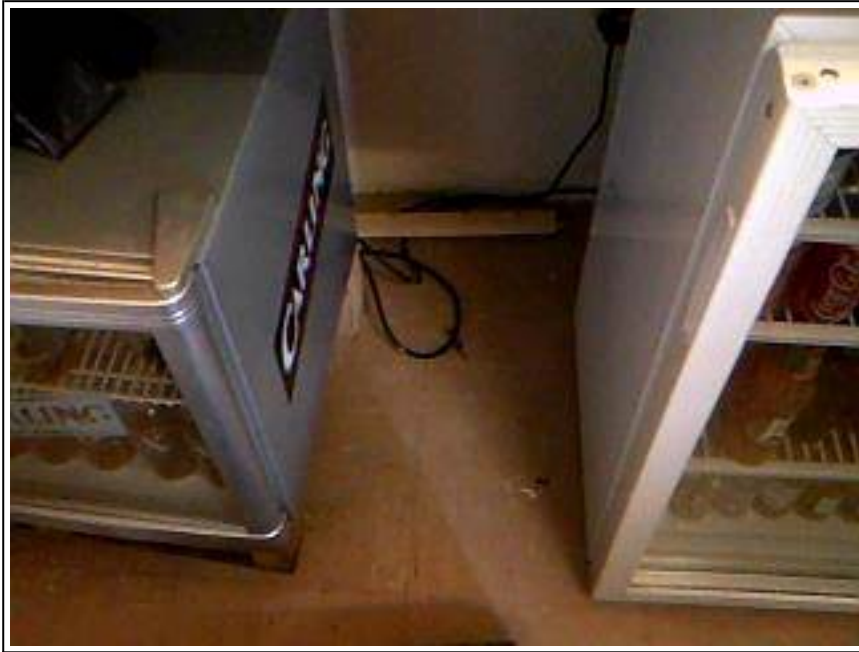
Sample Ref	FI	Location	Description	Qty	Analysis Result	Total M.A.S	Licensed Material Y/N
REFER (AD005879)	Ground Floor	Store (bowls pavillion). 007	Floor - Vinyl floor tile and adhesive - Well Bound Material	2m ²	Chrysotile in bitumen	2	N

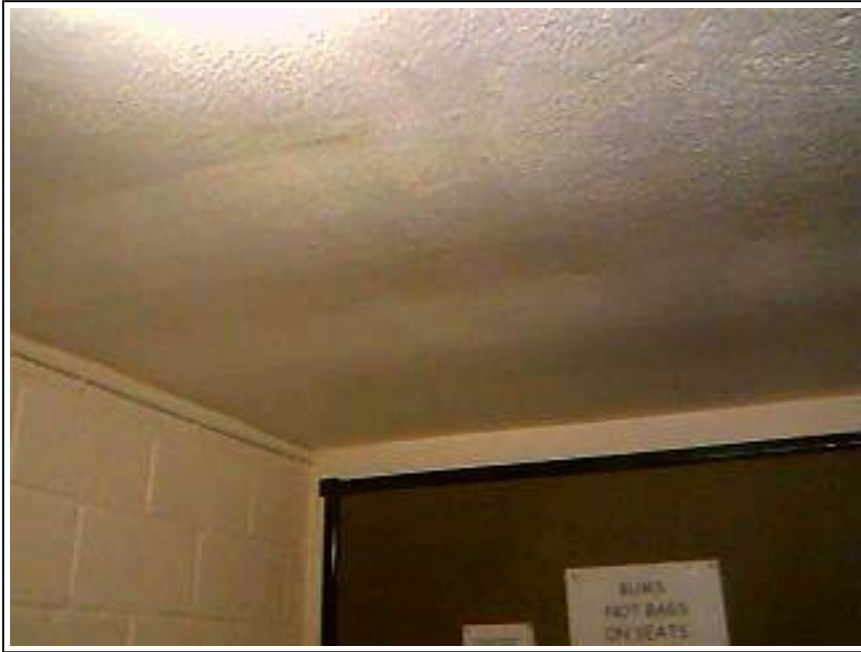
Sample Ref	FI	Location	Description	Qty	Analysis Result	Total M.A.S	Licensed Material Y/N
ENS B18	Ground Floor	Ladies Changing Rooms (bowls pavillion). 008	Ceiling - Decorative coating - Textured Coating	12m ²	Chrysotile	2	N

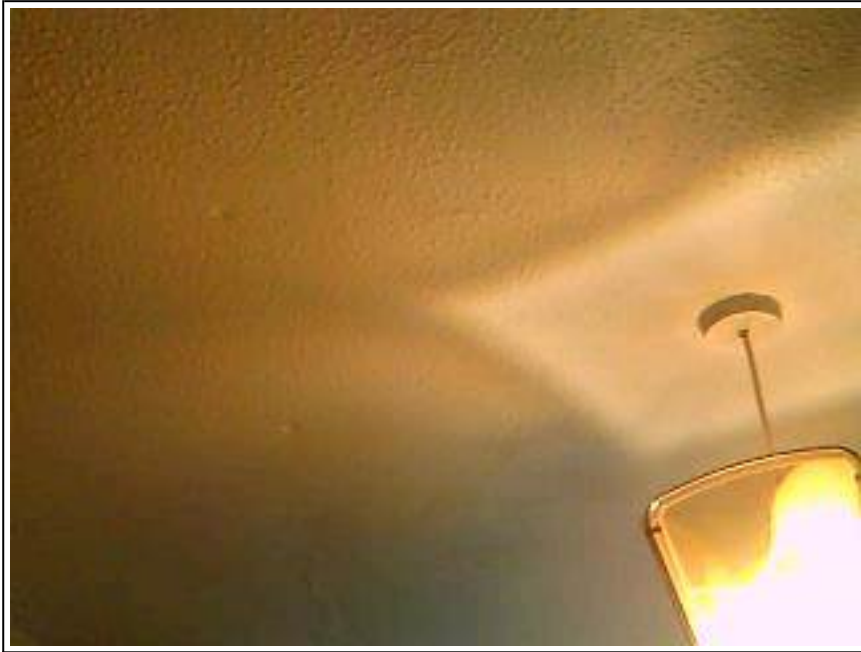
Sample Ref	FI	Location	Description	Qty	Analysis Result	Total M.A.S	Licensed Material Y/N
REFER (ENS B18)	Ground Floor	Ladies Toilets (bowls pavillion). 009	Ceiling - Decorative coating - Textured Coating	6m ²	Chrysotile	2	N

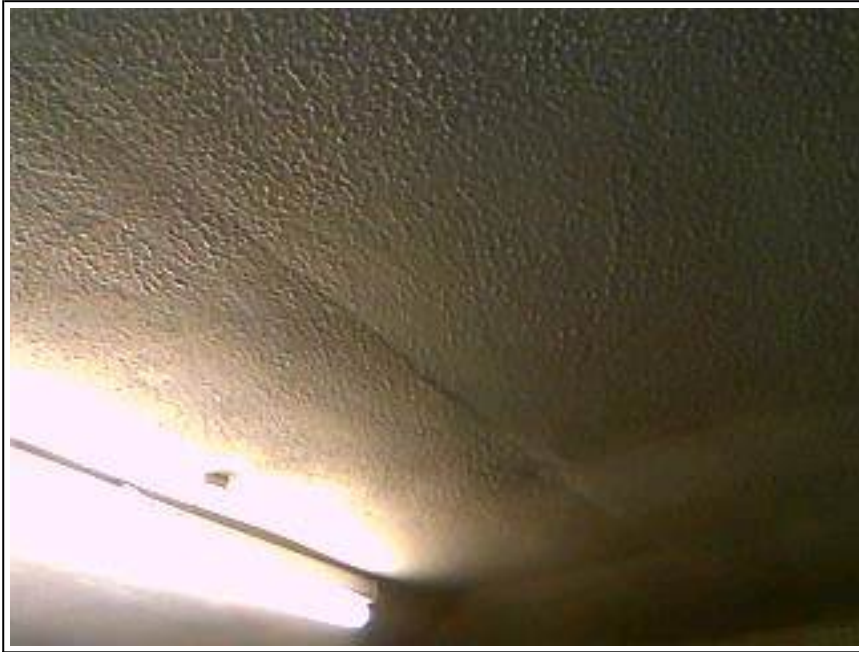
Sample Ref	FI	Location	Description	Qty	Analysis Result	Total M.A.S	Licensed Material Y/N
ENS B17	Ground Floor	Mens Changing Rooms (bowls pavillion). 010	Ceiling - Decorative coating - Textured Coating	12m ²	Chrysotile	2	N

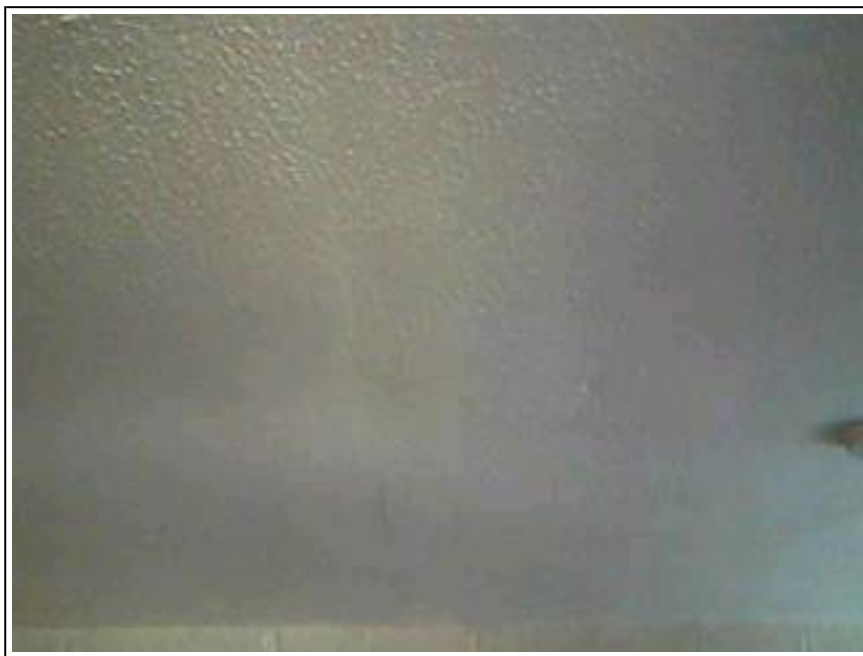
Sample Ref	FI	Location	Description	Qty	Analysis Result	Total M.A.S	Licensed Material Y/N
REFER (ENS B17)	Ground Floor	Mens Toilets (bowls pavillion). 011	Ceiling - Decorative coating - Textured Coating	6m ²	Chrysotile	2	N

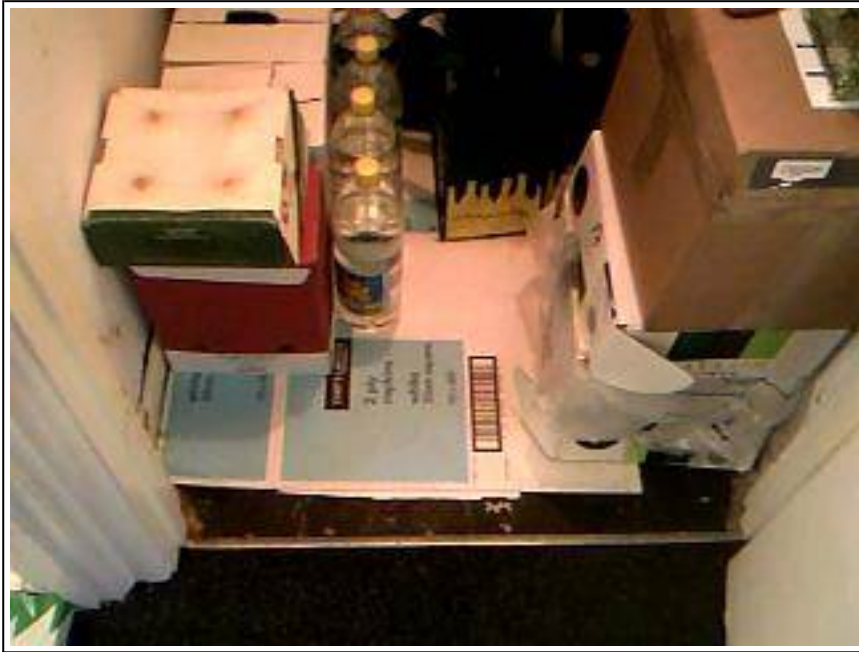
Sample Ref	FI	Location	Description	Qty	Analysis Result	Total M.A.S	Licensed Material Y/N
AD005882	Ground Floor	Cylinder Cupboard (bowls pavillion). 012	Floor - Adhesive residue - Well Bound Material	2m ²	Chrysotile	2	N

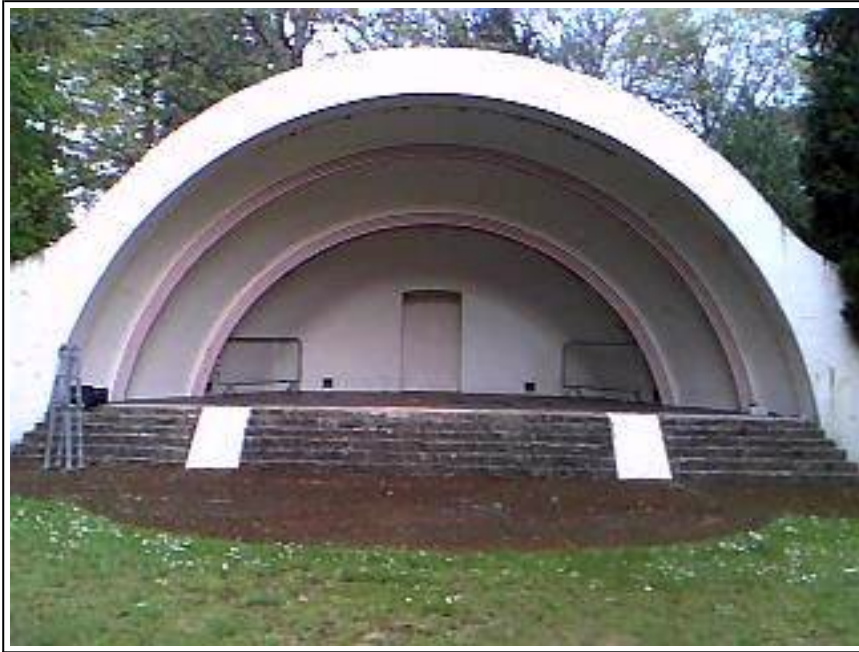
Sample Ref	Fl	Location	Description	Qty	Analysis Result	Total M.A.S	Licensed Material Y/N
ENS B03	Ground Floor	Stage (bowl). 021	Walls and ceiling - Cement panels - Cement	50m ²	Chrysotile	3	N

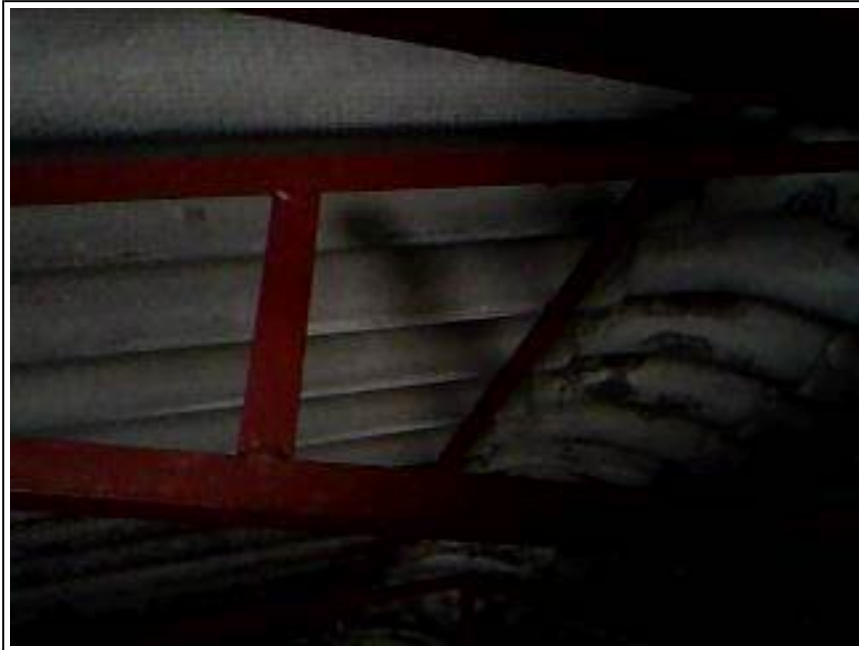
Sample Ref	Fl	Location	Description	Qty	Analysis Result	Total M.A.S	Licensed Material Y/N
AD005887	Ground Floor	Storage Shed One (bowl). 023	Roof - Cement sheets - Cement	14m ²	NADIS		N

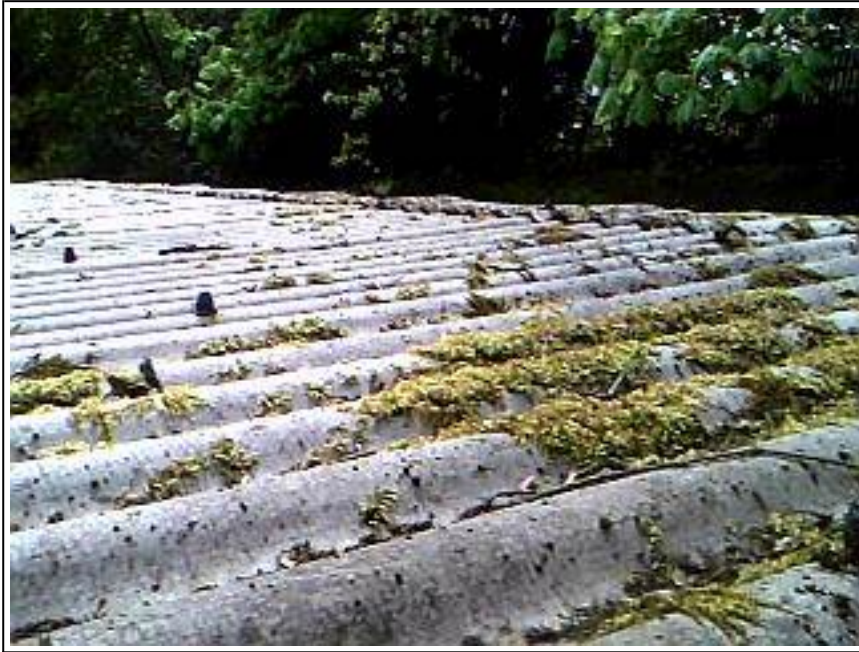
Sample Ref	Fl	Location	Description	Qty	Analysis Result	Total M.A.S	Licensed Material Y/N
REFER (AD005887)	Ground Floor	Storage Shed Two (bowl). 024	Roof - Cement sheets - Cement	30m ²	NADIS		N

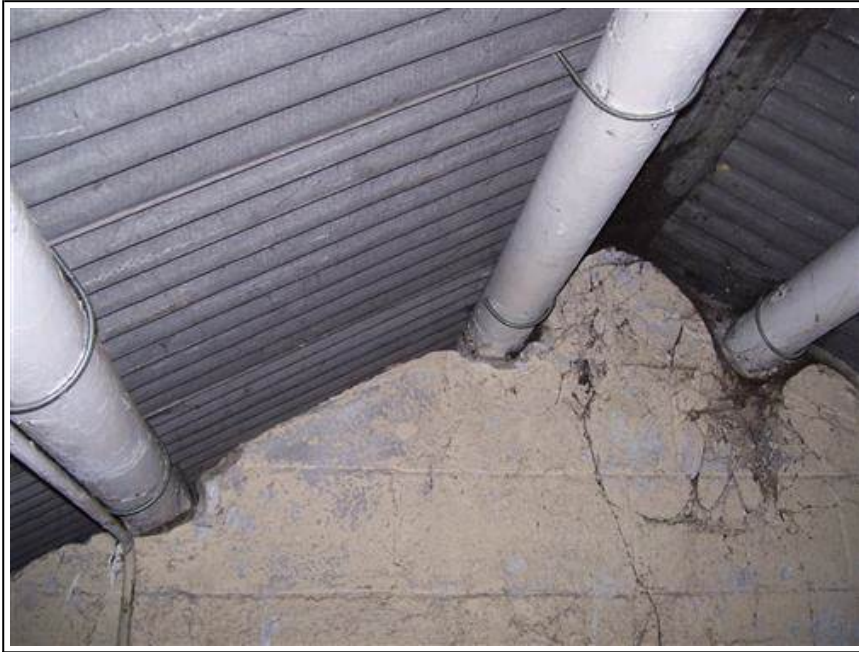
Sample Ref	Fl	Location	Description	Qty	Analysis Result	Total M.A.S	Licensed Material Y/N
REFER (ENS B07)	Roof Void	Attic (mess). A01	Roof supports - Cement surrounds - Cement	12lm	Chrysotile	3	N

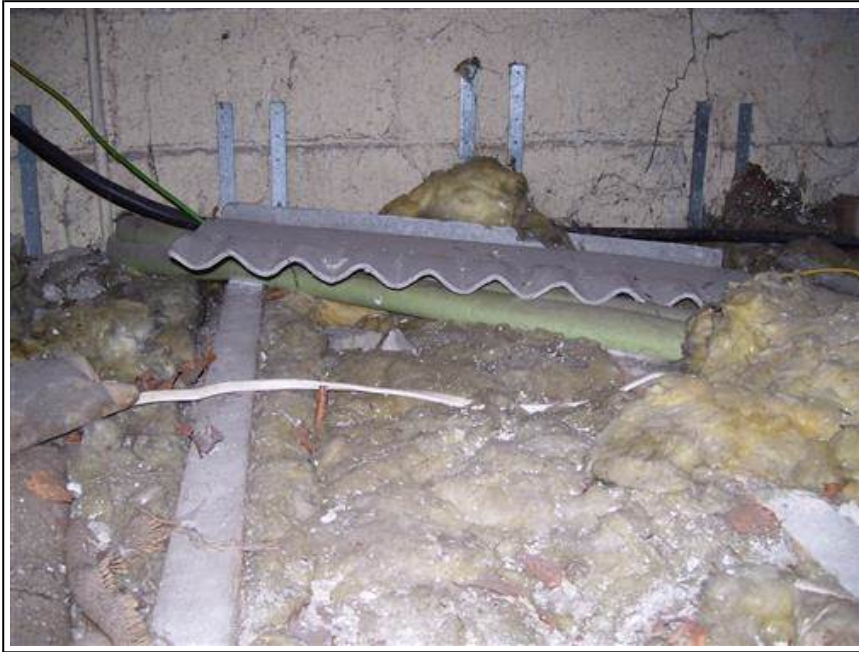
Sample Ref	FI	Location	Description	Qty	Analysis Result	Total M.A.S	Licensed Material Y/N
AD005876	Roof Void	Attic (mess). A01	Floor - Cement debris - Cement	<1m ²	NADIS		N

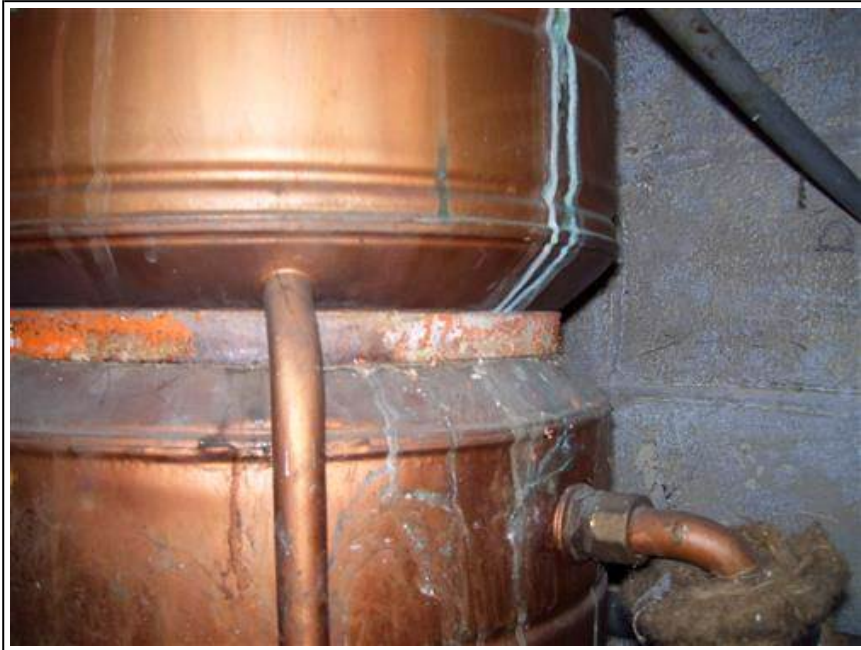
Sample Ref	FI	Location	Description	Qty	Analysis Result	Total M.A.S	Licensed Material Y/N
AD005877	Roof Void	Attic (mess). A01	Cylinder - Textile band - Textiles/Paper	<1m ²	NADIS		N

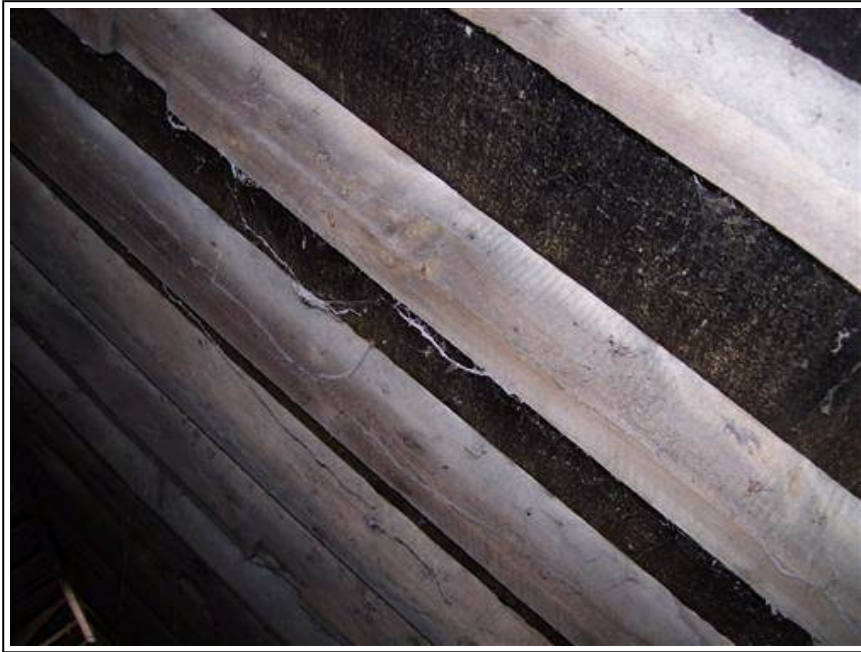
Sample Ref	FI	Location	Description	Qty	Analysis Result	Total M.A.S	Licensed Material Y/N
AD005884	Roof Void	Attic (ladies WC block). A03	Internal roof - Bitumen felt - Well Bound Material	25m ²	NADIS		N

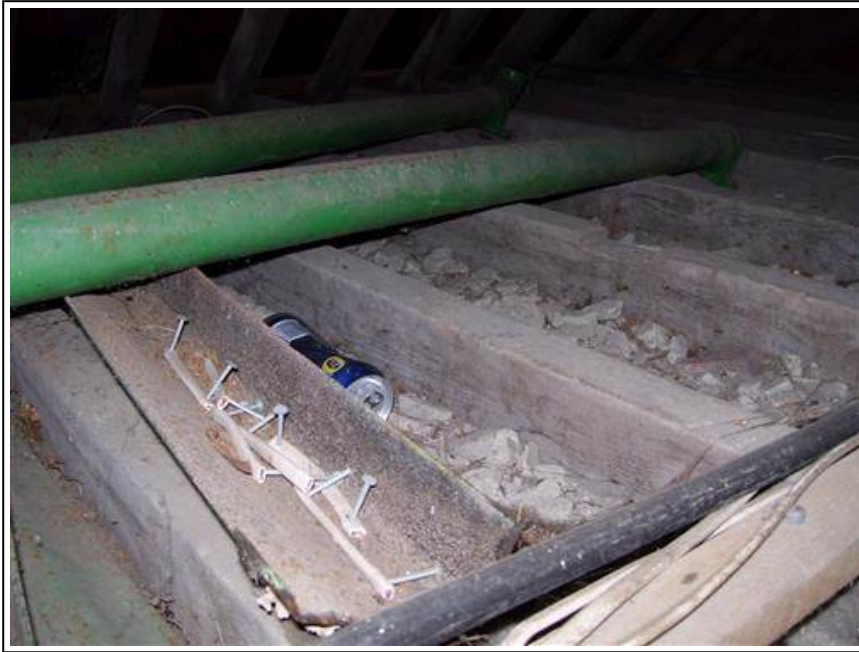
Sample Ref	FI	Location	Description	Qty	Analysis Result	Total M.A.S	Licensed Material Y/N
AD005885	Roof Void	Attic (ladies WC block). A03	Joints to metal guttering - Putty - Well Bound Material	<1m ²	NADIS		N

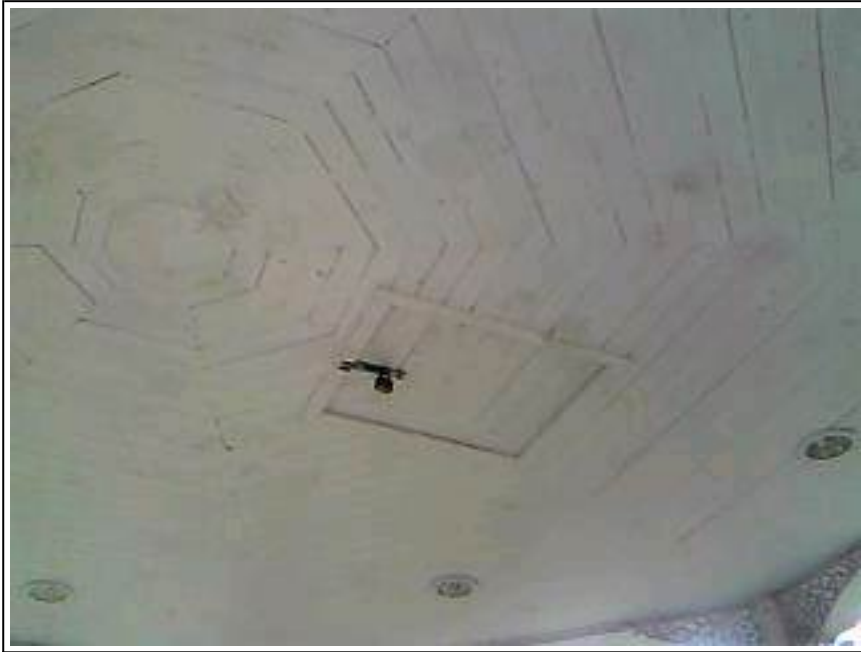
Sample Ref	FI	Location	Description	Qty	Analysis Result	Total M.A.S	Licensed Material Y/N
No Access	Roof Void	Attic (bandstand). A04			No Access

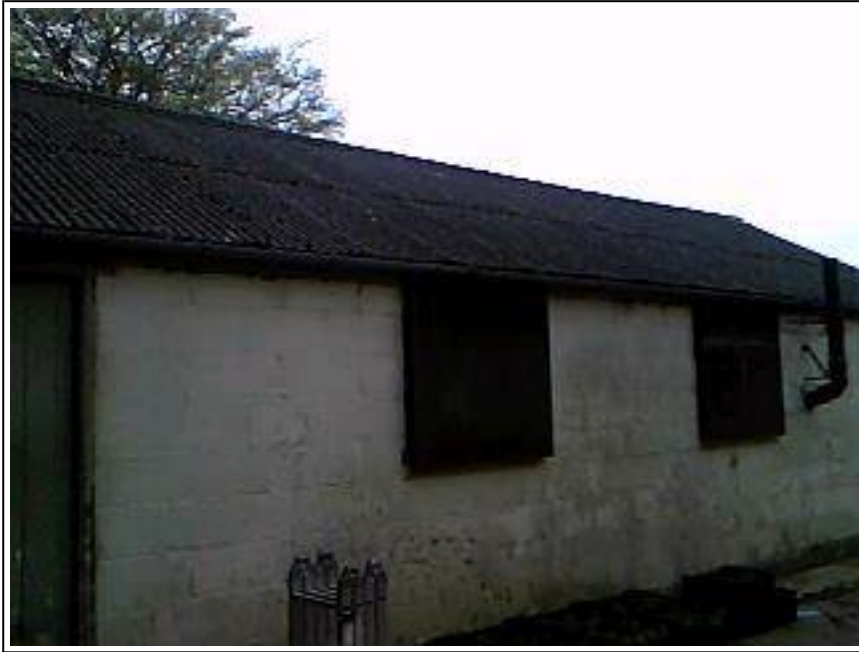
Sample Ref	FI	Location	Description	Qty	Analysis Result	Total M.A.S	Licensed Material Y/N
AD005875	External	External (mess)	Roof - Cement sheets - Cement	74m ²	NADIS		N

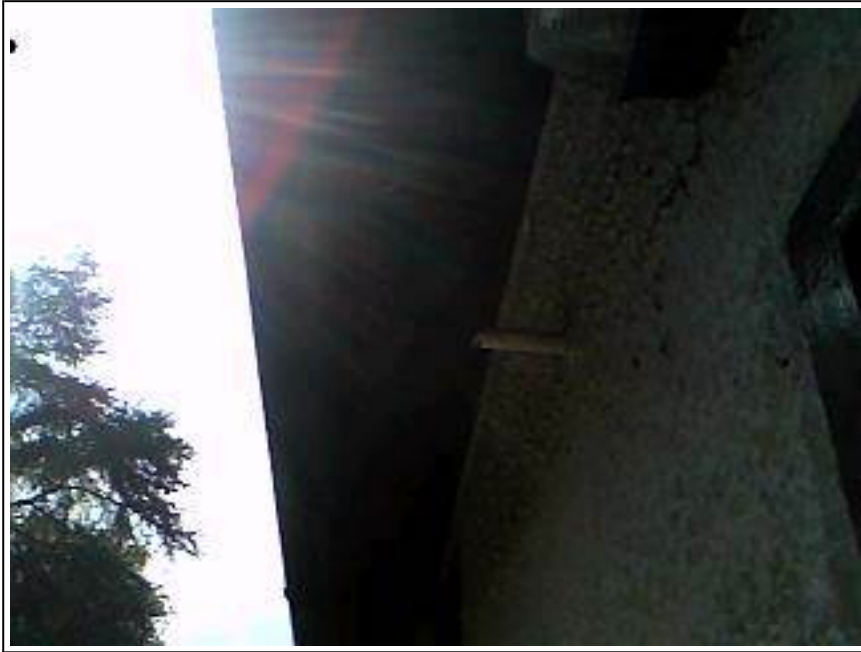
Sample Ref	FI	Location	Description	Qty	Analysis Result	Total M.A.S	Licensed Material Y/N
AD005883	External	External (disabled WC block)	Roof - Insulation board soffits - Insulating Board	20lm	NADIS		N

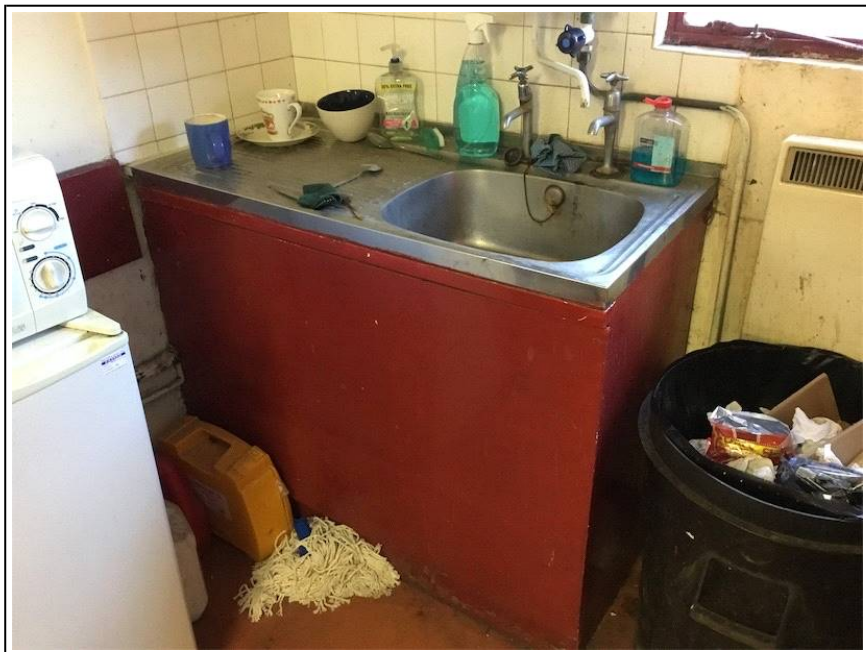
Sample Ref	Fl	Location	Description	Qty	Analysis Result	Total M.A.S	Licensed Material Y/N
AD005872*	Ground Floor	Mess (mess area). 001	Sink - Acoustic pad residue - Well Bound Material	1no.	Chrysotile	4	N

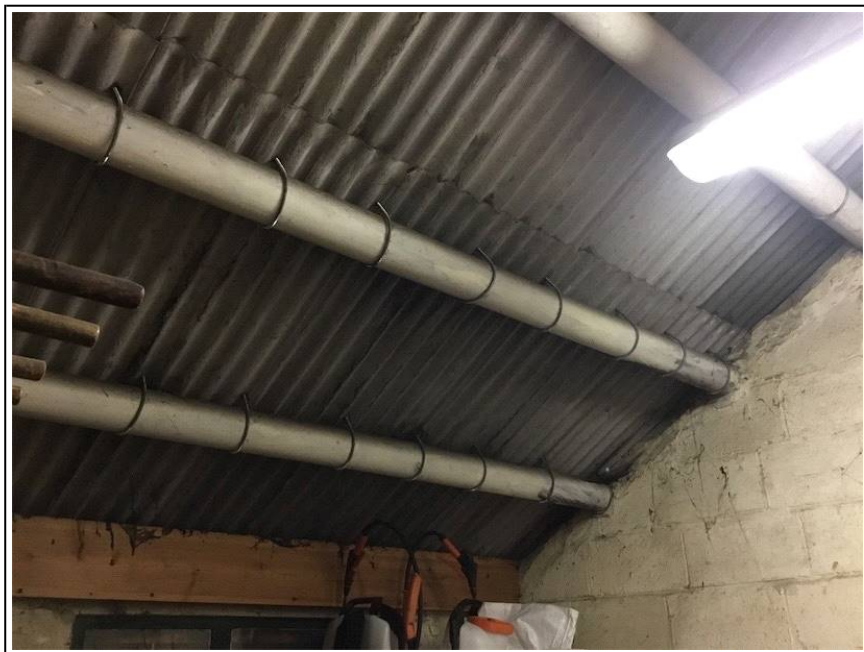
Sample Ref	FI	Location	Description	Qty	Analysis Result	Total M.A.S	Licensed Material Y/N
ENS B07 {AD005874}*	Ground Floor	Store (mess area). 002	Roof supports - Cement surrounds - Cement	18lm	Chrysotile	3	N

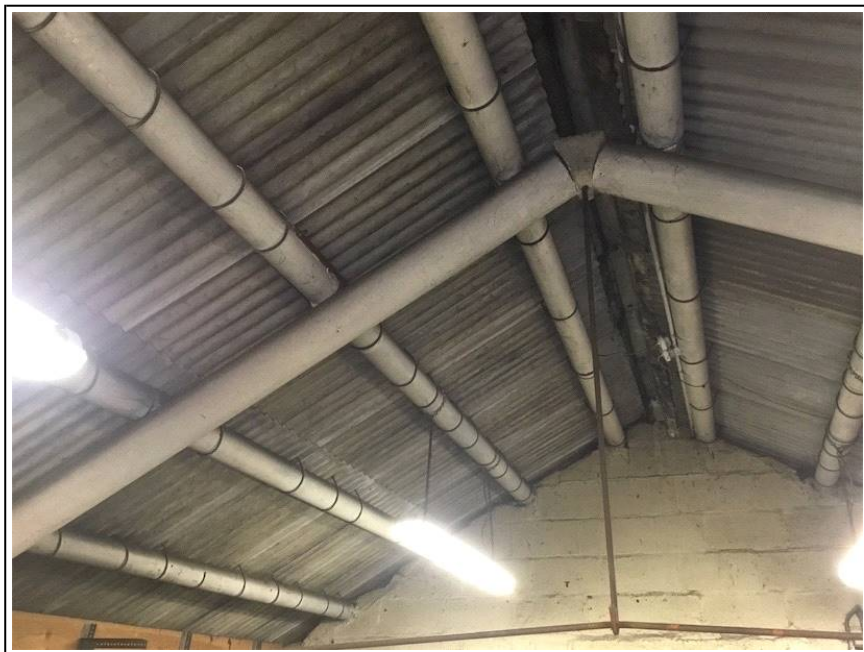
Sample Ref	Fl	Location	Description	Qty	Analysis Result	Total M.A.S	Licensed Material Y/N
REFER (ENS B07 {AD005874}*)	Ground Floor	Garage (mess area). 003	Roof supports - Cement surrounds - Cement	56lm	Chrysotile	3	N

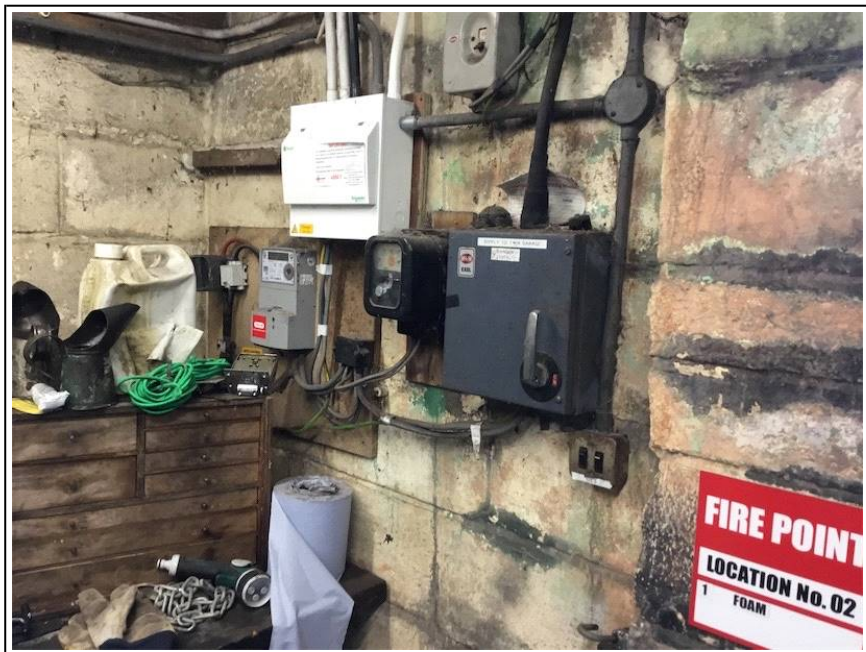
Sample Ref	FI	Location	Description	Qty	Analysis Result	Total M.A.S	Licensed Material Y/N
Presumed	Ground Floor	Garage (mess area). 003	Within MEM switchgear - Presumed textiles - Asbestos Textiles/Paper	<1m ²	Chrysotile	5	N

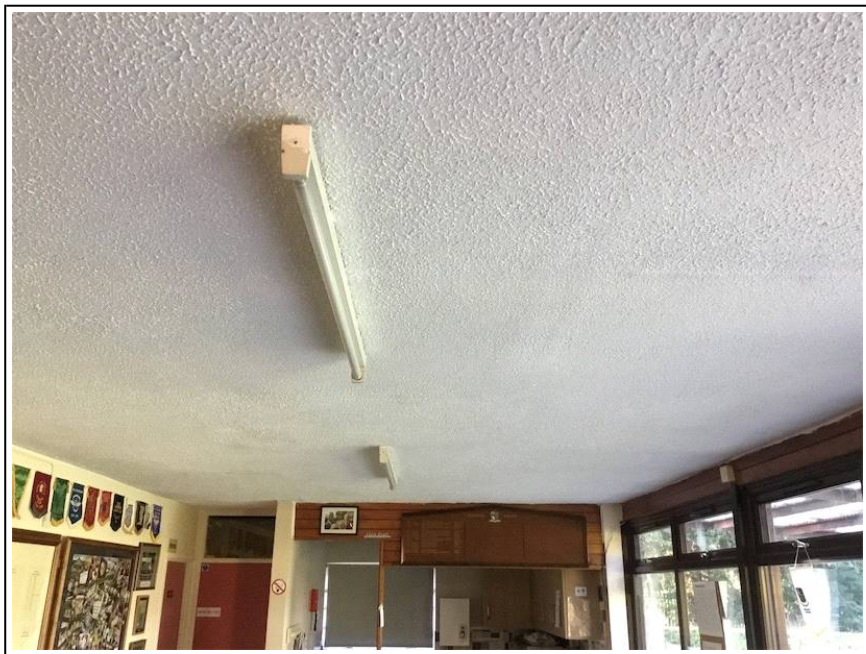
Sample Ref	FI	Location	Description	Qty	Analysis Result	Total M.A.S	Licensed Material Y/N
ENS B11 {AD005878}*	Ground Floor	Club Room (bowls pavillion). 006	Ceiling - Decorative coating - Textured Coating	30m ²	Chrysotile	3	N

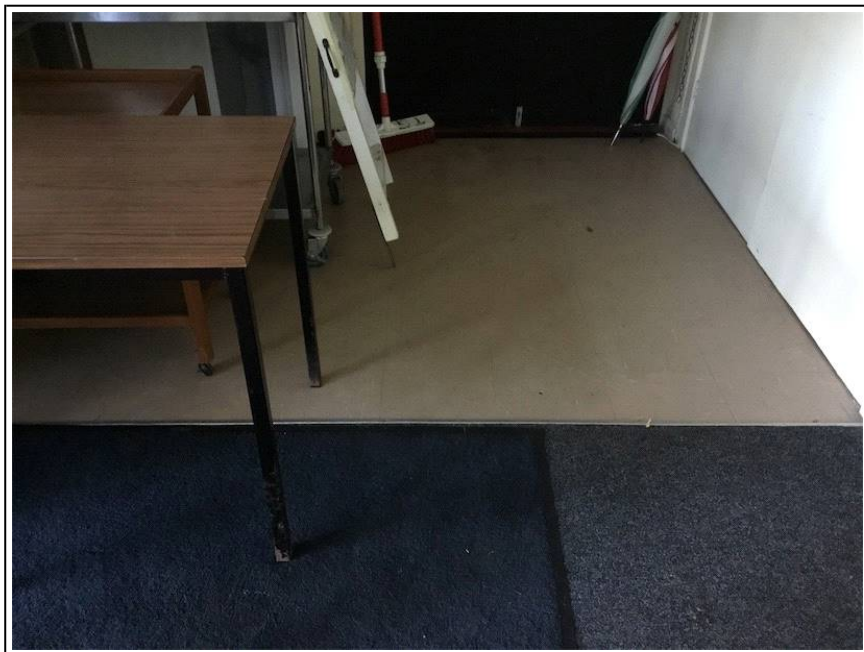
Sample Ref	Fl	Location	Description	Qty	Analysis Result	Total M.A.S	Licensed Material Y/N
AD005879*	Ground Floor	Club Room (bowls pavillion). 006	Part of floor - Vinyl floor tile and adhesive - Well Bound Material	6m ²	Chrysotile in bitumen	2	N

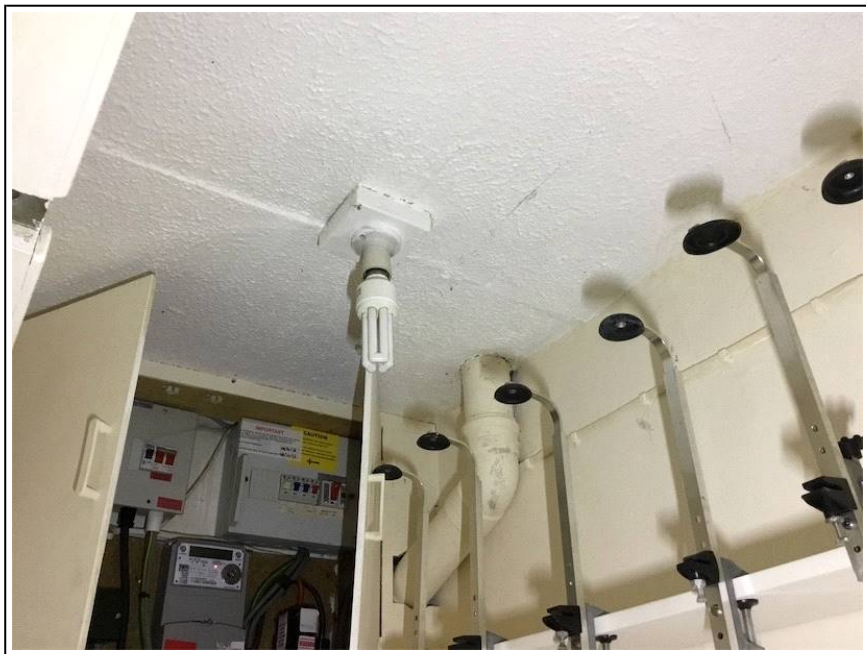
Sample Ref	FI	Location	Description	Qty	Analysis Result	Total M.A.S	Licensed Material Y/N
REFER (ENS B11 {AD005878}*)	Ground Floor	Store (bowls pavillion). 007	Ceiling - Decorative coating - Textured Coating	2m ²	Chrysotile	2	N

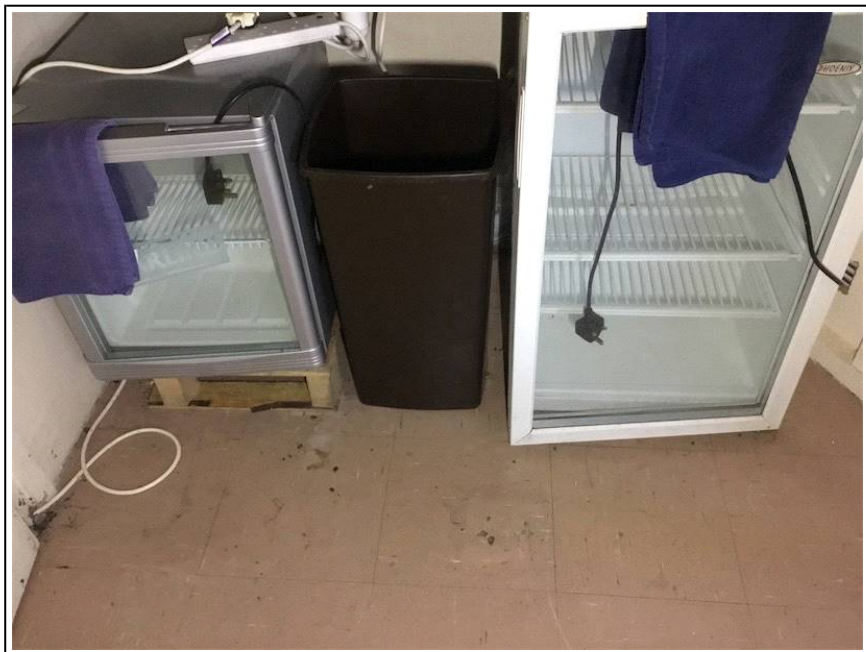
Sample Ref	Fl	Location	Description	Qty	Analysis Result	Total M.A.S	Licensed Material Y/N
REFER (AD005879*)	Ground Floor	Store (bowls pavillion). 007	Floor - Vinyl floor tile and adhesive - Well Bound Material	2m ²	Chrysotile	2	N
