Annual Inspection

West Swindon Parish Council

Claypit/Plattes

Annual Inspection - 19 December 2017 at 10:20 Inspector: Leon Pope RPII Annual Inspector

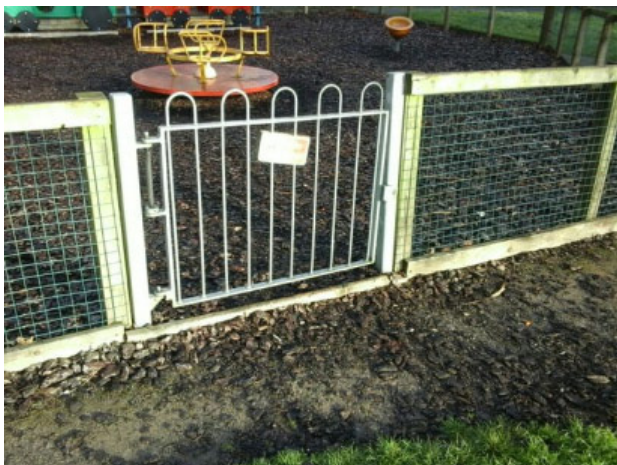
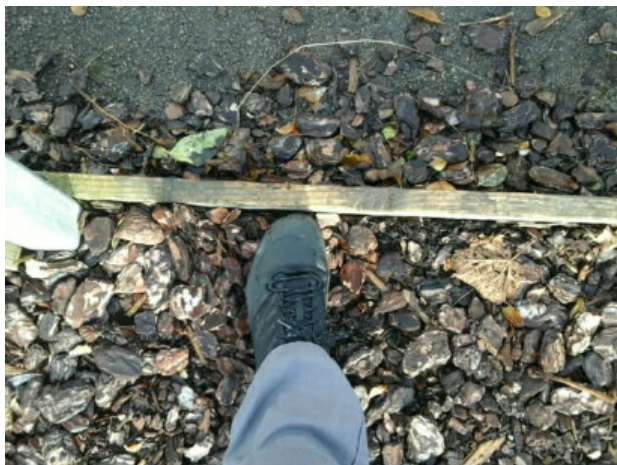
Finding:	There are trip hazards at the entrance / exit to the play area		Action: Reinstate surrounding surfaces to level to remove the trip points

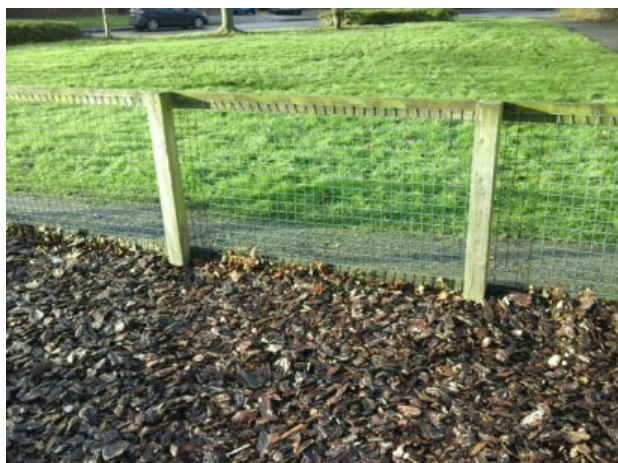
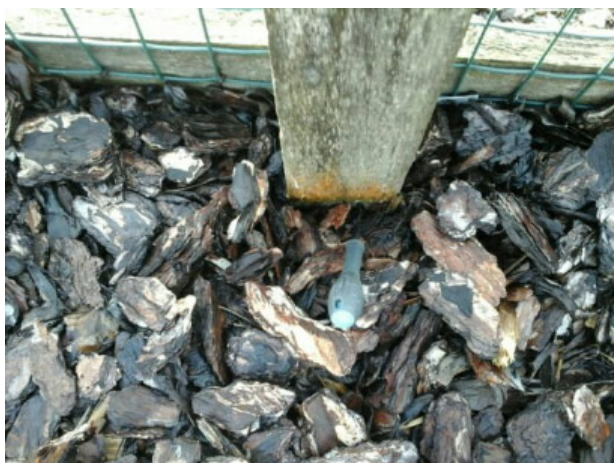
Finding: There are areas or parts of the timber on the structure that have rotted

Action: Replace all affected timbers

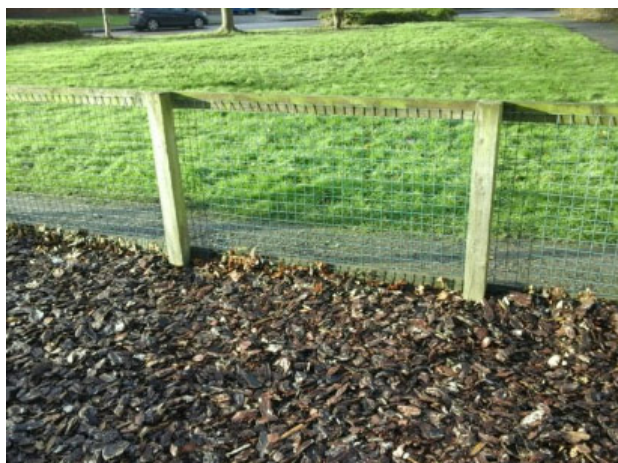
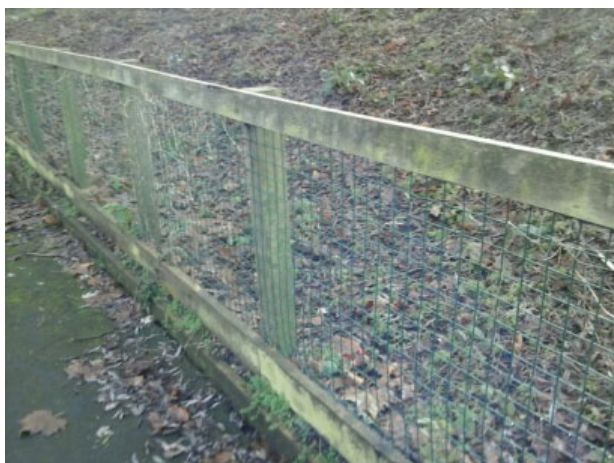
Finding: There are a number of loose posts around the fence

Action: Monitor for any further deterioration and reset as required

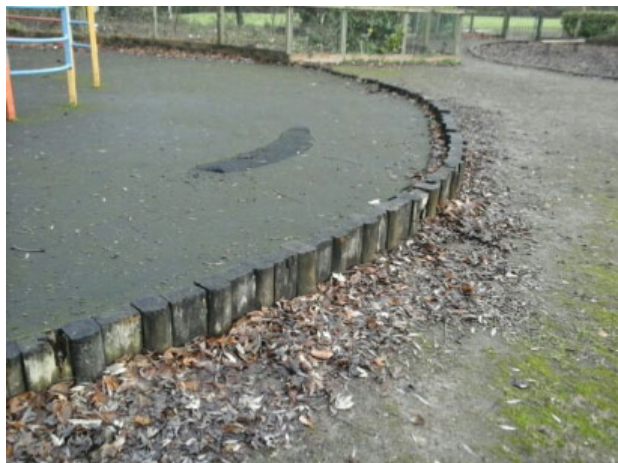
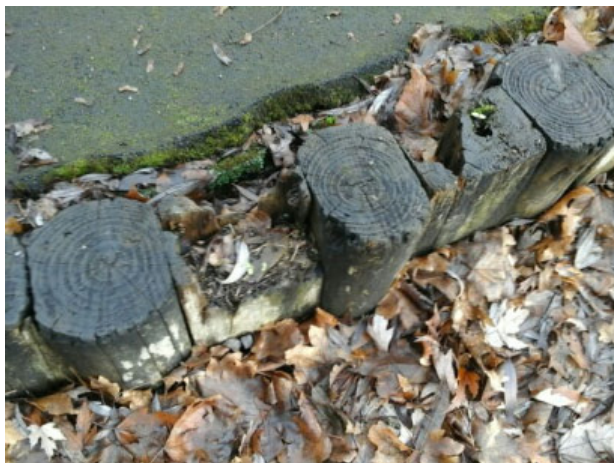
Finding: There are areas or parts of the timber on the structure that have rotted

Action: Replace all affected timbers

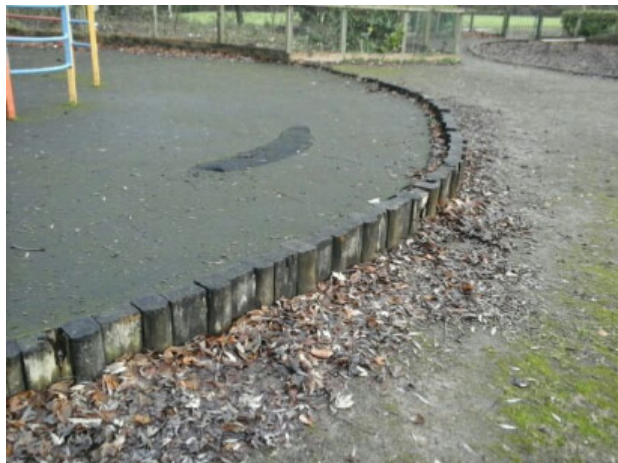
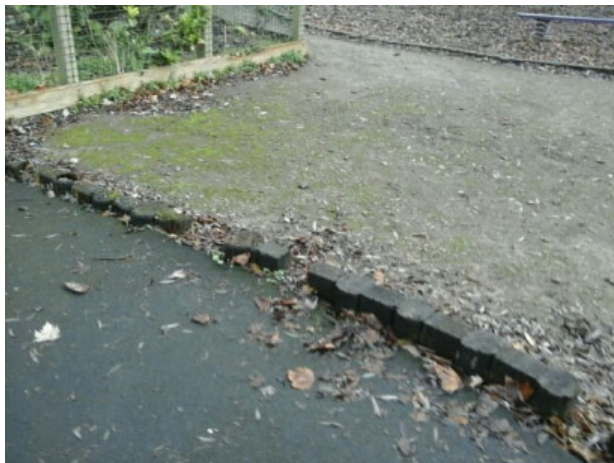
Finding: There are missing posts

Action: Replace as required

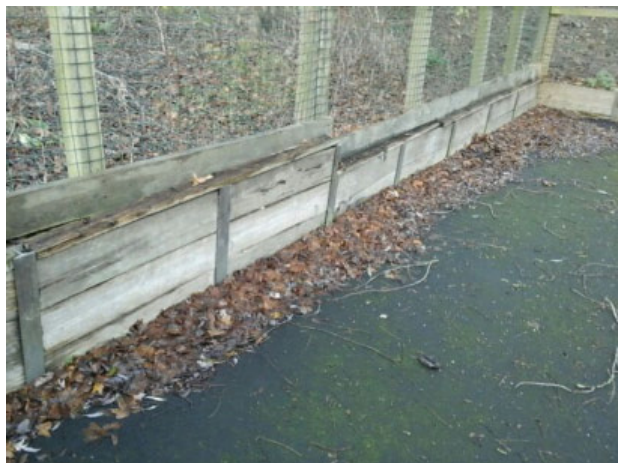
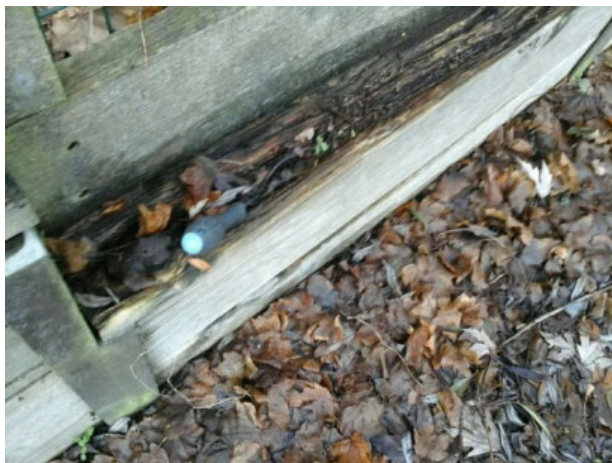
Finding: There are areas or parts of the timber on the structure that have rotted

Action: Replace all affected timbers

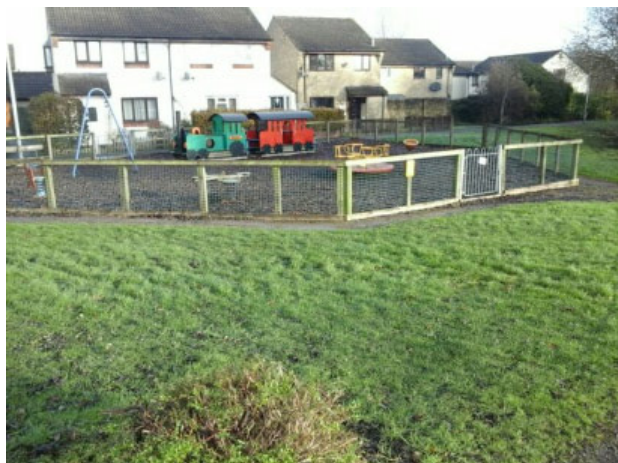
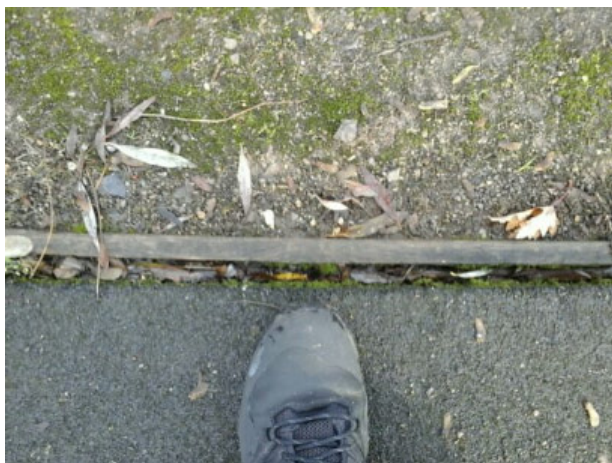
Finding: There are gaps opening between the wet pour surfacing and the edging surround or between the joints in the surfacing

Action: Monitor for any further deterioration and repair as required

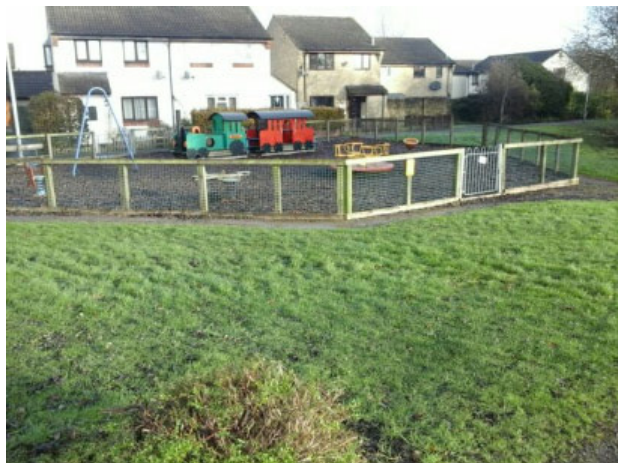
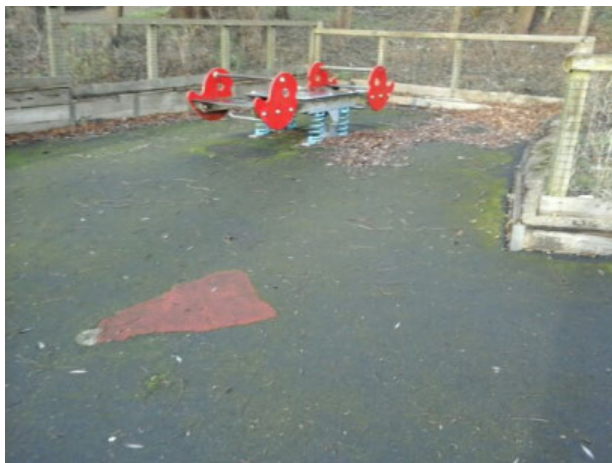
Finding: There is algae or moss growth on the wet pour surfacing resulting in slippery conditions

Action: Clean and treat appropriately

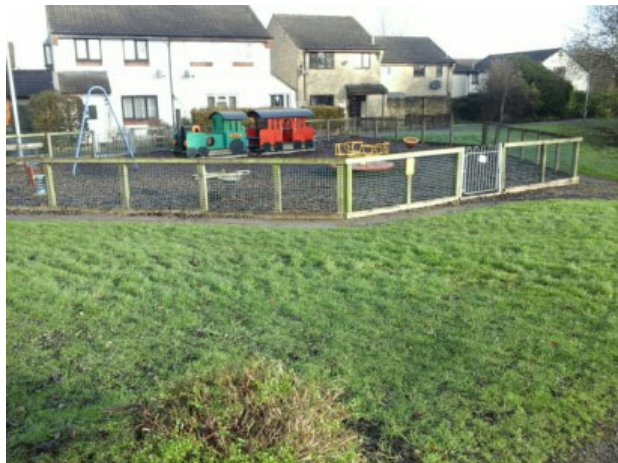
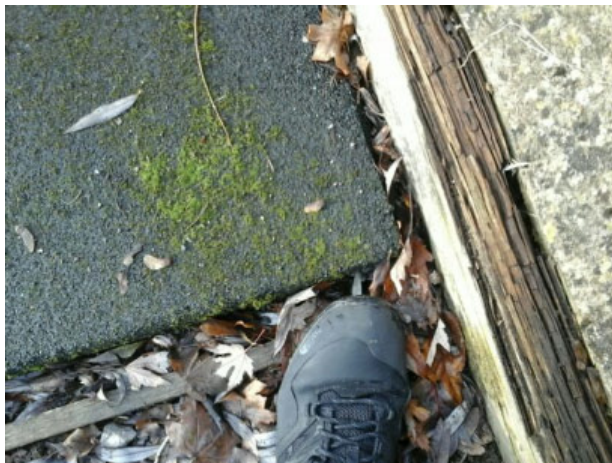
Finding: The wet pour surfacing is lifting at the edges and creating trip points

Action: Repair perimeter of surfacing to remove trip points

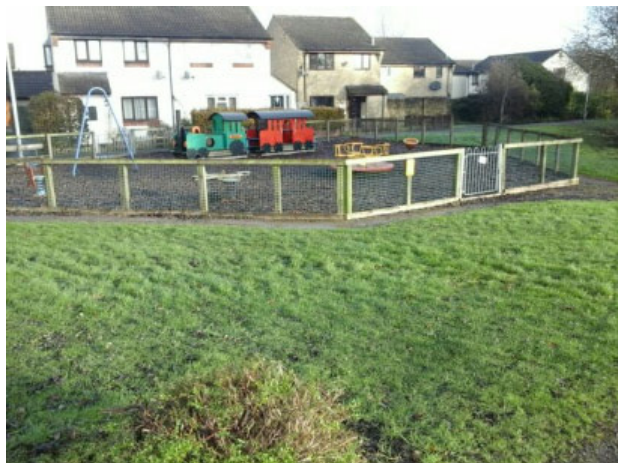
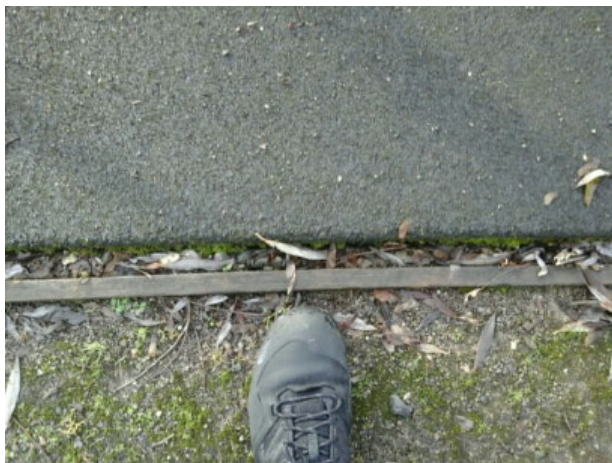
Finding: There are trip hazards at the edges of the wet pour surfacing
Action: Reinstate surrounding surface levels to remove the trip points

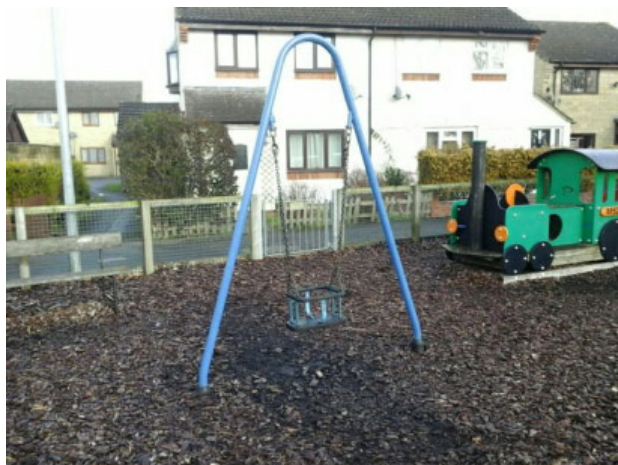
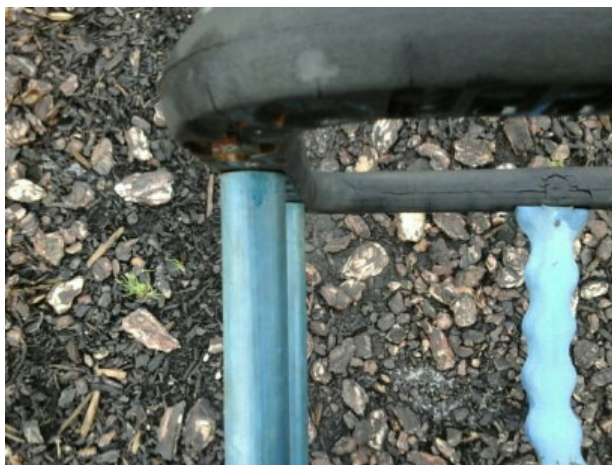
Finding: There are caps missing from the underside of the seats

Action: Replace missing caps under the seats

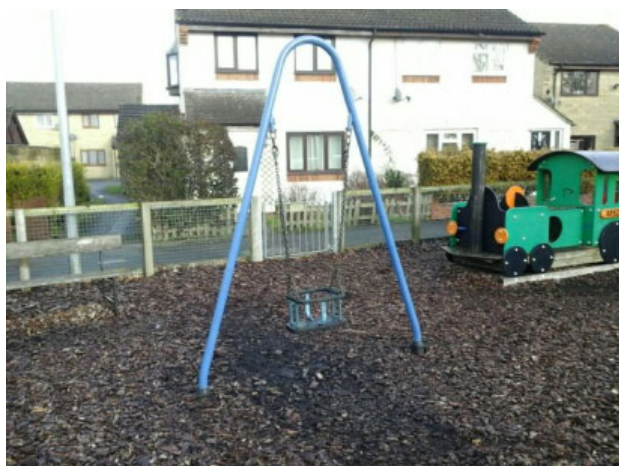
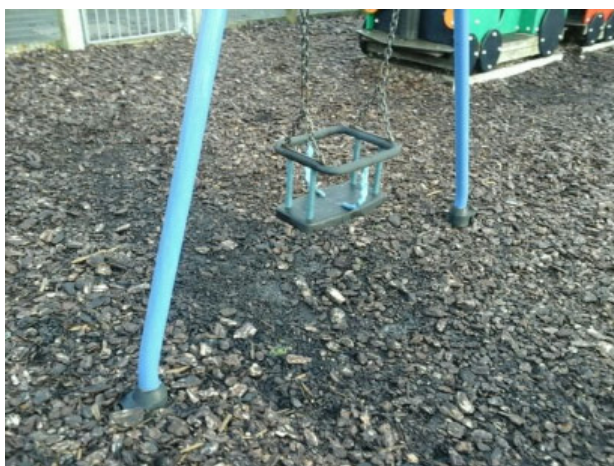
Finding: The item is slightly loose in its foundations

Action: Monitor for any further deterioration and repair as required

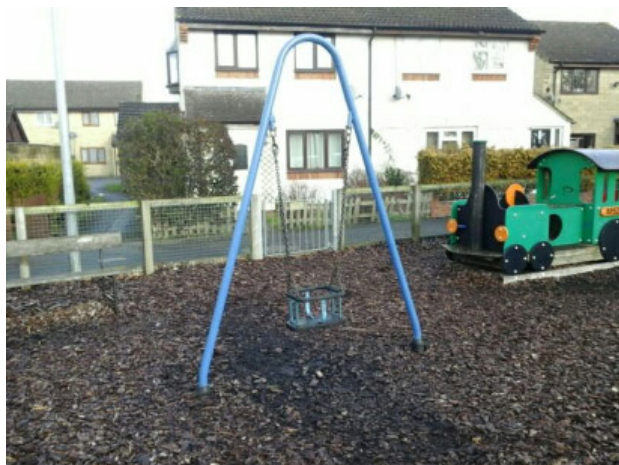
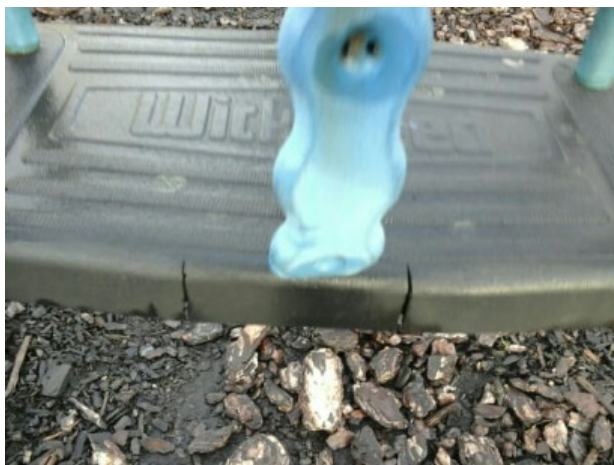
Finding: The seat has minor damage or wear

Action: Monitor for any further deterioration and replace as required

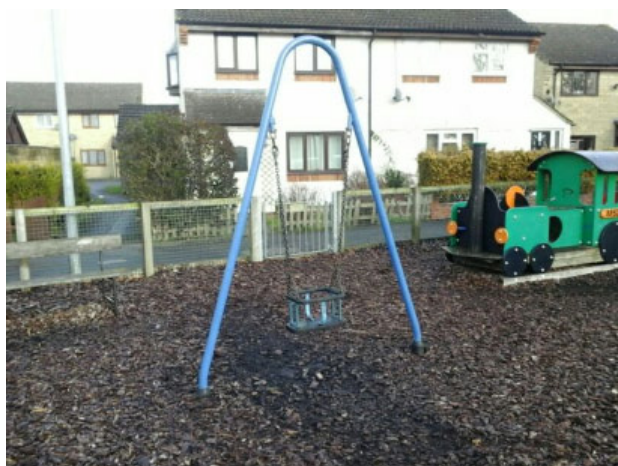
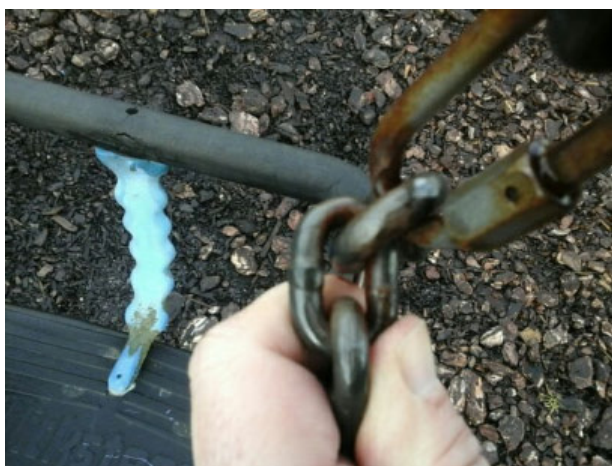
Finding: There is some notable evidence of chain wear

Action: Monitor for any further deterioration and replace when 40% worn

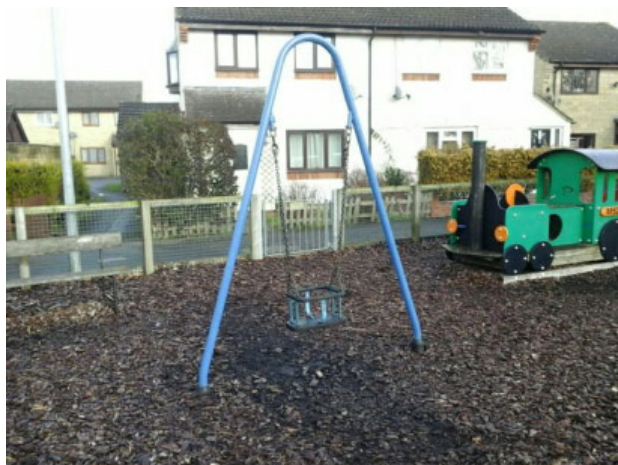
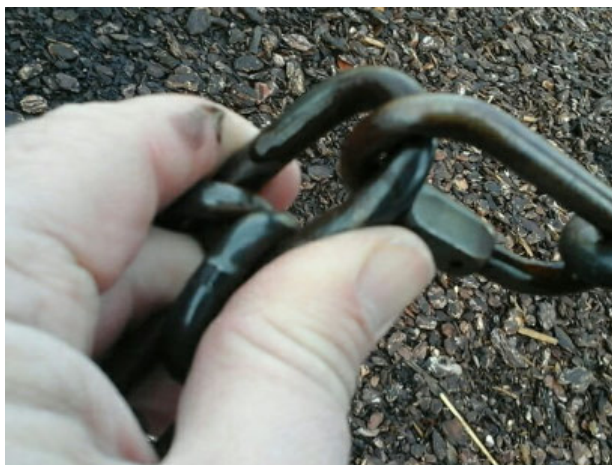
Finding: There is some wear to the connecting links

Action: Monitor for any further deterioration and replace when 40% worn

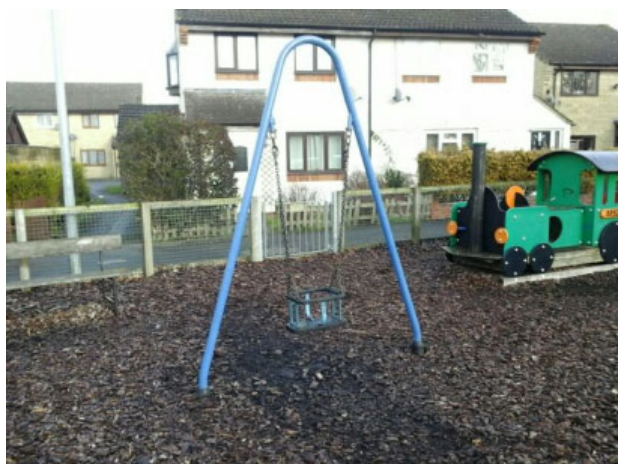
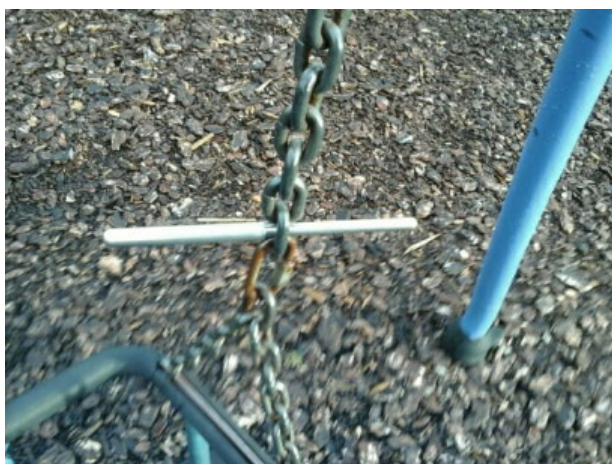
Finding: The chain openings are in excess of the 8.6mm as recommended by BS EN 1176

Action: Monitor use and replace with compliant chains during next maintenance cycle.

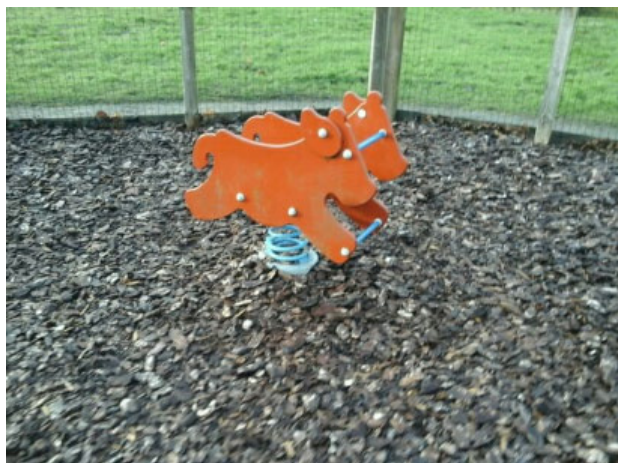
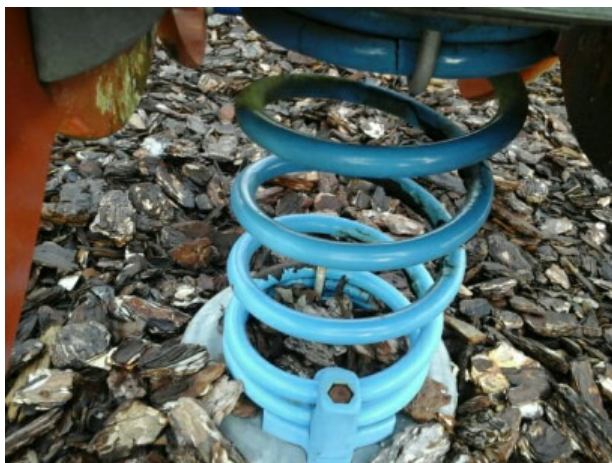
Finding: The paintwork on the spring has been damaged or worn exposing the metal underneath which is rusting

Action: Treat any rusting components and repaint

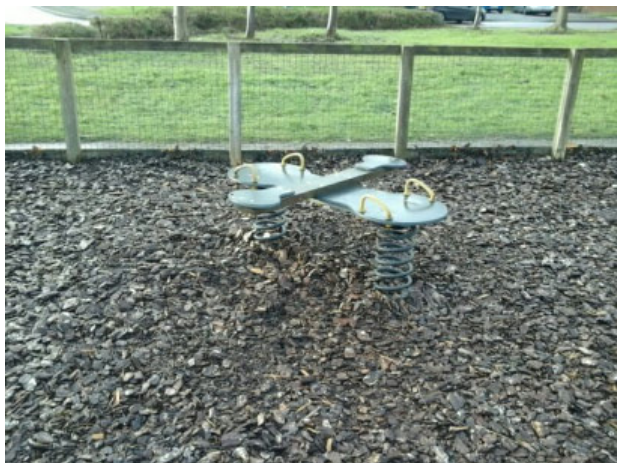
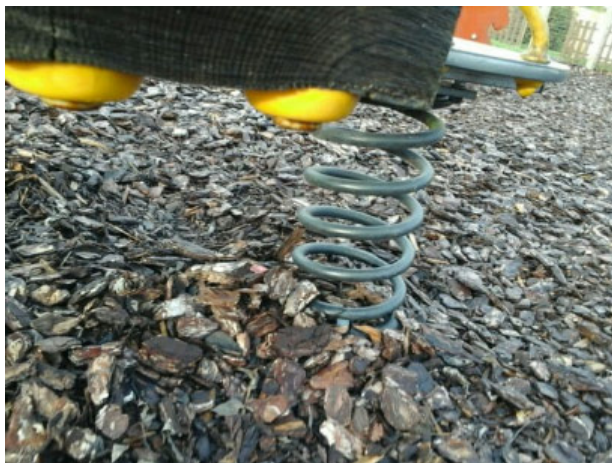
Finding: There is/are bolt cap covers missing or damaged on the item

Action: Replace missing or damaged bolt cap covers

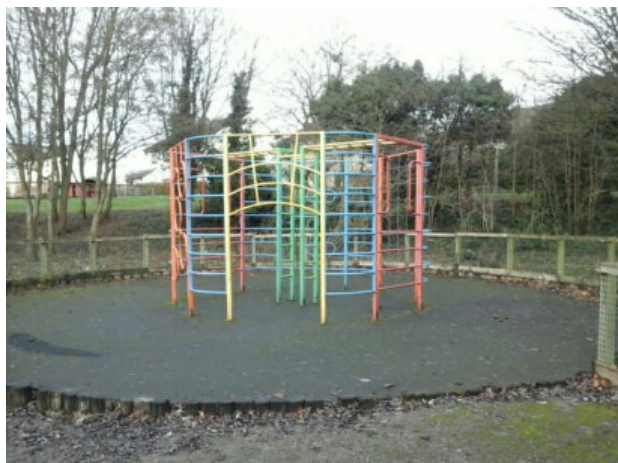
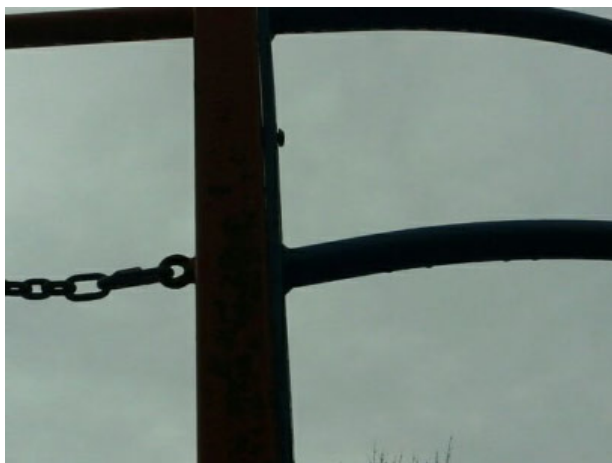
Finding: A number of fixing(s) have worked loose

Action: Secure all loose fixings

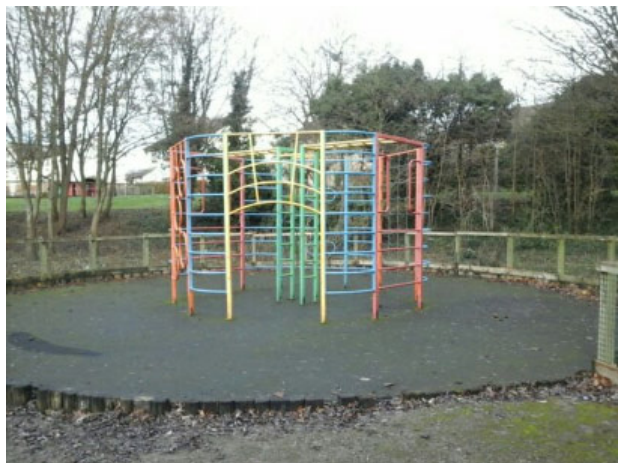
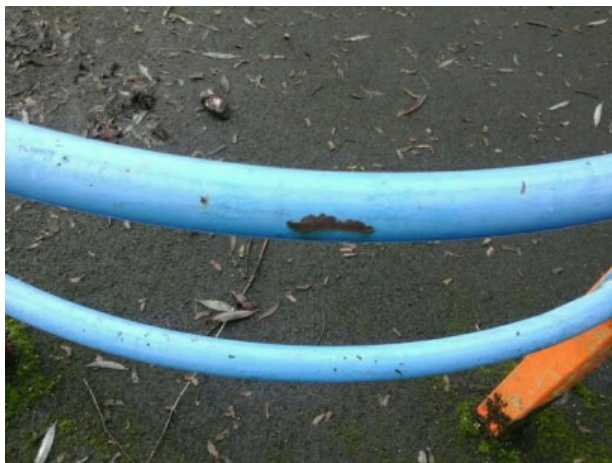
Finding: The paintwork on this item has been damaged or worn exposing the metal underneath which is rusting

Action: Treat any rusting components and repaint

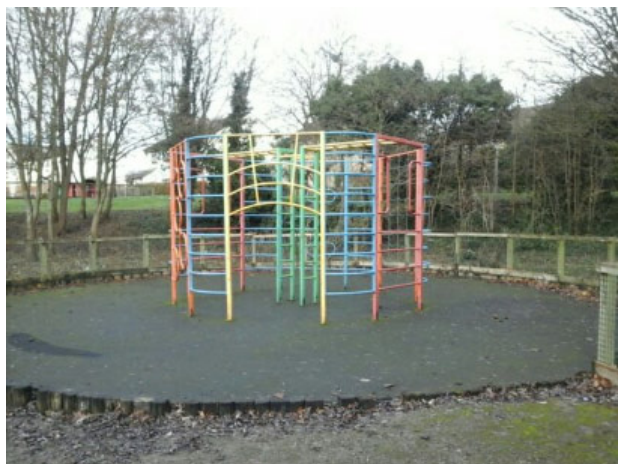
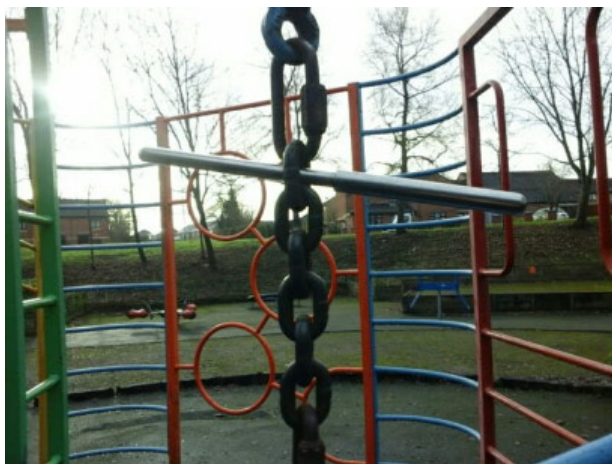
Finding: The chain openings are in excess of the 8.6mm as recommended by BS EN 1176

Action: Monitor use and replace with compliant chains during next maintenance cycle.

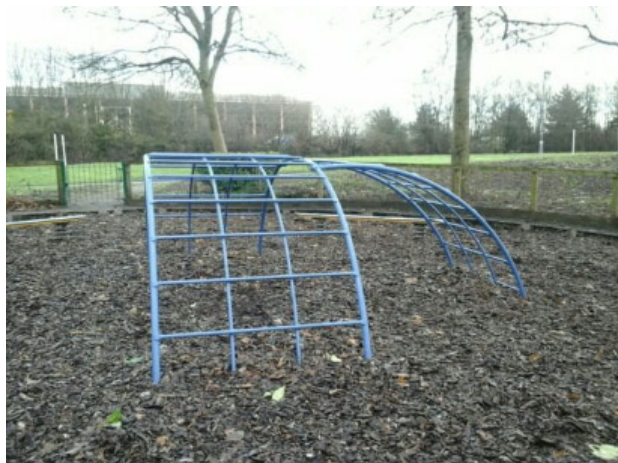
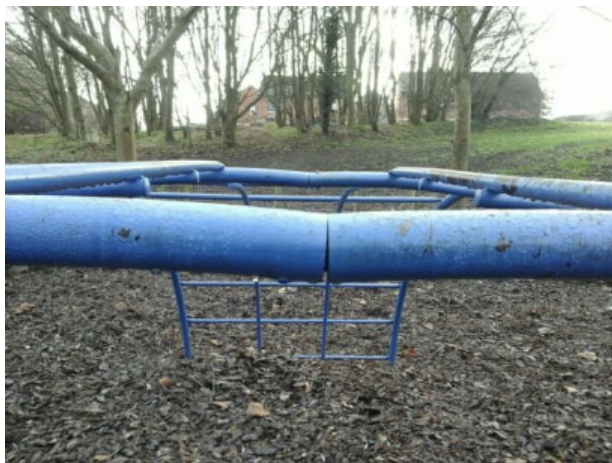
Finding: The framework join is not flush

Action: Monitor for any further deterioration and repair as required

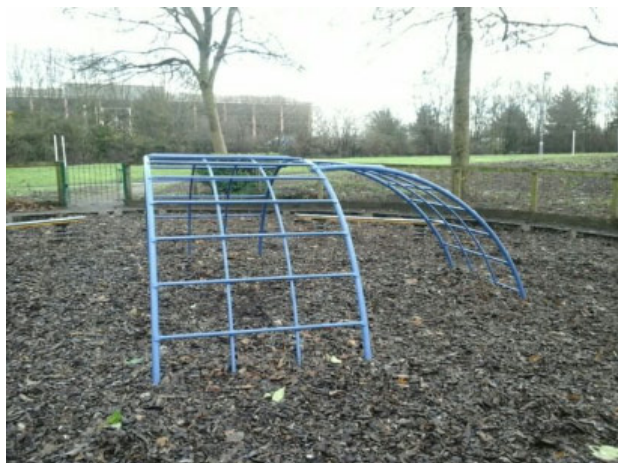
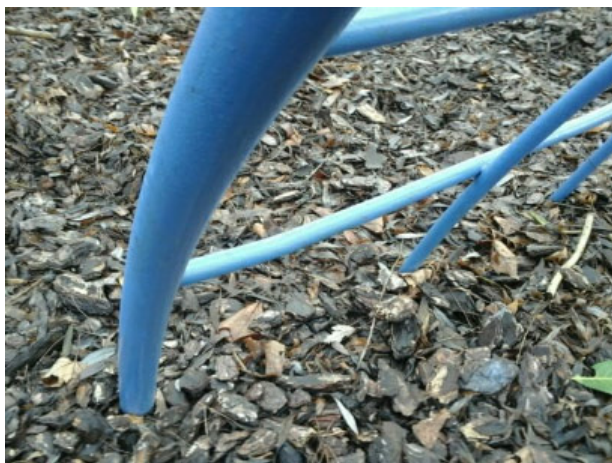
Finding: There is some minor damage to the framework

Action: Monitor for any further deterioration and repair as required

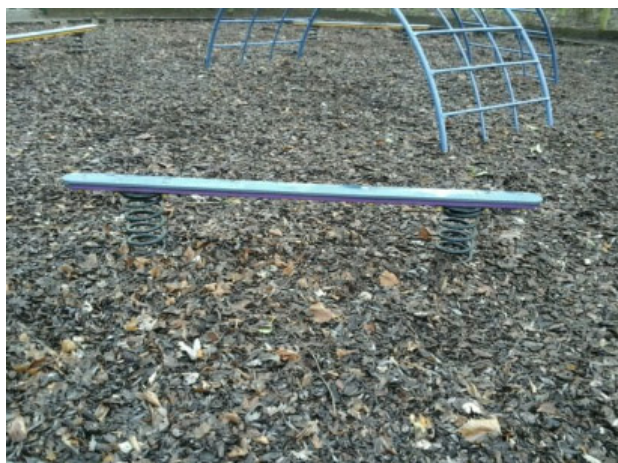
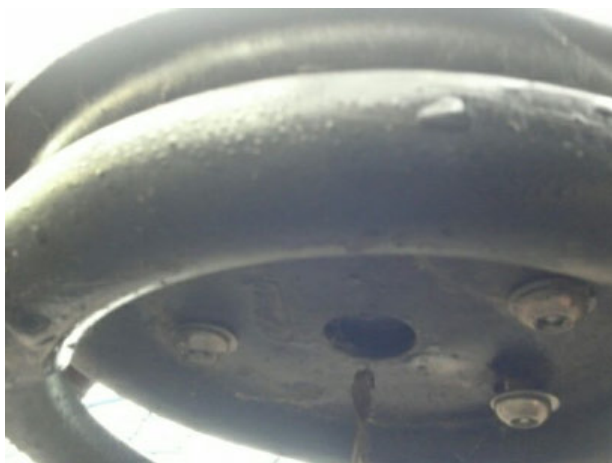
Finding: A number of spring mount fixing(s) have worked loose

Action: Secure all loose fixings

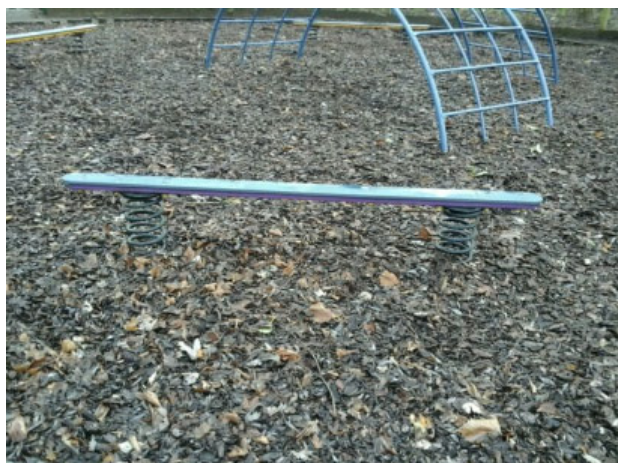
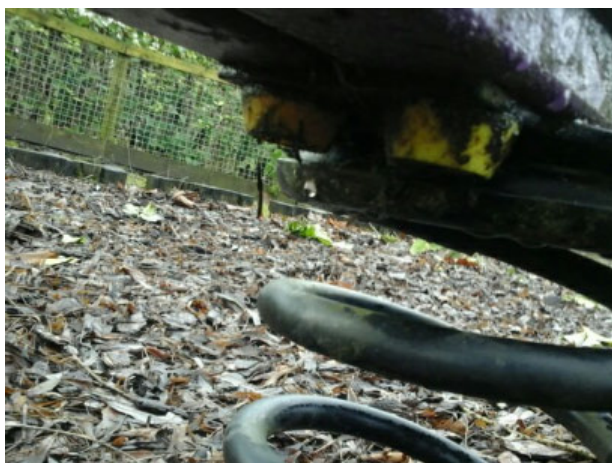
Finding: There is/are bolt cap covers missing or damaged on the item

Action: Replace missing or damaged bolt cap covers

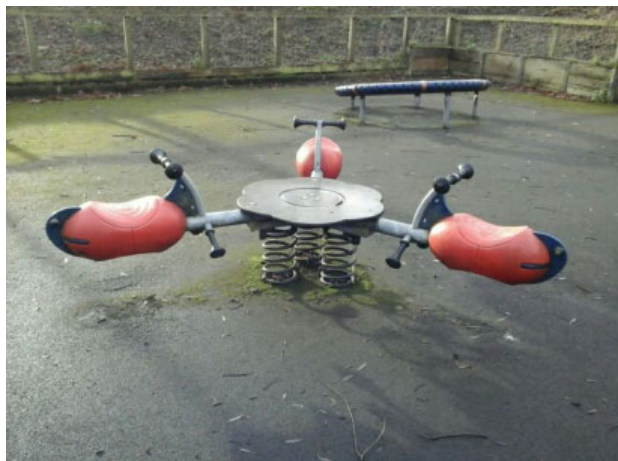
Finding: The paintwork on the spring has been damaged or worn exposing the metal underneath which is rusting

Action: Treat any rusting components and repaint

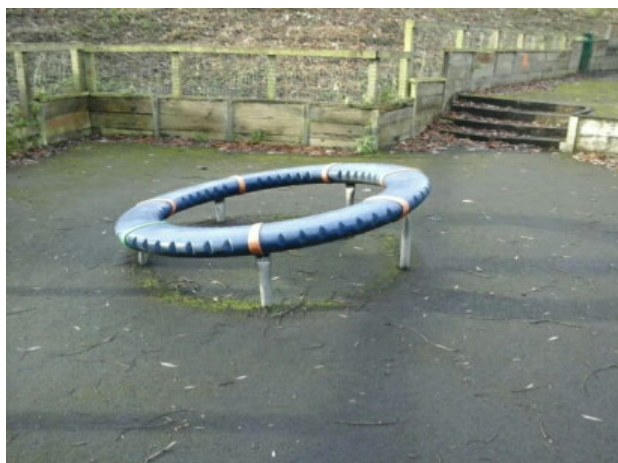
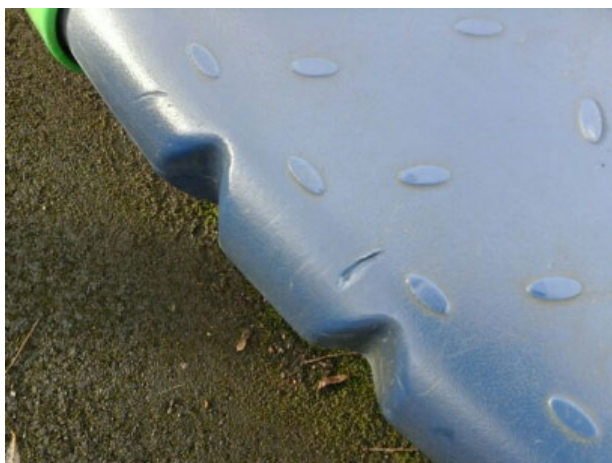
Finding: There is some minor damage to the item

Action: Monitor for any further deterioration and remove any rough or sharp edges

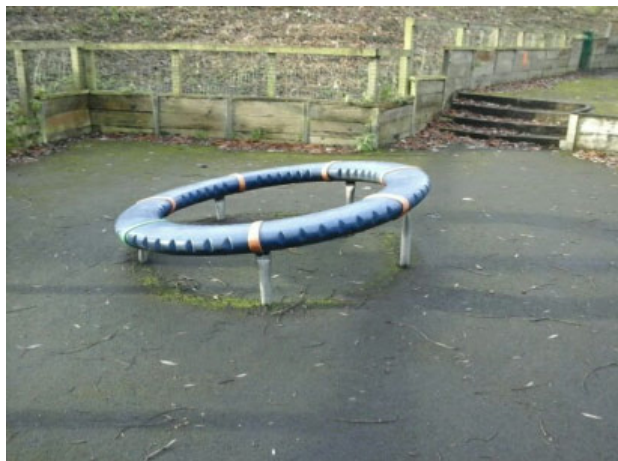
Finding: There is/are bolt cap covers missing or damaged on the item

Action: Replace missing or damaged bolt cap covers

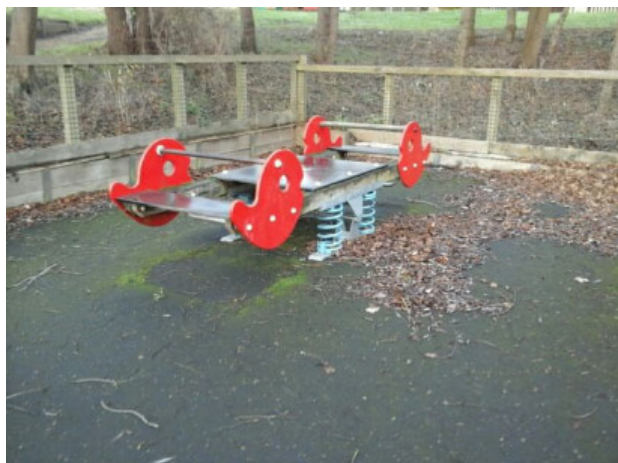
Finding: The paintwork on the spring has been damaged or worn exposing the metal underneath which is rusting

Action: Treat any rusting components and repaint

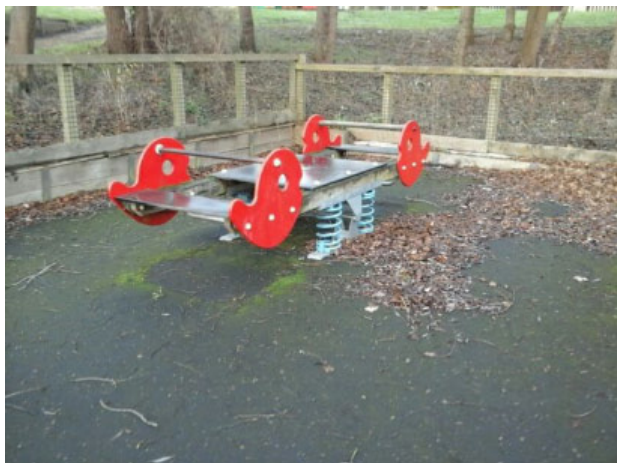
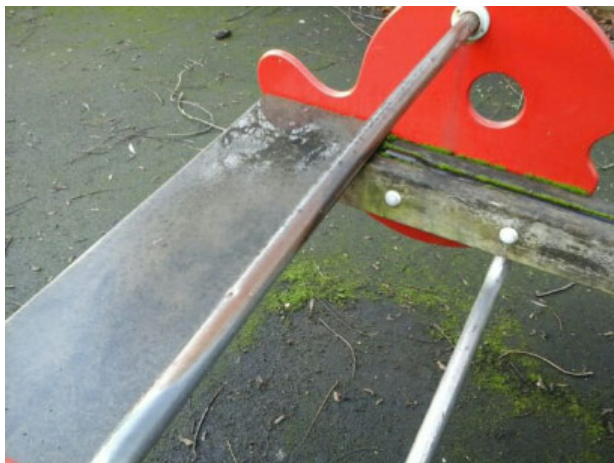
Finding: The paintwork on this item has been damaged or worn exposing the metal underneath which is rusting

Action: Treat any rusting components and repaint

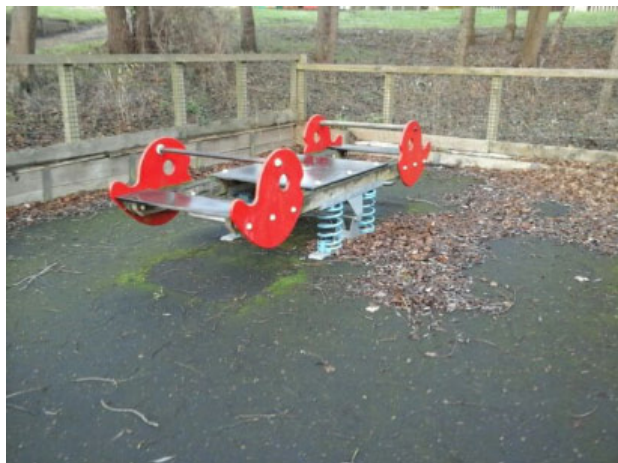
Finding: A number of fixing(s) have worked loose and the handgrip is not secured

Action: Secure all loose fixings

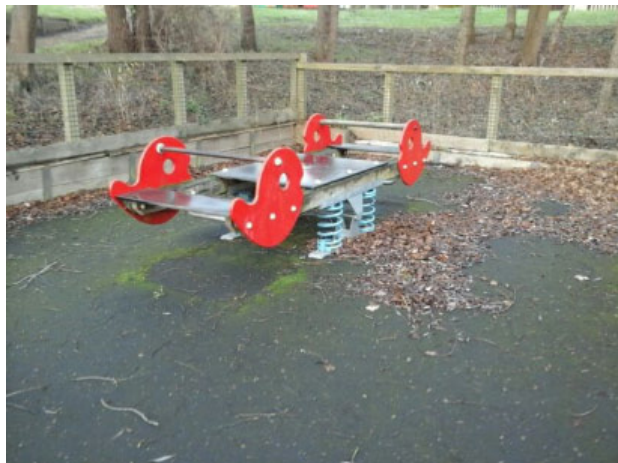
Finding: The spring mounting plates are slightly loose in the ground

Action: Monitor for any further deterioration and repair as required

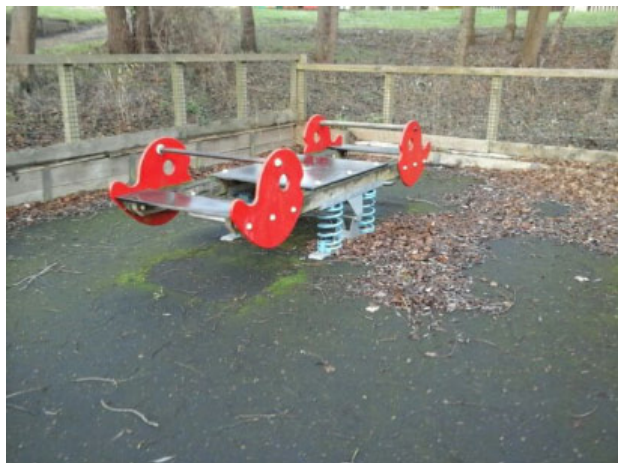
Finding: The safety surface under or around this unit has been damaged

Action: Monitor for any further deterioration and repair as required
