> Project: Lymm Village Hall
> Client: Lymm Parish Council Address: 5 Pepper Street, Lymm, WA13 0JB Title: Main Hall Roof- Proposed External Roof Works-Rear Elevation (North Facing) Sketch Number: 19-8550-13

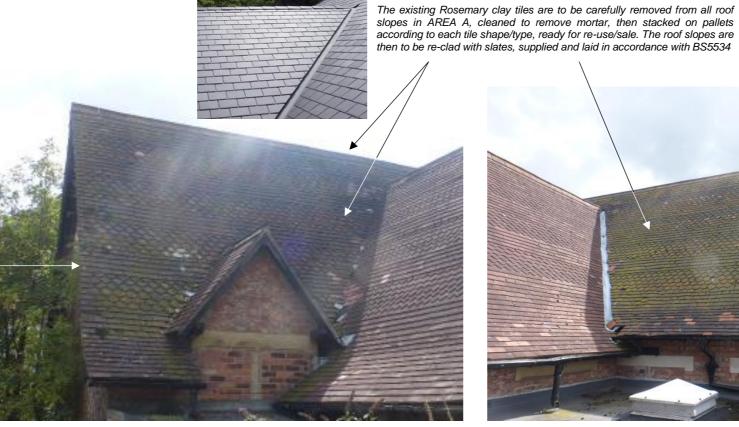
Main rear roof slope and dormer at East end of building showing patch repairs

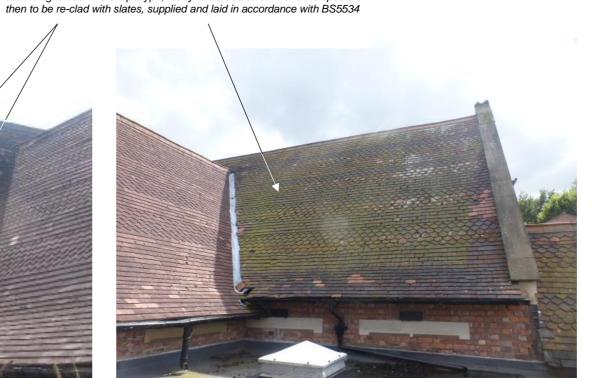
Main rear roof slope at West end of building, showing patch repairs & slipped tiles

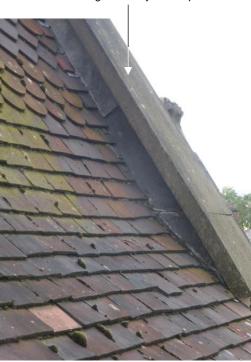
Parapet wall at West end of building

Existing stone coping blocks are to be removed to allow lead flashings to be replaced.

The copings are to be replaced using stainless steel restraint angles in the joints as per SE detail

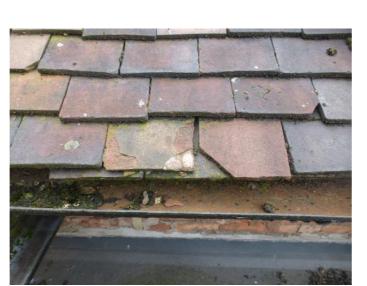
Cast iron gutter and broken and spalling roof tiles

Gutters are to be cleaned out and all support bracket fixings are to be checked and repaired as necessary. Provide and fit matching brackets as required, to re-align the gutter

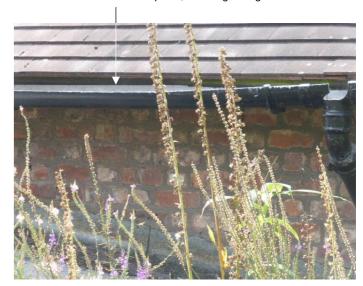
Deflected gutter above main flat roof area
