CBC Asbestos Management Survey Report Pytchley Court - Canopy, Corby 12th March 2019

CBC Asbestos Management Survey Report Pytchley Court, Corby 12th March 2019

Pytchley Court - Canopy, Corby

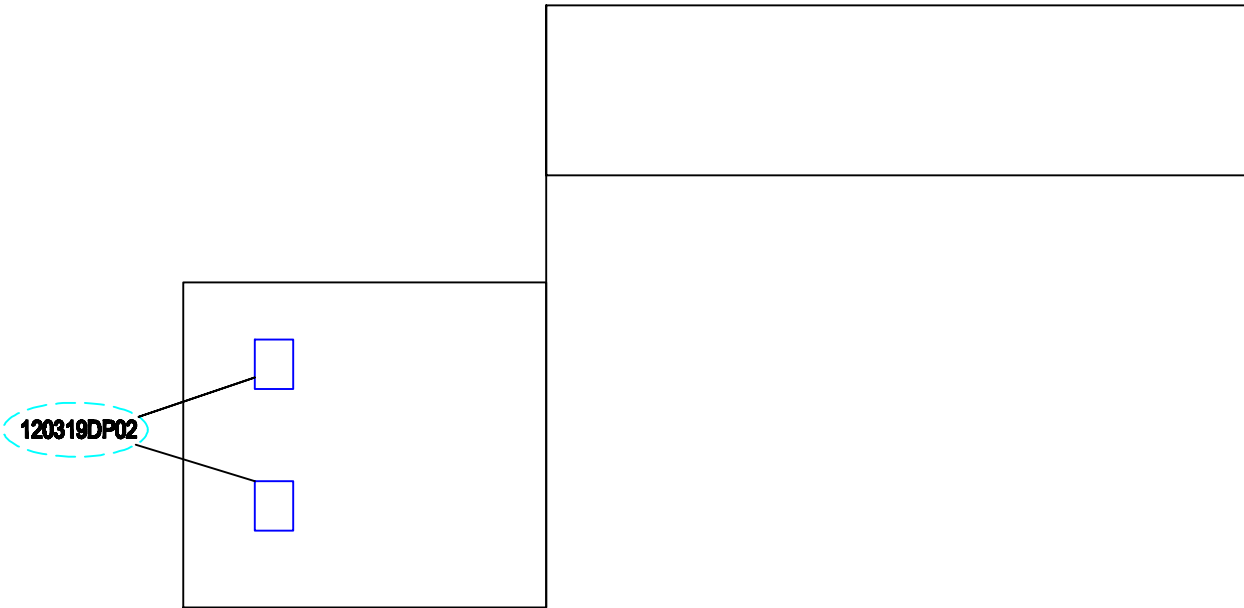
Textured coating to columns (Render)
