## DEMOLITION SURVEY REPORT

**Changing Rooms  
Shotton Parish Community Park  
Station Road  
Shotton Colliery  
DH6 2JL**

*Report Number: 2023/03/23/14291*

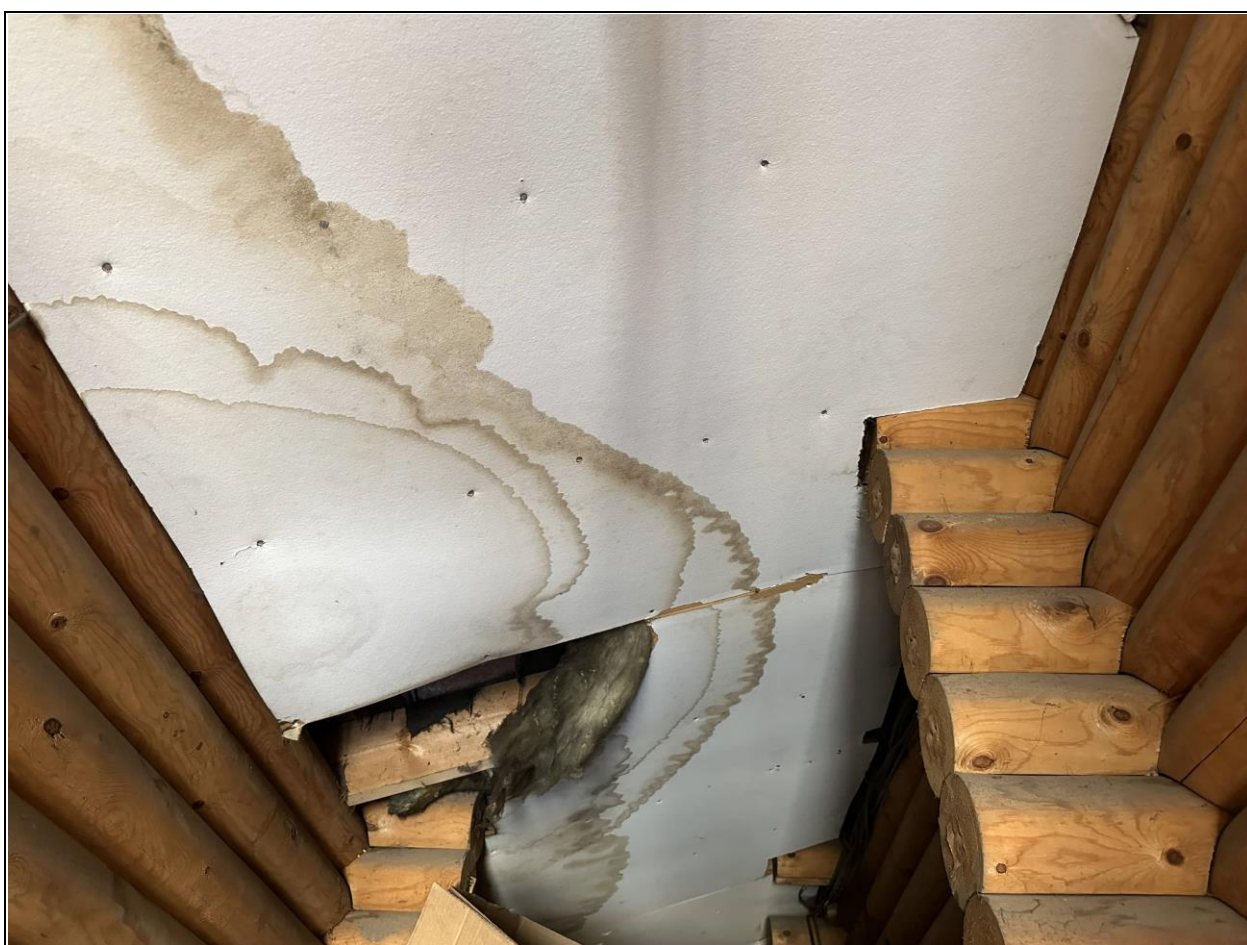
| <b>Sample Ref:</b> | SC/001 | |

| <b>Area:</b> | G/001/Room | |
| <b>Element:</b> | Ceiling | |
| <b>Sample description:</b> | Paper to fibreboard ceiling | |
| <b>Asbestos Type:</b> | No asbestiforms detected | -- |

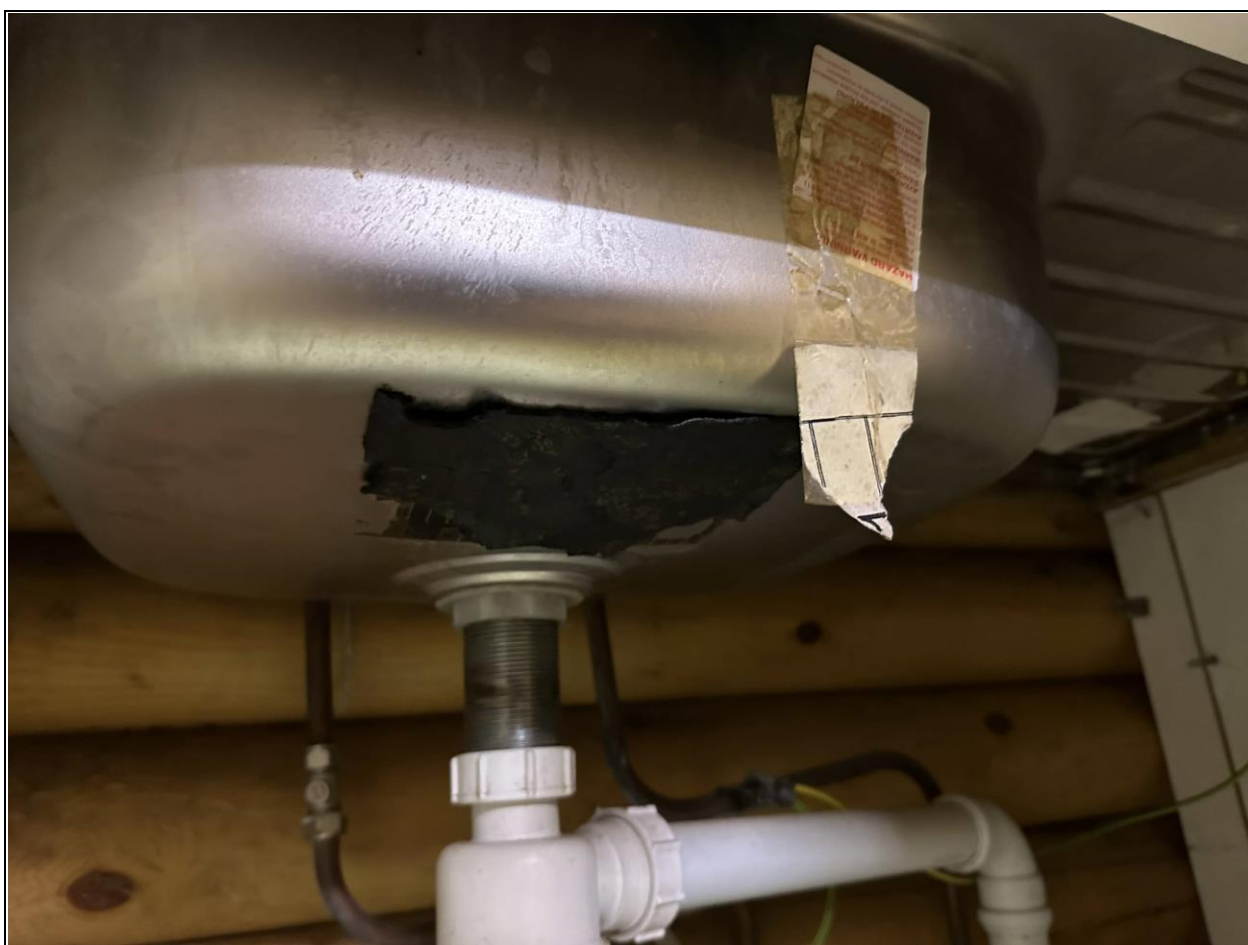
| <b>Sample Ref:</b> | SC/002 | |

| <b>Area:</b> | G/004/Room | |
| <b>Element:</b> | Sink | |
| <b>Sample description:</b> | Acoustic pad under sink | |
| <b>Asbestos Type:</b> | No asbestiforms detected | -- |

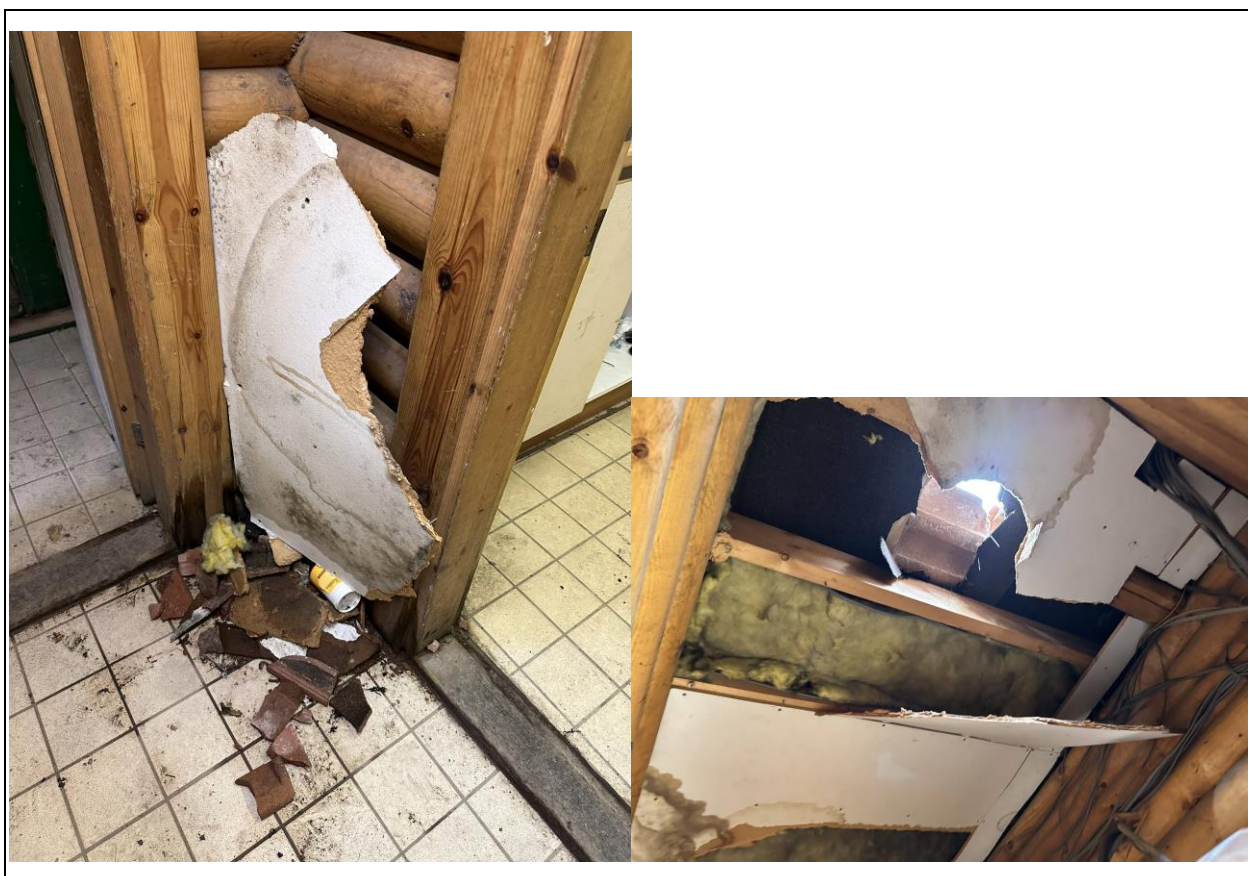
| <b>Sample Ref:</b> | As SC/001 | |

| <b>Area:</b> | G/007/Room | |
| <b>Element:</b> | Debris | |
| <b>Sample description:</b> | Paper to fibreboard & debris to floor | |
| <b>Asbestos Type:</b> | No asbestiforms detected | -- |

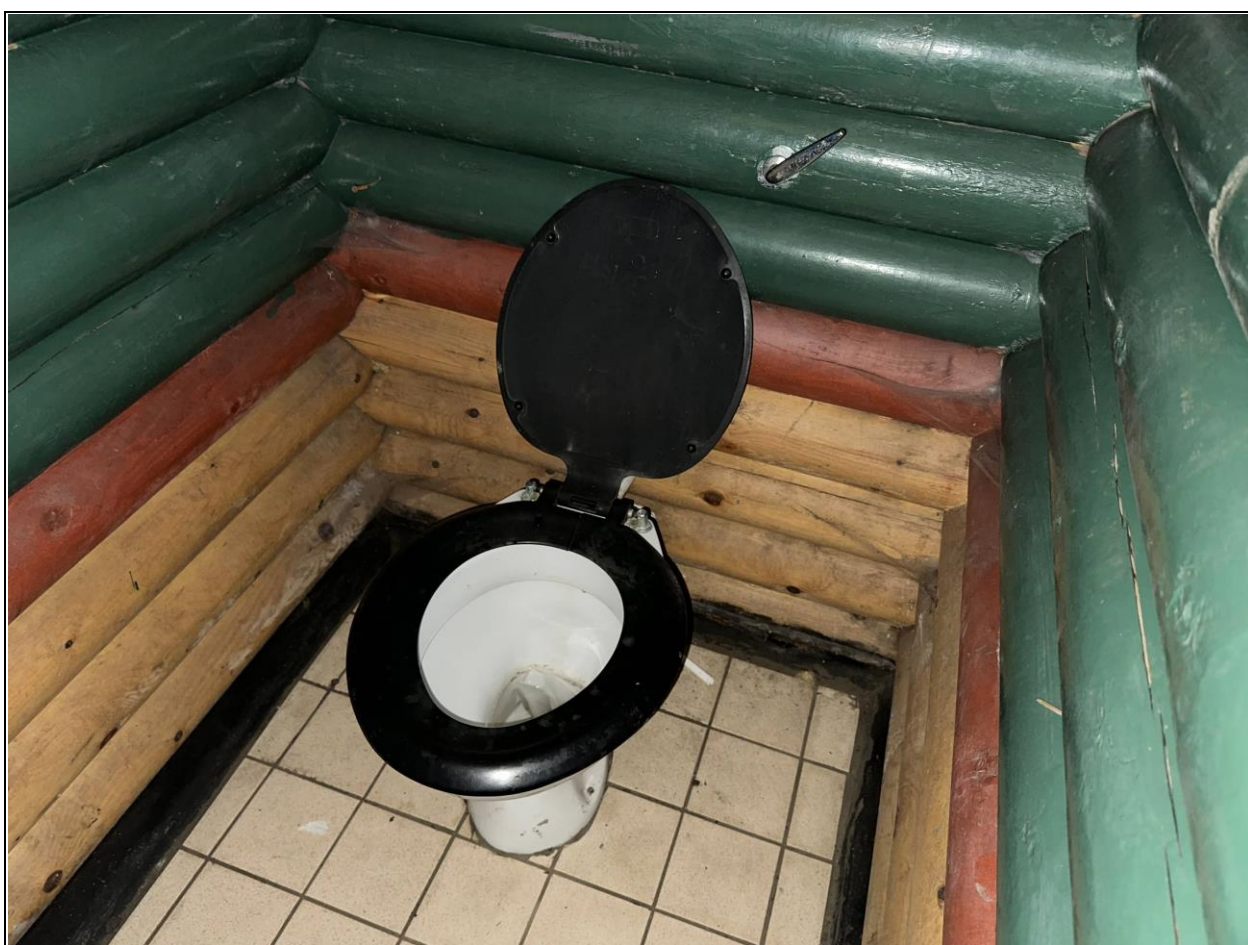
| <b>Sample Ref:</b> | SC/003 | |

| <b>Area:</b> | G/010/Room | |
| <b>Element:</b> | Toilet | |
| <b>Sample description:</b> | Composite toilet seats | |
| <b>Asbestos Type:</b> | No asbestiforms detected | -- |

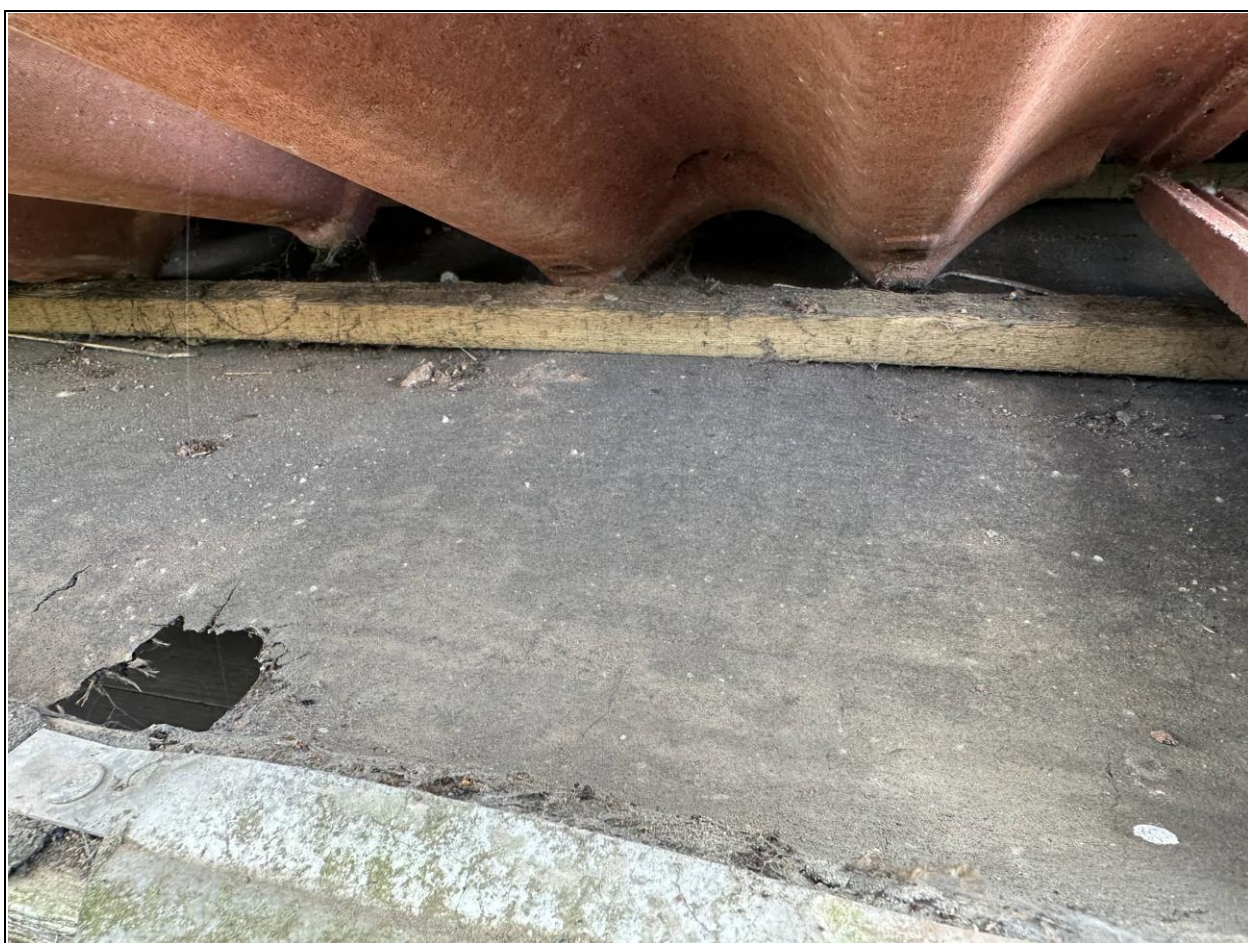
| <b>Sample Ref:</b> | SC/004 | |

| <b>Area:</b> | External | |
| <b>Element:</b> | Roof | |
| <b>Sample description:</b> | Felt sarking to underside of roof | |
| <b>Asbestos Type:</b> | No asbestiforms detected | -- |

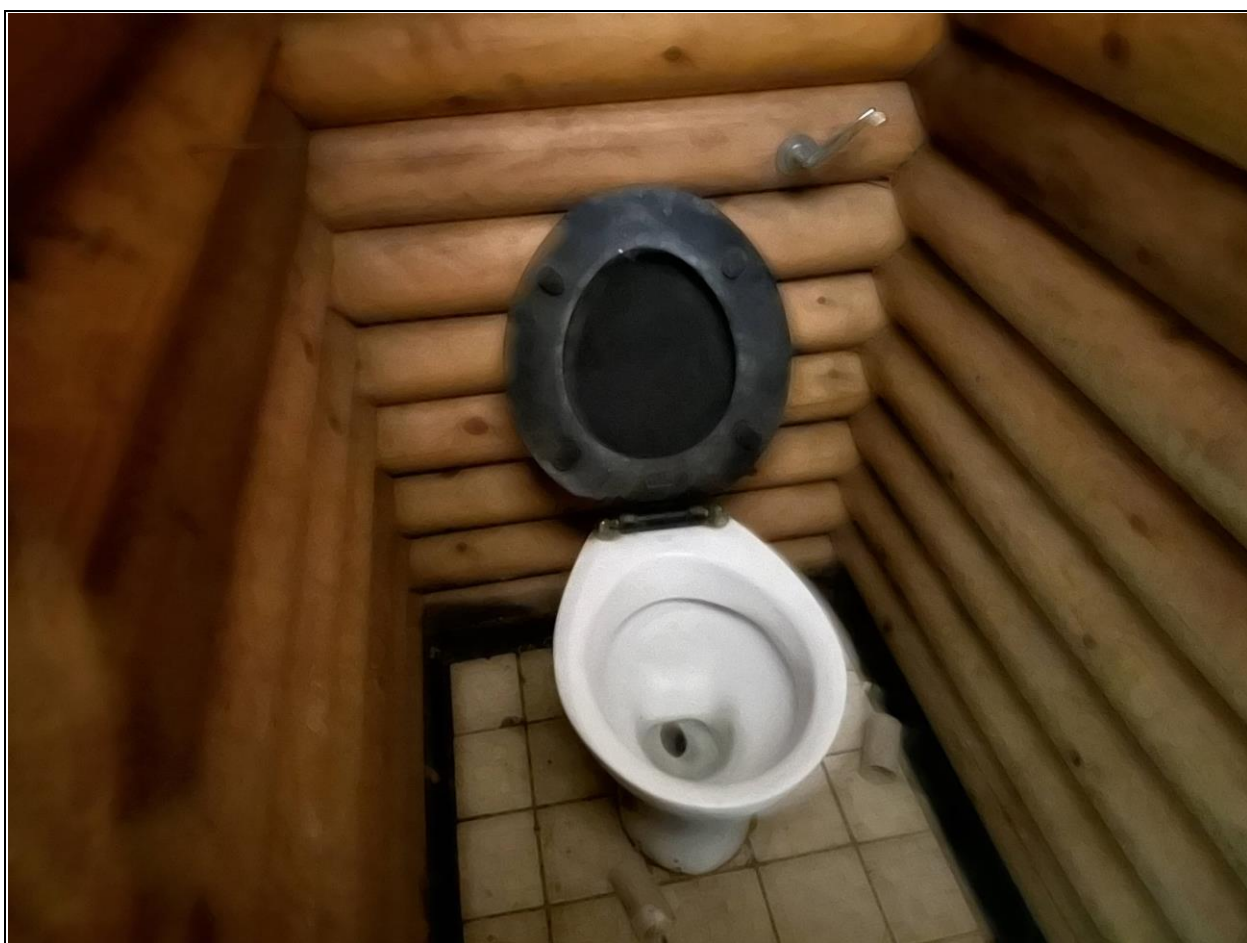
| <b>Sample Ref:</b> | As SC/003 | |

| <b>Area:</b> | G/011/Room | |
| <b>Element:</b> | Toilet | |
| <b>Sample description:</b> | Composite toilet seat | |
| <b>Asbestos Type:</b> | No asbestiforms detected | -- |

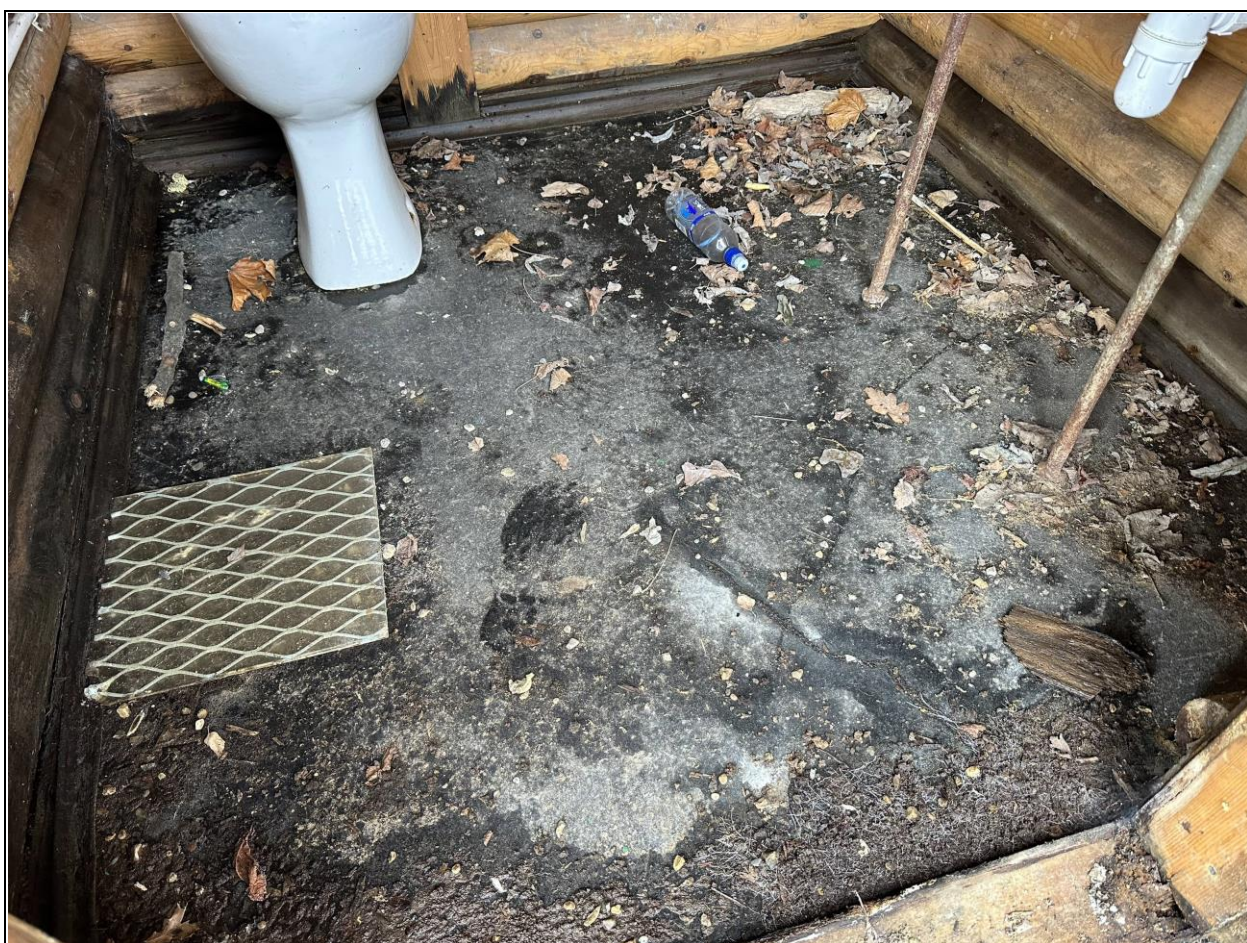
| <b>Sample Ref:</b> | SC/005 | |

| <b>Area:</b> | G/012/Room | |
| <b>Element:</b> | Floor | |
| <b>Sample description:</b> | Composite/asphalt flooring | |
| <b>Asbestos Type:</b> | No asbestiforms detected | -- |
