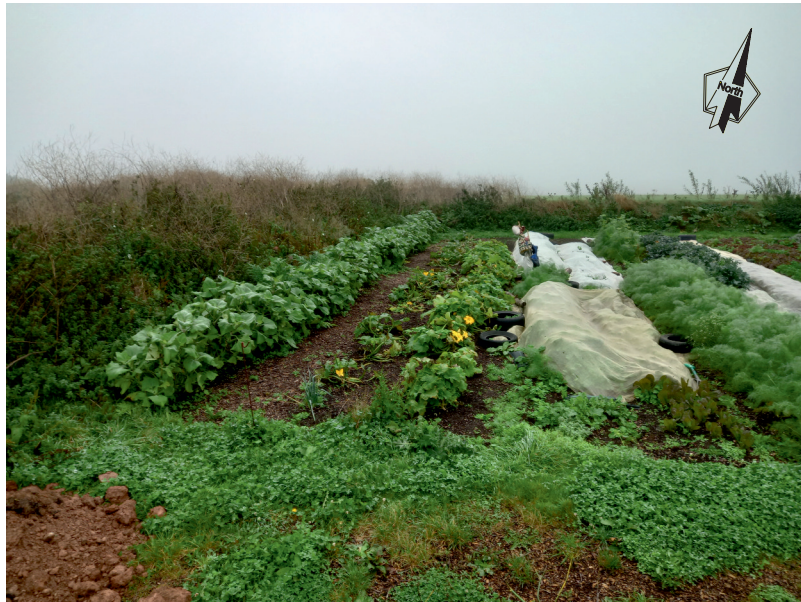
Photograph 1. General view of site, of proposed new barn looking north-eastwards.

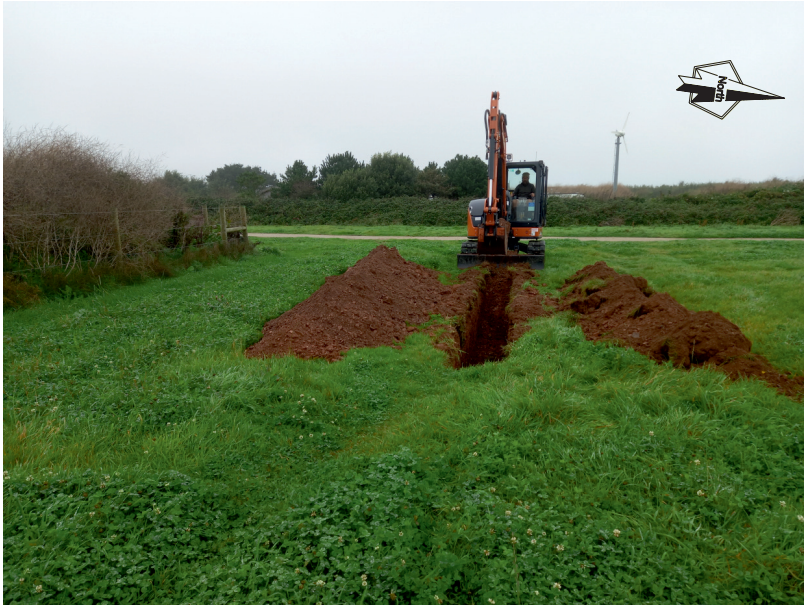
Photograph 2. Trench 1 excavated in fallow field to north of proposed new barn location.

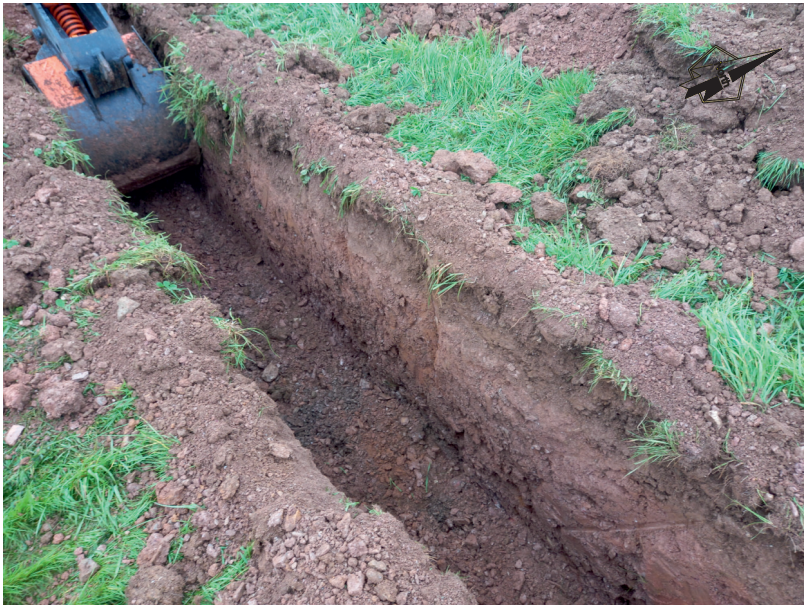
Photograph 3. Detail of horizons of weathered fractured, in-situ, undisturbed, unmineralised sedimentary bedrock, overlain by soils. exposed in Trench 1.

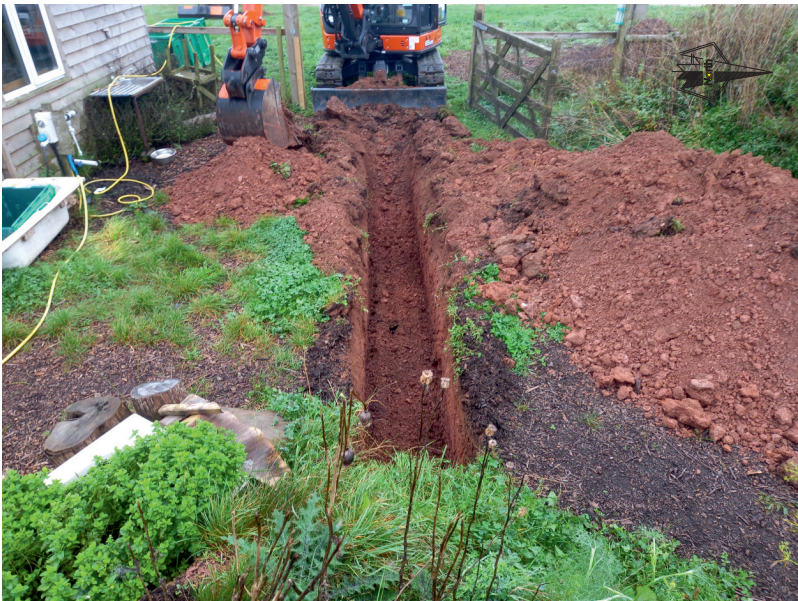
Photograph 4 Trench 2 excavated from inside of the garden area to the south of the proposed new barn .

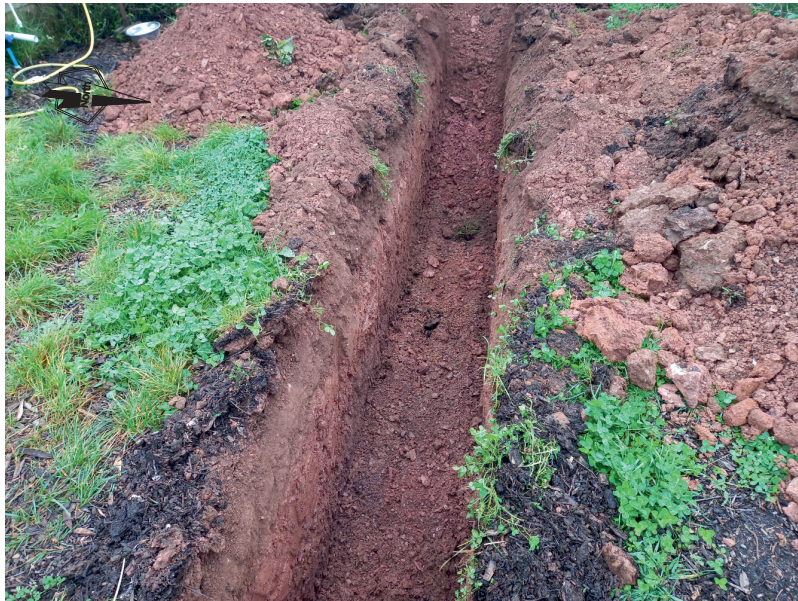
Photograph 5. Detail of intact, undisturbed horizons of soil and stony clays underlain by fractured weathered bedrock in Trench 2.

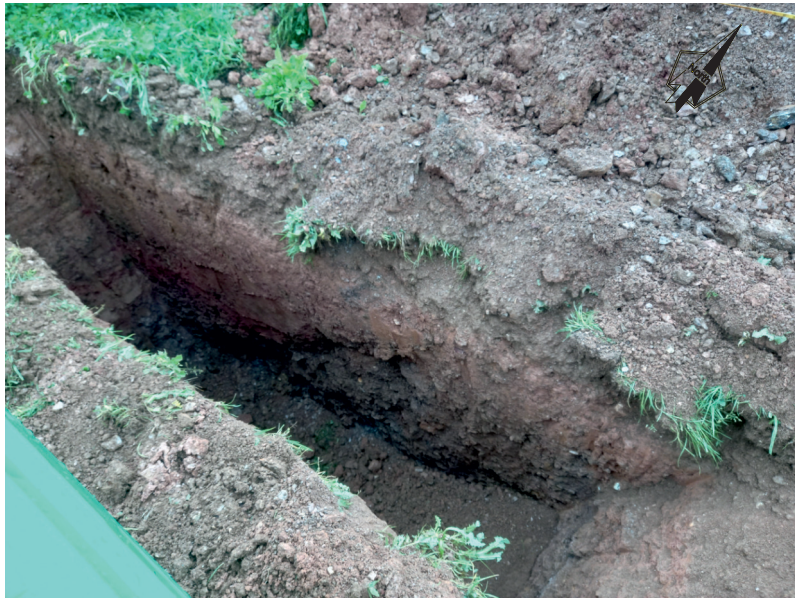
Photograph 6. Pit excavated for percolation testing, showing undisturbed fractured, weathered sedimentary bedrock, overlain by stony red clay and soil.
