# Pitch & Putt Building

Refurbishment and Demolition Survey

Asbestos Report – Copy 1

**Project No:** J1581

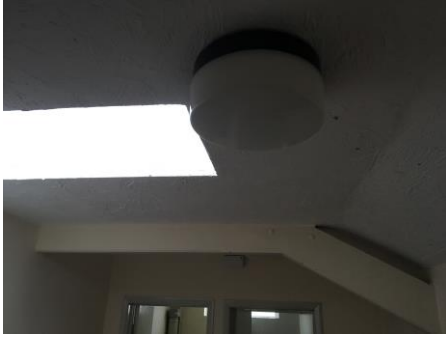
Floor	Location	Sample Number	Item Description	Photograph
Ground	Ladies WC	002	Textured coating to ceiling

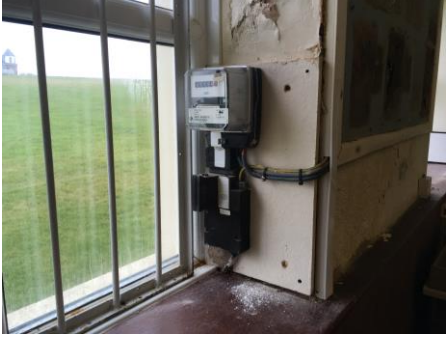
Floor	Location	Comments	Photograph
Ground	Shop	No access into live electrical switchgear

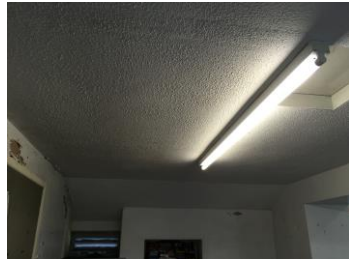
Sample No.	Location	Item Description	Item Extent	Analysis	Material Assessment				Priority Assessment				Risk Assessment Score	Comments and Recommendation	Photograph
					Product Type	Condition	Treatment	Asbestos Type	Occupancy	Likelihood of Disturbance	Human Exposure Potential	Maintenance Activity			
001	Shop (club storage area)	Textured coating to ceiling	18m2	Chrysotile	1	0	0	1	1	1	1	0	5	Coating extends to entrance lobby. Remove by an approved contractor under controlled conditions.

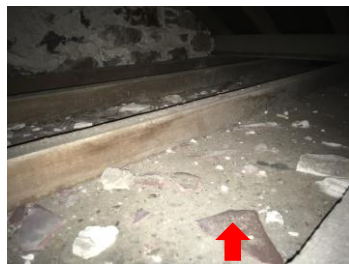
Access to the loft can be made in three locations – above the Club storage area asbestos roof tile debris has been identified on top of the ceiling.

X003	Loft above club storage areas	Roof Tile Debris	2m2	Chrysotile	1	1	1	1	0	0	0	0	4	Remove by an approved contractor under controlled conditions.

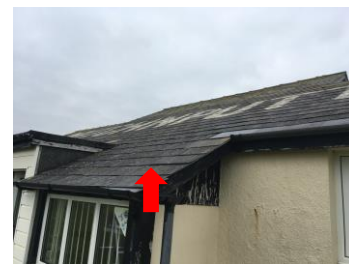
Externally asbestos roof tiles have been identified to the pitched roof.

Sample No.	Location	Item Description	Item Extent	Analysis	Material Assessment				Priority Assessment				Risk Assessment Score	Comments and Recommendation	Photograph
					Product Type	Condition	Treatment	Asbestos Type	Occupancy	Likelihood of Disturbance	Human Exposure Potential	Maintenance Activity			
003	Roof	Roof Tiles	Through-out	Chrysotile	1	1	1	1	0	1	0	0	5	Remove by an approved contractor under controlled conditions.

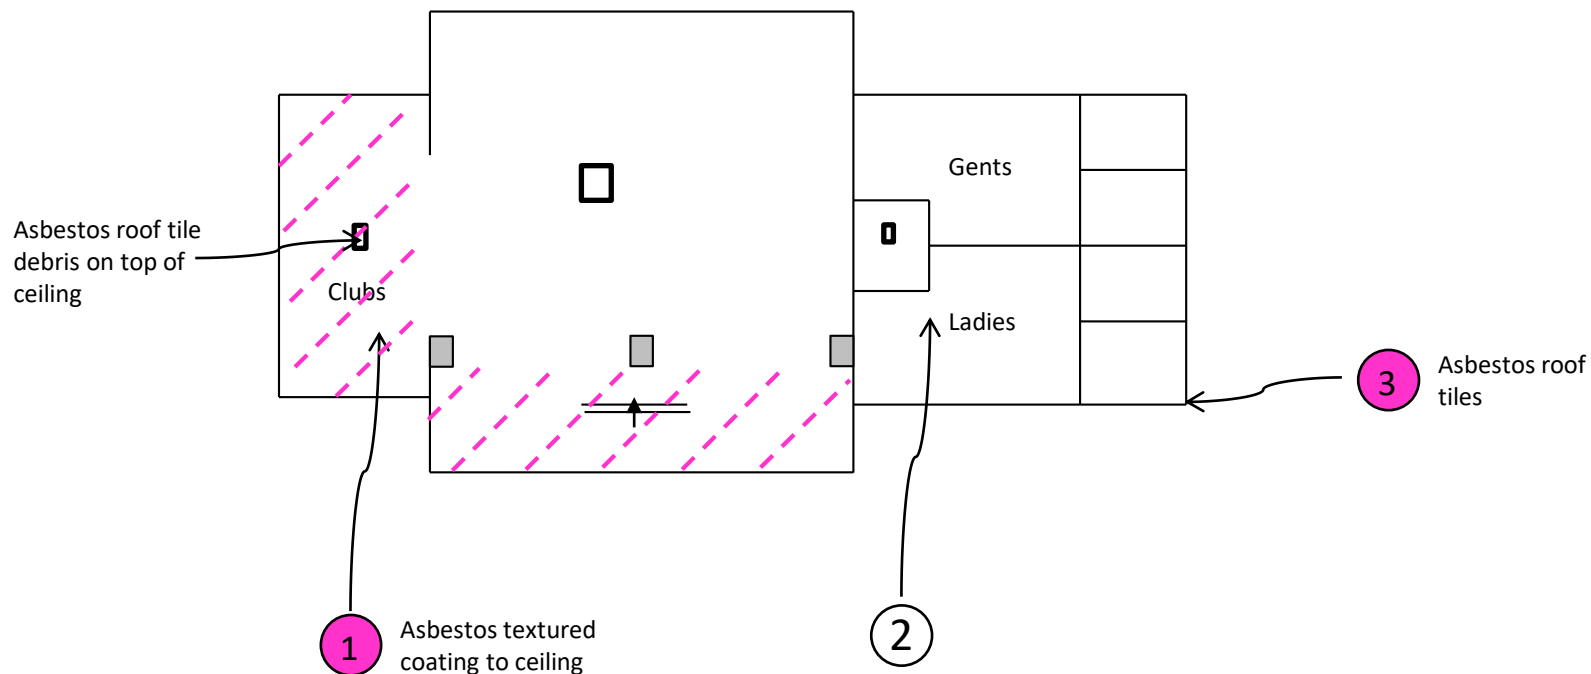
Site	Bude – Pitch & Putt
Floor	Ground
Page	1 of 1
Asbestos	
No access

Asbestos textured coating to ceiling
